UT to Barnes Creek Restoration Plan Montgomery County, North Carolina

Prepared For North Carolina Department of Environment and Natural Resources
Ecosystem Enhancement Program

Design Report Prepared By Buck Engineering PC

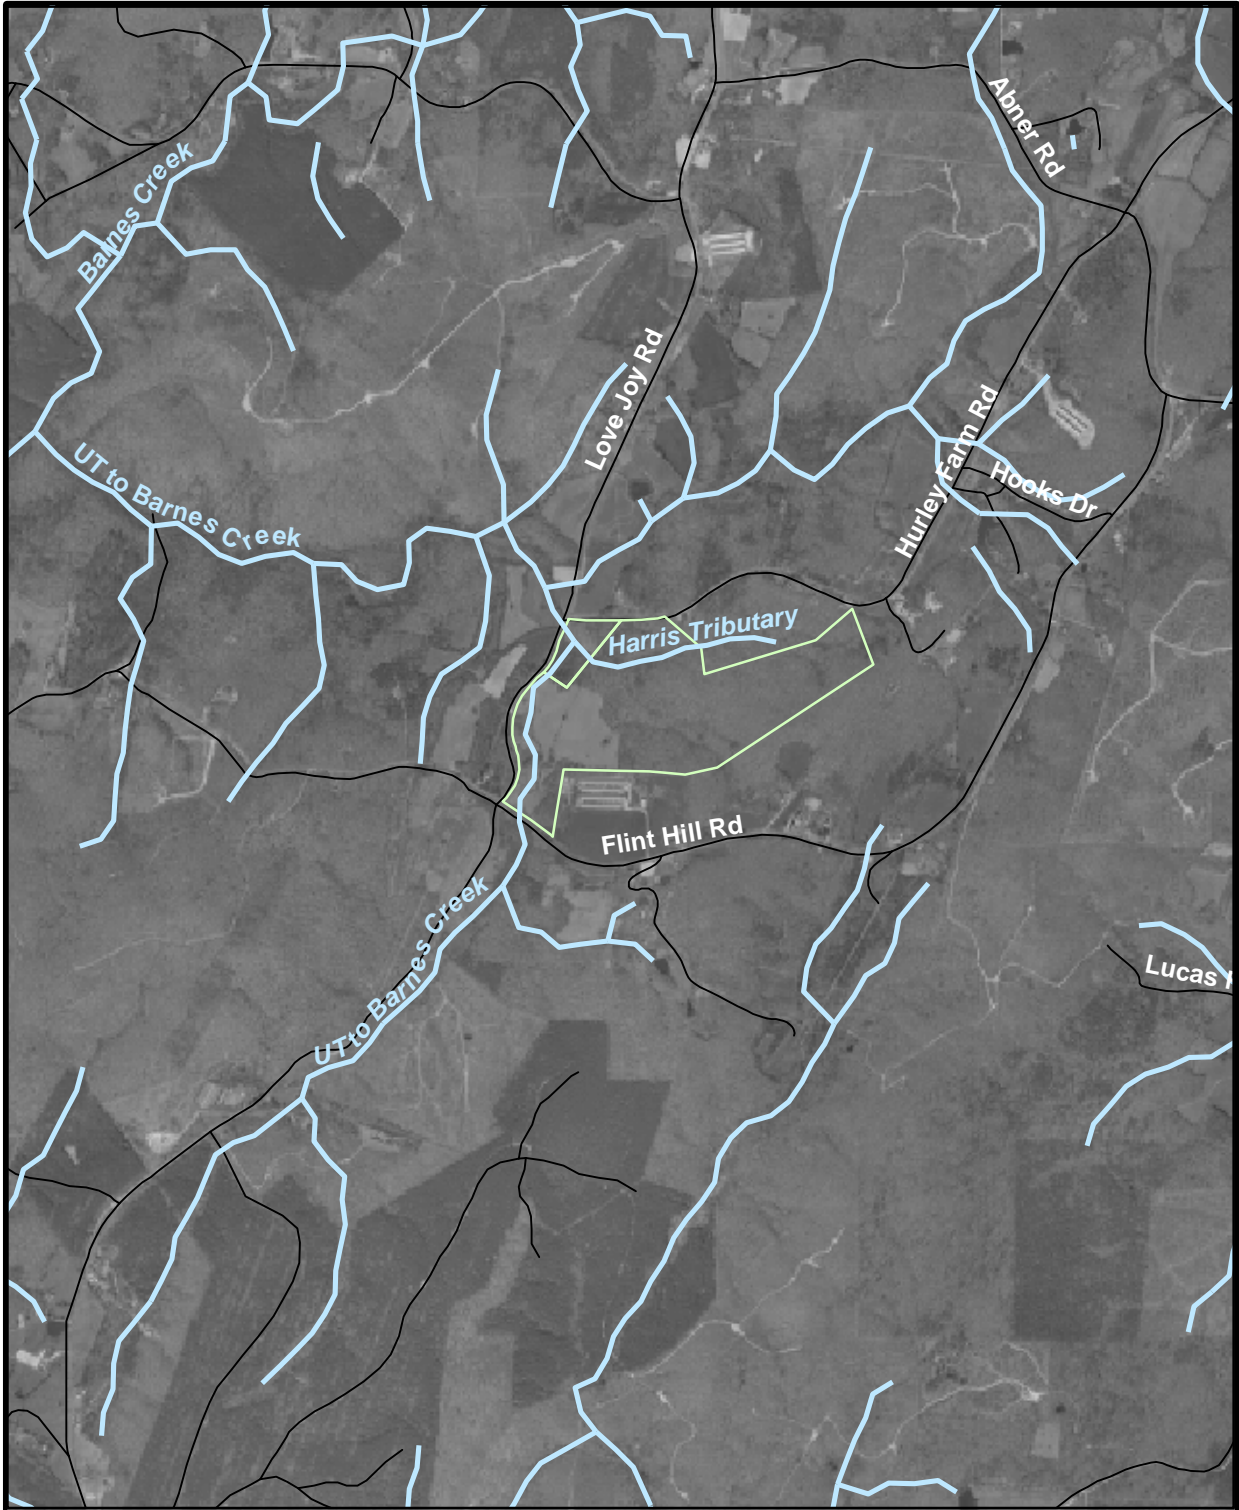
Figure 1.1: Site Location Map

- Parcels
- Existing Stream
- Streets

One distinct tributary discharges into the UT mainstem within the project site. Due to its entrance to the UT from what was originally the Harris property, it is denoted as the Harris Tributary. The tributary is shown in Figure 1.1, 1.2, and 1.3. The watershed size is detailed in Table 4.3.

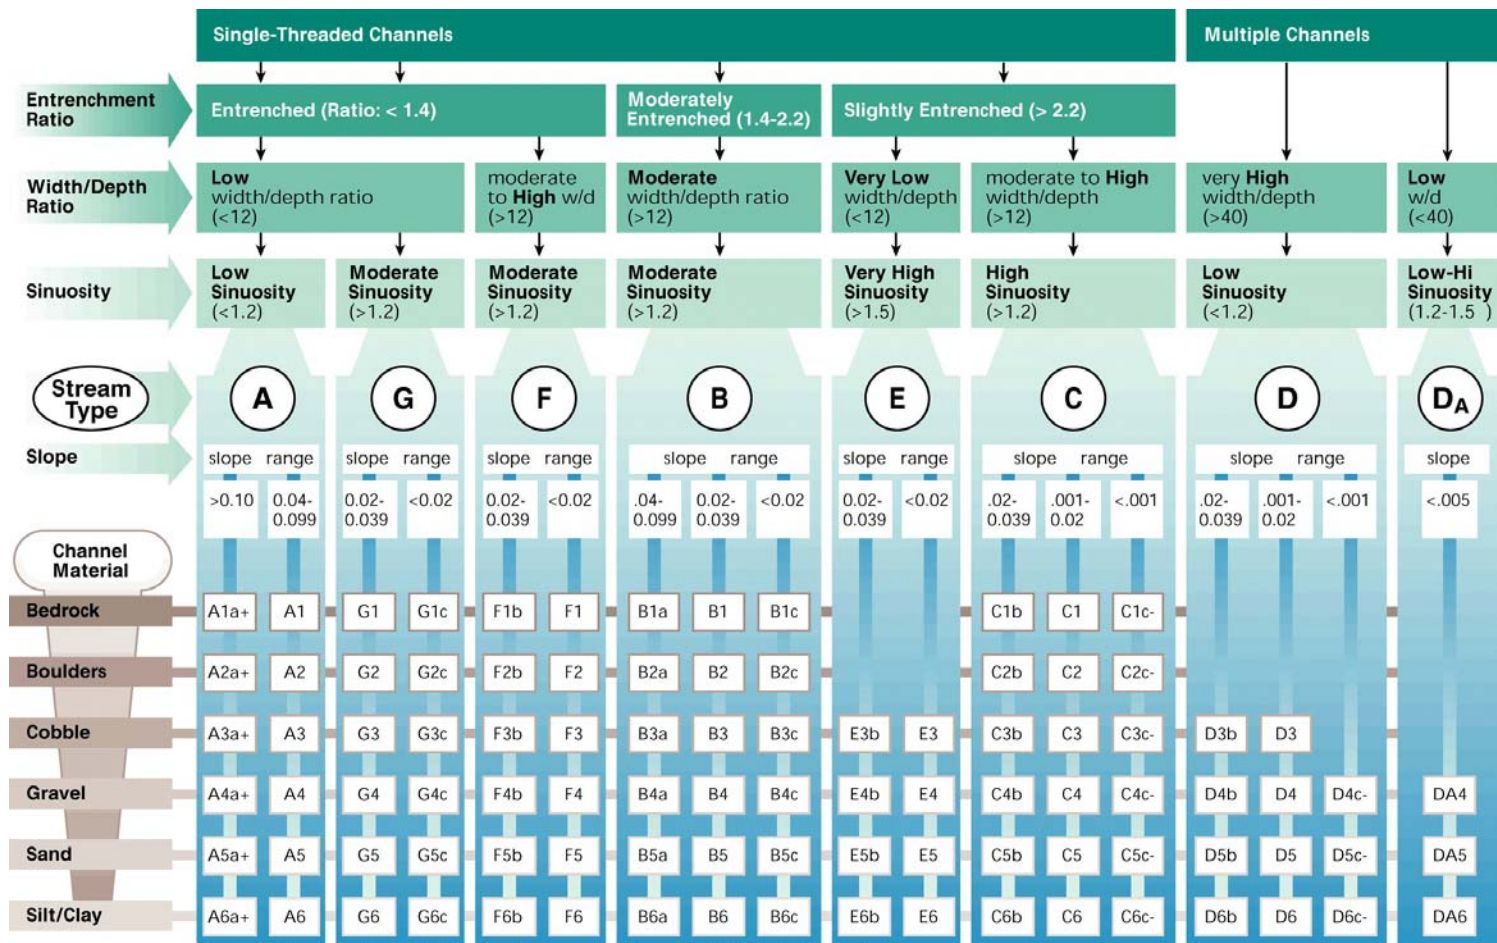
Figure 2.1
 Rosgen Stream Classification
 UT to Barnes Creek Restoration Plan

Fig. 7.12 – Rosgen's stream classification system (Level II).
 In Stream Corridor Restoration: Principles, Processes, and Practices, 10/98.
 Interagency Stream Restoration Working Group (FISRWG)(15 Federal agencies of the US).

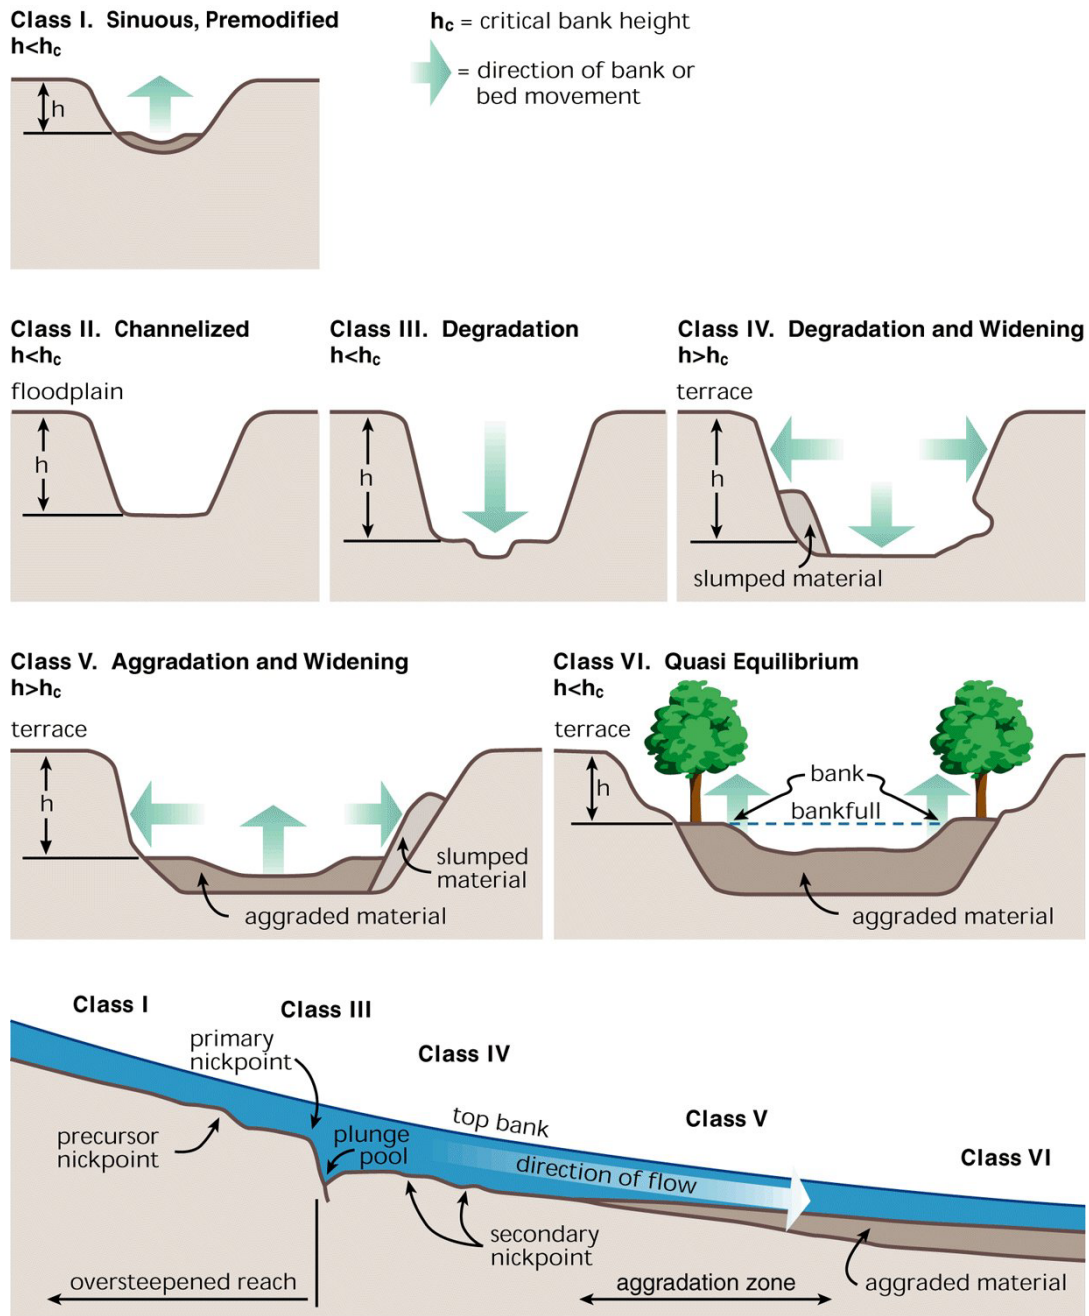
Figure 2.3
 Simon Channel Evolution Model
 UT to Barnes Creek Restoration Plan

Source: Simon, 1989; US Army Corps of Engineers, 1990.
 Fig. 7.14 -- Channel evolution model.
 In Stream Corridor Restoration: Principles, Processes, and Practices, 10/98.
 Interagency Stream Restoration Working Group (FISRWG)(15 Federal agencies of the US).

Figure 2.3 illustrates the six steps of the Simon channel evolution model.

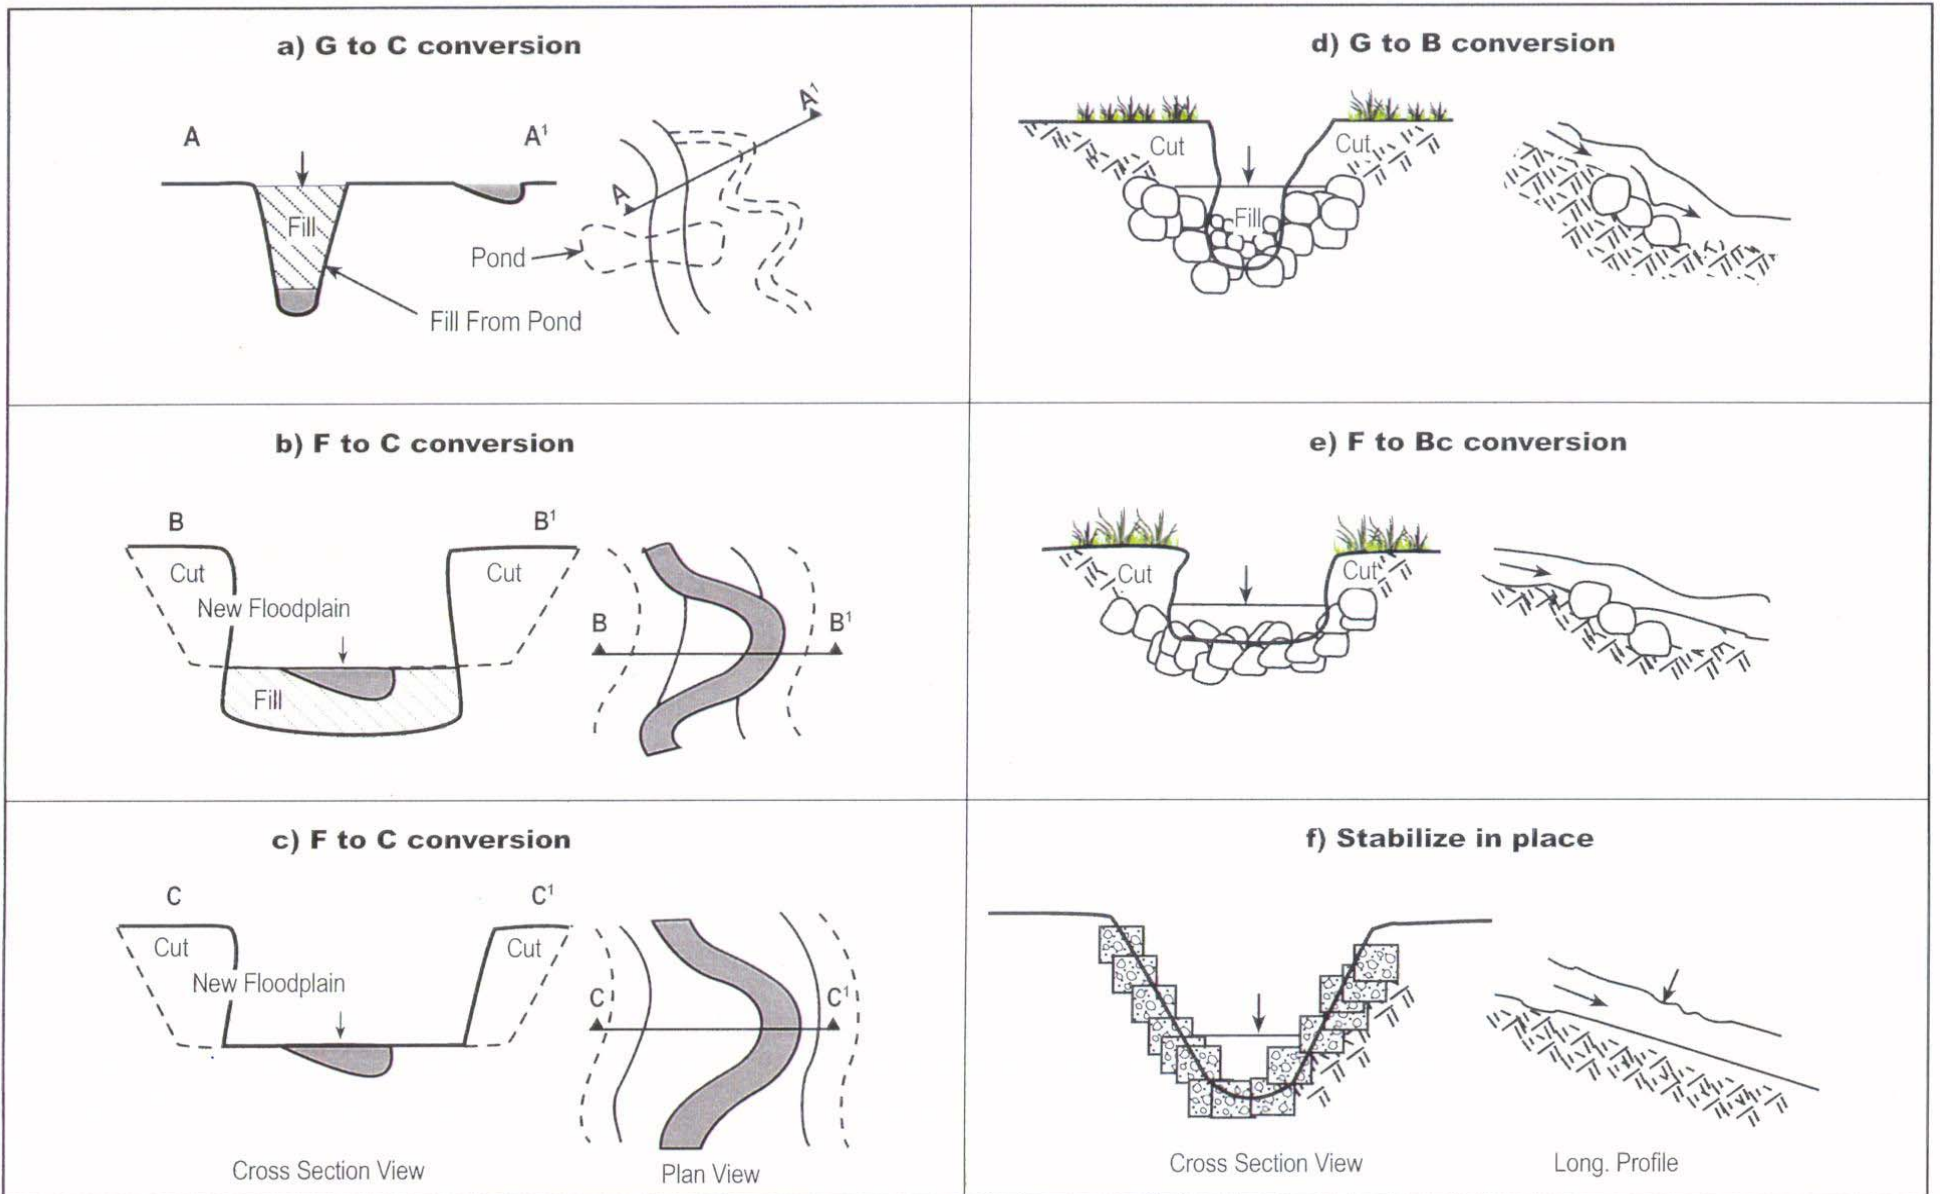
Figure 2.4
 Restoration Priorities for Incised Channels
 UT to Barnes Creek Restoration Plan

Source: Rosgen, David L., "A Geomorphological Approach to Restoration of Incised Rivers," *Proceedings of the Conference on Management of Landscapes Disturbed by Channel Incision*, 1997

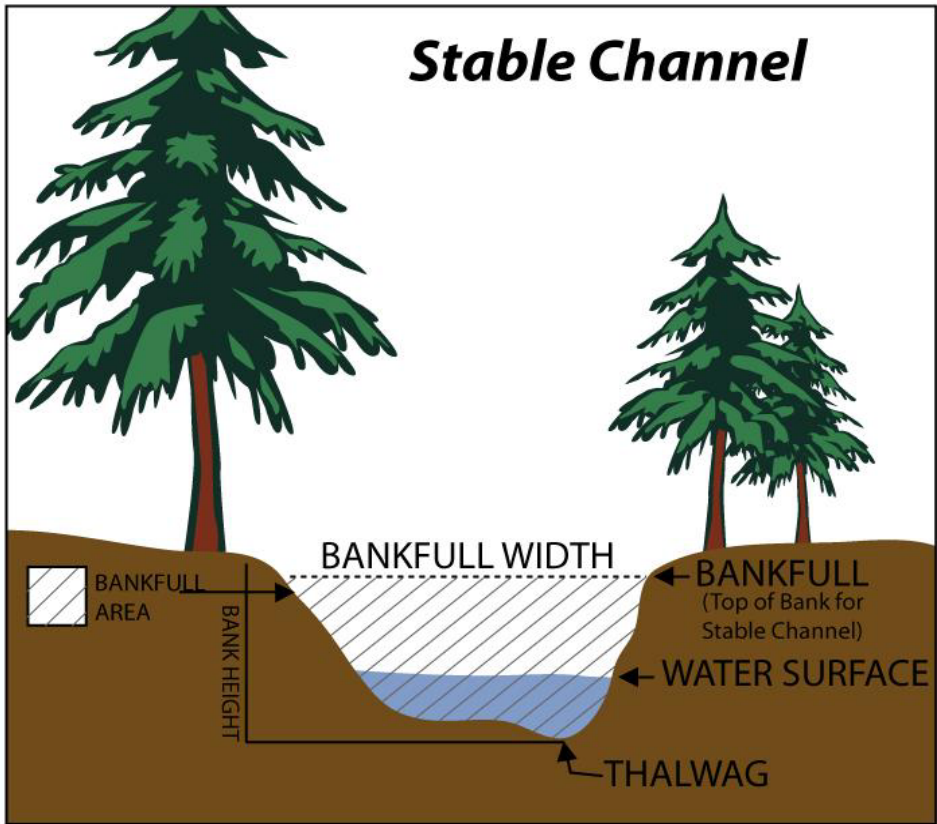
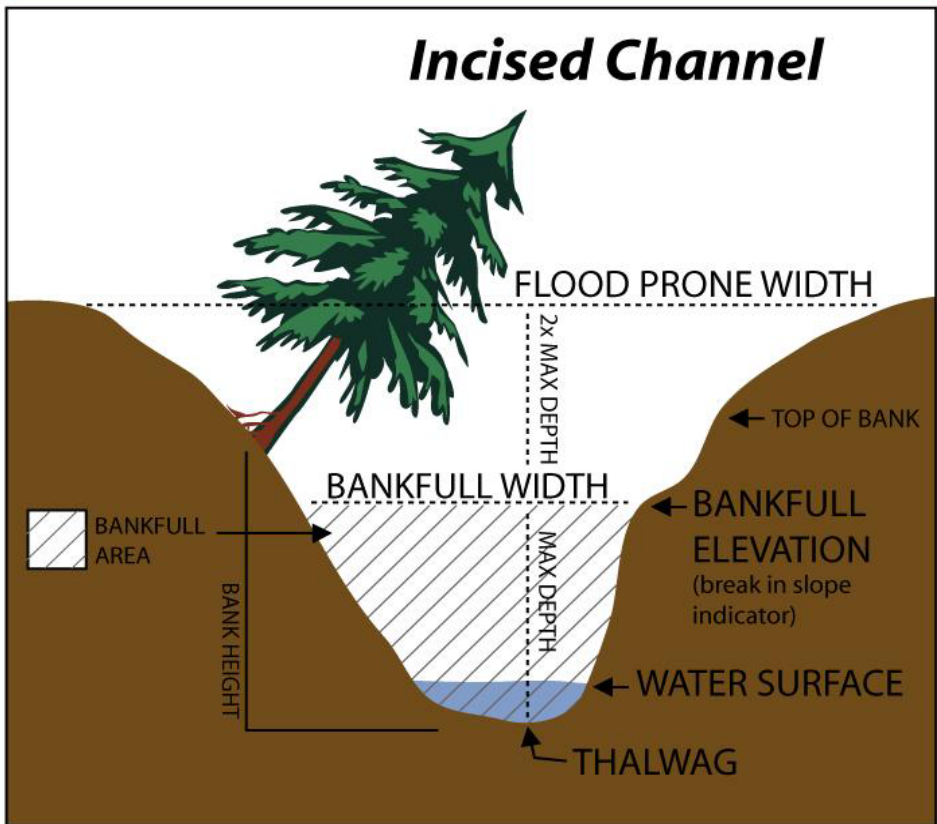
Figure 2.5
Channel Dimension Measurements
UT to Barnes Creek Restoration Plan

Channel Dimension Measurements

Bankfull Elevation is associated with the channel forming discharge. It is the point where channel processes and flood plain processes begin.

Entrenchment Ratio: Floodprone width ÷ bankfull width

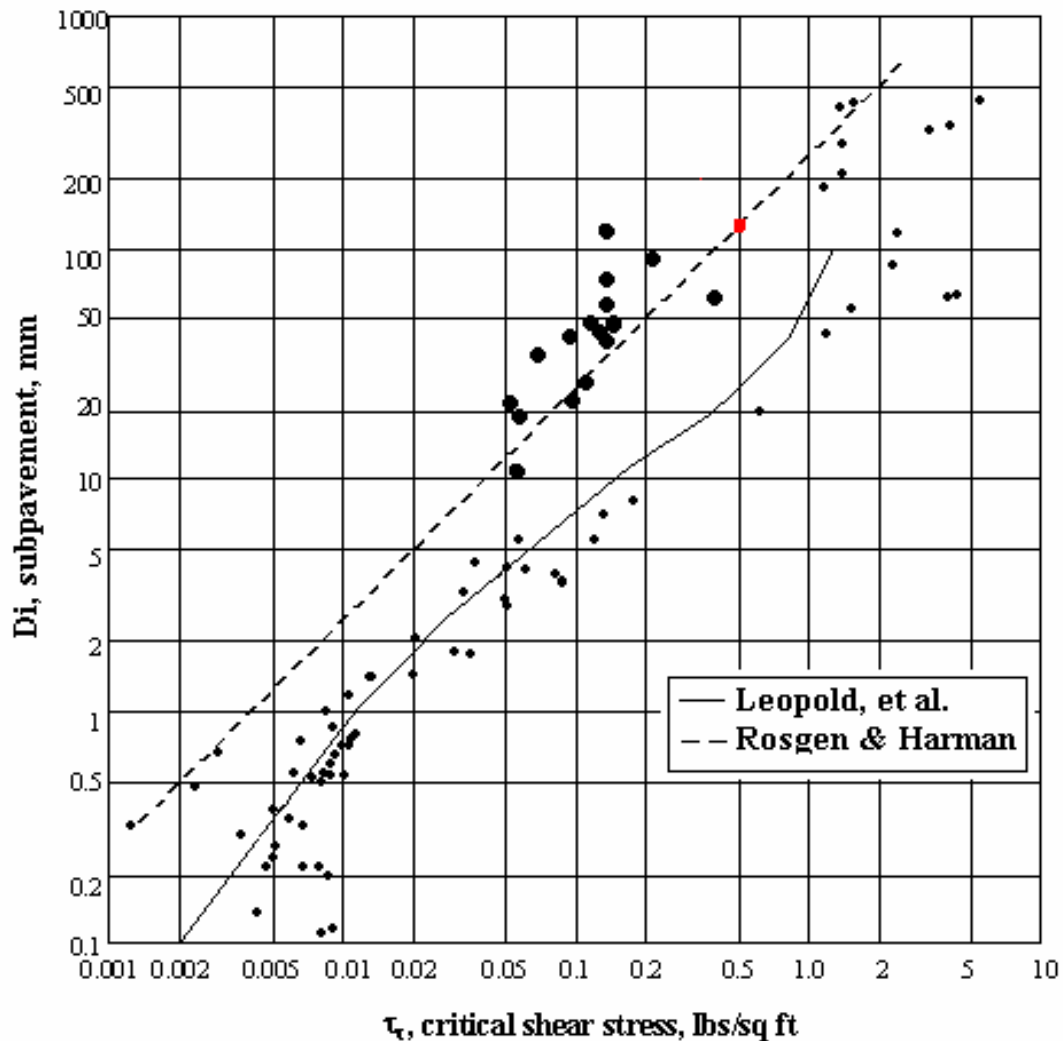
Figure 2.7
Shields Curve
UT to Barnes Creek Restoration Plan

(Data from: Leopold, Wolman, and Miller 1964; Rosgen, personal commun.; and Harman, personal commun.)

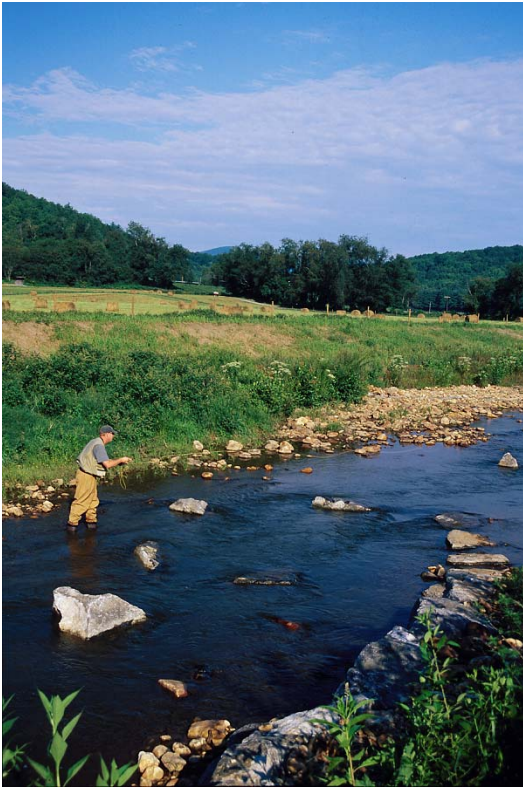
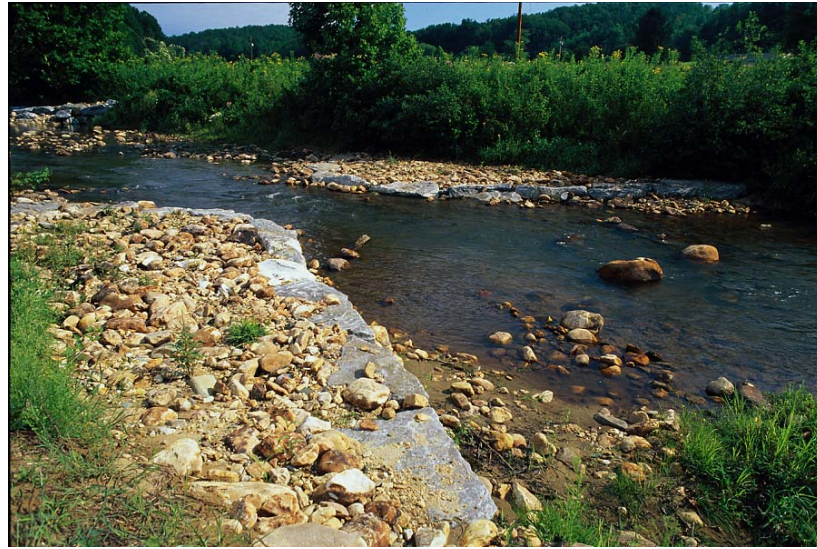
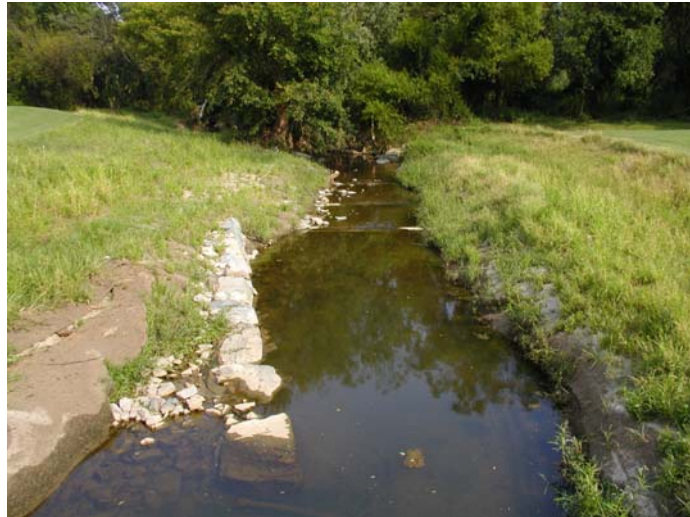
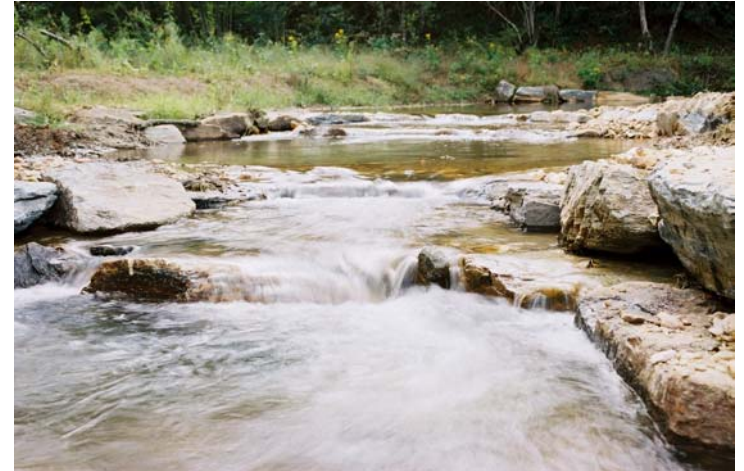
Figure 2.8
Examples of In-Stream Structures
UT to Barnes Creek Restoration Plan

J-Hook

Double Wing Deflector

Rock Vane

Double Drop Rock Cross Vane

There are a variety of in-stream structural elements used in restoration. Figure 2.8 illustrates a few typical structures. These elements are comprised of natural materials such as stone, wood, and live vegetation. Their shape and location works with the flow dynamics to reinforce, stabilize, and enhance the function of the stream channel. In-stream structures provide three primary functions: grade control, stream bank protection, and habitat enhancement.

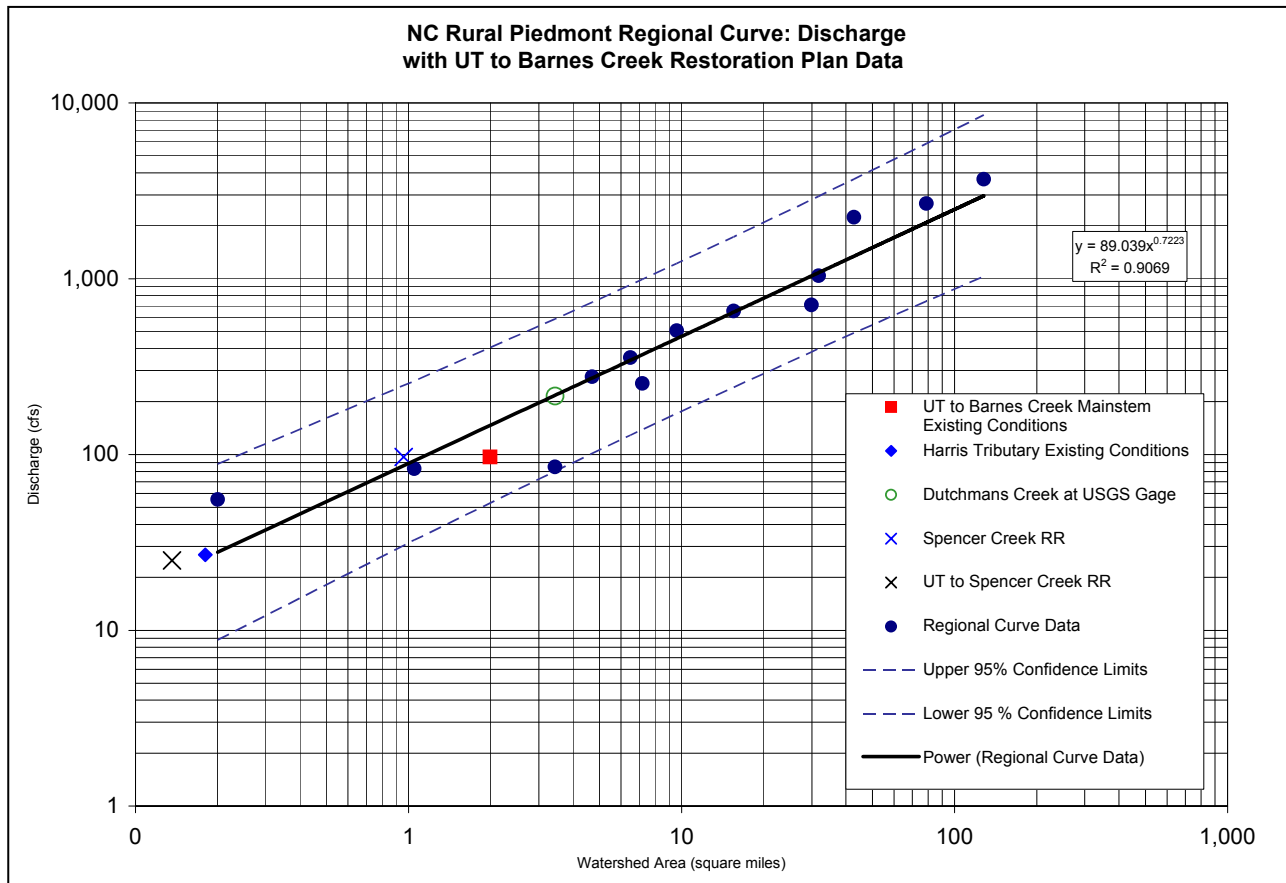
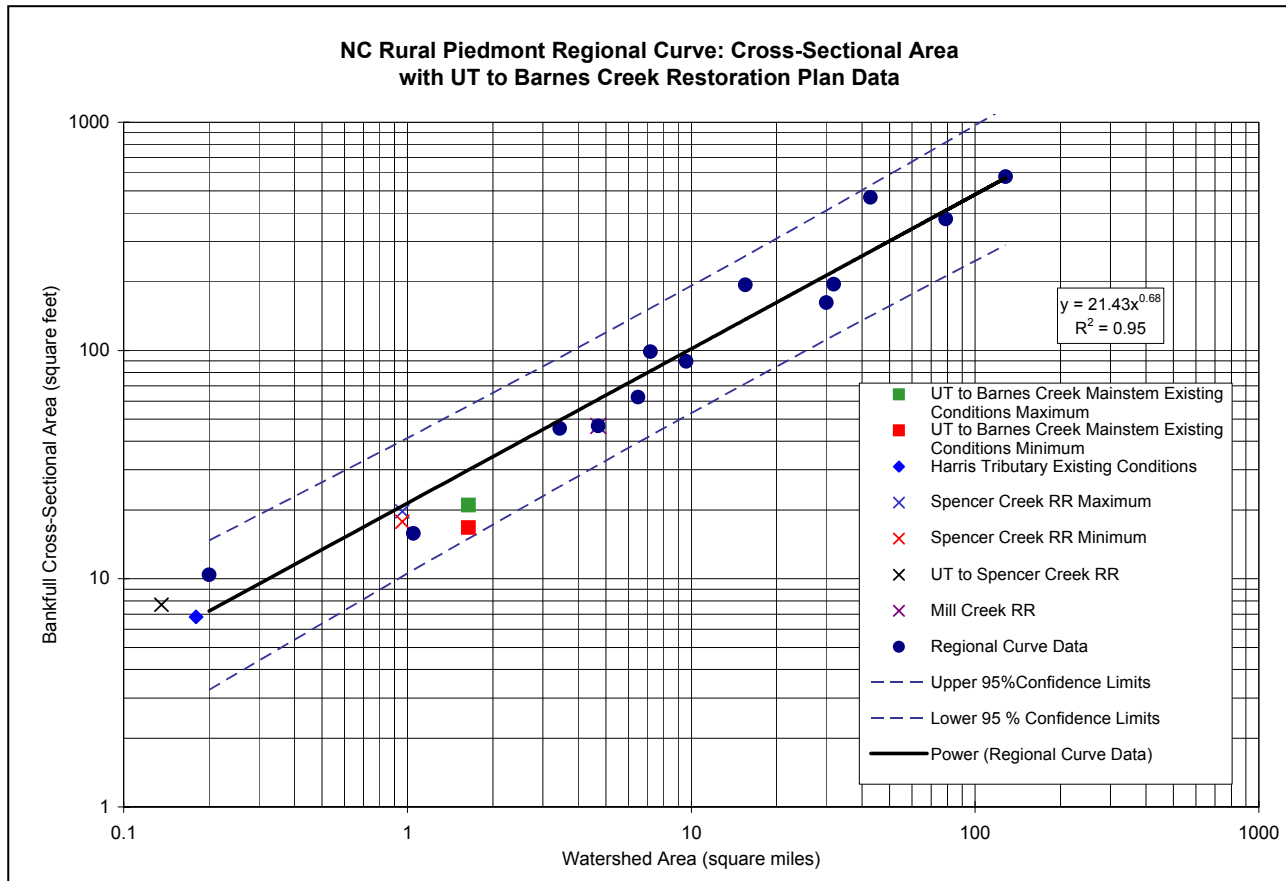
Figure 4.2
NC Piedmont Rural Regional Curve with Bankfull Discharge For Project Reaches and Reference Cross-Sections
UT to Barnes Creek Restoration Plan

Note: Project data were not considered in regional curve development.

Harris tributary, and the reference reaches. As shown in Figure 4.2, all of the values fall within the 95% confidence limits of the rural Piedmont regional curve.

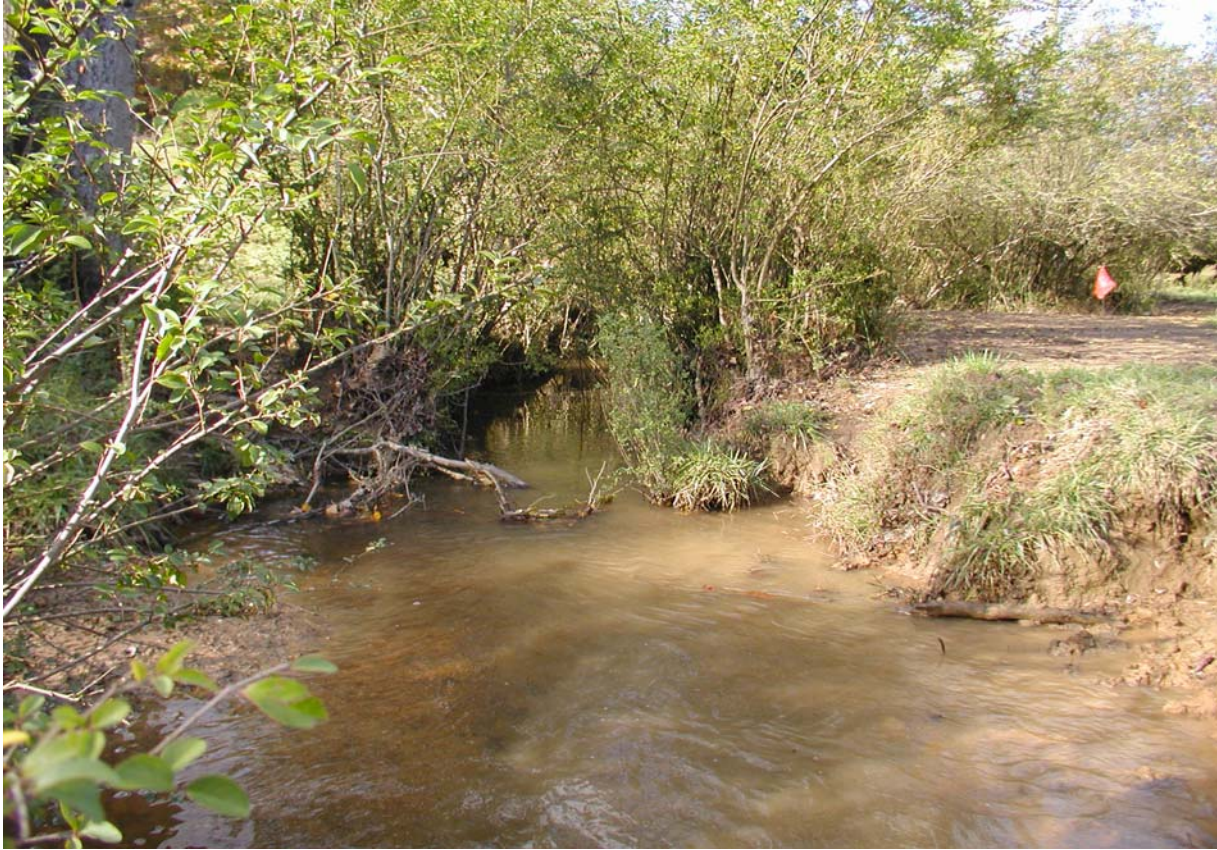
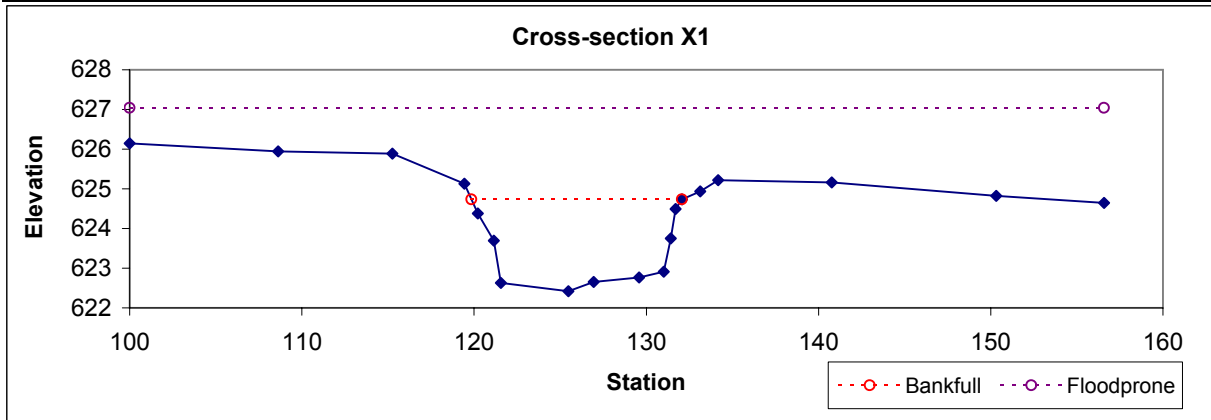
Cross-section Data:

| Feature | Stream Type | BKF Area | BKF Width | BKF Depth | Max BKF Depth | W/D | BH Ratio | ER | BKF Elev | TOB Elev |
| Riffle | E | 21 | 12.23 | 1.72 | 2.31 | 7.12 | 1 | 4.6 | 624.73 | 624.73 |

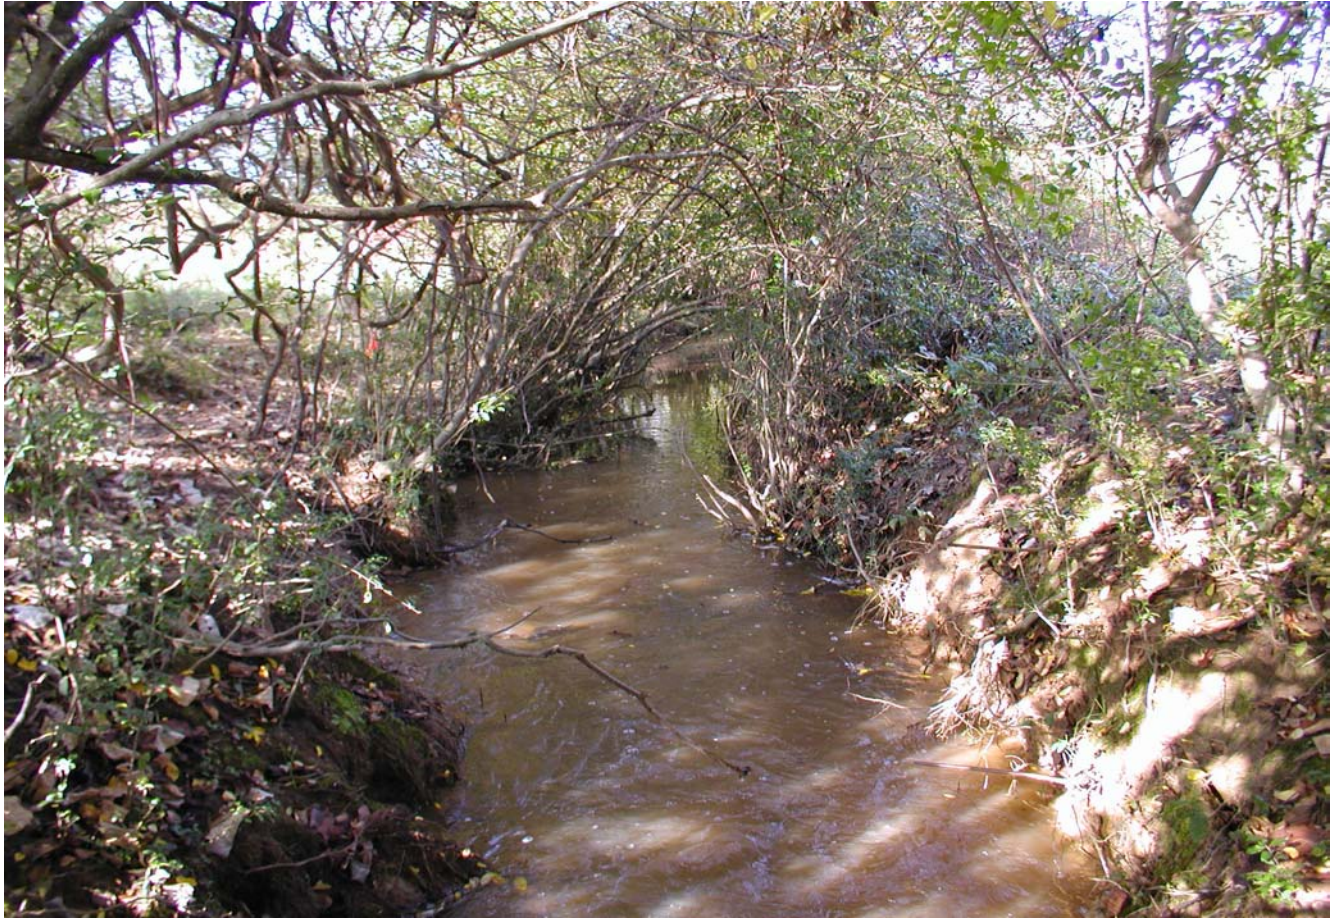
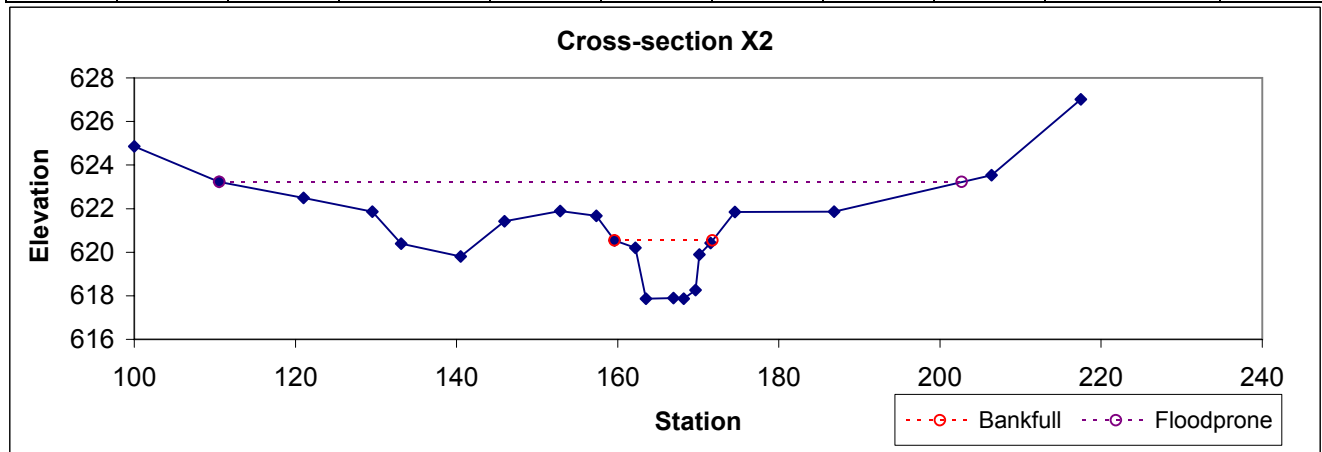
Cross-section Data:

| Feature | Stream Type | BKF Area | BKF Width | BKF Depth | Max BKF Depth | W/D | BH Ratio | ER | BKF Elev | TOB Elev |
| Riffle | E | 19.3 | 12.18 | 1.59 | 2.68 | 7.67 | 1.4 | 7.6 | 620.54 | 621.67 |

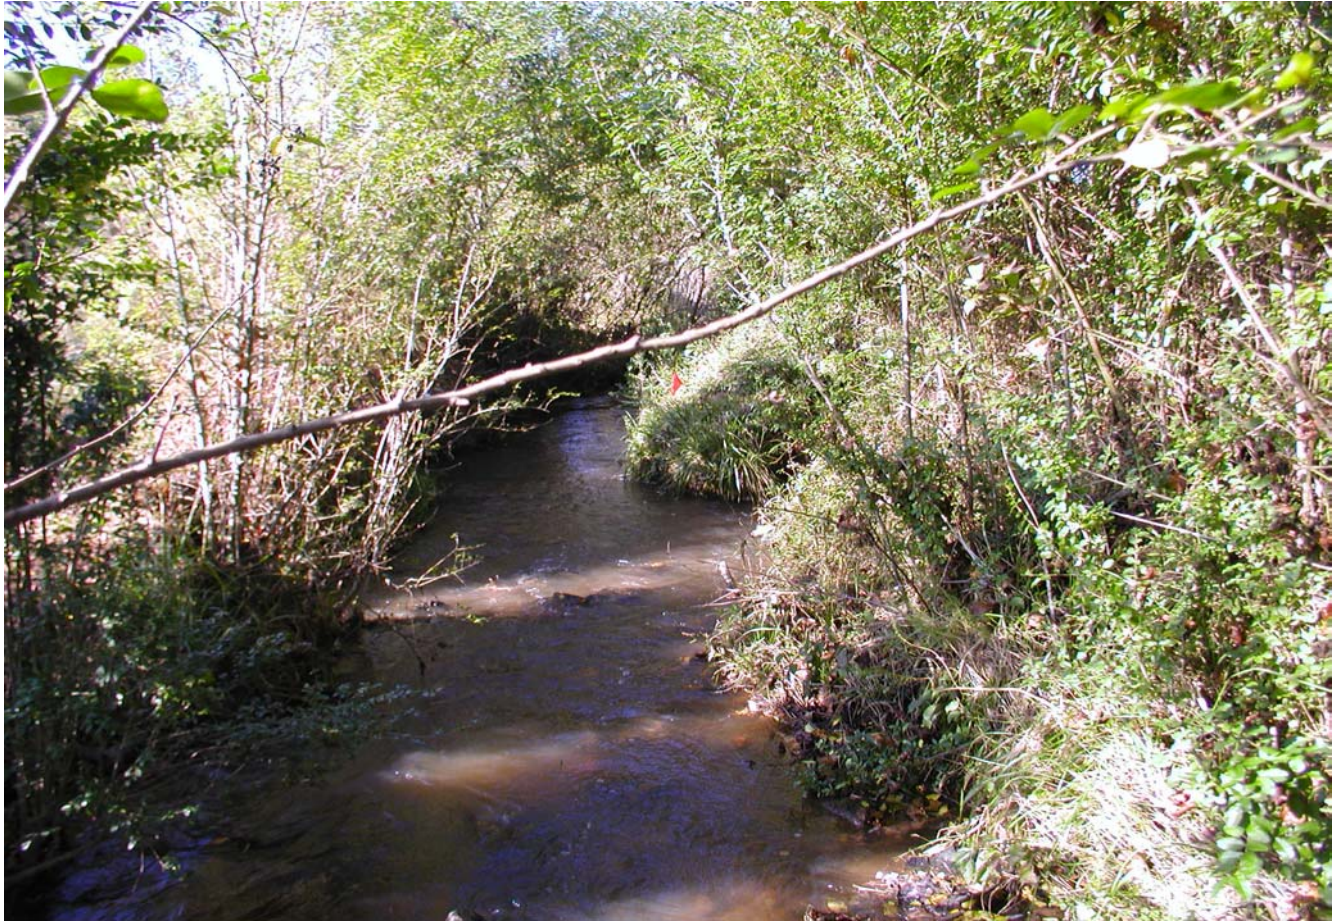
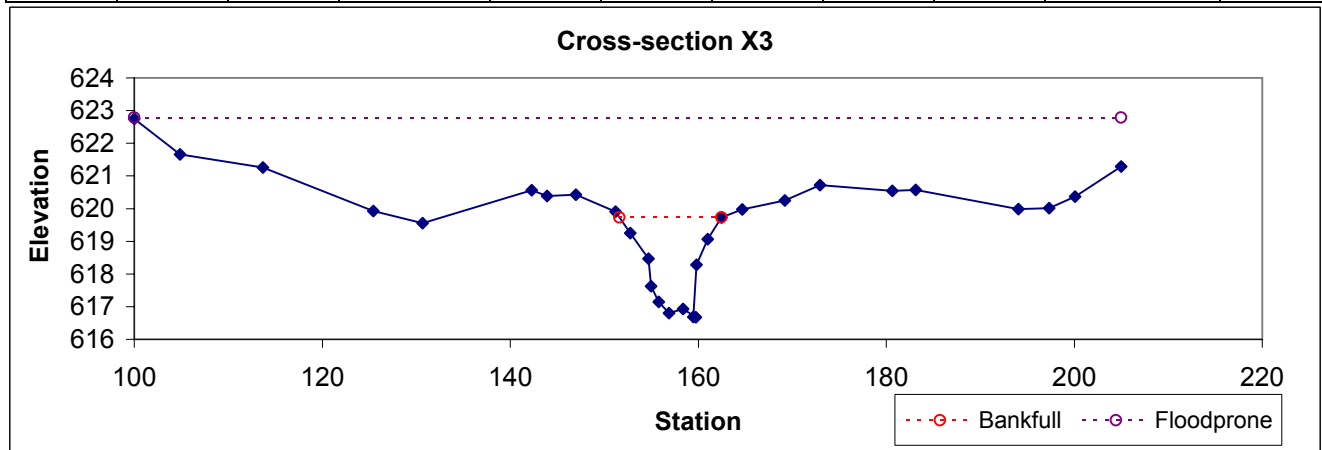
Cross-section Data:

| Feature | Stream Type | BKF Area | BKF Width | BKF Depth | Max BKF Depth | W/D | BH Ratio | ER | BKF Elev | TOB Elev |
| Riffle | E | 17.2 | 10.84 | 1.59 | 3.06 | 6.83 | 1 | 9.7 | 619.73 | 619.73 |

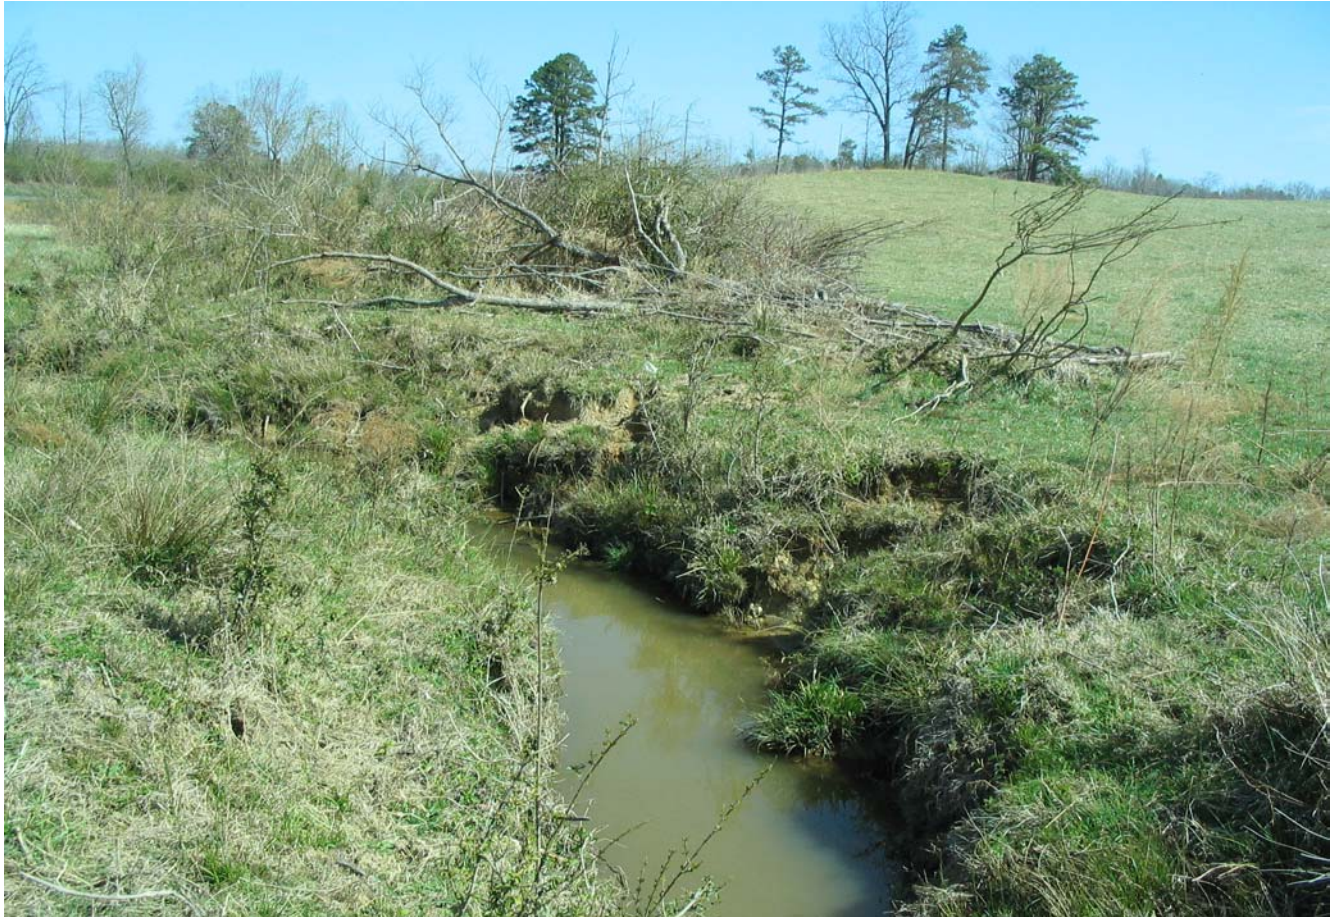
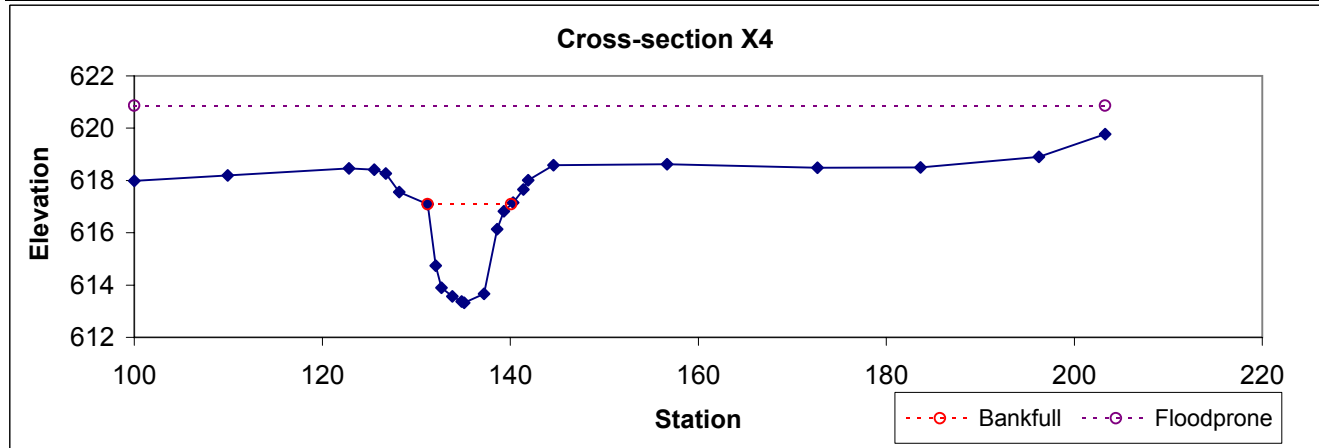
Cross-section Data:

| Feature | Stream Type | BKF Area | BKF Width | BKF Depth | Max BKF Depth | W/D | BH Ratio | ER | BKF Elev | TOB Elev |
| Pool | | 21.6 | 8.88 | 2.44 | 3.77 | 3.64 | 1.3 | 11.6 | 617.09 | 618.27 |
