UT to Barnes Creek Restoration Plan Montgomery County, North Carolina

Prepared For North Carolina Department of Environment and Natural Resources
Ecosystem Enhancement Program

Design Report Prepared By Buck Engineering PC

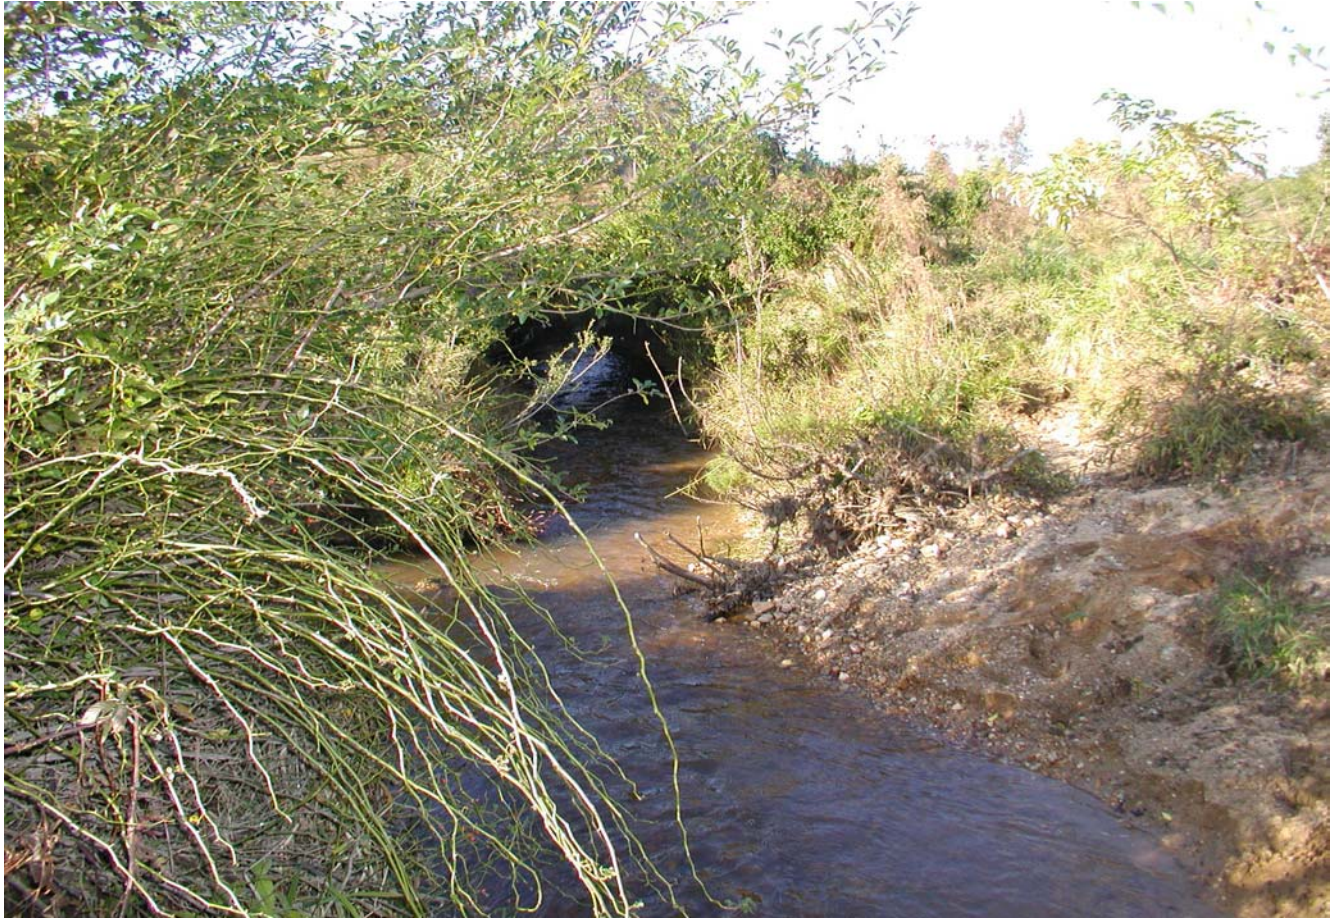
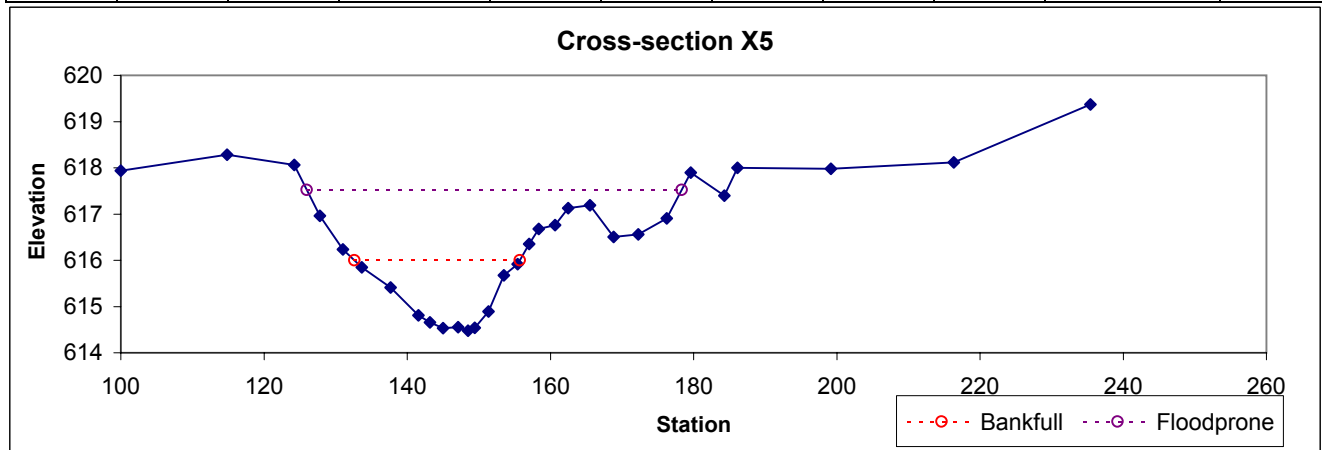
Cross-section Data:

| Feature | Stream Type | BKF Area | BKF Width | BKF Depth | Max BKF Depth | W/D | BH Ratio | ER | BKF Elev | TOB Elev |
| Riffle | C | 20.6 | 23.1 | 0.89 | 1.52 | 25.92 | 1.7 | 2.3 | 616 | 617.13 |

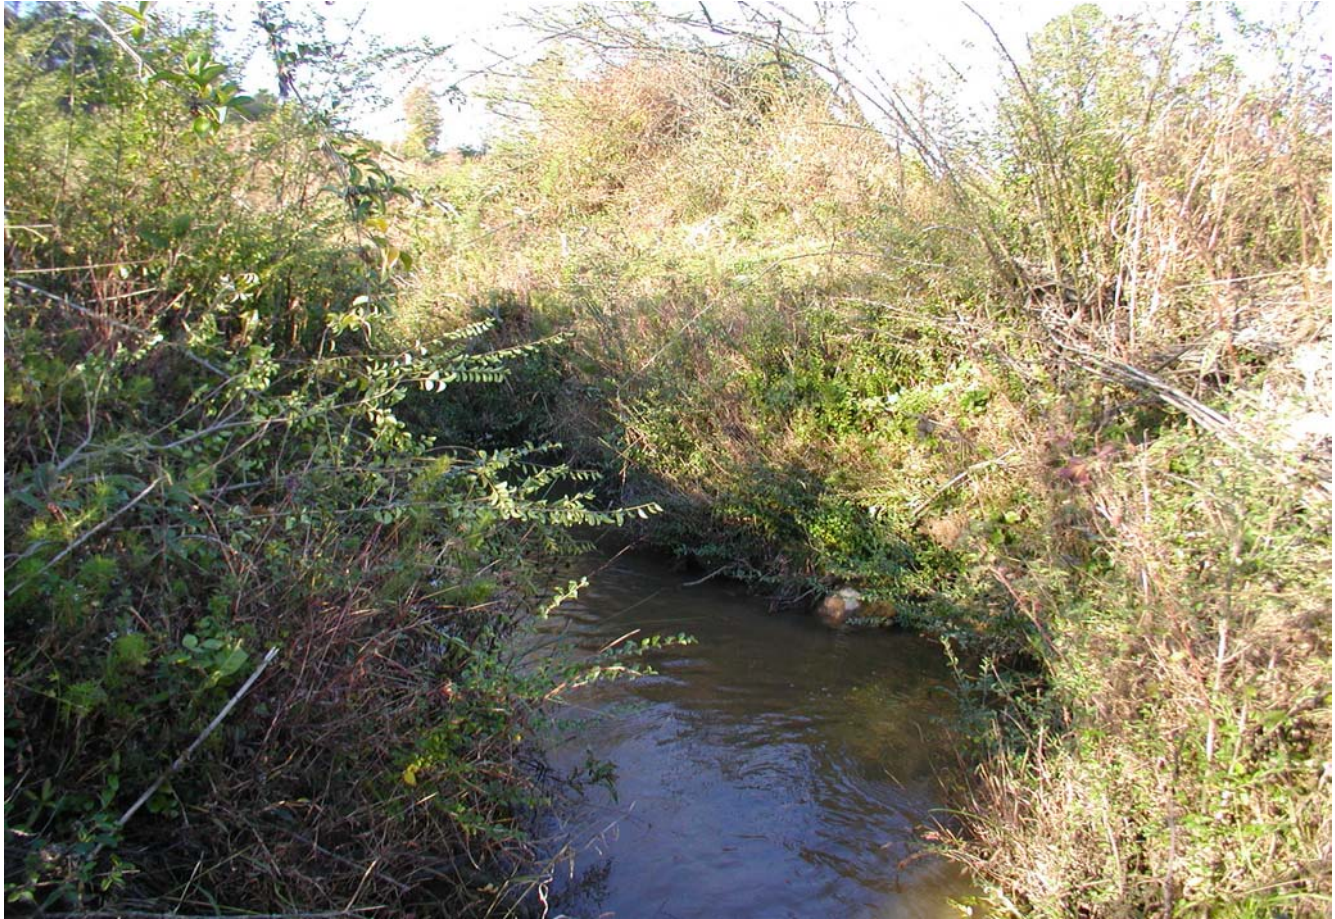
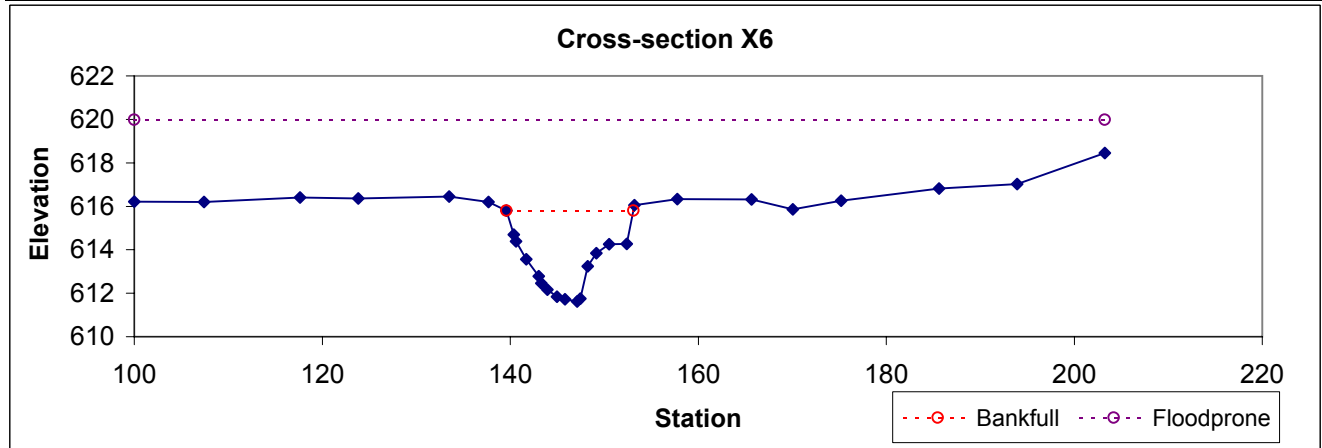
Cross-section Data:

| Feature | Stream Type | BKF Area | BKF Width | BKF Depth | Max BKF Depth | W/D | BH Ratio | ER | BKF Elev | TOB Elev |
| Pool | | 33.9 | 13.5 | 2.51 | 4.18 | 5.38 | 1 | 7.6 | 615.8 | 615.8 |

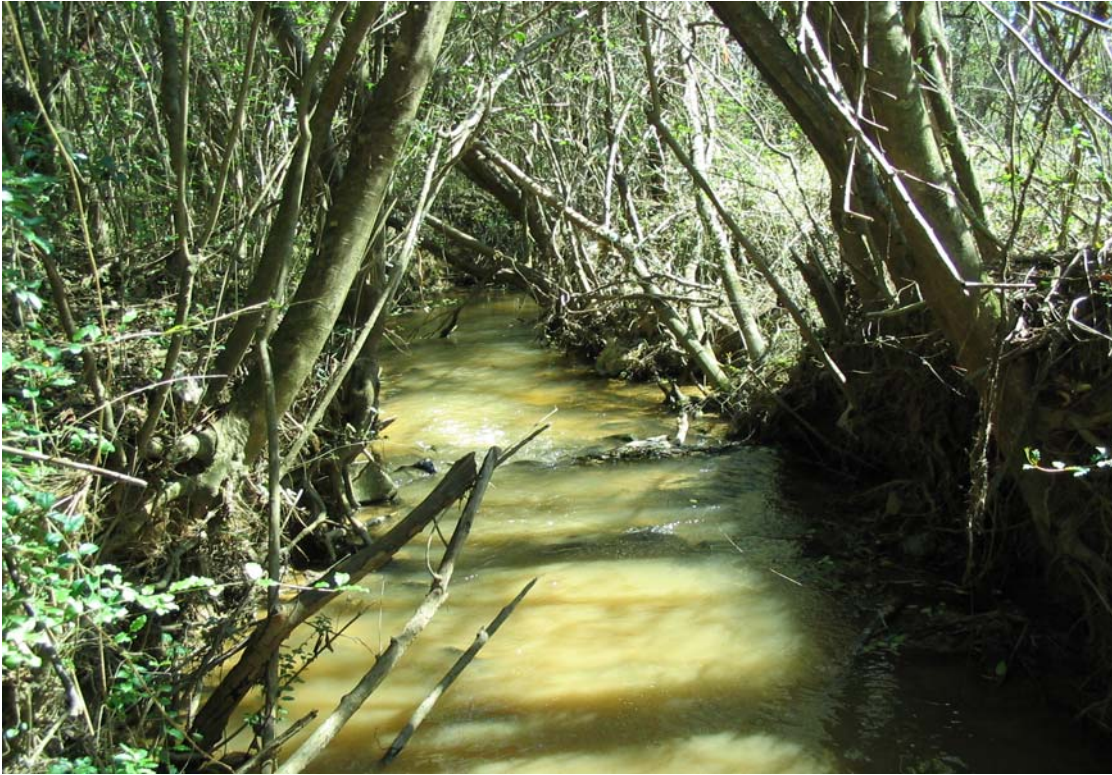
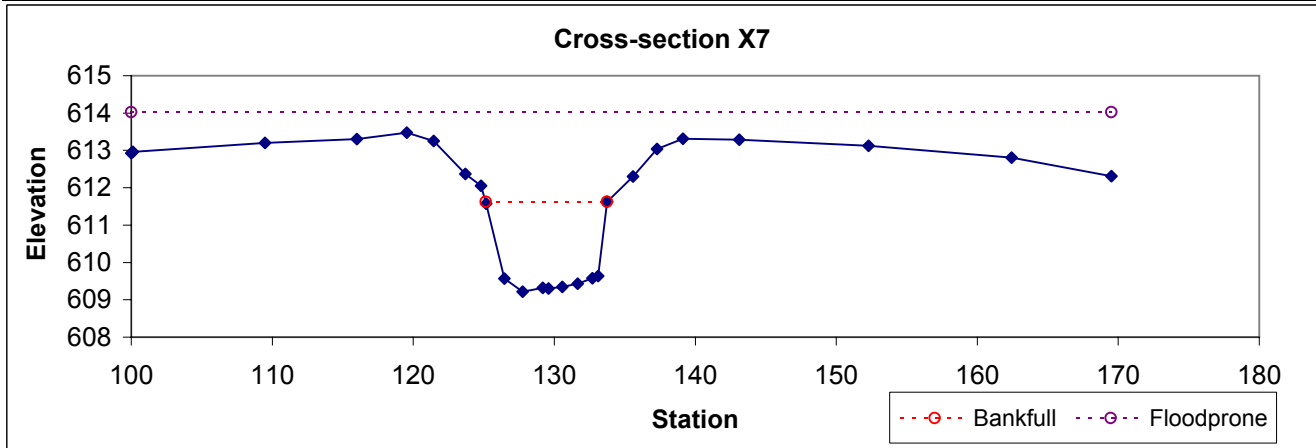
Cross-section Data:

| Feature | Stream Type | BKF Area | BKF Width | BKF Depth | Max BKF Depth | W/D | BH Ratio | ER | BKF Elev | TOB Elev |
| Riffle | E | 16.8 | 8.61 | 1.95 | 2.4 | 4.42 | 1 | 8.1 | 611.62 | 611.62 |

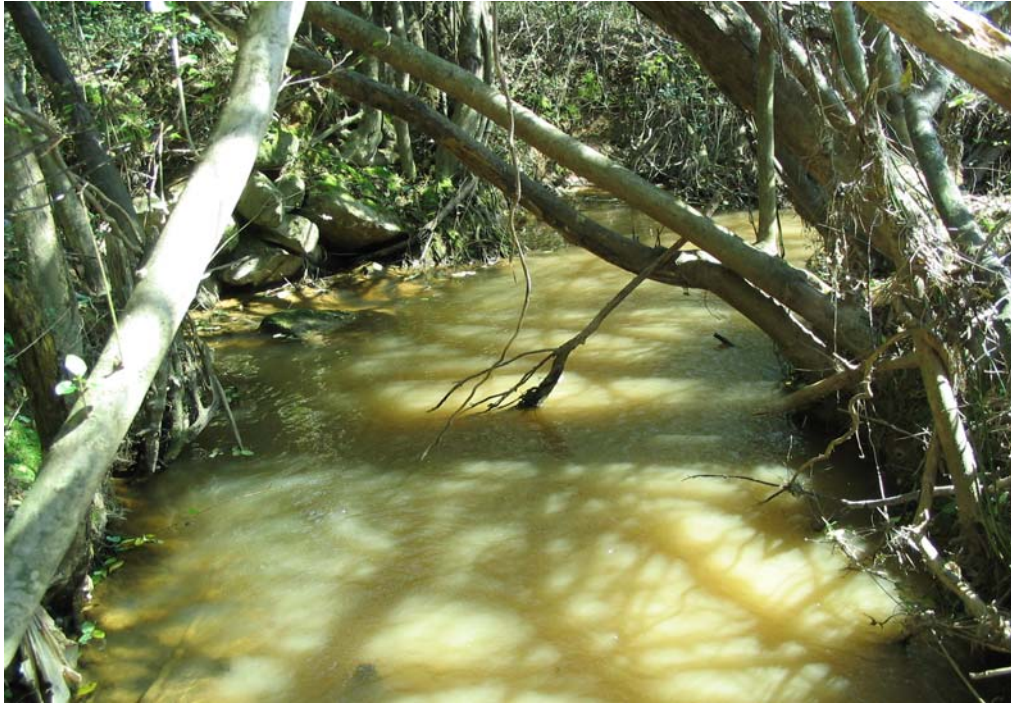
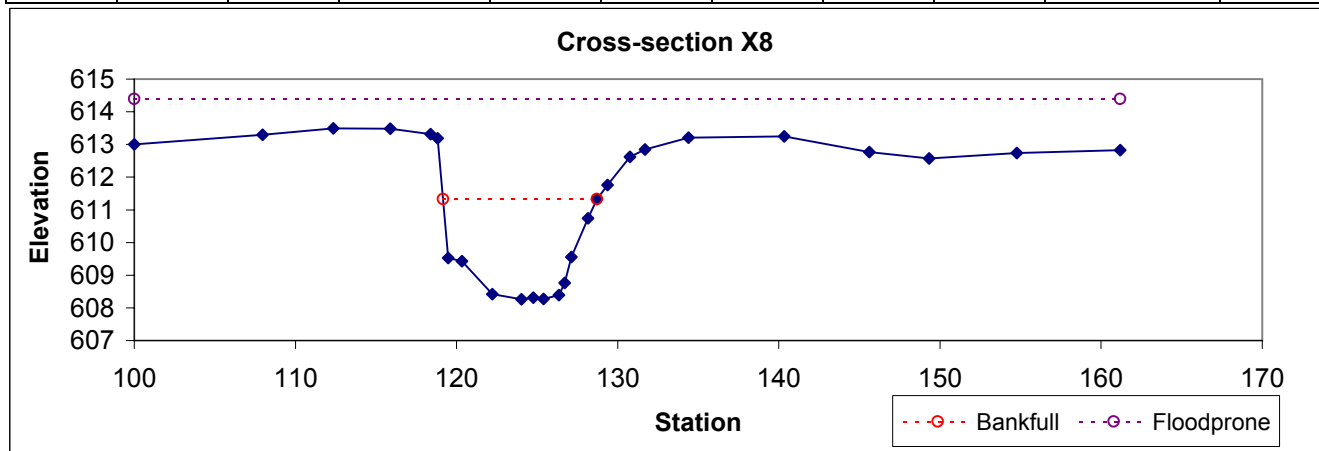
Cross-section Data:

| Feature | Stream Type | BKF Area | BKF Width | BKF Depth | Max BKF Depth | W/D | BH Ratio | ER | BKF Elev | TOB Elev |
| Pool | | 20.9 | 9.56 | 2.18 | 3.06 | 4.38 | 1.4 | 6.4 | 611.33 | 612.62 |

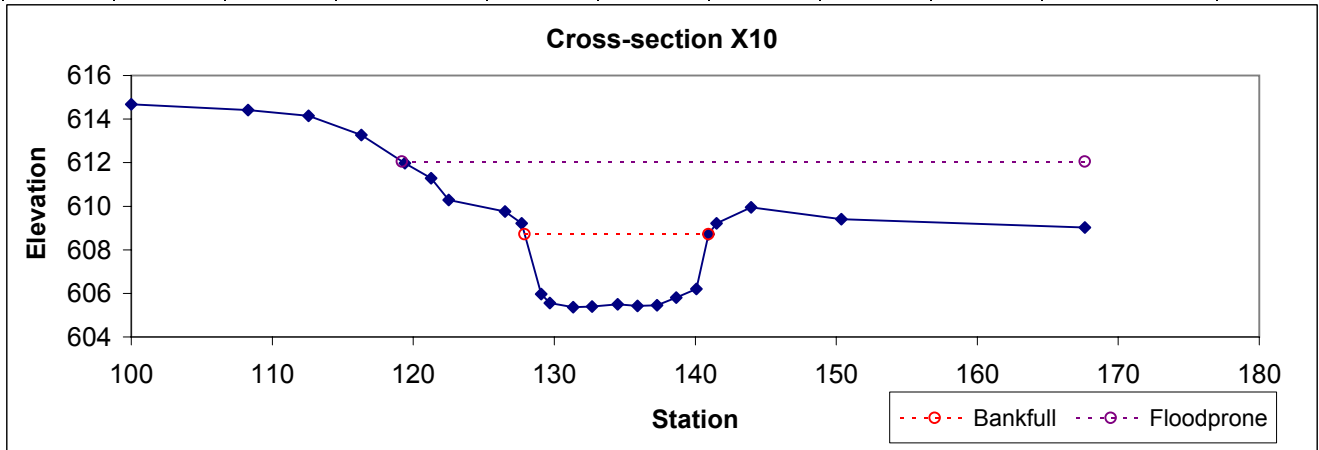
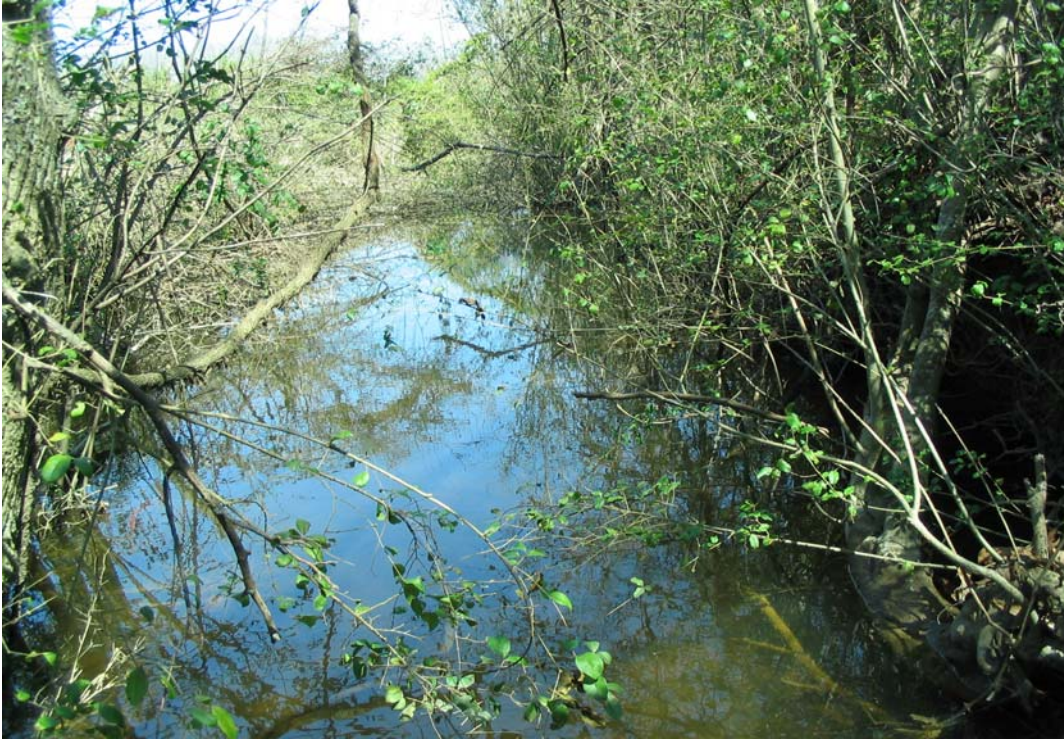
Cross-section Data:

| Feature | Stream Type | BKF Area | BKF Width | BKF Depth | Max BKF Depth | W/D | BH Ratio | ER | BKF Elev | TOB Elev |
| Pool | | 36.7 | 13.05 | 2.81 | 3.34 | 4.64 | 1 | 3.7 | 608.71 | 608.71 |

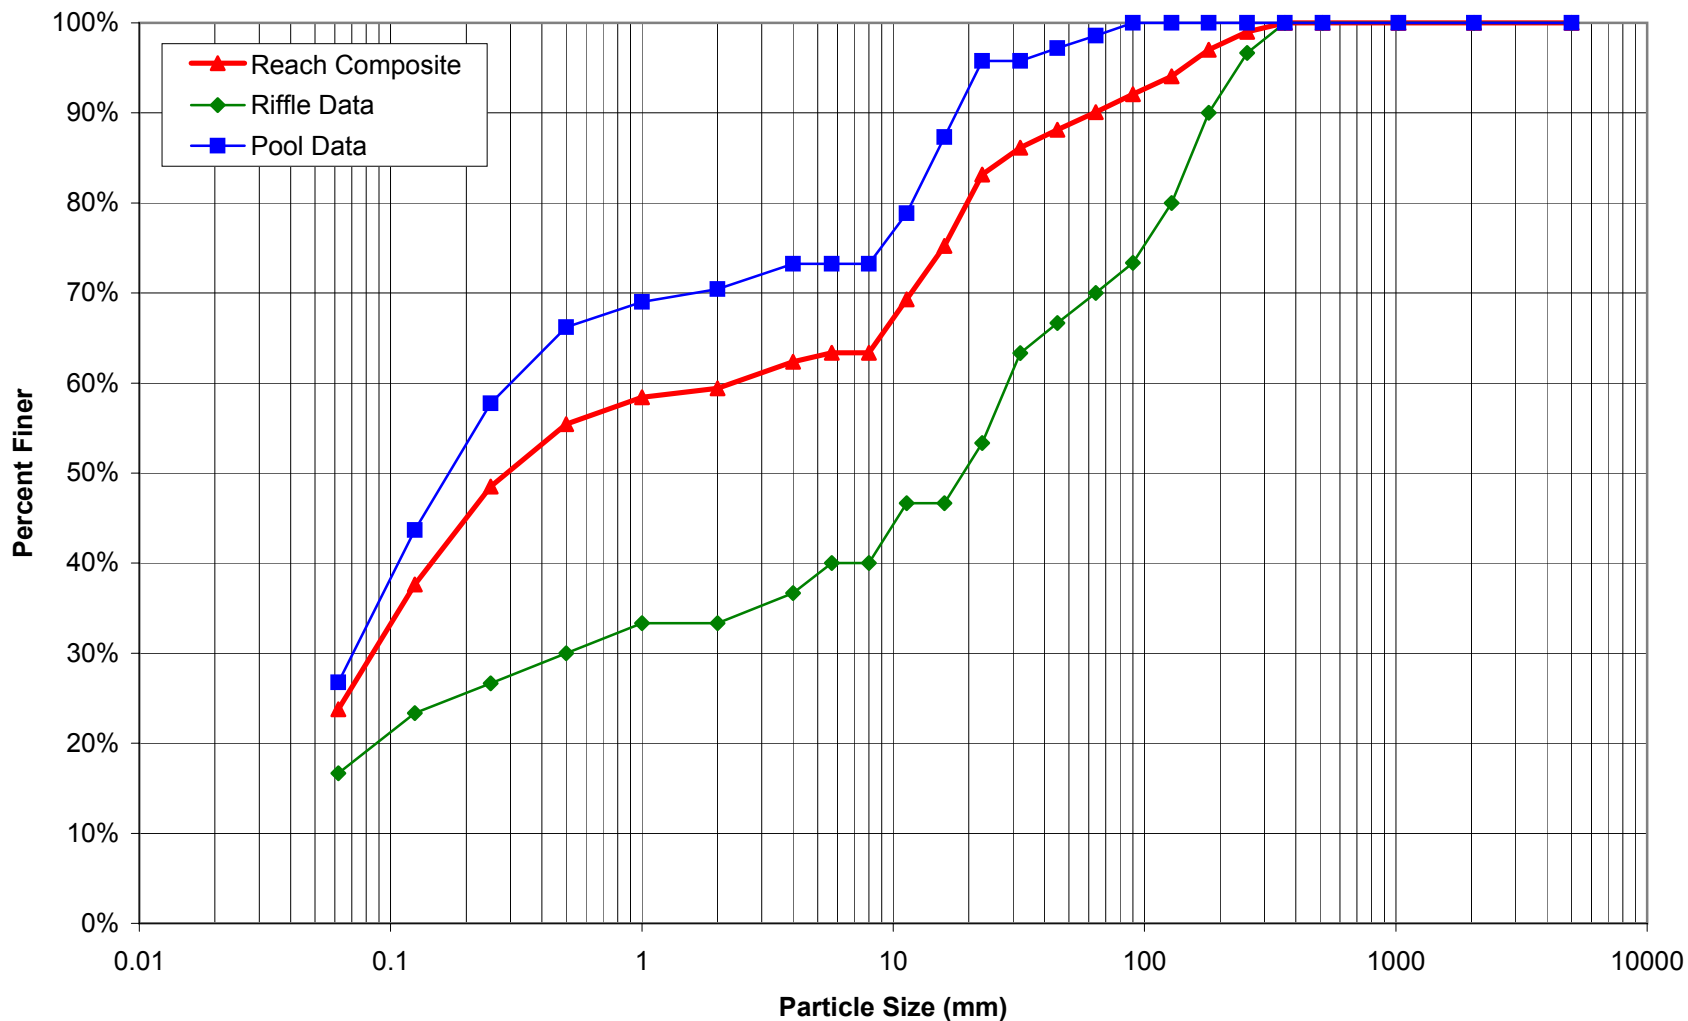
**UT to Barnes Creek
Harris Property
Pebble Count Particle Size Distributions**

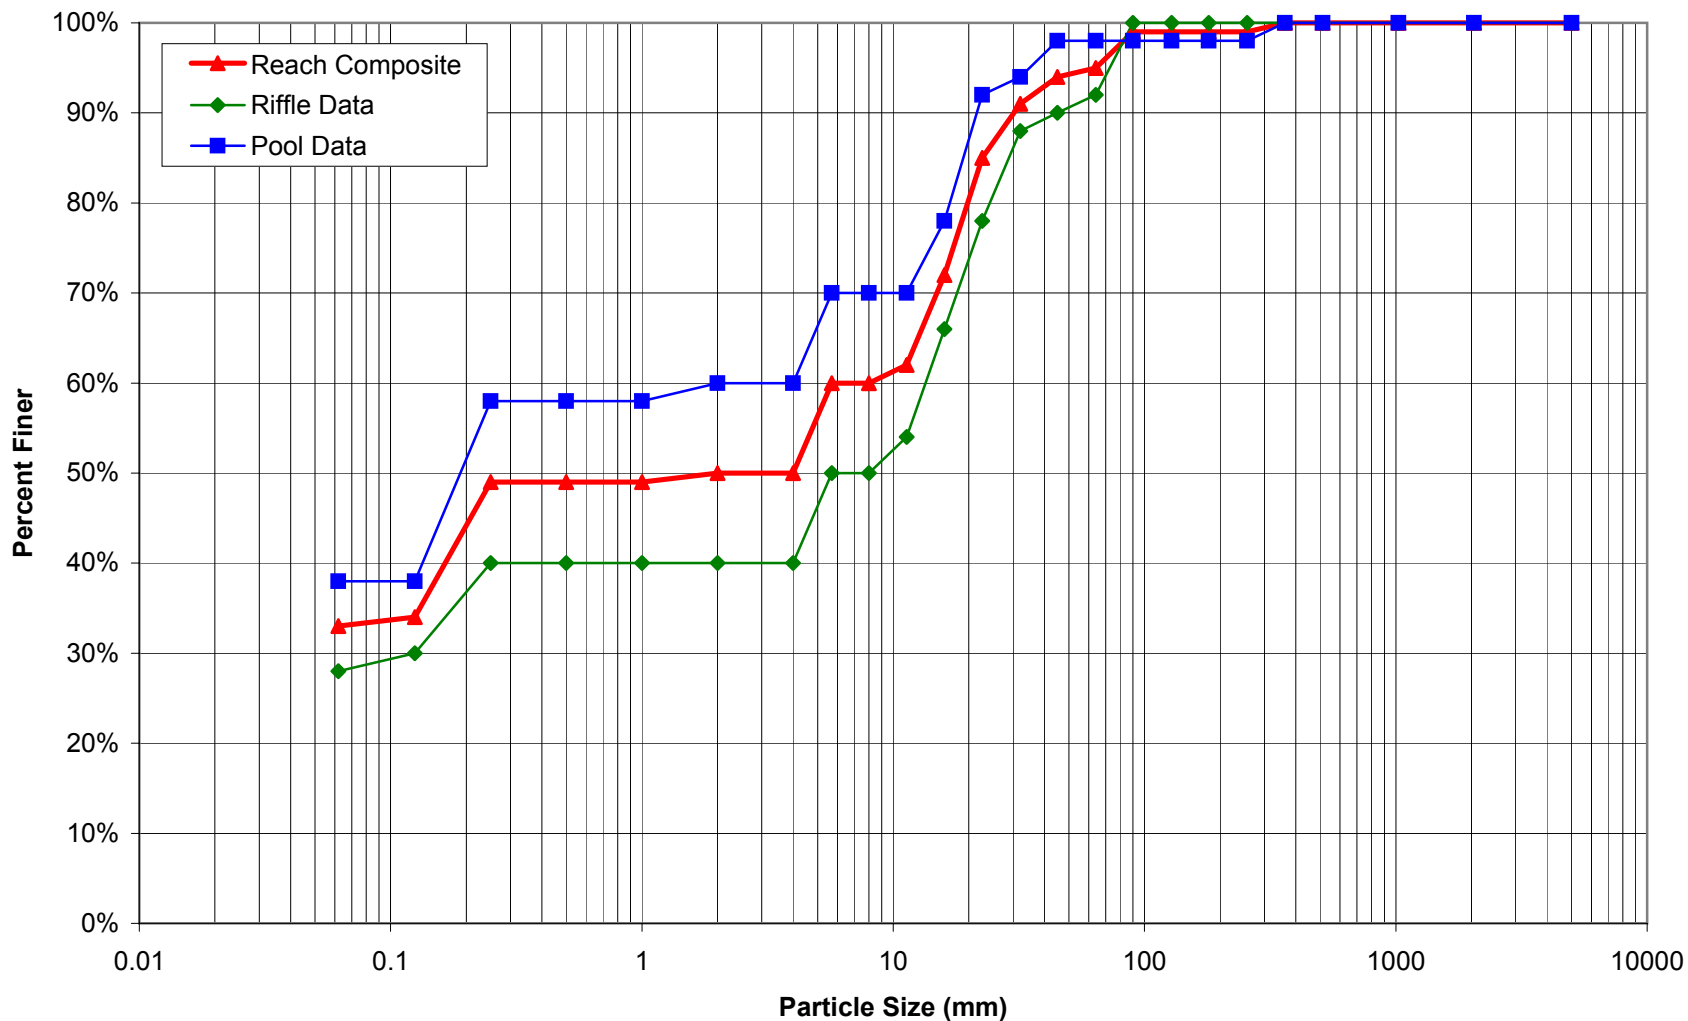
**UT to Barnes Creek
Hurley Property
Pebble Count Particle Size Distributions**

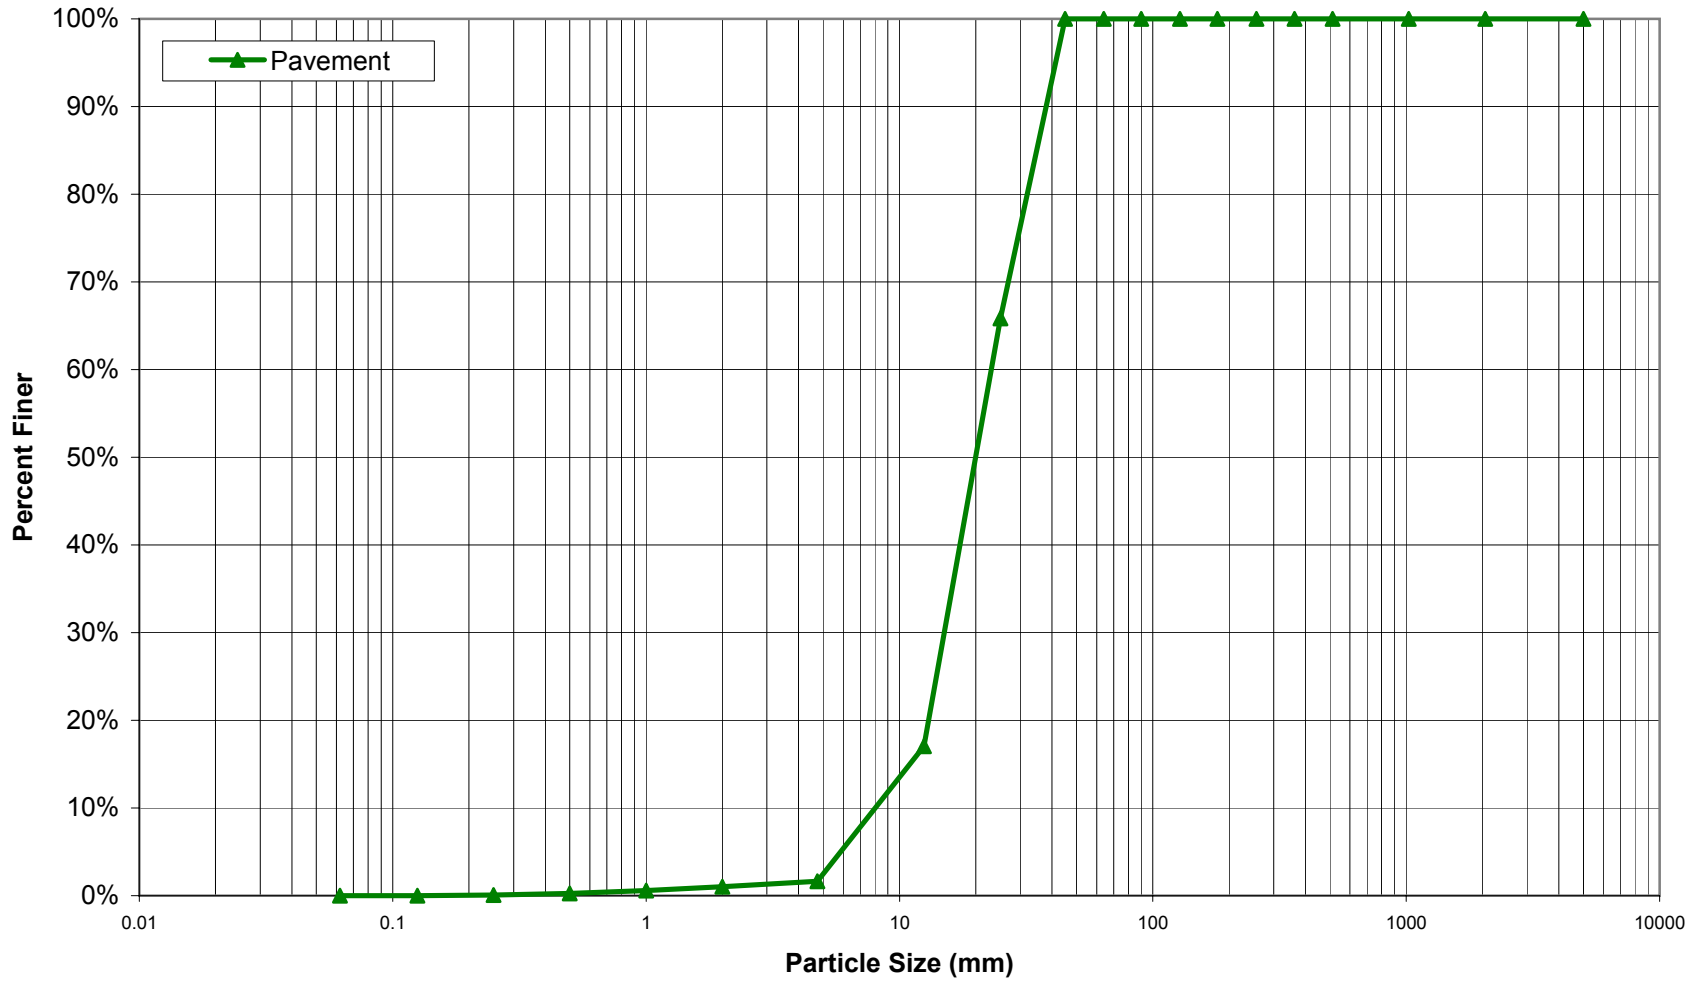
**UT to Barnes Creek
on Harris Property
Pavement Particle Size Distribution**

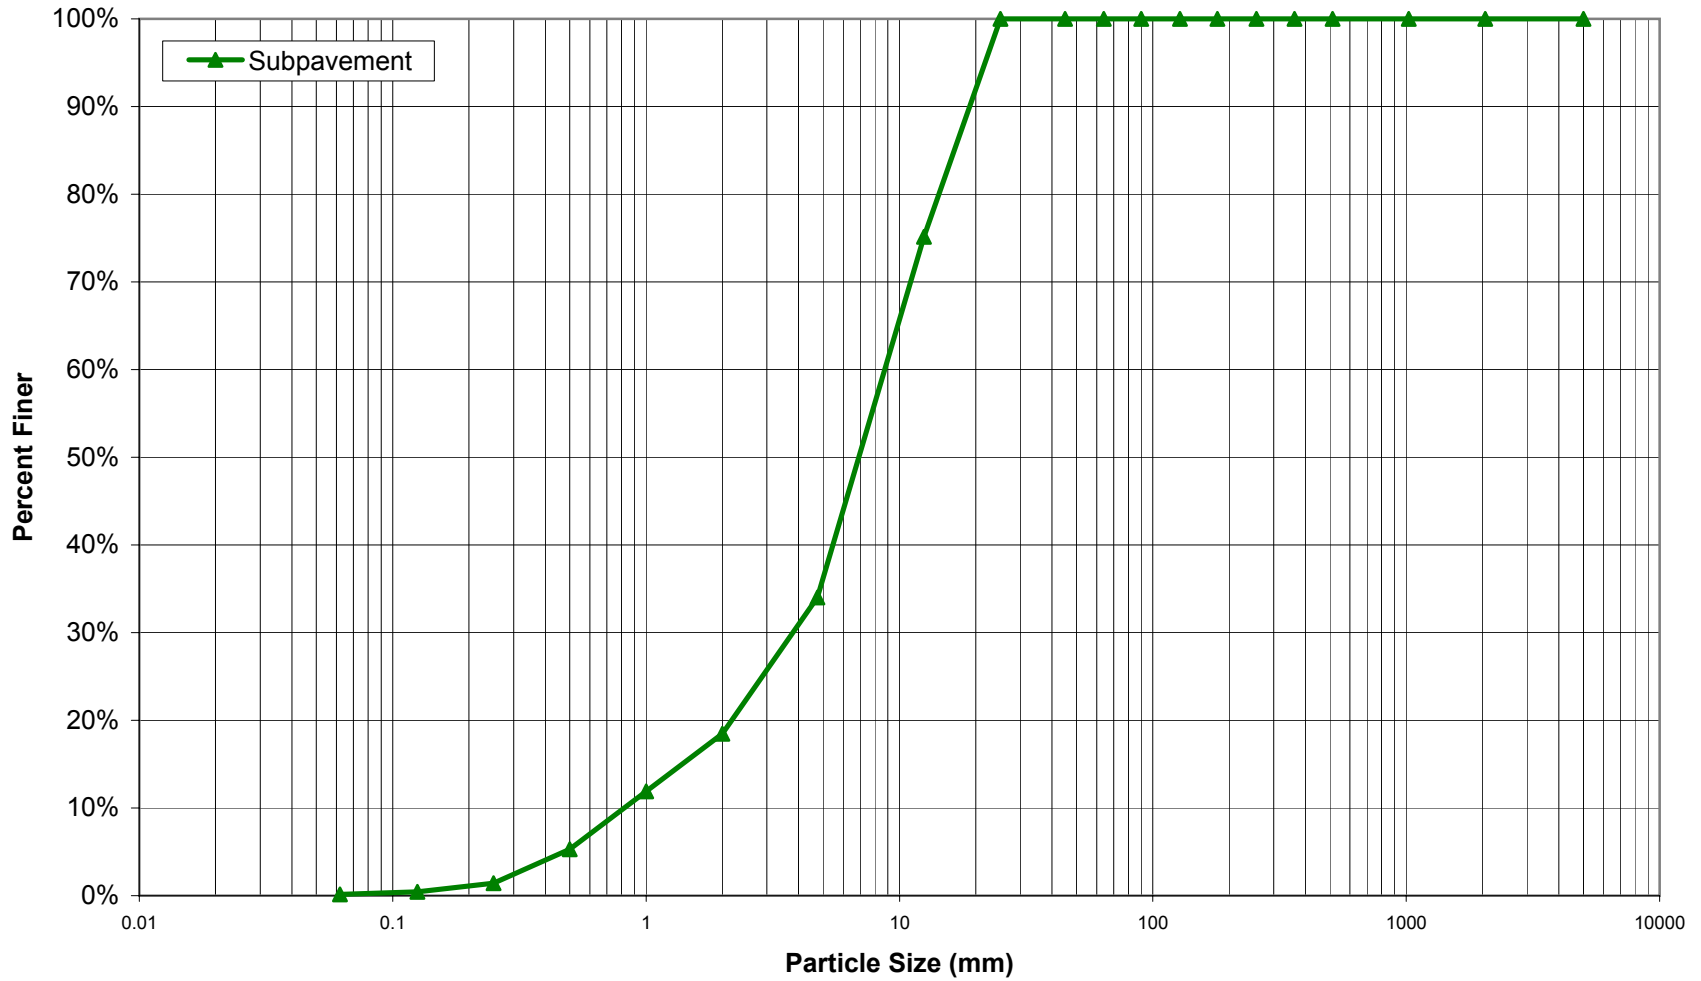
**UT to Barnes Creek
UT on Harris Property
Subpavement Particle Size Distribution**

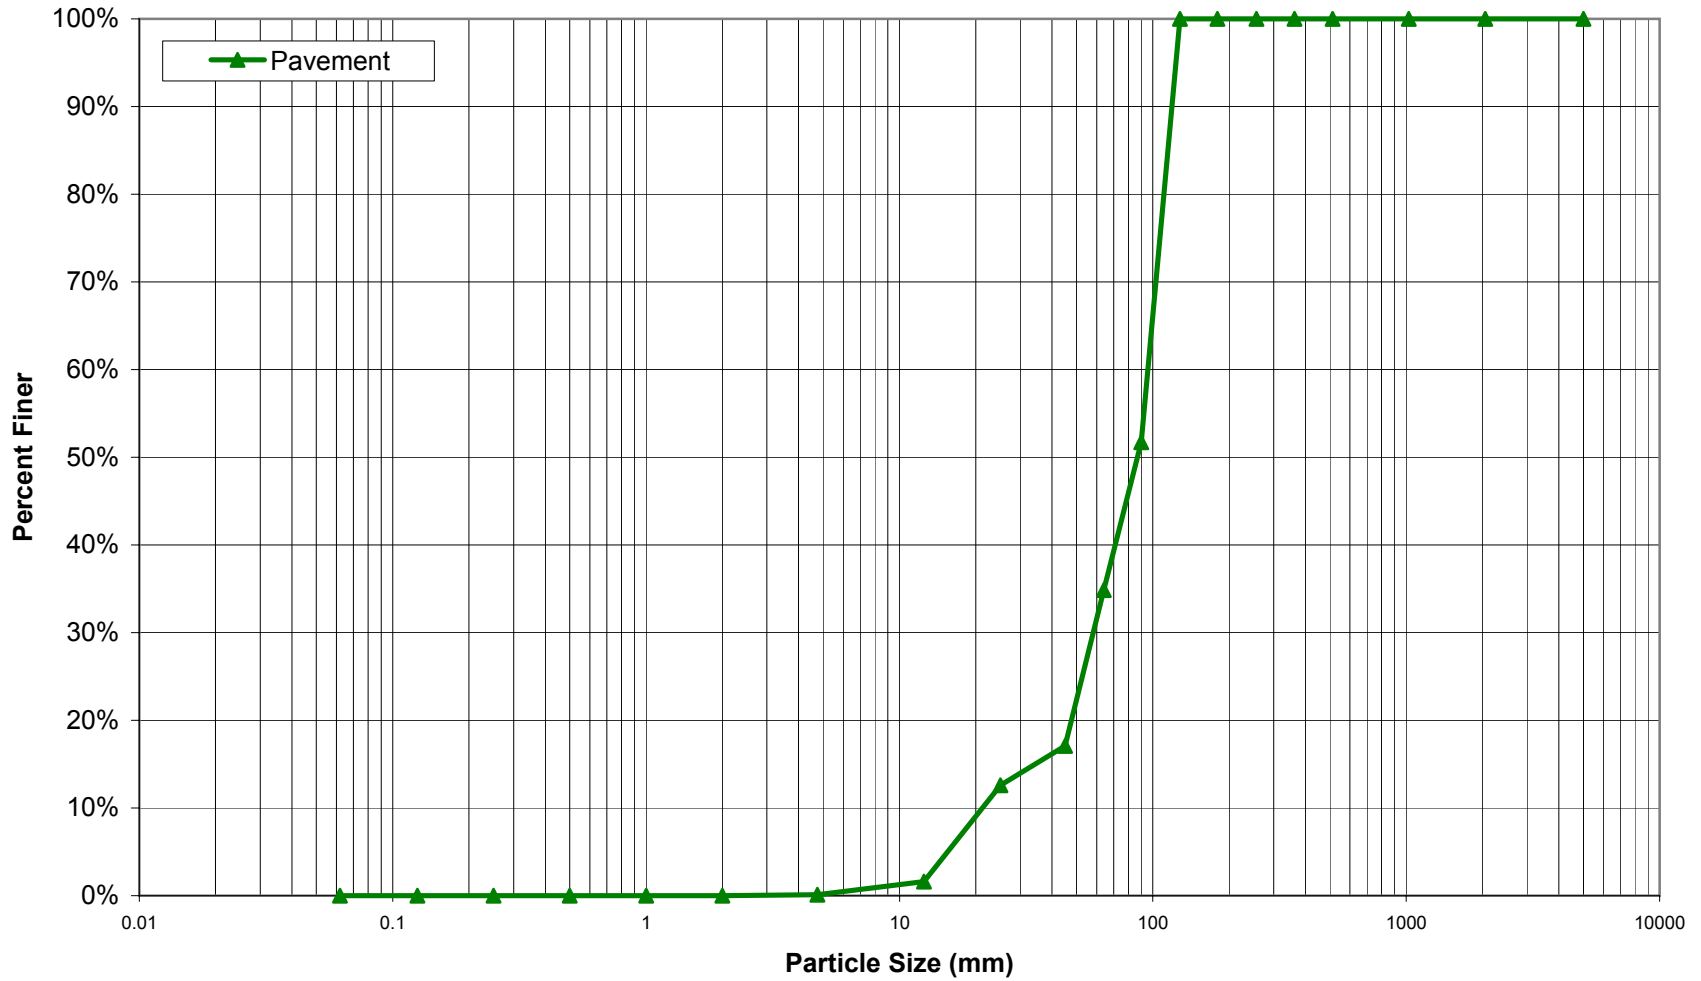
UT to Barnes Creek
Reach 1
Pavement Particle Size Distribution

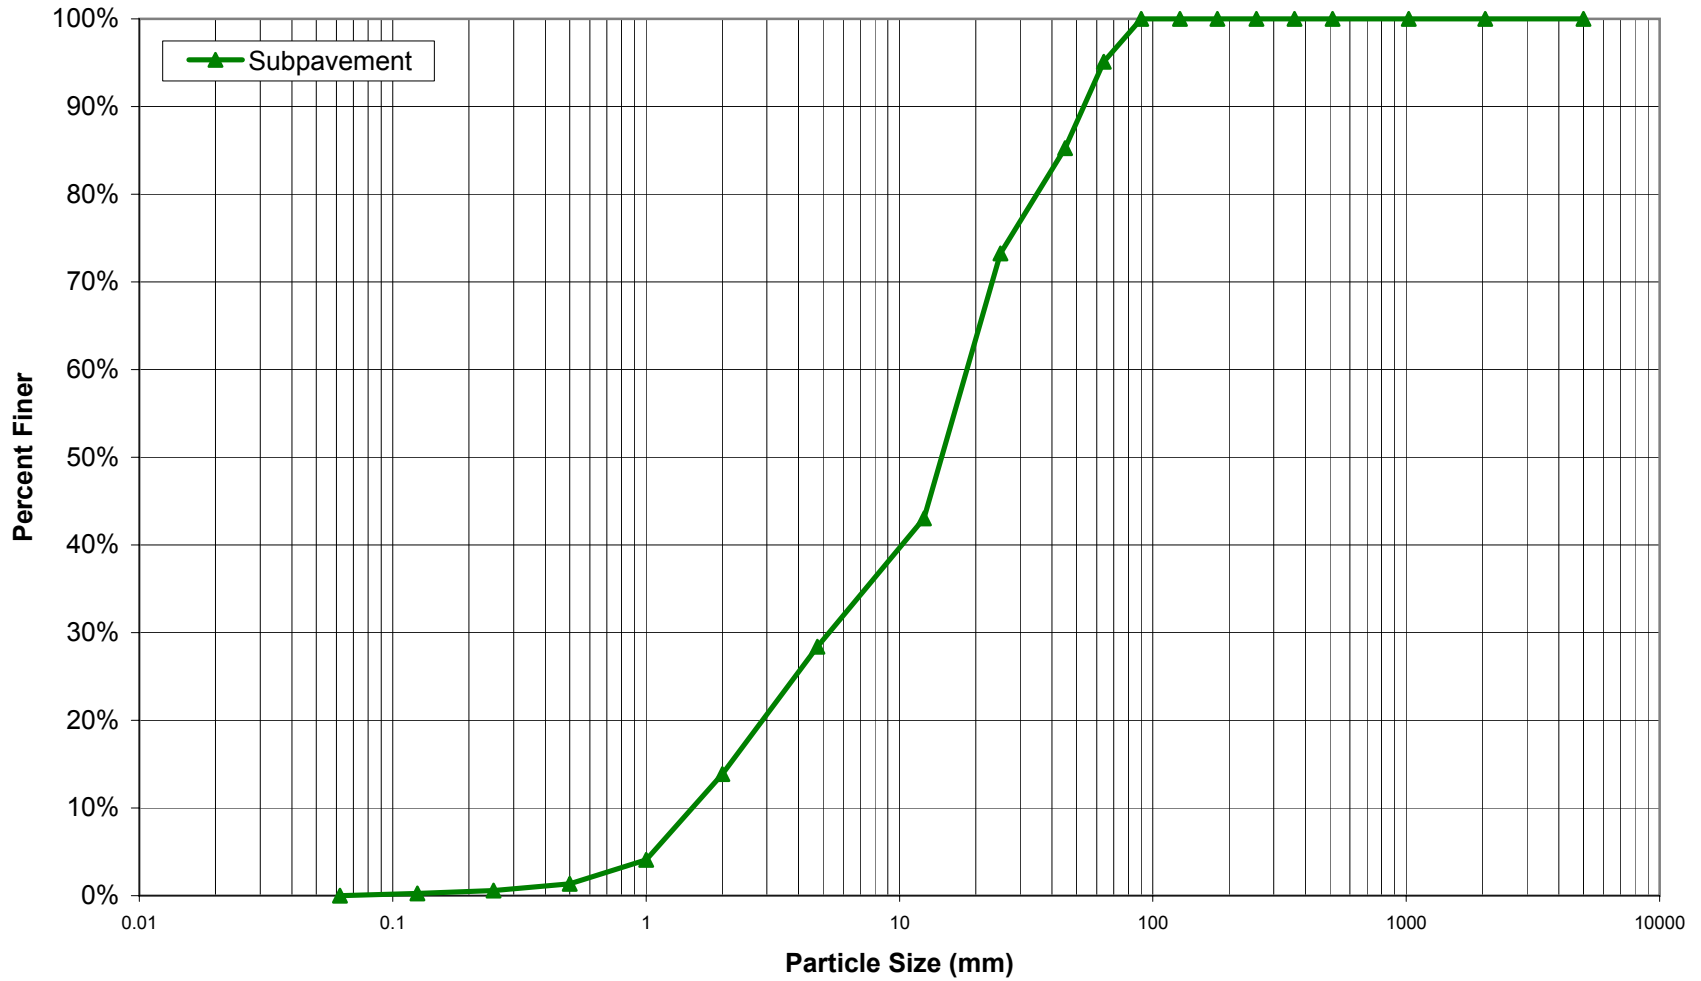
**UT to Barnes Creek
Reach 1
Subpavement Particle Size Distribution**

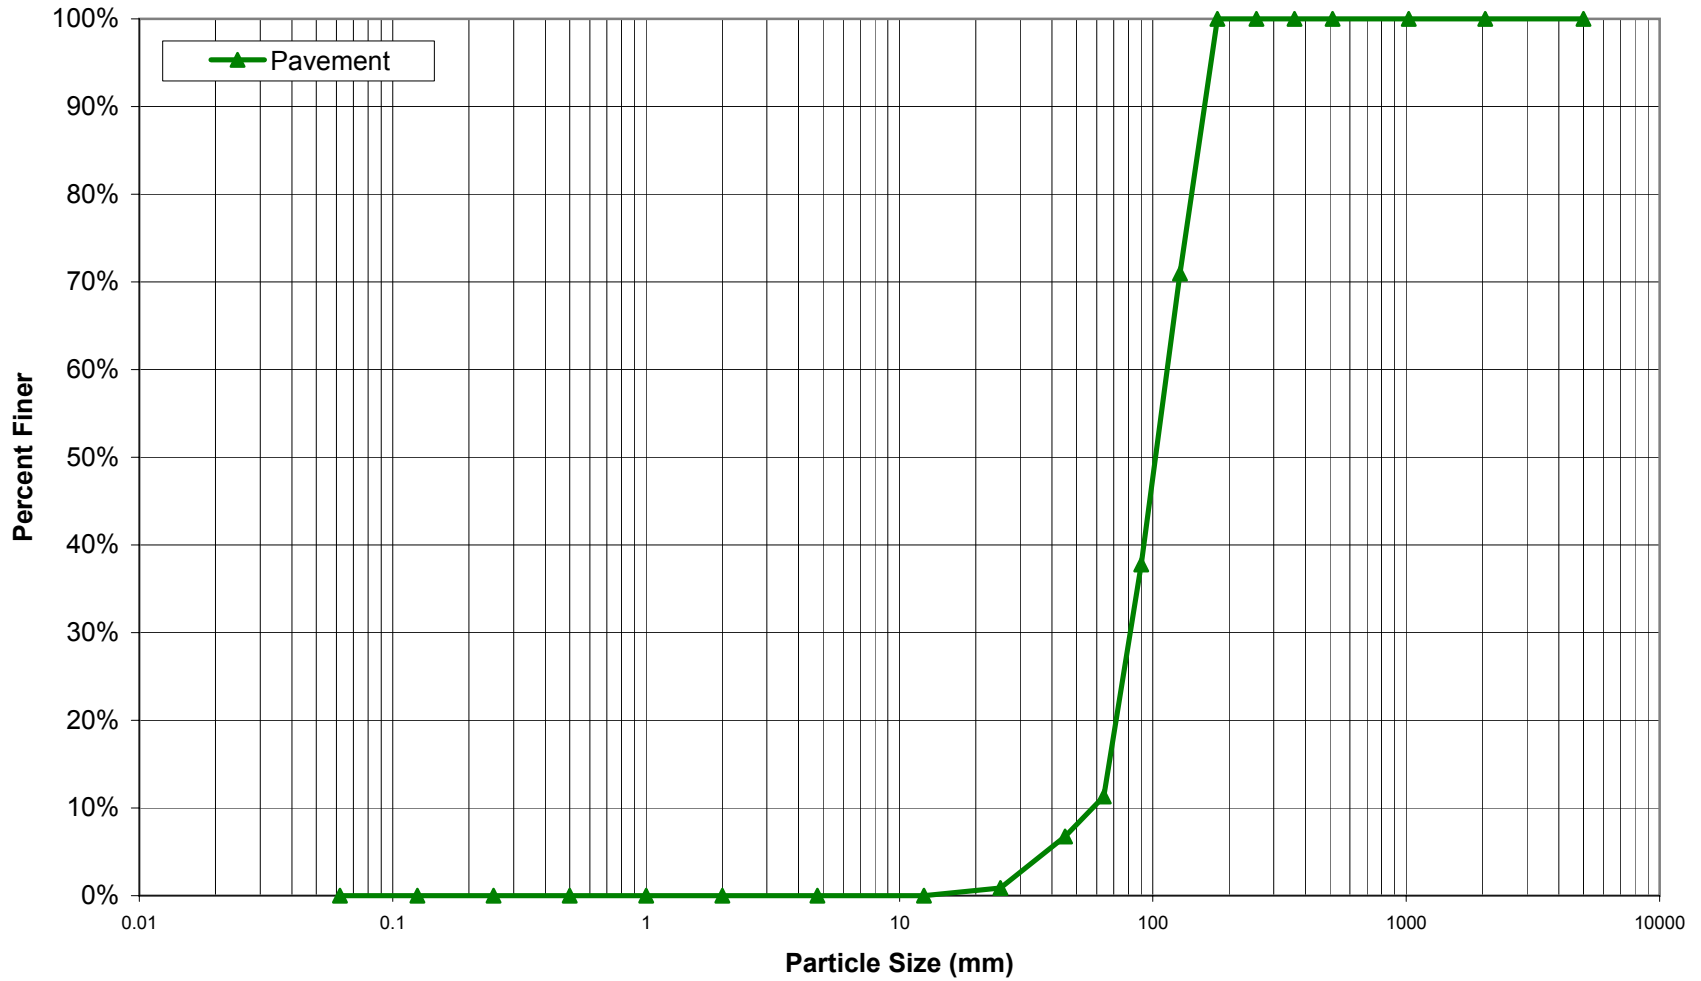
UT to Barnes Creek
Reach 2
Pavement Particle Size Distribution

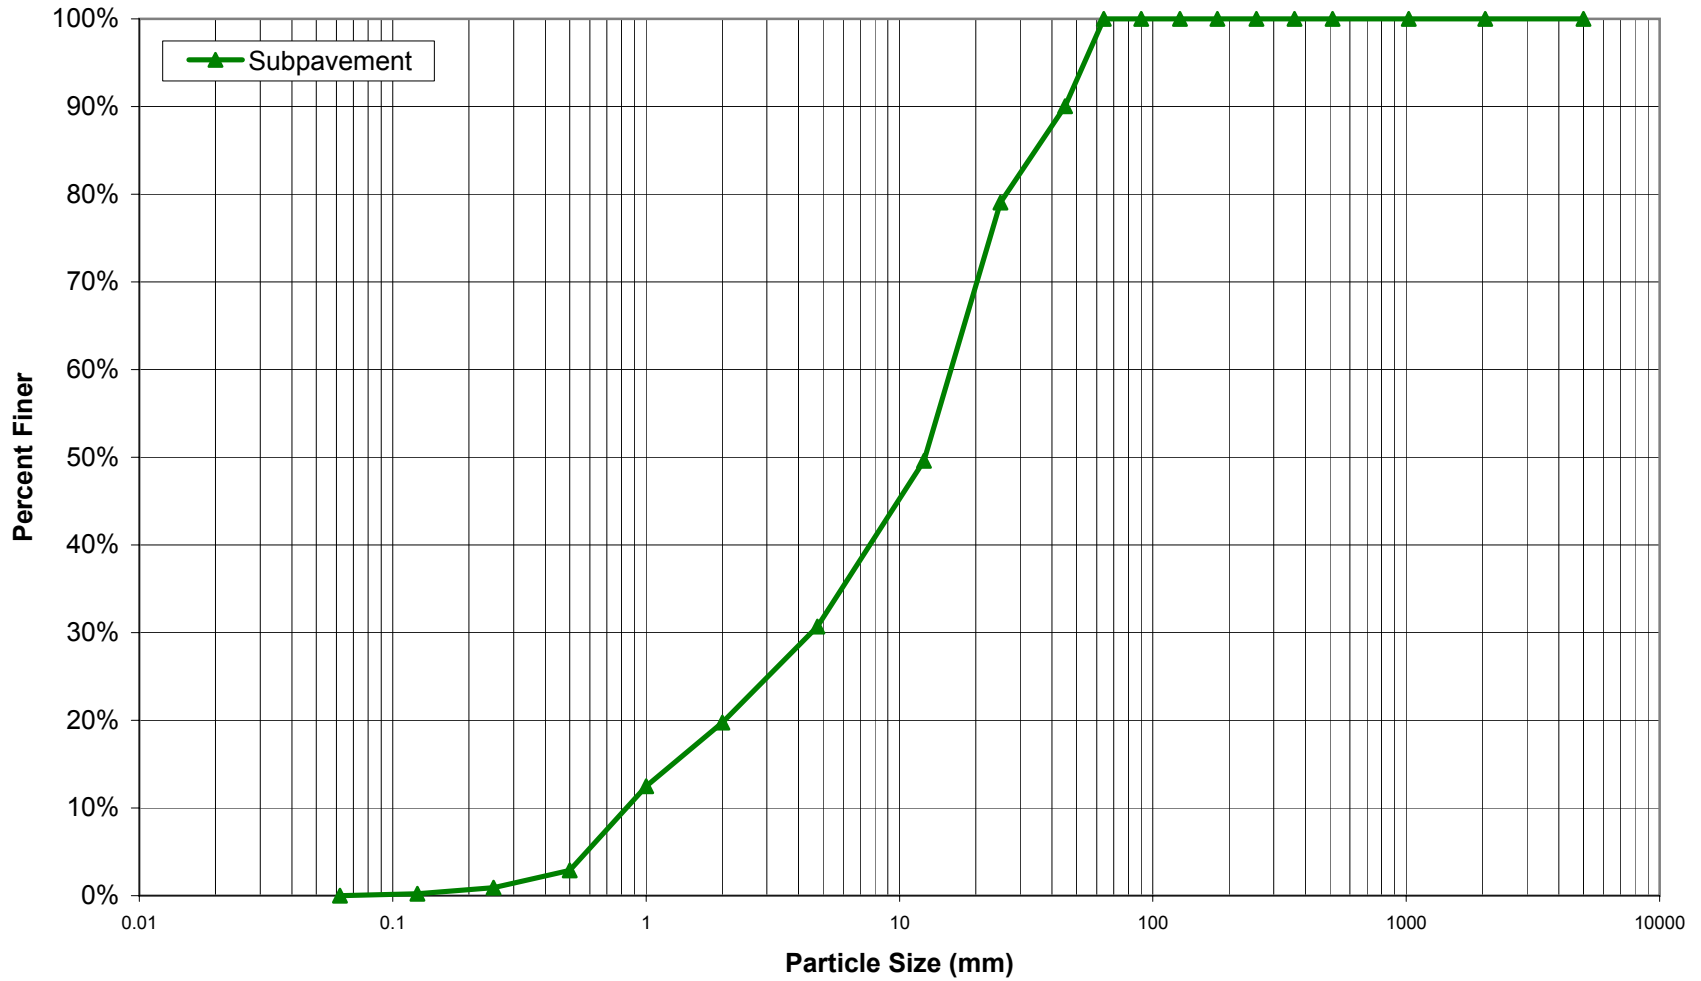
**UT to Barnes Creek
Reach 2
Subpavement Particle Size Distribution**
