UT to Barnes Creek Restoration Plan Montgomery County, North Carolina

Prepared For North Carolina Department of Environment and Natural Resources
Ecosystem Enhancement Program

Design Report Prepared By Buck Engineering PC

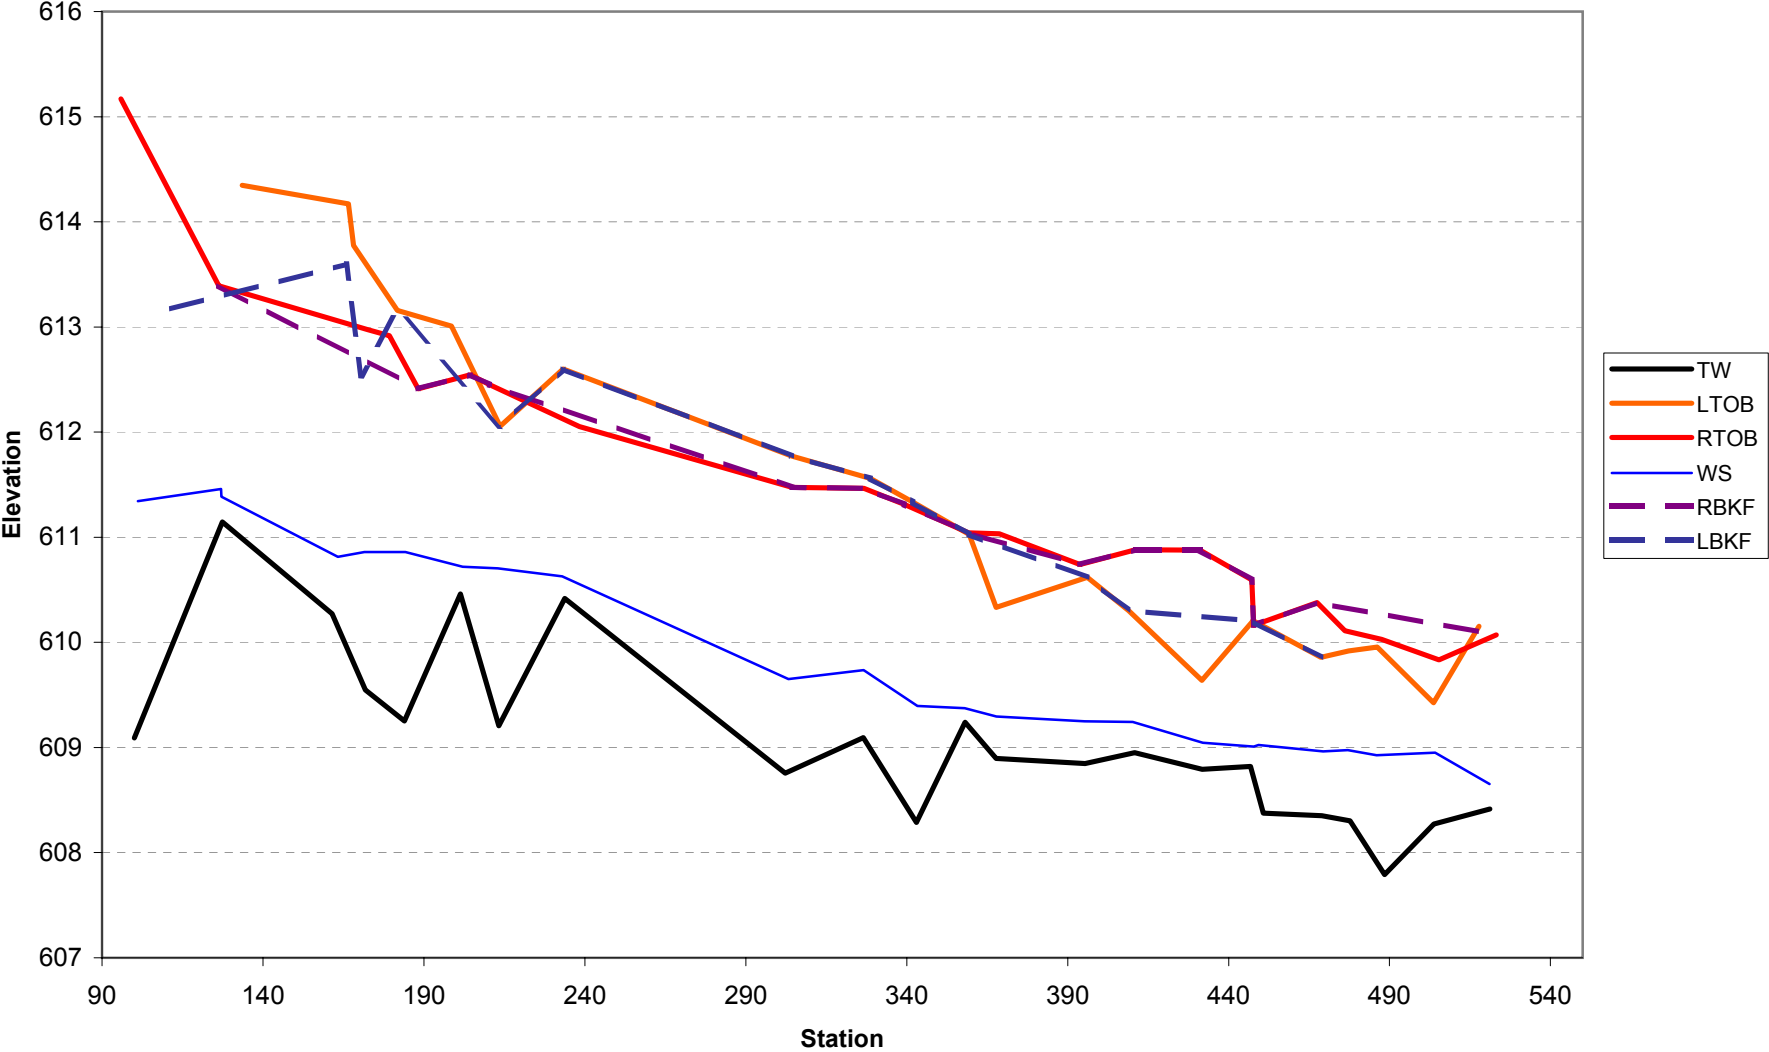
Harris Tributary Existing Conditions Profile

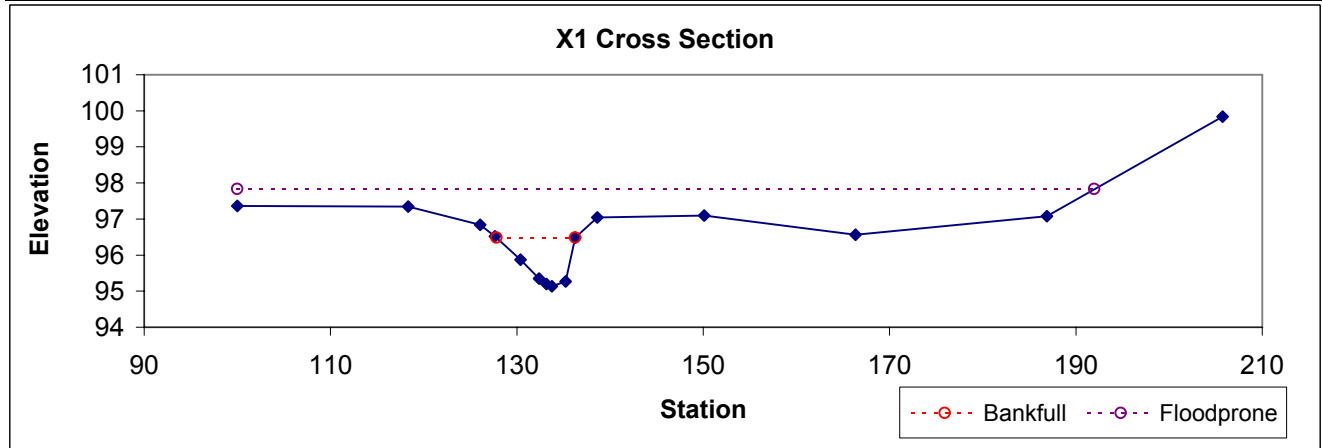
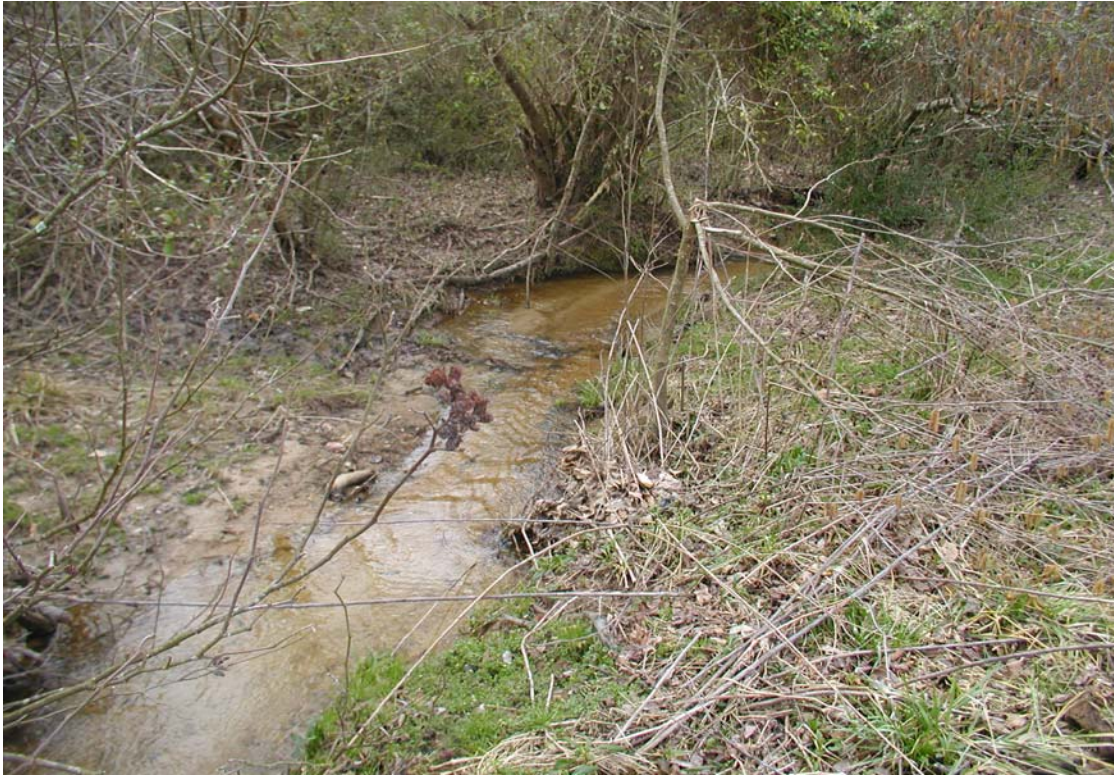
Cross-section Data:

| Feature | Stream Type | BKF Area | BKF Width | BKF Depth | Max BKF Depth | W/D | BH Ratio | ER | BKF Elev | TOB Elev |
| Riffle | E | 6.8 | 8.46 | 0.8 | 1.34 | 10.58 | 1 | 10.9 | 96.48 | 96.48 |

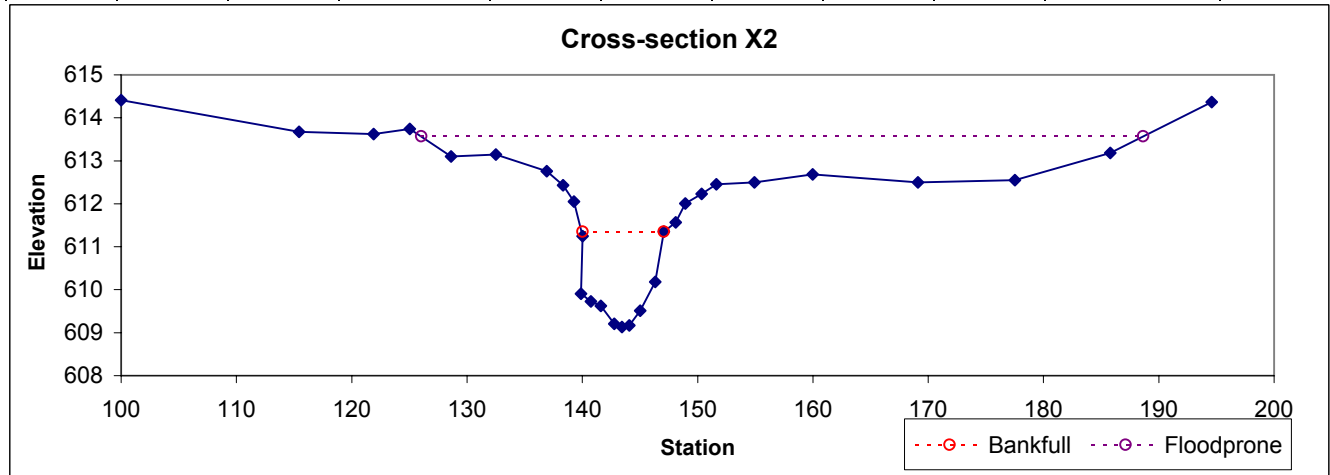
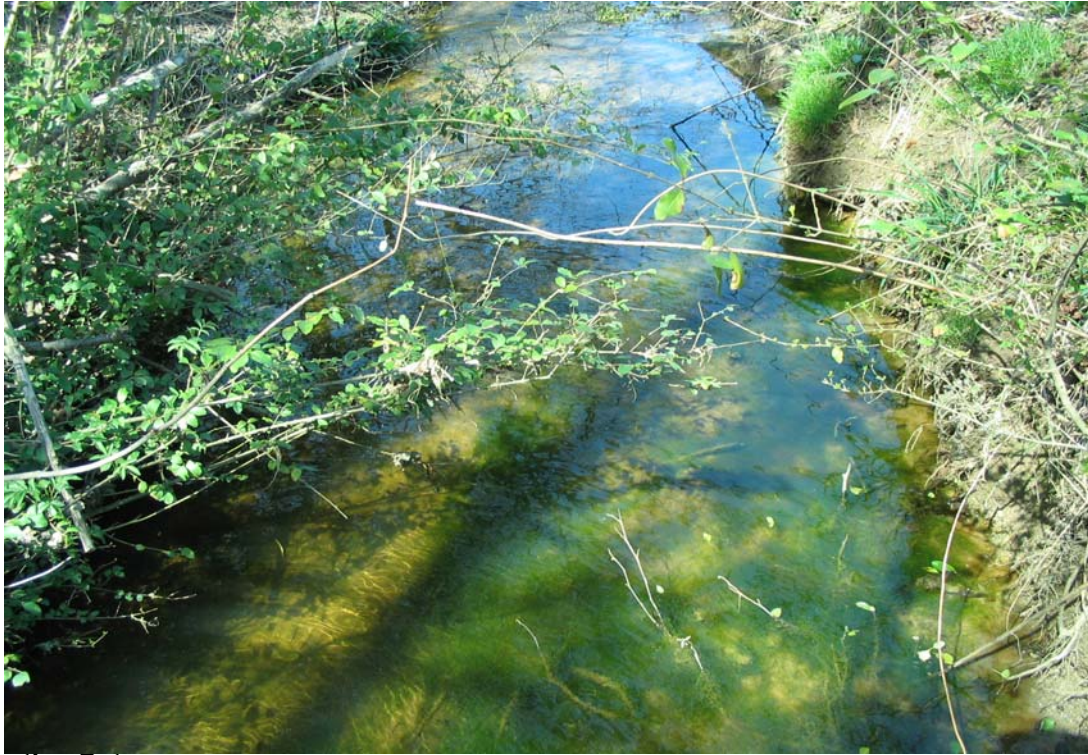
Cross-section Data:

| Feature | Stream Type | BKF Area | BKF Width | BKF Depth | Max BKF Depth | W/D | BH Ratio | ER | BKF Elev | TOB Elev |
| Pool | | 11.9 | 7.59 | 1.56 | 2.22 | 4.85 | 1.3 | 8.2 | 611.35 | 612.05 |

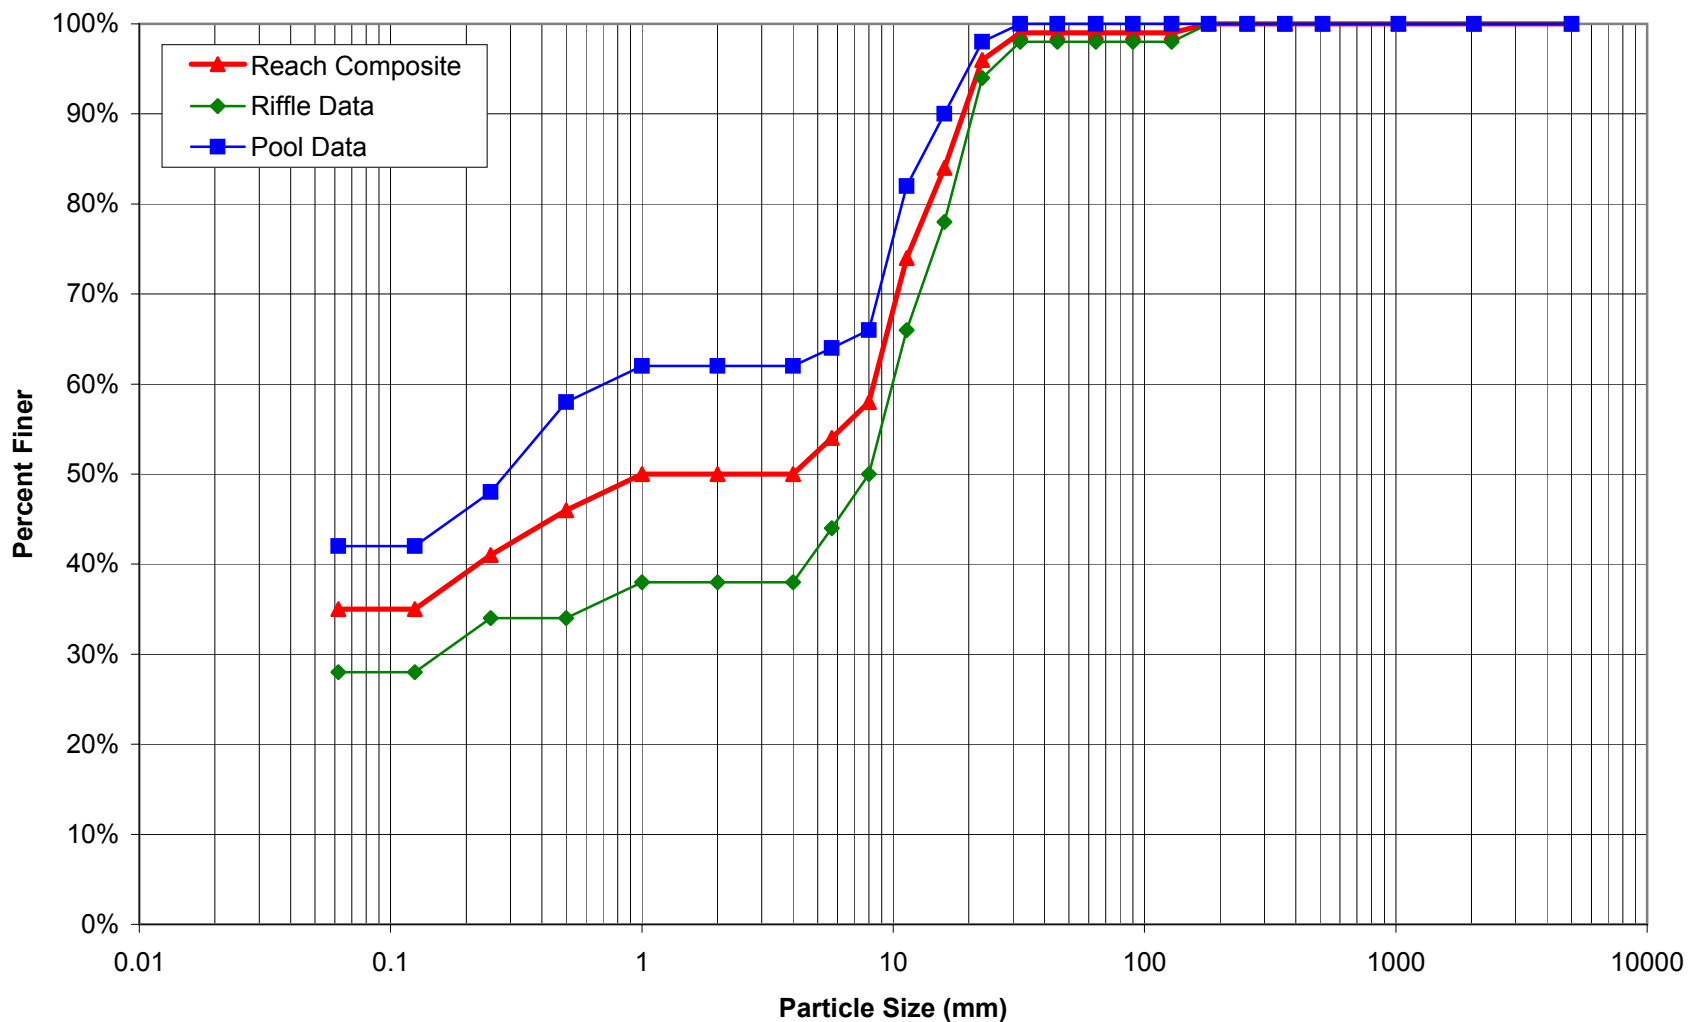
Harris Tributary Harris Property Pebble Count Particle Size Distributions

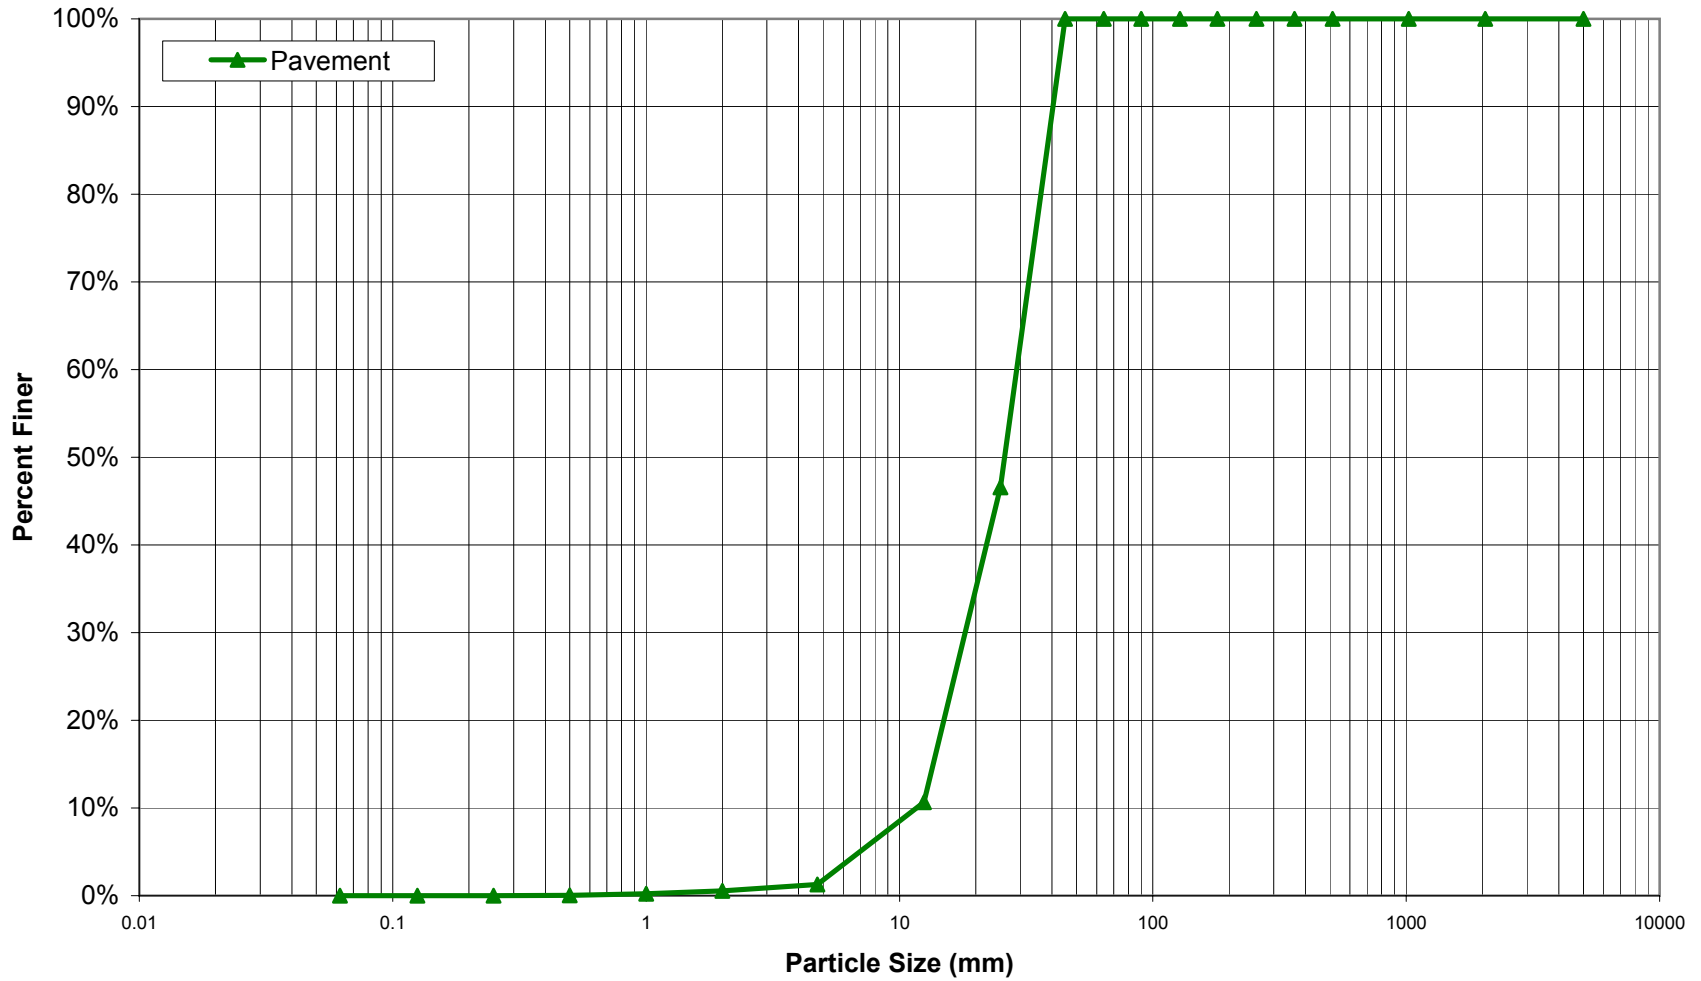
UT to Barnes Creek
Harris Property Tributary
Pavement Particle Size Distribution

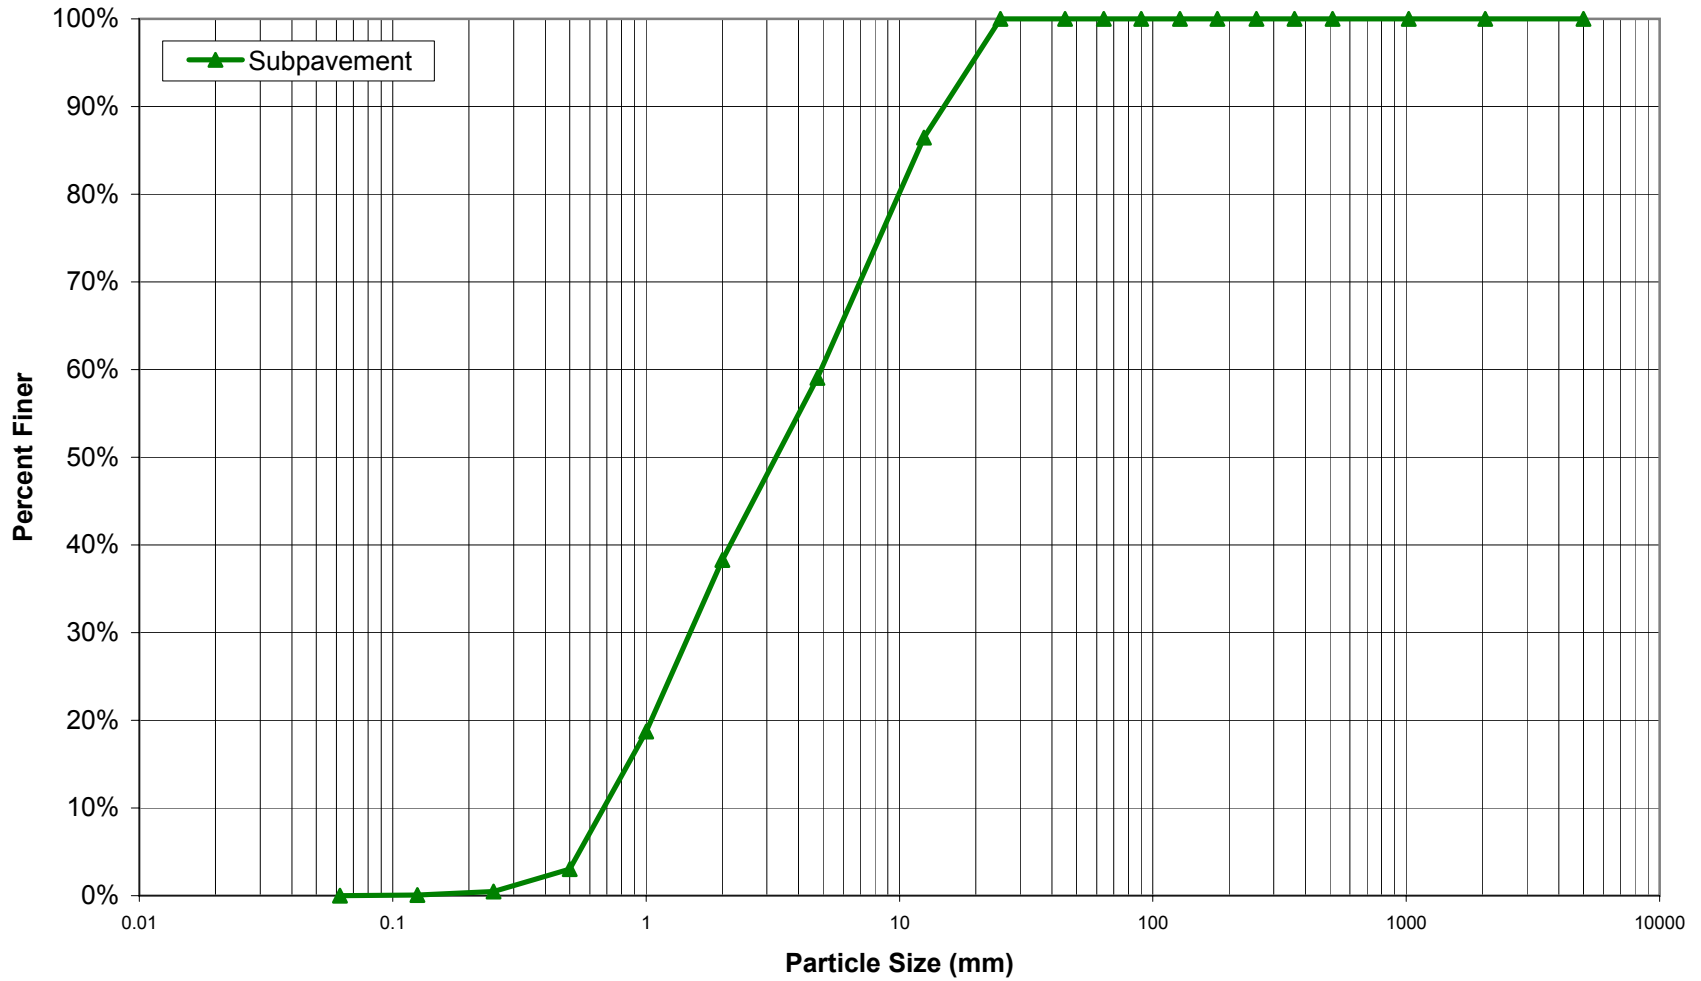
**UT to Barnes Creek
Harris Property Tributary
Subpavement Particle Size Distribution**

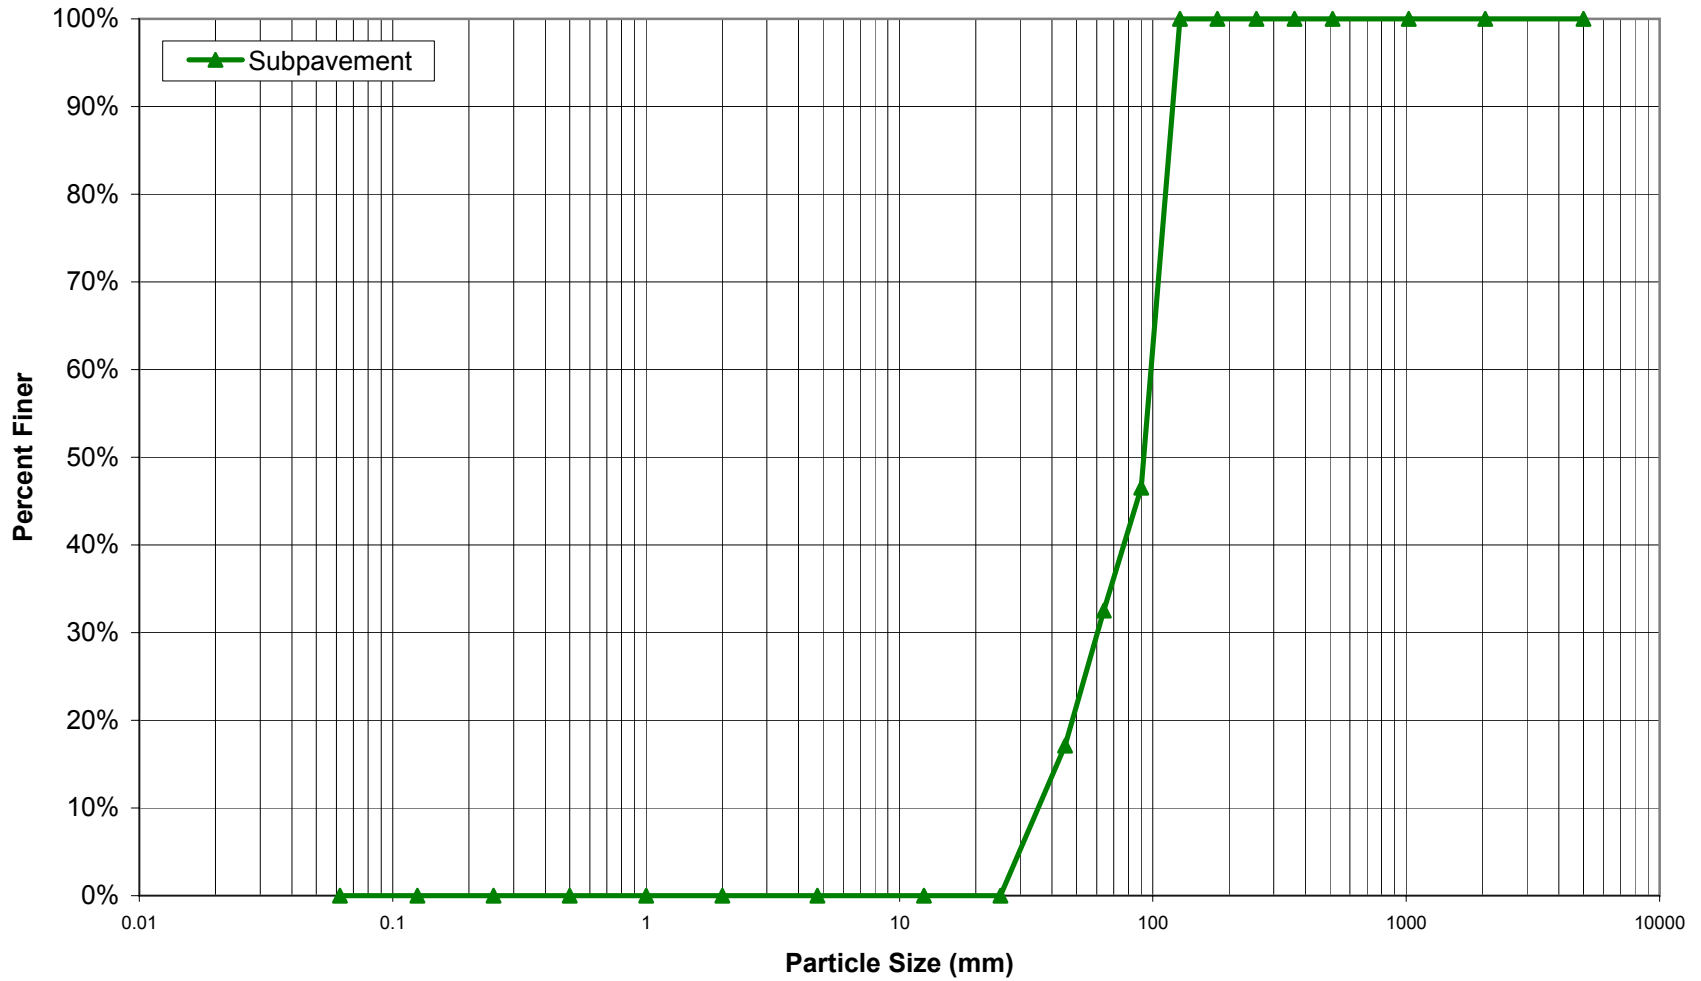
UT to Barnes Creek
Gage Station
Pavement Particle Size Distribution

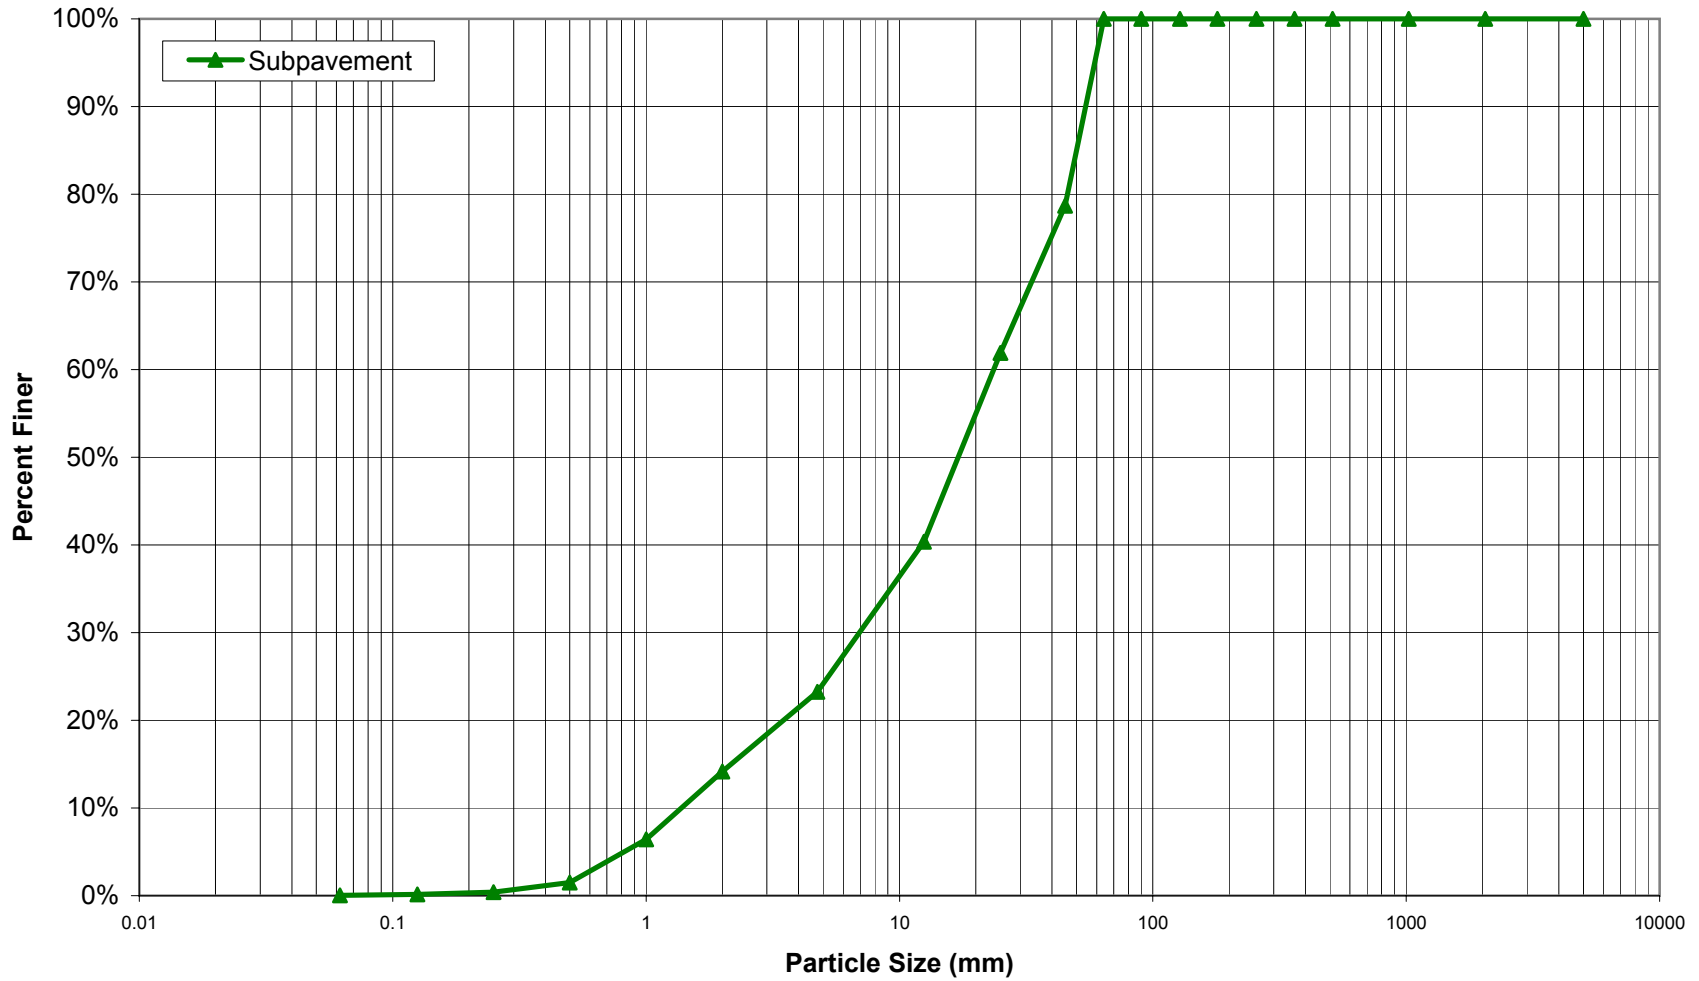
**UT to Barnes Creek
Gage Station
Subpavement Particle Size Distribution**

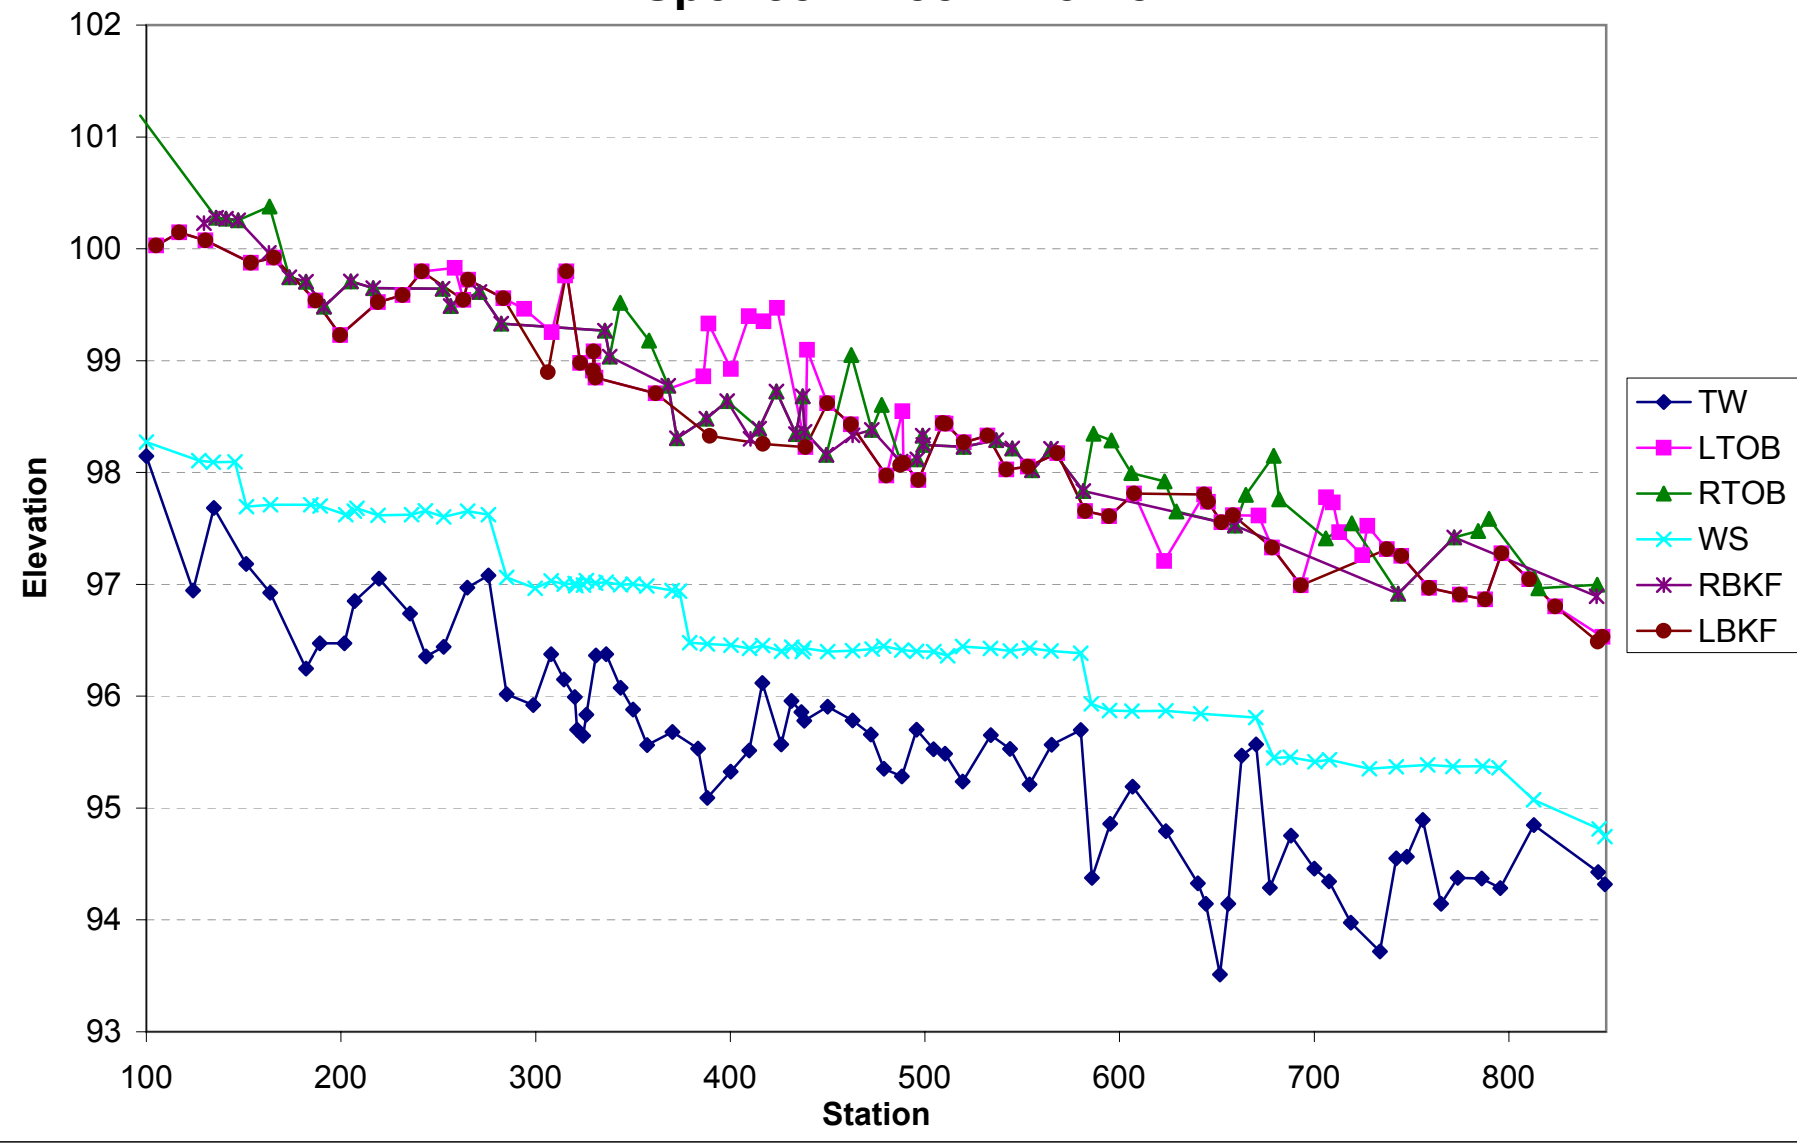
Spencer Creek Profile

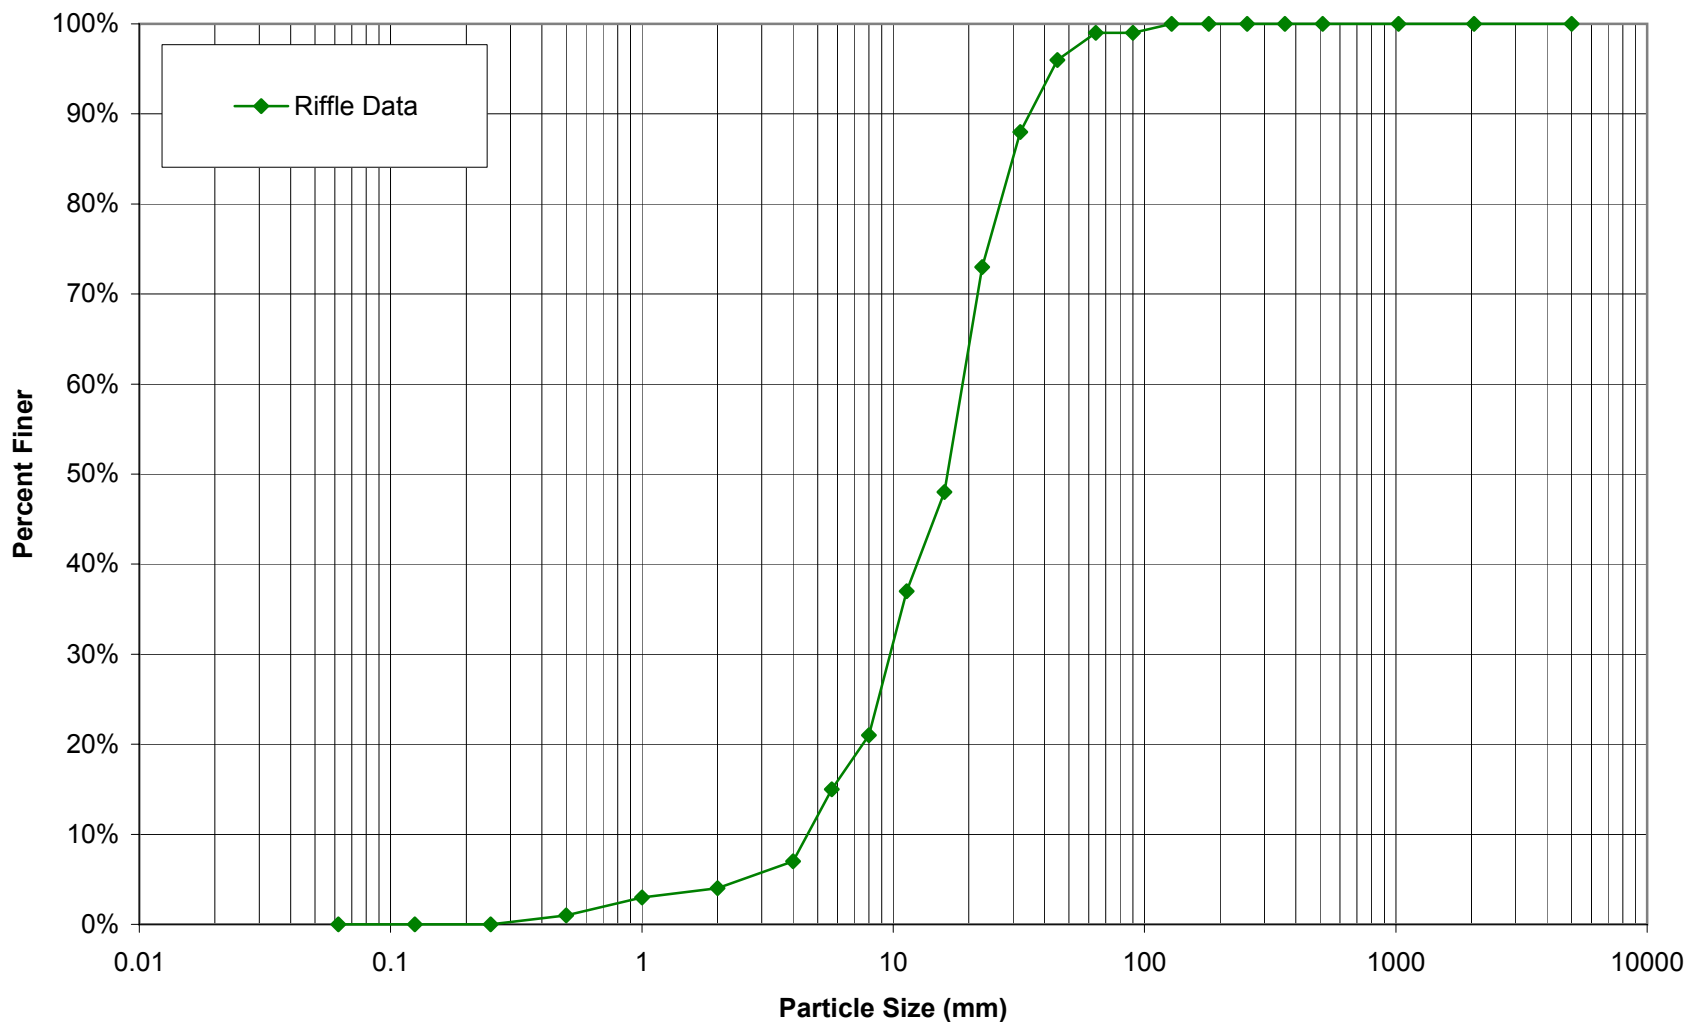
Spencer Creek
Riffle 100 Count
Pebble Count Particle Size Distributions

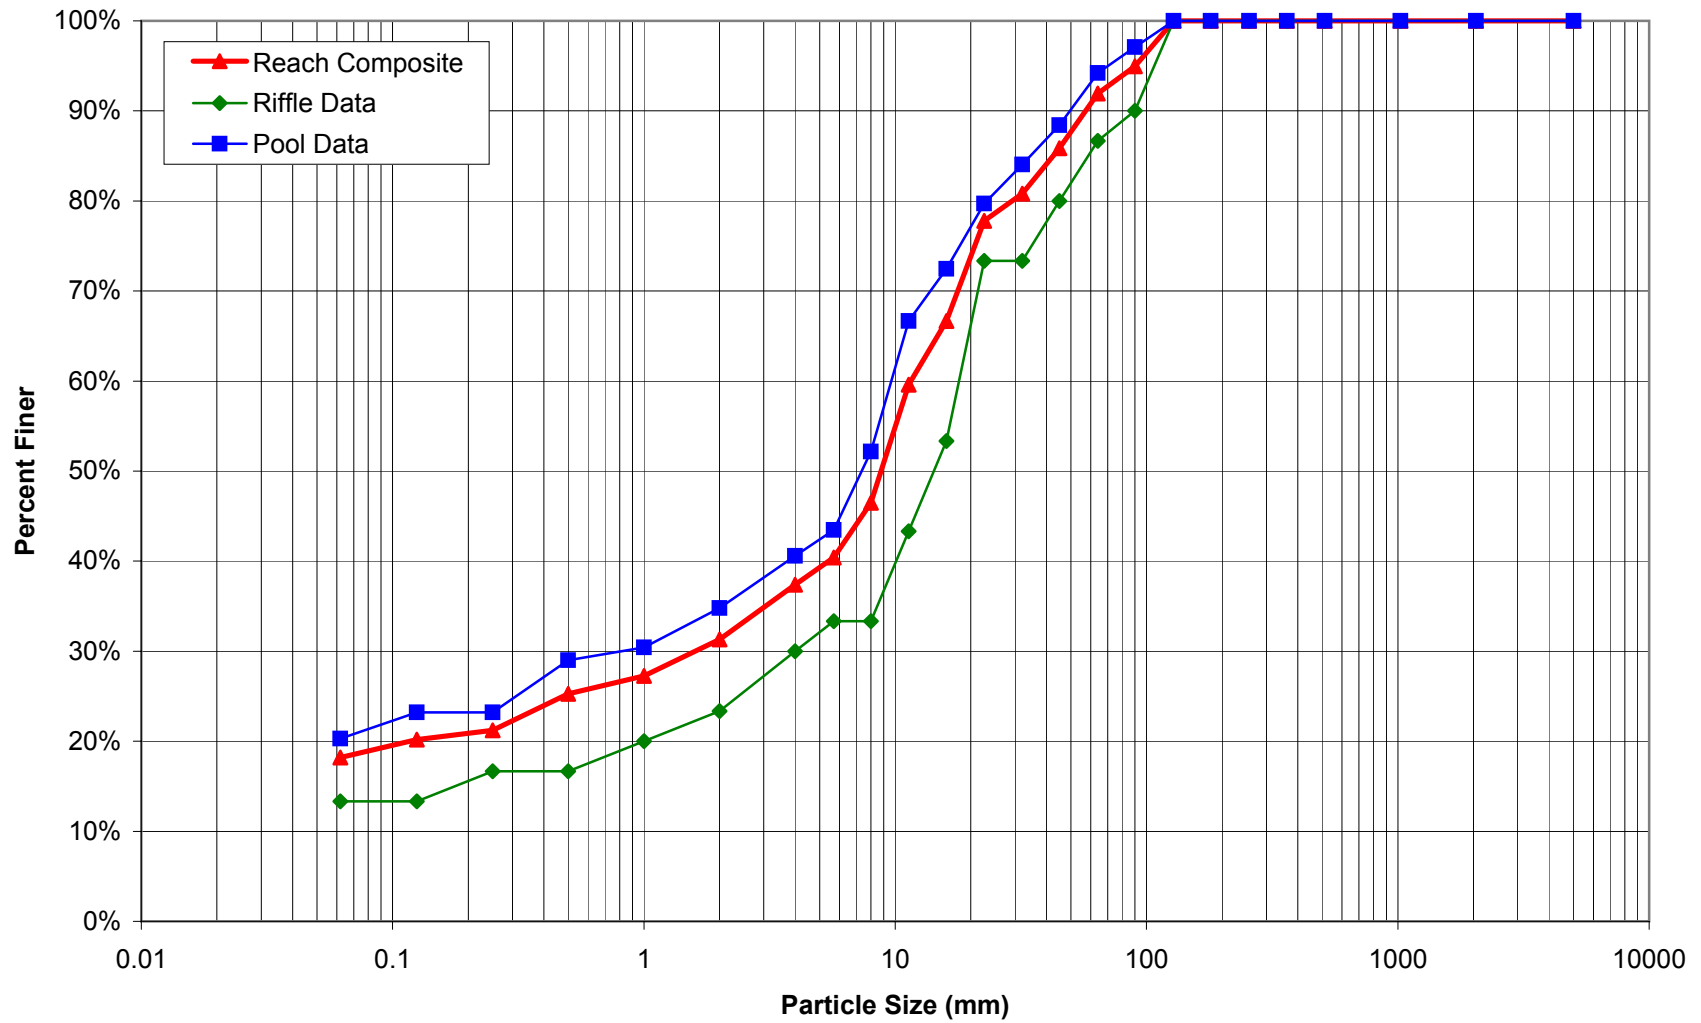
Spencer Creek

Pebble Count Particle Size Distributions

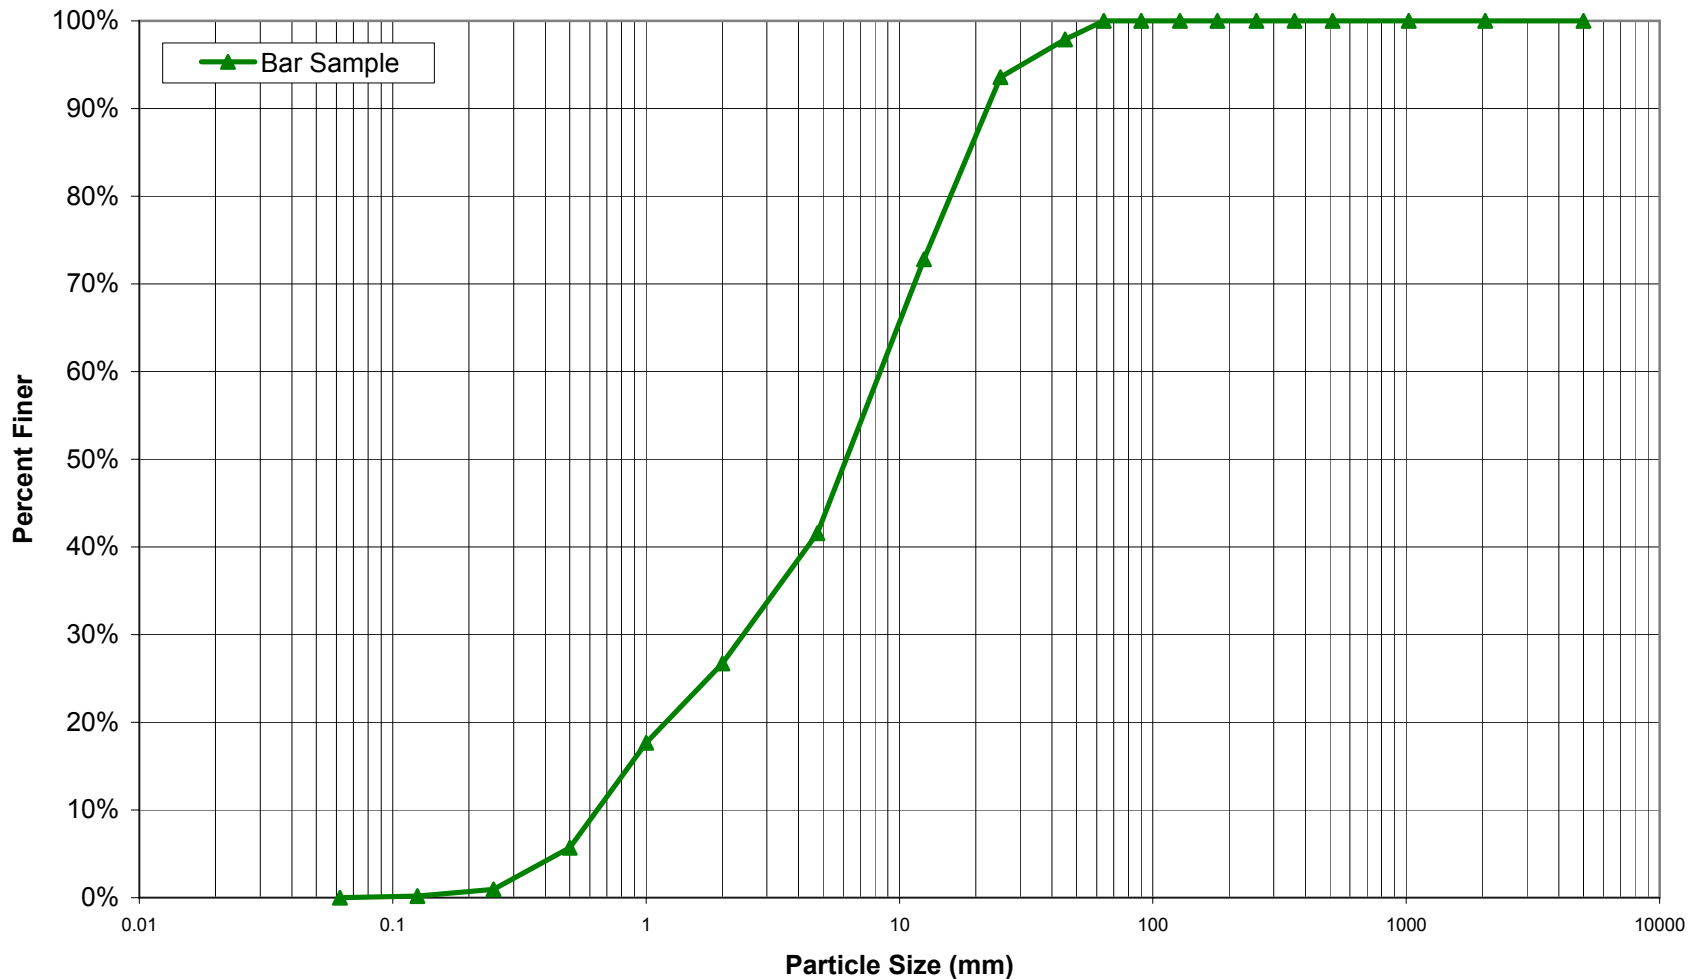
Spencer Creek
Bar Sample
Particle Size Distribution

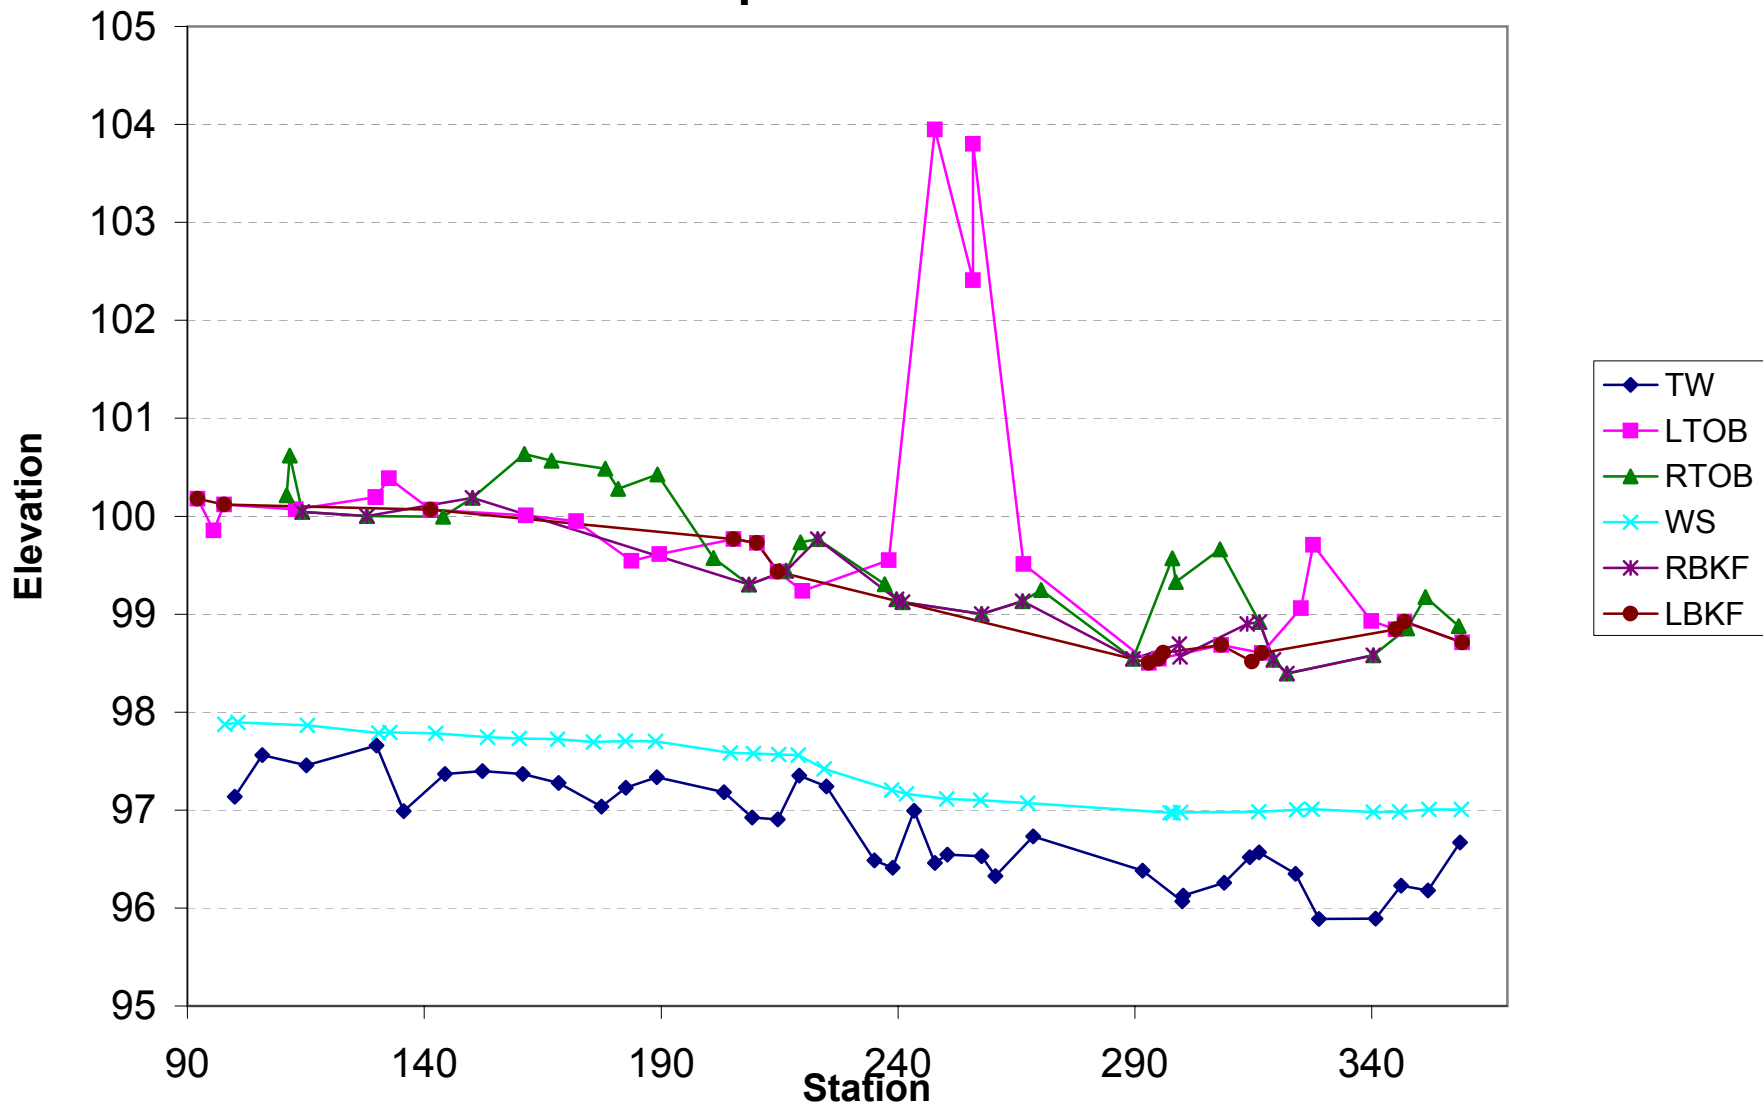
UT to Spencer Creek Profile
