UT to Barnes Creek Restoration Plan Montgomery County, North Carolina

Prepared For North Carolina Department of Environment and Natural Resources
Ecosystem Enhancement Program

Design Report Prepared By Buck Engineering PC

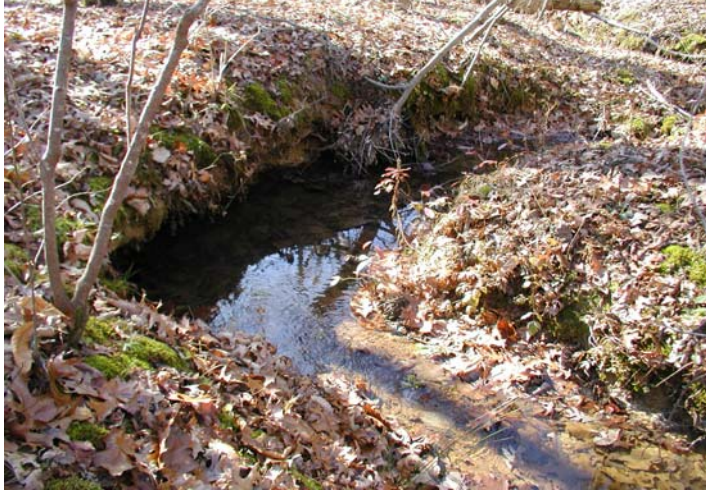
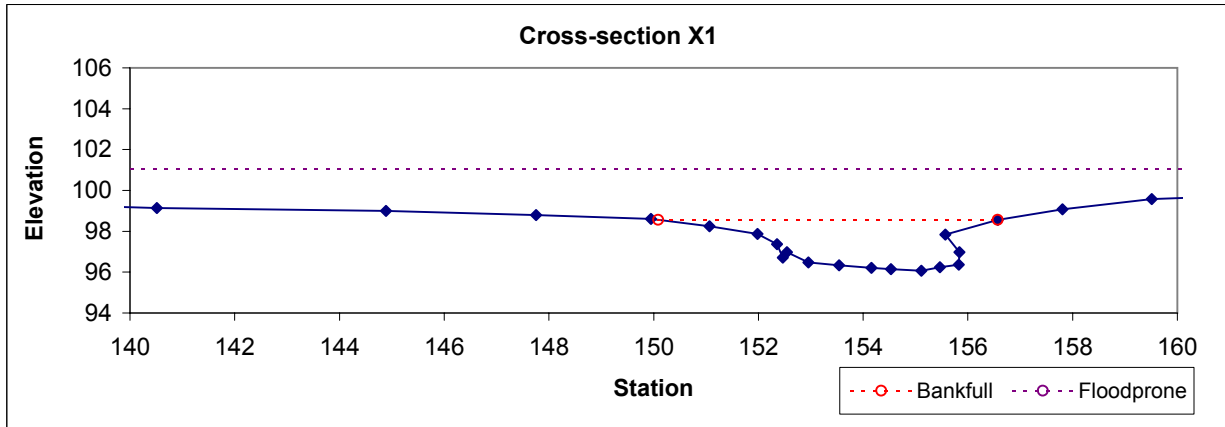
| Feature | Stream Type | BKF Area | BKF Width | BKF Depth | Max BKF Depth | W/D | BH Ratio | ER | BKF Elev | TOB Elev |
| Pool | | 8.8 | 6.48 | 1.39 | 2.5 | 4.66 | 1 | 17.5 | 98.56 | 98.61 |

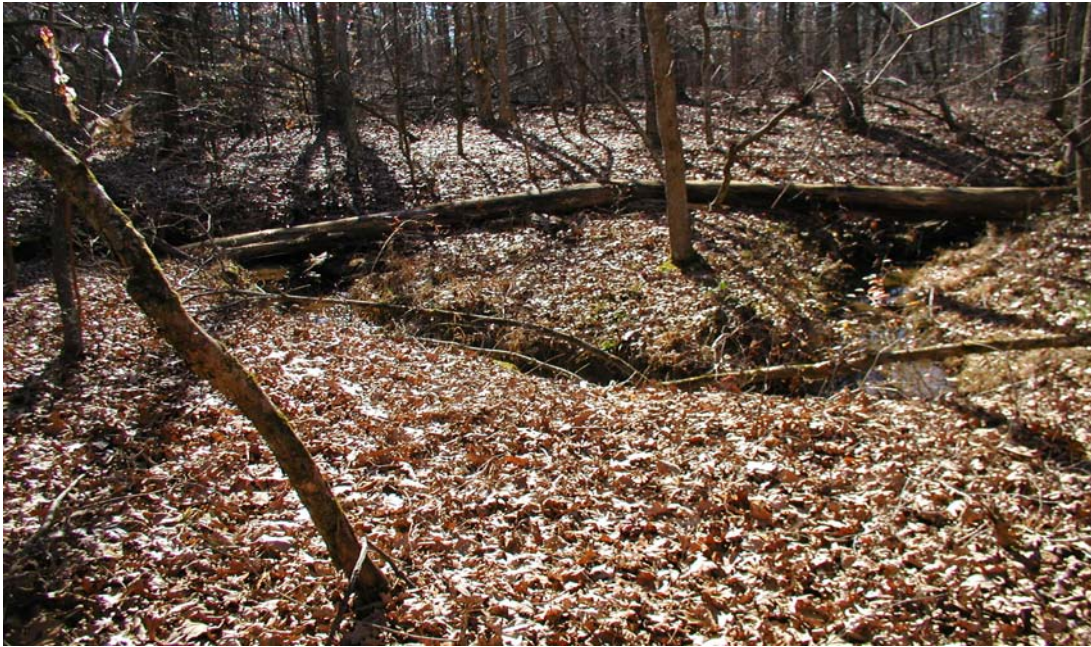
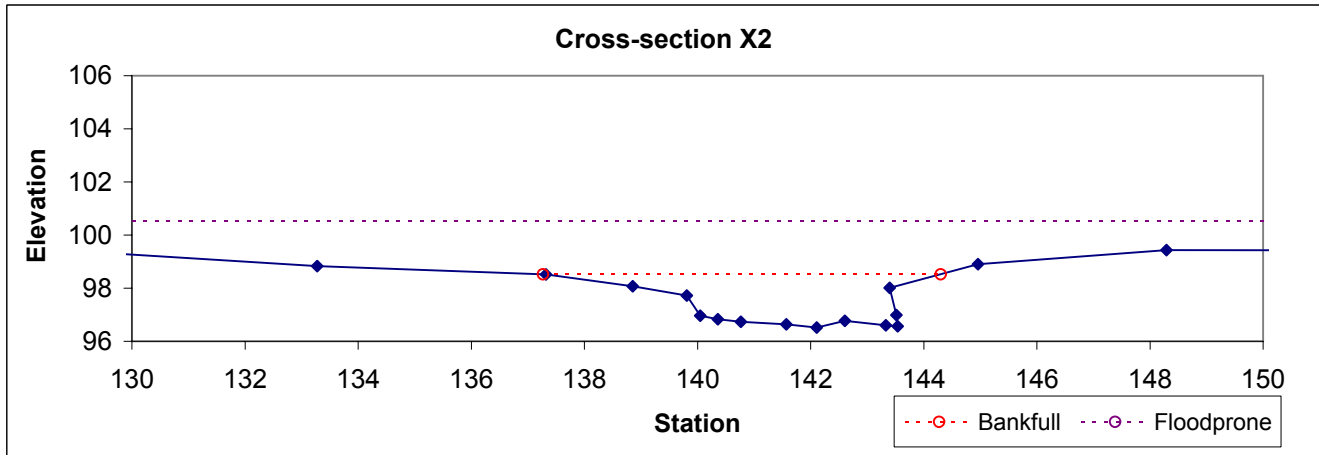
| Feature | Stream Type | BKF Area | BKF Width | BKF Depth | Max BKF Depth | W/D | BH Ratio | ER | BKF Elev | TOB Elev |
| Riffle | E | 7.7 | 7 | 1.1 | 2 | 6.41 | 1 | 11.57 | 98.52 | 98.52 |

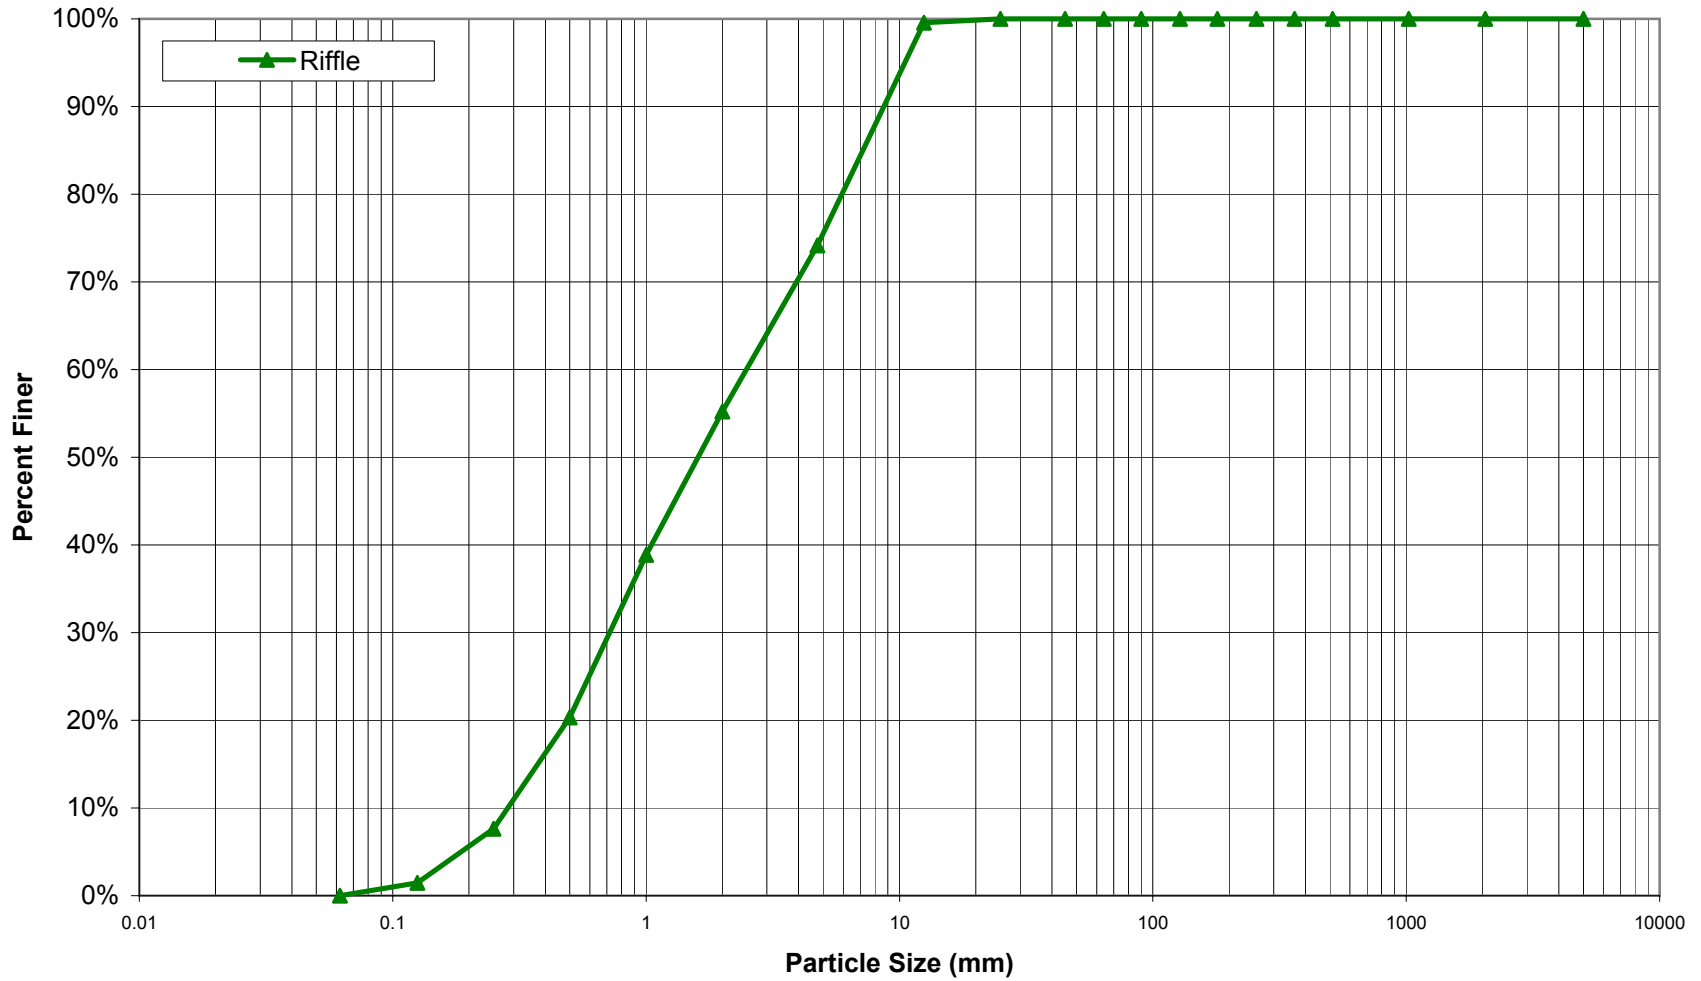
UT to Spencer Creek
Reach 1 Riffle
Particle Size Distribution

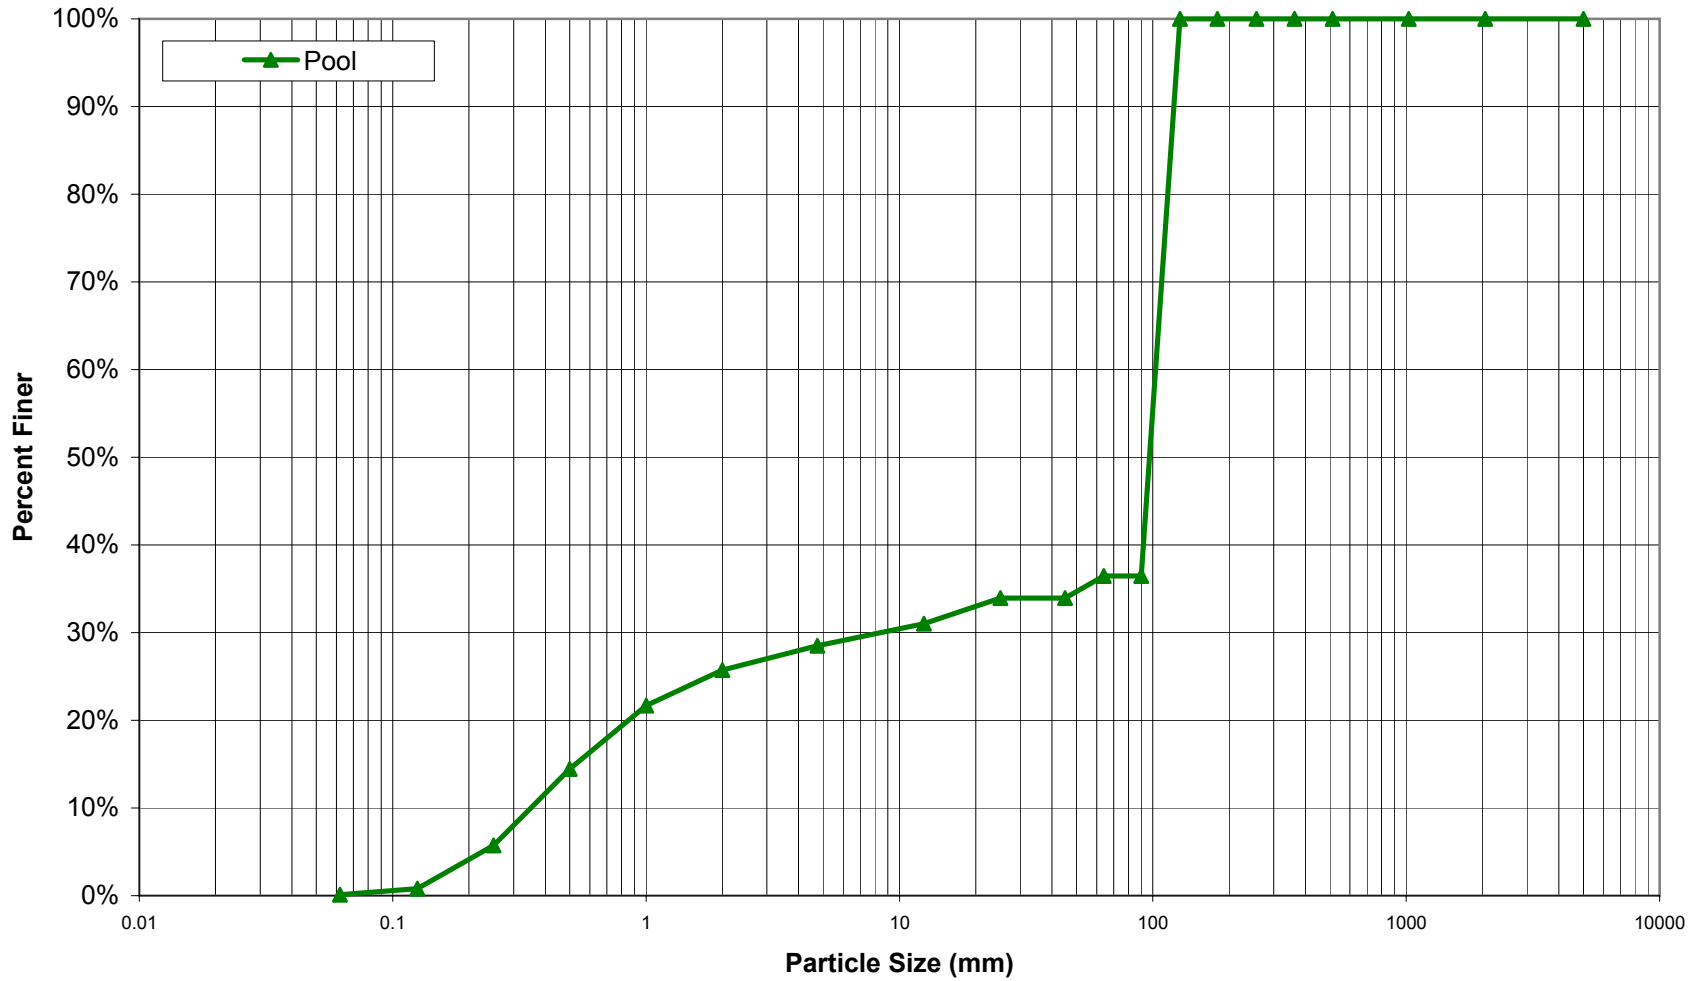
UT to Spencer Creek
Reach 1 Pool
Particle Size Distribution

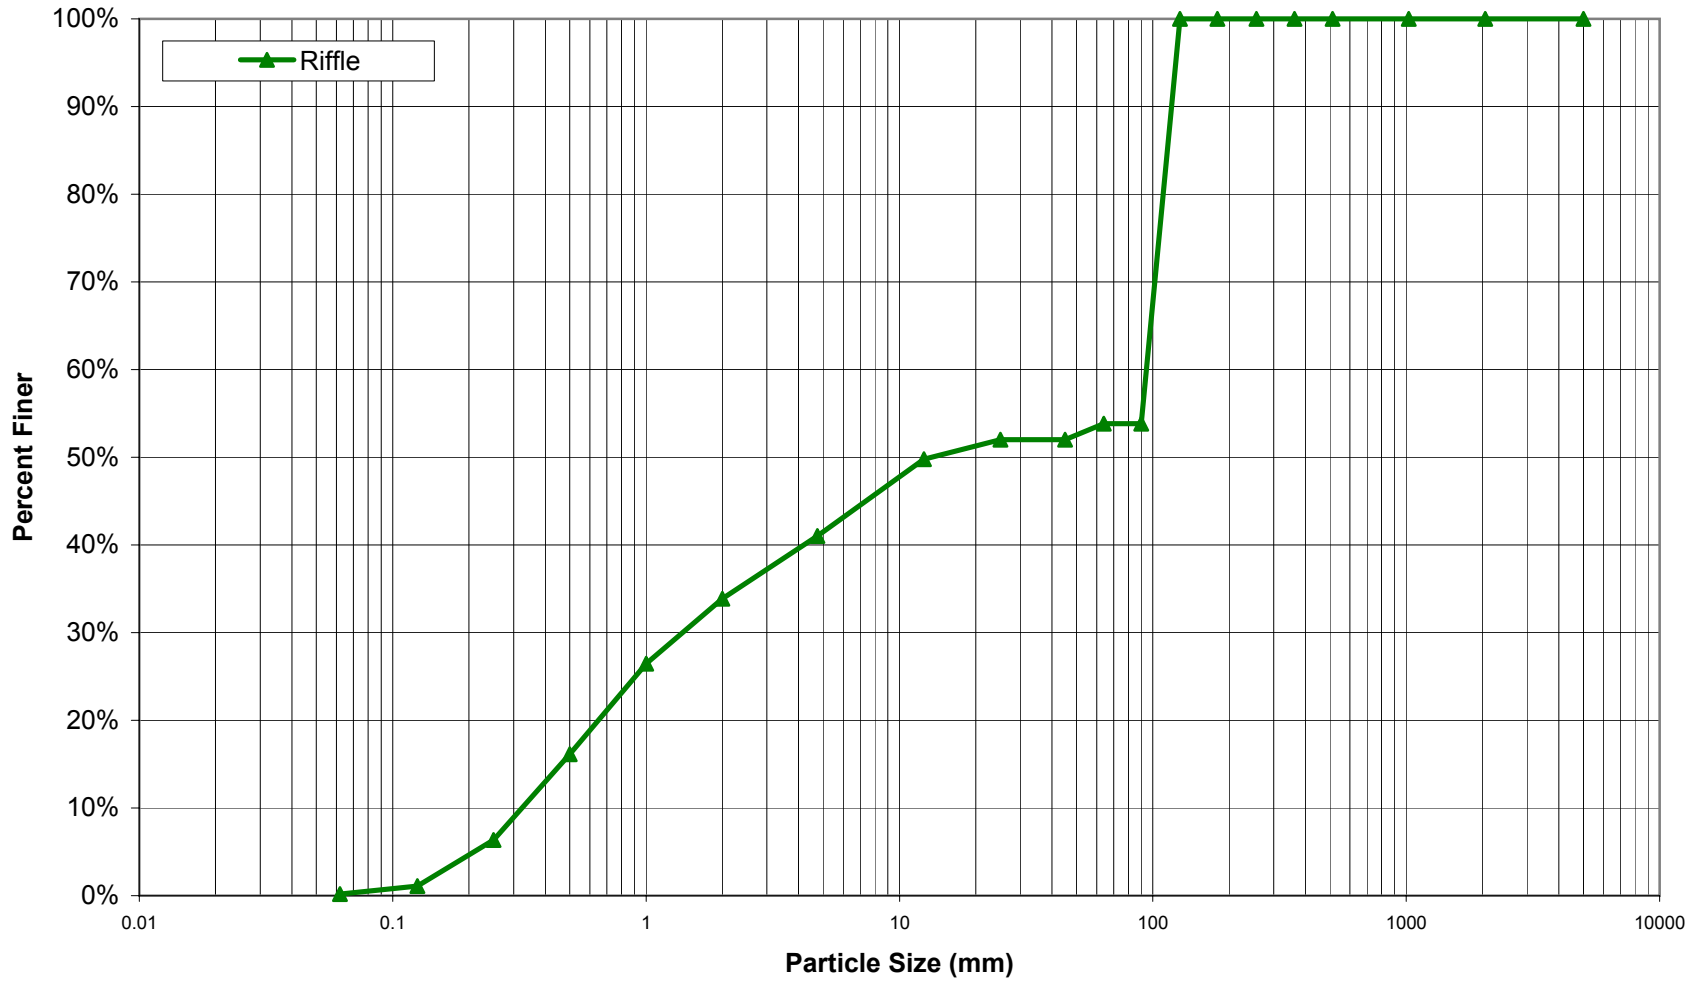
UT to Spencer Creek
Reach 1 Totals
Particle Size Distribution

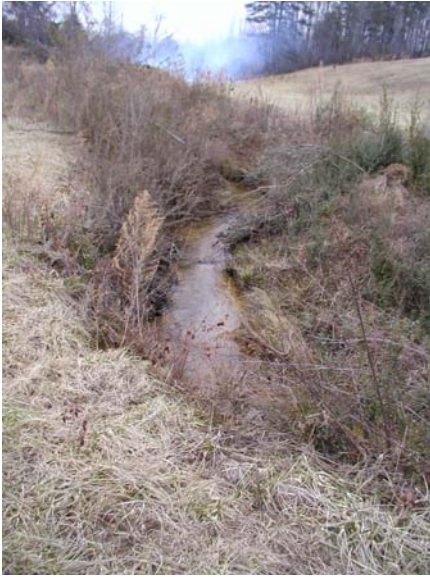
Existing UT on the Hurley property.

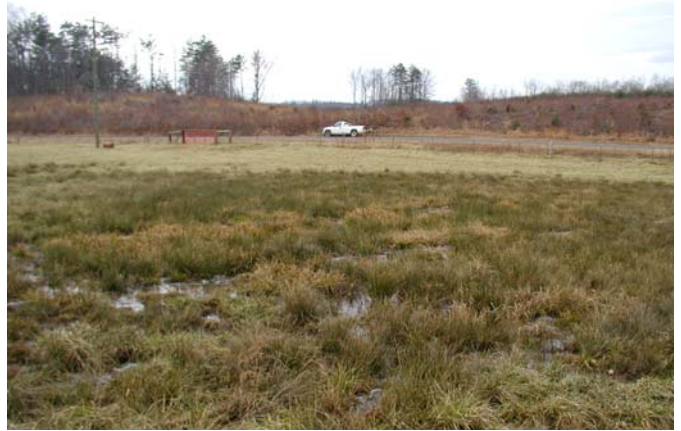
Existing active wetland area on the Hurley Property

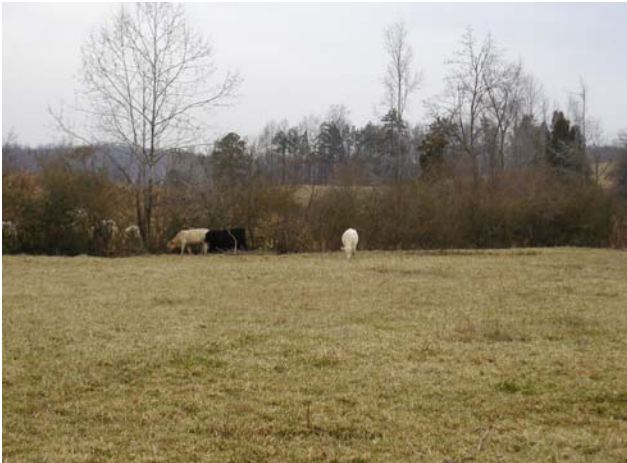
Grazing along the stream corridor on the Hurley property.

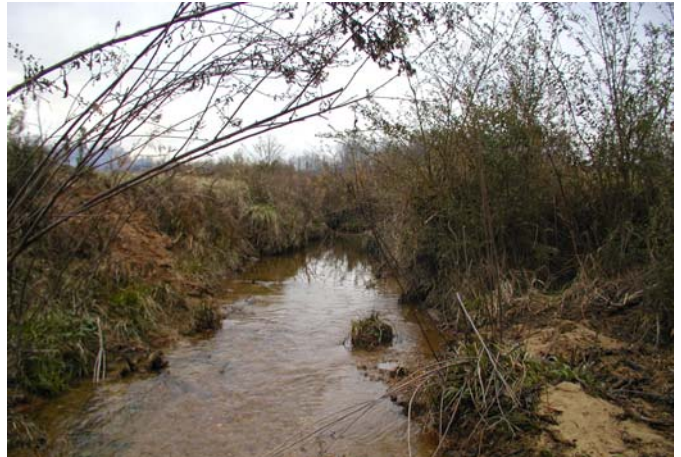
Localized stream overwidening on the Hurley property

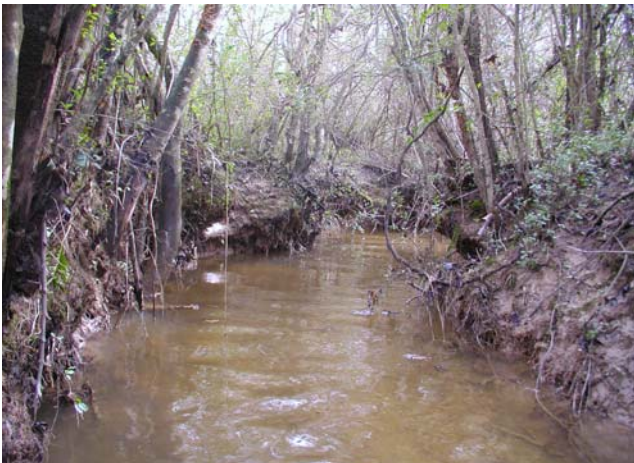
The UT on the Harris Property, overgrown with privet.

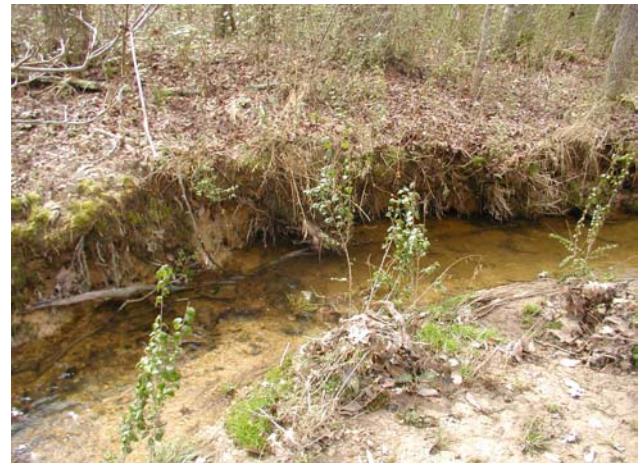
Bank erosion on a small tributary on the Harris property.

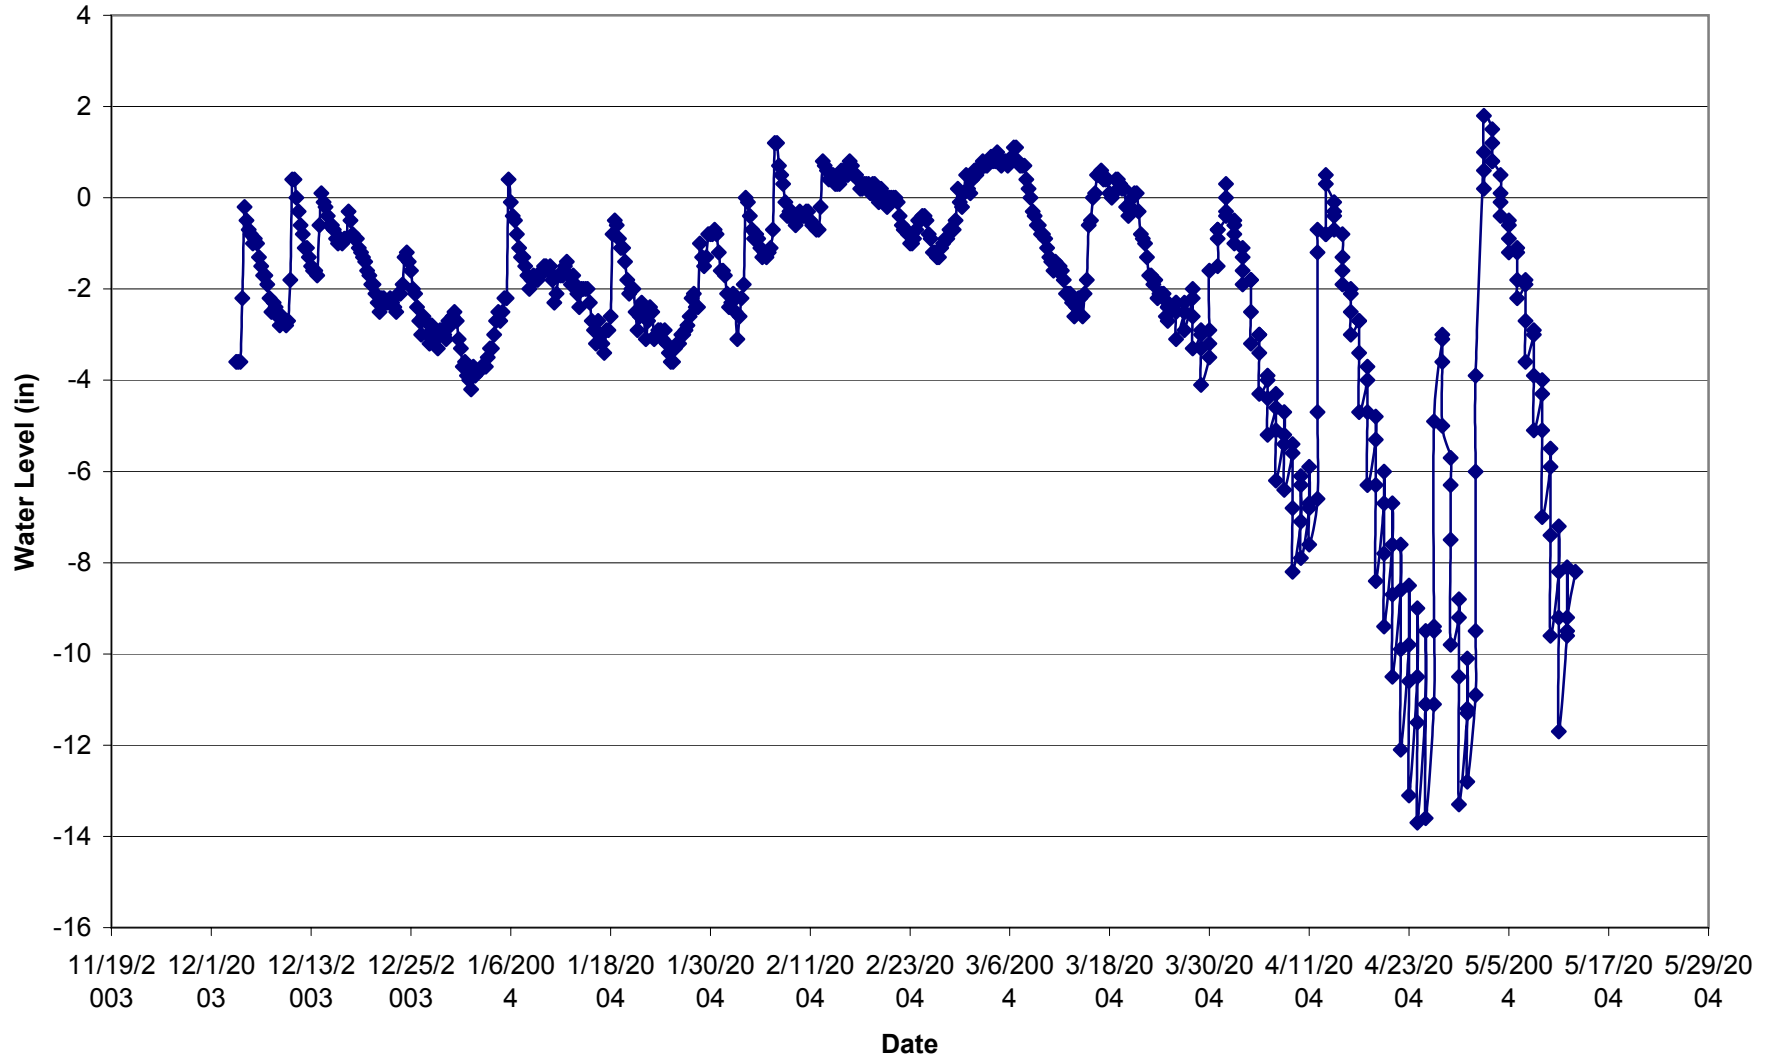
◆ Gauge 1

UT to Barnes Creek Gauge 1

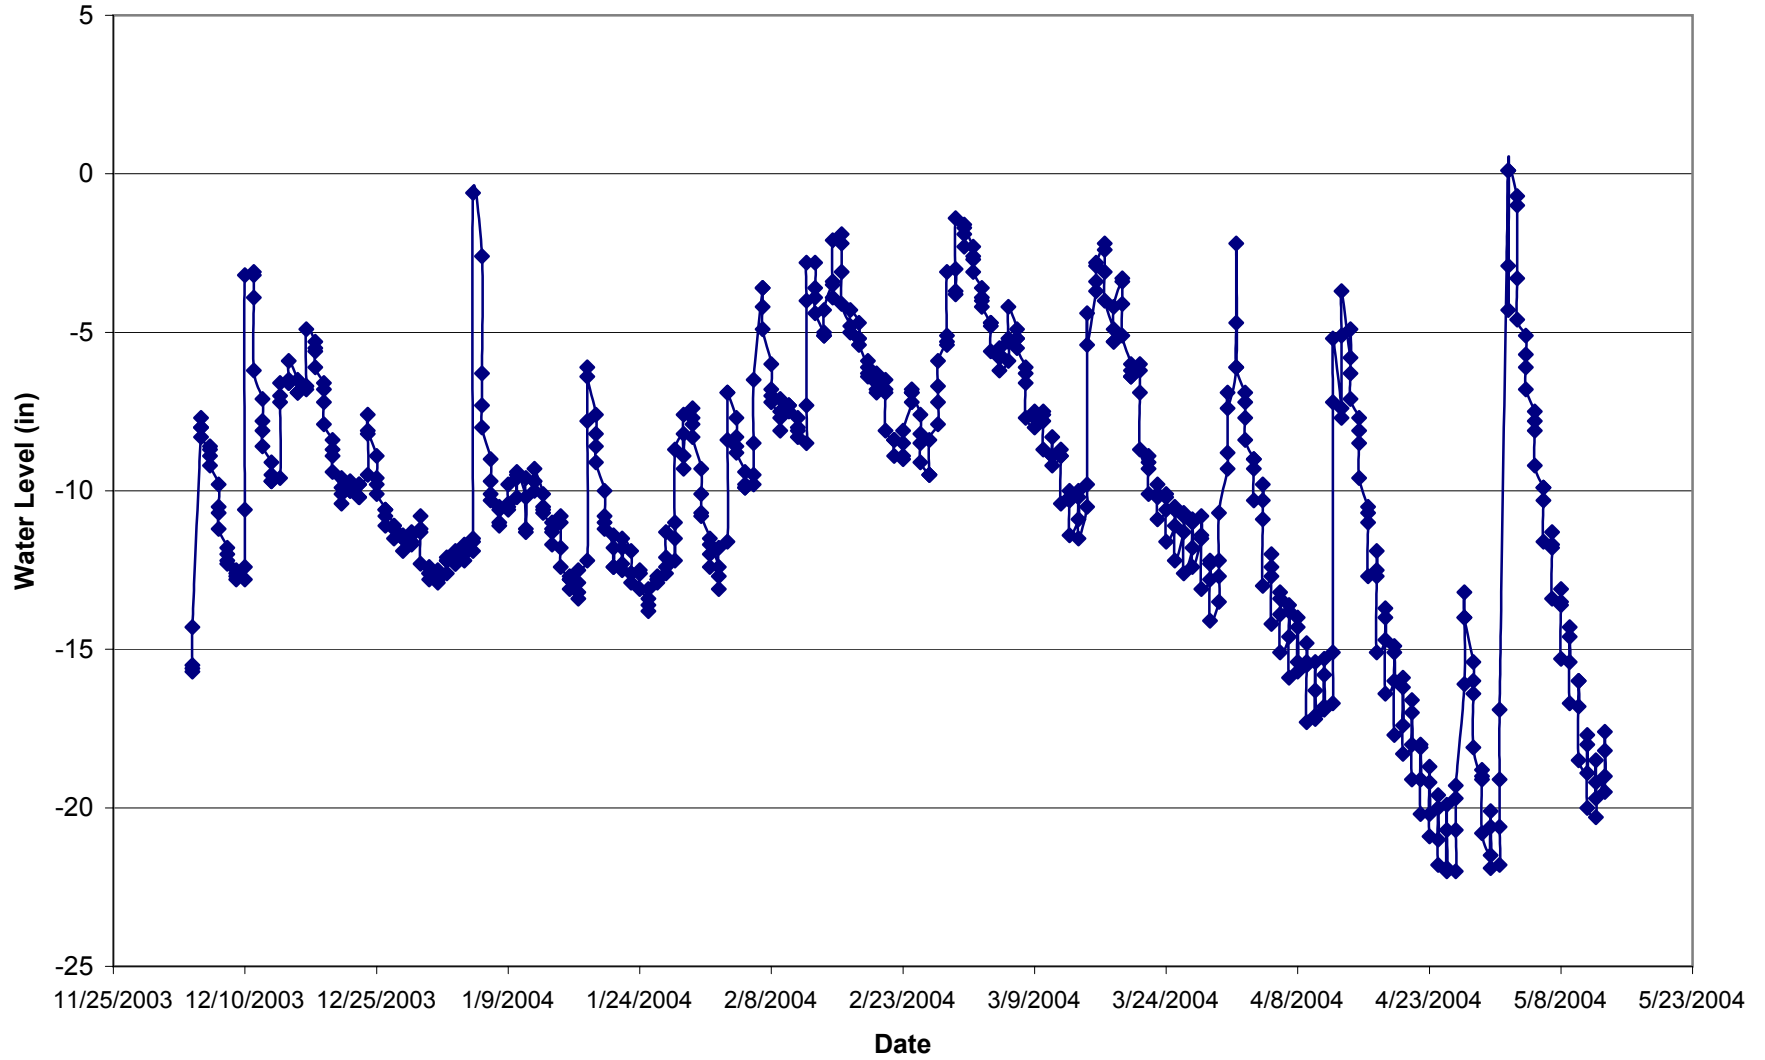
Ut to Barnes Creek
Gauge 2

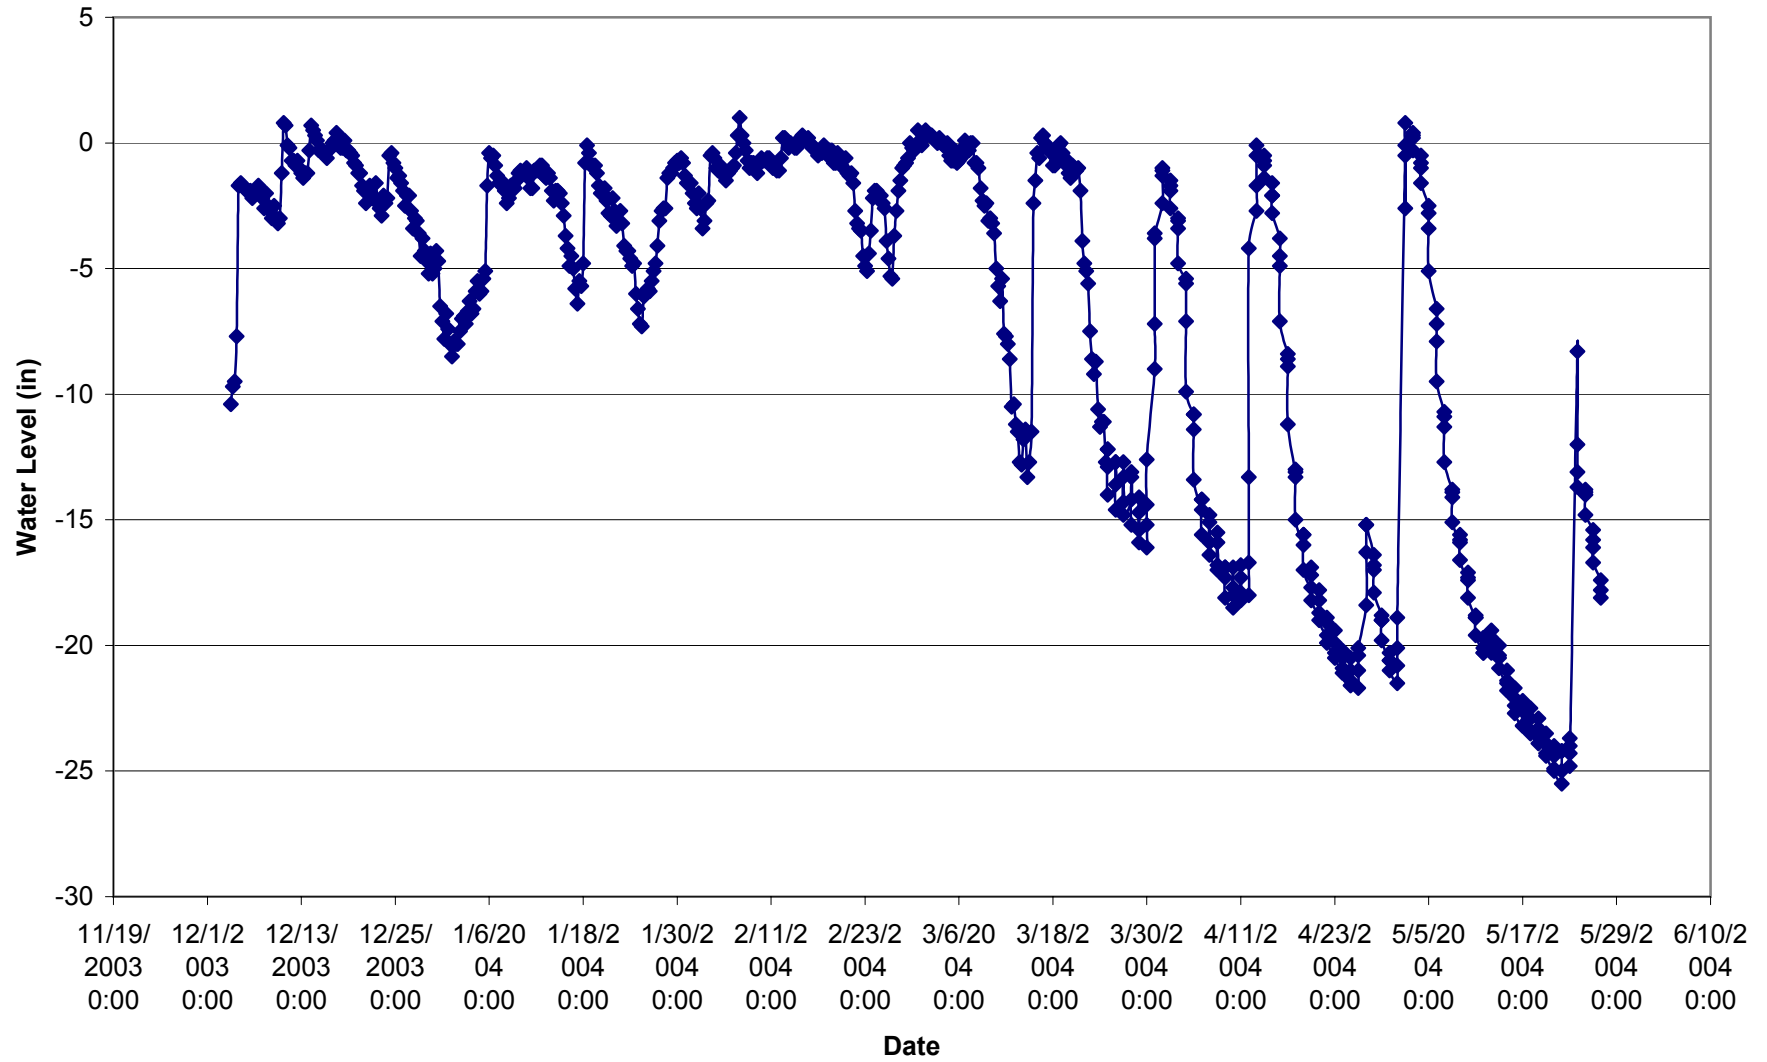
Ut to Barnes Creek Gauge 3

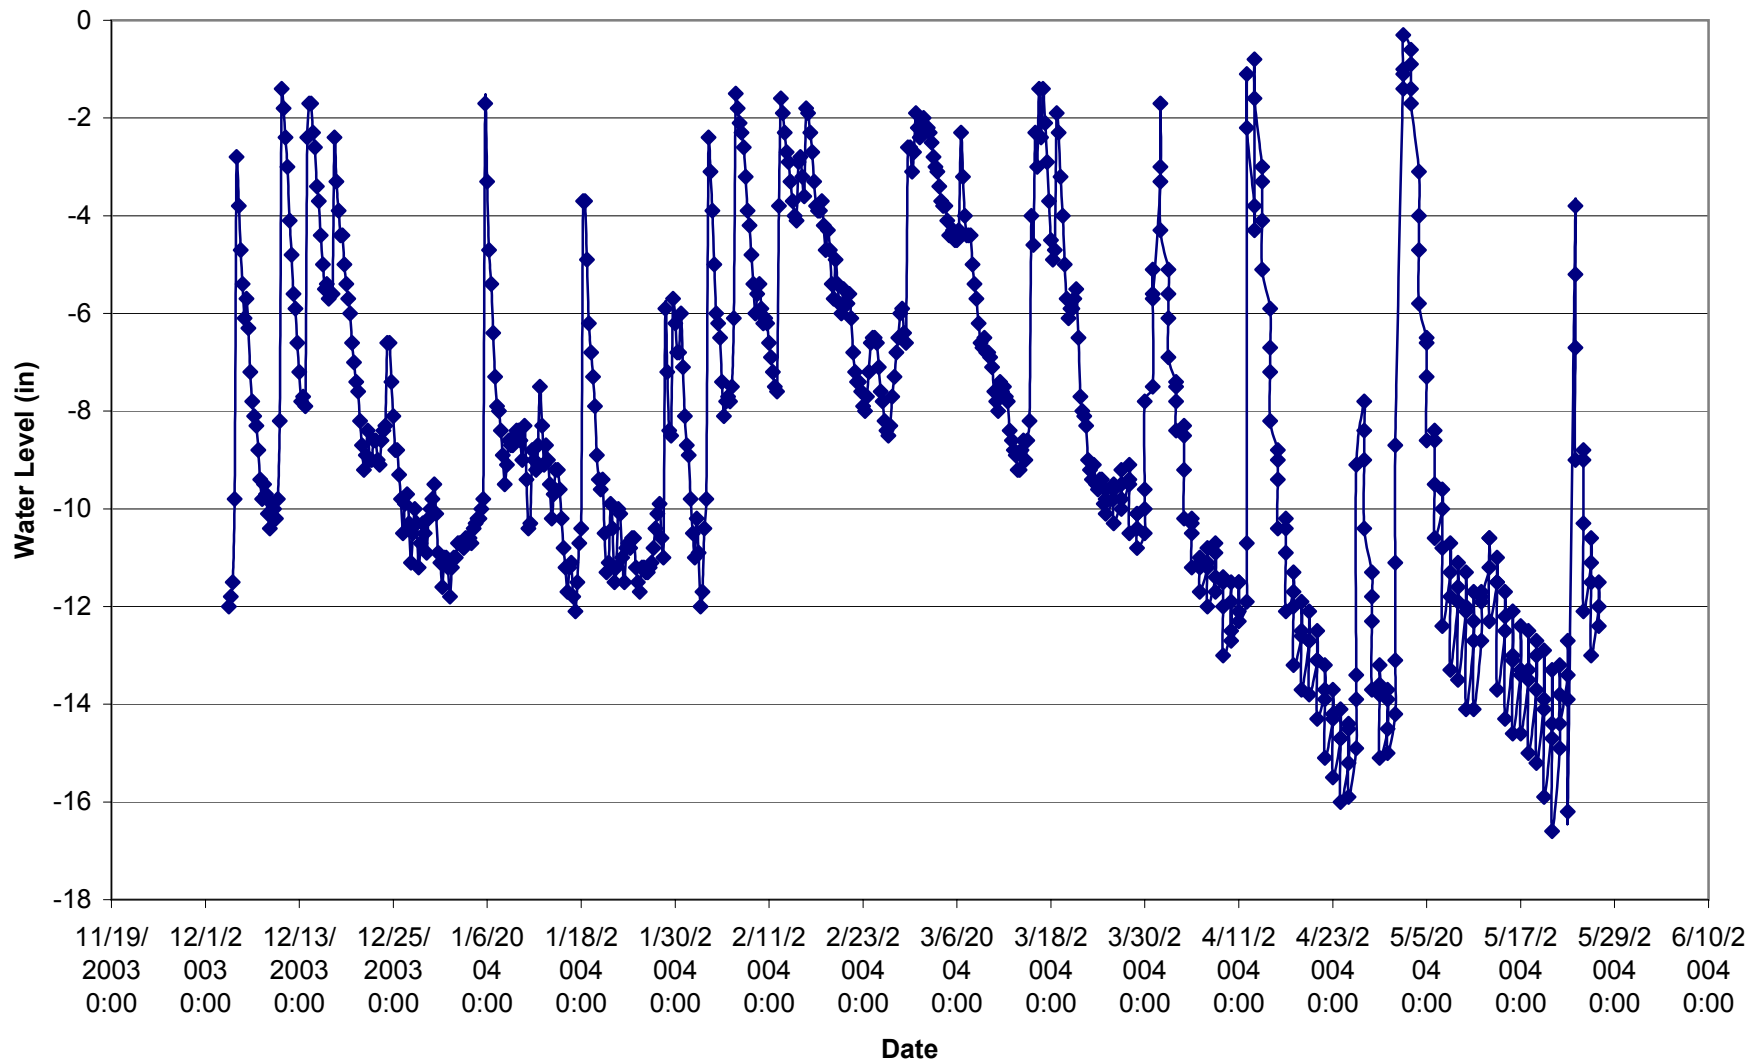
UT to Barnes Creek Gauge 4

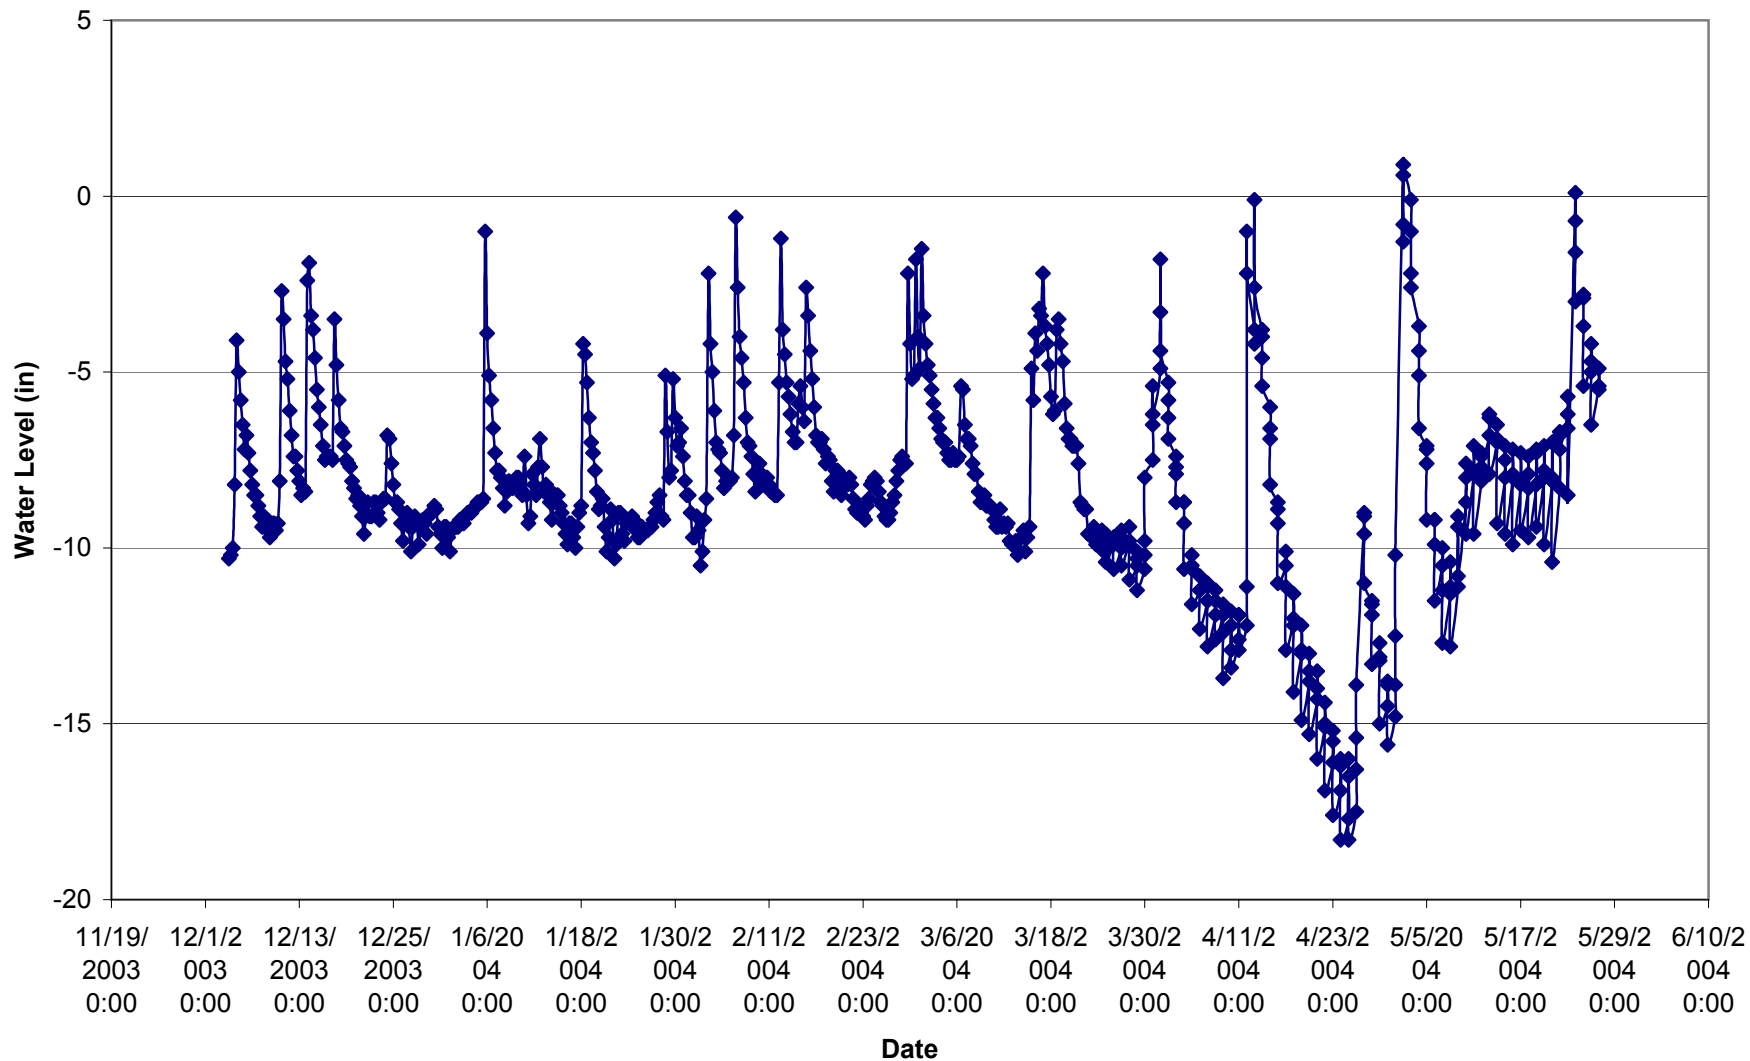
UT to Barnes Creek Gauge 5

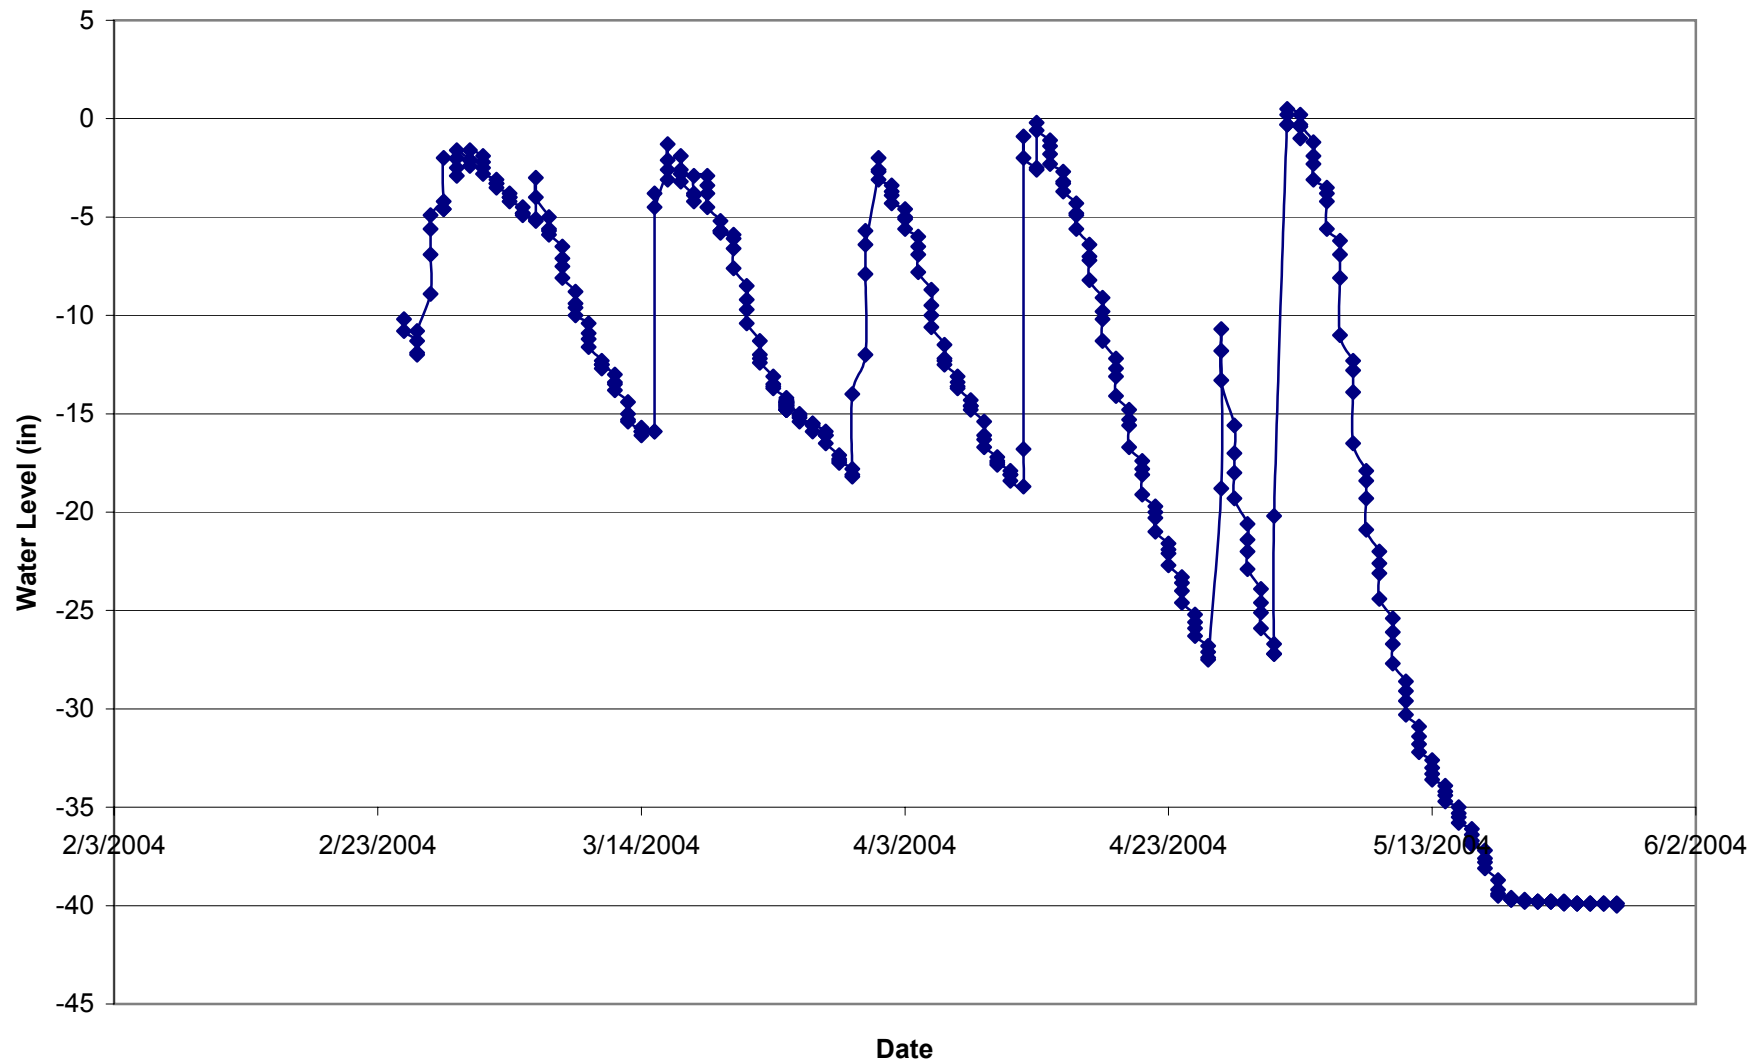
◆ Reference Gauge

UT to Barnes Creek Reference Gauge
