Stream Restoration Plan

**Unnamed Tributary to Cane Creek
(Pickard Property)
Alamance County, North Carolina
SCO File #020594101**

**Final Restoration Plan
February 13, 2006**

EXECUTIVE SUMMARY

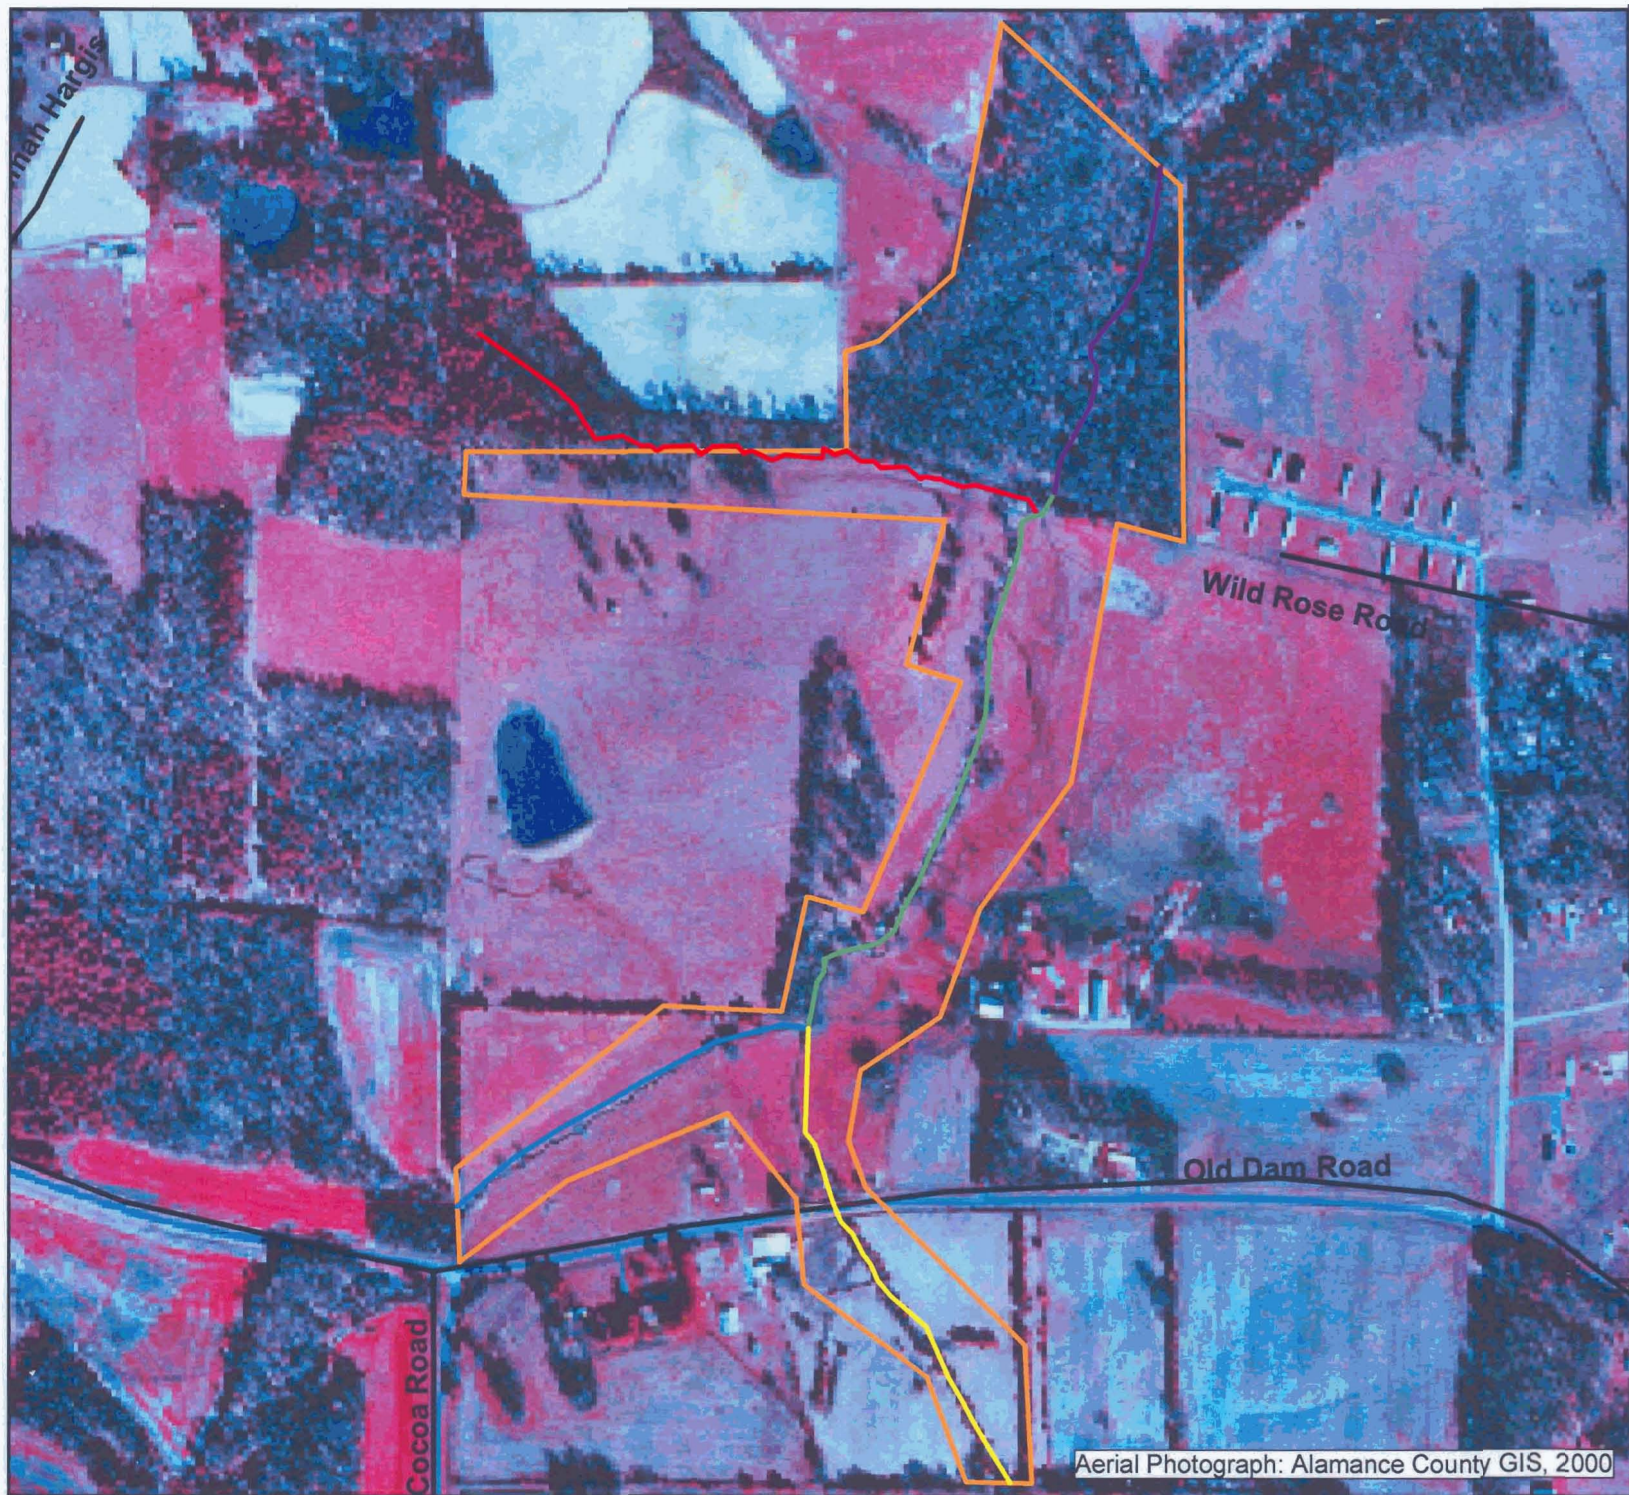
FIGURE 5
Watershed
Land Cover

Land Cover Data Source: NCCGIA 1996

The primary land uses in the project drainage area are agriculture and forest, with some residential development and secondary surface transportation routes. Land cover in the drainage area consists primarily of mixed upland forest and managed herbaceous cover (Figure 5: Watershed Land Cover).

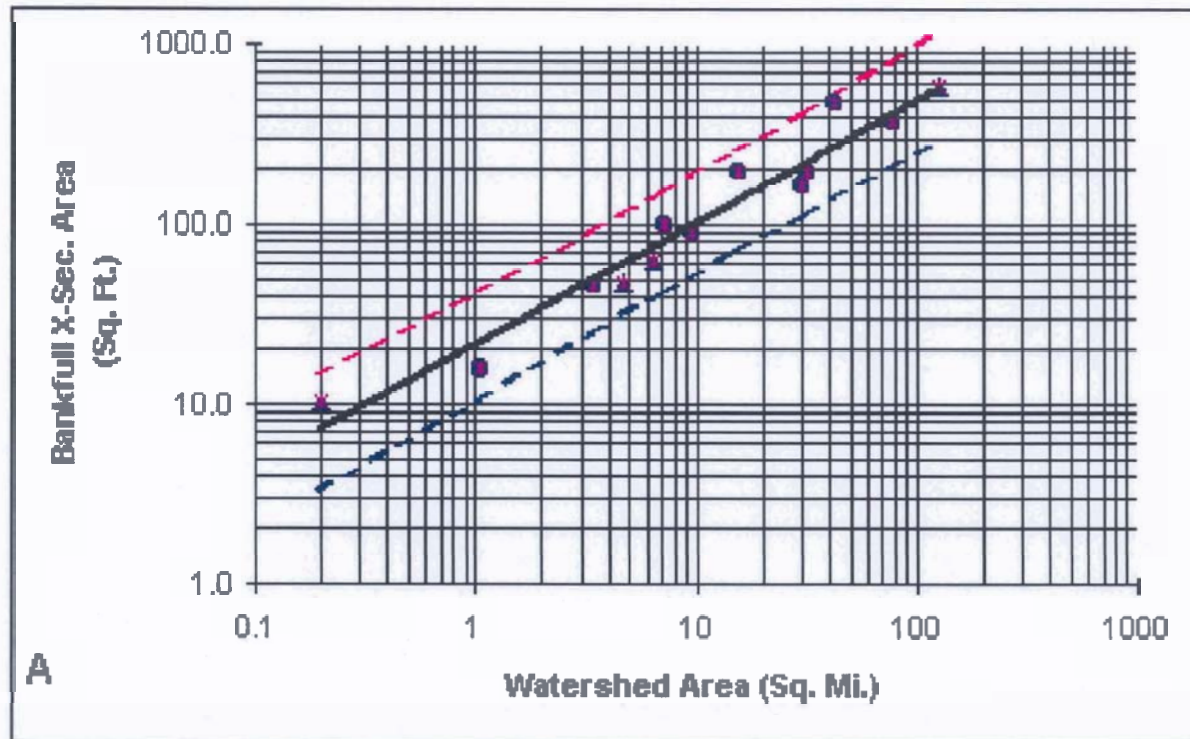
FIGURE 9

Bankfull hydraulic geometry relationships for rural Piedmont North Carolina Streams. The circles represent gauge stations and the triangles represent ungauged streams. The outside dashed lines are the 95% confidence intervals for all the data points.

The bankfull cross-sectional area for each project reach is consistent with the bankfull area regressed power function curve from the North Carolina Piedmont Rural Regional Curve; plotting within the 95% confidence limits (Figure 9: NC Rural Piedmont Regional Curve). The closest USGS gauging station is on the Rocky River near Crutchfield Crossroads. However, this gauge does not appropriately correlate with the Site due to lack of proximity and stream characteristics.

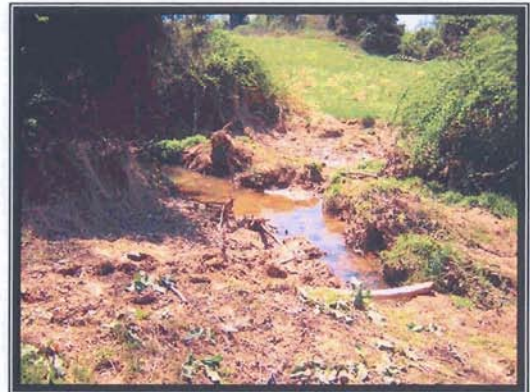
Photo 4 – UT to Cane Creek Reach A, cattle crossing

With the exception of Reach C, the Site is heavily impacted by cattle accessing the stream. The cattle repeatedly use the same pathways to the water, destroying vegetation and forming gullies in the banks. These conditions have created highly erosive areas where sediment can enter the channel and cover the natural substrate. Further, livestock waste products are deposited directly into the stream channel, causing substantial nutrient and fecal coliform loading.

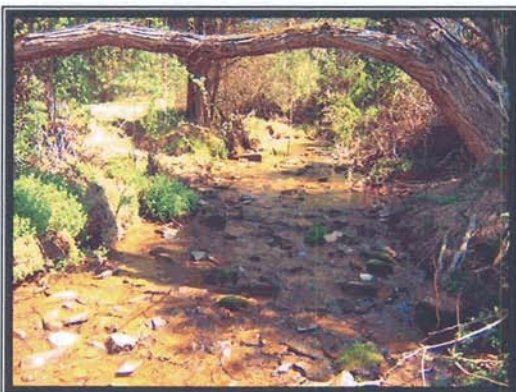
Photo 5 – Reach A riffle cross-section, looking downstream (upstream of Old Dam Road)

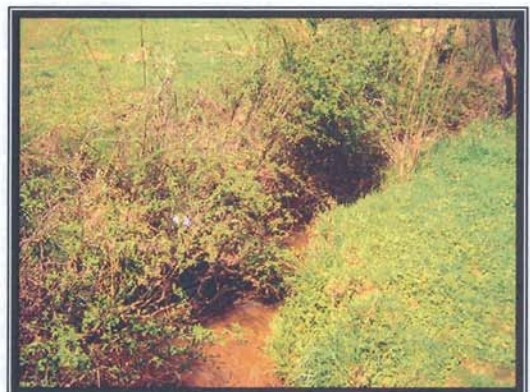
Photo 6 – Reach A pool cross-section, looking downstream (downstream of Old Dam Road)

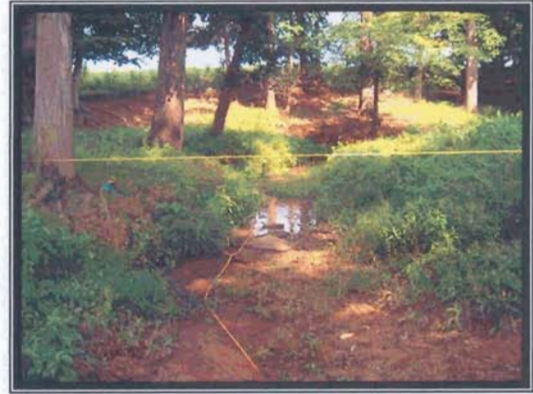
Photo 8 – Reach B riffle cross section, looking downstream

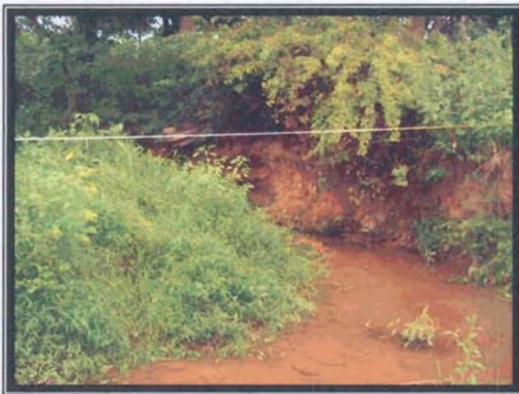
Photo 9 – Reach B pool cross section, looking upstream

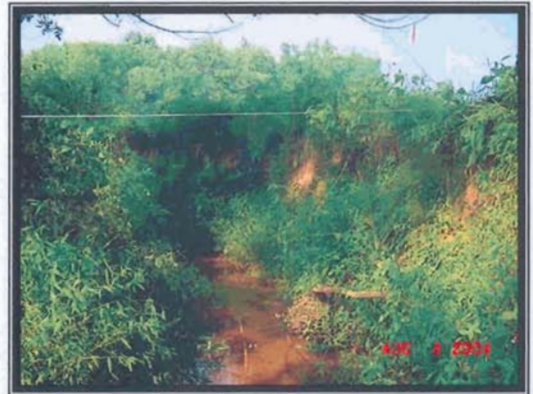
Photo 10 – Reach B riffle cross section, looking downstream

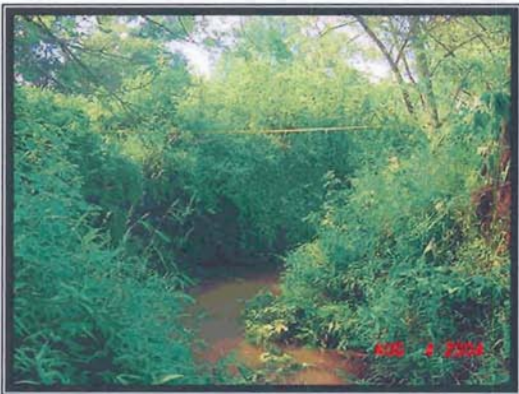
Photo 11 – Reach B pool cross section, looking downstream

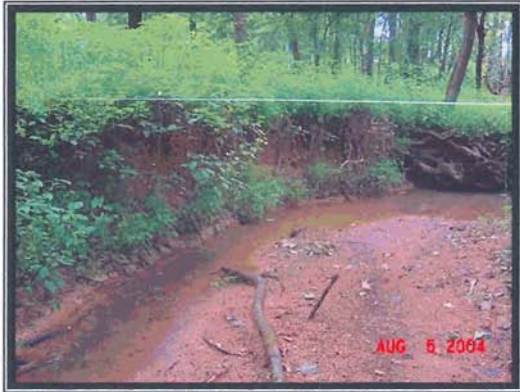
Photo 13 – Reach C riffle cross section, looking downstream

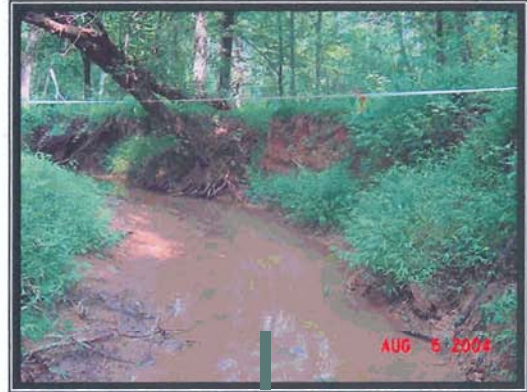
Photo 14 – Reach C pool cross section, looking downstream

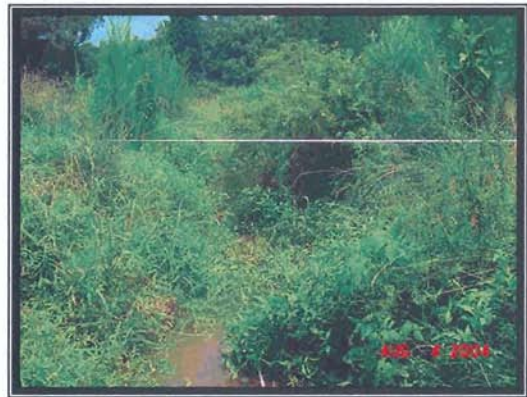
Photo 16 – Reach D riffle cross section, looking downstream

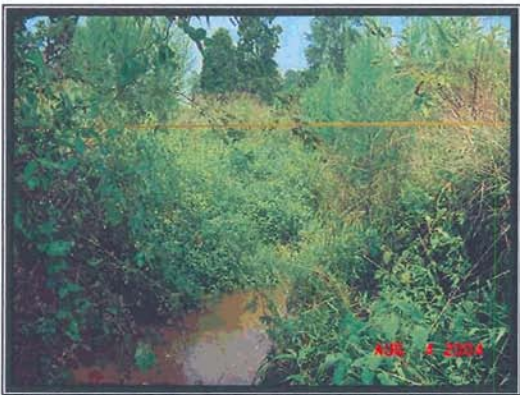
Photo 17 – Reach D pool cross section, looking downstream

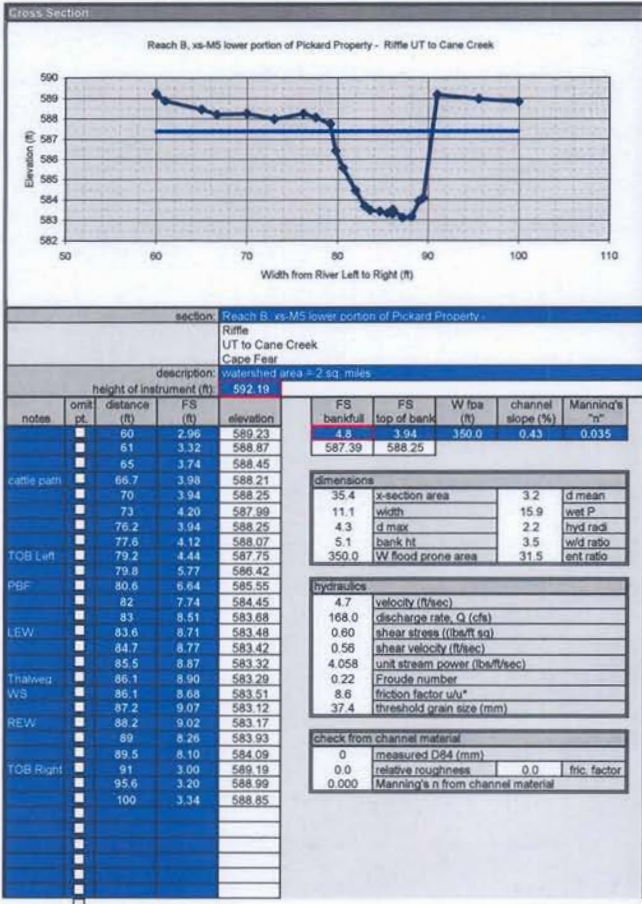
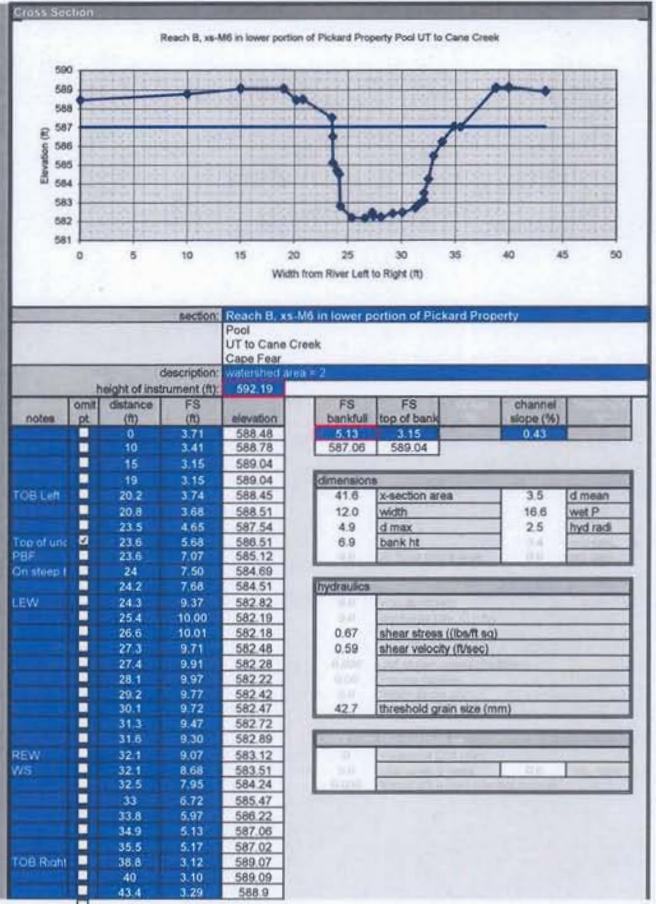
Slope Profile

UT Cane Creek Cape Fear Reach B

notes	cross section	station	Elevation BM				depth water	FS BKF	FS TOB	FS	FS	AZ azimuth	ELEV bed	ELEV water srf	ELEV BKF	ELEV TOB	ELEV -	ELEV -
			BS	HI	FS TP	FS bed												
Head of Pool		0	5.41	597.8		9.58	7.39	6.38				588.22	588.71	590.41	591.42			
Dmax		7		597.8		10.05						587.75						
Glide		11		597.8		9.59						588.21						
Top of Riffle		16.5		597.8		9.33	0.24					588.47	588.71					
Mid Riffle		22		597.8		9.29						588.51						
Bottom of f	xs-M7	30		597.8		9.38	0.26	7.33	6.86			588.42	588.68	590.47	590.94			
Run		32		597.8		9.5						588.3						
Run		39		597.8		9.46						588.34						
Top of Riffle		47		597.8		9.39	0.16					588.41	588.57					
Mid Riffle		55		597.8		9.47						588.33						
Bottom of Riffle		65		597.8		9.66	0.13	7.02	6.27			588.14	588.27	590.78	591.53			
Head of Pool		69		597.8		9.98						587.82						
Dmax		72		597.8		10.24						587.56						
Glide		77		597.8		10.03						587.77

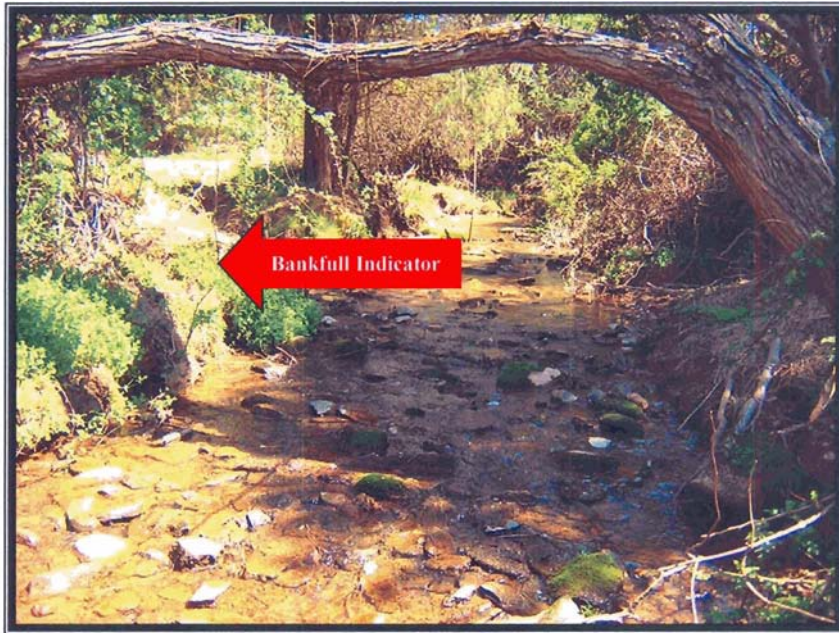
Reach A (Fogelman Property) Bankfull Indicator (looking downstream)

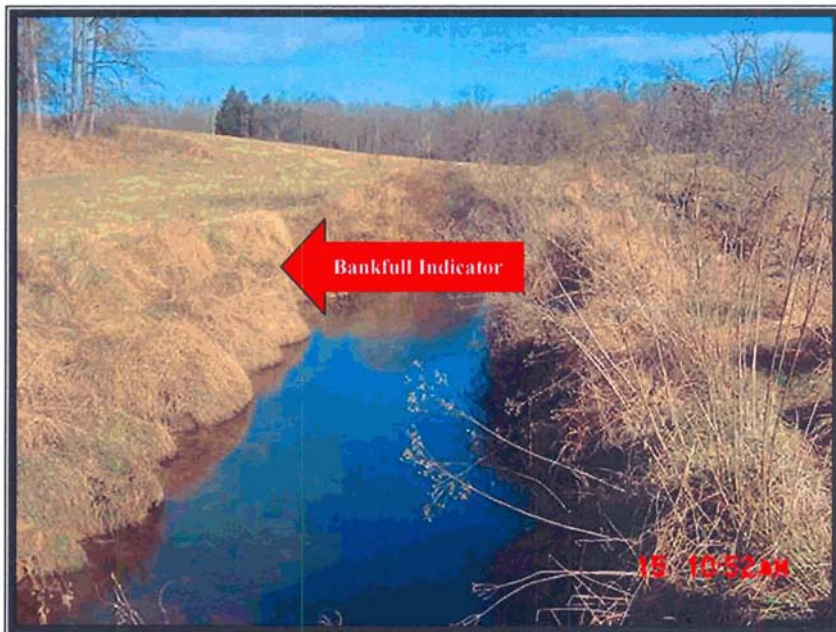
Reach B (Pickard Property) Bankfull Indicator (looking downstream)

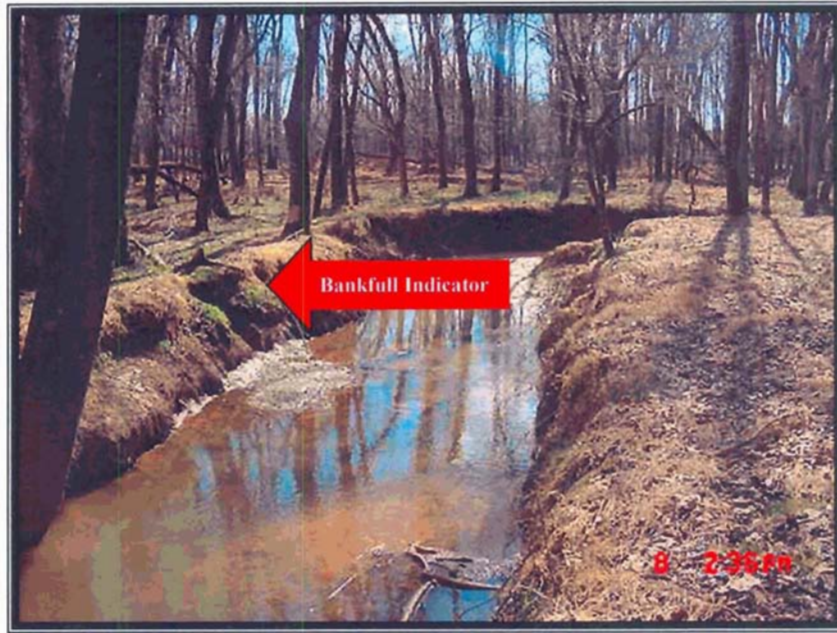
Reach C (Wright Property) Bankfull Indicator (looking downstream)

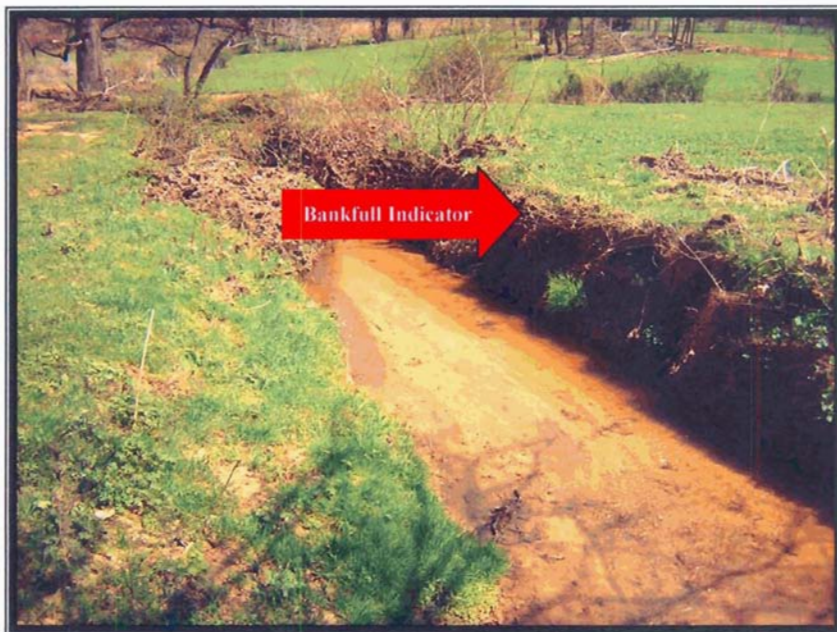
Reach D (Tributary 1) Bankfull Indicator (looking downstream)

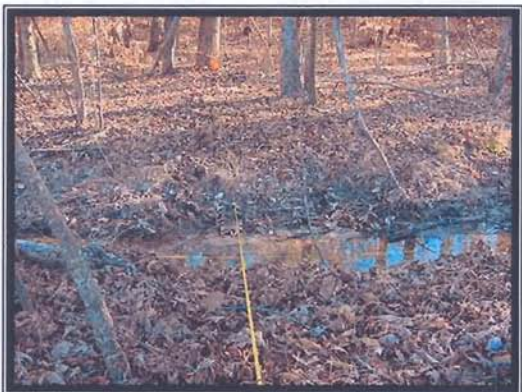
Photo 5 – A1, riffle cross section

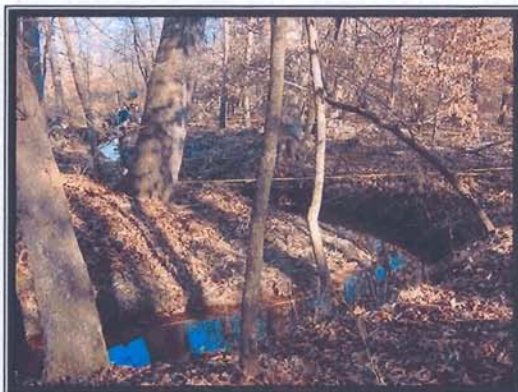
Photo 6 – A1, pool cross section

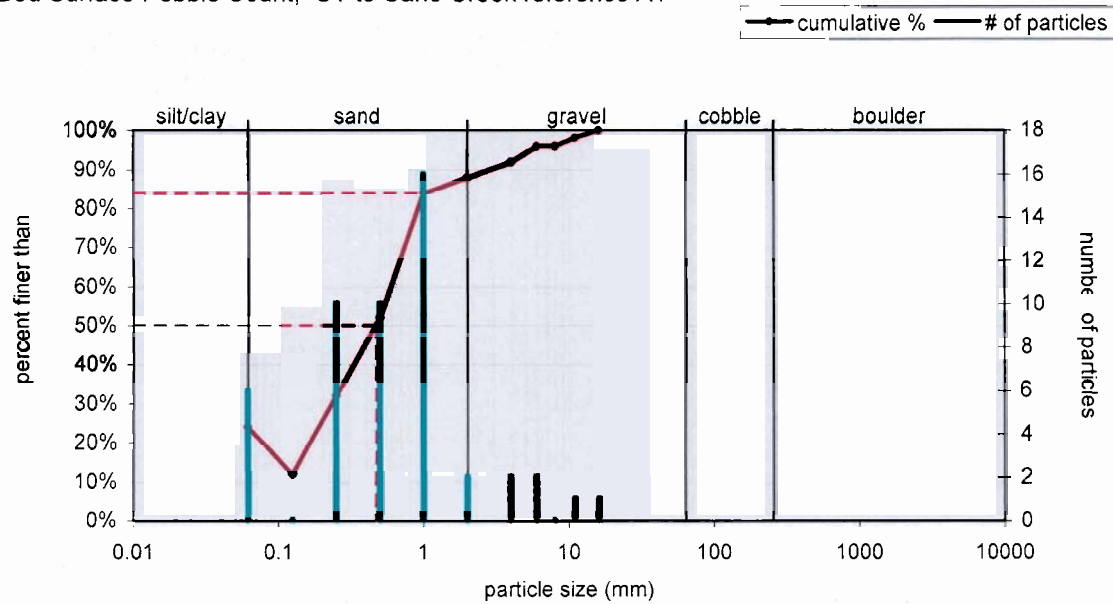
Bed Surface Pebble Count, UT to Cane Creek reference A1

Bed Surface		
Material	Size Range (mm)	Count
silt/clay	0 - 0.062	6
very fine sand	0.062 - 0.125	0
fine sand	0.125 - 0.25	10
medium sand	0.25 - 0.5	10
coarse sand	0.5 - 1	16
very coarse sand	1 - 2	2
very fine gravel	2 - 4	2
fine gravel	4 - 6	2
fine gravel	6 - 8	0
medium gravel	8 - 11	1
medium gravel	11 - 16	1
coarse gravel	16 - 22	
coarse gravel	22 - 32	
very coarse gravel	32 - 45	
very coarse gravel	45 - 64	
small cobble	64 - 90	
medium cobble	90 - 128	
large cobble	128 - 180	
very large cobble	180 - 256	
small boulder	256 - 362	
small boulder	362 - 512	
medium boulder	512 - 1024	
large boulder	1024 - 2048	
very large boulder	2048 - 4096	
total particle count:		50
bedrock	-----	
clay hardpan	-----	
detritus/wood	-----	
artificial	-----	
total count:		50
Note:

Size (mm)			Size Distribution		Type	
D16	0.062	3.4	mean	0.2	silt/clay	12%
D35	0.28	12	dispersion	4.9	sand	76%
D50	0.47	17	skewness	-0.25	gravel	12%
D65	0.66	20			cobble	0%
D84	1	29			boulder	0%
D95	5.4	39

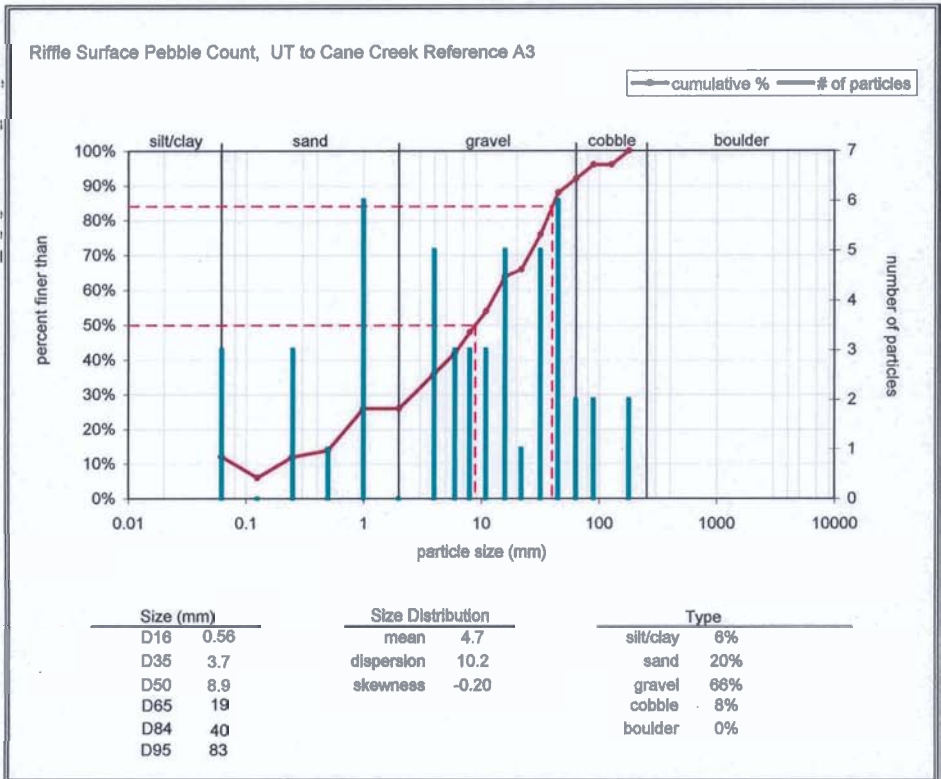
Riffle Surface		
Material	Size Range (mm)	Count
silt/clay	0 - 0.062	3
very fine sand	0.062 - 0.125	0
fine sand	0.125 - 0.25	3
medium sand	0.25 - 0.5	1
coarse sand	0.5 - 1	6
very coarse sand	1 - 2	0
very fine gravel	2 - 4	5
fine gravel	4 - 6	3
fine gravel	6 - 8	3
medium gravel	8 - 11	3
medium gravel	11 - 16	5
coarse gravel	16 - 22	1
coarse gravel	22 - 32	5
very coarse gravel	32 - 45	6
very coarse gravel	45 - 64	2
small cobble	64 - 90	2
medium cobble	90 - 128	
large cobble	128 - 180	2
very large cobble	180 - 256	
small boulder	256 - 362	
small boulder	362 - 512	
medium boulder	512 - 1024	
large boulder	1024 - 2048	
very large boulder	2048 - 4096	
total particle count:		50
bedrock		
clay hardpan		
detritus/wood		
artificial		
total count:		50
