**Year 3 Annual Monitoring Document**

**UT to Haw River (#747)**

**Alamance County**

Data Collection Period: August 26, 2014  
Submission Date: December 16, 2014

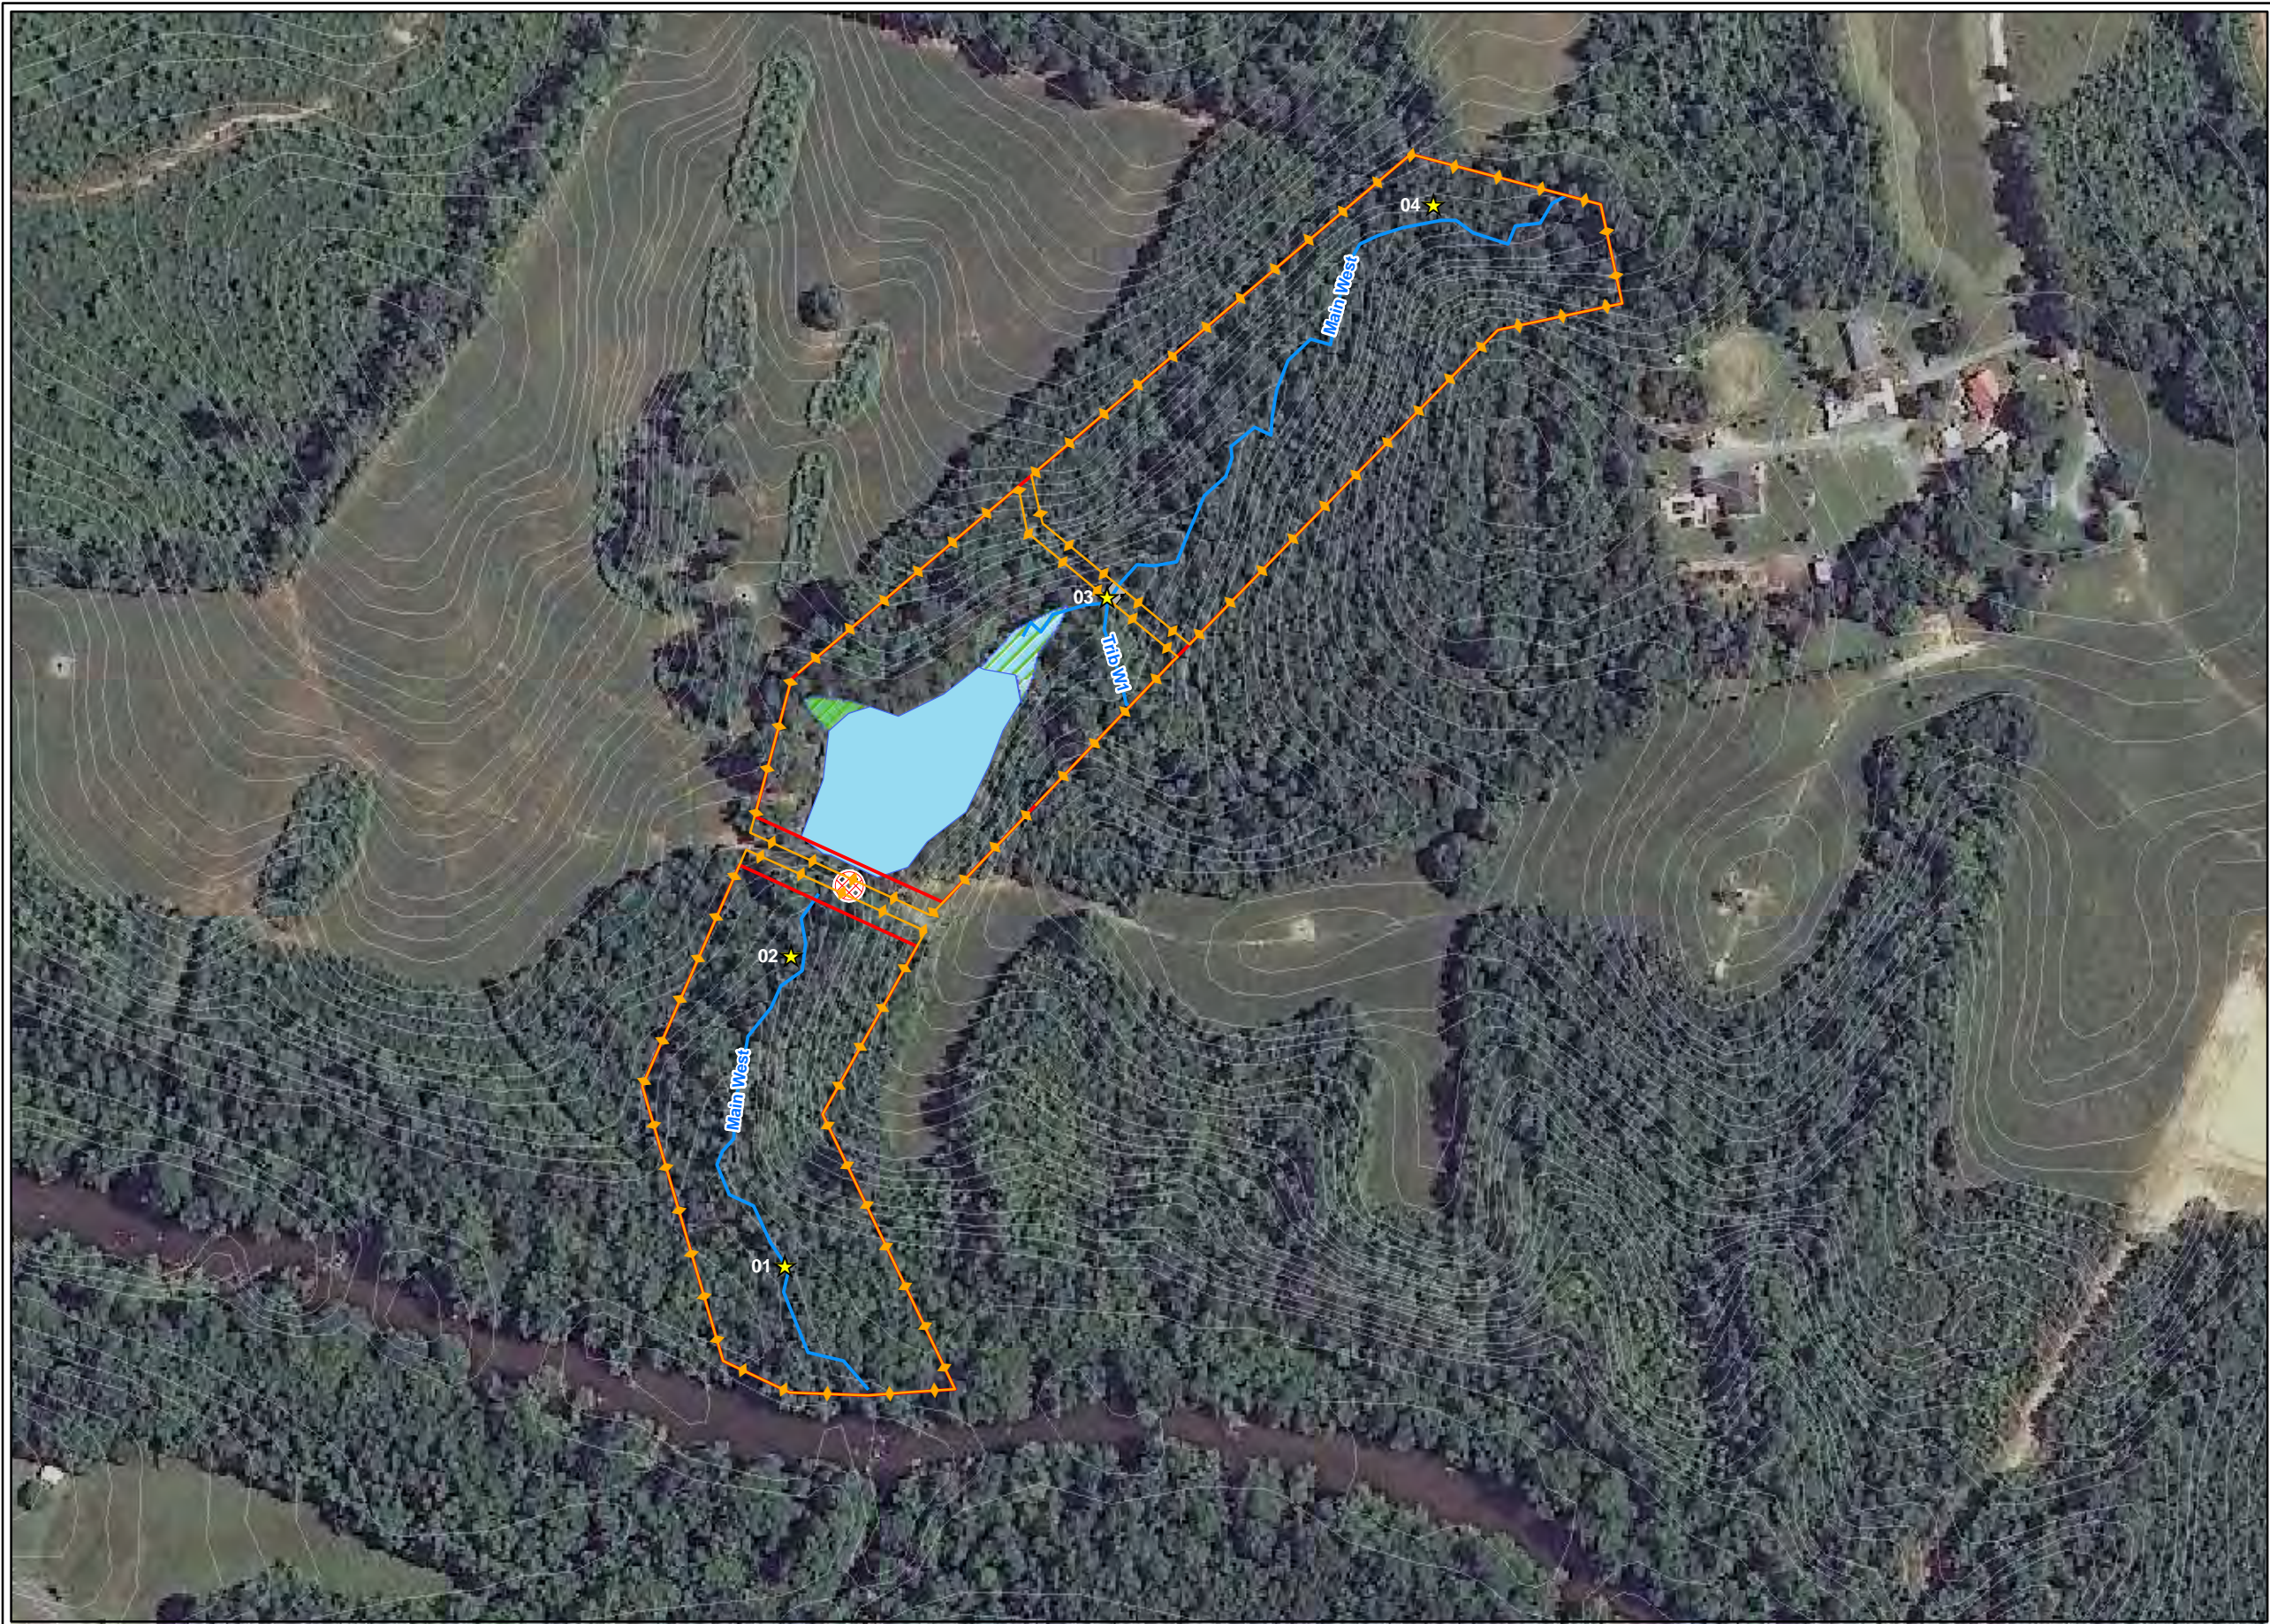
**CURRENT CONDITION PLAN VIEW**

Veg Plot 4 placement was chosen as a representative location of planted woody stems observed during Baseline/MY1 data collection. Planting Zone 3 boundary was enlarged during construction and the boundaries shown are approximations only.

Numerous small stems of Chinese privet (*Ligustrum sinense*) are located inside the easement boundary along Trib E2, Trib C2 and C1 near crossing. The locations of these populations are mapped on the Current Condition Plan View (CCPV) map (Figure 2). Additionally, several patches of multiflora rose (*Rosa multiflora*) are located along Main West, Main Center, Southwest trib, Trib C1, C2, C2a and E3 south of the pond, however, these stems are isolated and very small in size. Invasive/exotic vegetation is not currently compromising the vegetative success of the site.

Six at-grade stream crossings and one rock structure to stabilize an existing crossing were installed on project reaches at the Site during construction. The conditions of these features were observed during the site visit in August 2014. All of these features are stable and functioning properly as depicted on the CCPV.

The UT to Haw River project includes preservation and enhancement level II restoration. Since there were no changes made to dimension, pattern, or profile for any project reaches, no morphological characteristics were measured. Instead, project-wide stream monitoring was accomplished using visual assessment as well as photo documentation. Any areas showing evidence of aggradation, degradation, and/or bank erosion are identified and mapped on the CCPV.

Vegetation monitoring was conducted according to the CVS-EEP Protocol for Recording Vegetation, Version 4.0 (Lee, M.T. et al., 2008). Four 100 square meter vegetation monitoring plots were observed and data collected along the enhancement reaches on August 26, 2014. Two plots measure ten meters by ten meters, and two plots measure five meters by twenty meters. The four corners of each plot are marked with one-half inch steel rebar. Level 2 (planted and volunteer woody stems) data collection was performed in all plots. Each planted woody stem location (x and y), height (cm), and live stem diameter (dbh) were recorded. All planted stems were identified with pink flagging and silver tree tags indicating tree species. Vegetation was identified using Weakley (Weakley 2011). Photos were taken of each vegetation plot. Plots lacking cover, or with low planted-stem density or vigor, are identified and mapped on the CCPV.

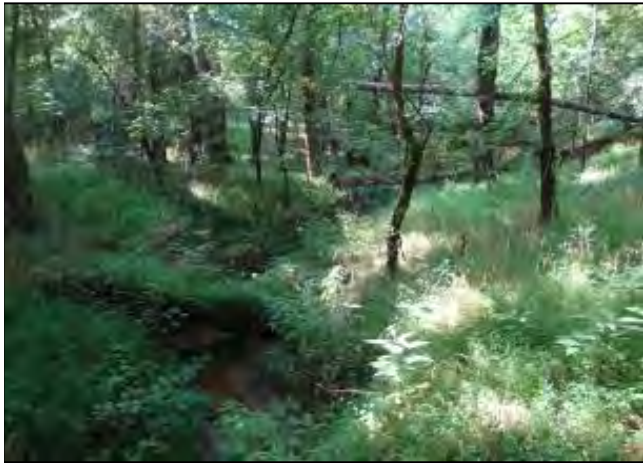
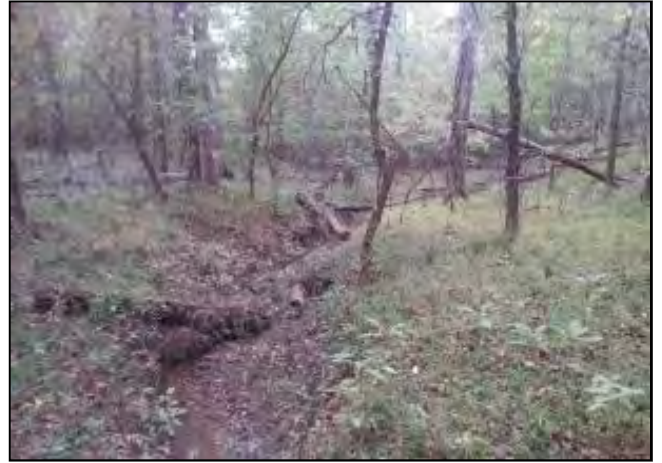
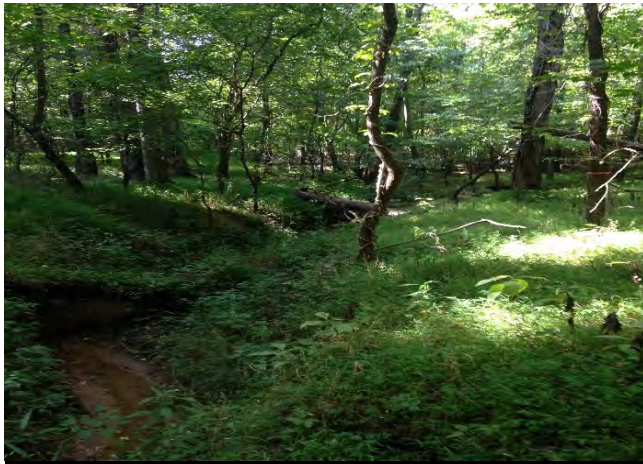
Photo Point 1: Looking Upstream on Main West

As-Built/Year 1 Survey: August 2012

Year 2 Monitoring: October 2013

Year 3 Monitoring: August 2014

Year 3 monitoring surveys along UT to Haw River project occurred in August 2014. Thirty photo point locations were reviewed and subsequent photographs taken during data collection at the Site. These photographs serve as documentation of the Year 3 stream condition as well as reference photos for future monitoring years. Based on available data and visual comparison

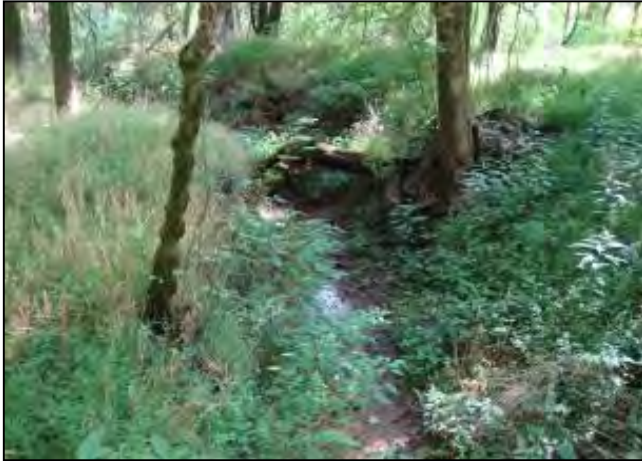
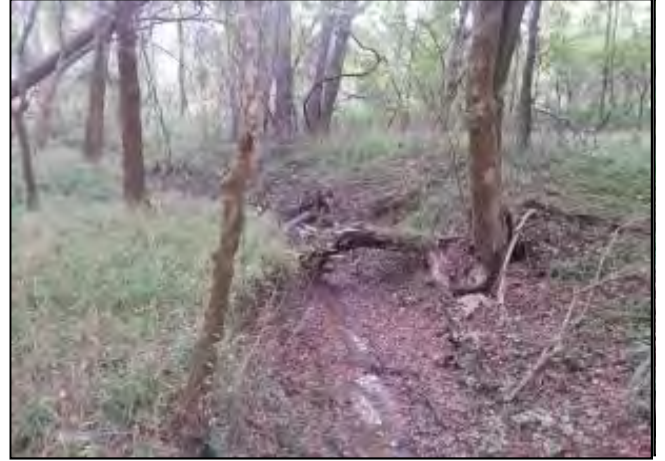
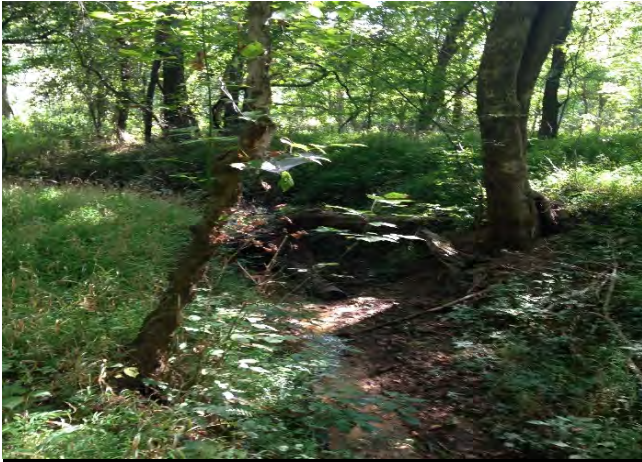
Photo Point 1: Looking Downstream on Main West

As-Built/Year 1 Survey: August 2012

Year 2 Monitoring: October 2013

Year 3 Monitoring: August 2014

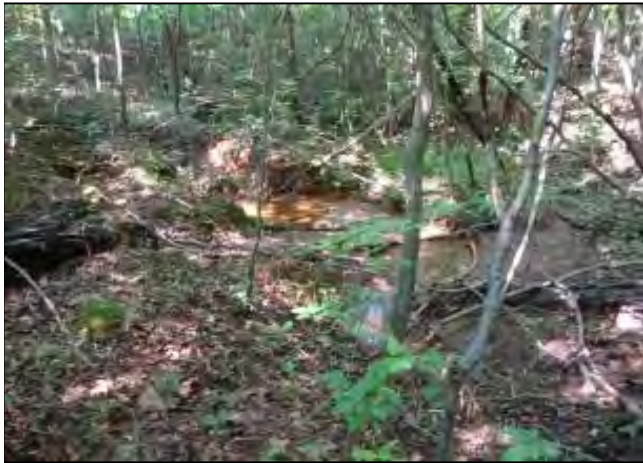
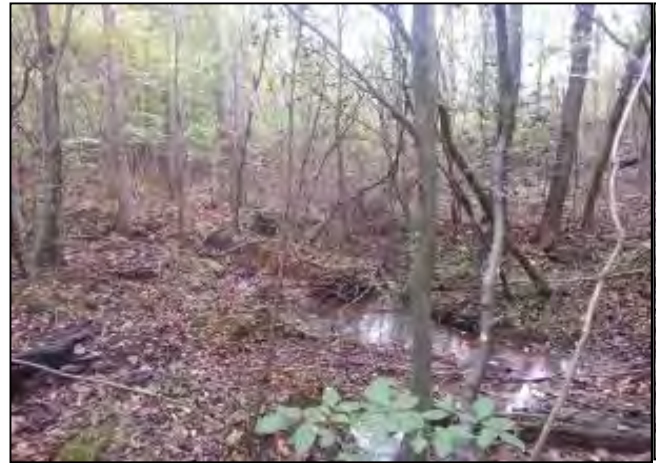
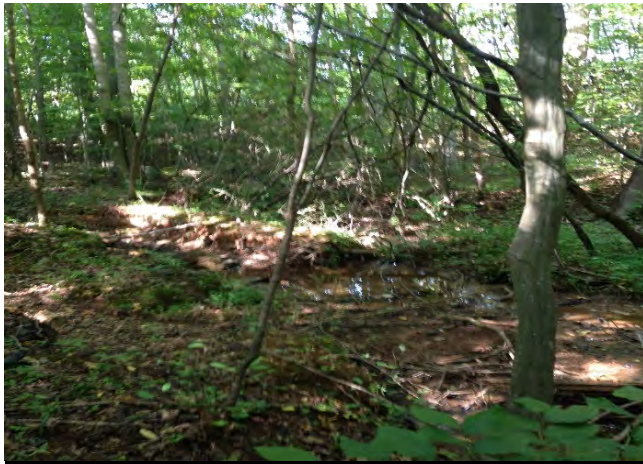
Photo Point 2: Looking Upstream on Main West

As-Built/Year 1 Survey: August 2012

Year 2 Monitoring: October 2013

Year 3 Monitoring: August 2014

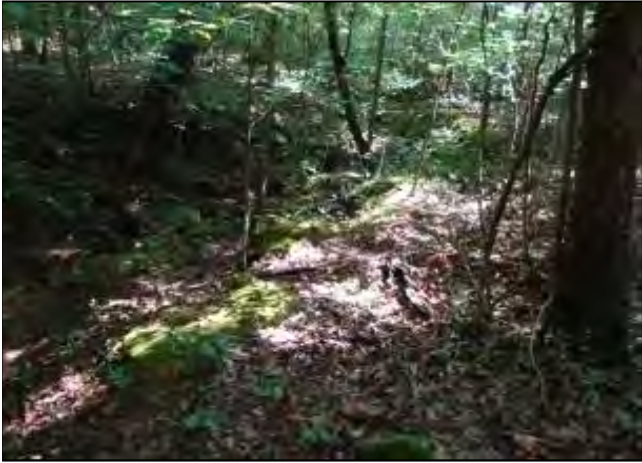
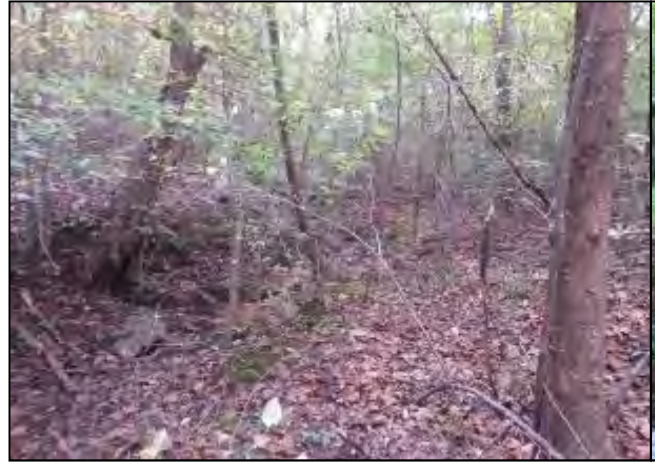
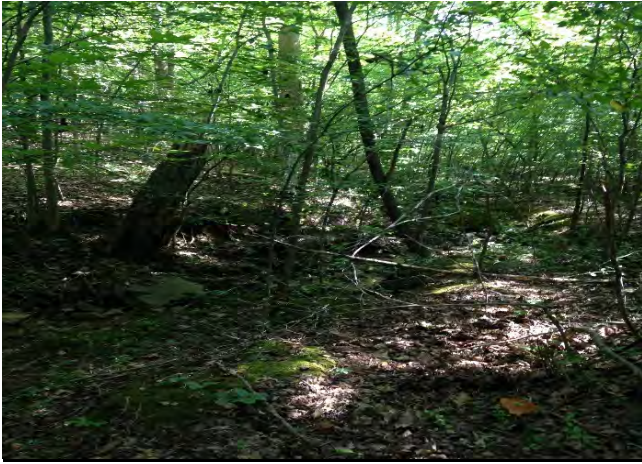
Photo Point 2: Looking Downstream on Main West

As-Built/Year 1 Survey: August 2012

Year 2 Monitoring: October 2013

Year 3 Monitoring: August 2014

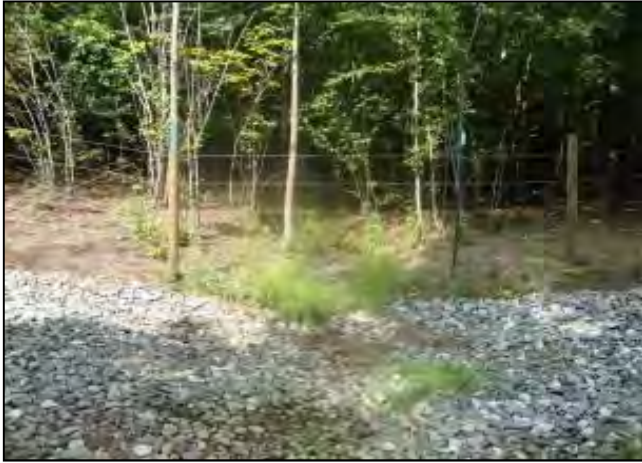
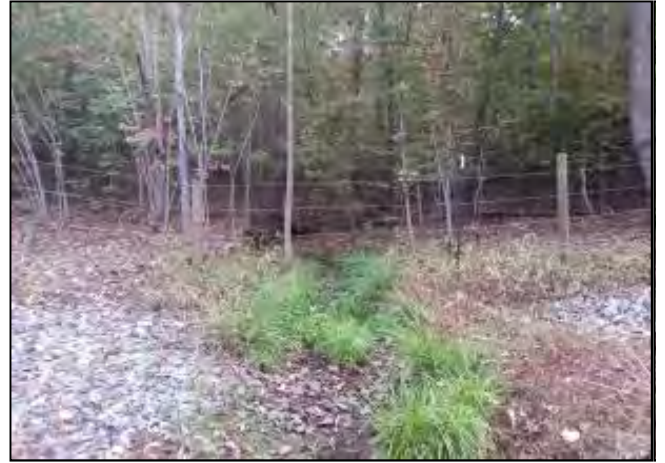
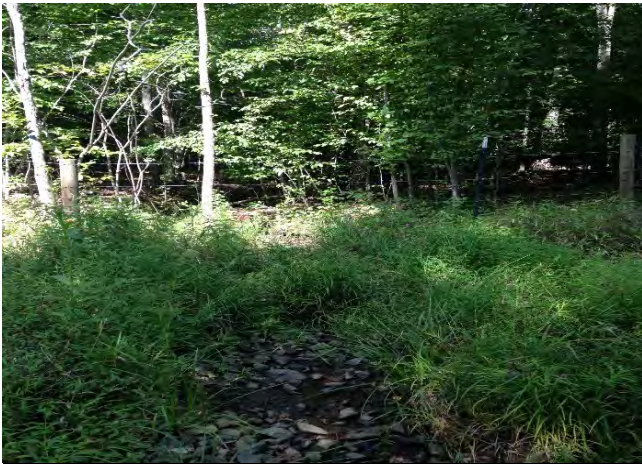
Photo Point 3: Looking Upstream Main West

As-Built/Year 1 Survey: August 2012

Year 2 Monitoring: October 2013

Year 3 Monitoring: August 2014

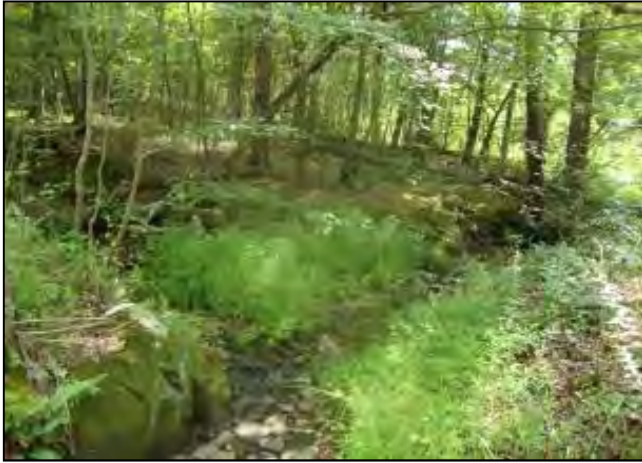
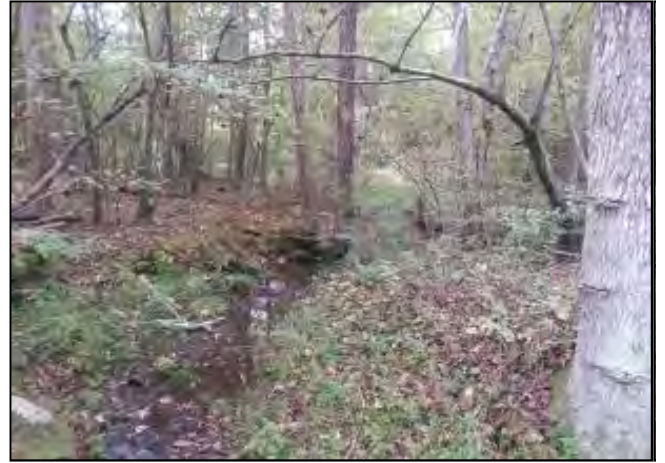
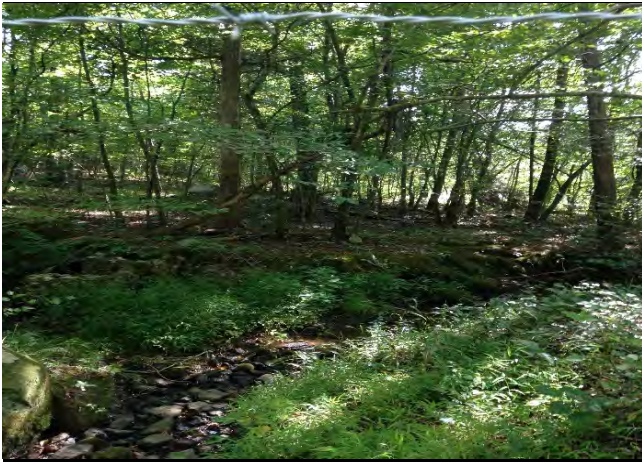
Photo Point 3: Looking Downstream Along Main West

As-Built/Year 1 Survey: August 2012

Year 2 Monitoring: October 2013

Year 3 Monitoring: August 2014

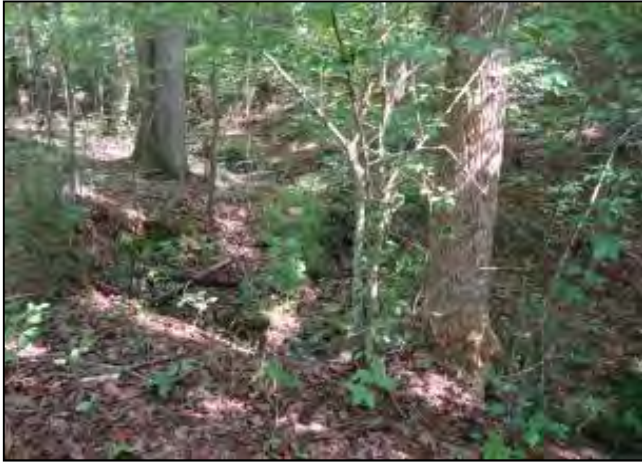
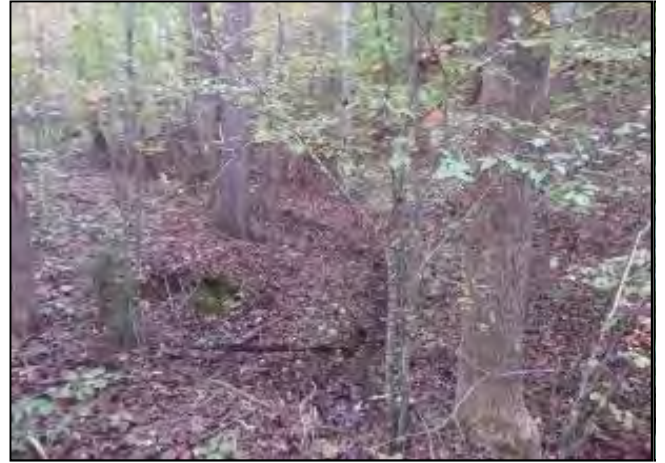
Photo Point 4: Looking Upstream Along Main West

As-Built/Year 1 Survey: August 2012

Year 2 Monitoring: October 2013

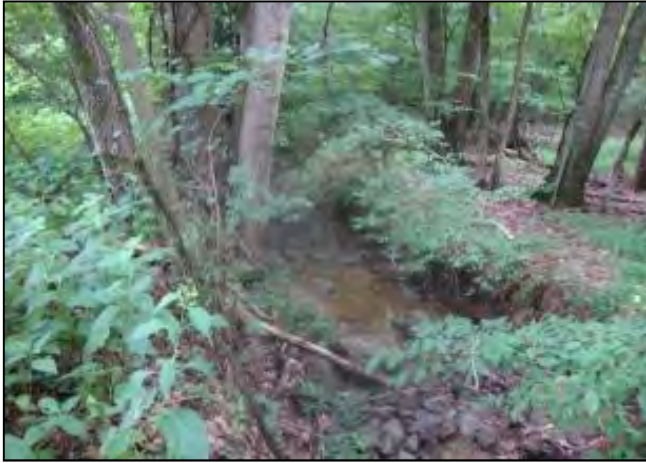
Photo Point 9: Looking Downstream Along Main Center

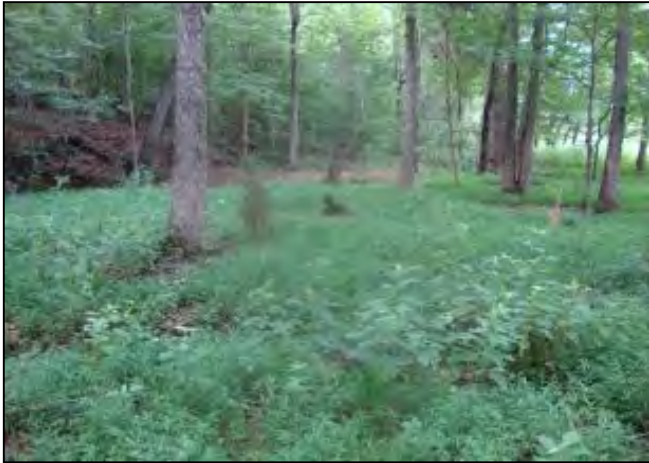
Photo Point 10: Looking Upstream Along Main Center (across planted area)

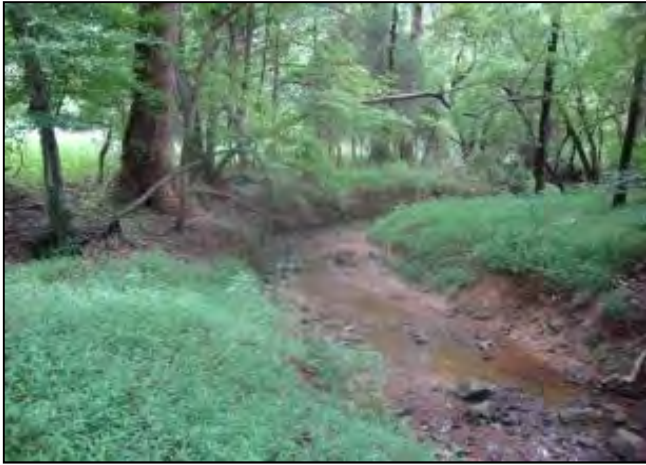
Photo Point 10: Looking Downstream Along Main Center

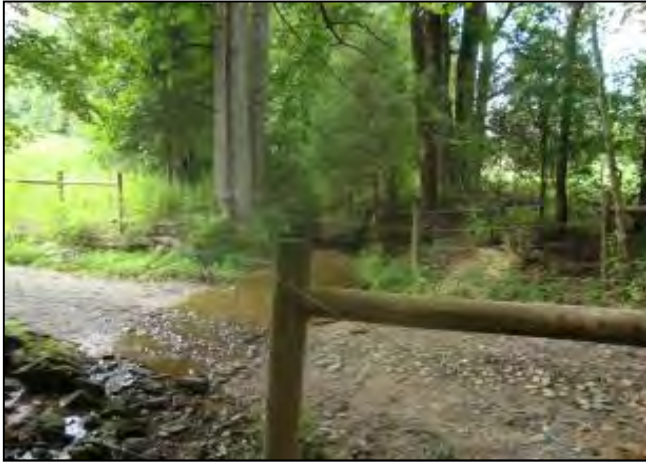
Photo Point 11: Looking Upstream Along Main Center at Crossing

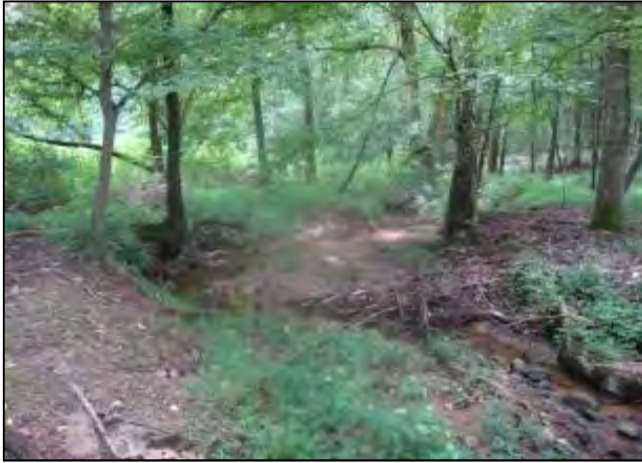
Photo Point 11: Looking Downstream Along Main Center

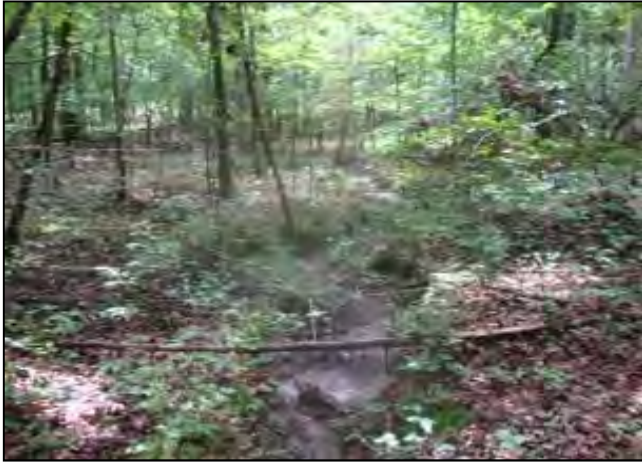
Photo Point 12: Looking Downstream Along C2-b

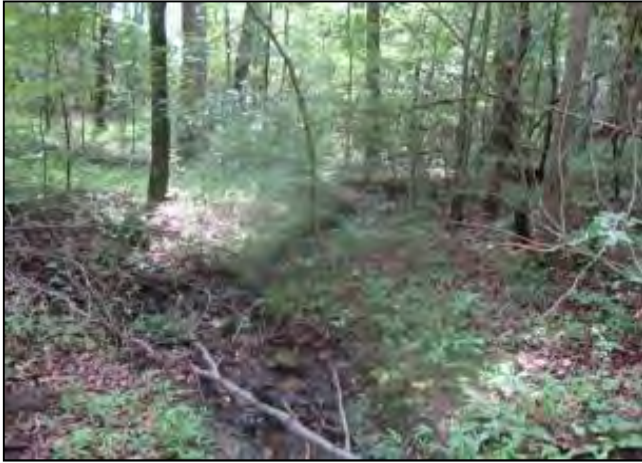
Photo Point 13: Looking Downstream Along C2

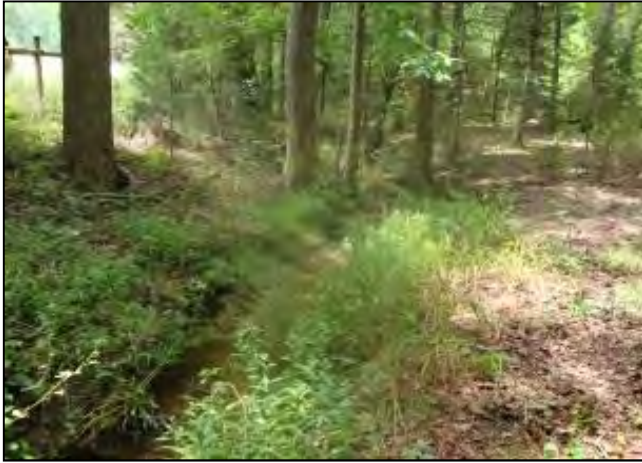
Photo Point 14: Looking Downstream Along C2-a

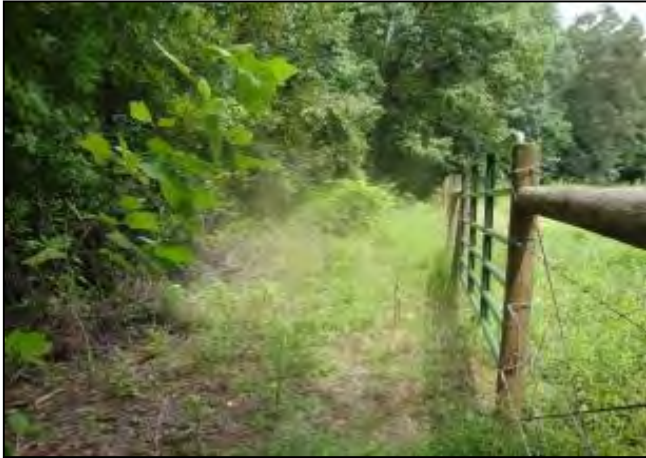
Photo Point 15: Looking Upstream Along Fence on Trib C2 at Pond

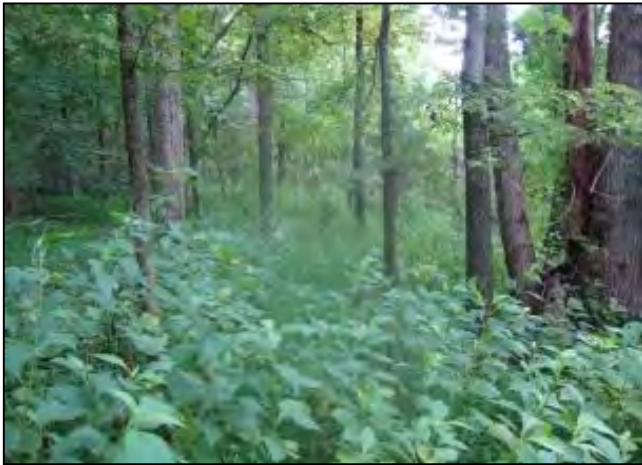
As-Built/Year 1 Survey: August 2012

Photo Point 29: Looking Upstream Along Main East

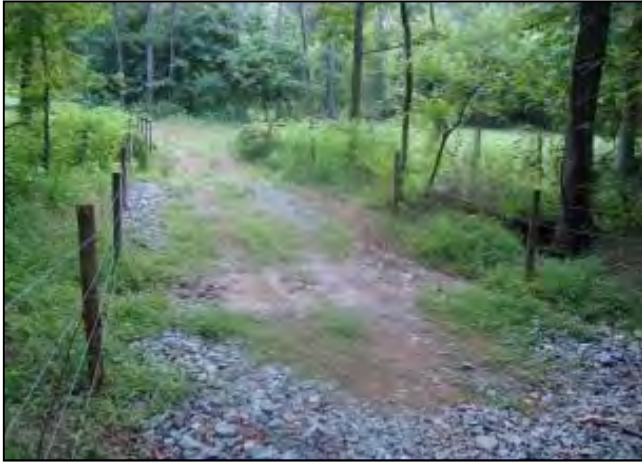
As-Built/Year 1 Survey: August 2012

Photo Point 29: Looking Across Main East at Lower Crossing

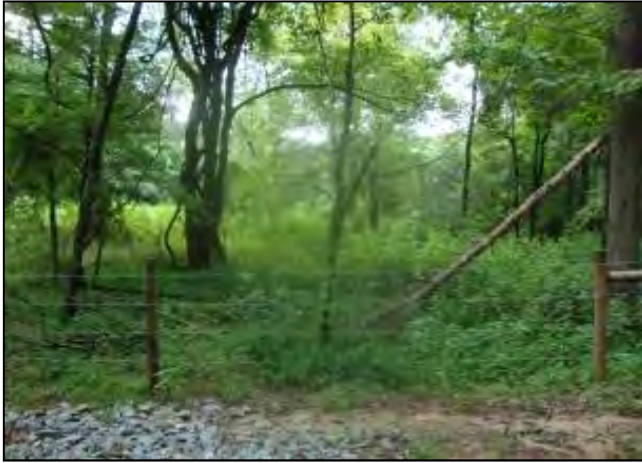
As-Built/Year 1 Survey: August 2012

Photo Point 29: Looking Downstream Along Main East

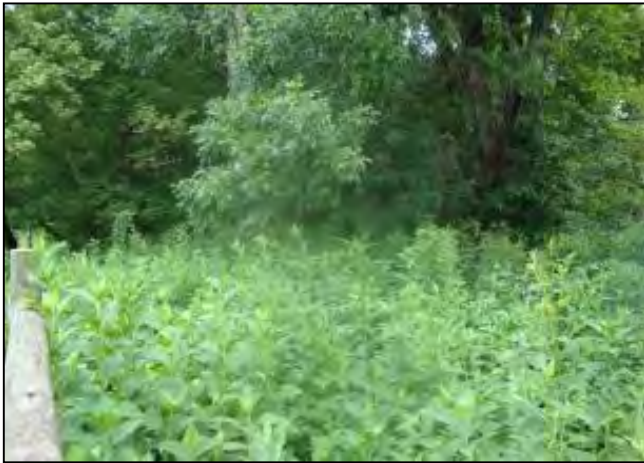
As-Built/Year 1 Survey: August 2012

Photo Point 30: Looking Upstream Along Main East

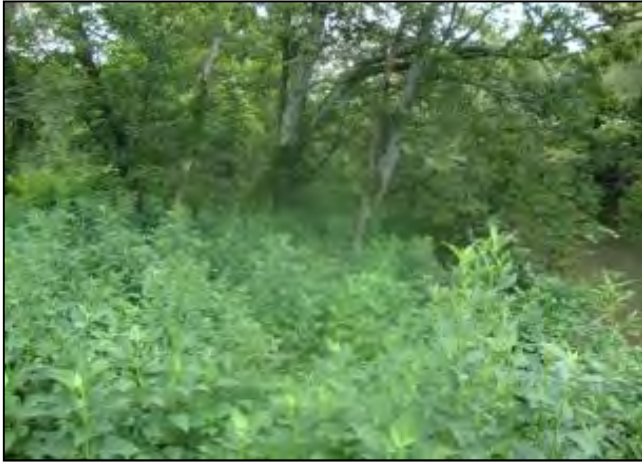
As-Built/Year 1 Survey: August 2012

Photo Point 30: Looking Across Main East

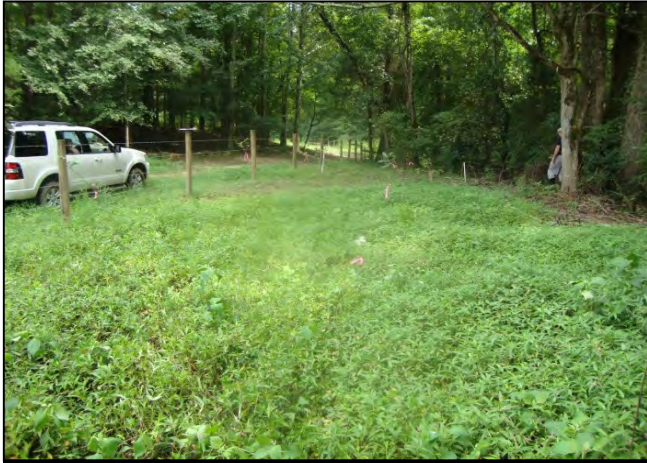
As-Built Survey/Year 1 Monitoring: September 2012

Vegetation Plot 1

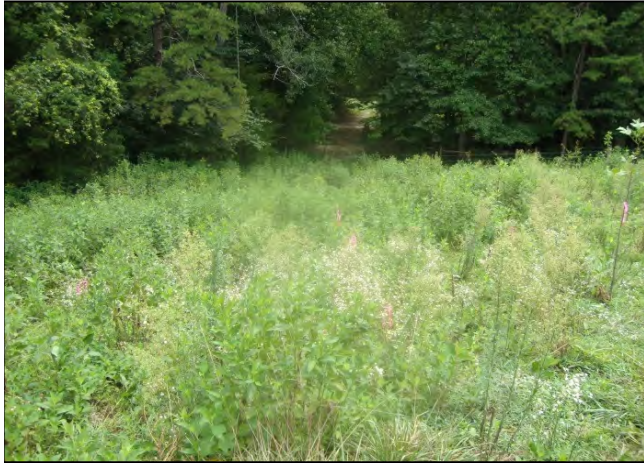
As-Built Survey/Year 1 Monitoring: September 2012

Vegetation Plot 2

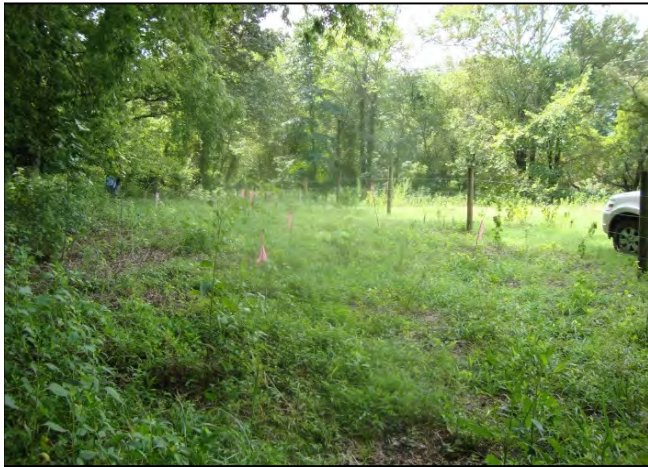
As-Built Survey/Year 1 Monitoring: September 2012

Vegetation Plot 3

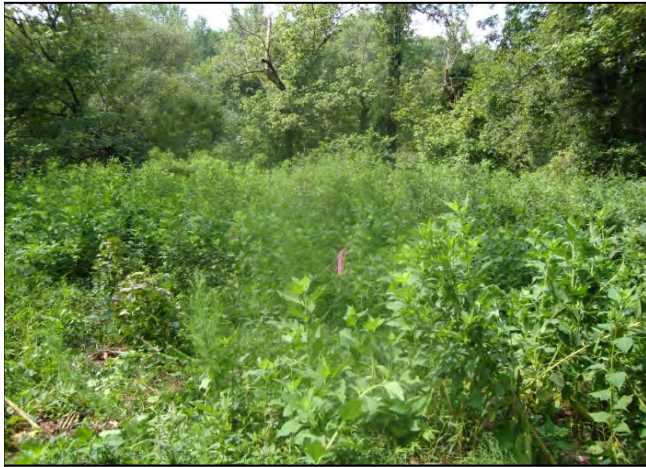
As-Built Survey/Year 1 Monitoring: September 2012

Vegetation Plot 4
