UT to JUMPING RUN CREEK
STREAM & WETLAND RESTORATION

FINAL AS-BUILT & BASELINE MONITORING REPORT

Cumberland County, North Carolina
SCO Project Number 09-0806104
EEP Project Number 92345

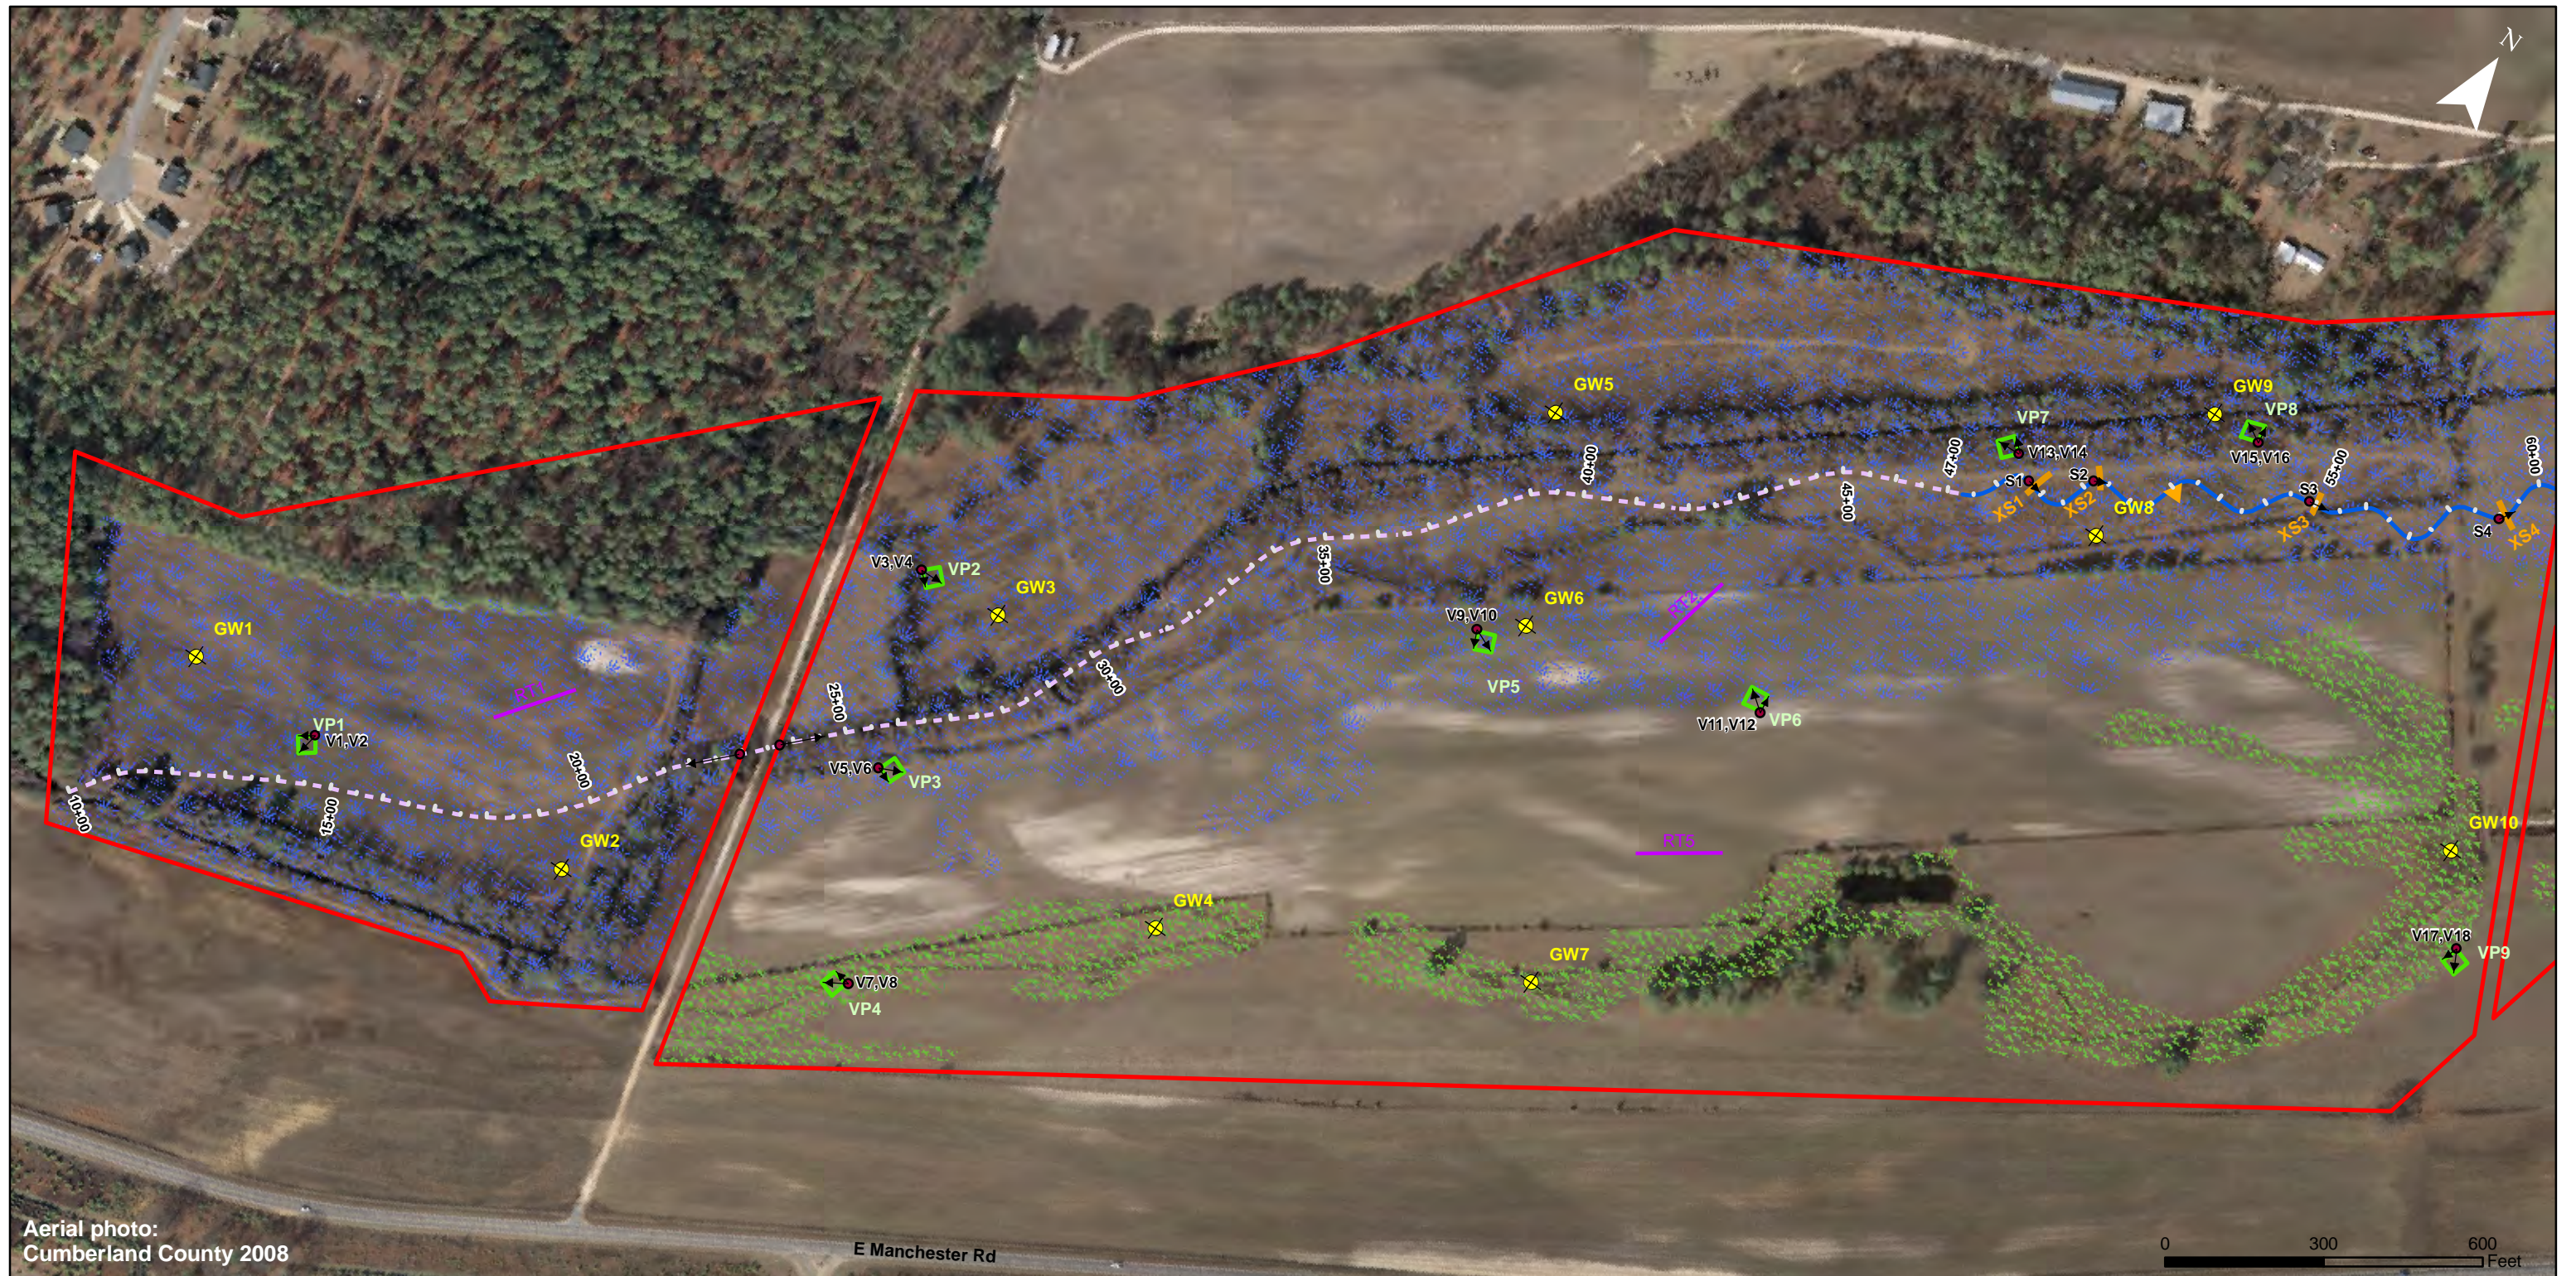
Figure 2a. Project Components and Baseline Monitoring Map

- + Precipitation gage
- Photo points (Veg=V, Stream=S)
- ★ Reference well
- ⊗ Groundwater monitoring wells (Well 1-15)
- Vegetation monitoring plots (VP 1-12)
- Random transects MY0 (RT 1-5)
- Stream cross-section surveys (XS 1-10)
- Stream stationing
- - - Headwater system (UT1A) - valley length shown
- As-built stream restoration centerline MY0 (UT1B)
- - - As-built stream enhancement MY0 (UT1C)
- Proposed wetland features
- Non-riparian wetland
- Riparian wetland
- Easement boundary

Fifteen automated groundwater monitoring gauges have been installed across the project area to document the hydrologic conditions of the site. Refer to Figure 2 in Appendix A for the location of the groundwater monitoring gauges. Eleven wells have been installed in the riparian areas and four have been installed in the non-riparian areas of the site. Groundwater gauges will be downloaded on at least a bi-monthly basis during the growing season. A reference well is located in the existing wetlands onsite in the northeast corner of the property and is depicted on Figure 2 in Appendix A.

A total of 10 permanent cross-sections (7 riffles, 3 pools) have been installed along UT1b. Each cross-section was marked on both banks with permanent pins. A common benchmark has been established for cross-sections to facilitate comparison of year-to-year data. The annual cross-section survey will include points measured at all breaks in slope including top of bank, bankfull, inner berm, edge of water, and thalweg if the features are present. Dimensional data will be compared from year to year to ensure project stability. Stream channel stability and geomorphic monitoring for reaches UT1a and UT1c restoration success will be documented visually. Refer to Figure 2 in Appendix A for locations of cross-sections along reach UT1b and representative photo station points.

Representative photo station points have been identified and located using GPS. The stations are shown on Figure 2 in Appendix A. Photos will be taken at each location at approximately the same time each year. Vegetation plot photos will be taken during the vegetation monitoring event each year.

A plan view of the monitoring scheme is presented in Figure 2 in Appendix A.

Photo stations were established in 36 locations along the project. The location of the stations can be seen in Figure 2 in Appendix A. Baseline vegetation station photos were taken on April 26 and 27, 2010 during the baseline vegetation monitoring. Vegetation station photos for the baseline monitoring year are provided in Appendix C. Baseline stream station photos were taken on May 4, 2010. Stream station photos for the baseline monitoring year are provided in Appendix B.

Fifteen 40" Ecotone groundwater monitoring gauges were installed onsite on April 27, 2010. Gauges 1-3 and 6 are located in the headwater riparian wetland zone while gauges 8-9, 11-12 and 14-15 are located in the riparian wetland restoration areas along the single thread channel. Gauges 4, 7, 10, and 13 are located in the non-riparian wetland restoration areas and gauge 5 is located in the wetland enhancement area. A reference gauge (gauge 16) was installed during the project design period and is located in the existing wetlands on the northeastern portion of the site. A rain gauge was installed onsite on July 8, 2010. A crest gauge was installed onsite on April 27, 2010. The crest gauge will be used in future monitoring to verify bankfull events. The location of the precipitation gauge, reference well, and groundwater monitoring wells are included in Figure 2 in Appendix A.

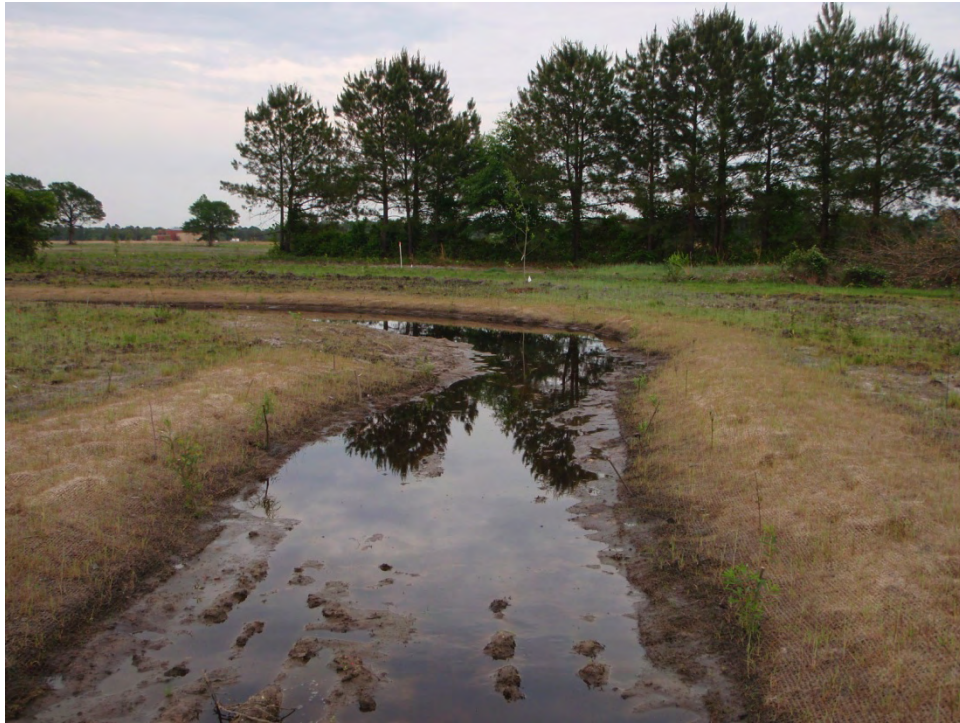
Photo Station S1 – Stream channel looking downstream at cross-section 1
Station 48+81 (5/4/2010 Year 0)

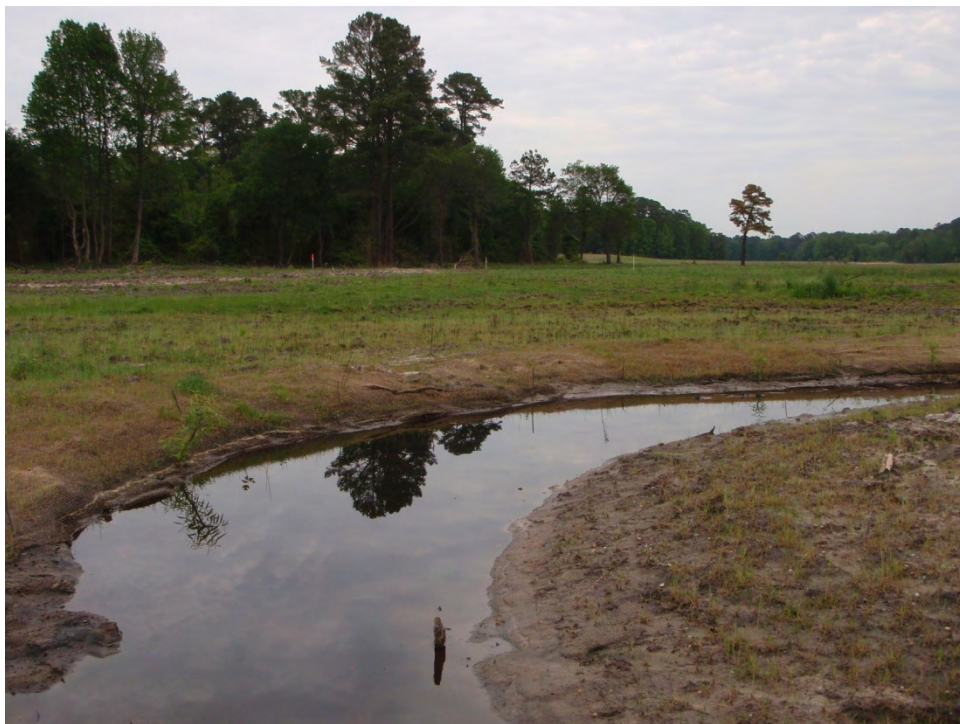
Photo Station S2 – Stream channel looking downstream at cross-section 2
Station 50+30 (5/4/2010 Year 0)

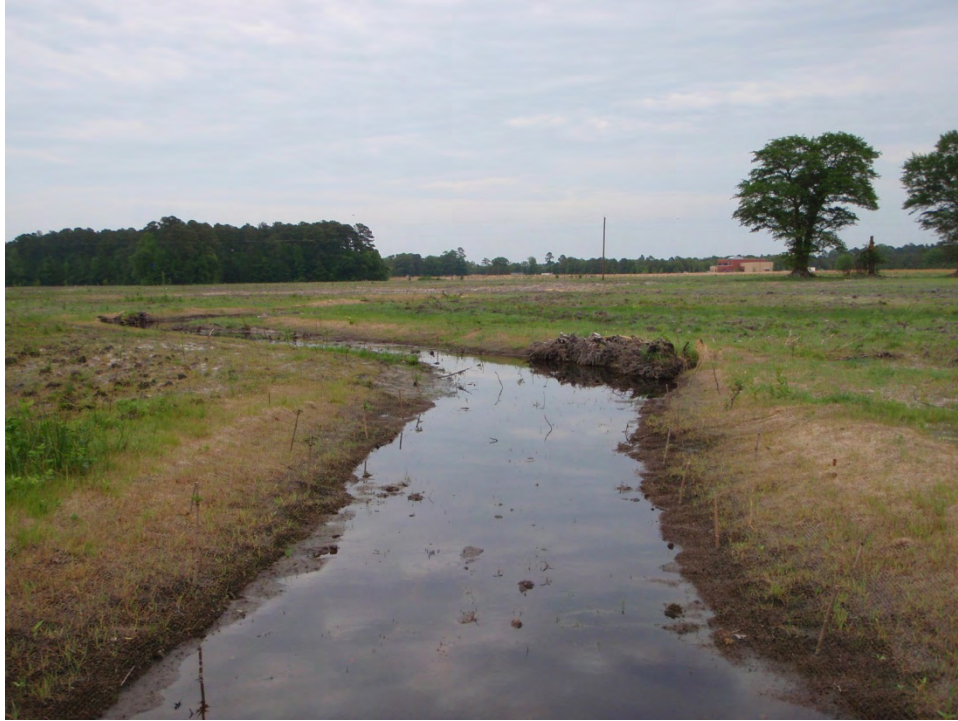
Photo Station S3 – Stream channel looking downstream at cross-section 3
Station 54+98 (5/4/2010 Year 0)

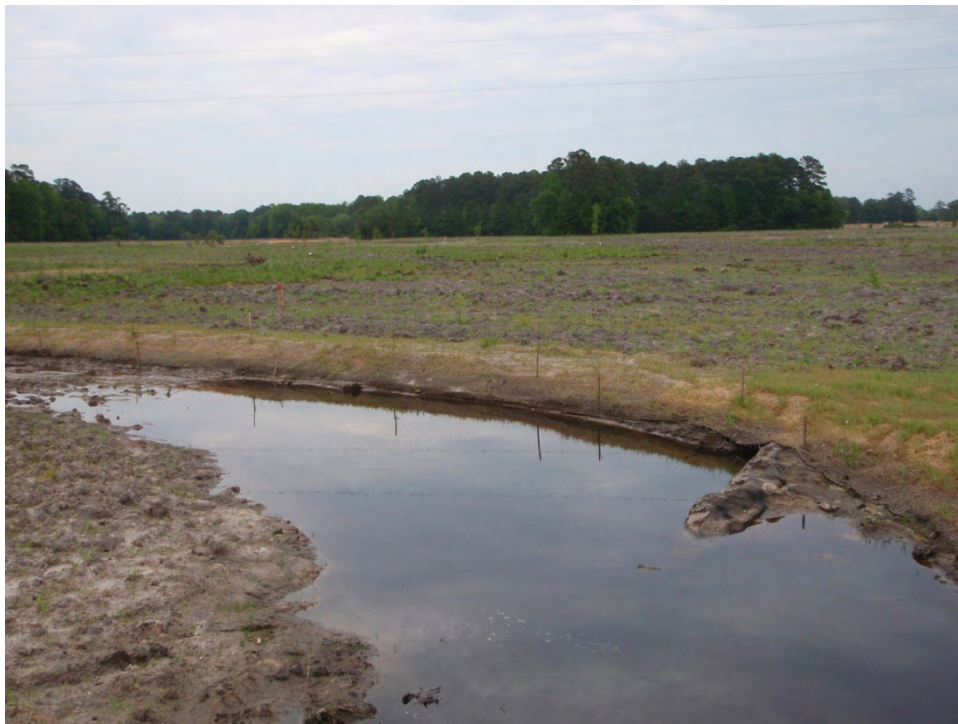
Photo Station S4 – Stream channel looking downstream at cross-section 4
Station 59+09 (5/4/2010 Year 0)

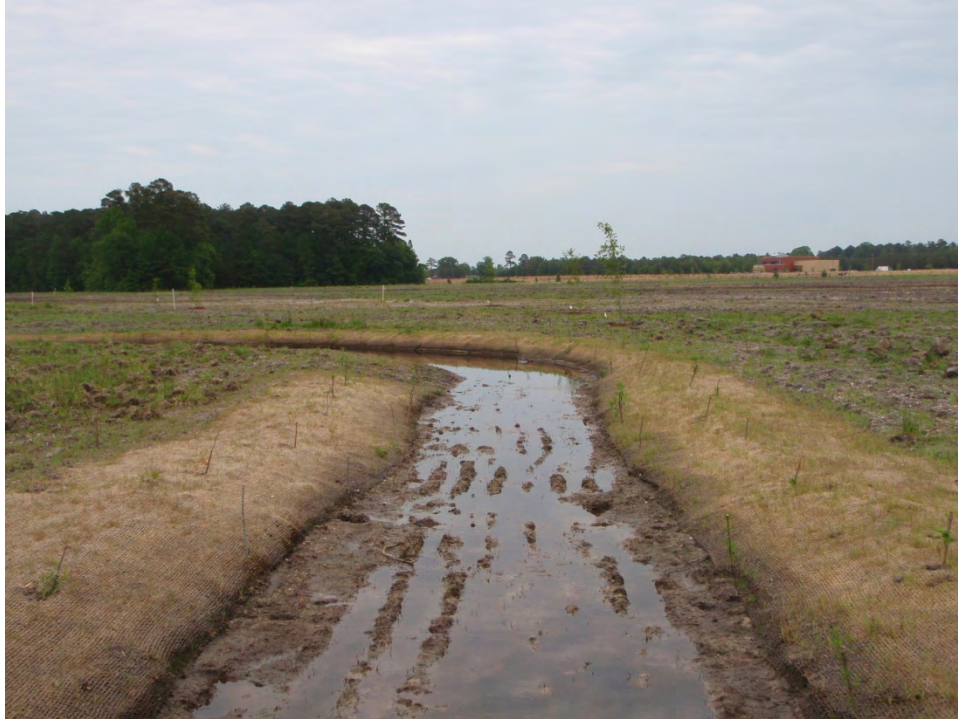
Photo Station S5 – Stream channel looking downstream at cross-section 5
Station 62+87 (5/4/2010 Year 0)

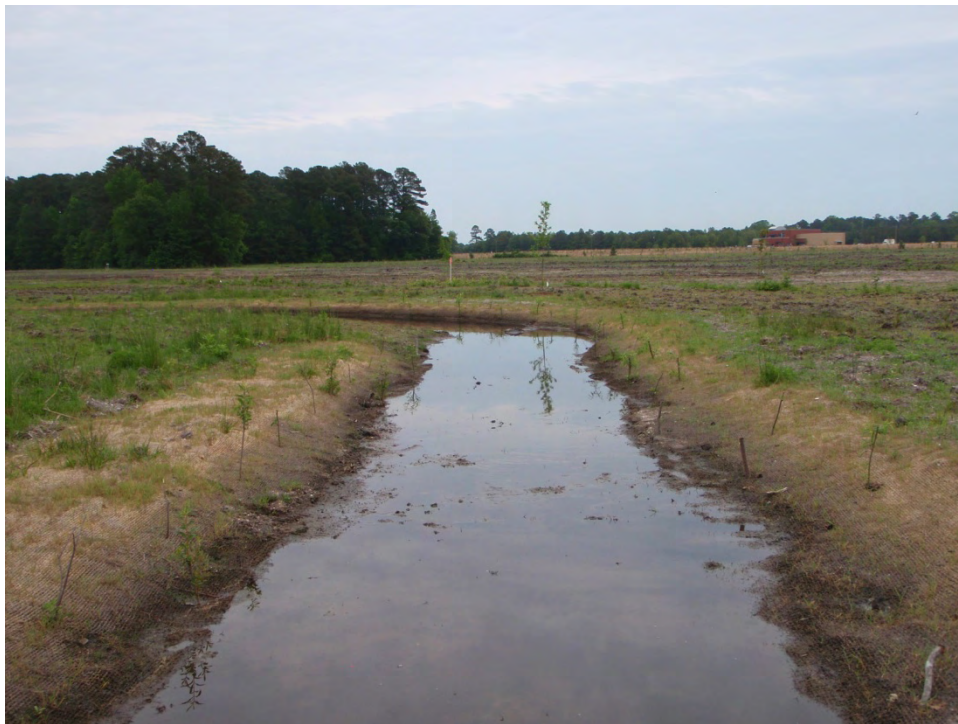
Photo Station S6 – Stream channel looking downstream at cross-section 6
Station 65+44 (5/4/2010 Year 0)

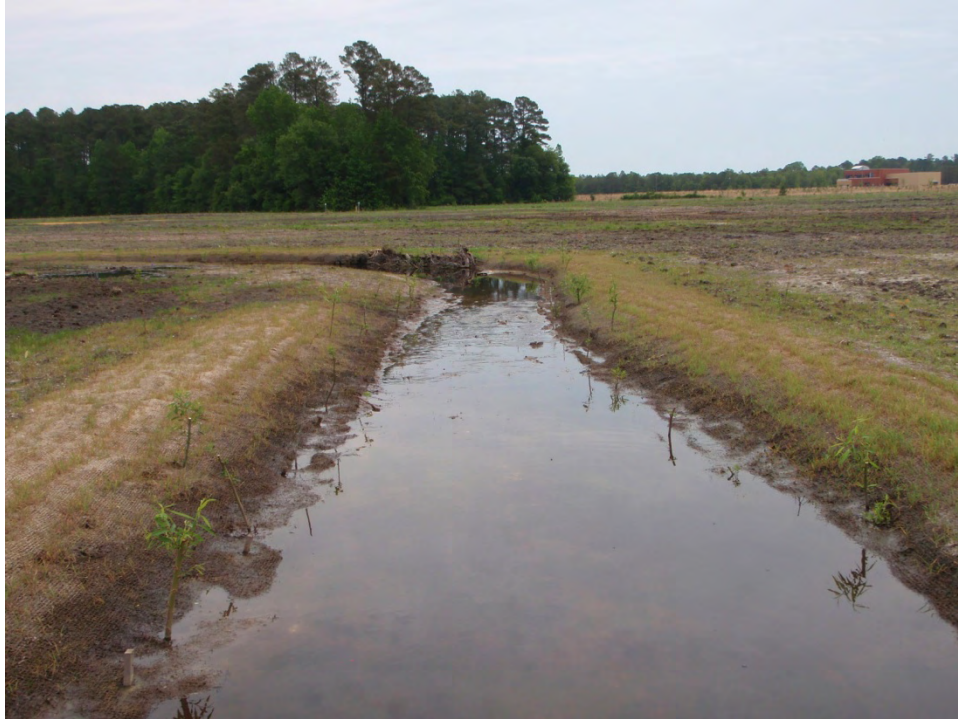
Photo Station S7 – Stream channel looking downstream at cross-section 7
Station 68+24 (5/4/2010 Year 0)

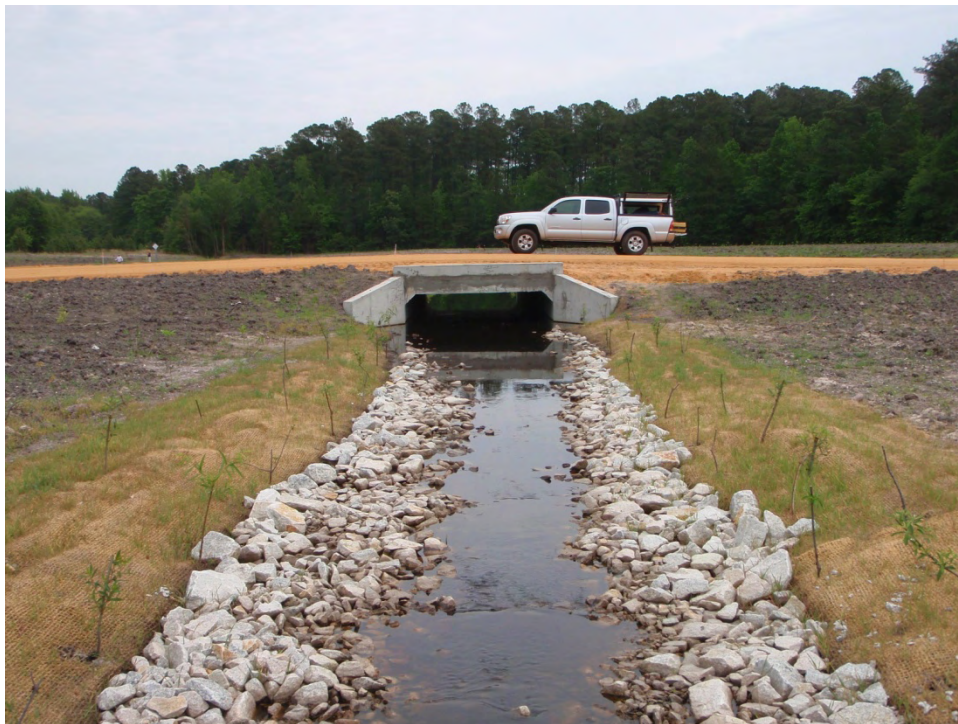
Photo Station S8 – Stream channel looking downstream at cross-section 8
Station 74+84 (5/4/2010 Year 0)

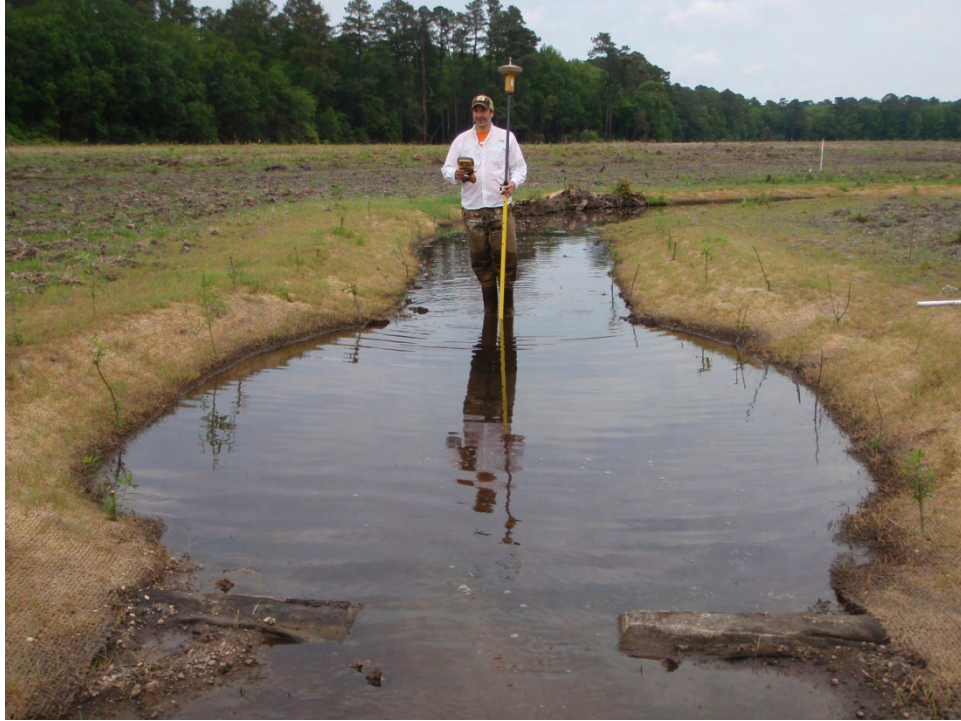
Photo Station S9 – Stream channel looking downstream at cross-section 9
Station 75+30 (5/4/2010 Year 0)

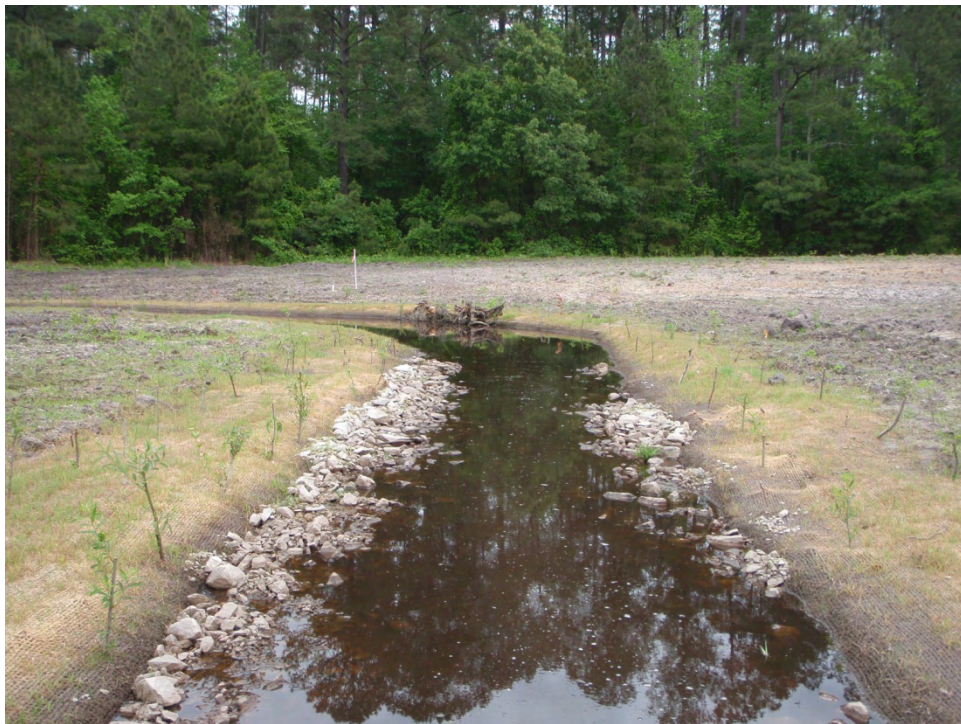
Photo Station S10 – Stream channel looking downstream at cross-section 10
Station 80+45 (5/4/2010 Year 0)

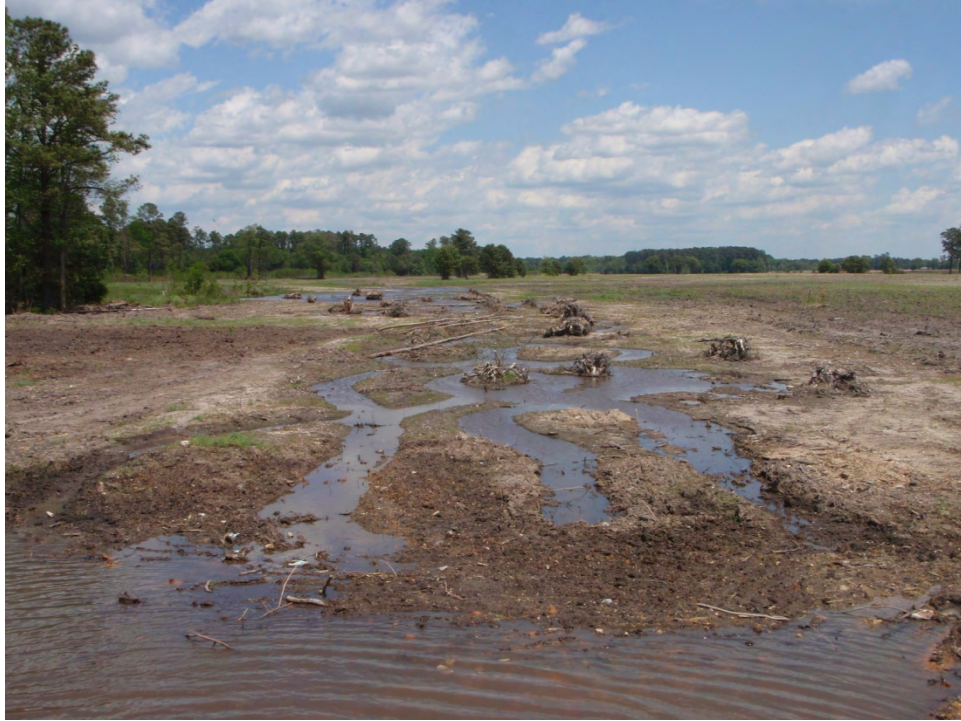
Photo Station S11 – Stream channel looking downstream at upper road crossing
(4/26/2010 Year 0)

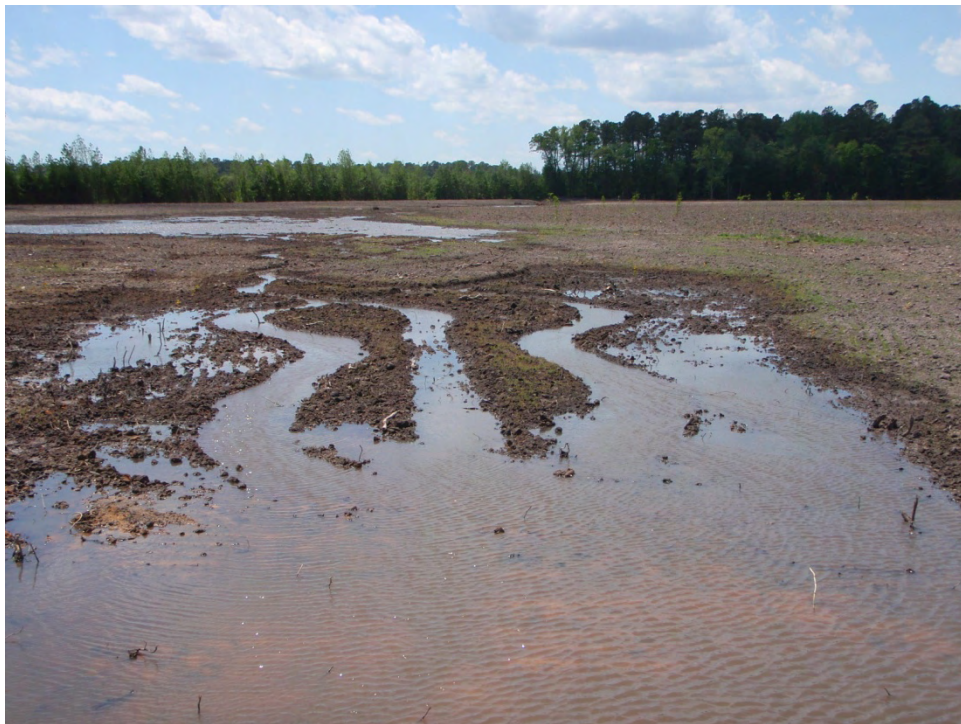
Photo Station S12 – Stream channel looking upstream at upper road crossing
(4/26/2010 Year 0)

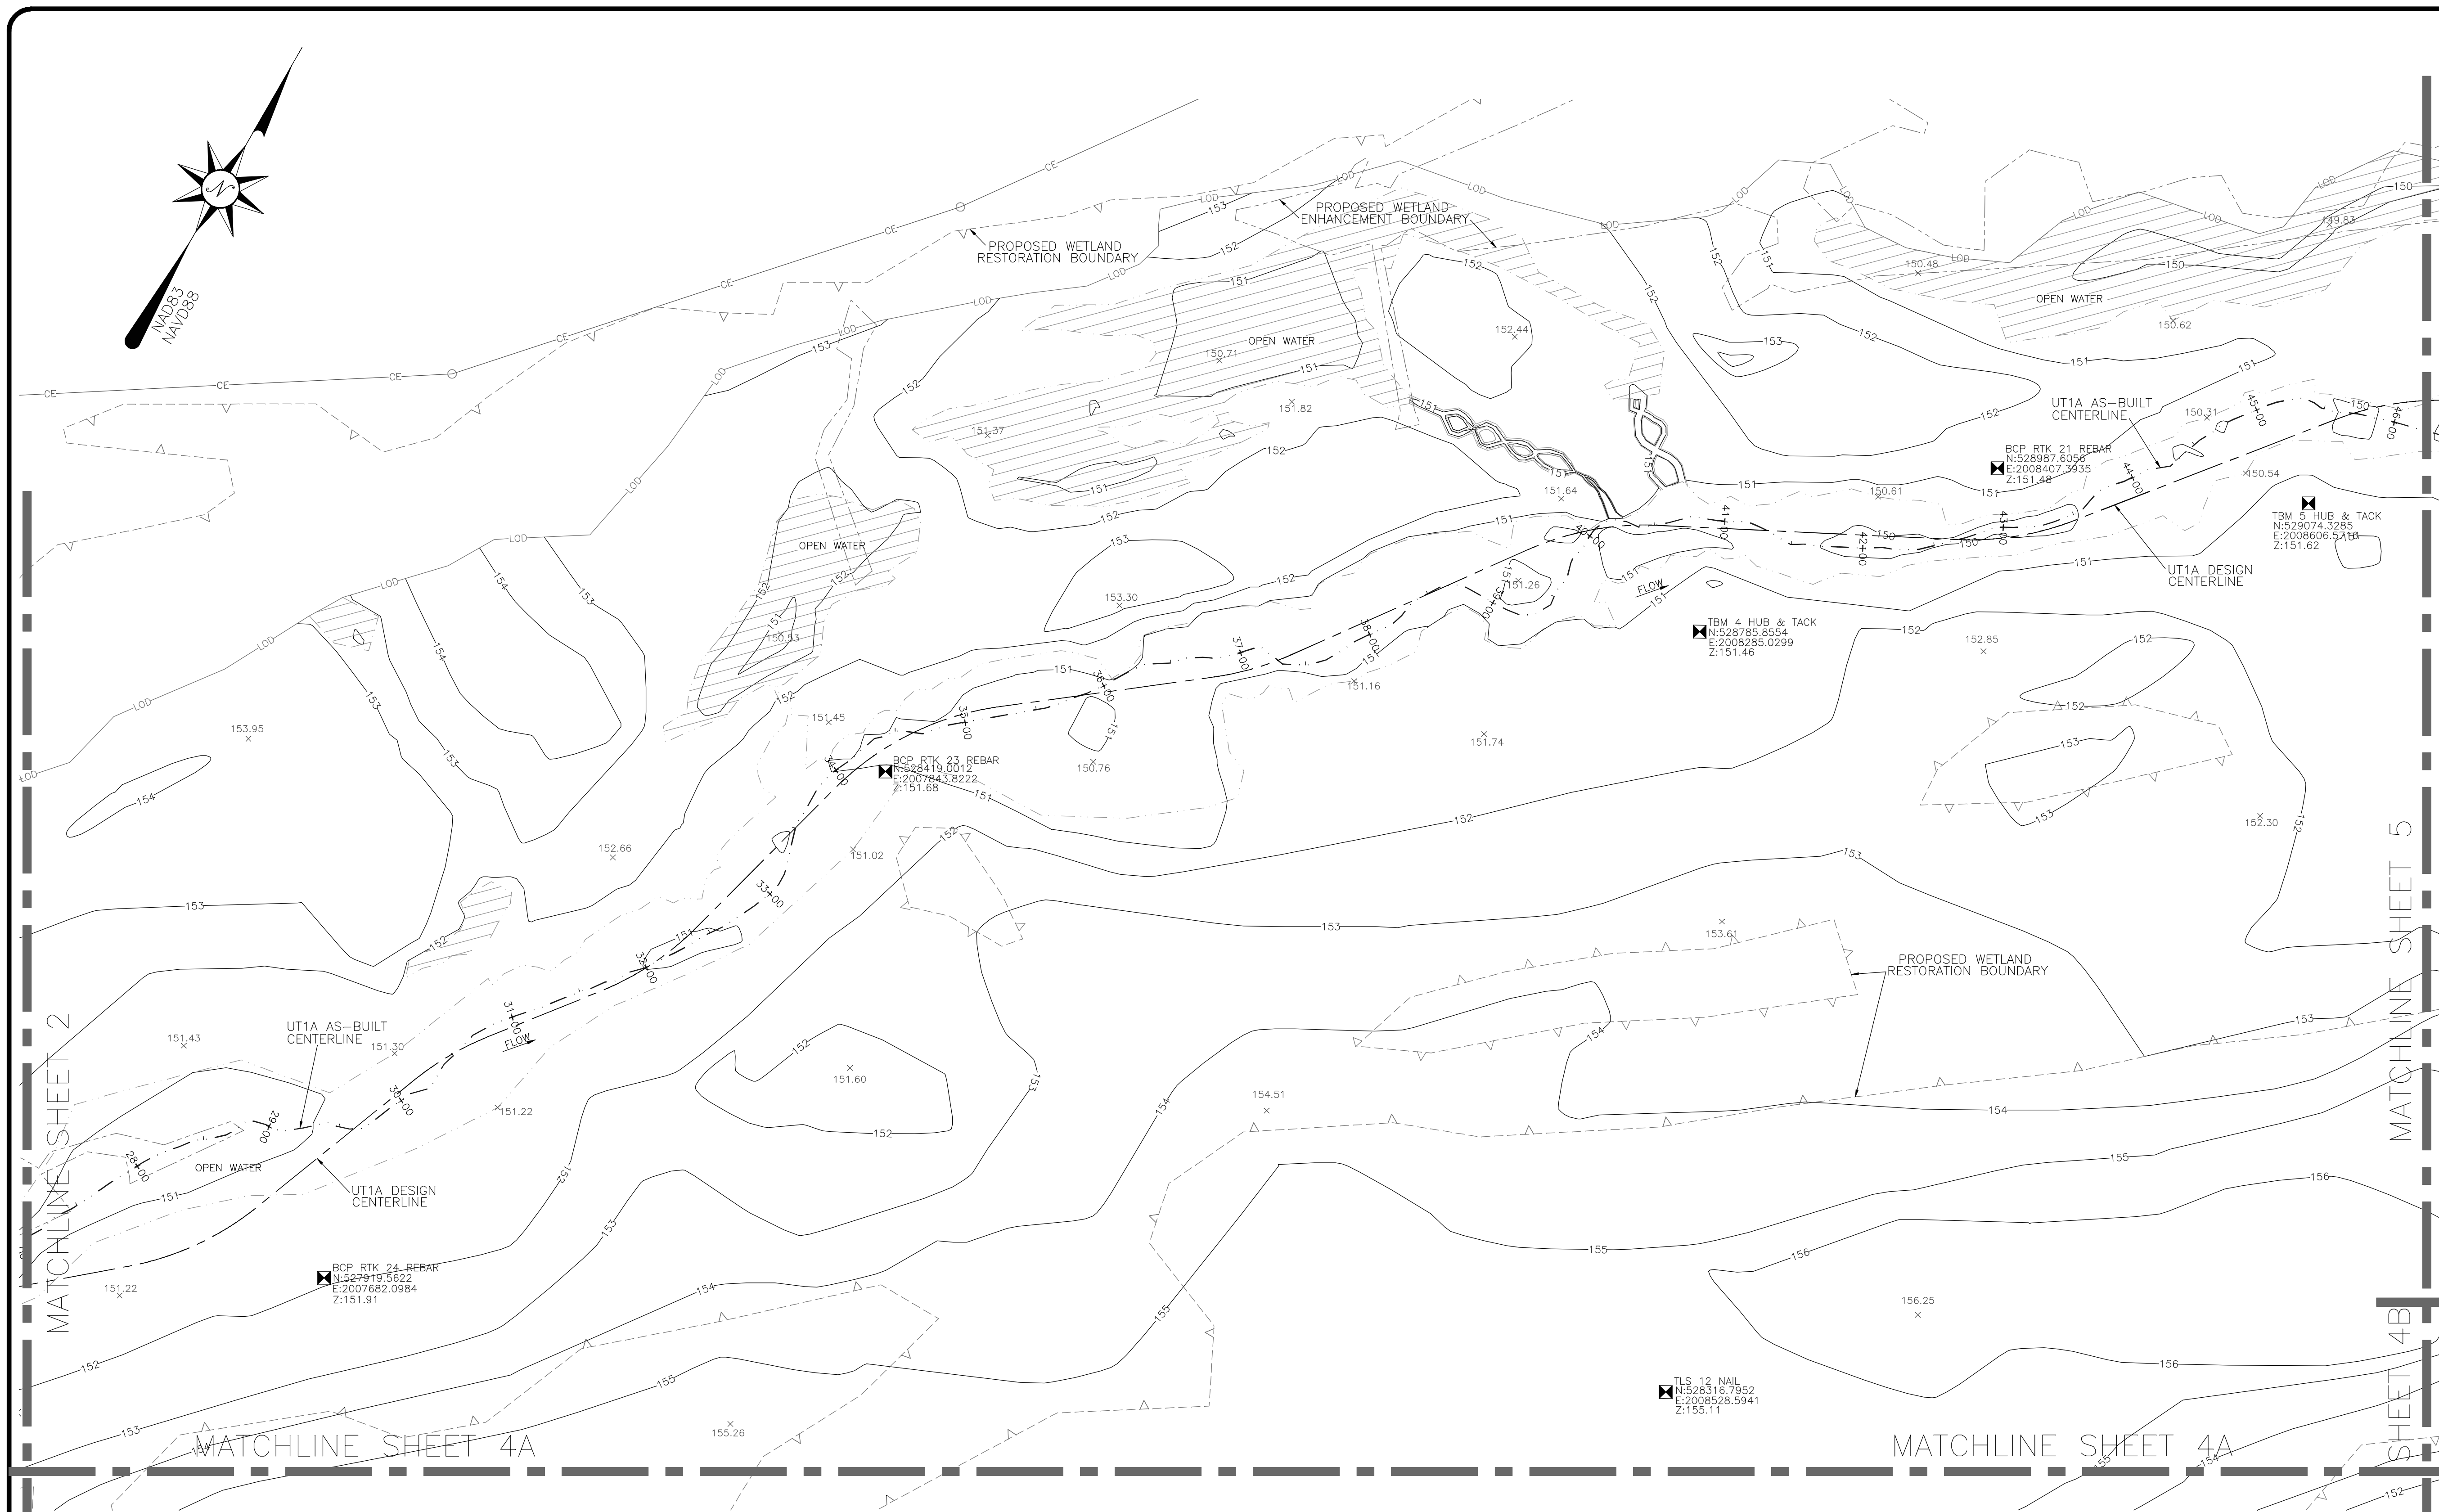
PLAN VIEW
 AS-BUILT SURVEY OF
UT TO JUMPING RUN CREEK - STREAM & WETLAND RESTORATION SCO# 06-06901-01
 SPRING LAKE
 CUMBERLAND COUNTY
 NORTH CAROLINA

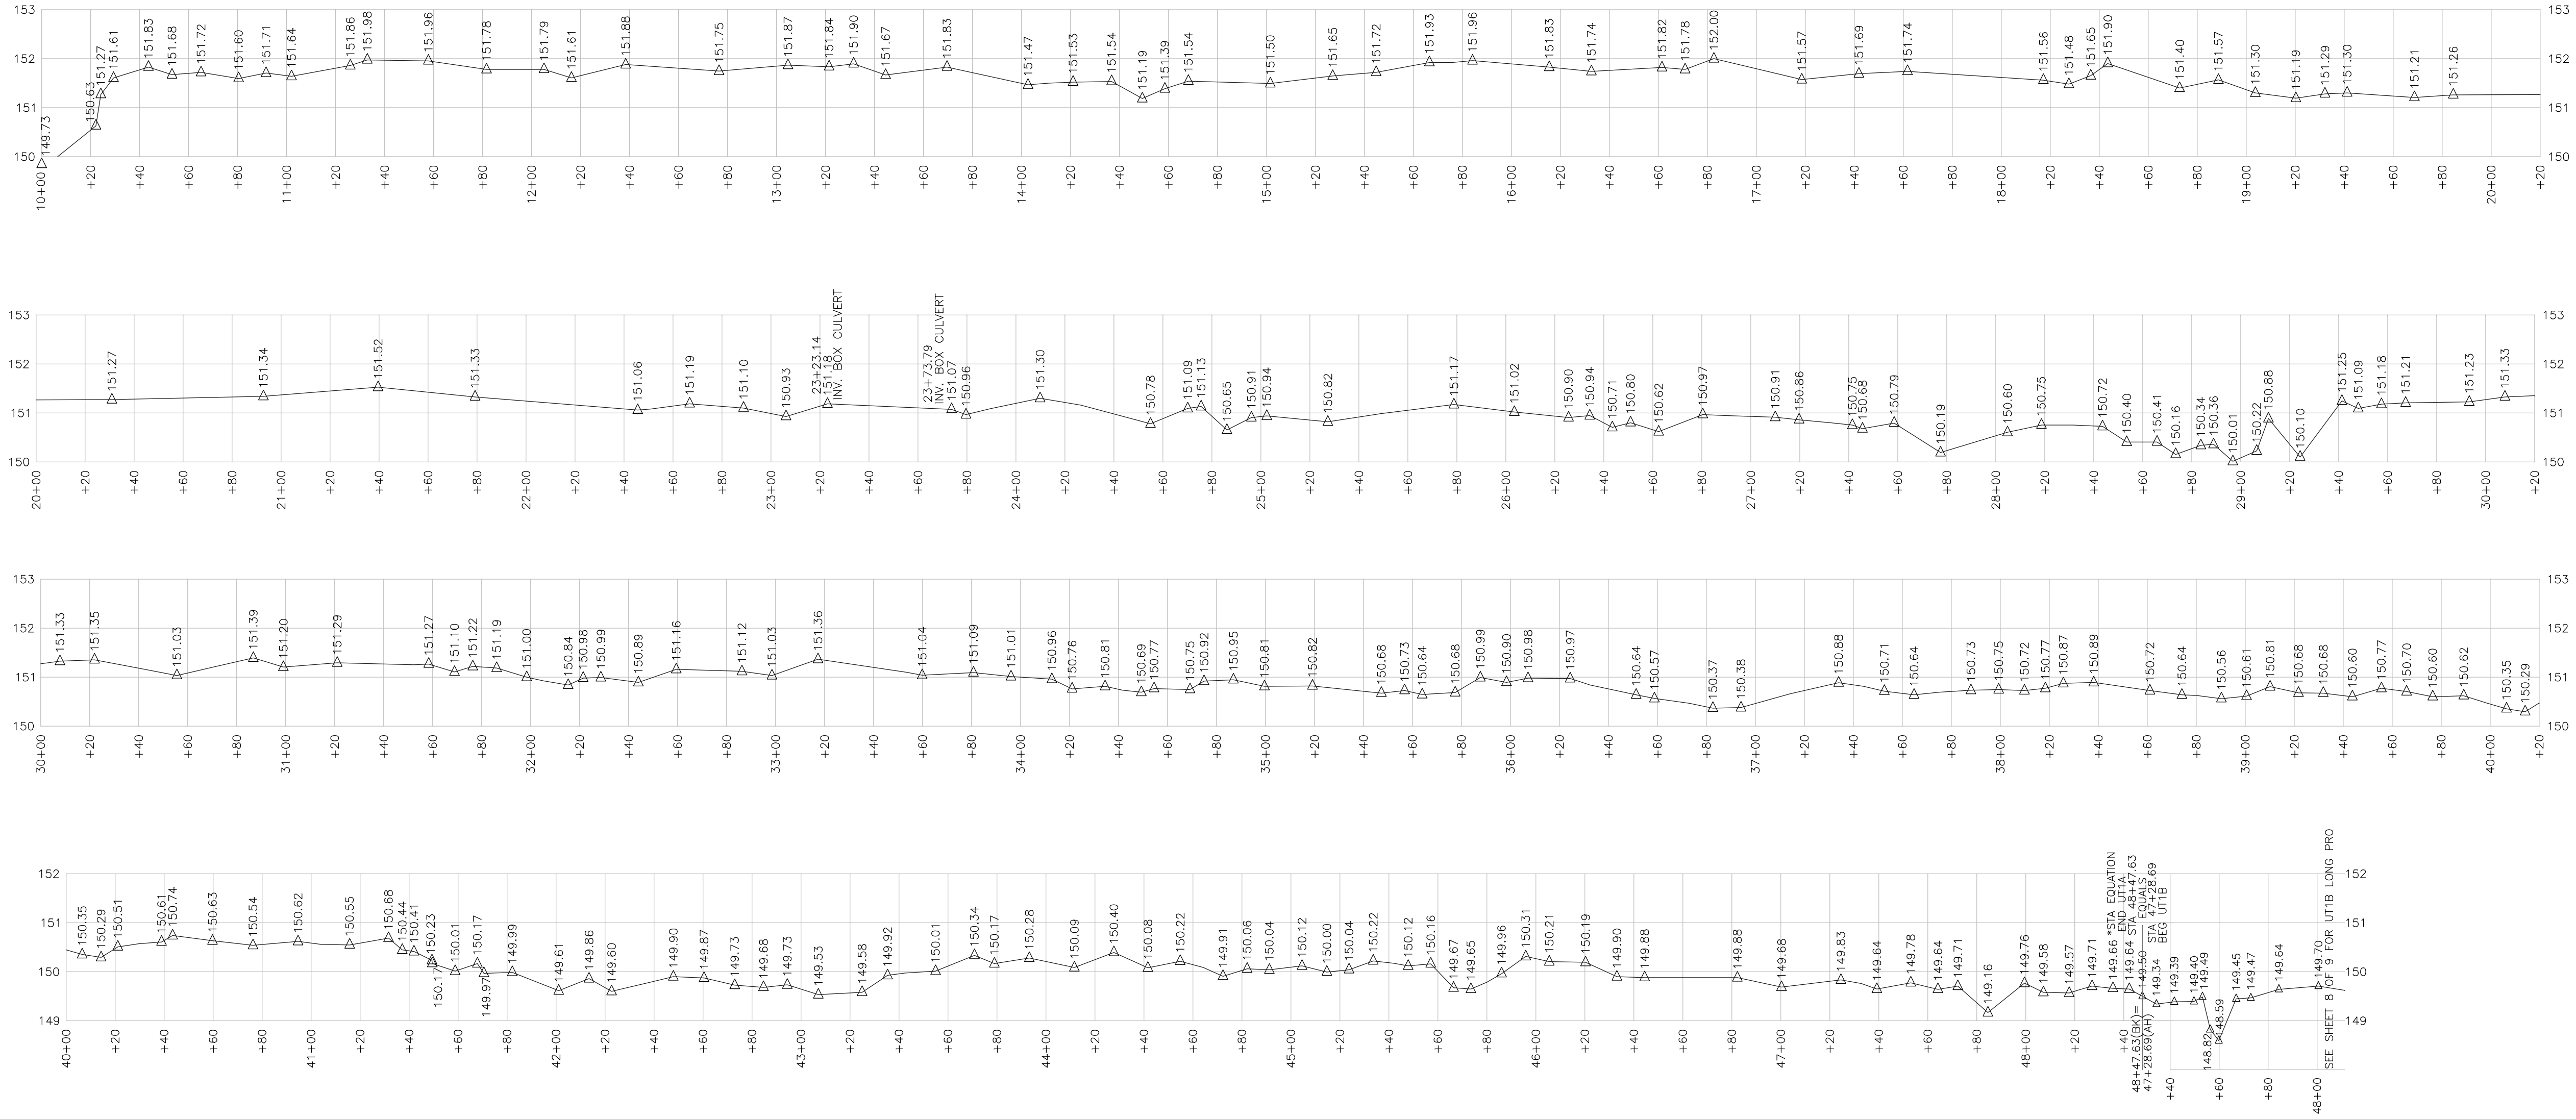
UT1A AS-BUILT LONGITUDINAL PROFILE

PROFILE - UT1A AS-BUILT SURVEY OF UT TO JUMPING RUN CREEK - STREAM & WETLAND RESTORATION SCO# 06-06901-01

The entire length of the single thread restoration reach (UT1b) was surveyed by Stantec staff using survey-grade GPS to assess baseline conditions. Multiple parameters were located including top of bank, thalweg, and water surface. The longitudinal profile is shown in Appendix B. The channel slope lies within the design parameters for this reach.
