FINAL
YEAR 2 (2015) MONITORING REPORT
UT TO MARTIN'S CREEK (CONTRERAS) MITIGATION PROJECT
Cherokee County, North Carolina
DMS Project No. 92766 (Contract No. 005717)
USACE Action ID No. 2010-00961/DWR Project No. 2010-00448
SCO No. 08-07249-01

**CURRENT CONDITIONS PLAN VIEW
 UT TO MARTINS CREEK (CONTRERAS)
 DMS PROJECT # 92766
 Cherokee County, North Carolina**

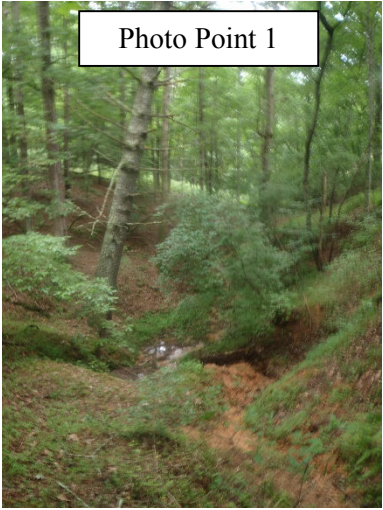
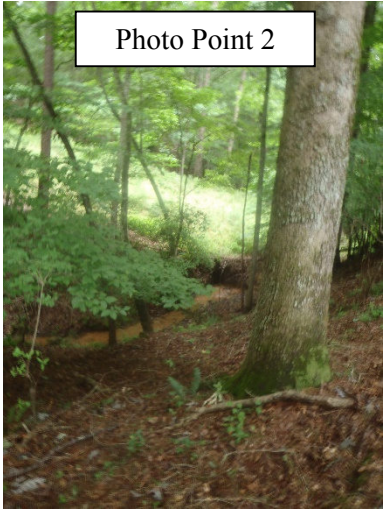
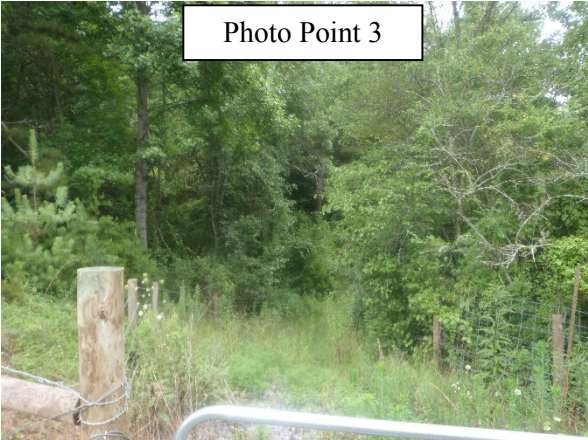
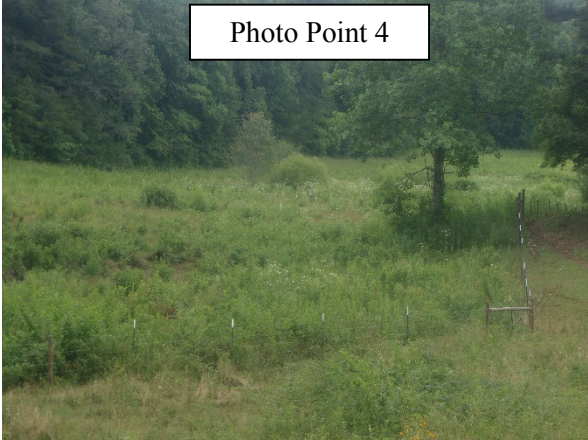
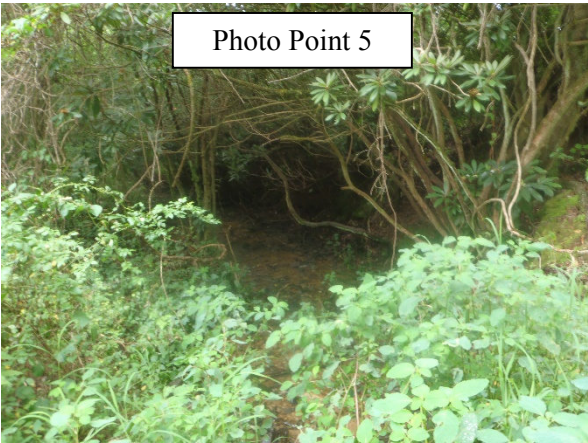
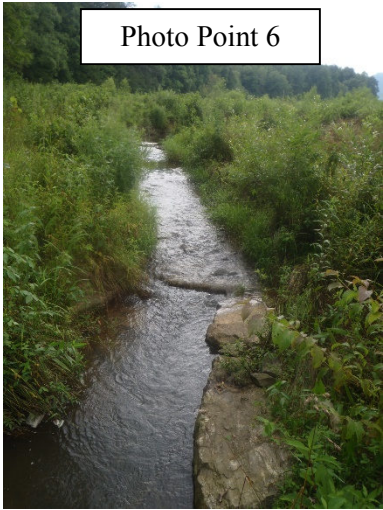
**UT to Martin's Creek (Contreras)
Year 1 Fixed Station Photographs
Taken July 2015**

Year 2 (2015) photo reference sites show no channel aggradation or degradation, or bank erosion. In addition, riparian vegetation is meeting success criteria based on stem counts across the Site; however, it is too early in the monitoring period to show successive maturation of riparian vegetation.

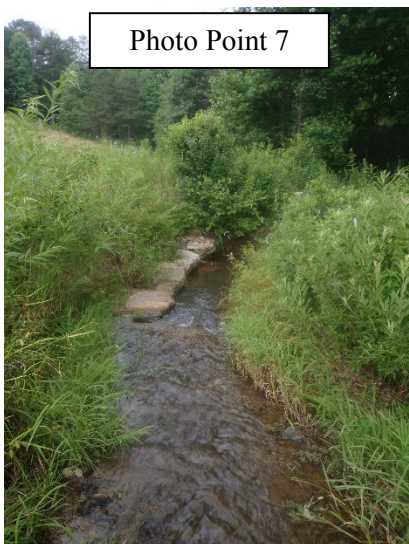
Photo Point 7

UT to Martin's Creek (Contreras)
Year 1 Fixed Station Photographs (continued)
Taken July 2015

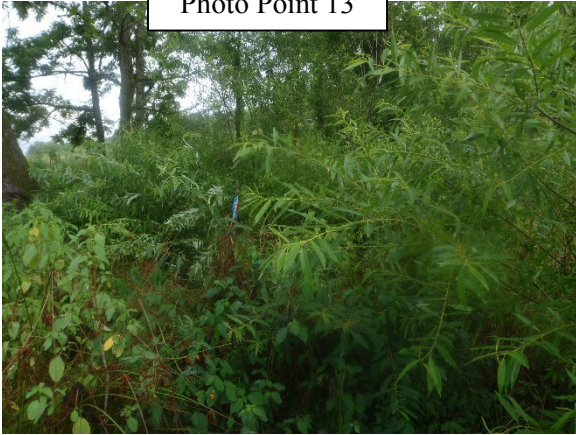
Photo Point 13

**UT to Martin's Creek (Contreras)
Year 1 Fixed Station Photographs (continued)
Taken July 2015**

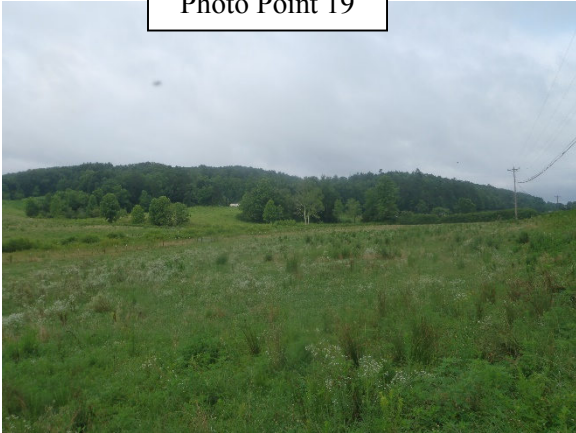
Photo Point 19

**UT to Martin's Creek (Contreras)
Year 1 Fixed Station Photographs (continued)
Taken July 2015**

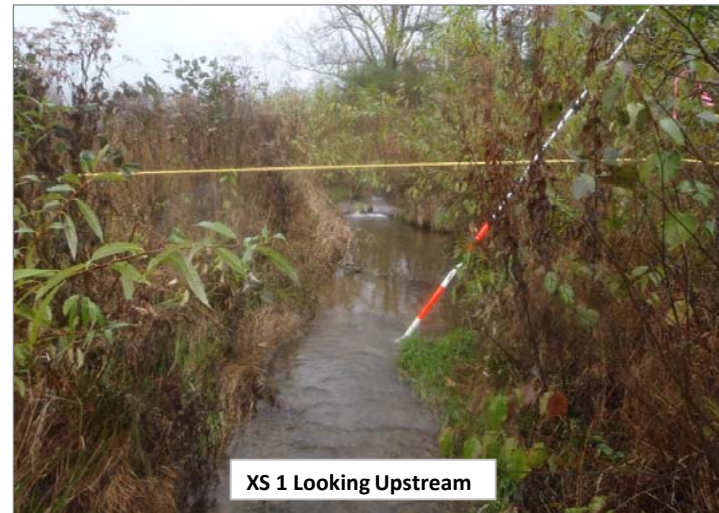
XS 1 Looking Upstream

Station	Elevation
0.00	90.66
2.13	90.69
3.45	90.48
4.15	90.07
4.89	89.90
5.42	89.40
6.07	88.99
6.26	88.99
7.06	89.00
7.54	88.87
8.47	88.89
9.41	88.90
10.23	88.91
10.93	88.94
11.56	89.31
12.1	89.88
12.9	89.88
13.9	90.32
15.3	90.64
17.2	90.54

SUMMARY DATA	
Bankfull Elevation:	90.6
Bankfull Cross-Sectional Area:	12.4
Bankfull Width:	11.9
Flood Prone Area Elevation:	92.3
Flood Prone Width:	100.0
Max Depth at Bankfull:	1.7
Mean Depth at Bankfull:	1.0
W / D Ratio:	11.4
Entrenchment Ratio:	8.4
Bank Height Ratio:	1.0

Stream Type	E
--------------------	---

No areas of concern or indicators of instability were observed during year 2 (2015) monitoring; therefore, stream dimension measurements are currently meeting success criteria.

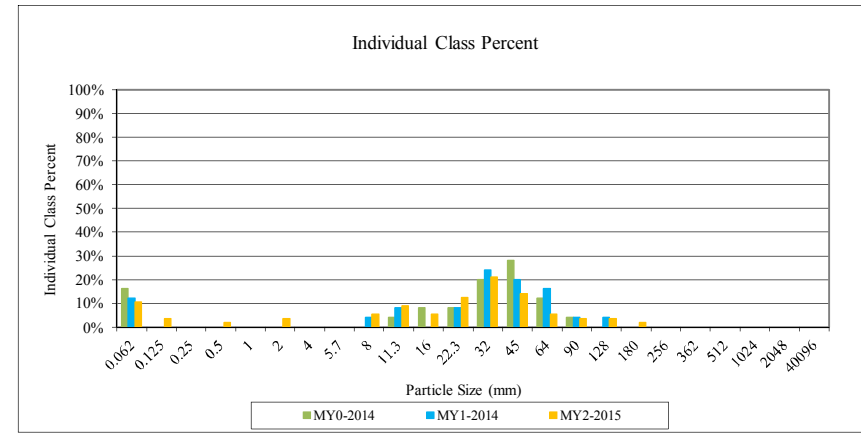
Project Name: UT to Martins Creek (Contreras)					
Cross-Section: 5					
Feature: Riffle					
		2015			
Description	Material	Size (mm)	Total #	Item %	Cum %
Silt/Clay					
	silt/clay	0.062	6	11%	11%
Sand					
	very fine sand	0.125	2	4%	14%
	fine sand	0.250		0%	14%
	medium sand	0.50	1	2%	16%
	coarse sand	1.00		0%	16%
	very coarse sand	2.0	2	4%	19%
Gravel					
	very fine gravel	4.0		0%	19%
	fine gravel	5.7		0%	19%
	fine gravel	8.0	3	5%	25%
	medium gravel	11.3	5	9%	33%
	medium gravel	16.0	3	5%	39%
	course gravel	22.3	7	12%	51%
	course gravel	32.0	12	21%	72%
	very coarse gravel	45	8	14%	86%
	very coarse gravel	64	3	5%	91%
Cobble					
	small cobble	90	2	4%	95%
	medium cobble	128	2	4%	98%
	large cobble	180	1	2%	100%
	very large cobble	256		0%	100%
Boulder					
	small boulder	362		0%	100%
	small boulder	512		0%	100%
	medium boulder	1024		0%	100%
	large boulder	2048		0%	100%
Bedrock					
	bedrock	40096		0%	100%
TOTAL % of whole count			57	100%	100%

Summary Data	
D16	1.042
D35	12.39
D50	21.5
D84	43
D95	92

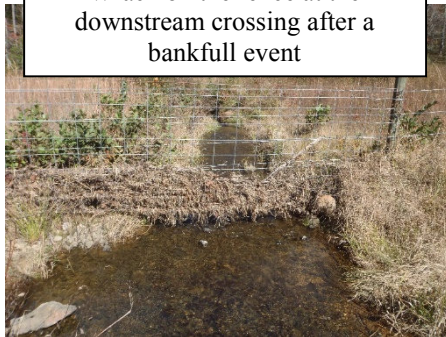
Bankfull Photo 2:
Wrack on the fence at the downstream crossing after a bankfull event

April 12, 2015	November 17, 2014	Crest gauge data indicates a bankfull event after approximately 1.44 inches of rain documented in one day at a nearby rain gauge.	---
July 13, 2015	June 11, 2015	Crest gauge data and laid back vegetation in the floodplain of UT1 indicate a bankfull event after approximately 1.68 inches of rain documented in one day at a nearby rain gauge.	---
July 13, 2015	June 26, 2015	Crest gauge data indicates a bankfull event after approximately 1.57 inches of rain was documented in one day at a nearby rain gauge.	3
September 11, 2015	August 19, 2015	Crest gauge data indicates a bankfull event after approximately 2.94 inches of rain was documented over three days at a nearby rain gauge.	---
November 18, 2015	September 26, 2015	Crest gauge data indicates a bankfull event after approximately 2.65 inches of rain was documented over two days at a nearby rain gauge.	---
November 18, 2015	October 3, 2015	Crest gauge data indicates a bankfull event after approximately 4.50 inches of rain was documented over three days at a nearby rain gauge.	---

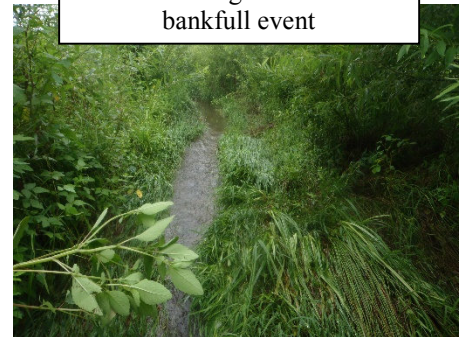
Bankfull Photo 3:
Laid-back vegetation after a bankfull event
