***BASELINE MONITORING DOCUMENT &  
AS-BUILT BASELINE REPORT***

**UNNAMED TRIBUTARY TO MILLERS CREEK  
STREAM AND WETLAND MITIGATION SITE**

Duplin County, North Carolina  
DMS Project # 95719

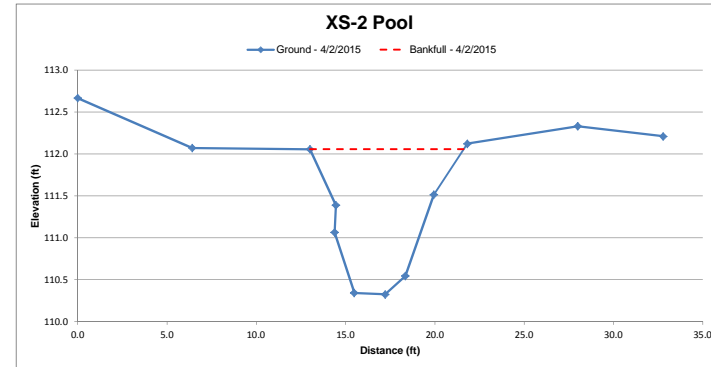
Baseline/As-Built		MY1		MY2		MY3		MY4		MY5	
	Station	Elev.	Station	Elev.	Station	Elev.	Station	Elev.	Station	Elev.	Station	Elev.
XS-2	0.00	112.67										
	6.42	112.07										
	13.01	112.06										
	14.46	111.39										
	14.39	111.06										
	15.49	110.34										
	17.22	110.32										
	18.35	110.54										
	19.94	111.51										
	21.82	112.12										
	28.00	112.33										
	32.79	112.21

Dimension and substrate	Cross Section 2 (Pool)						
	Base	MY1	MY2	MY3	MY4	MY5	MY+
<b>Based on fixed baseline bankfull elevation</b>							
Bankfull Width (ft)	8.6						
Floodprone Width (ft)							
Bankfull Mean Depth (ft)	1						
Bankfull Max Depth (ft)	1.7						
Bankfull Cross Sectional Area (ft <sup>2</sup> )	8.8						
Bankfull Width/Depth Ratio							
Bankfull Entrenchment Ratio							
Bankfull Bank Height Ratio

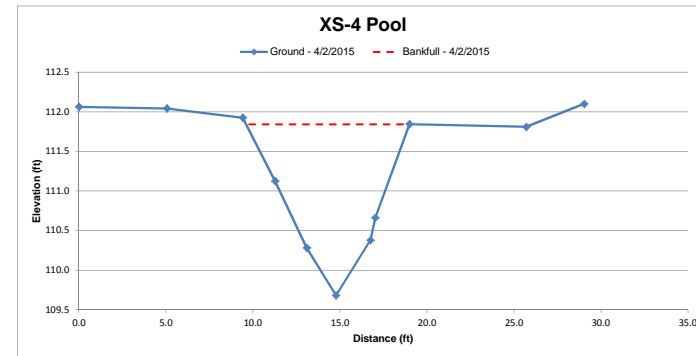
Baseline/As-Built		MY1		MY2		MY3		MY4		MY5	
	Station	Elev.	Station	Elev.	Station	Elev.	Station	Elev.	Station	Elev.	Station	Elev.
XS-4	0.00	112.06										
	5.06	112.04										
	9.42	111.93										
	11.27	111.13										
	13.10	110.28										
	14.78	109.68										
	16.76	110.38										
	17.03	110.66										
	19.00	111.84										
	25.71	111.81										
	29.04	112.10

Dimension and substrate	Cross Section 4 (Pool)						
	Base	MY1	MY2	MY3	MY4	MY5	MY+
<b>Based on fixed baseline bankfull elevation</b>							
Bankfull Width (ft)	9.4						
Floodprone Width (ft)							
Bankfull Mean Depth (ft)	1.2						
Bankfull Max Depth (ft)	2.2						
Bankfull Cross Sectional Area (ft <sup>2</sup> )	10.9						
Bankfull Width/Depth Ratio							
Bankfull Entrenchment Ratio							
Bankfull Bank Height Ratio

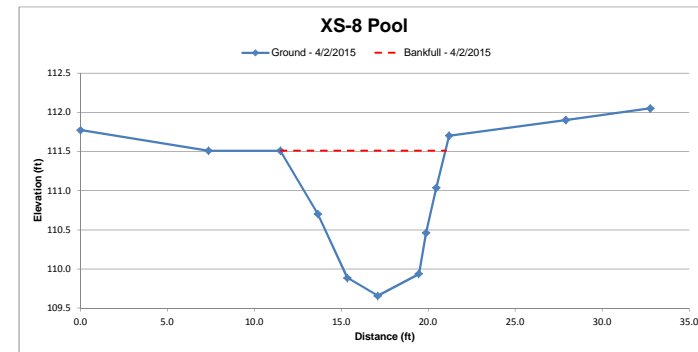
Baseline/As-Built		MY1		MY2		MY3		MY4		MY5	
	Station	Elev.	Station	Elev.	Station	Elev.	Station	Elev.	Station	Elev.	Station	Elev.
XS-8	0.00	111.77										
	7.37	111.51										
	11.50	111.51										
	13.65	110.70										
	15.35	109.89										
	17.09	109.66										
	19.46	109.94										
	19.87	110.46										
	20.46	111.04										
	21.20	111.70										
	27.91	111.90										
	32.76	112.05

Dimension and substrate	Cross Section 8 (Pool)						
	Base	MY1	MY2	MY3	MY4	MY5	MY+
<b>Based on fixed baseline bankfull elevation</b>							
Bankfull Width (ft)	9.5						
Floodprone Width (ft)							
Bankfull Mean Depth (ft)	1.2						
Bankfull Max Depth (ft)	1.9						
Bankfull Cross Sectional Area (ft <sup>2</sup> )	11.1						
Bankfull Width/Depth Ratio							
Bankfull Entrenchment Ratio							
Bankfull Bank Height Ratio

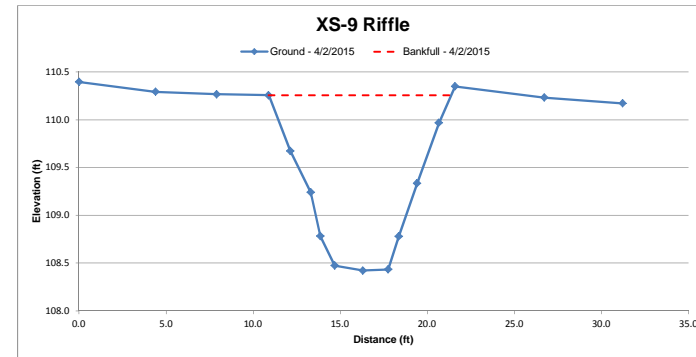
Baseline/As-Built		MY1		MY2		MY3		MY4		MY5	
	Station	Elev.	Station	Elev.	Station	Elev.	Station	Elev.	Station	Elev.	Station	Elev.
XS-9	0.00	110.40										
	4.40	110.29										
	7.91	110.27										
	10.89	110.26										
	12.13	109.67										
	13.31	109.24										
	13.86	108.78										
	14.69	108.47										
	16.31	108.42										
	17.75	108.43										
	18.36	108.78										
	19.42	109.34										
	20.67	109.97										
	21.59	110.35										
	26.72	110.23										
31.22	110.17

Dimension and substrate	Cross Section 9 (Riffle)						
	Base	MY1	MY2	MY3	MY4	MY5	MY+
<b>Based on fixed baseline bankfull elevation</b>							
Bankfull Width (ft)	10.5						
Floodprone Width (ft)	219						
Bankfull Mean Depth (ft)	1.1						
Bankfull Max Depth (ft)	1.8						
Bankfull Cross Sectional Area (ft <sup>2</sup> )	12.0						
Bankfull Width/Depth Ratio	9.1						
Bankfull Entrenchment Ratio	20.9						
Bankfull Bank Height Ratio	1.0

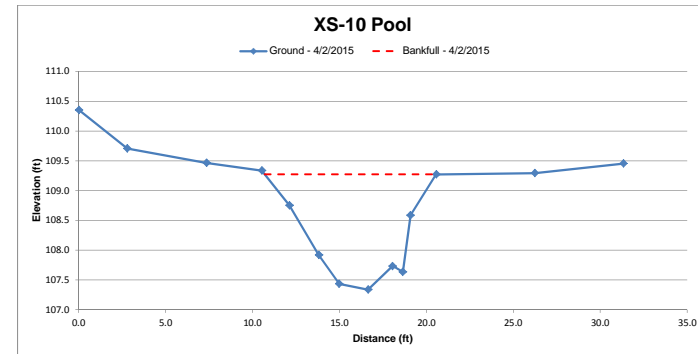
Baseline/As-Built		MY1		MY2		MY3		MY4		MY5	
	Station	Elev.	Station	Elev.	Station	Elev.	Station	Elev.	Station	Elev.	Station	Elev.
XS-10	0.00	110.36										
	2.79	109.71										
	7.35	109.47										
	10.53	109.34										
	12.12	108.75										
	13.81	107.92										
	14.98	107.44										
	16.64	107.34										
	18.05	107.73										
	18.64	107.63										
	19.08	108.58										
	20.57	109.27										
	26.23	109.29										
	31.34	109.46

Dimension and substrate	Cross Section 10 (Pool)						
	Base	MY1	MY2	MY3	MY4	MY5	MY+
<b>Based on fixed baseline bankfull elevation</b>							
Bankfull Width (ft)	9.8						
Floodprone Width (ft)							
Bankfull Mean Depth (ft)	1.2						
Bankfull Max Depth (ft)	1.9						
Bankfull Cross Sectional Area (ft <sup>2</sup> )	11.4						
Bankfull Width/Depth Ratio							
Bankfull Entrenchment Ratio							
Bankfull Bank Height Ratio
