FINAL
Baseline Monitoring Document and As-Built Baseline Report
UT to Mill Swamp Restoration Project

Onslow County, North Carolina

EEP Project ID No. 95019

White Oak River Basin: 03030001-010020

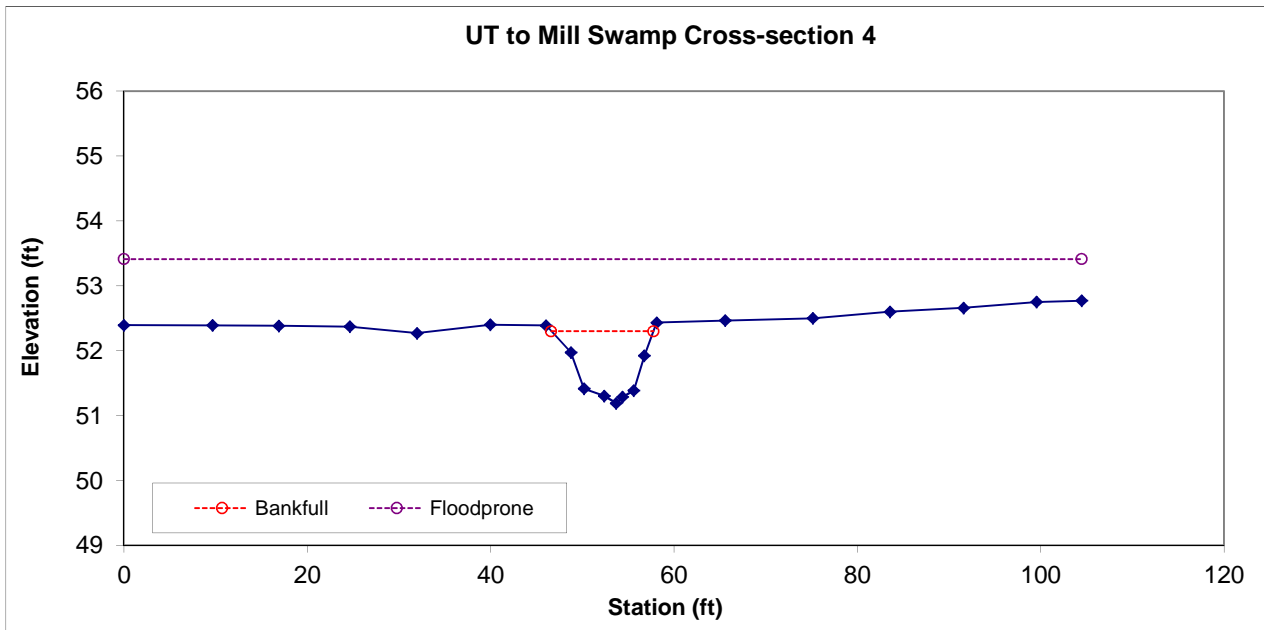
Permanent Cross-section 4
 (As-Built Data - collected August 2013)

Feature	Stream Type	BKF Area	BKF Width	BKF Depth	Max BKF Depth	W/D	BH Ratio	ER	BKF Elev	TOB Elev
Riffle	C	7.5	11.15	0.67	1.11	16.52	1.1	9.4	52.3	52.39

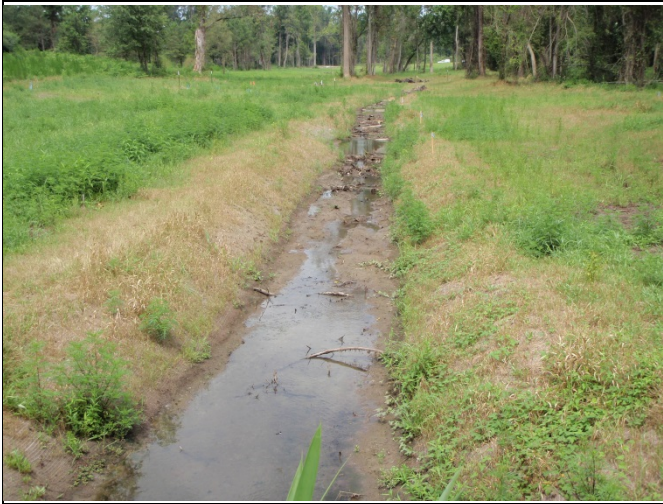
Photo Point 1, UT1c – Station 52+37 (August 13, 2013)

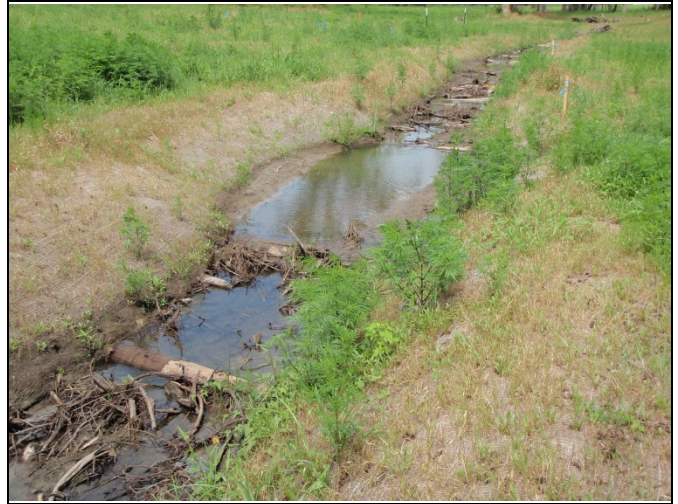
Photo Point 2, UT1c – Station 51+60 (August 13, 2013)

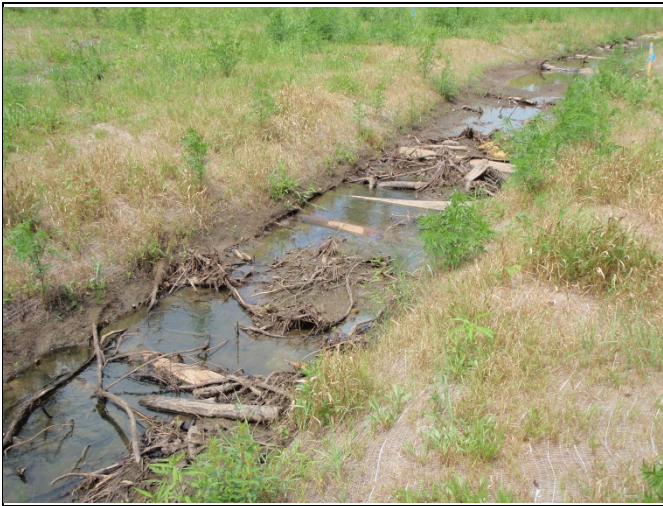
Photo Point 3, UT1c – Station 51+40 (August 13, 2013)

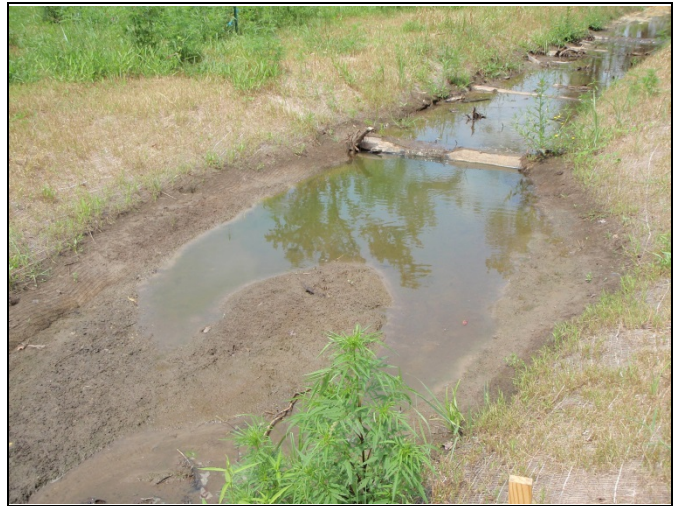
Photo Point 4, UT1c – Station 50+90 (August 13, 2013)

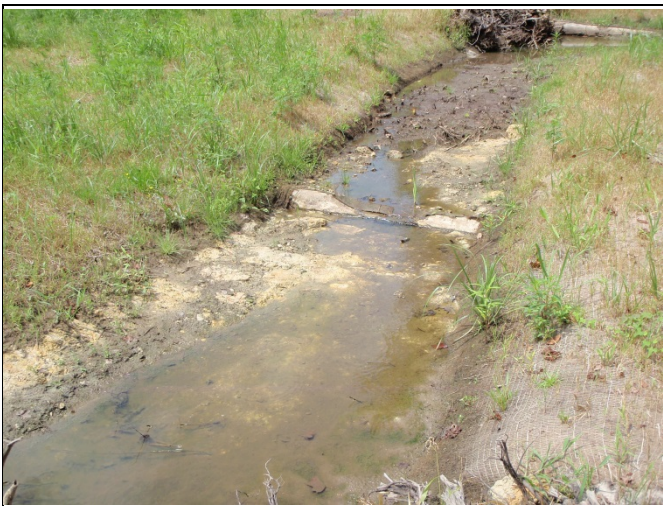
Photo Point 5, UT1c – Station 49+90 (August 13, 2013)

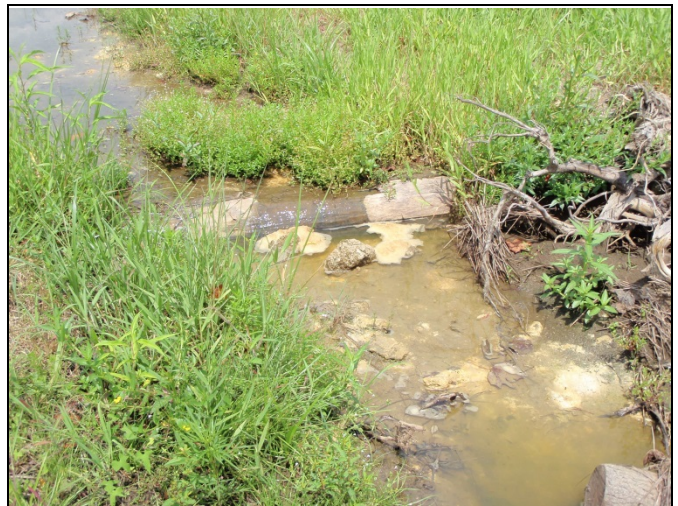
Photo Point 6, UT1c – Station 44+25 (August 13, 2013)

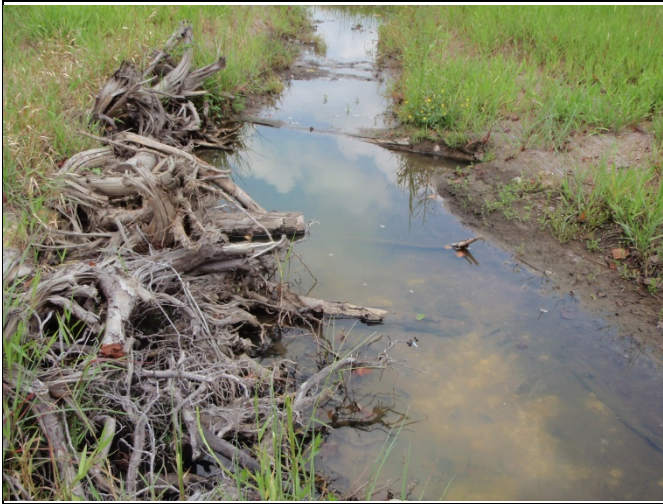
Photo Point 7, UT1c – Station 44+00 (August 13, 2013)

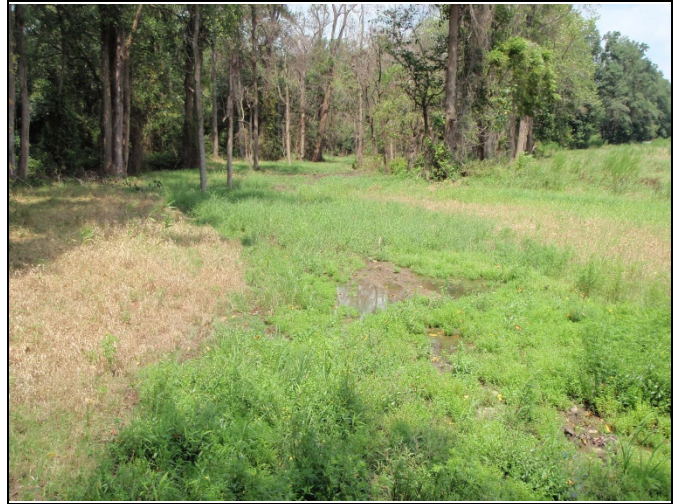
Photo Point 8 (Upstream), UT1b – Station 37+00
(August 13, 2013)

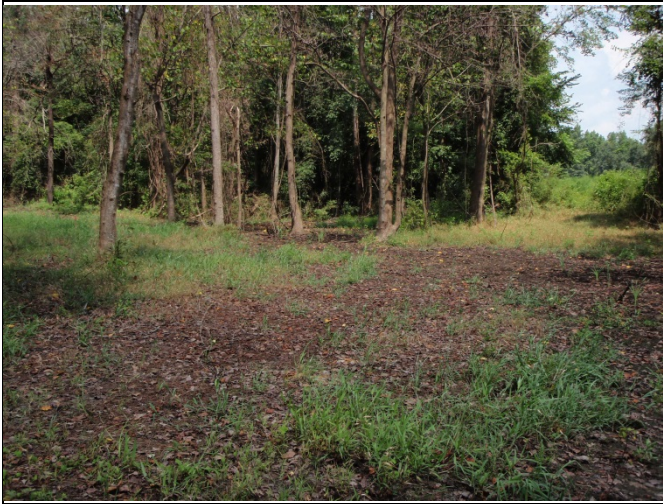
Photo Point 9 (Upstream), UT1b – Station 34+25
(August 13, 2013)

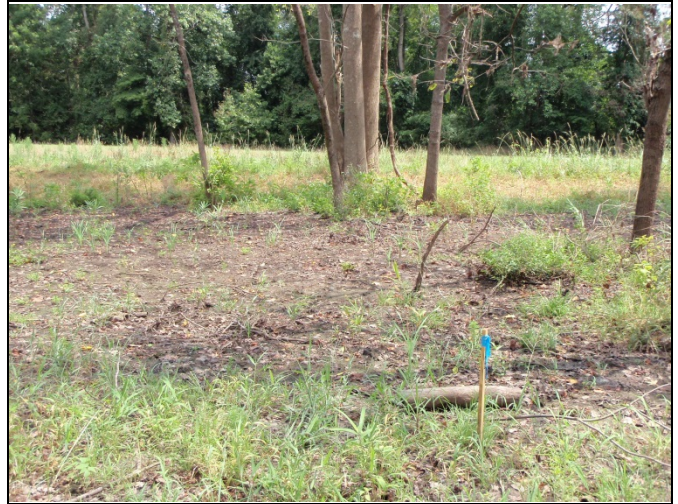
Photo Point 9 (East), UT1b – Station 34+25
(August 13, 2013)

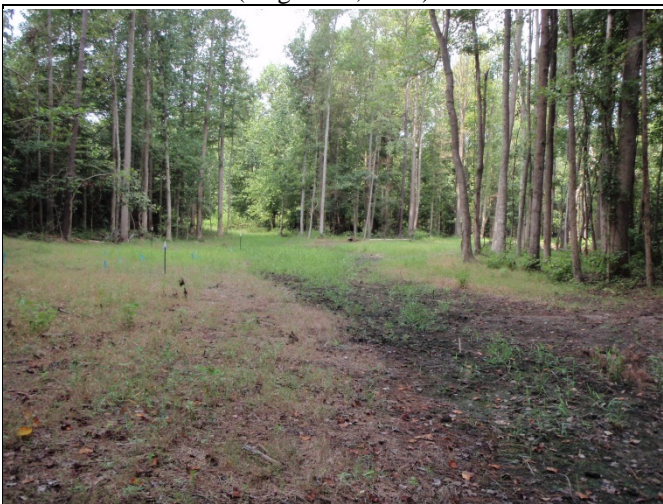
Photo Point 10 (Upstream), UT1b – Station 22+15
(August 13, 2013)

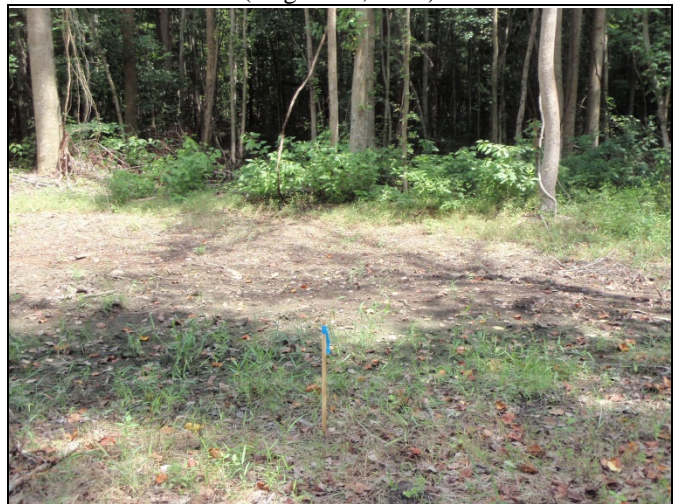
Photo Point 10 (North), UT1b – Station 22+15
(August 13, 2013)

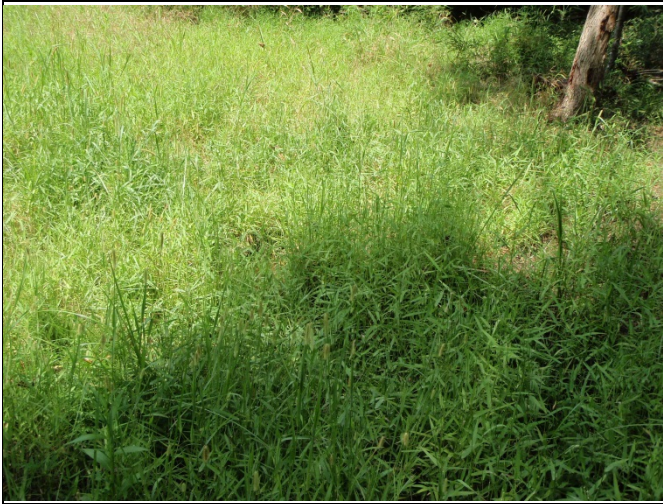
Photo Point 11, UT3 – Station 19+40 (August 13, 2013)

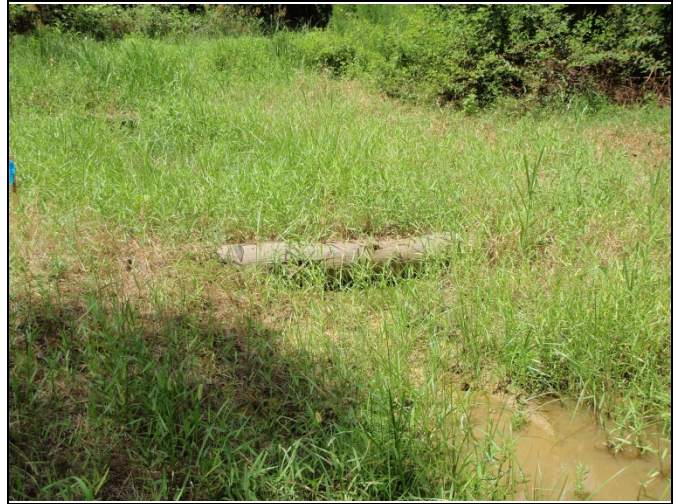
Photo Point 12, UT3 – Station 19+25 (August 13, 2013)

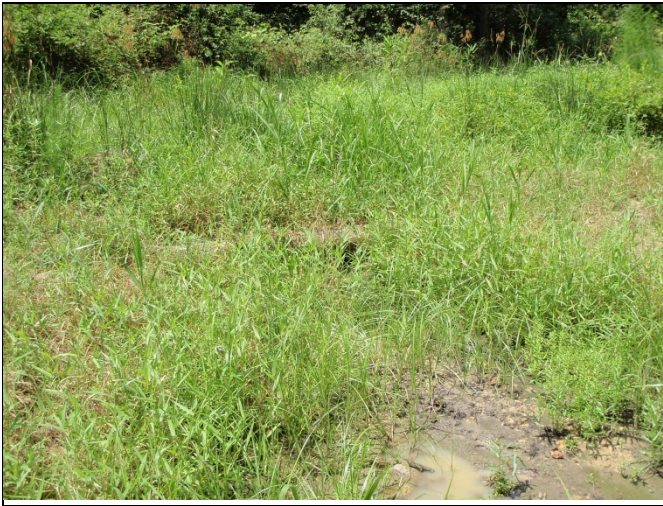
Photo Point 13, UT3 – Station 19+10 (August 13, 2013)

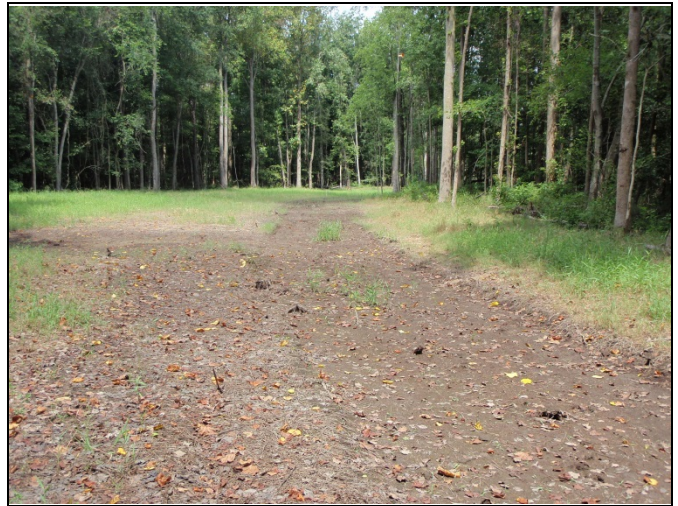
Photo Point 14 (Upstream), UT1b – Station 21+20 (August 13, 2013)

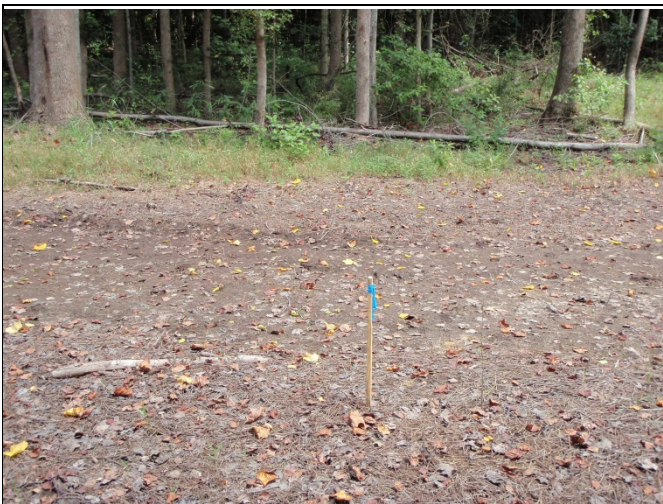
Photo Point 14 (Northeast), UT1b – Station 21+20 (August 13, 2013)

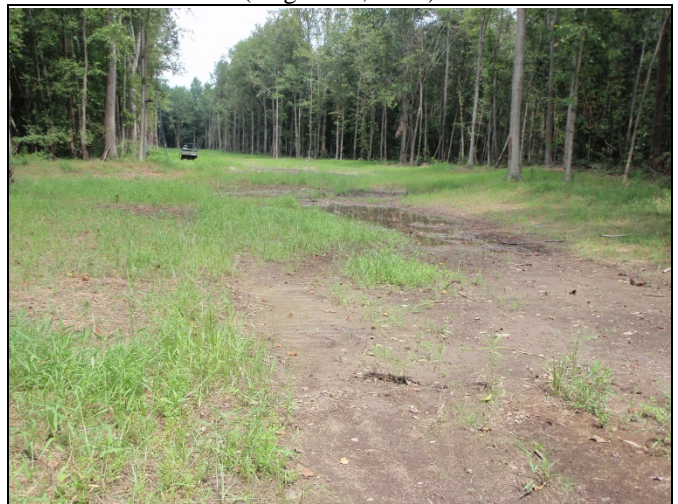
Photo Point 15 (Upstream), UT1b – Station 18+75 (August 13, 2013)

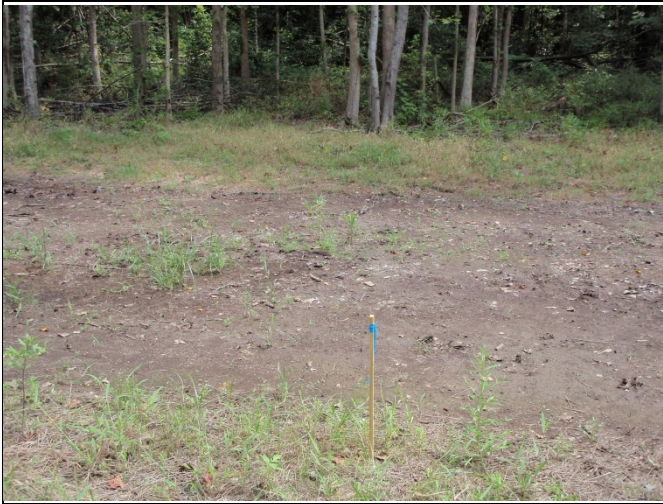
Photo Point 15 (east), UT1b – Station 18+75
(August 13, 2013)

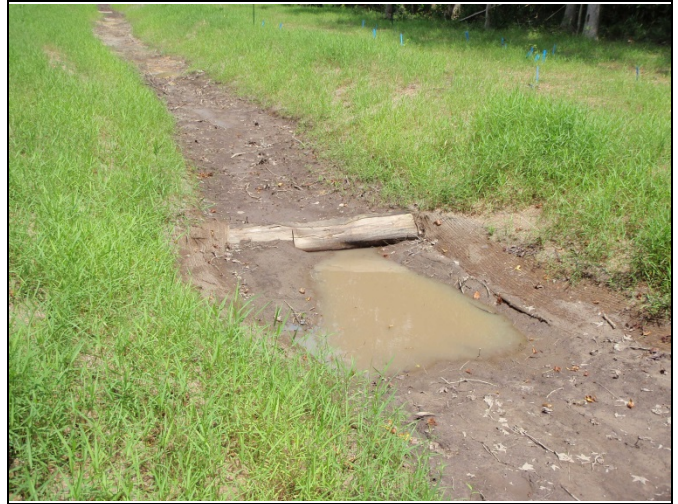
Photo Point 16, UT1a – Station 14+60 (August 13, 2013)

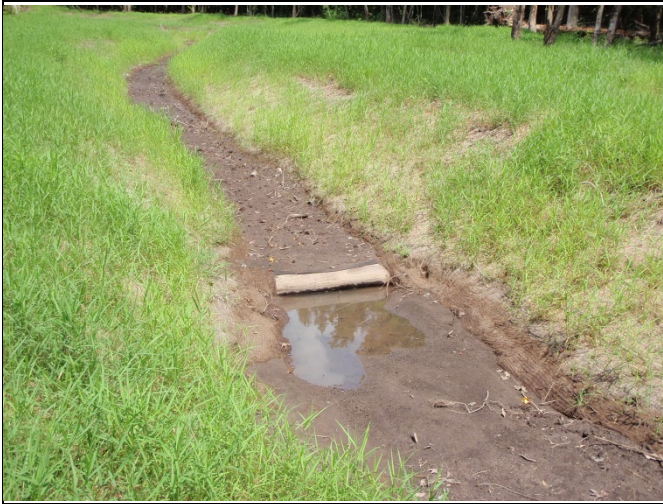
Photo Point 17, UT1a – Station 12+75 (August 13, 2013)

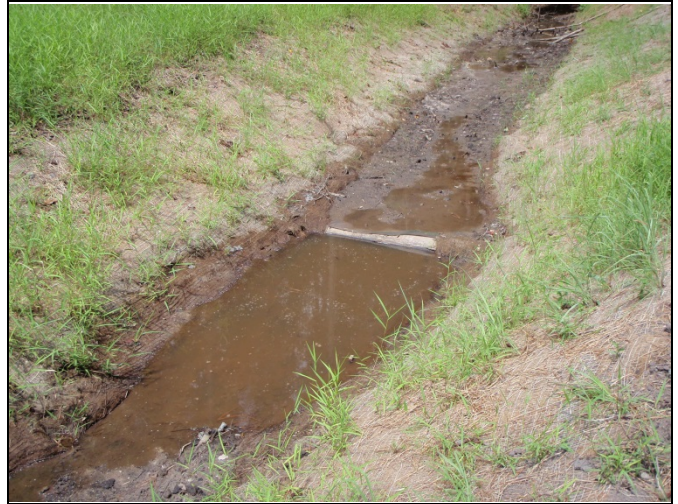
Photo Point 18, UT1a – Station 10+60 (August 13, 2013)

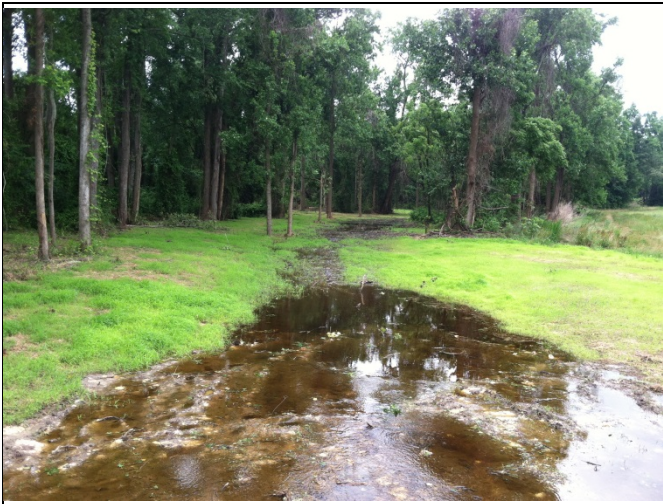
Photo Point 8, UT1b (June 12, 2013)

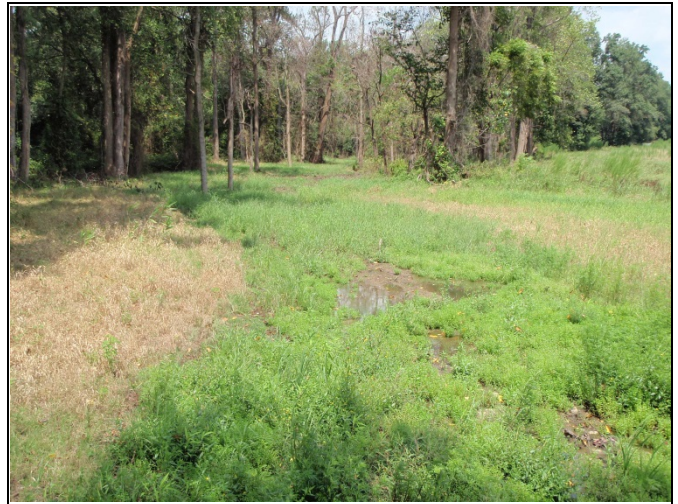
Photo Point 8, UT1b (August 13, 2013)

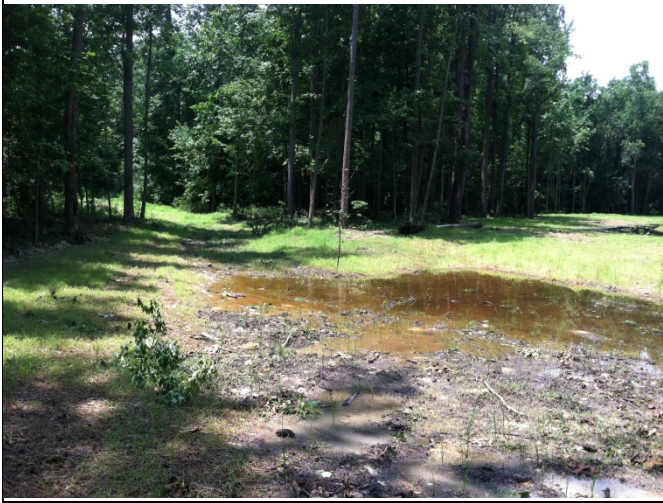
Photo Point 10 area, UT1b (June 12, 2013)

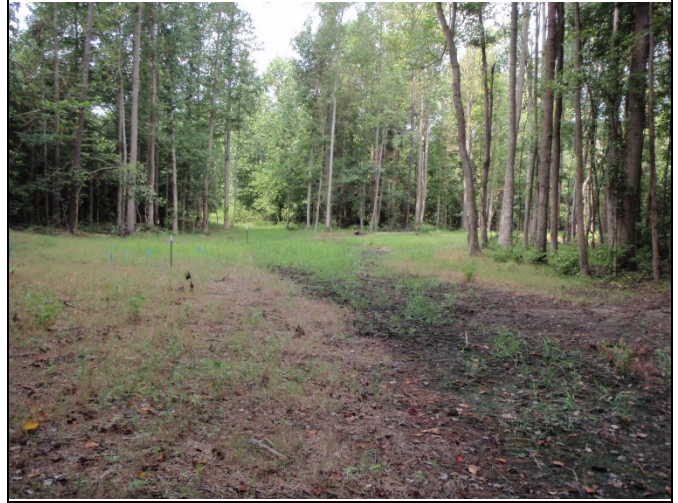
Photo Point 10, UT1b (August 13, 2013)

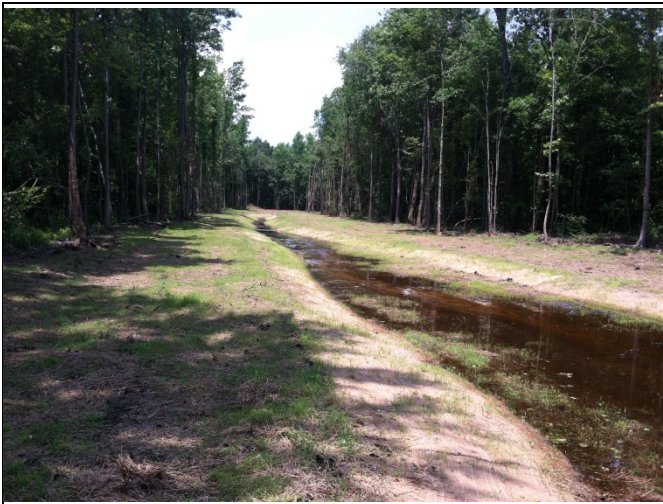
Photo Point 15 area, UT1b (June 12, 2013)

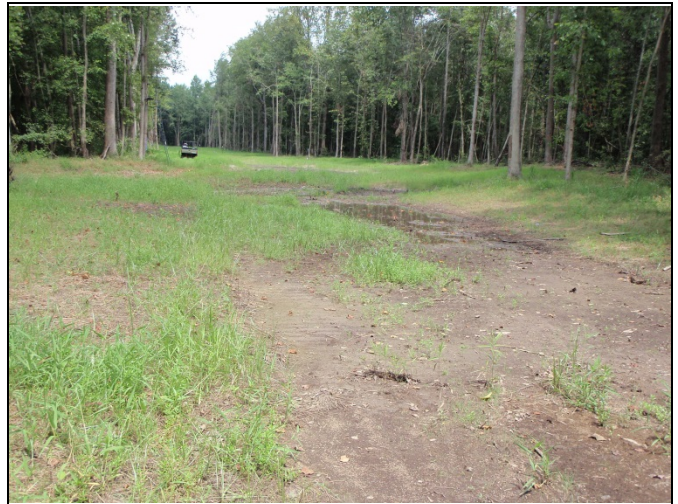
Photo Point 15, UT1b (August 13, 2013)

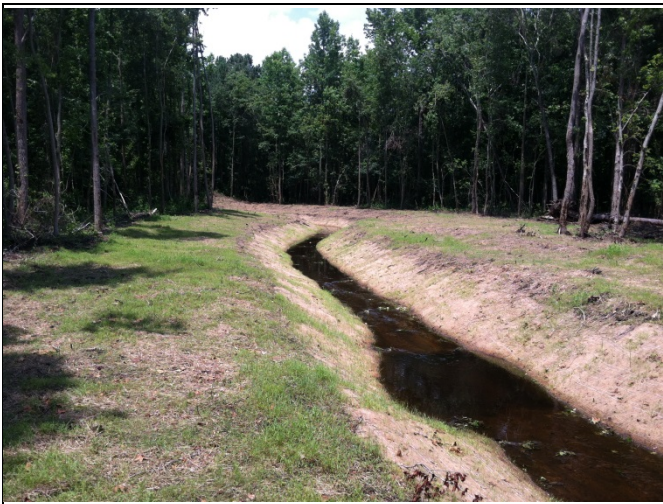
Photo Point 17 area, UT1a (June 12, 2013)
