TRIBUTARY TO REEDY FORK CREEK STREAM RESTORATION

GUILFORD COUNTY, NORTH CAROLINA

ANNUAL MONITORING REPORT (YEAR 2 OF 5)

DECEMBER 2009

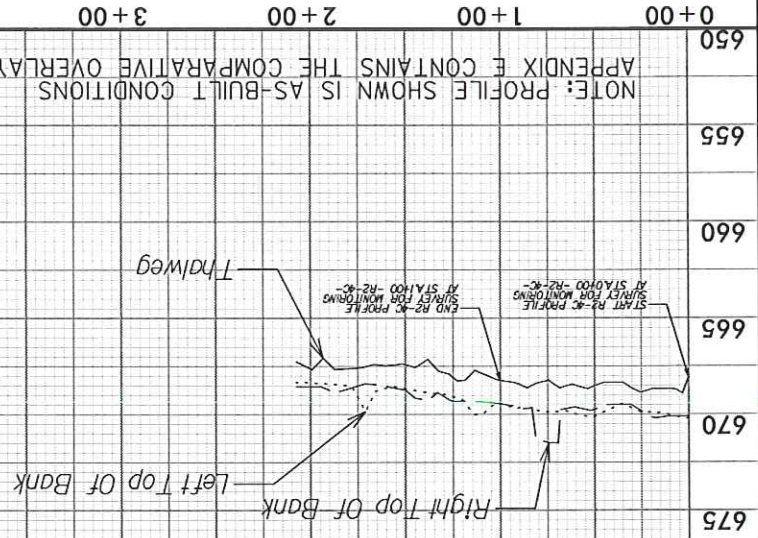
R2-4C

NOTE: PROFILE SHOWN IS AS-BUILT CONDITIONS
APPENDIX E CONTAINS THE COMPARATIVE OVERLAYS

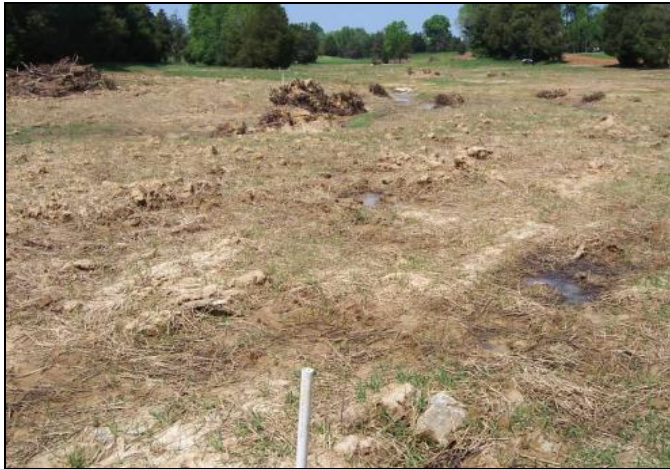
As-Built Surveys, April 2008

Veg Plot 1

total of 16 representative vegetation plots were installed at RFC based on the recommendations set forth by NCEEP regarding the acreage contained in the conservation easement. The survivability of the planted woody vegetation at RFC will be monitored using annual stem counts at each of the plots. In addition to the stem counts, annual photos will be taken at each of the plots and also from eight other permanent photo reference points. The vegetation plot photos will be used for photo documentation and comparison of the vegetation growth at each plot. The photo documentation at the reference points will be employed to assist in a project-wide visual assessment of the vegetation at RFC. Survivability will be based on achieving a minimum of 320 stems per acre, the rate required to be present during the third year of monitoring, across the project site. The stem counts will be conducted during the latter part of the growing season months (August, September, and October) to insure survival throughout a complete growing season while still allowing for relative ease in identification.

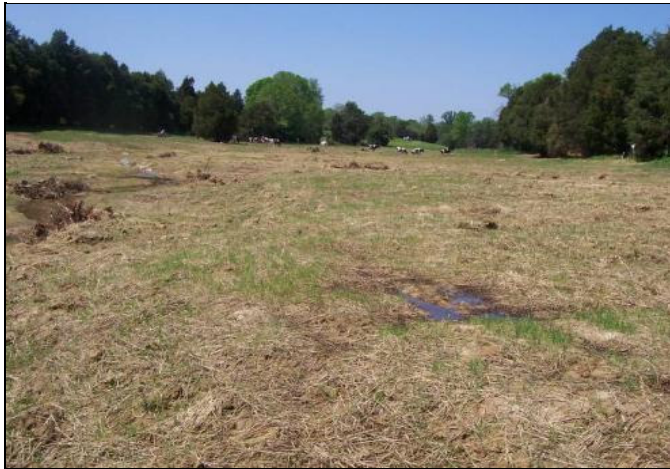
As-Built Surveys, April 2008

Veg Plot 2

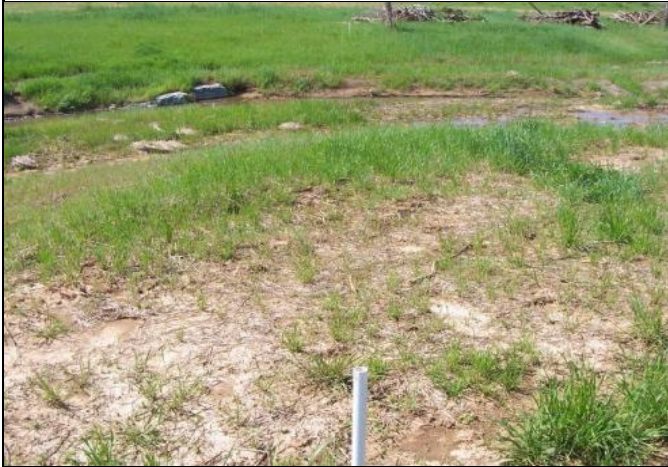
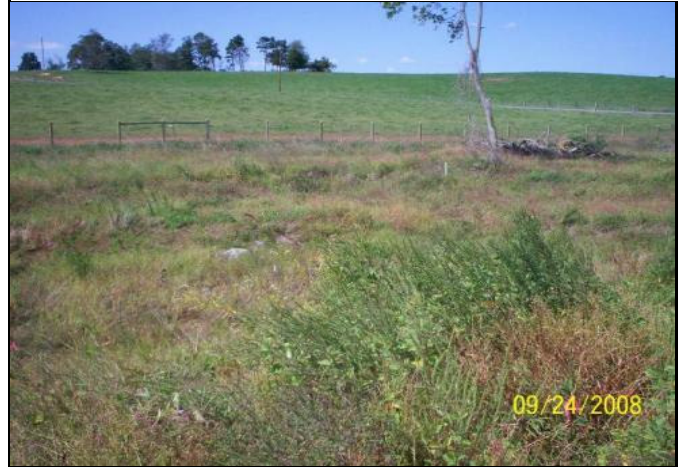
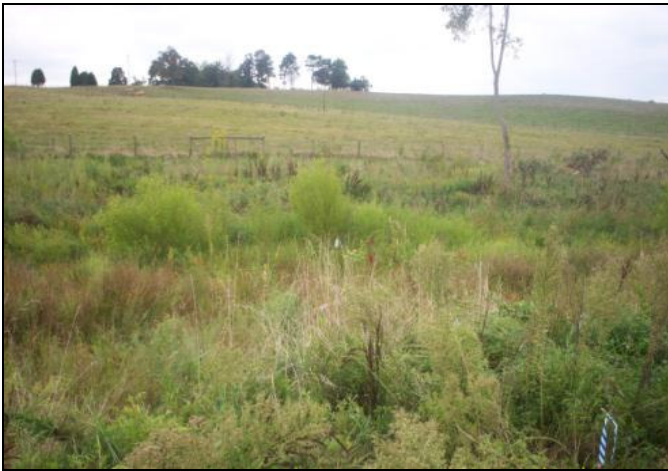
Veg Plot 13

As-Built Surveys, April 2008

Year 1 Monitoring, September 2008

Year 2 Monitoring, September 2009

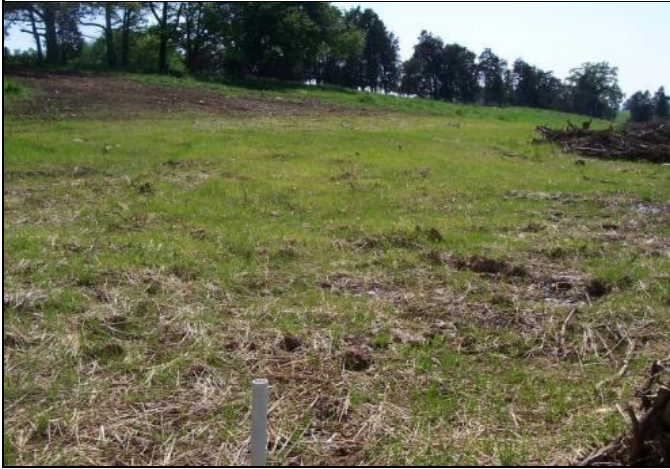
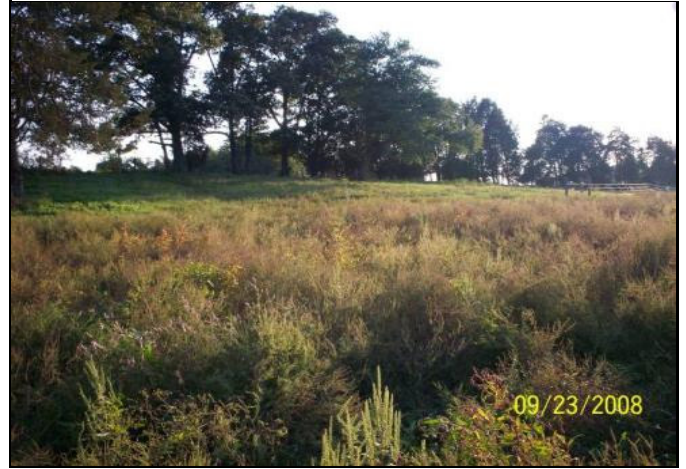
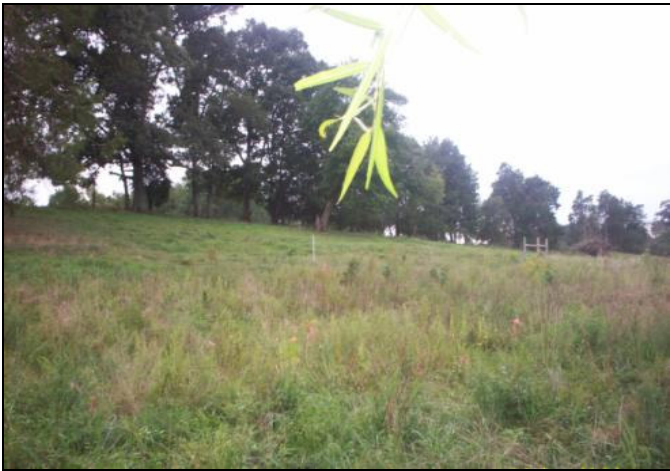
Veg Plot 14

As-Built Surveys, April 2008

Year 1 Monitoring, September 2008

Year 2 Monitoring, September 2009

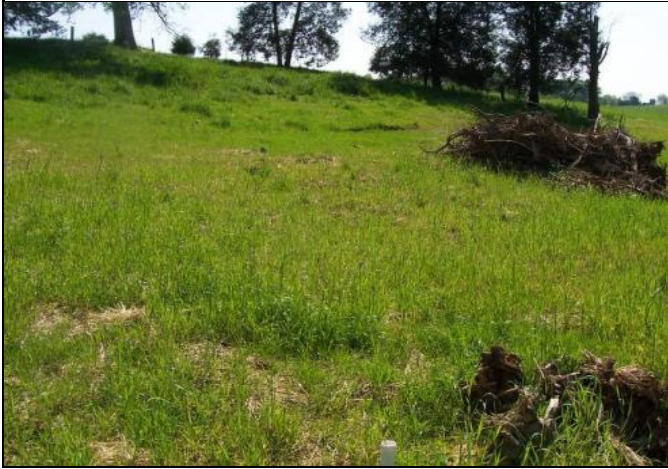
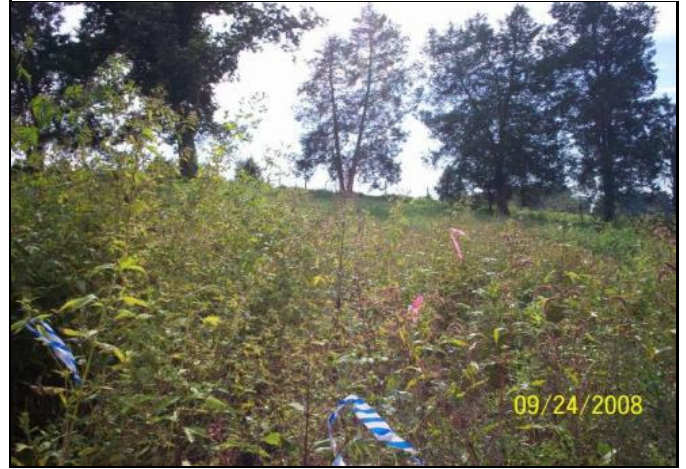
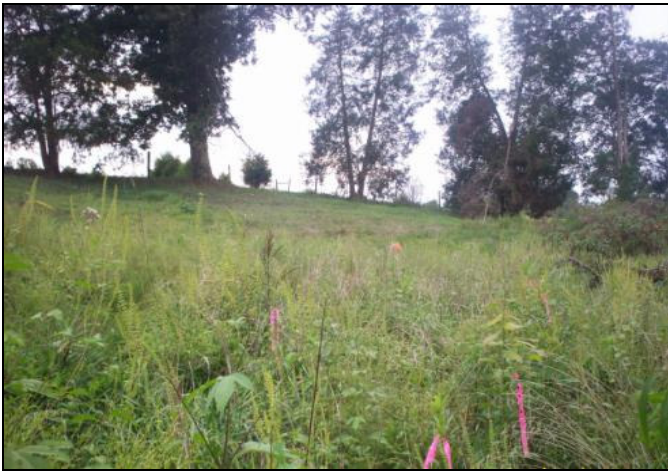
Veg Plot 15

As-Built Surveys, April 2008

Year 1 Monitoring, September 2008

Year 2 Monitoring, September 2009

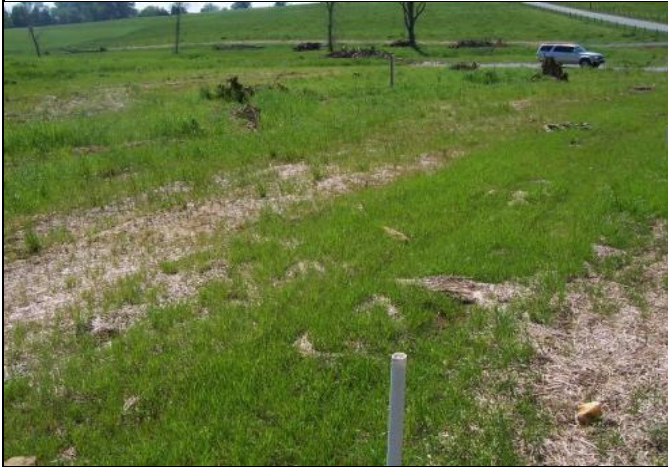
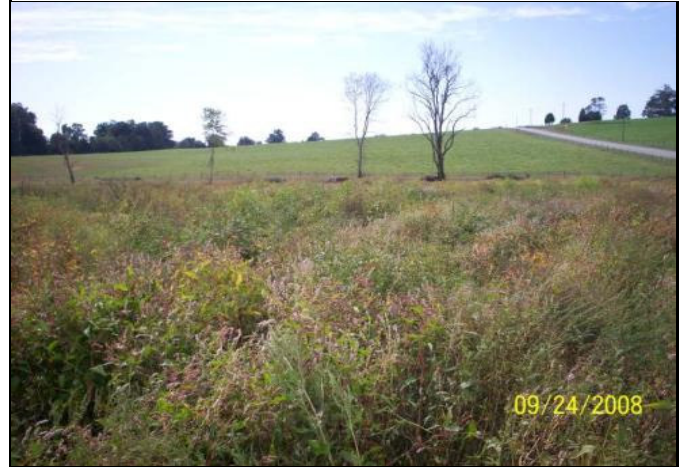
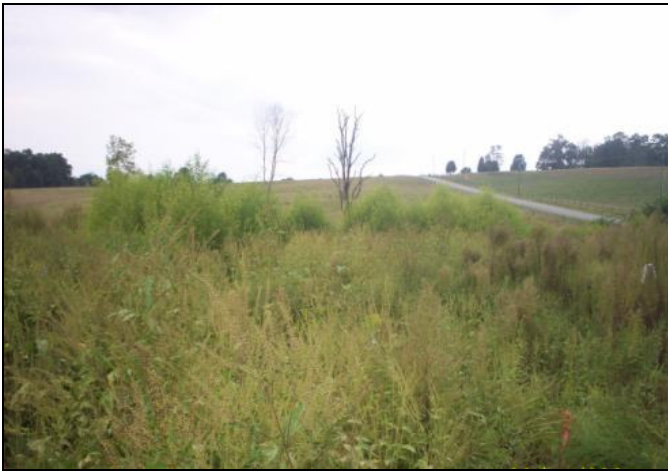
Veg Plot 16

As-Built Surveys, April 2008

Year 1 Monitoring, September 2008

Year 2 Monitoring, September 2009

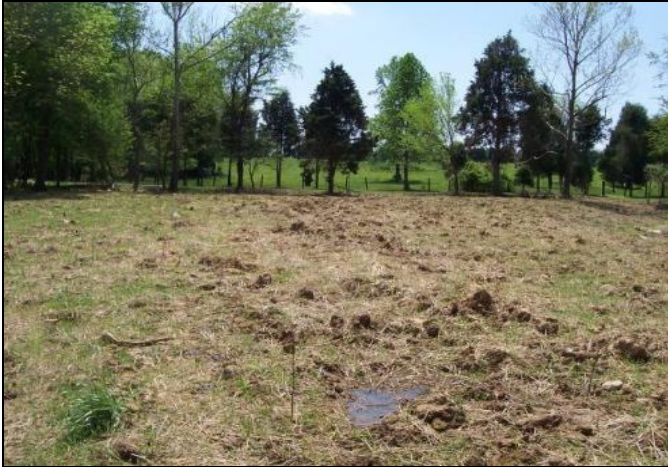
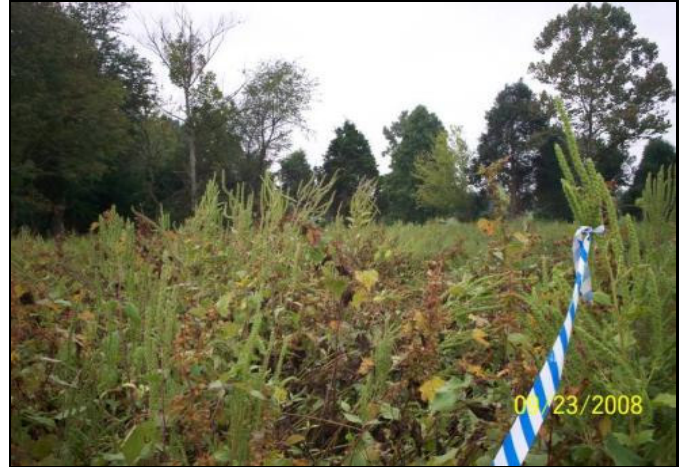
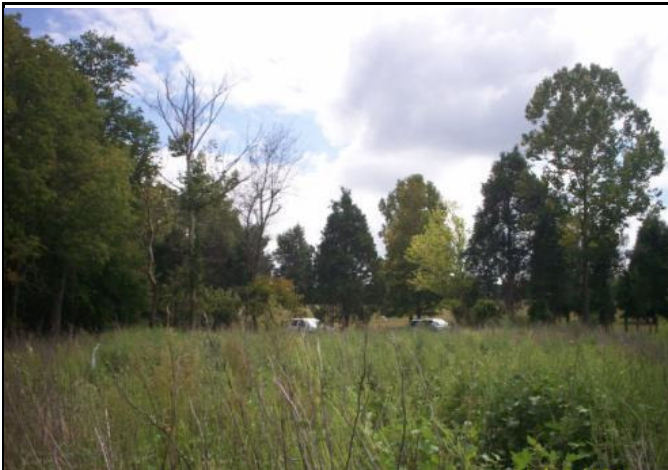
Photo Point 1: Looking upstream toward driveway

As-Built Surveys, April 2008

Year 1 Monitoring, September 2008

Year 2 Monitoring, September 2009

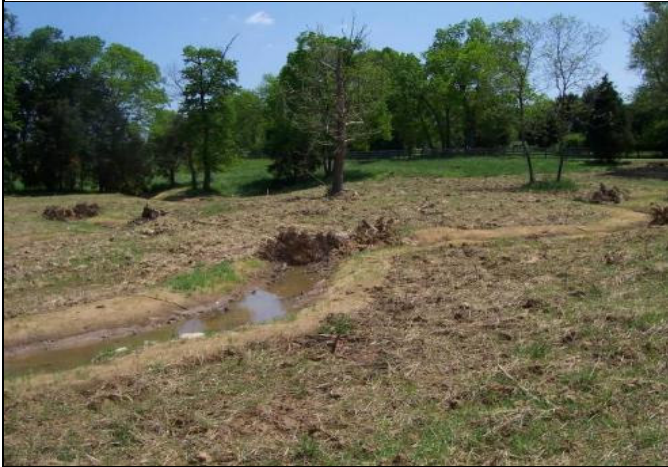
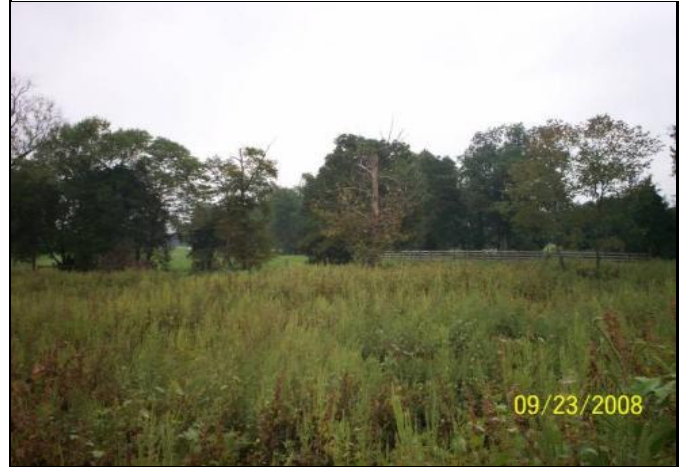
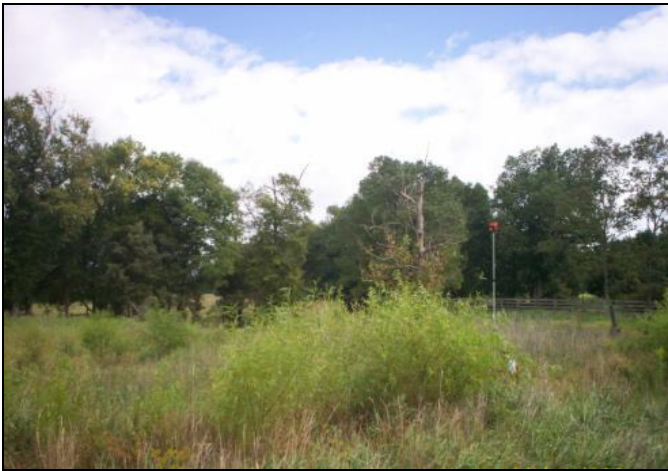
Photo Point 1: Looking toward Reach R2-4a and R2-4c

As-Built Surveys, April 2008

Year 1 Monitoring, September 2008

Year 2 Monitoring, September 2009

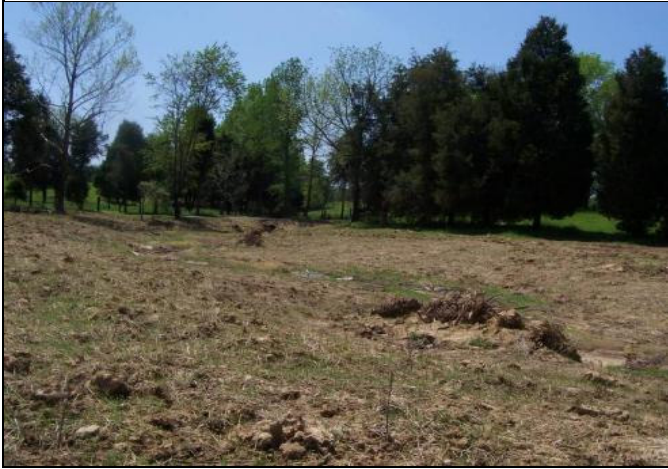
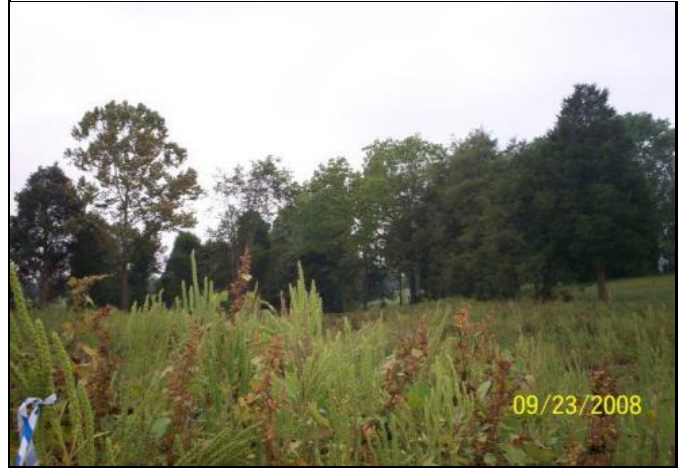
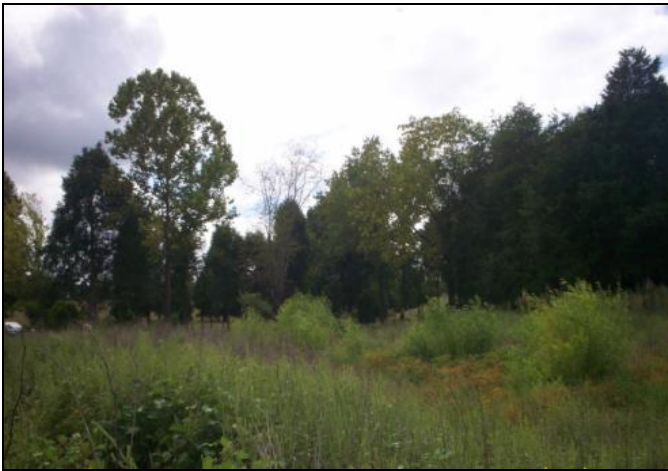
Photo Point 1: Looking upstream on Reach R2-4b

As-Built Surveys, April 2008

Year 1 Monitoring, September 2008

Year 2 Monitoring, September 2009

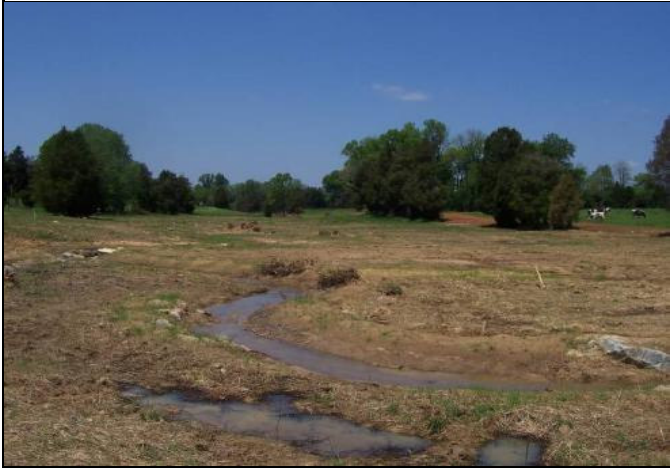
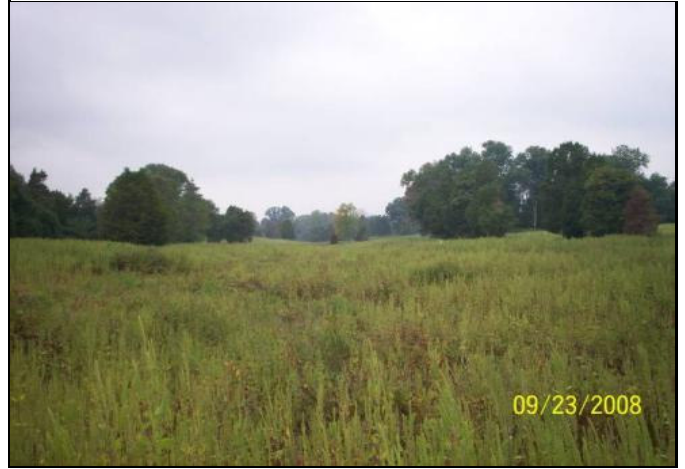
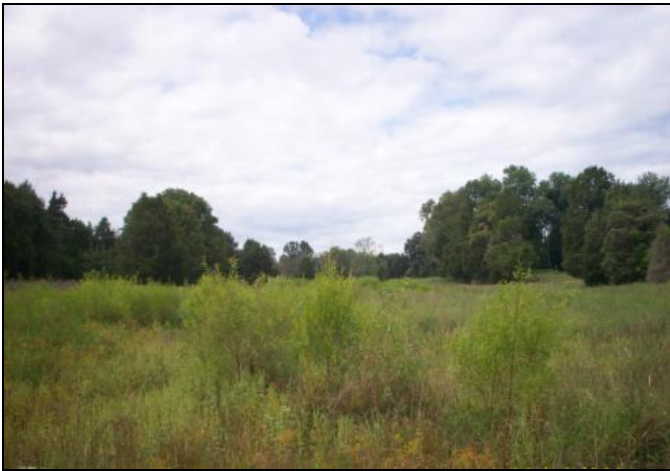
Photo Point 1: Looking downstream on Reach R2

As-Built Surveys, April 2008

Year 1 Monitoring, September 2008

Year 2 Monitoring, September 2009

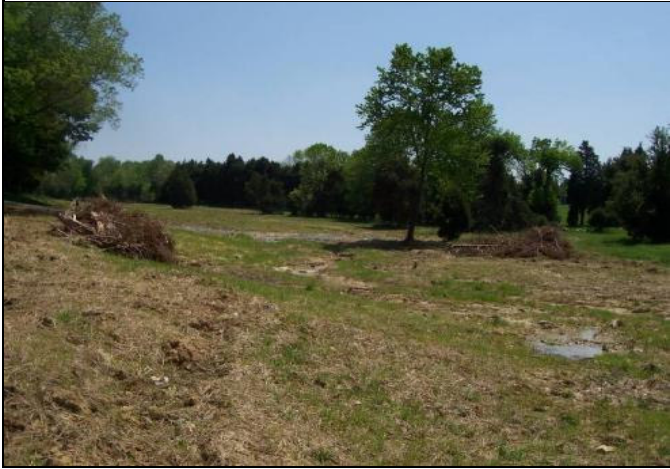
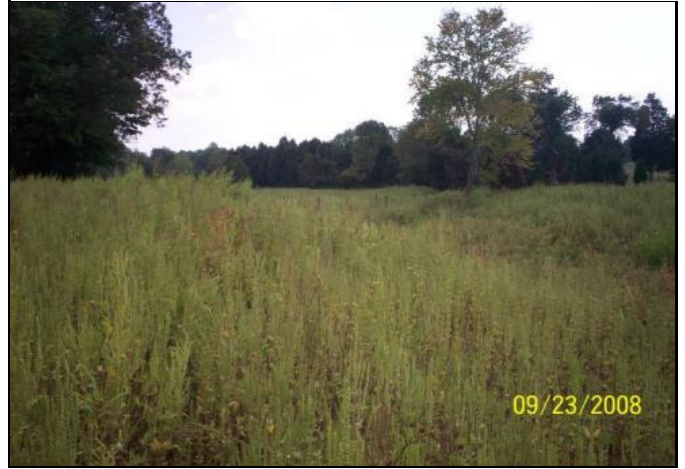
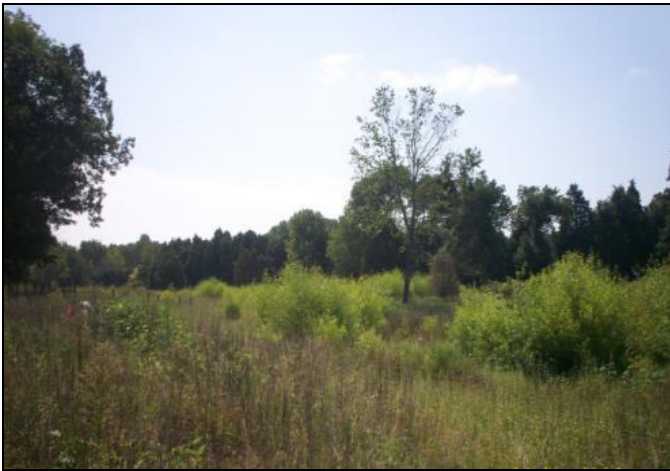
Photo Point 2: Looking upstream on Reach R2

As-Built Surveys, April 2008

Year 1 Monitoring, September 2008

Year 2 Monitoring, September 2009

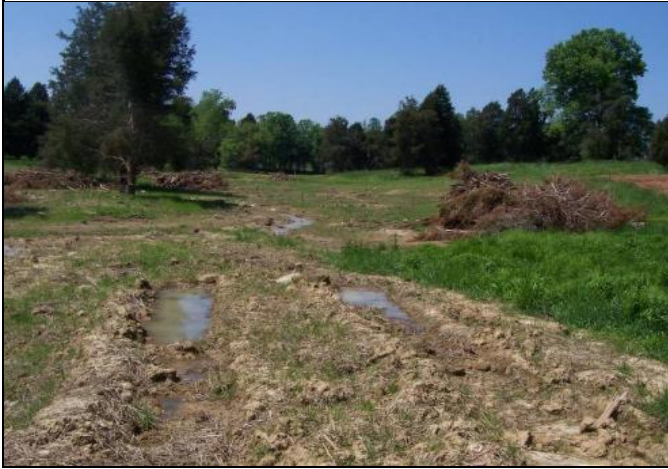
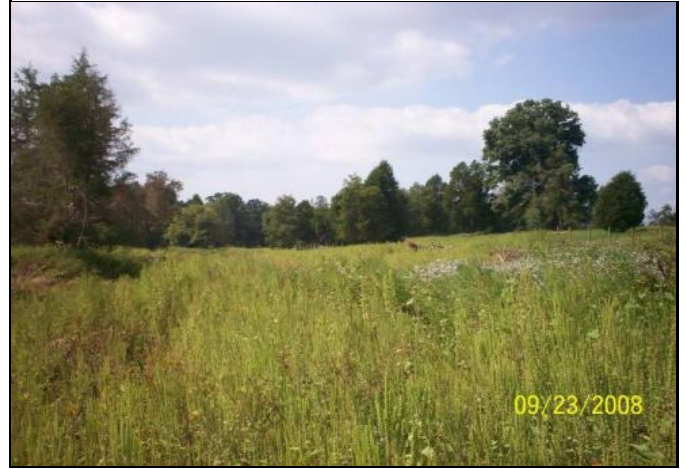
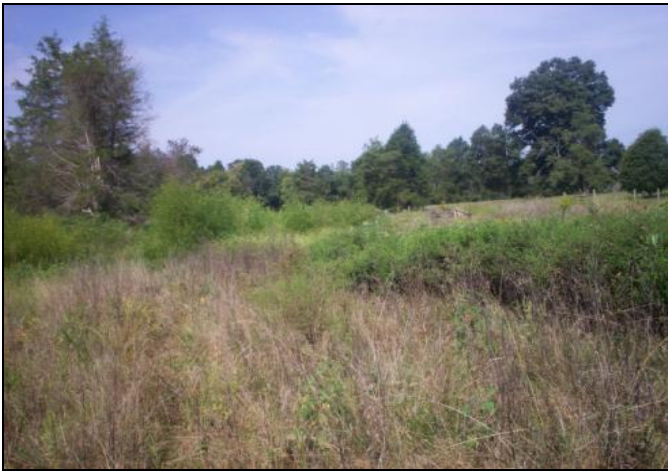
Photo Point 2: Looking downstream on Reach R2

As-Built Surveys, April 2008

Year 1 Monitoring, September 2008

Year 2 Monitoring, September 2009

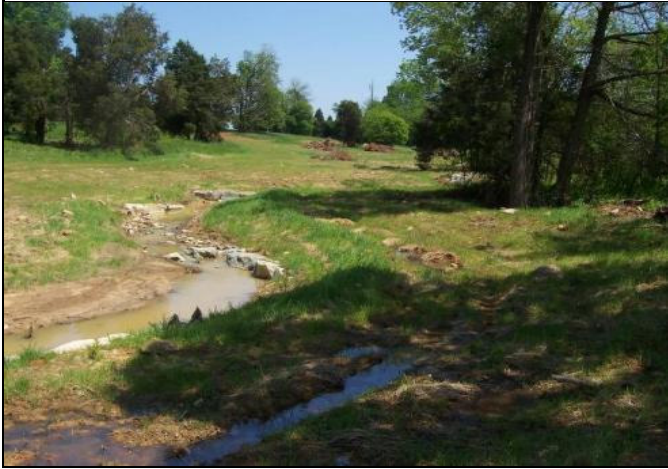
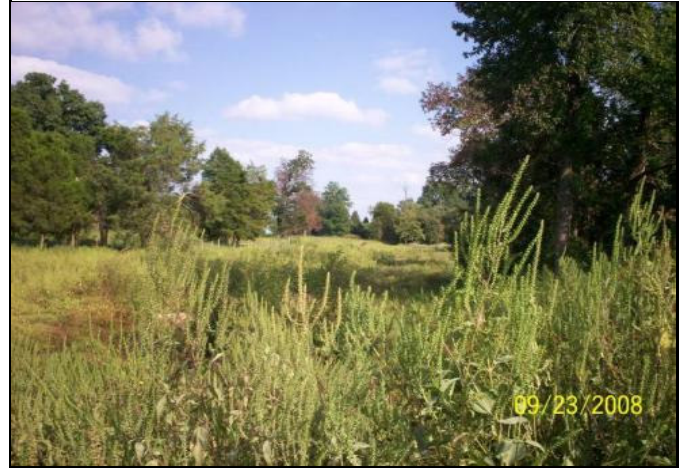
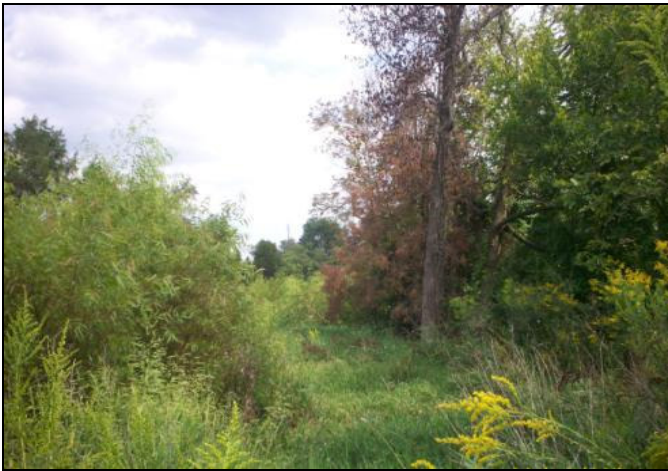
Photo Point 3: Looking upstream on Reach R2

As-Built Surveys, April 2008

Year 1 Monitoring, September 2008

Year 2 Monitoring, September 2009

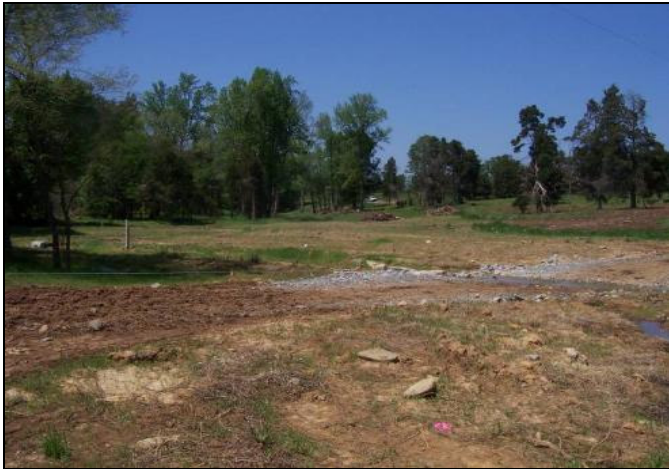
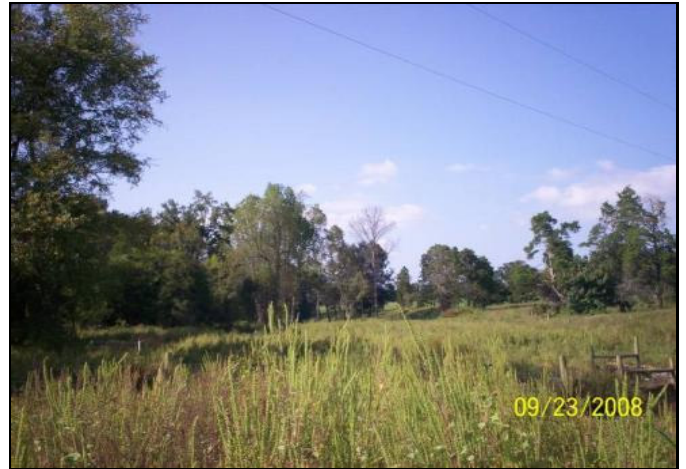
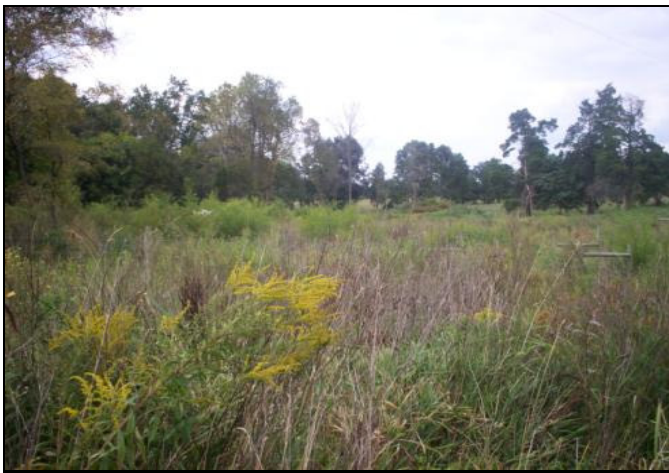
Photo Point 3: Looking downstream on Reach R2

As-Built Surveys, April 2008

Year 1 Monitoring, September 2008

Year 2 Monitoring, September 2009

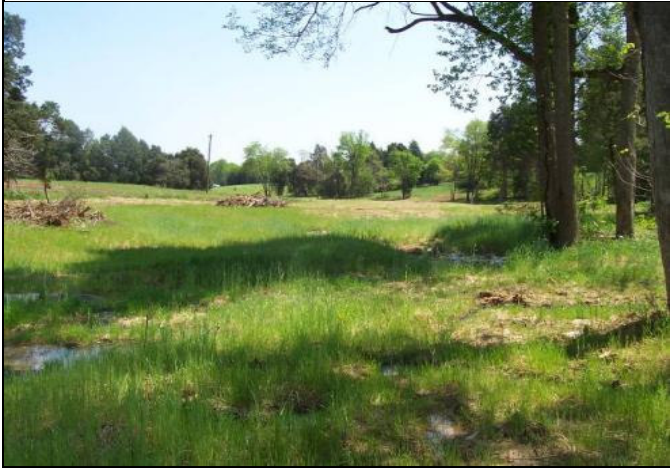
Photo Point 4: Looking upstream on Reach R2

As-Built Surveys, April 2008

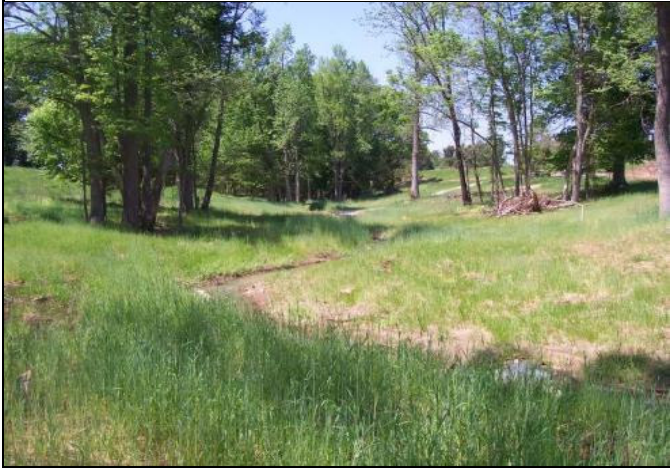
Photo Point 4: Looking downstream on Reach R2

As-Built Surveys, April 2008

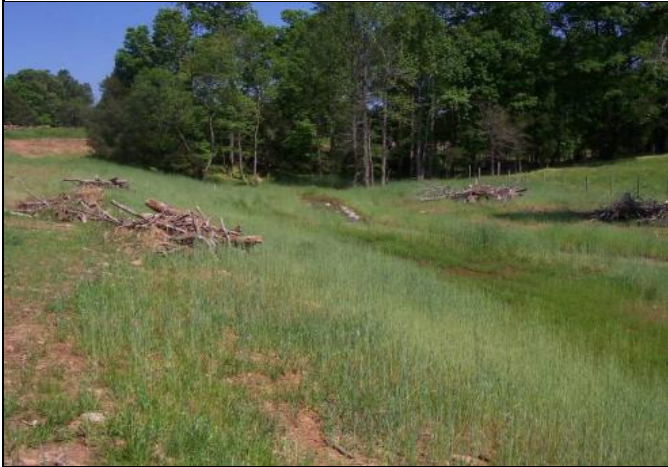
Photo Point 5: Looking upstream on Reach R2

As-Built Surveys, April 2008

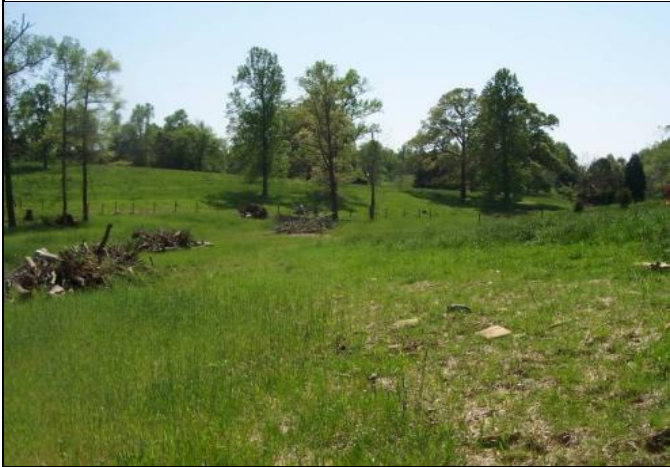
Photo Point 5: Looking downstream on Reach R2

As-Built Surveys, April 2008

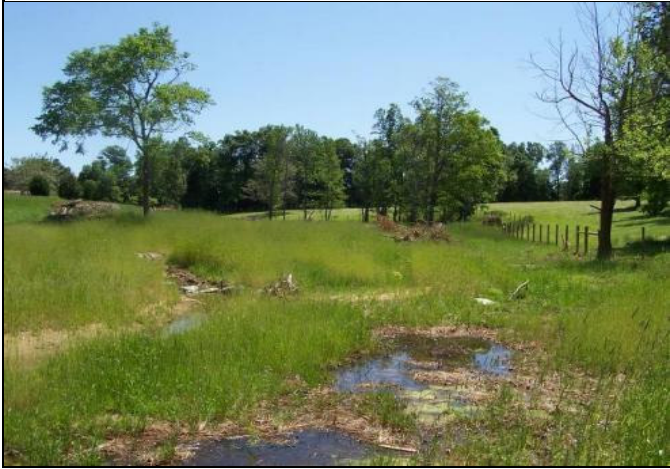
Photo Point 6: Looking upstream on Reach R2

As-Built Surveys, April 2008

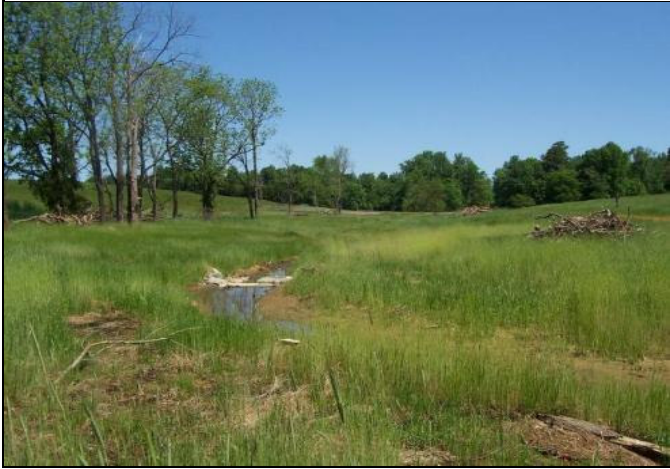
Photo Point 6: Looking downstream on Reach R2

As-Built Surveys, April 2008

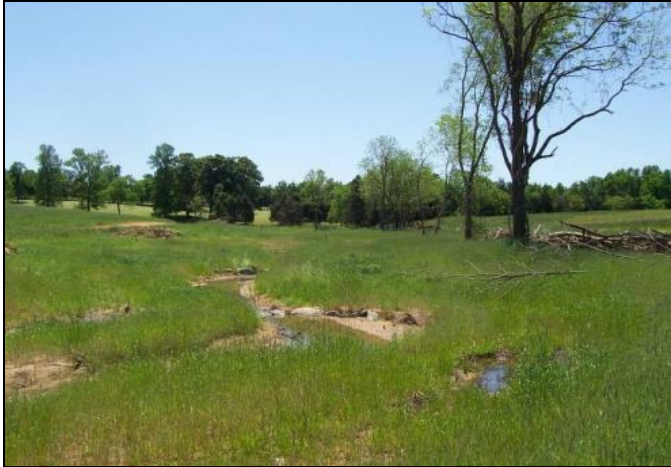
Photo Point 7: Looking upstream on Reach R2

As-Built Surveys, April 2008

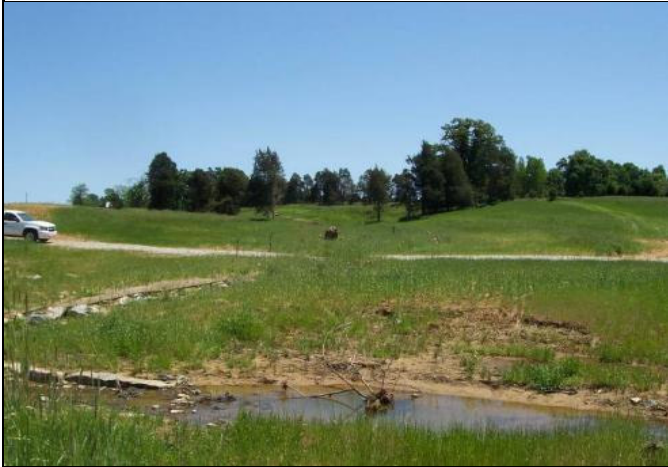
Photo Point 7: Looking across Reach R2, upstream on Reach R1

As-Built Surveys, April 2008

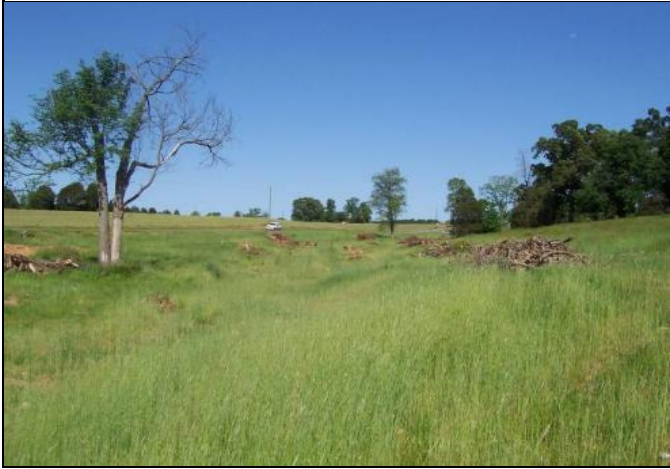
Photo Point 8; Looking upstream on Reach R1

As-Built Surveys, April 2008

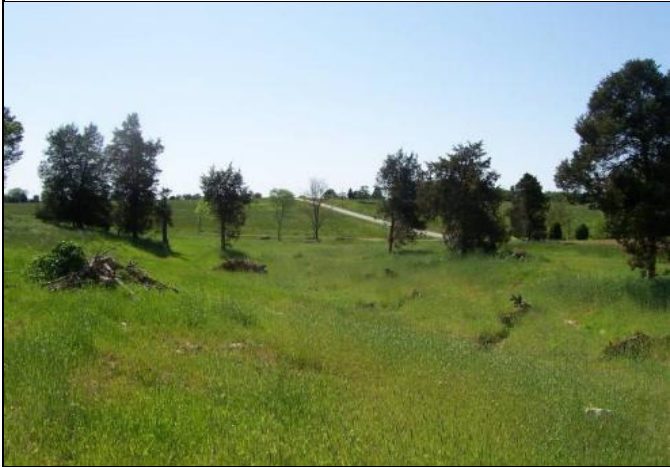
Photo Point 8: Looking downstream on Reach R1

As-Built Surveys, April 2008

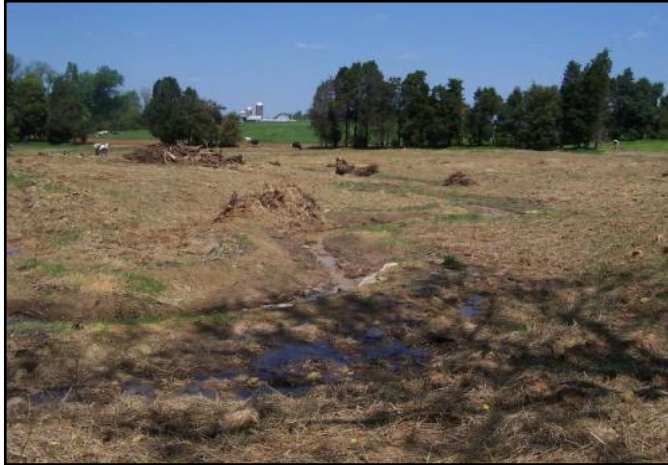
Permanent Cross Section 1

As-Built Surveys, April 2008

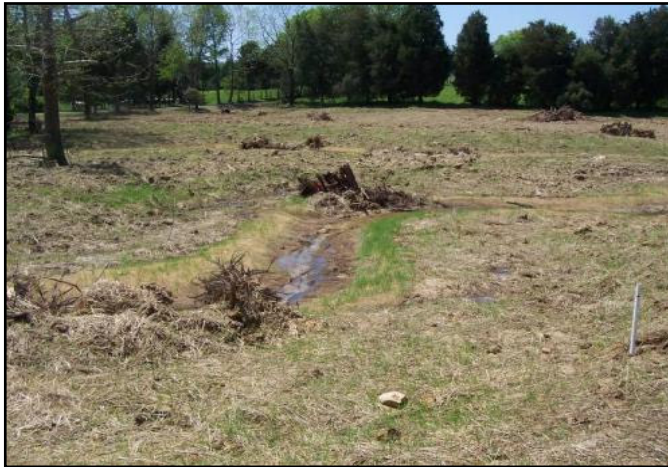
Permanent Cross Section 2

As-Built Surveys, April 2008

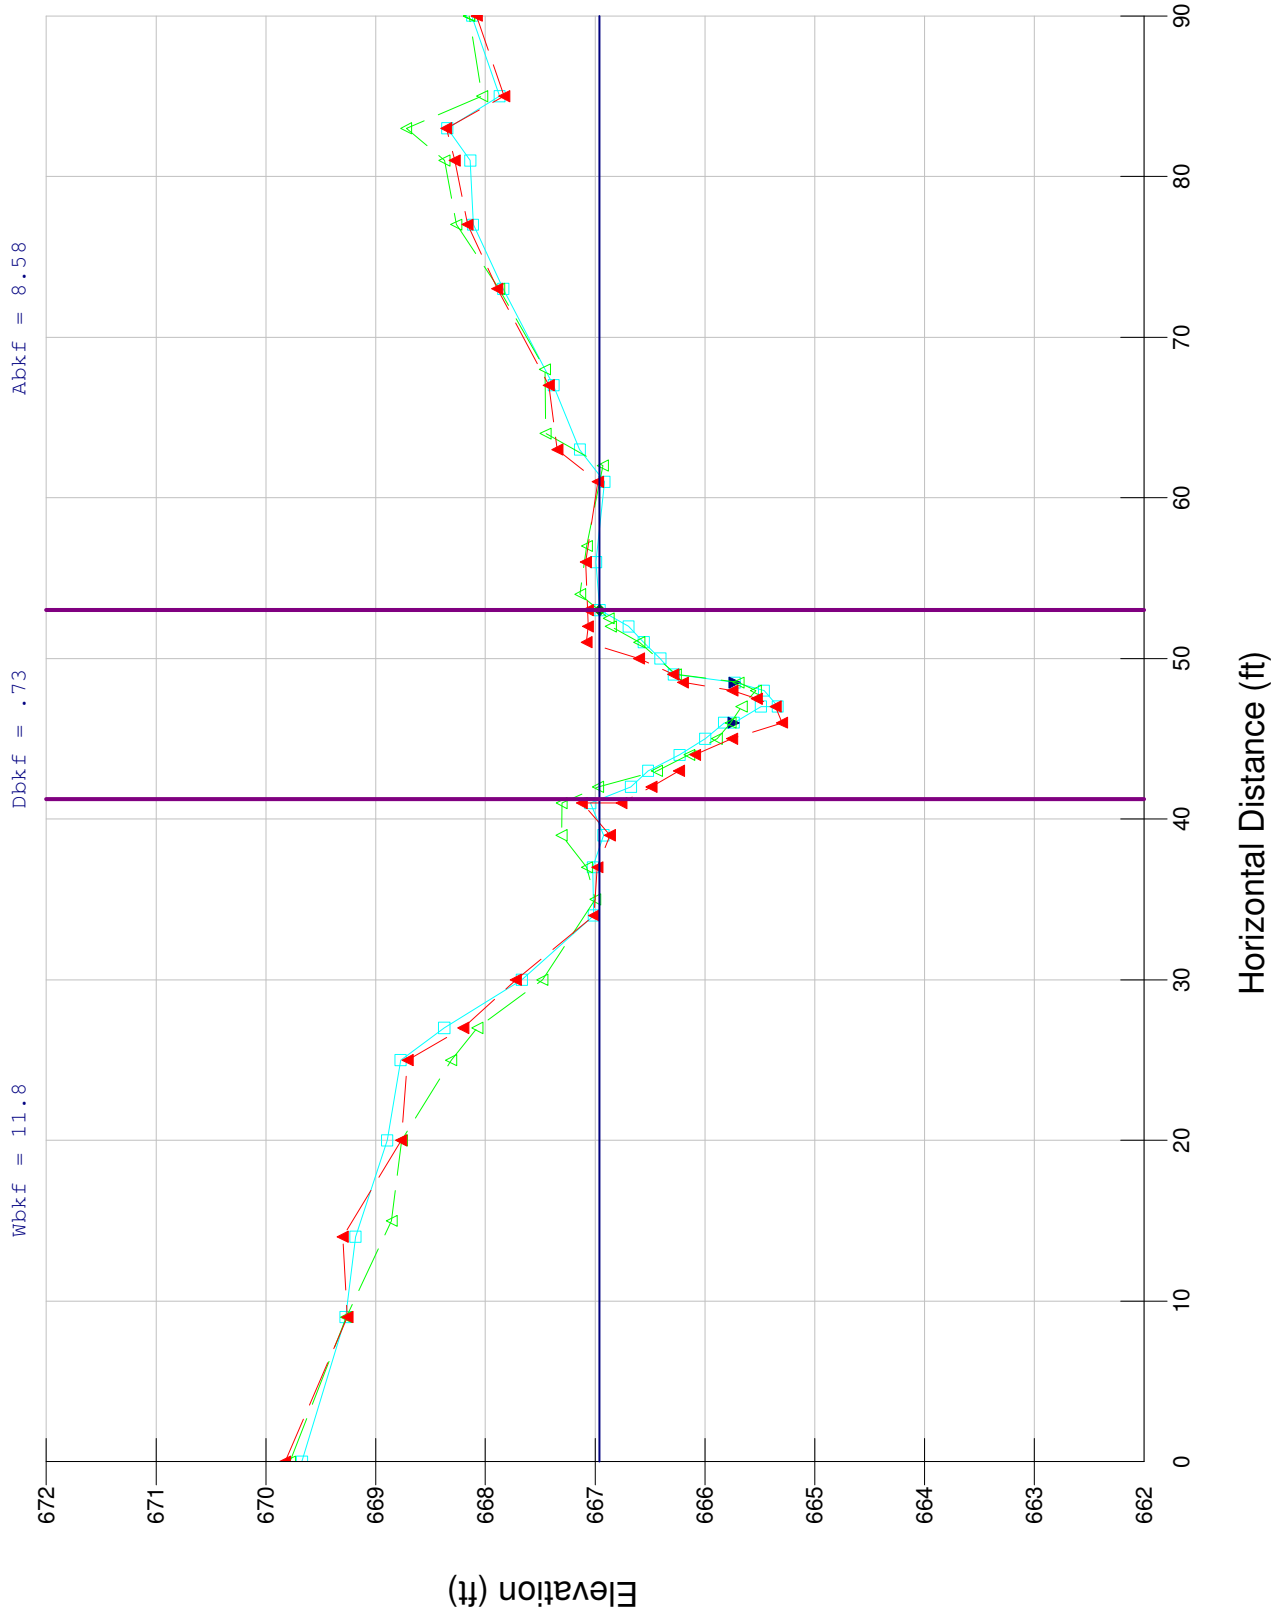
- (Year 2) Cross Section 3 - Pool (R2-3)
- ◆ Bankfull Indicators
- ▼ Water Surface Points
- △ (Year 0) Cross Section 3 - Pool (R2-3)
- ▲ (Year 1) Cross Section 3 - Pool (R2-3)

Maximum Depth (ft)	1.62	1.29	1.62
width/Depth Ratio	16.1	7.61	8.52
Bankfull Area (sq ft)	8.58	3.29	5.28
wetted Perimeter (ft)	12.56	6.56	8.58
Hydraulic Radius (ft)	0.68	0.5	0.62
Begin BKF Station	41.25	41.25	46.27
End BKF Station	53	46.27	53

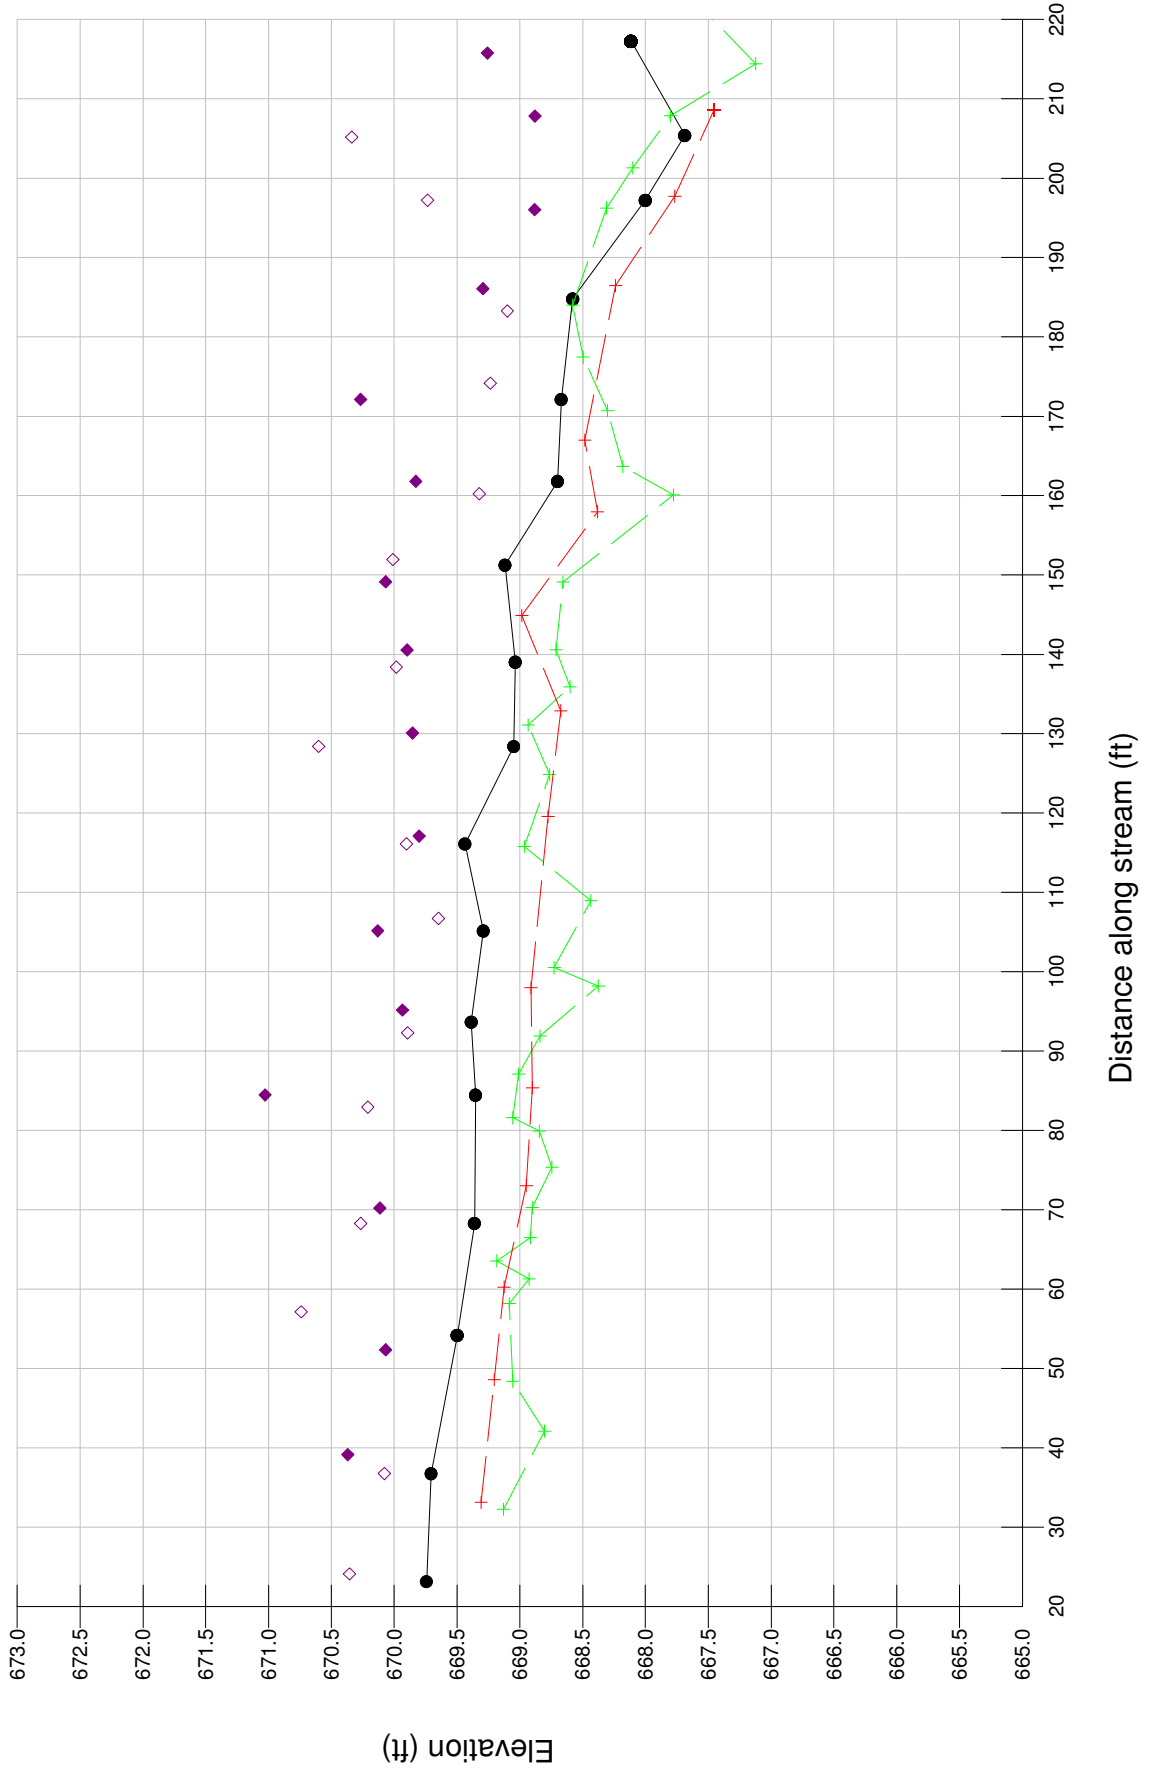
(Year 2) R2-4a Longitudinal Profile (STA 0+36 -- 2+10)

- CH
- WS
- ▼ BKF
- ◆ LB
- ◇ RB
- + P3
- × P4
- + (Year 0) R2-4a Longitudinal Profile (STA 0+36 -- 2+10)
- + (Year 1) R2-4a Long. Profile

RIVERMORPH PROFILE SUMMARY

River Name: (Year 2) Reedy Fork Creek
Reach Name: R2-4a
Profile Name: (Year 2) R2-4a Longitudinal Profile (0+36 -- 2+10)
Survey Date: 10/05/2009
