TRIBUTARY TO REEDY FORK CREEK STREAM RESTORATION

GUILFORD COUNTY, NORTH CAROLINA

ANNUAL MONITORING REPORT (YEAR 2 OF 5)

DECEMBER 2009

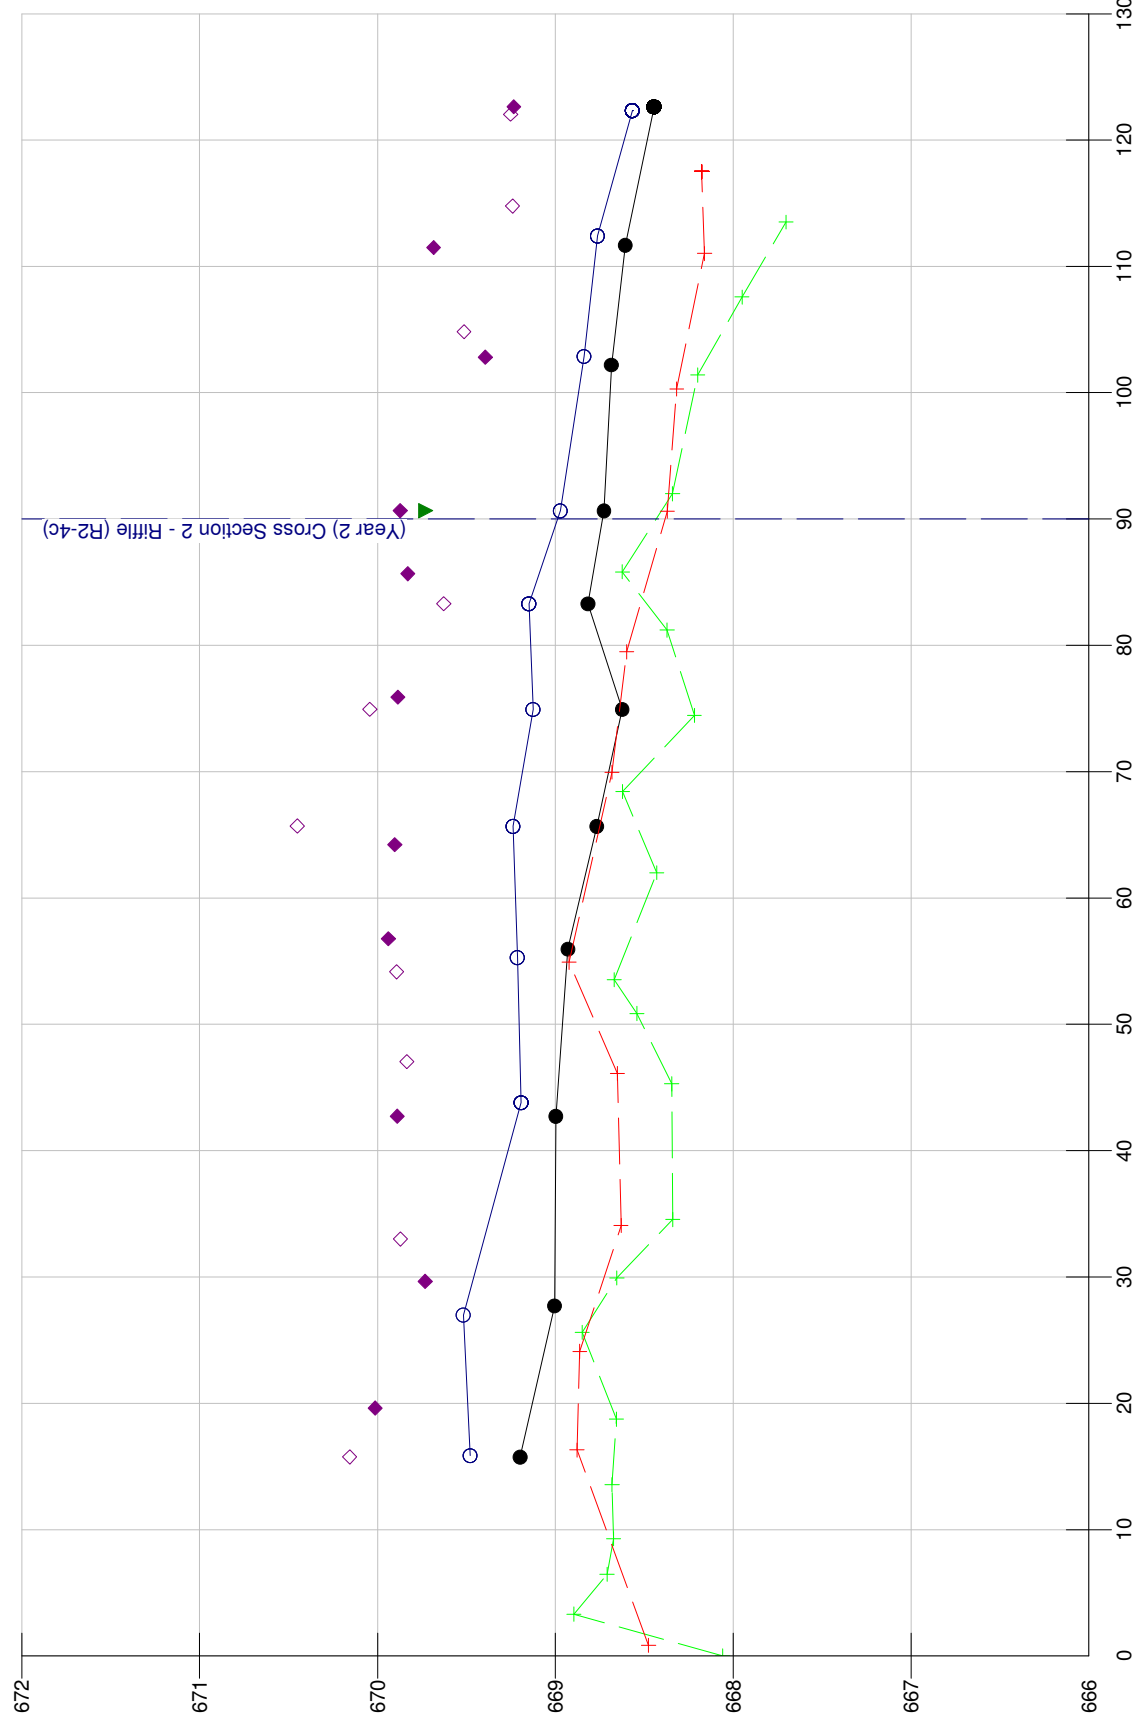
(Year 2) R2-4c Longitudinal Profile (STA 0+00 -- 1+00)

- CH
- WS
- ▼ BKF
- ◆ LB
- ◇ RB
- + P3
- × P4
- + (Year 0) R2-4c Longitudinal Profile
- + (Year 1) R2-4c Longitudinal Profile

RIVERMORPH PROFILE SUMMARY

River Name: (Year 2) Reedy Fork Creek
 Reach Name: R2-4c
 Profile Name: (Year 2) R2-4c Longitudinal Profile
 Survey Date: 10/05/2009
