**UT TO SOUTH FORK
FINAL MONITORING REPORT
YEAR 4 OF 5
2009**

EEP Project # 435
Alamance County, North Carolina

Appendix A: General Figures and Plan Views

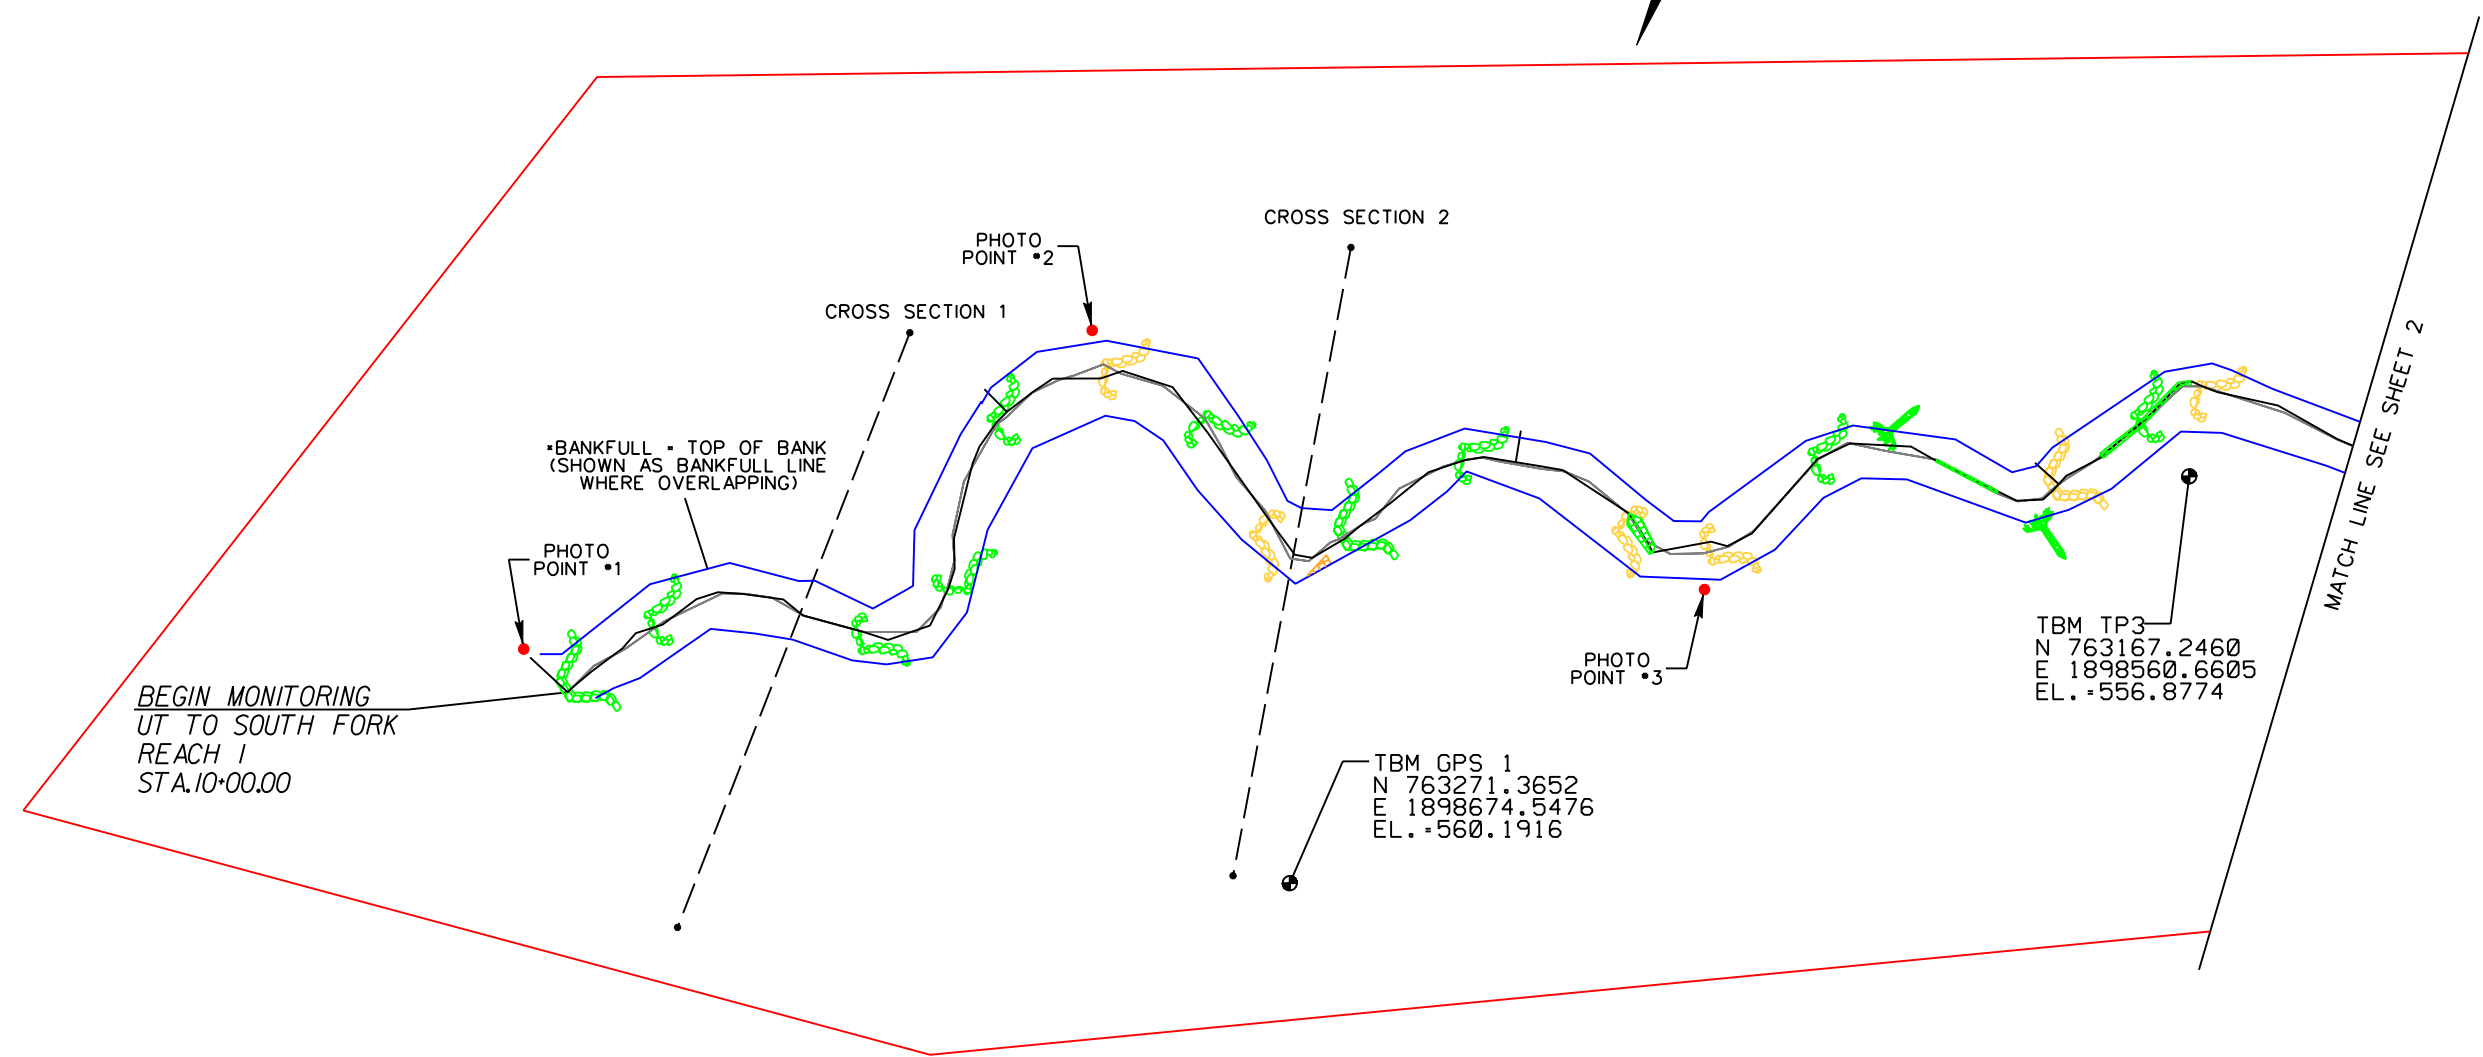
UT TO SOUTH FORK REACH 1

CROSS SECTION STAKING			
	NORTHING	EASTING	ELEVATION
XSC 1 LEFT	763207.9909	1898757.6600	559.5123
XSC 1 RIGHT	763307.6006	1898763.3135	561.2426
XSC 2 LEFT	763173.9086	1898696.2853	559.6677
XSC 2 RIGHT	763272.9699	1898683.3090	560.9459

LEGEND			
STREAM FEATURES		PROJECT ELEMENTS	
	THALWEG 2008		CONTROL POINT/ BENCHMARK (TBM)
	THALWEG 2009		CROSS-SECTIONS
	BANKFULL 2009		PHOTO POINT
	BANK EROSION		EASEMENT BOUNDARY
	SEVERE BANK EROSION	*SEPI was unable to locate quality aerial photographs for this figure. The old photographs were omitted due to poor quality.	
	AGGRADATION	STRUCTURE TYPES	
			ROCK CROSS VANE
			J-HOOK VANE
			ROOTWAD
			ROCK VANE
		COLOR CODE FOR STRUCTURES	
			GOOD STRUCTURE (ACTUAL LOCATION)
			STRUCTURE WITH POTENTIAL PROBLEM (ACTUAL LOCATION)
			FAILING STRUCTURE (ACTUAL LOCATION)

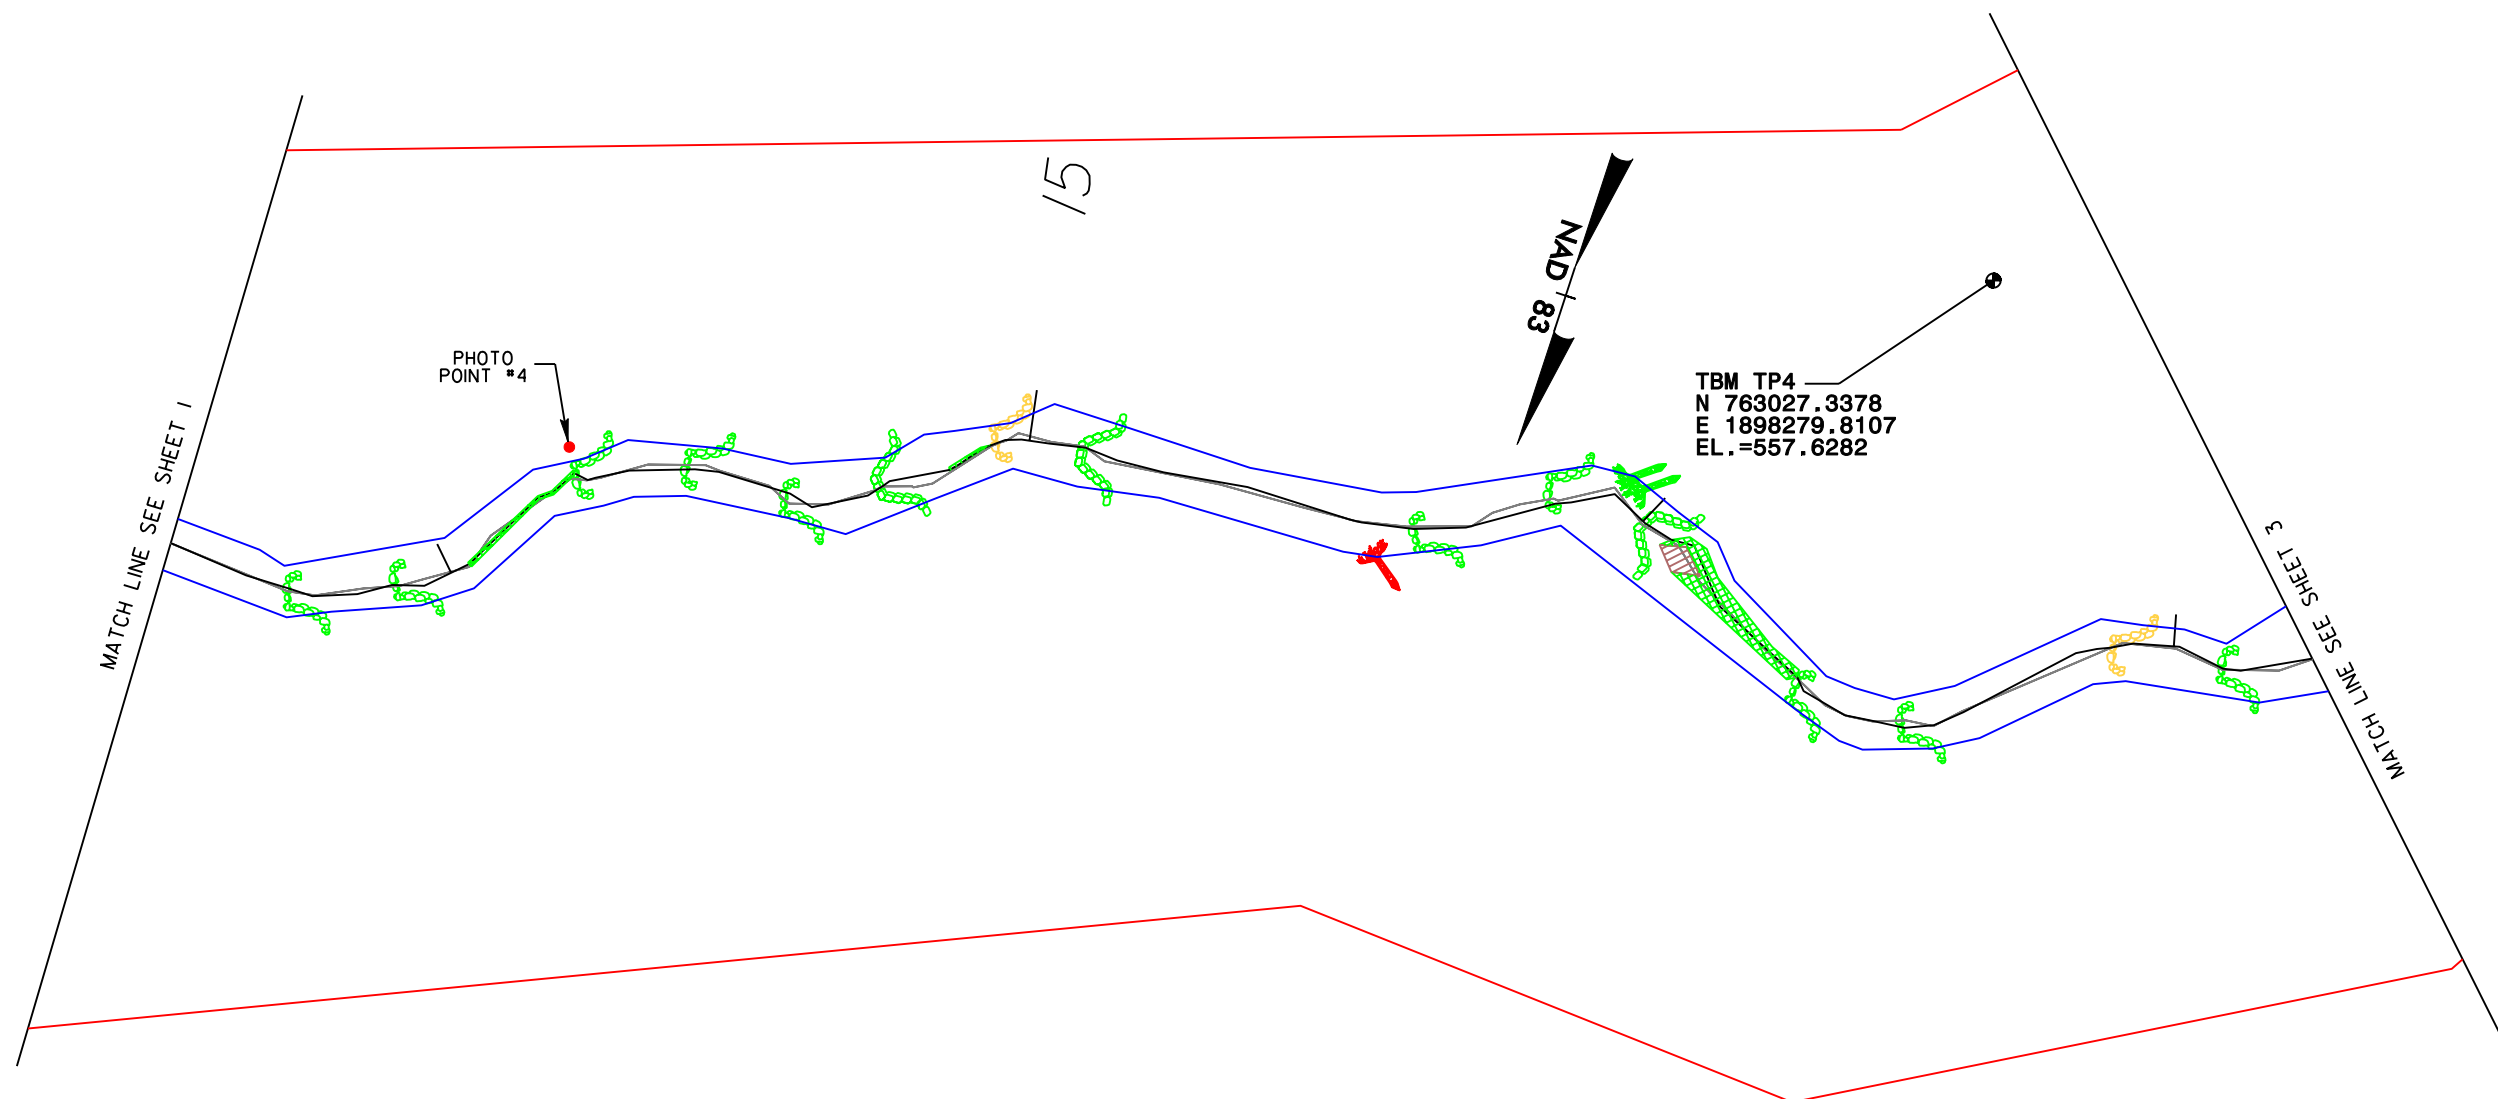
UT TO SOUTH FORK REACH 1

CROSS SECTION STAKING			
	NORTHING	EASTING	ELEVATION
XSC 3 LEFT	763020.3192	1898239.8346	555.1650
XSC 3 RIGHT	762987.3139	1898172.4883	552.3188
XSC 4 LEFT	762973.7664	1898215.1833	553.9285
XSC 4 RIGHT	762992.5881	1898174.6097	552.4553

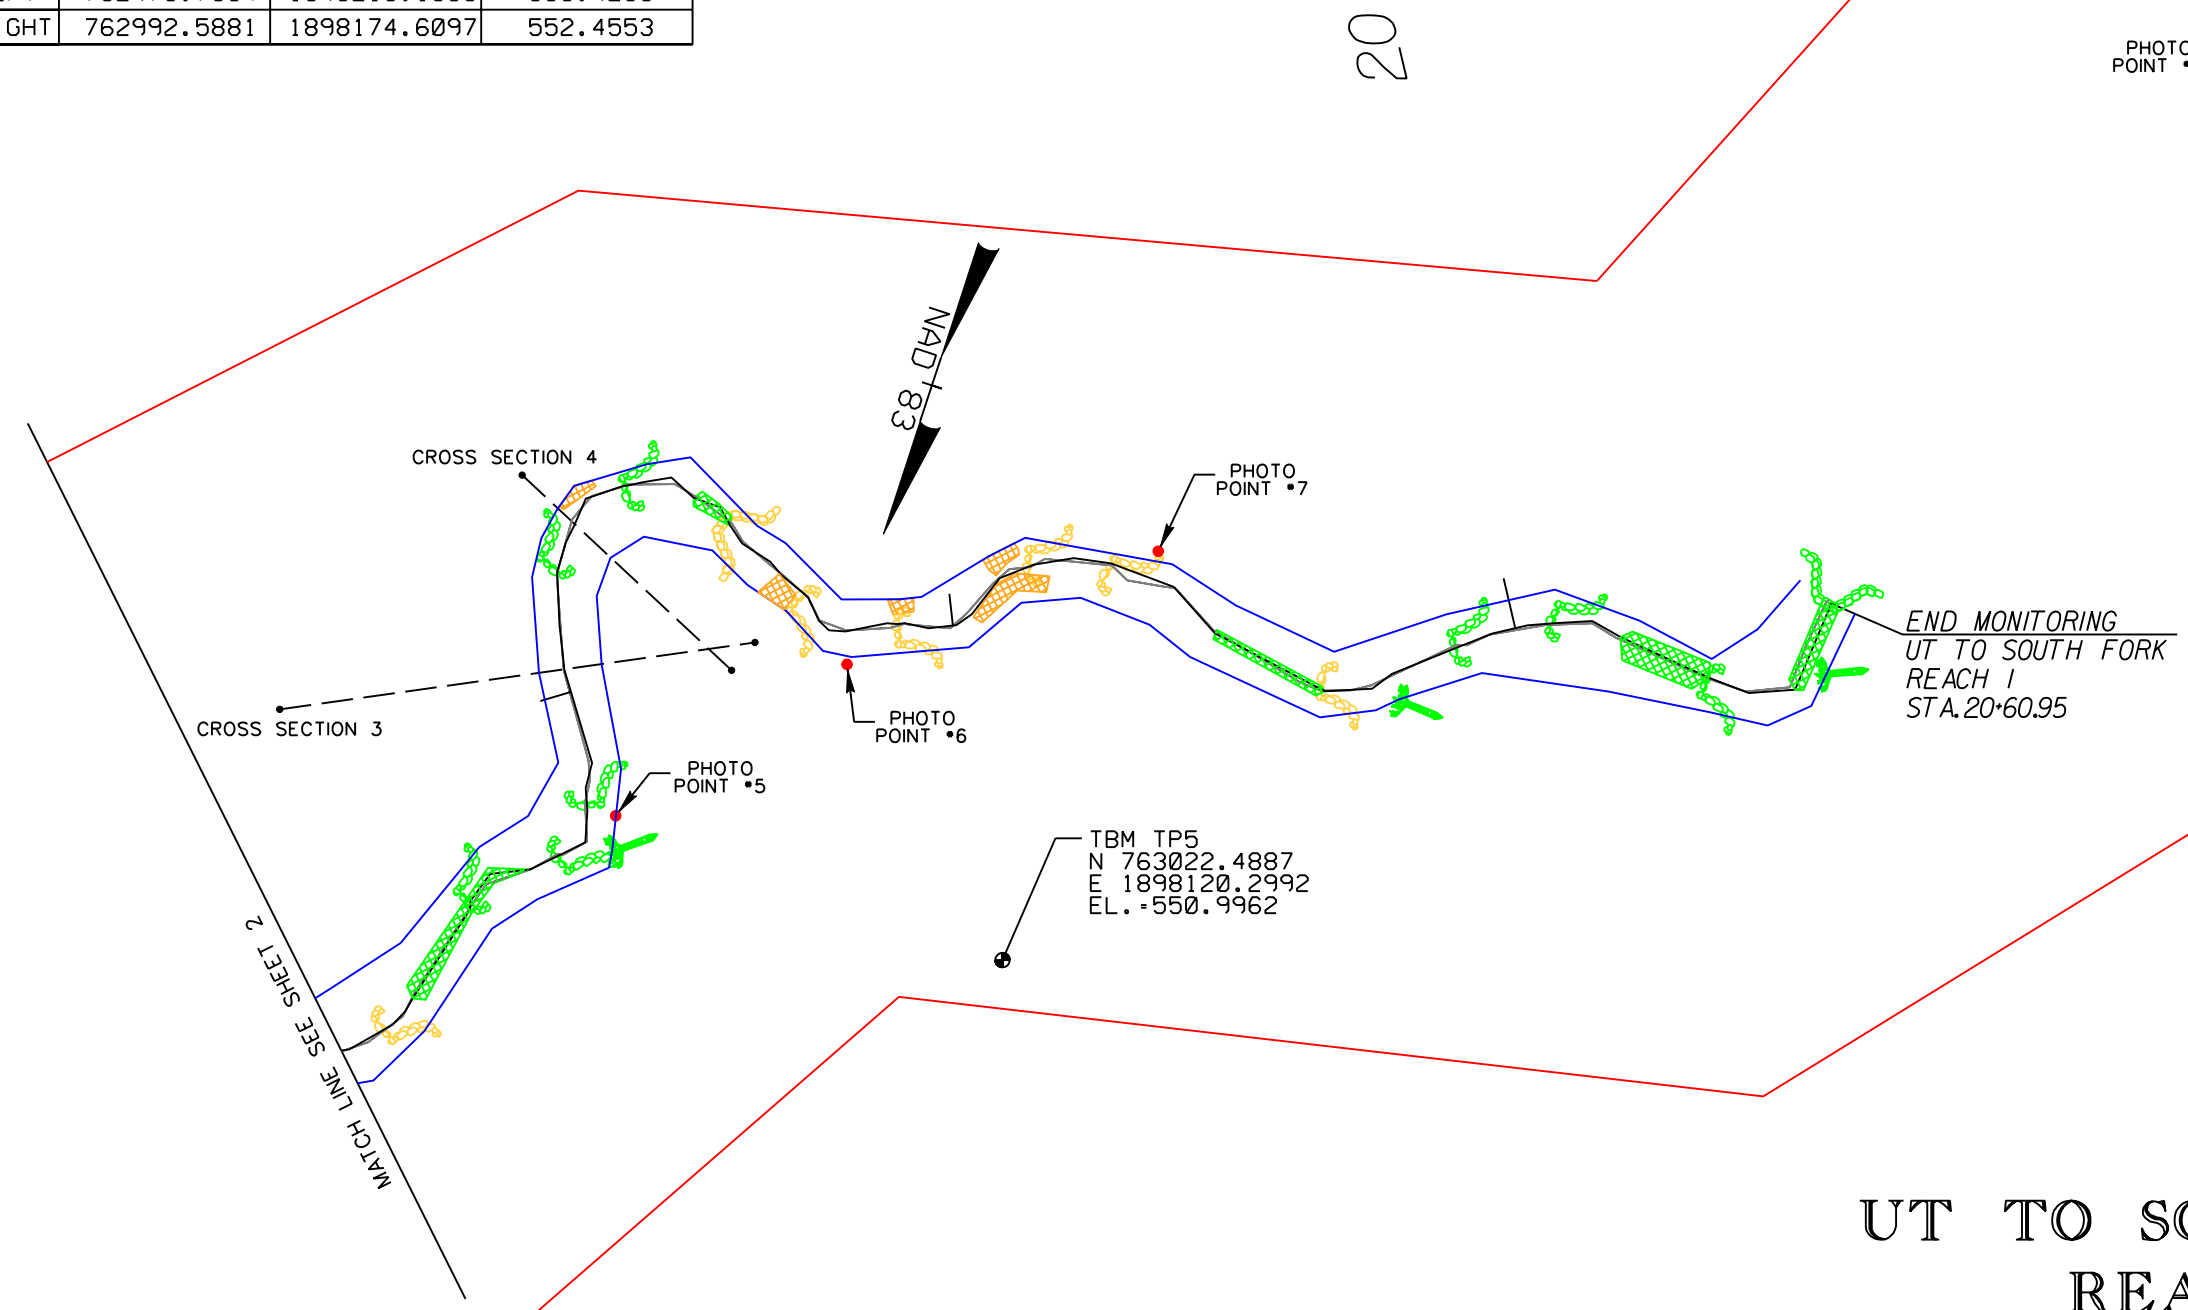
UT TO SOUTH FORK REACH 1

STREAM FEATURES	PROJECT ELEMENTS	STRUCTURE TYPES	COLOR CODE FOR STRUCTURES
THALWEG 2008	CONTROL POINT/BENCHMARK (TBM)	ROCK CROSS VANE	GOOD STRUCTURE (ACTUAL LOCATION)
THALWEG 2009	CROSS-SECTIONS	J-HOOK VANE	STRUCTURE WITH POTENTIAL PROBLEM (ACTUAL LOCATION)
BANKFULL 2009	PHOTO POINT	ROOTWAD	FAILING STRUCTURE (ACTUAL LOCATION)
BANK EROSION	EASEMENT BOUNDARY	ROCK VANE	
SEVERE BANK EROSION	<p>*SEPI was unable to locate quality aerial photographs for this figure. The old photographs were omitted due to poor quality.</p>		
AGGRADATION

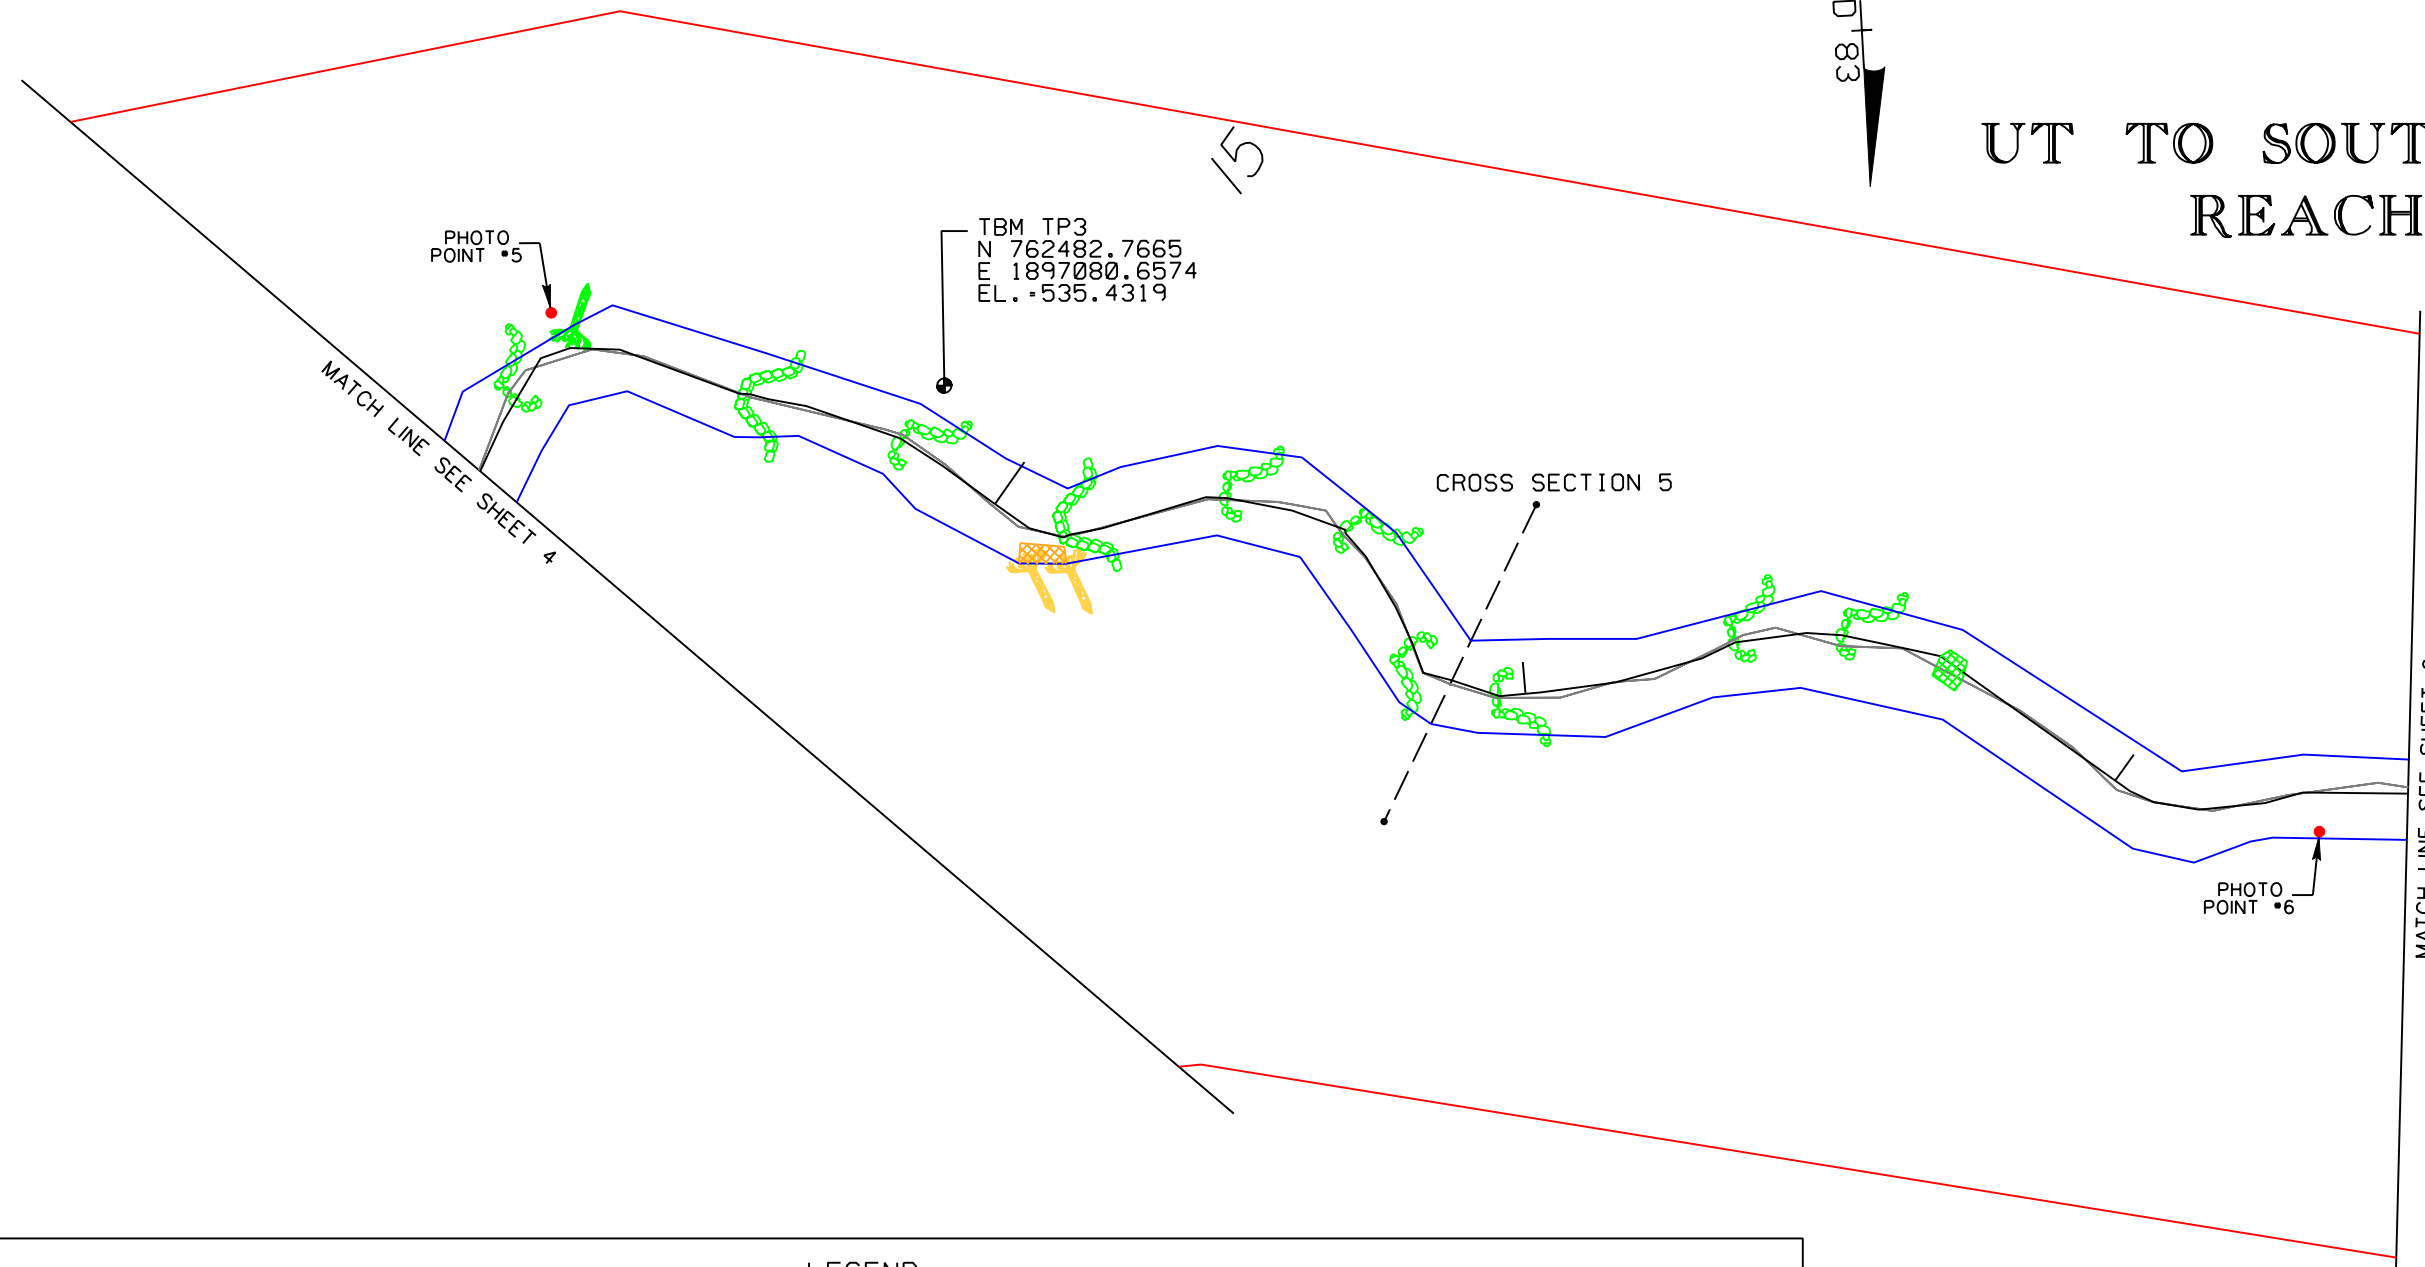
UT TO SOUTH FORK REACH 2

CROSS SECTION STAKING			
	NORTHING	EASTING	ELEVATION
XSC 5 LEFT	762506.3940	1896989.2978	536.3557
XSC 5 RIGHT	762554.5778	1897015.7169	535.6841

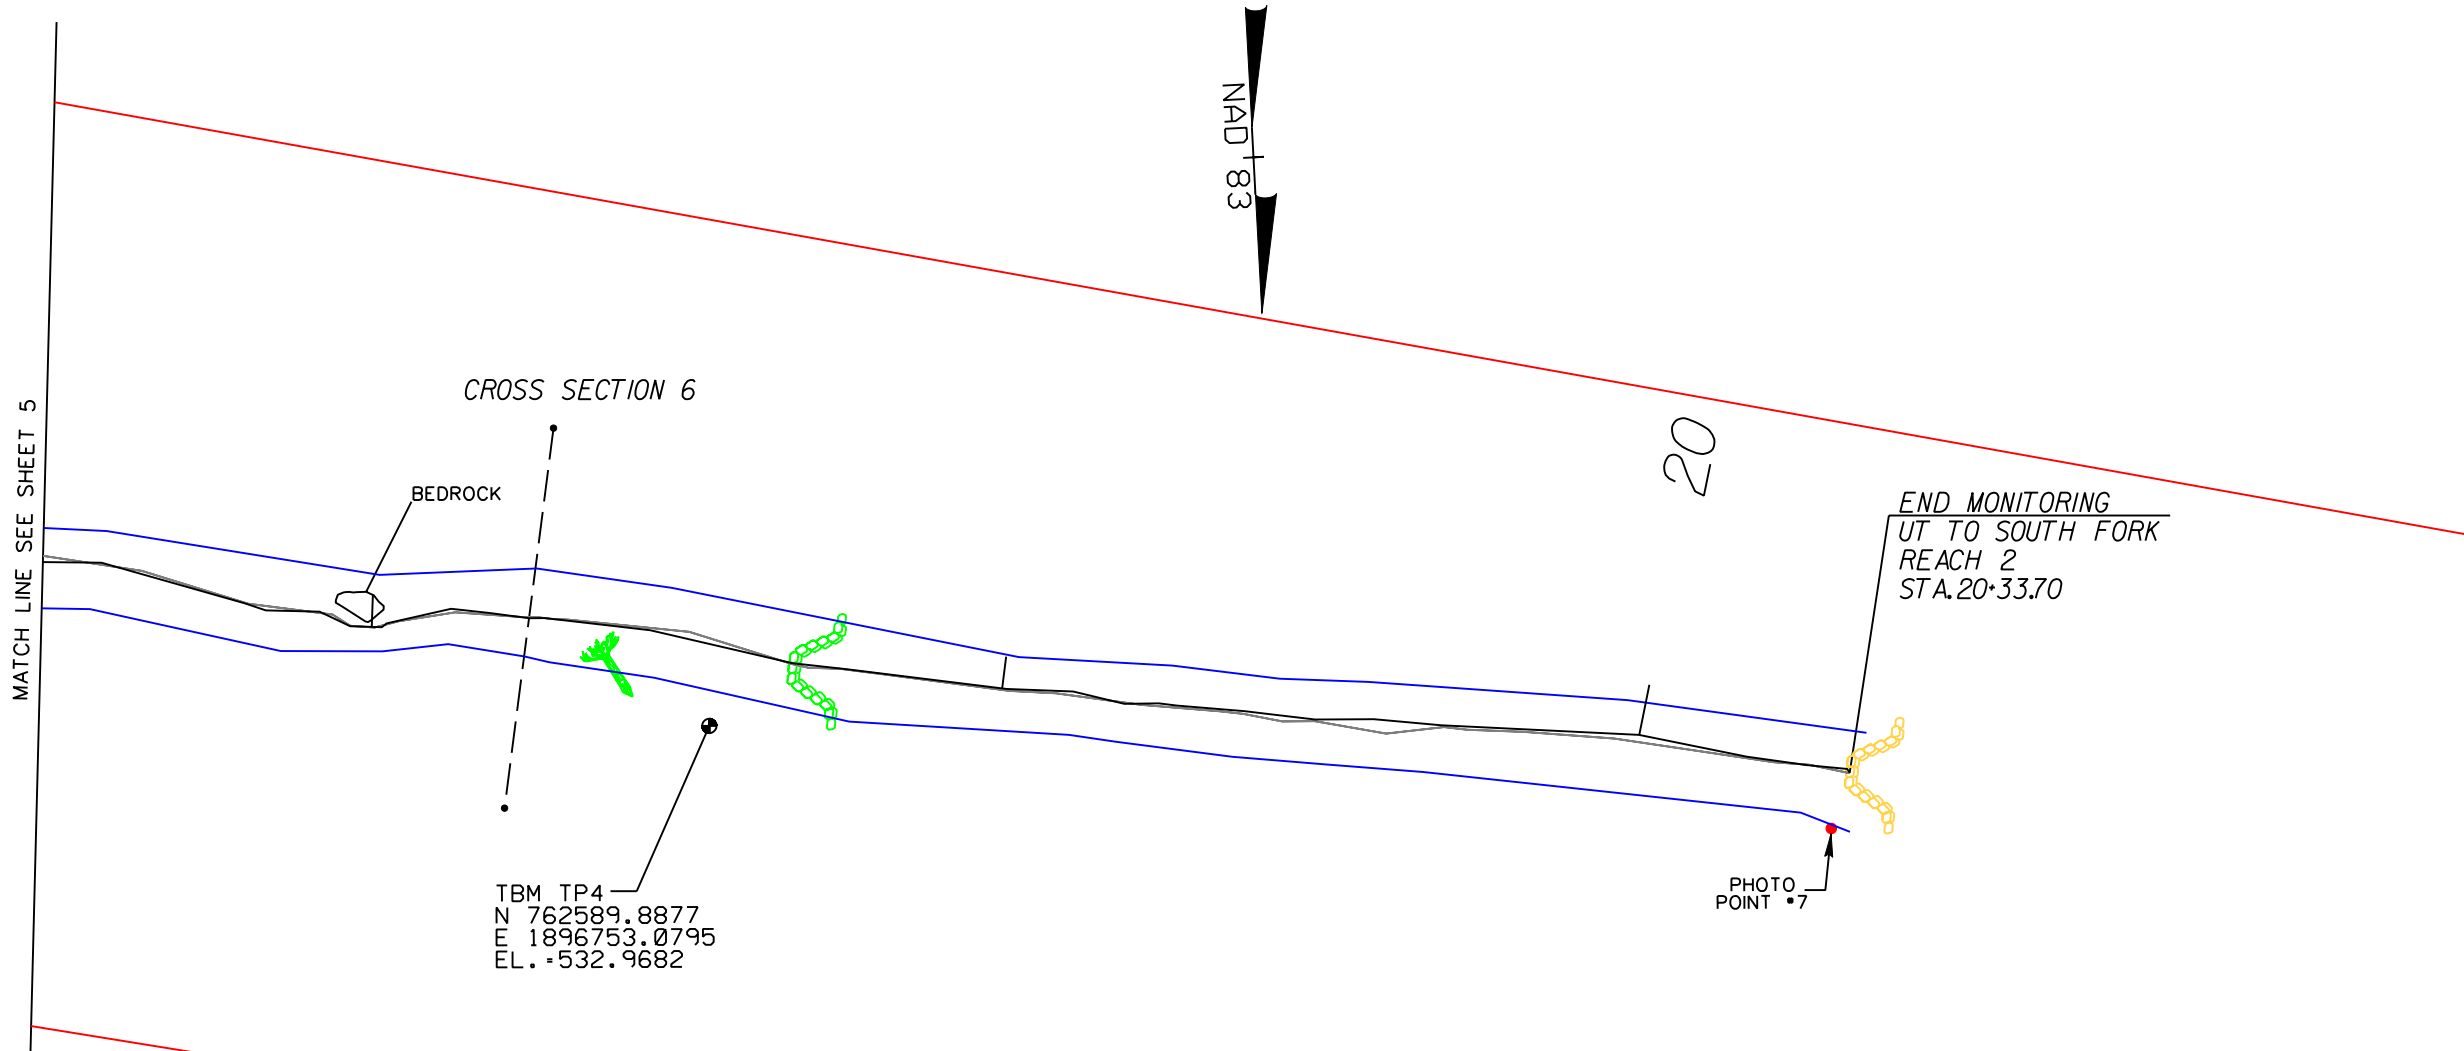
UT TO SOUTH FORK REACH 2

CROSS SECTION STAKING			
	NORTHING	EASTING	ELEVATION
XSC 6 LEFT	762542.1251	1896774.9056	534.7193
XSC 6 RIGHT	762601.0118	1896785.7229	534.8382

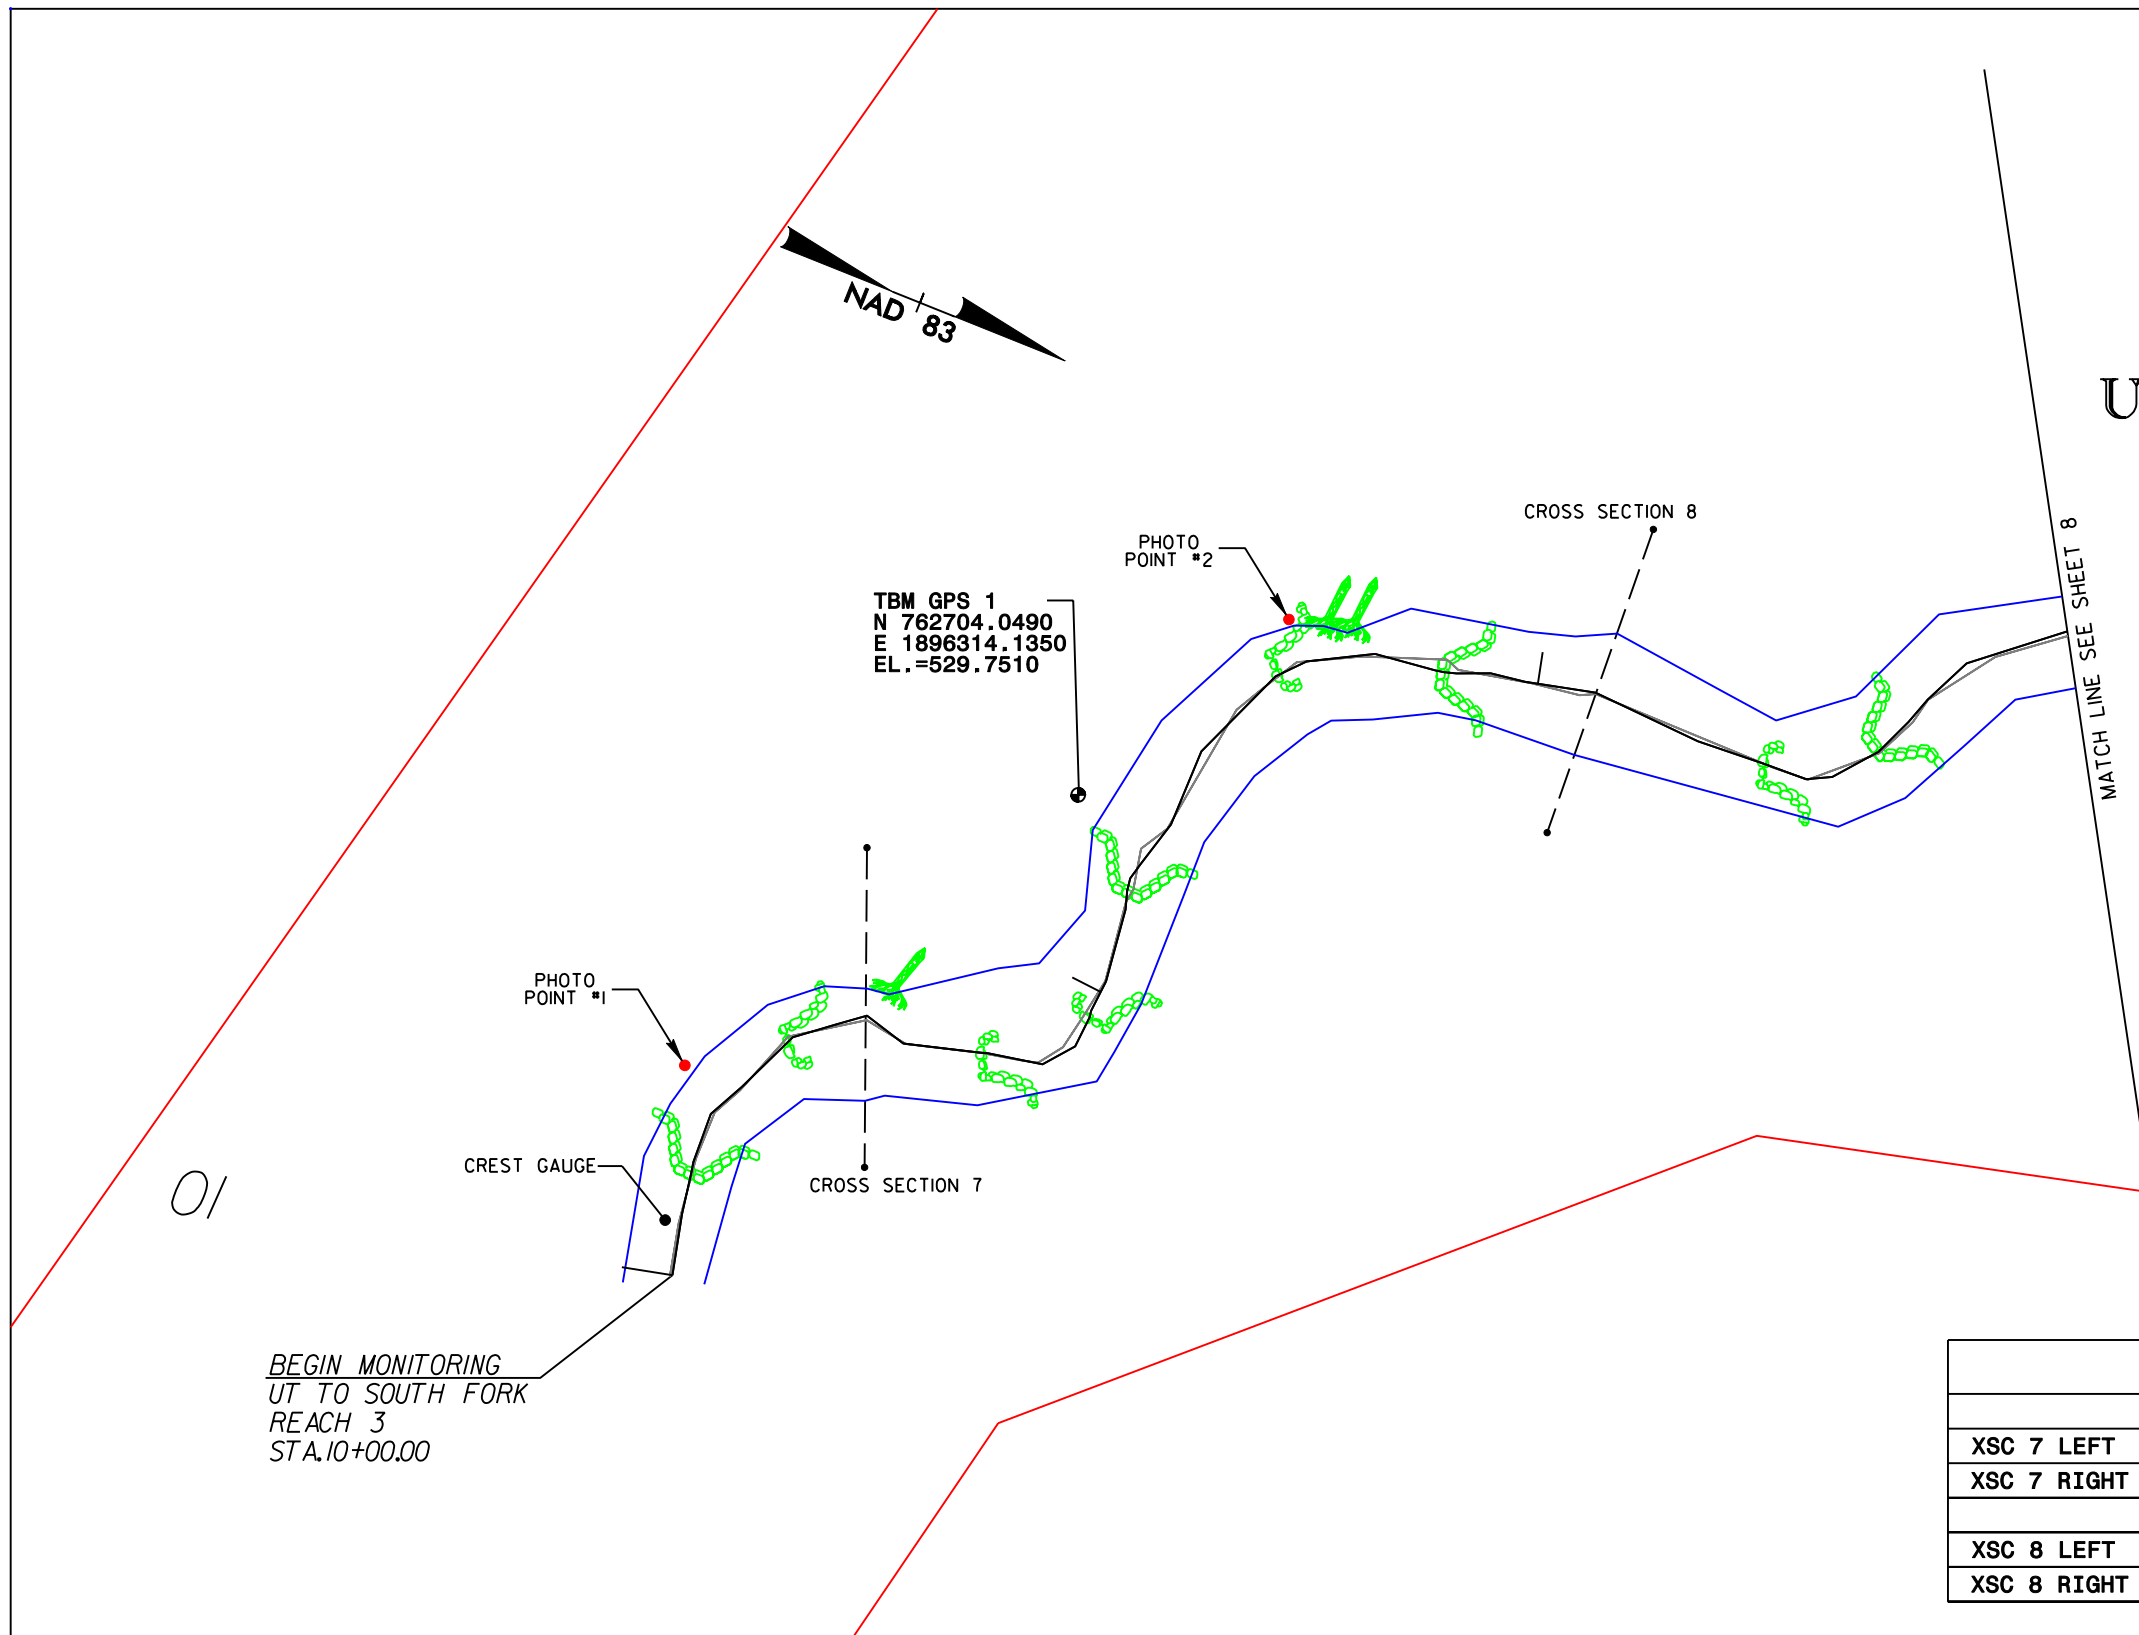
UT TO SOUTH FORK REACH 3

CROSS SECTION STAKING			
	NORTHING	EASTING	ELEVATION
XSC 7 LEFT	762676.4689	1896334.1190	530.1153
XSC 7 RIGHT	762694.7446	1896380.6050	531.6672
XSC 8 LEFT	762771.9483	1896242.1450	531.2732
XSC 8 RIGHT	762774.2250	1896292.2990	531.0435

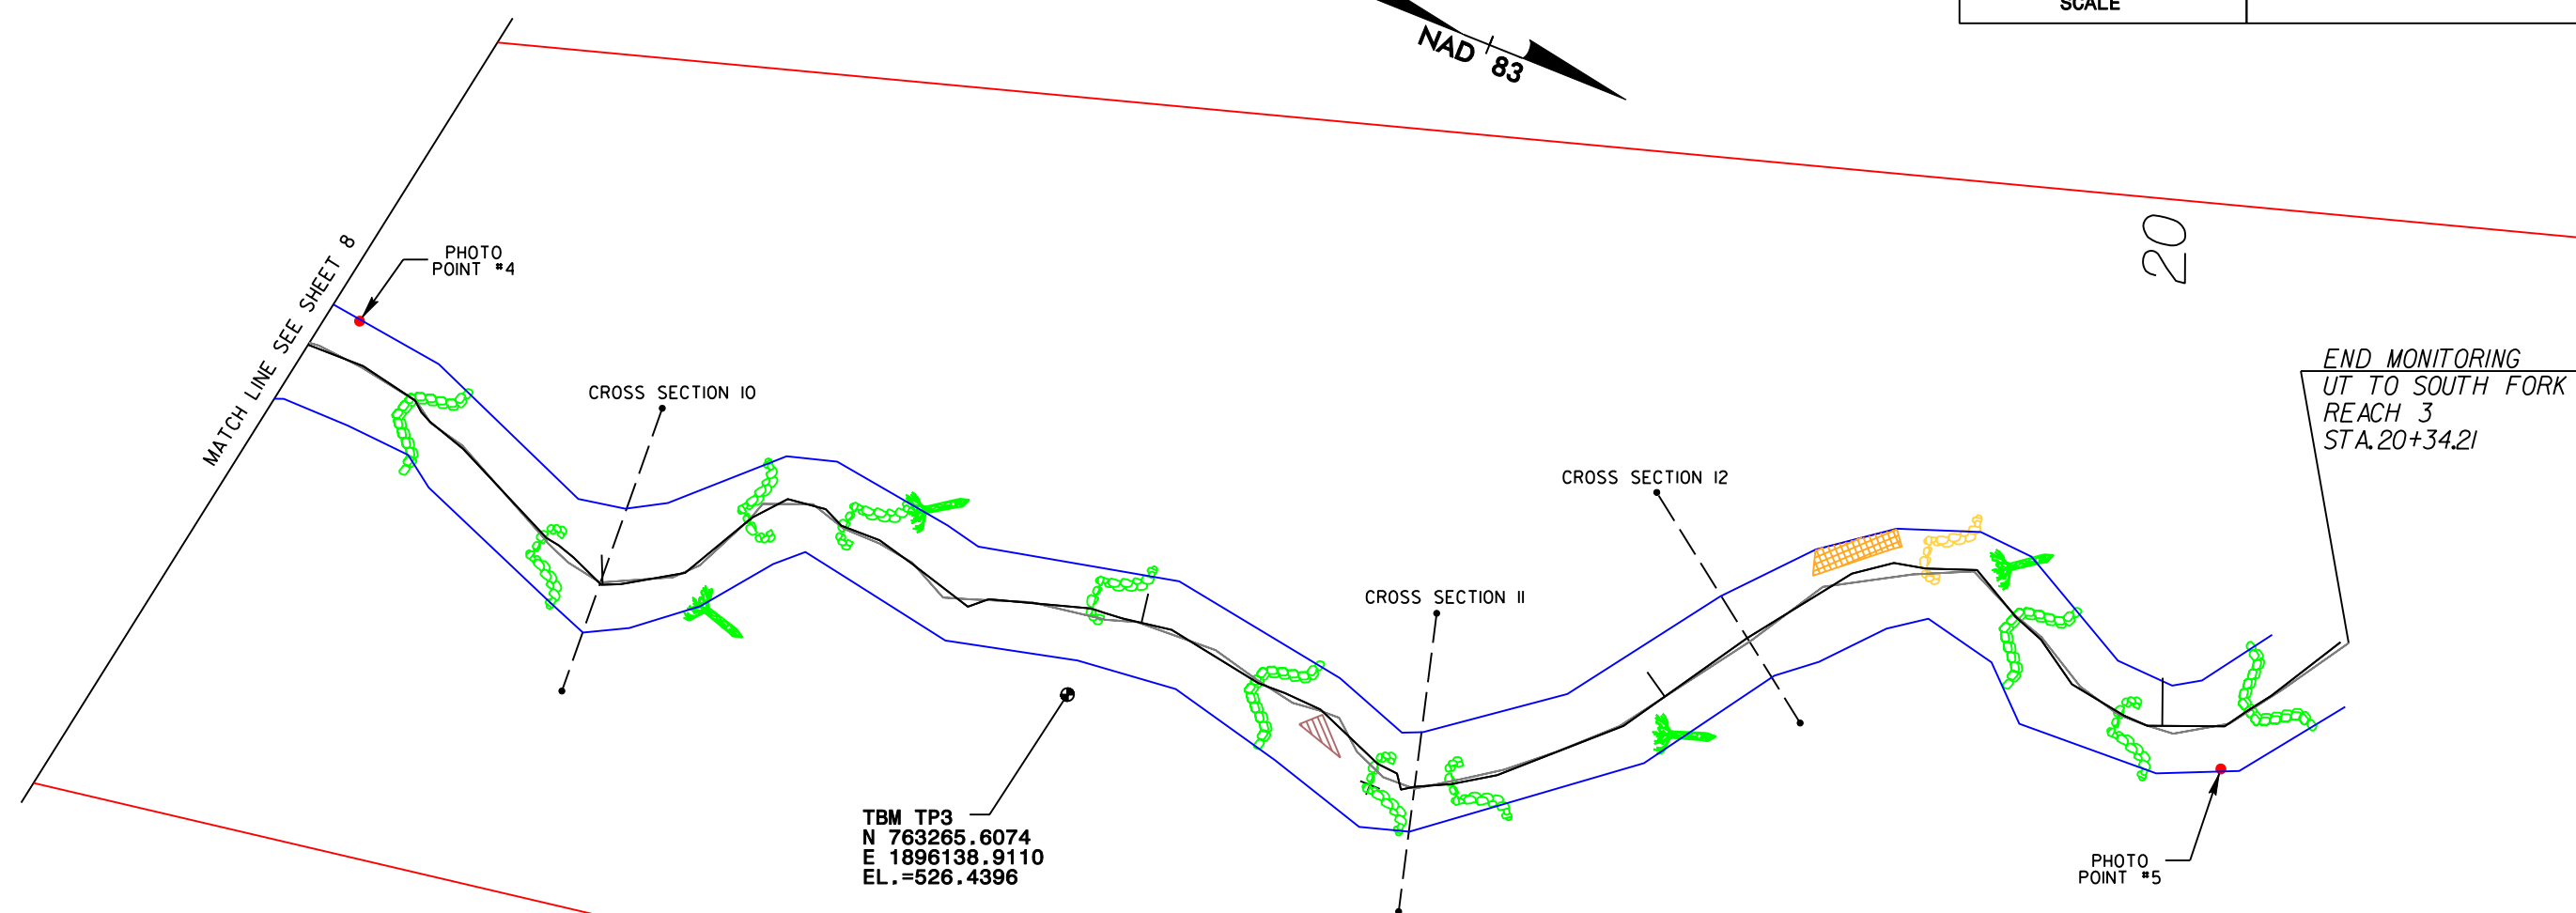
UT TO SOUTH FORK REACH 3

CROSS SECTION STAKING			
	NORTHING	EASTING	ELEVATION
XSC 10 LEFT	763185.3049	1896119.8830	528.6611
XSC 10 RIGHT	763187.3395	1896169.7620	527.3895
XSC 11 LEFT	763317.5403	1896103.5160	527.4576
XSC 11 RIGHT	763330.1768	1896151.9130	527.3963
XSC 12 LEFT	763344.0200	1896071.2010	527.7327
XSC 12 RIGHT	763380.4412	1896097.9050	526.4052

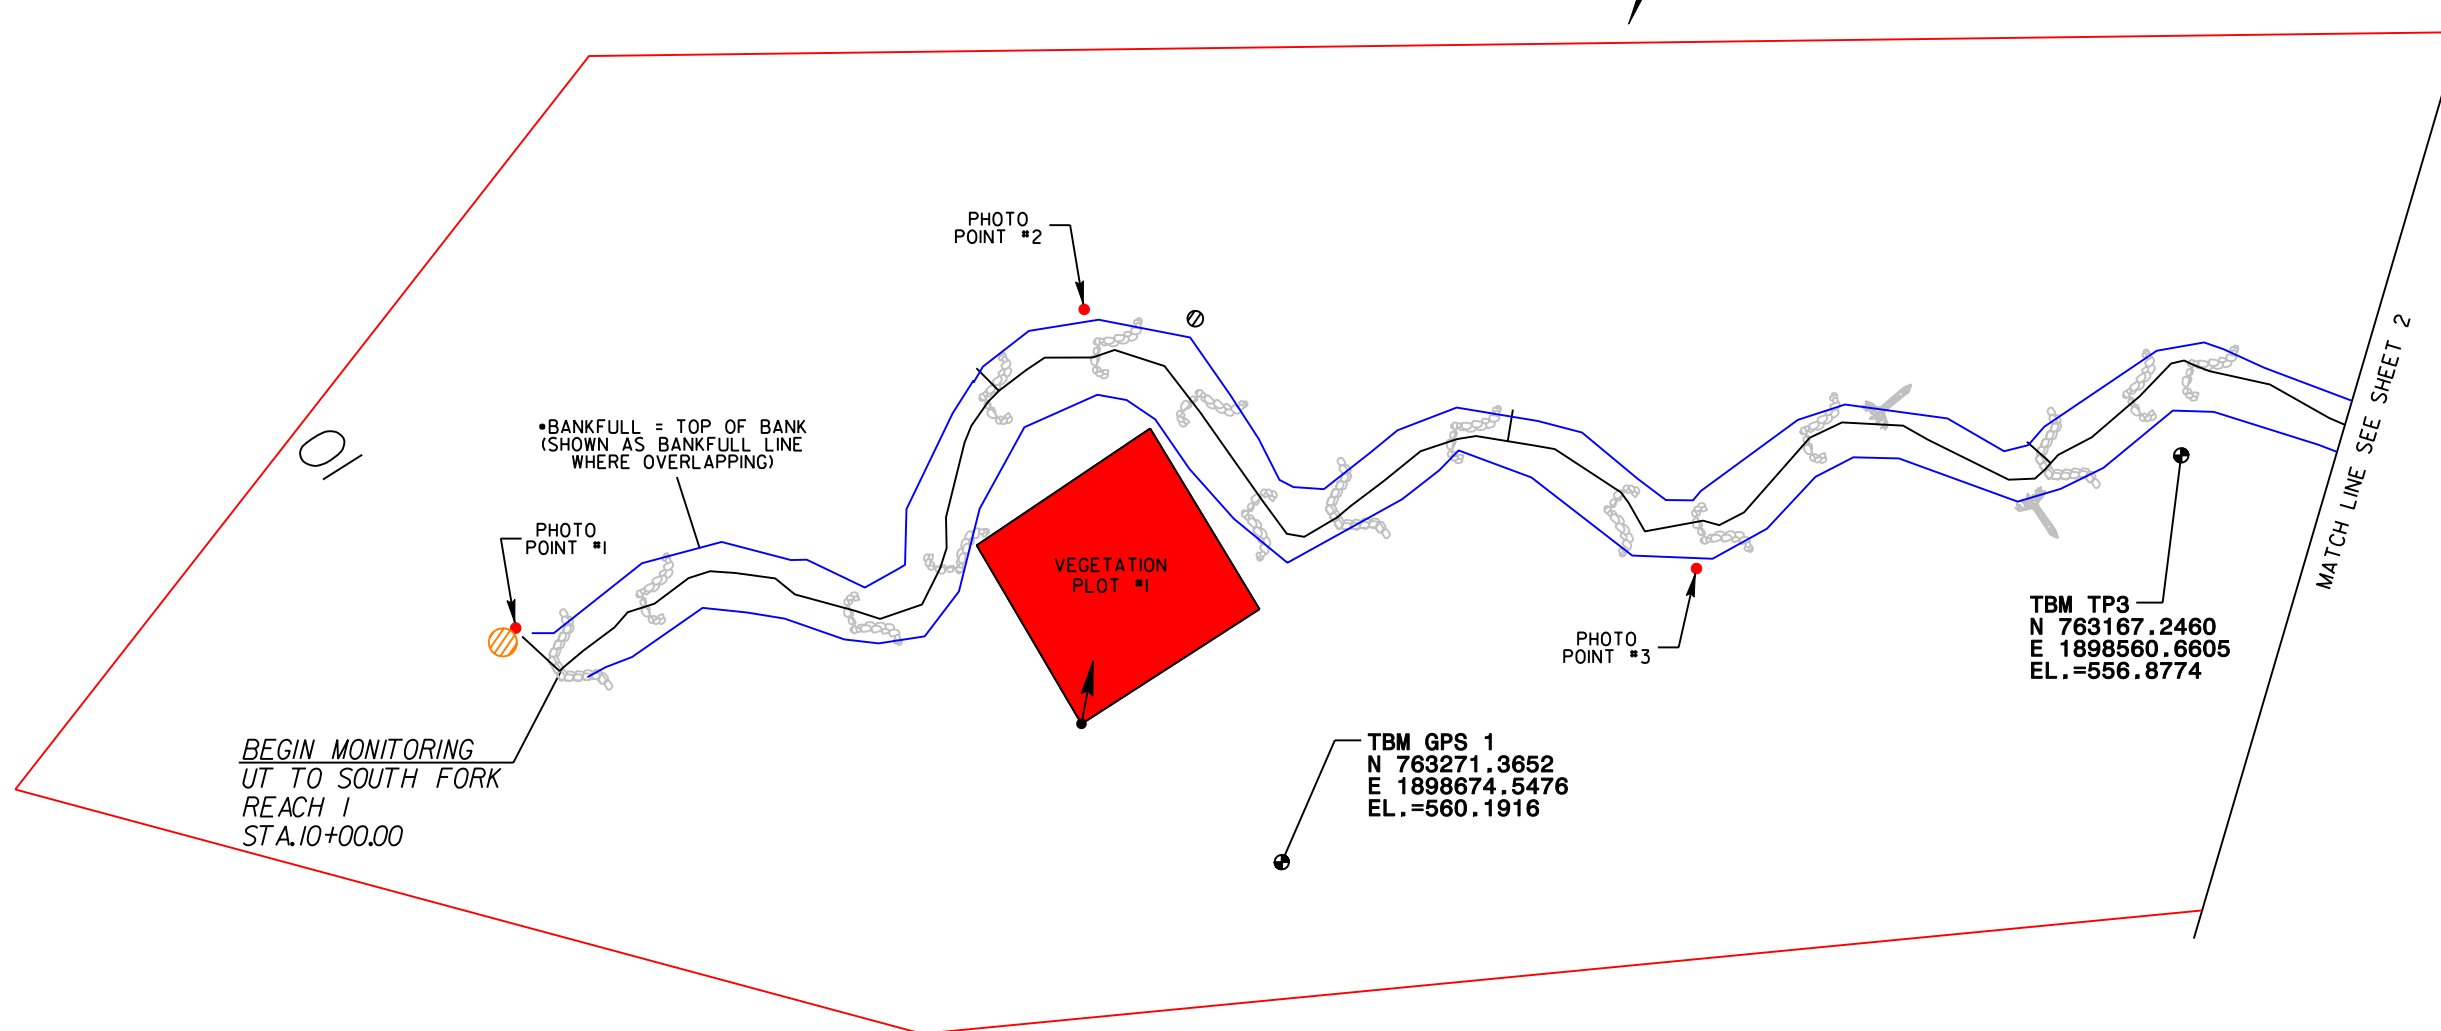
UT TO SOUTH FORK REACH 1

*THE HERBACEOUS UNDERSTORY COMPONENT OF THE VEGETATIVE COMMUNITY IS DOMINATED BY *FESTUCA SPP.* ALONG THE LENGTH OF SR1.

There was strong vegetative cover along the length of the project. Fescue has dominated the herbaceous understory of monitoring reach 1, which appears to be preventing the establishment of the planted bare root trees and other native vegetation. In Monitoring Year 4, several populations of exotic invasive species were noted. Invasive species found include: *Festuca spp.*, *Ligustrum sinense*, *Rosa multiflora*, *Microstegium virmineum*, and *Ailanthus altissima*. Planted stem survival in monitoring reach 1 remains a concern due to fescue dominance. All plots in monitoring reach 1 had planted stem densities below the Year 5 goal of 260 stems per acre. Vegetation Plot 2 is of particular concern because no planted stems were counted in this plot in Monitoring Year 4. The overall planted stem survival from Monitoring Year 1 to Monitoring Year 4 was 65% among all vegetation plots in all reaches. The overall planted stem density across all vegetation plots was 567 stems per acre.
