**UT TO SOUTH FORK
FINAL MONITORING REPORT
YEAR 4 OF 5
2009**

EEP Project # 435
Alamance County, North Carolina

Appendix A: General Figures and Plan Views

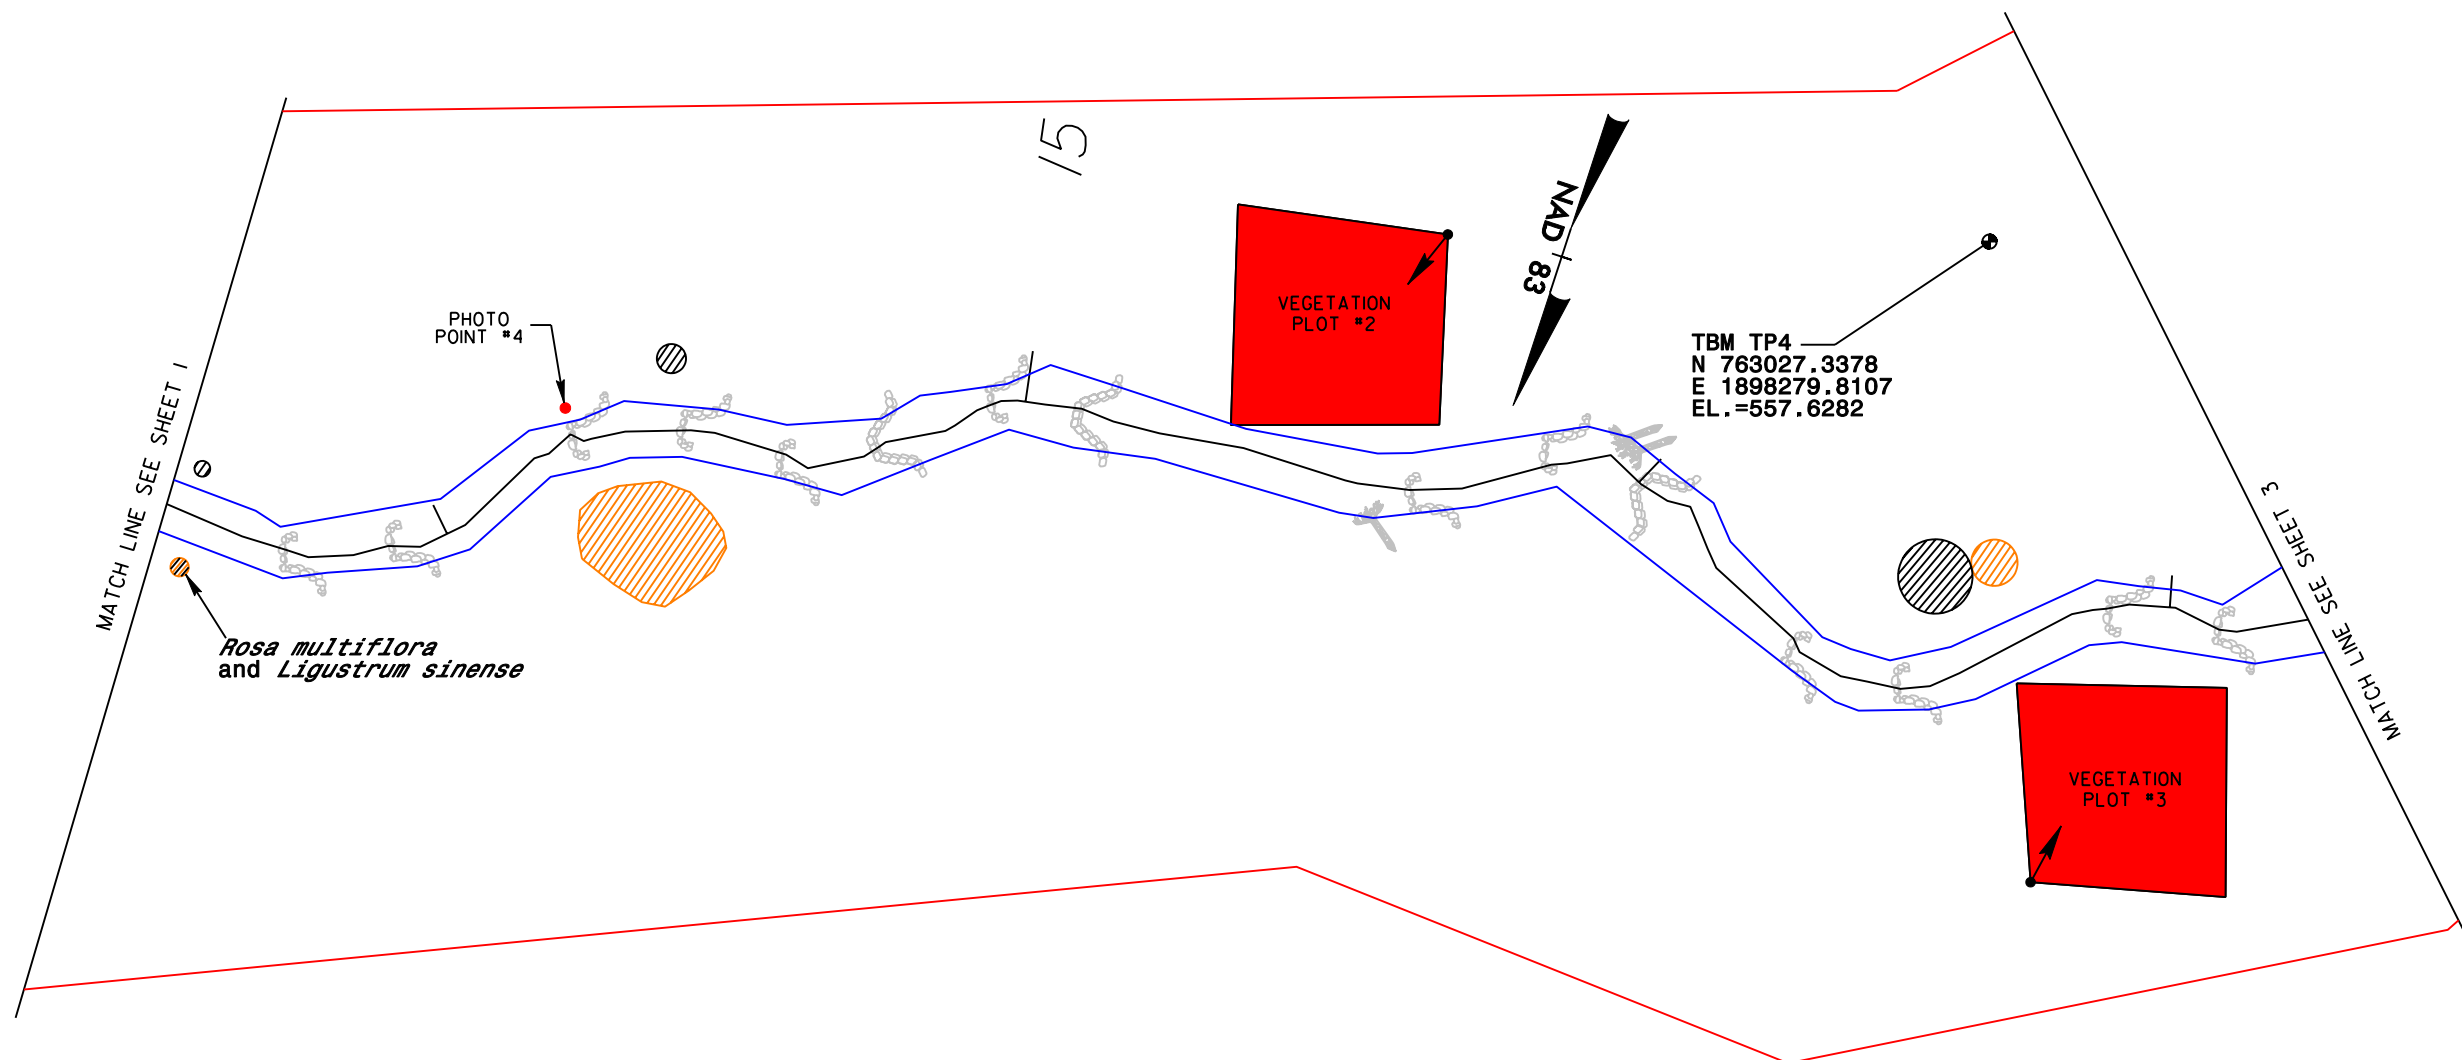
**UT TO SOUTH FORK
REACH 1**

*THE HERBACEOUS UNDERSTORY COMPONENT OF THE VEGETATIVE COMMUNITY IS DOMINATED BY *FESTUCA SPP.* ALONG THE LENGTH OF SR1.

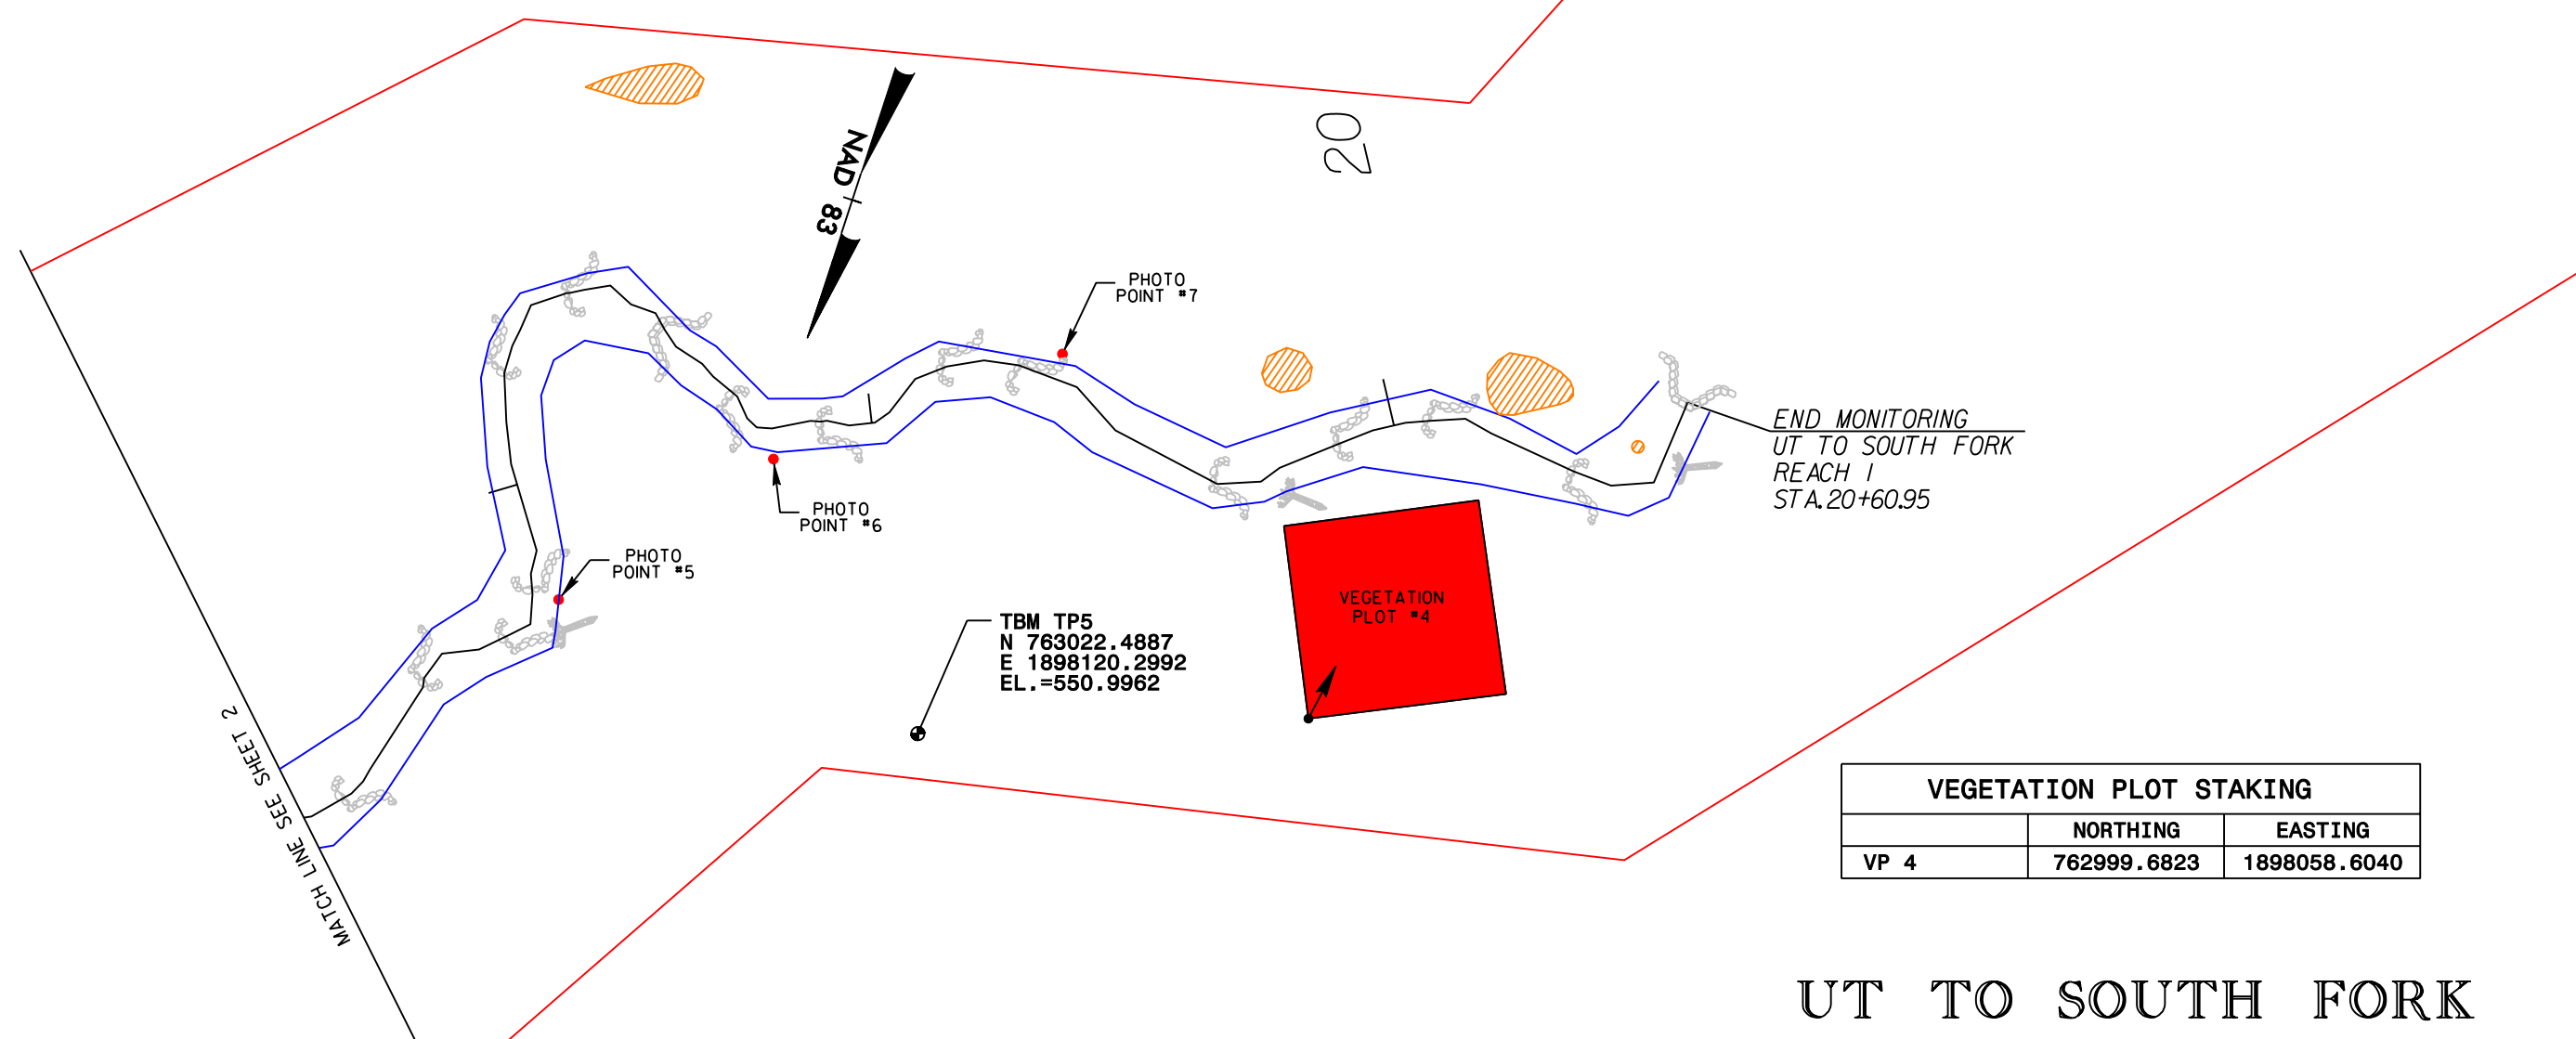
UT TO SOUTH FORK REACH 1

VEGETATION PLOT STAKING		
	NORTHING	EASTING
VP 4	762999.6823	1898058.6040

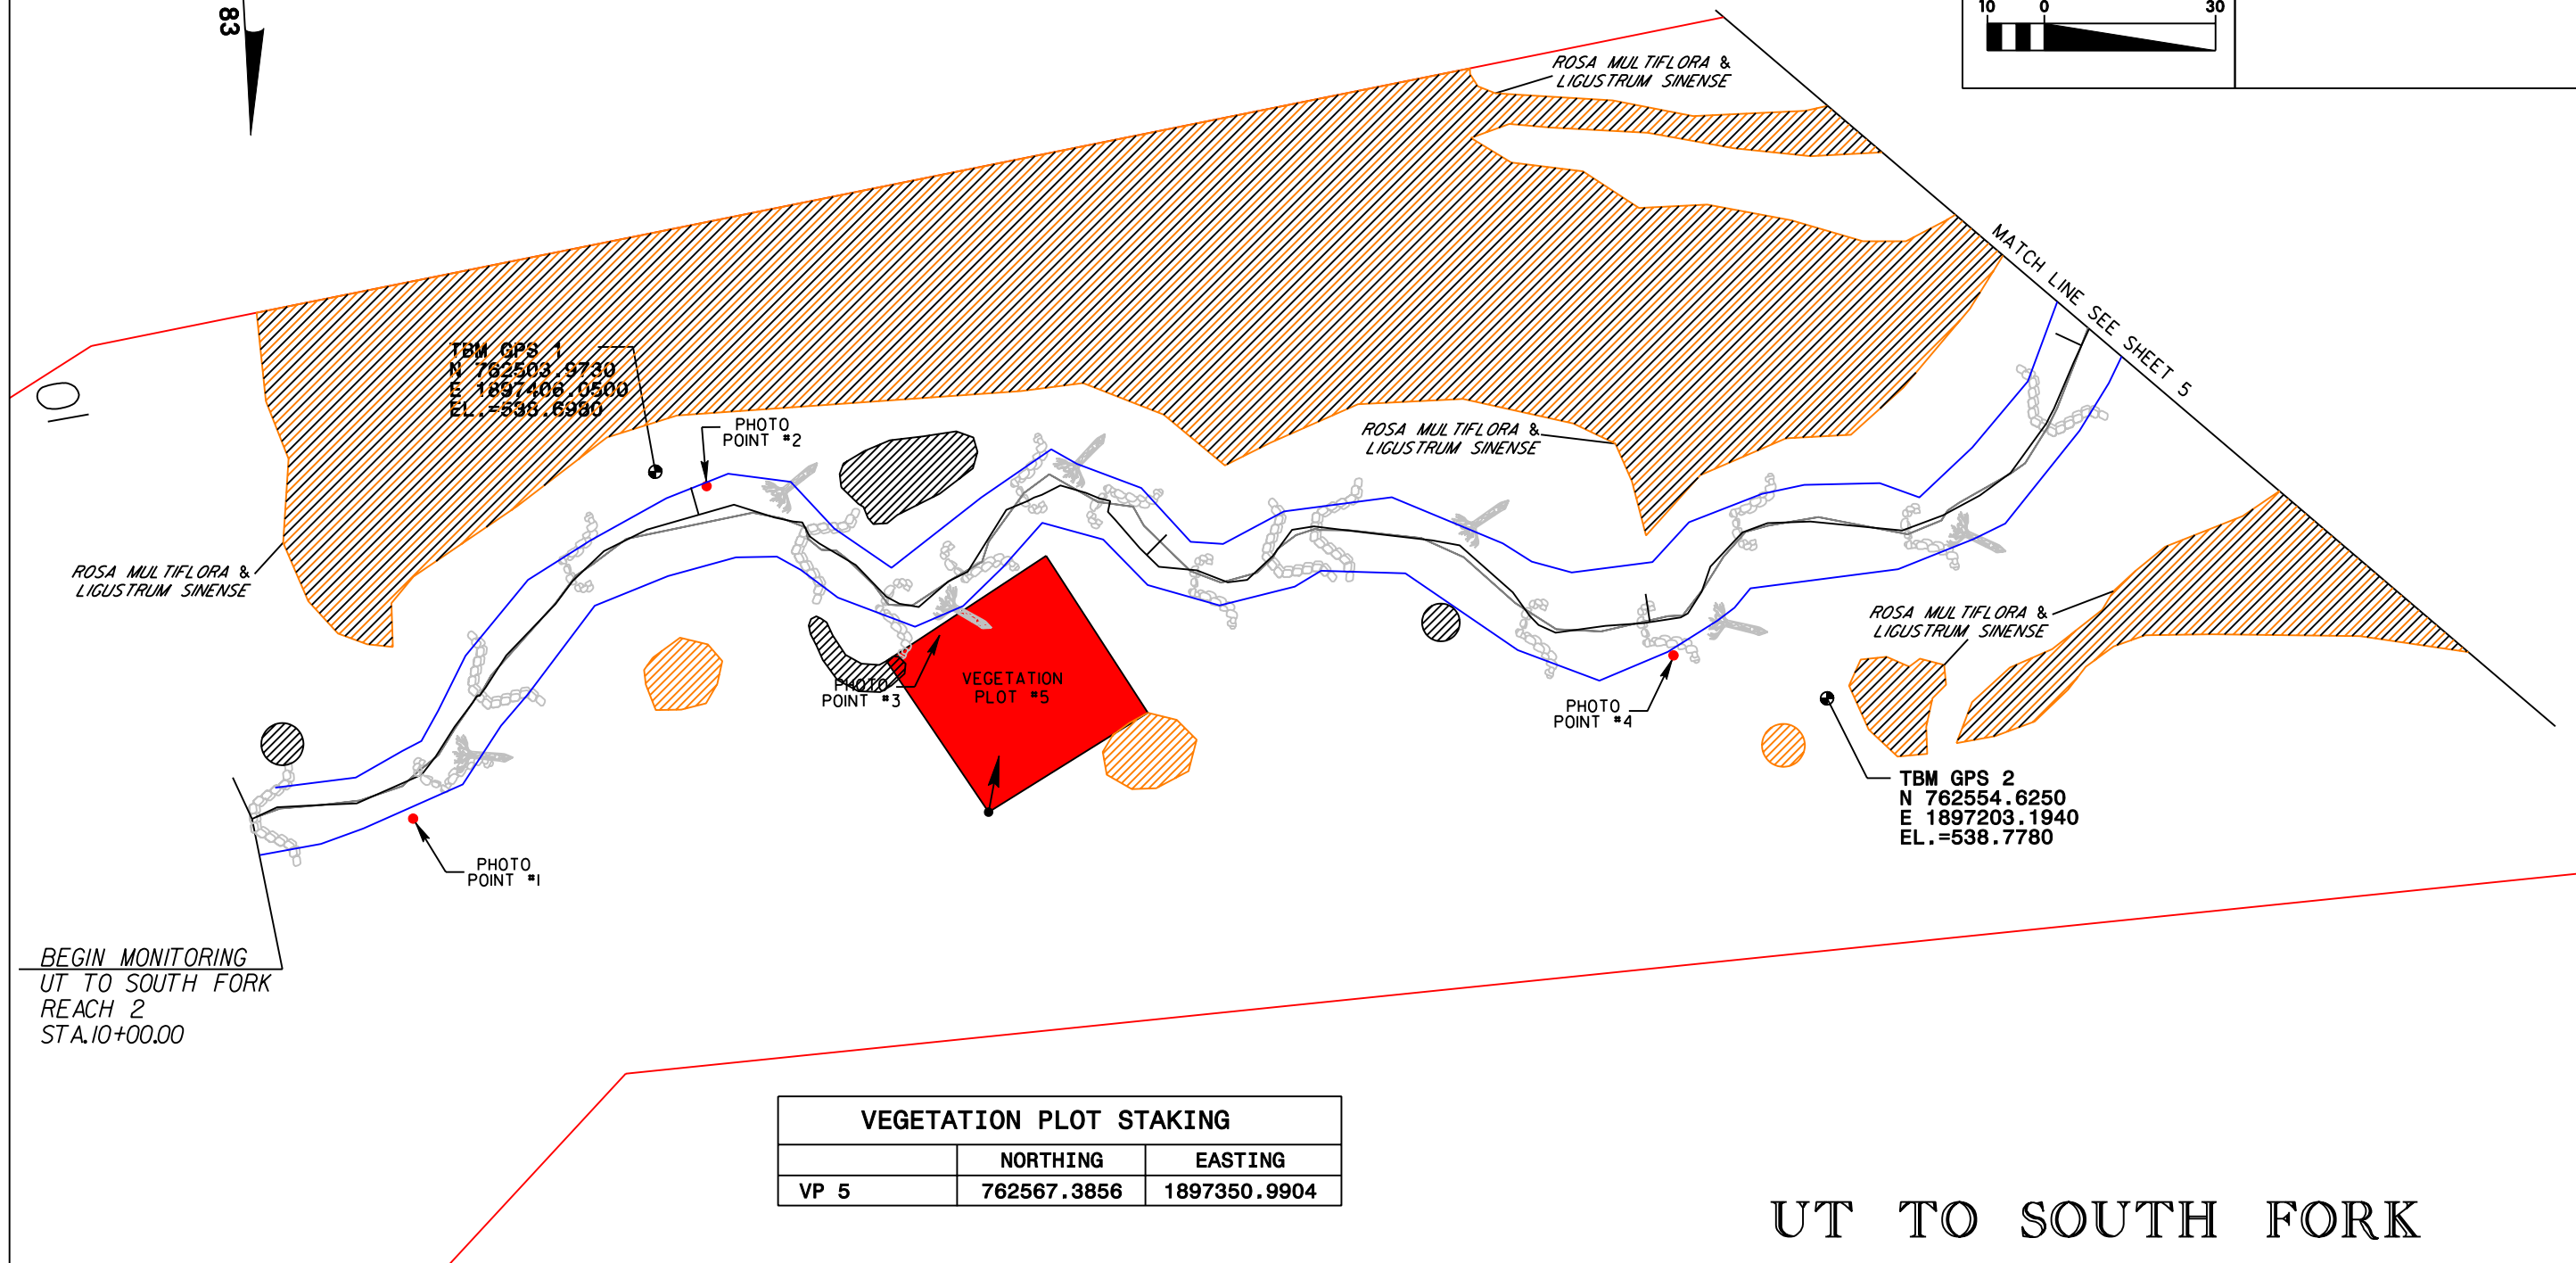
BEGIN MONITORING
UT TO SOUTH FORK
REACH 2
STA.10+00.00

VEGETATION PLOT STAKING		
	NORTHING	EASTING
VP 5	762567.3856	1897350.9904

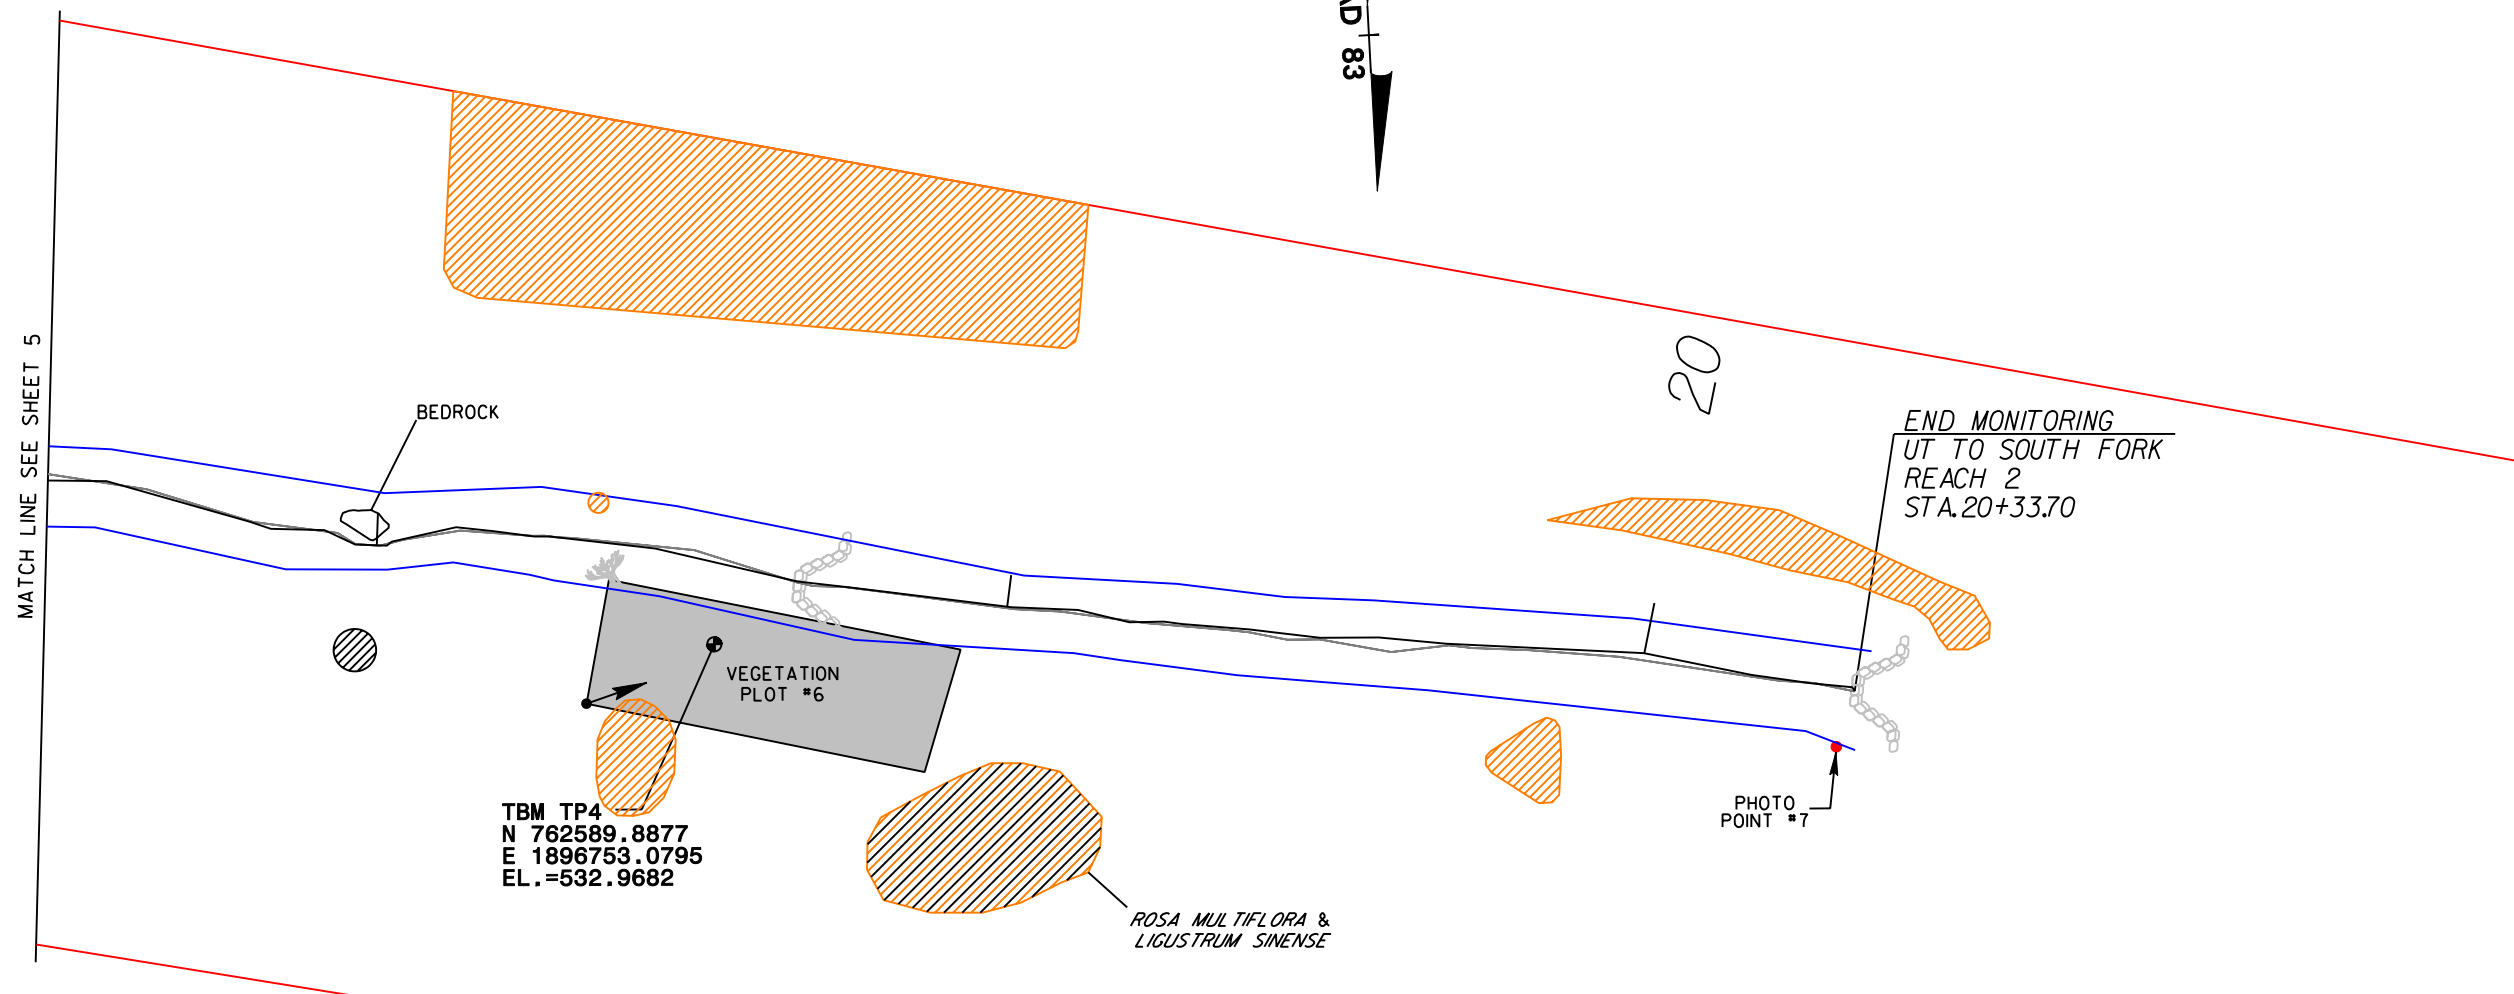
UT TO SOUTH FORK REACH 2

VEGETATION PLOT STAKING		
	NORTHING	EASTING
VP 6	762598.0885	1896773.5260

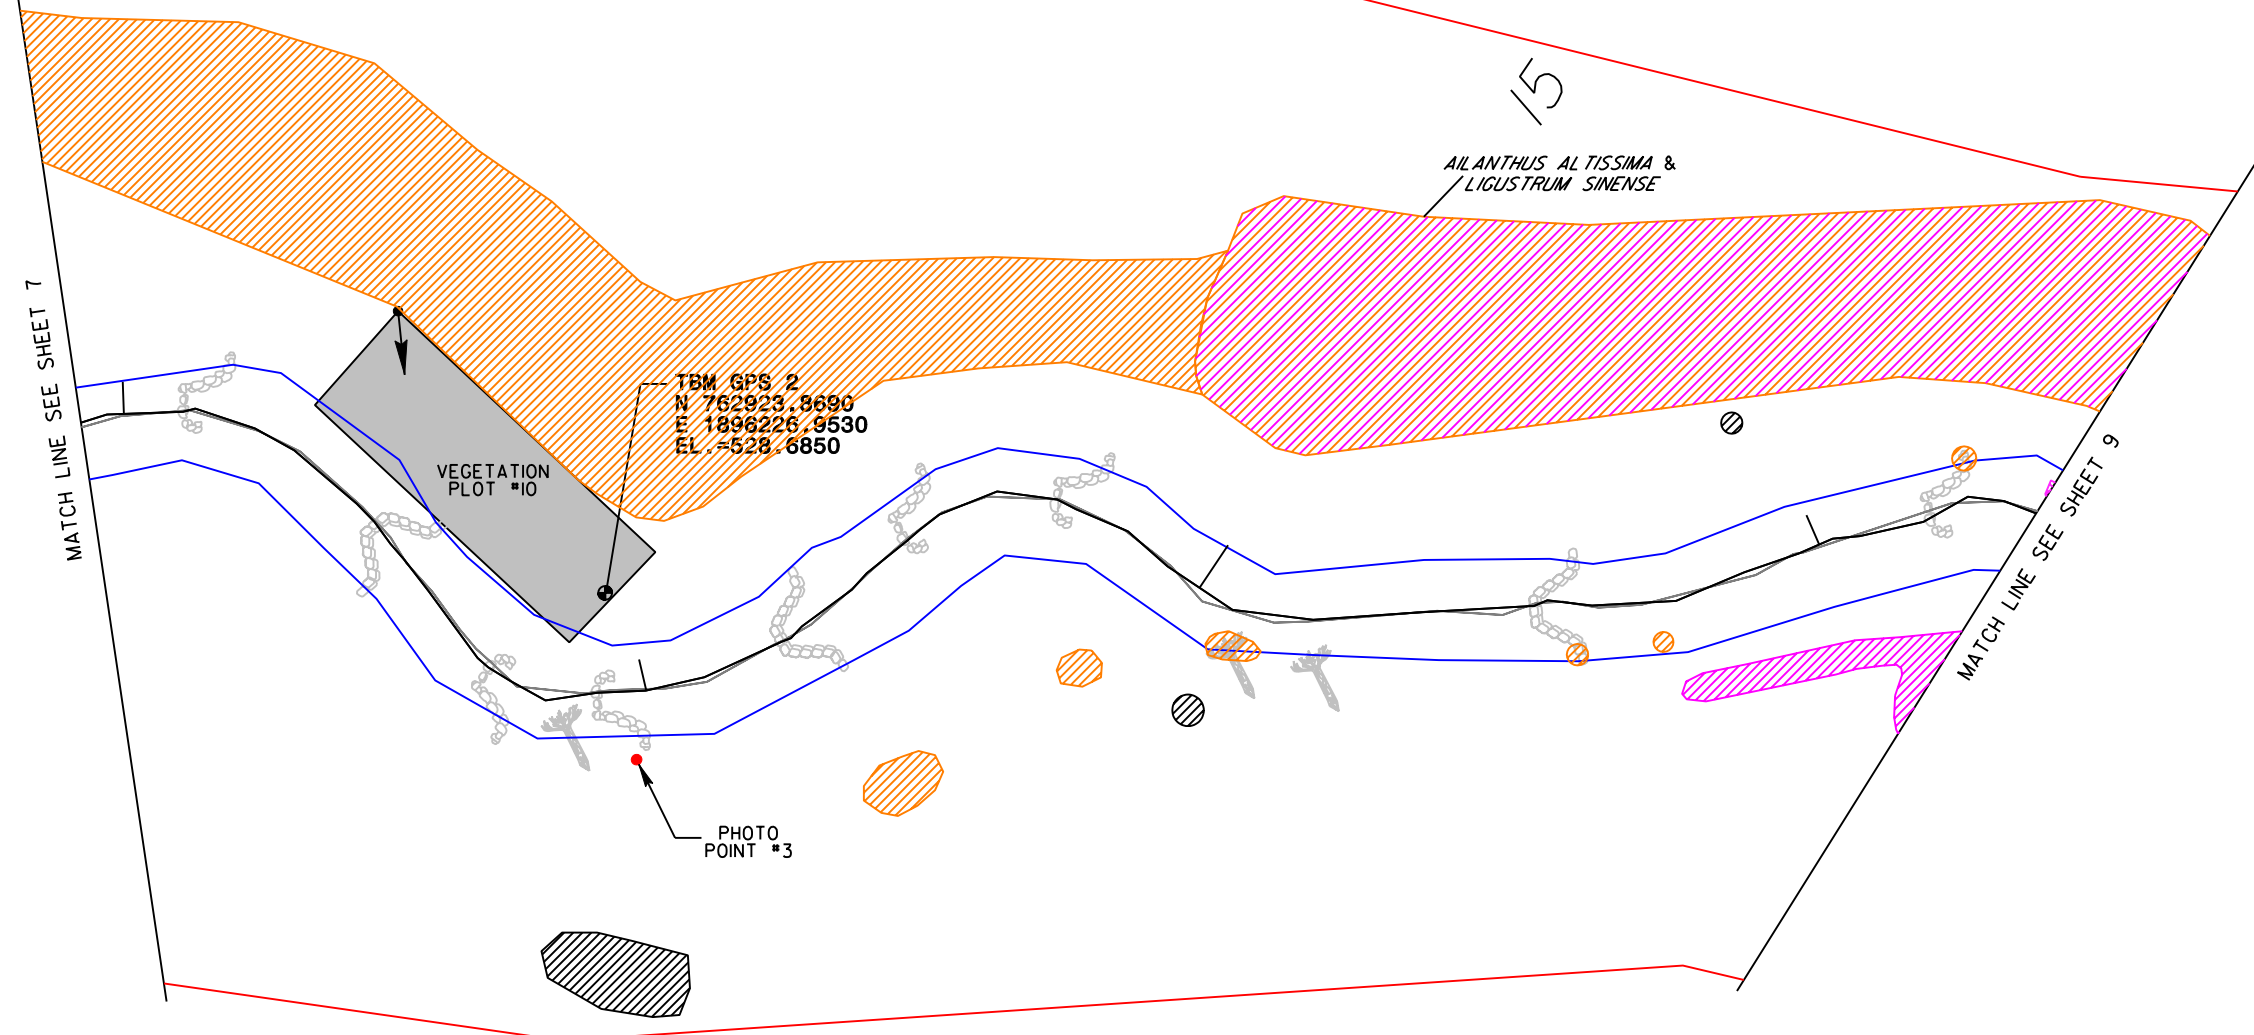
VEGETATION PLOT STAKING		
	NORTHING	EASTING
VP 10	762877.3945	1896198.1740

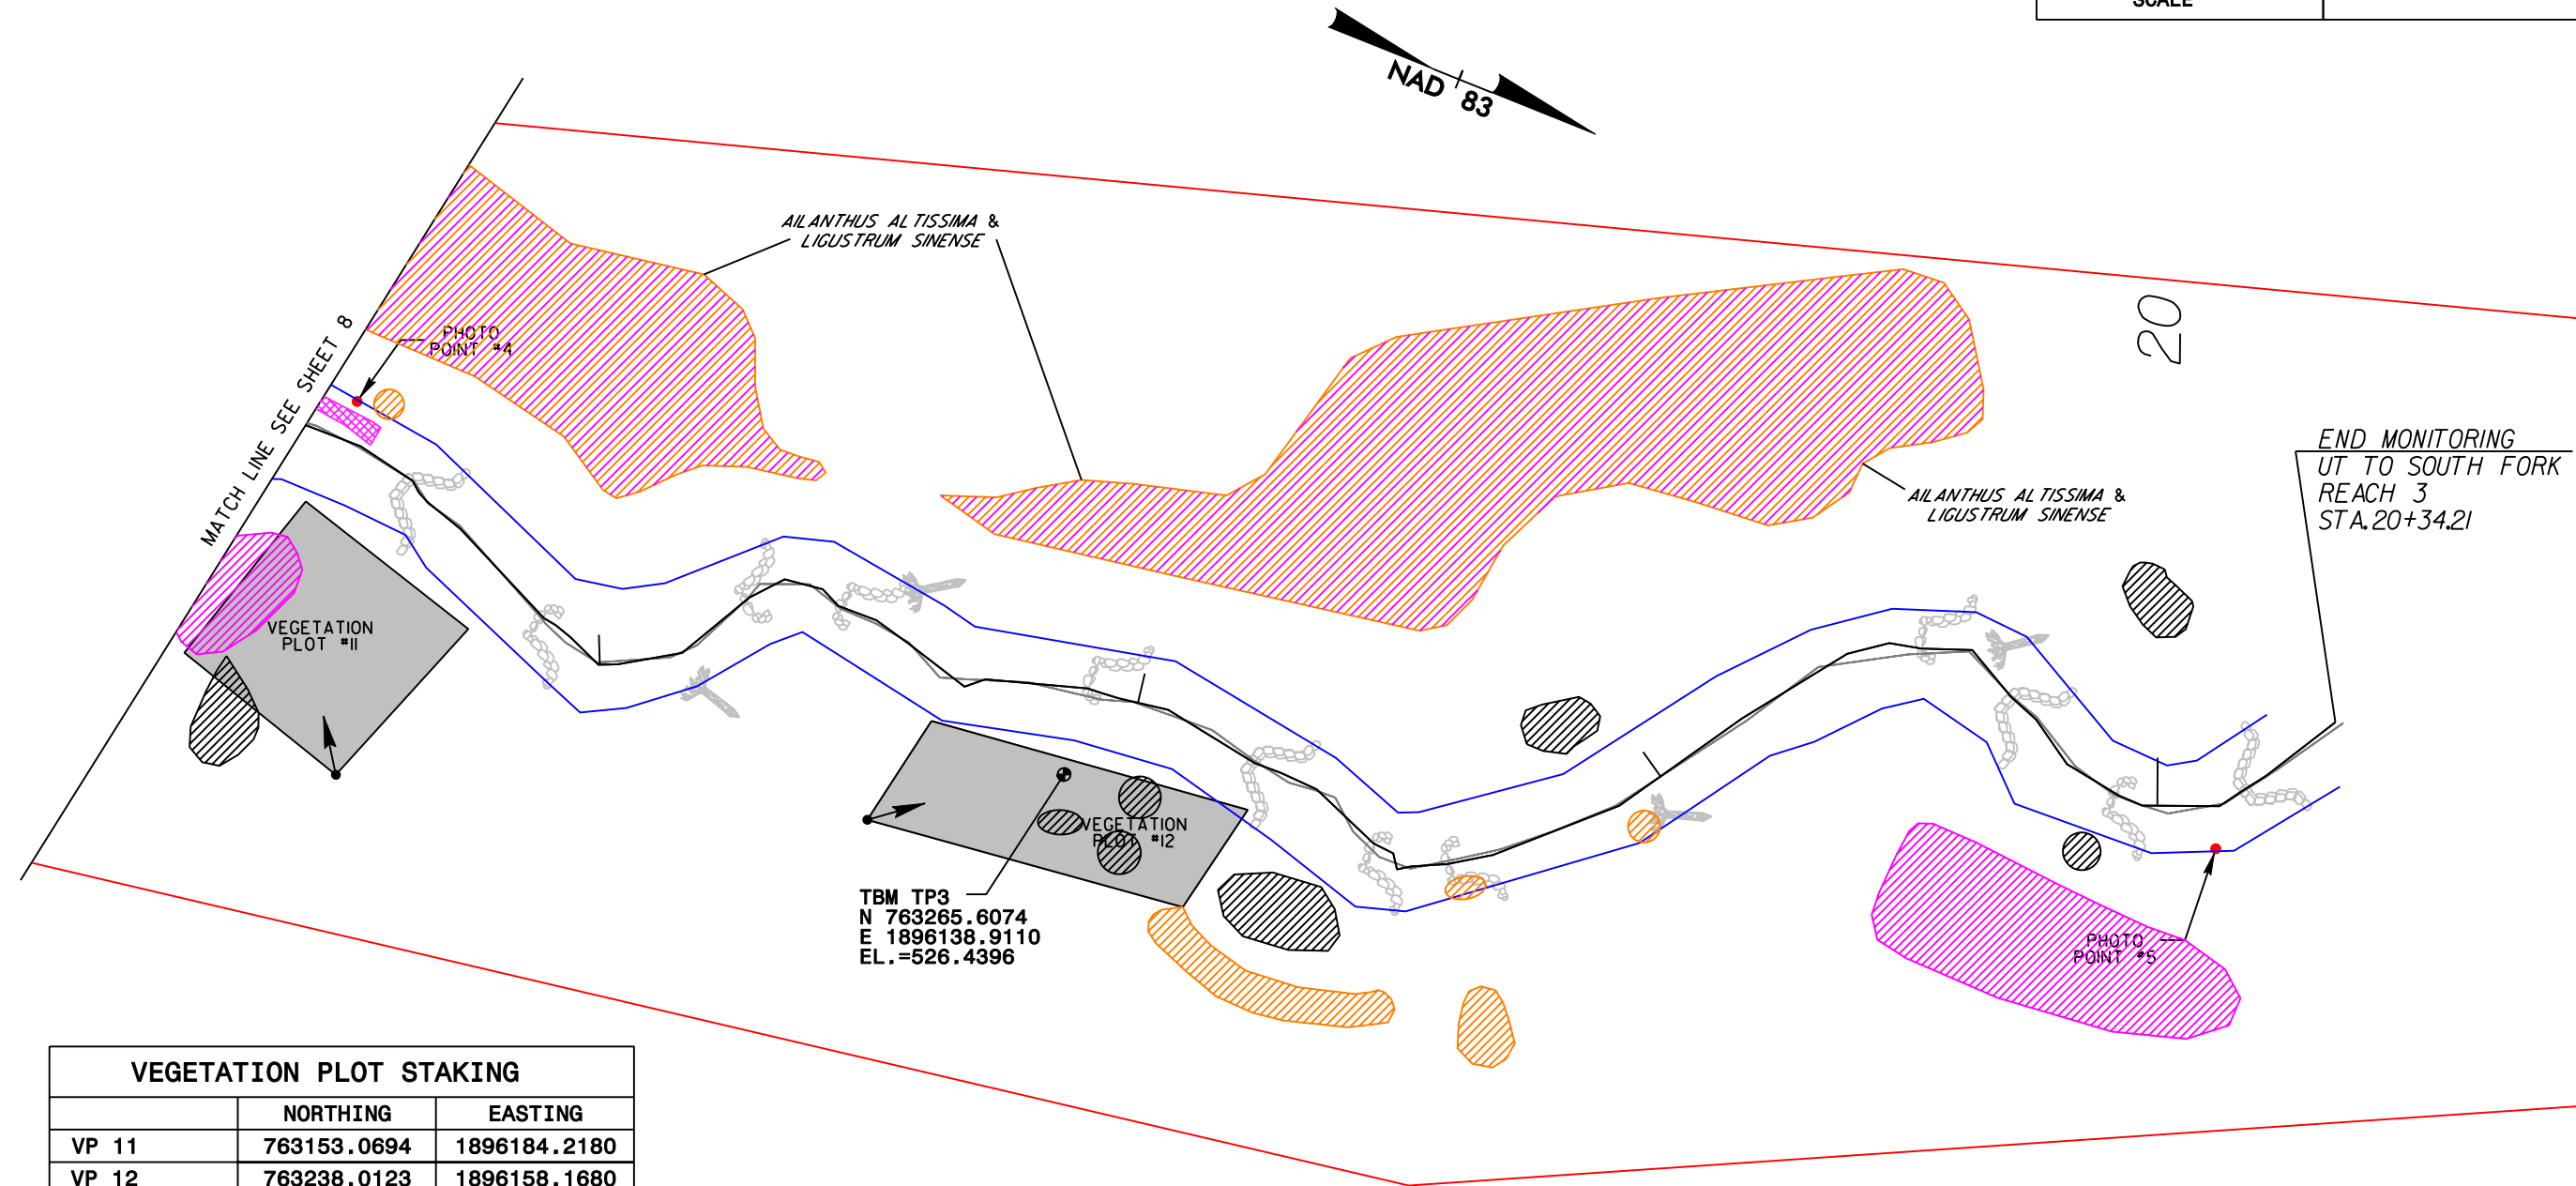
UT TO SOUTH FORK REACH 3

VEGETATION PLOT STAKING		
	NORTHING	EASTING
VP 11	763153.0694	1896184.2180
VP 12	763238.0123	1896158.1680

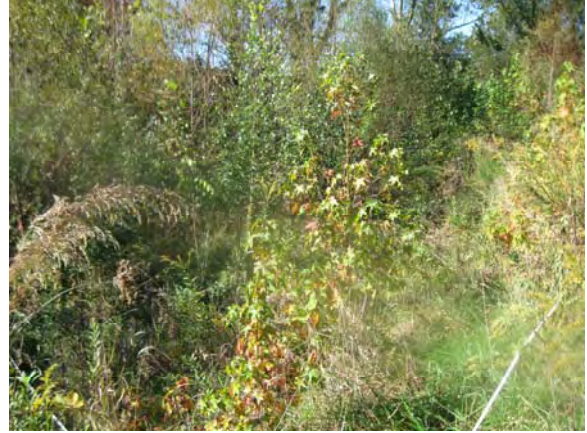
Photo 8: Vegetation Plot 8 (10-18-2009).

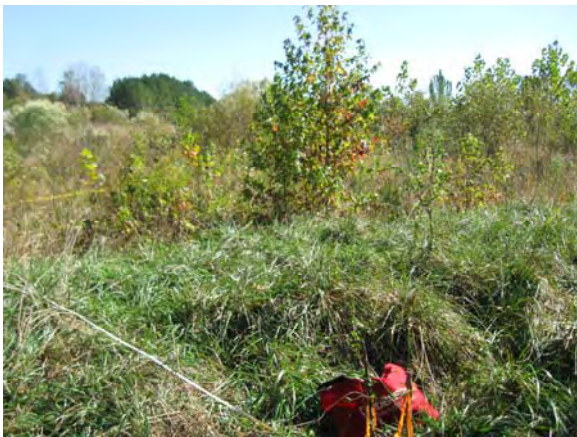
Photo 9: Vegetation Plot 9 (10-18-2009).

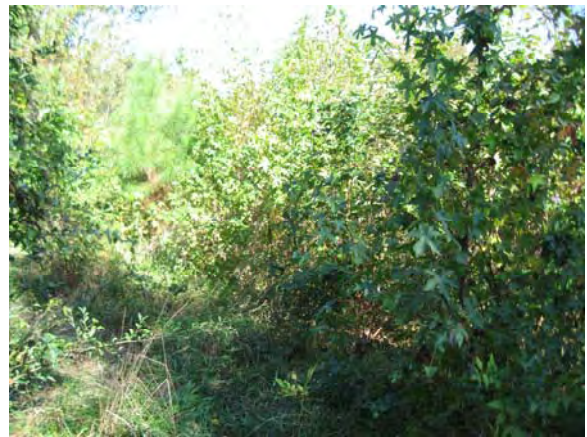
Photo 10: Vegetation Plot 10 (10-18-2009).

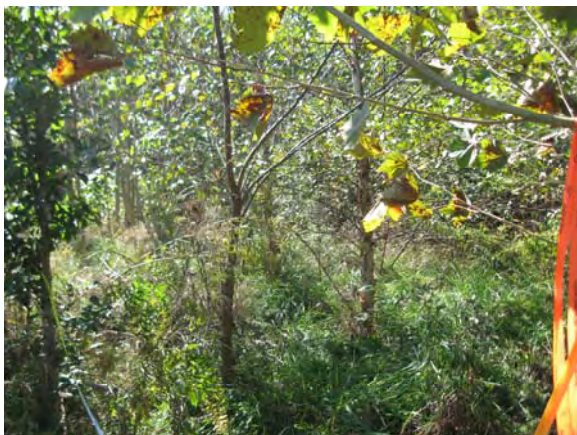
Photo 11: Vegetation Plot 11 (10-18-2009).

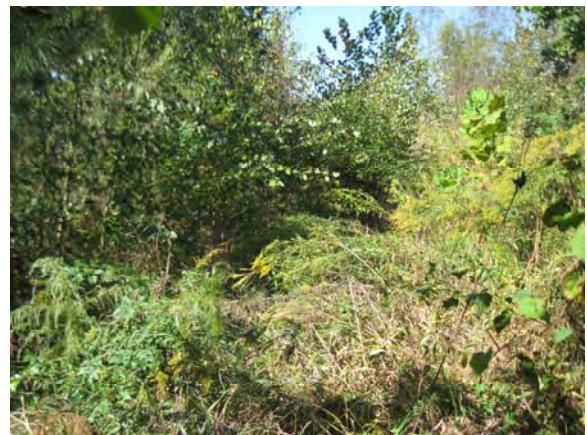
Photo 12: Vegetation Plot 12 (10-18-2009).

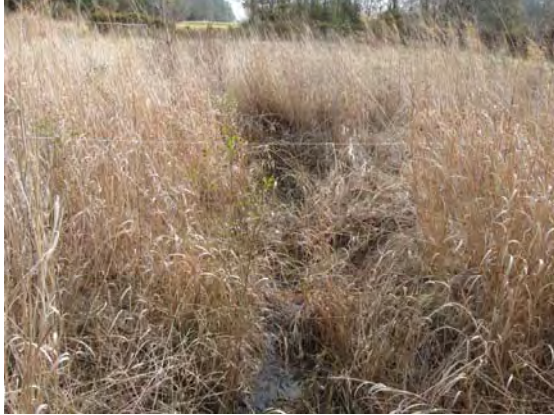
Cross-Section 1: View Upstream (2-11-2009).

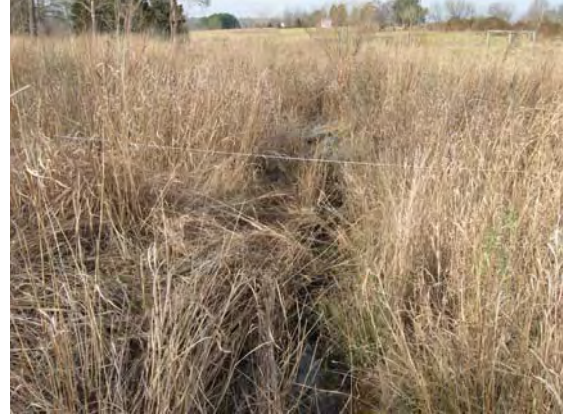
Cross-Section 1: View Downstream (2-11-2009).

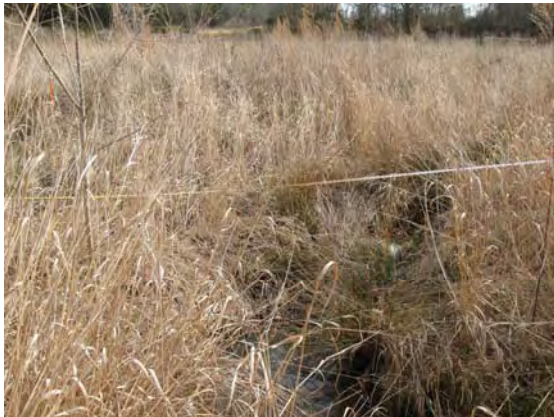
Cross-Section 2: View Upstream (2-11-2009).

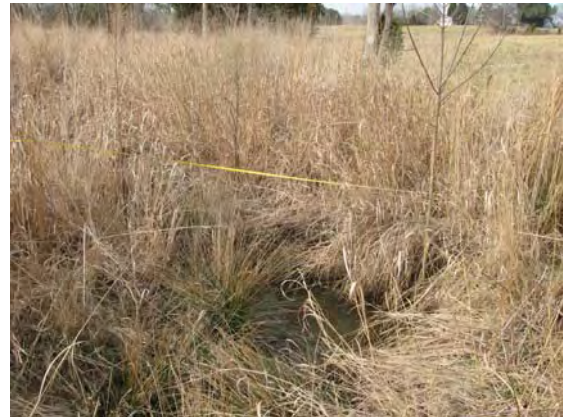
Cross-Section 2: View Downstream (2-11-2009).

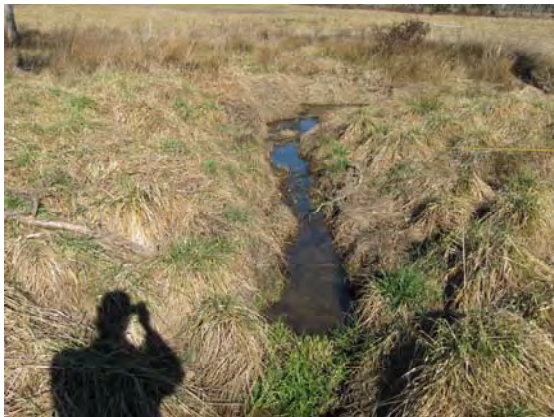
Cross-Section 3: View Upstream (2-12-2009).

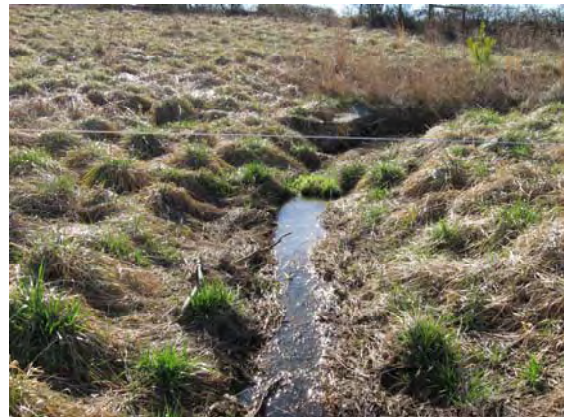
Cross-Section 3: View Downstream (2-12-2009).

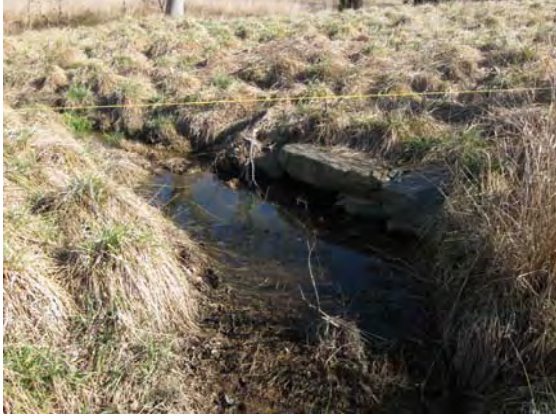
Cross-Section 4: View Upstream (2-12-2009).

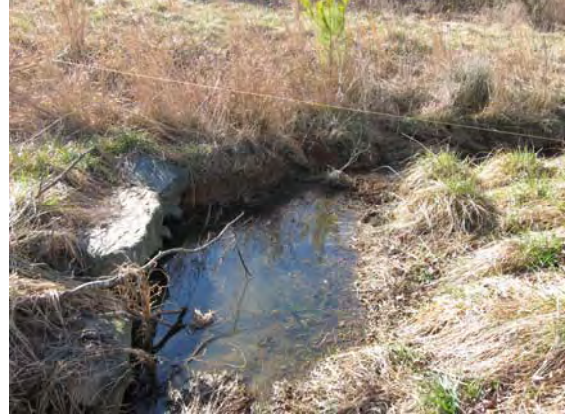
Cross-Section 4: View Downstream (2-12-2009).

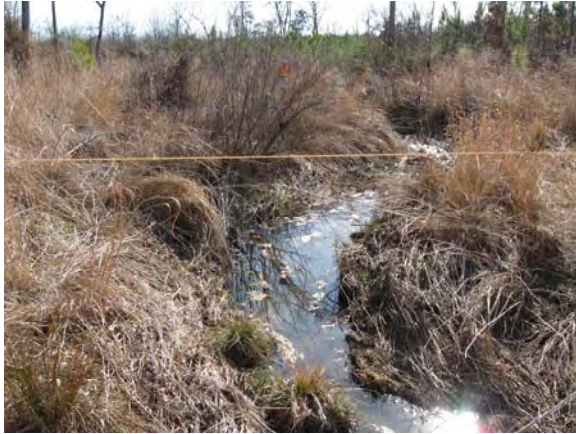
Cross-Section 5: View Upstream (2-17-2009).

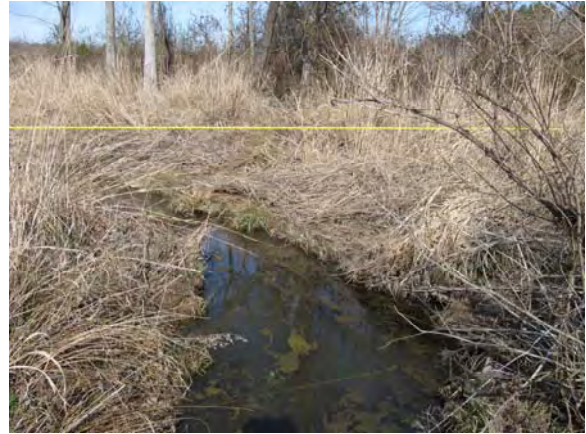
Cross-Section 5: View Downstream (2-17-2009).

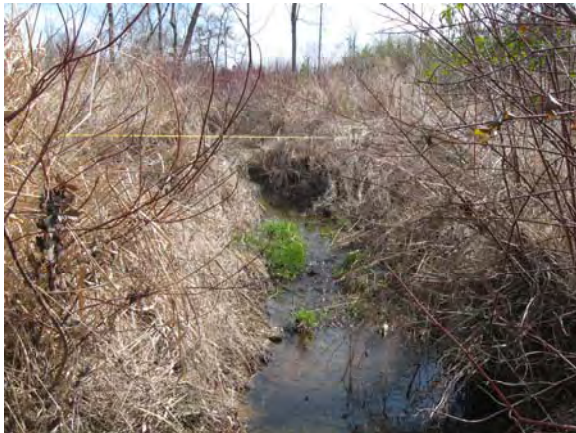
Cross-Section 6: View Upstream (2-17-2009).

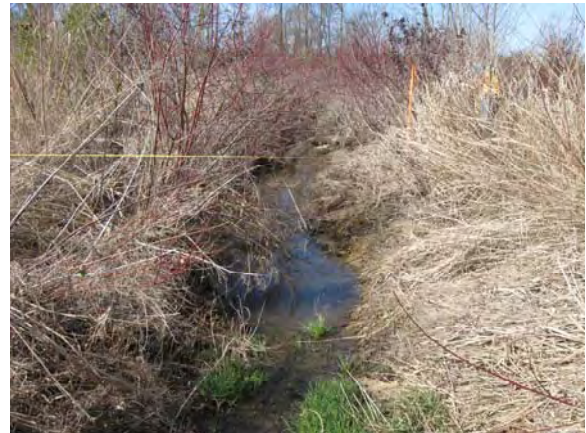
Cross-Section 6: View Downstream (2-17-2009).
