**UT TO SOUTH FORK
FINAL MONITORING REPORT
YEAR 4 OF 5
2009**

EEP Project # 435
Alamance County, North Carolina

Appendix A: General Figures and Plan Views

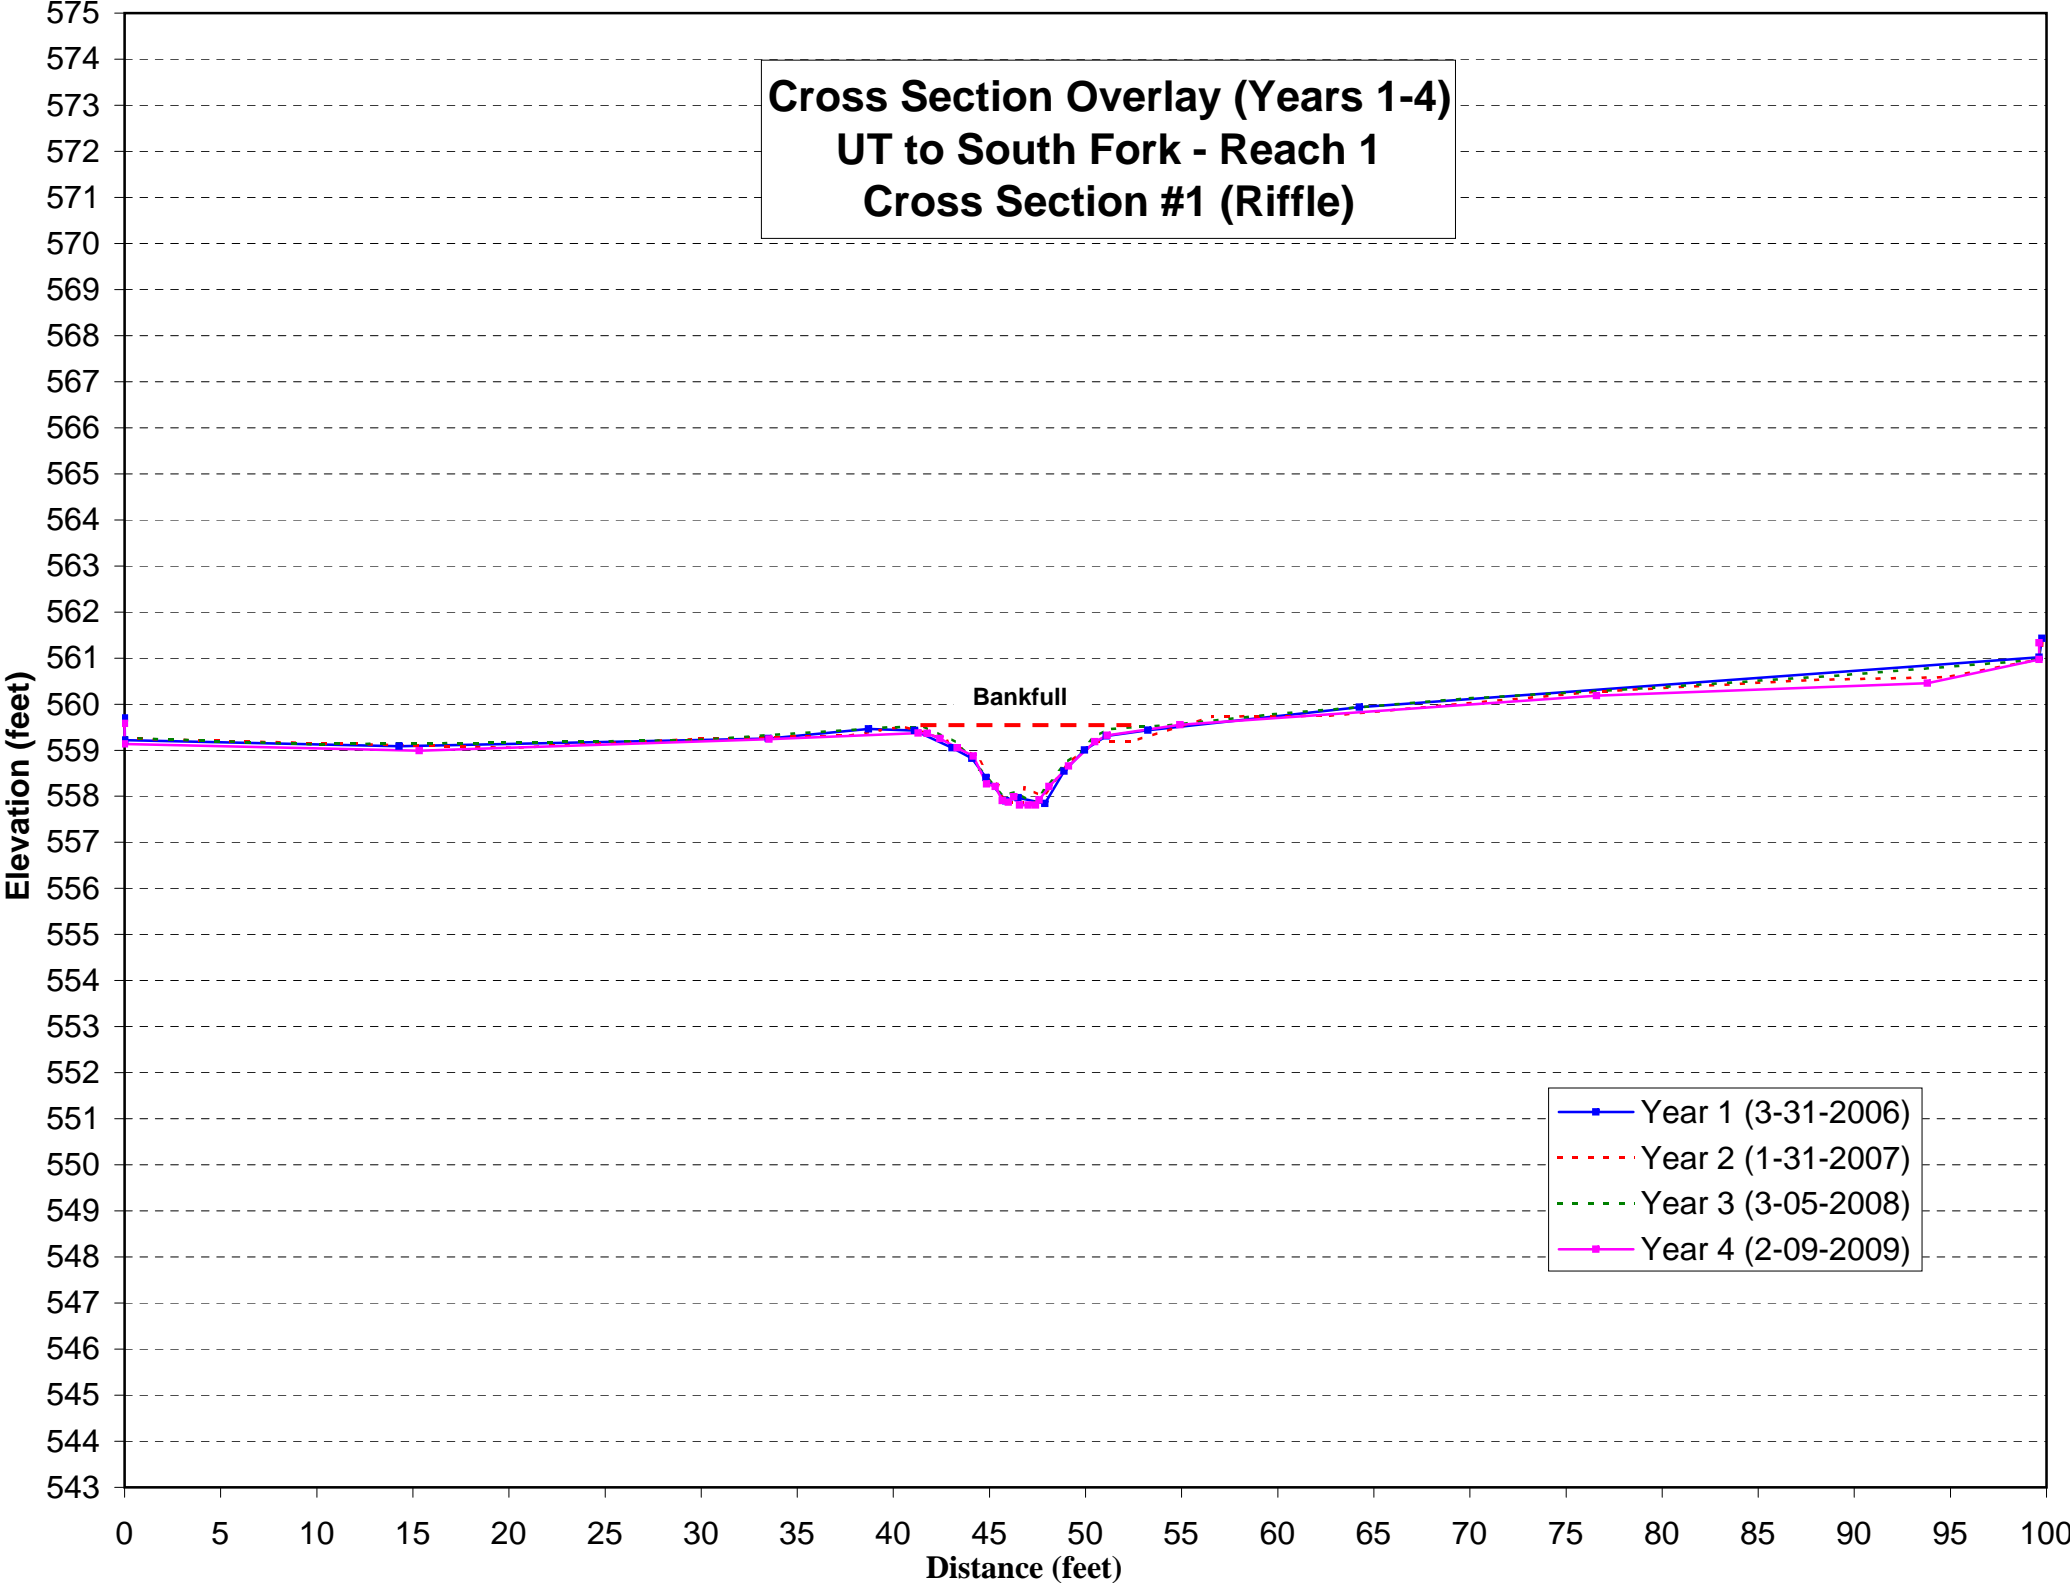
Cross Section Overlay (Years 1-4)
UT to South Fork - Reach 1
Cross Section #1 (Riffle)

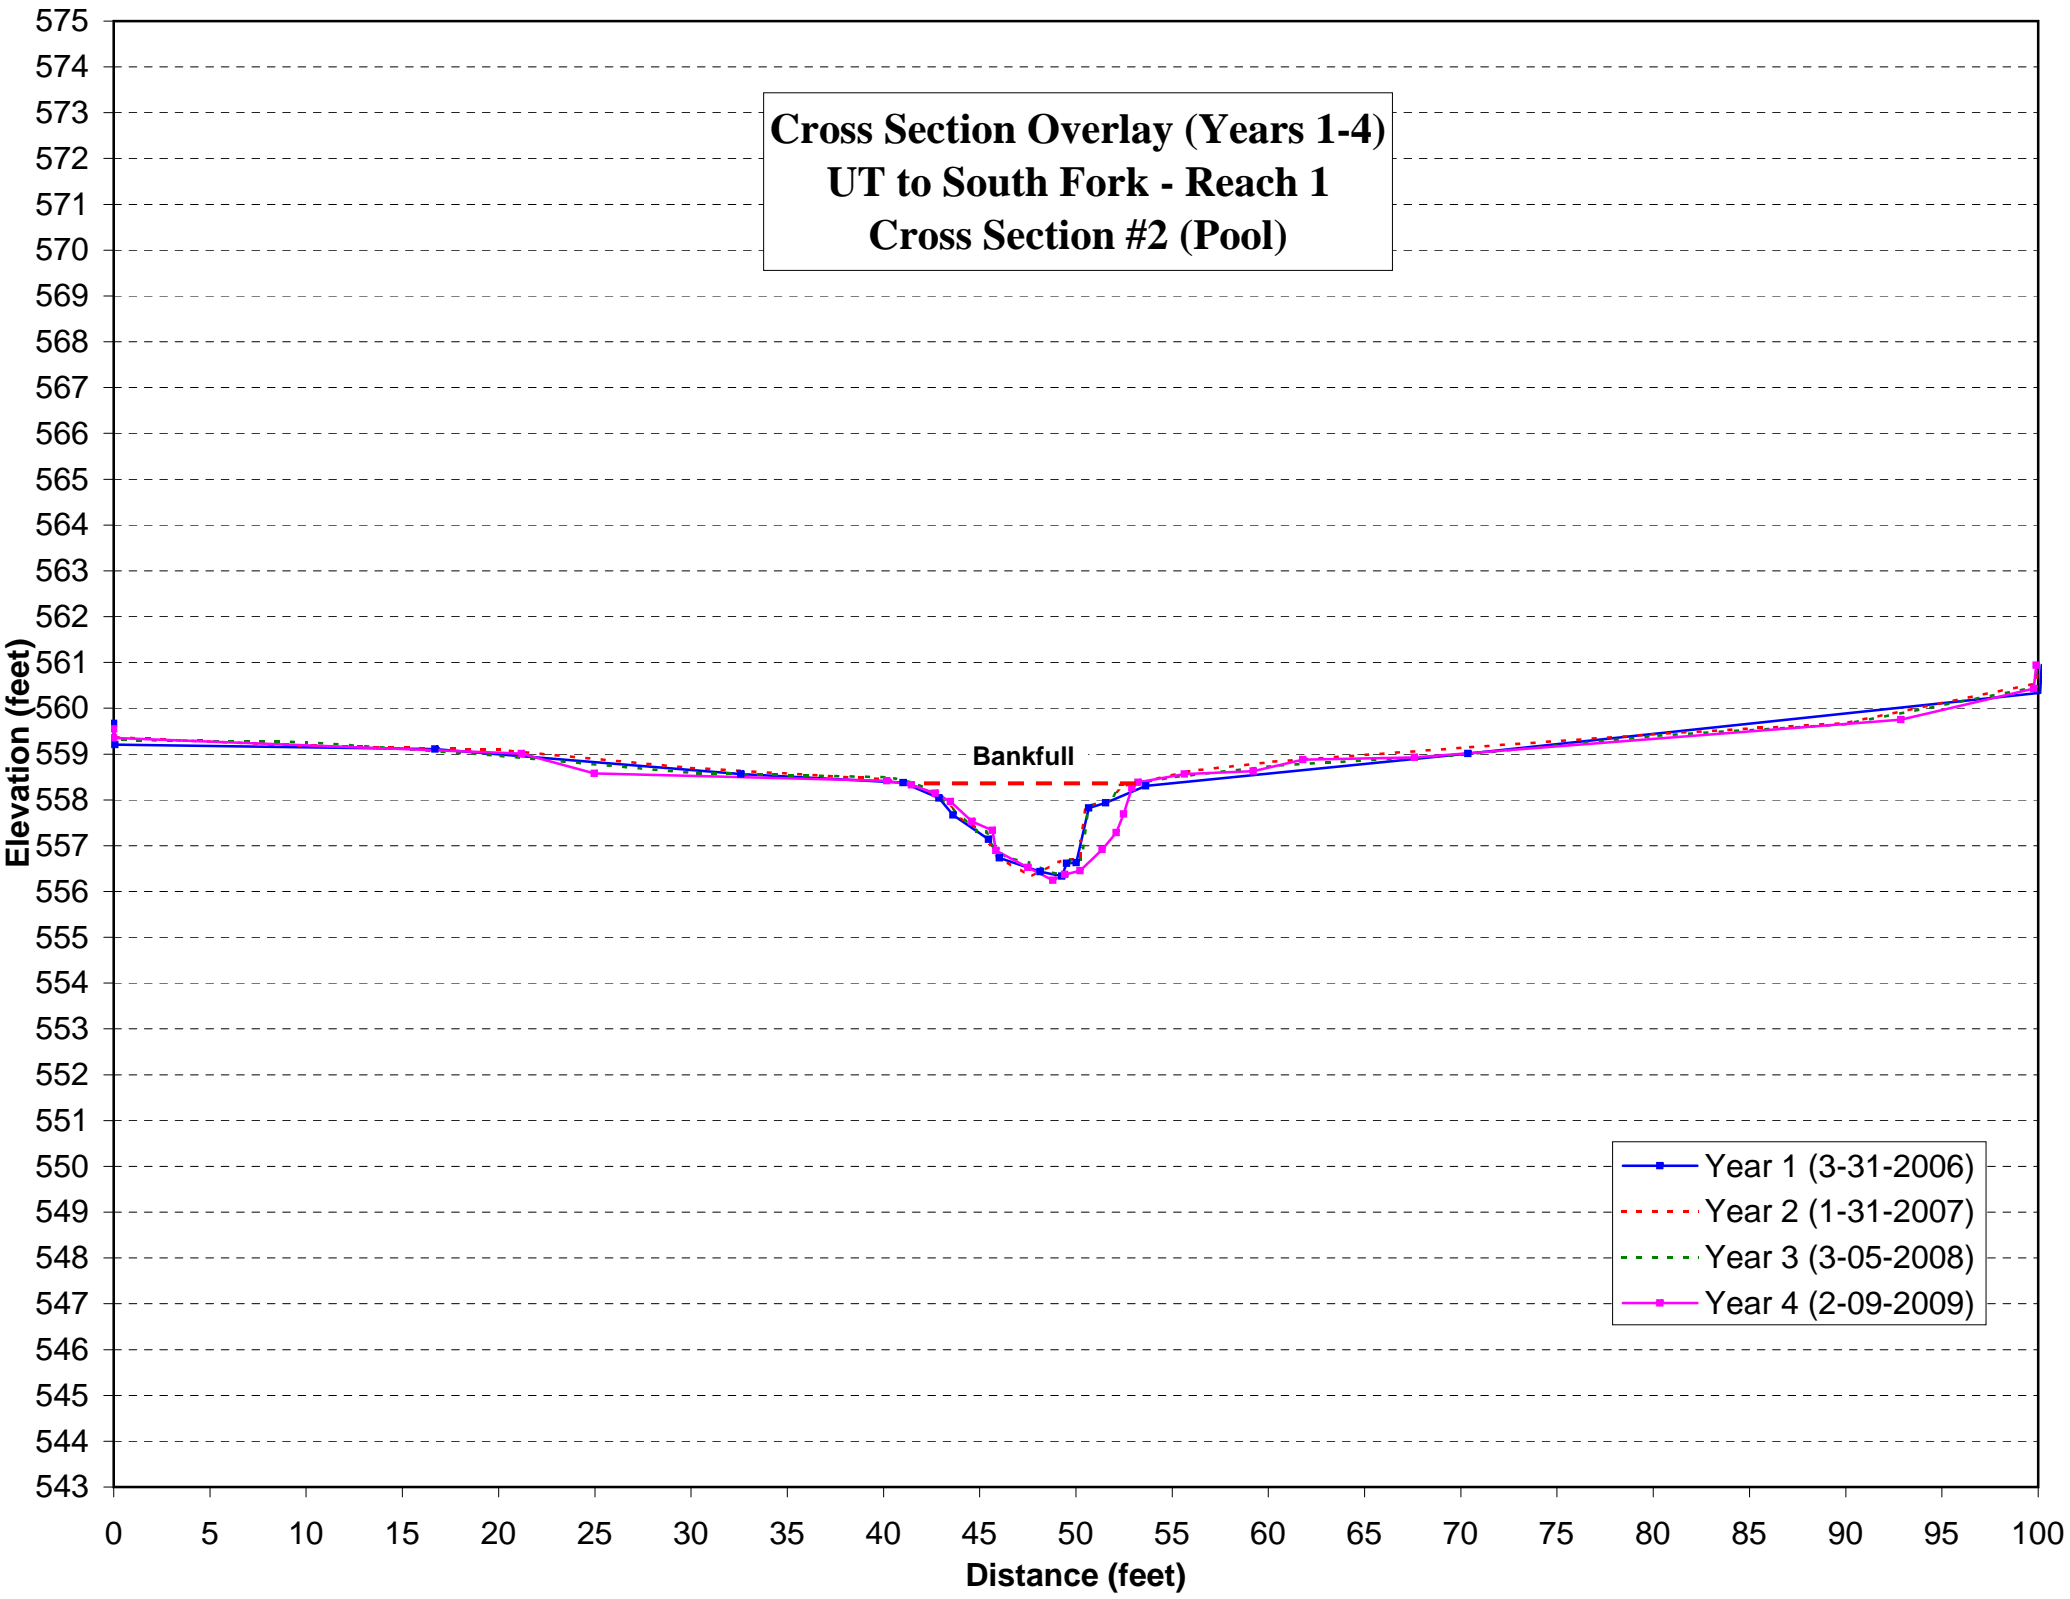
Cross Section Overlay (Years 1-4)
UT to South Fork - Reach 1
Cross Section #2 (Pool)

- Year 1 (3-31-2006)
- Year 2 (1-31-2007)
- Year 3 (3-05-2008)
- Year 4 (2-09-2009)

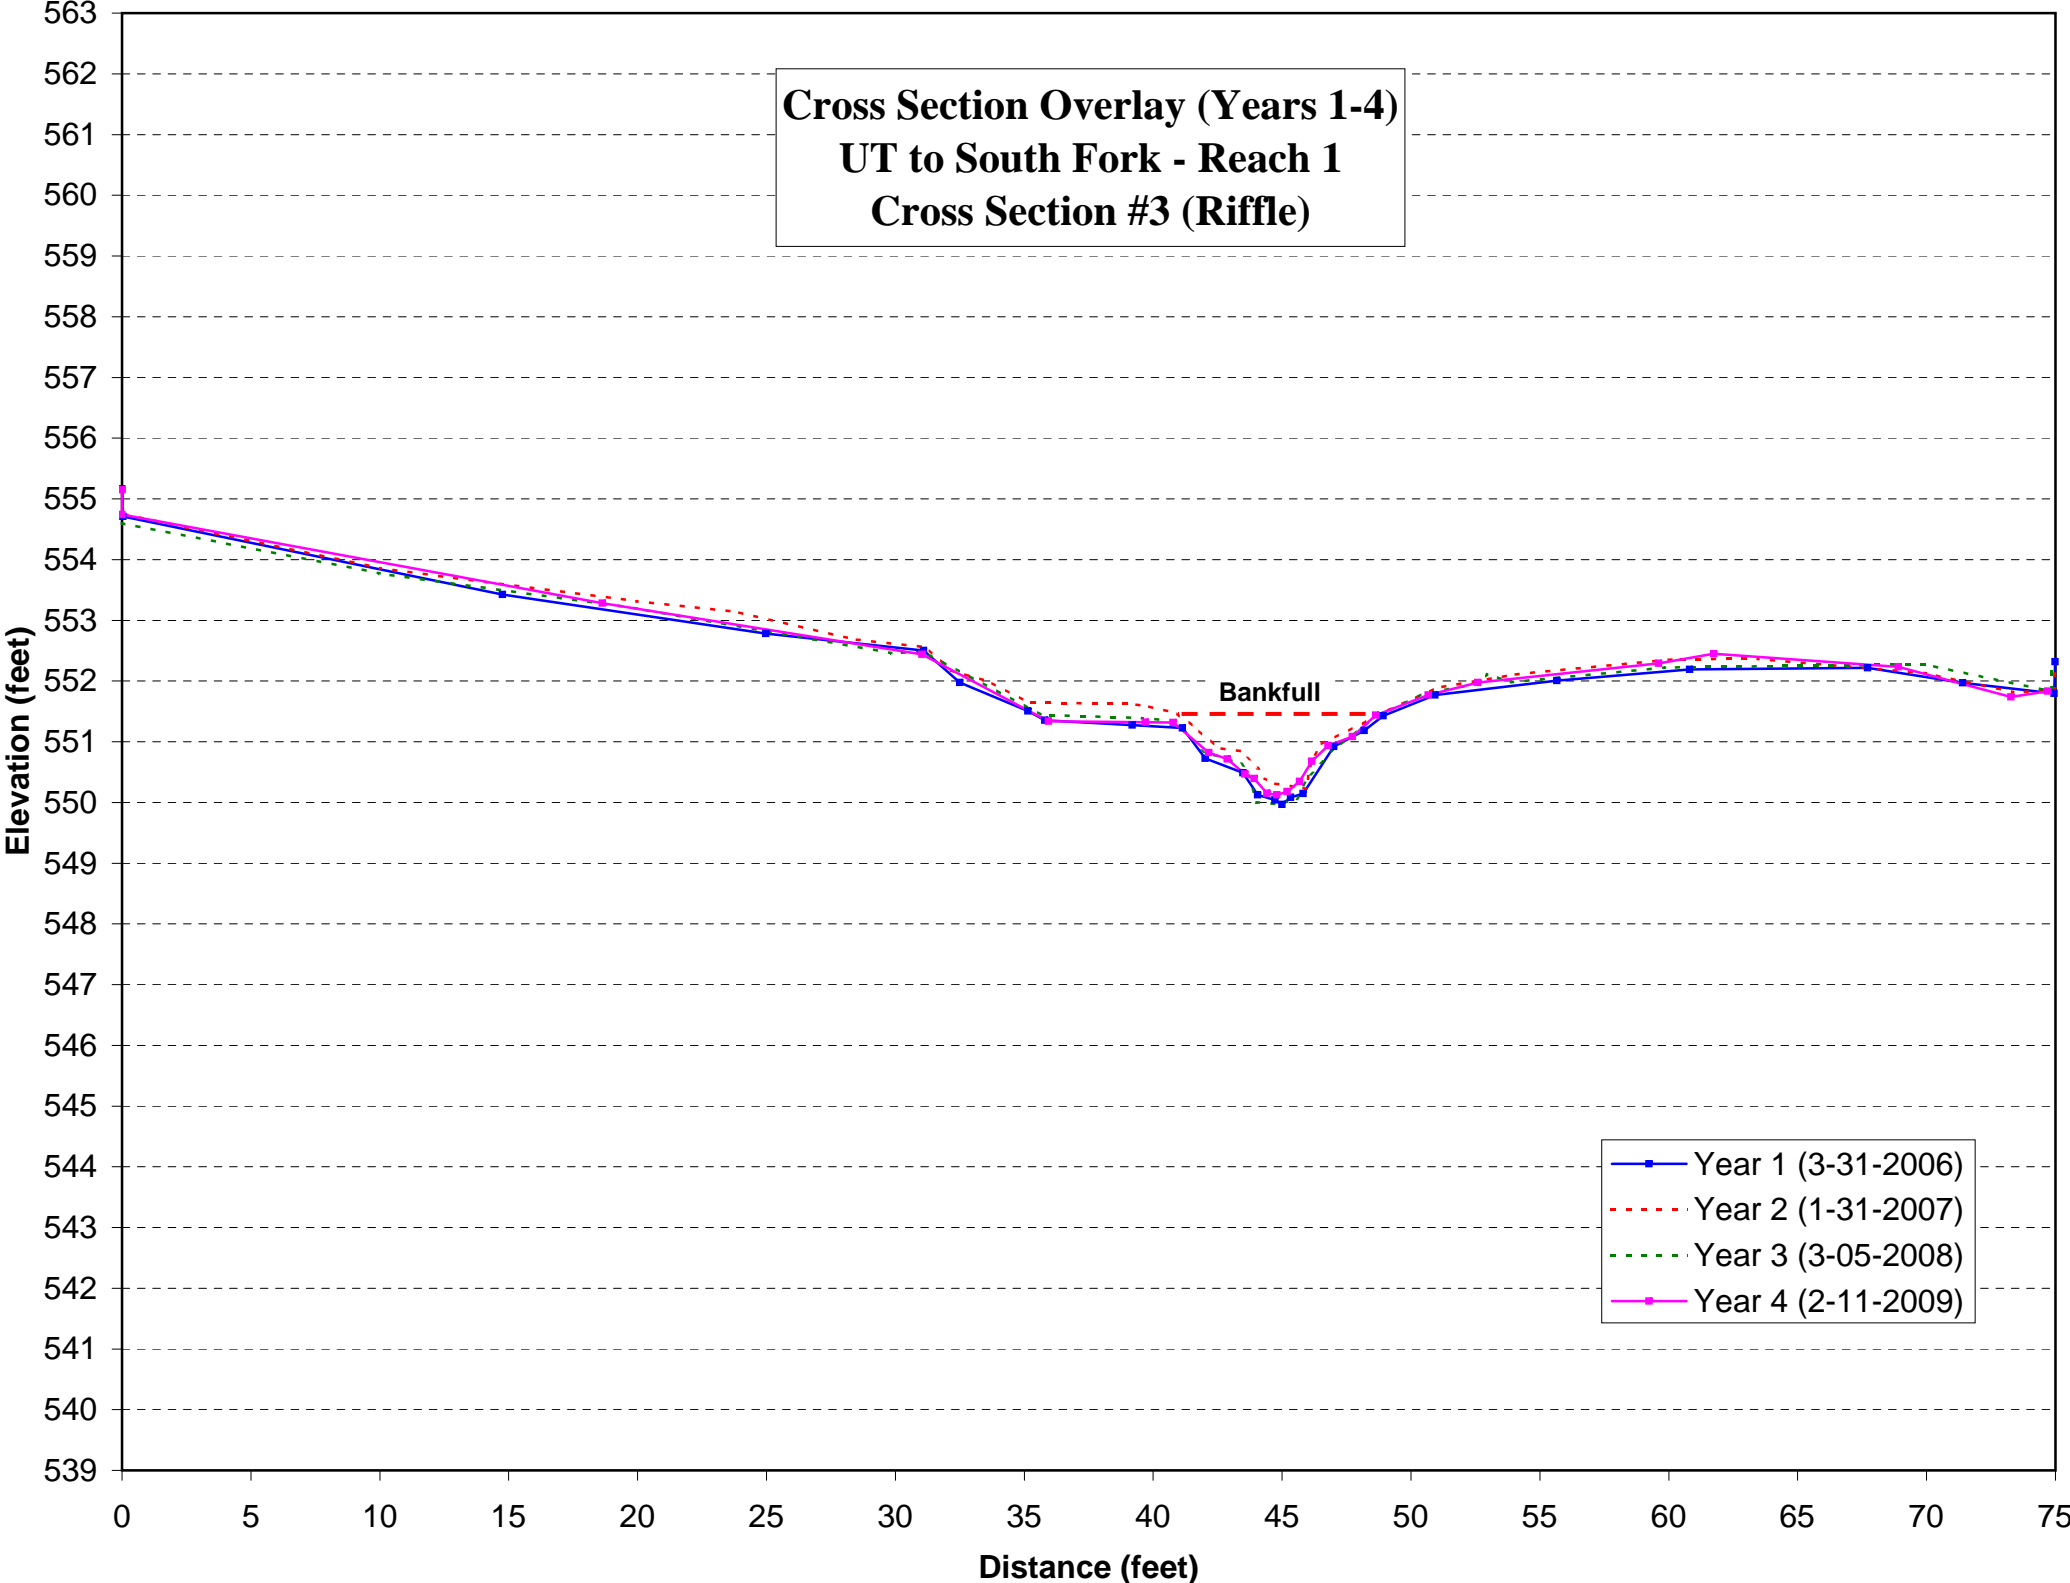
Cross Section Overlay (Years 1-4)
UT to South Fork - Reach 1
Cross Section #3 (Riffle)

- Year 1 (3-31-2006)
- Year 2 (1-31-2007)
- Year 3 (3-05-2008)
- Year 4 (2-11-2009)

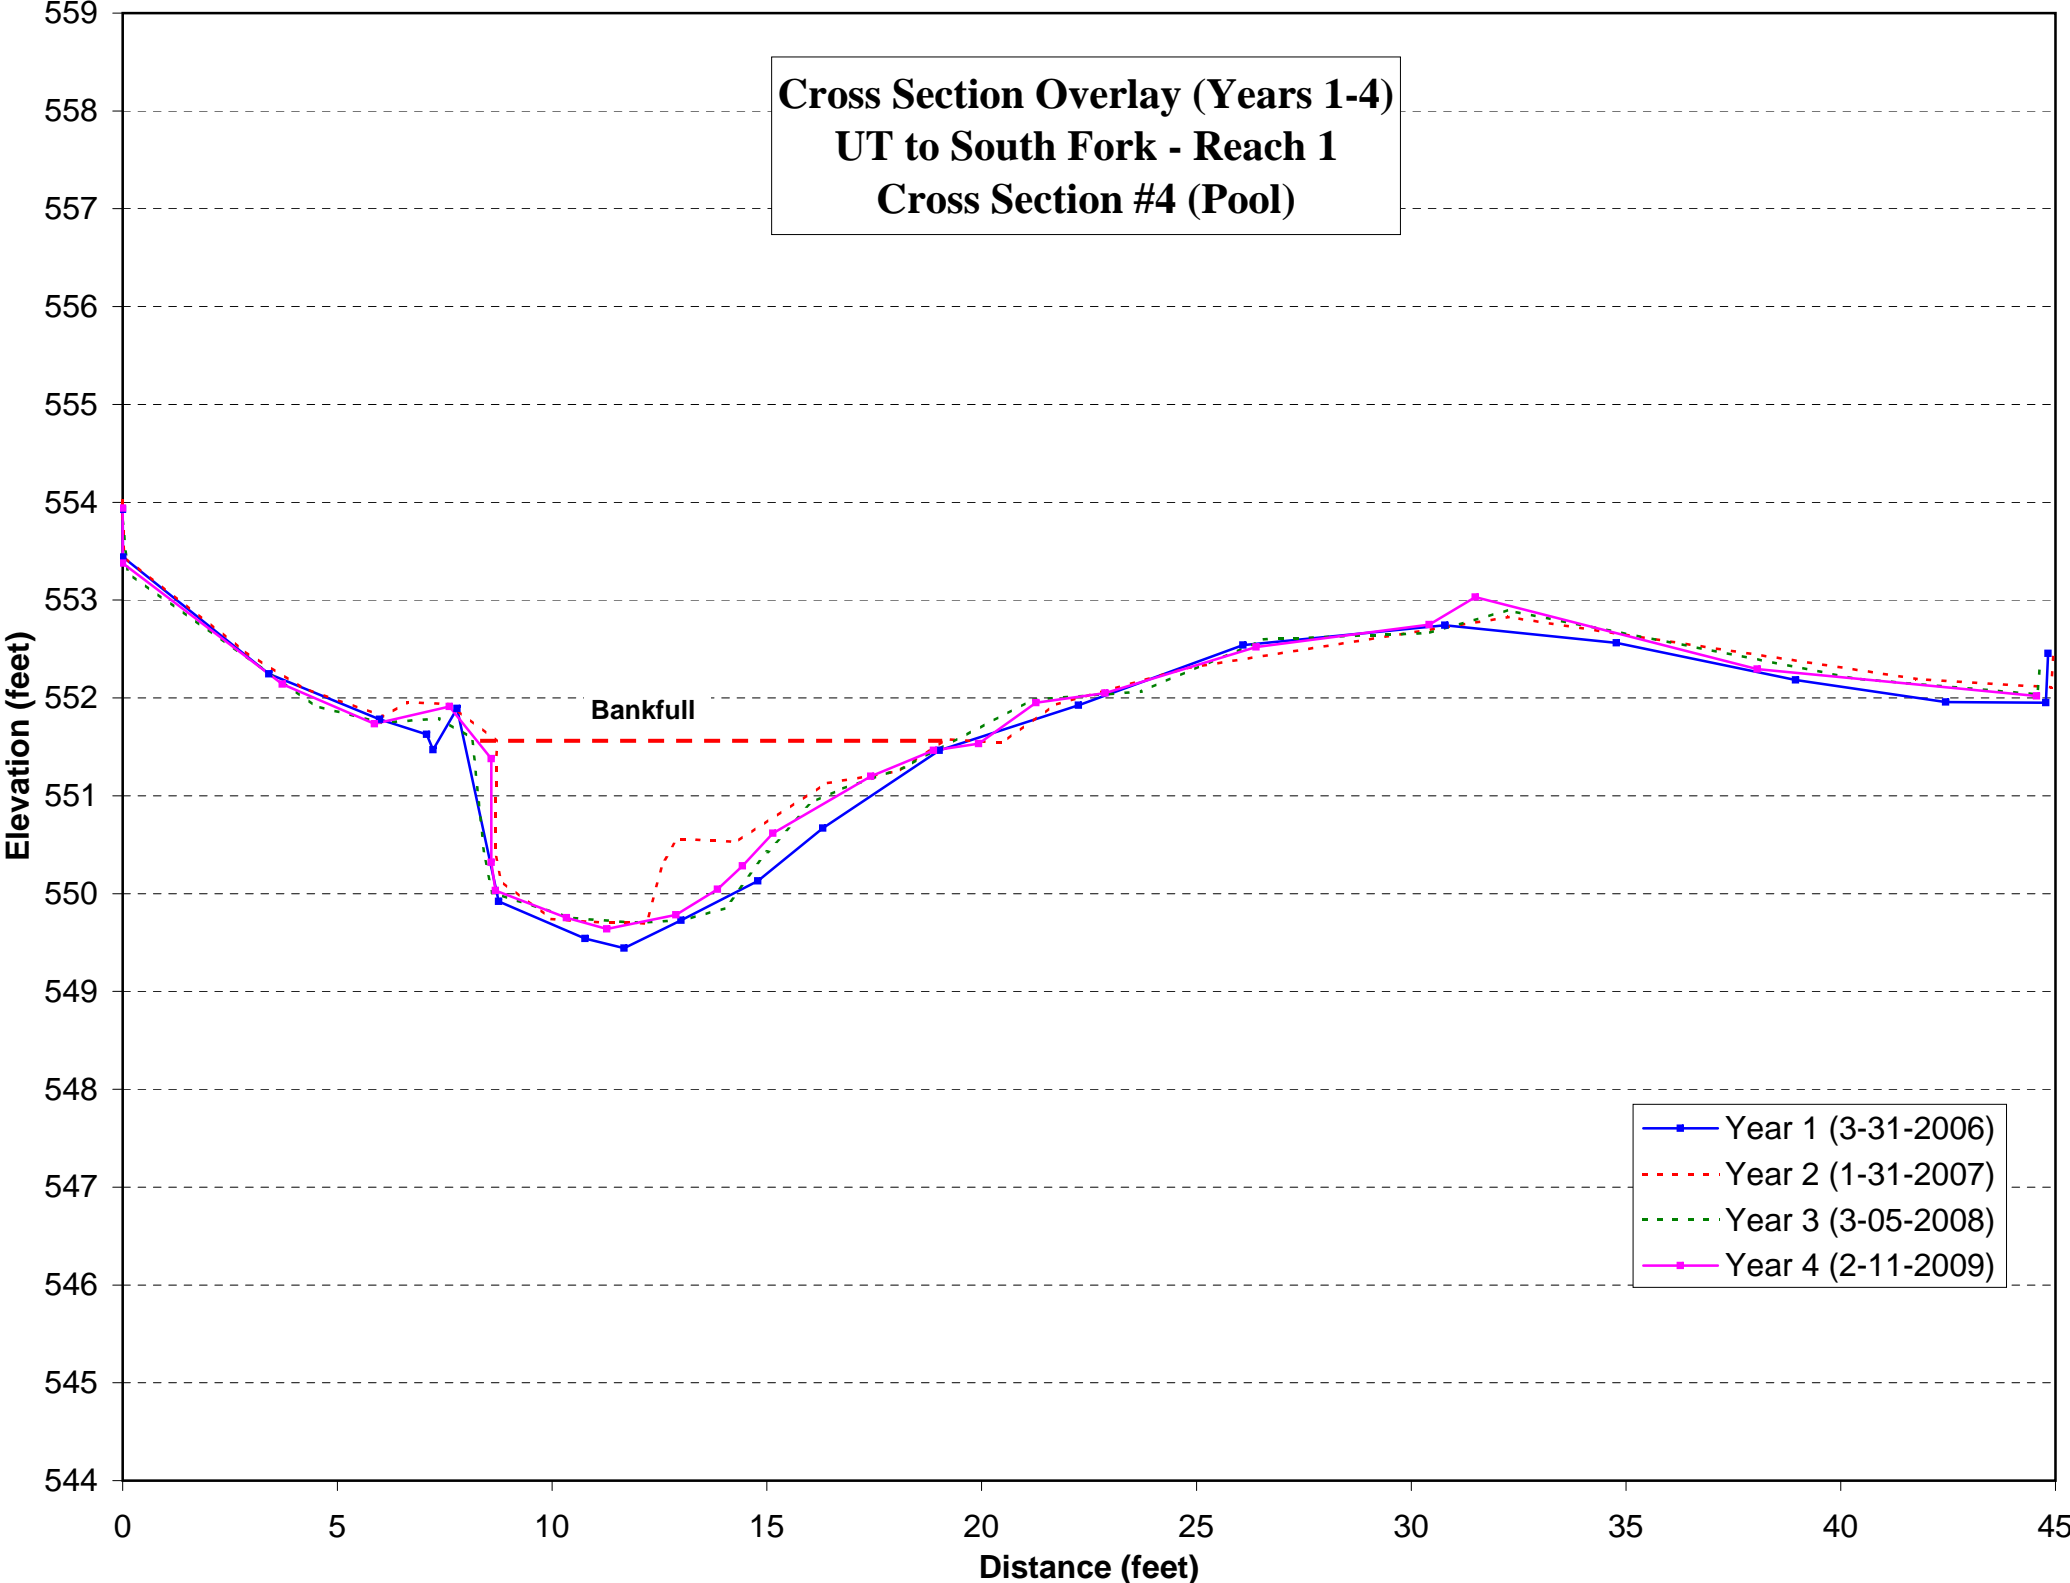
Cross Section Overlay (Years 1-4)
UT to South Fork - Reach 1
Cross Section #4 (Pool)

- Year 1 (3-31-2006)
- Year 2 (1-31-2007)
- Year 3 (3-05-2008)
- Year 4 (2-11-2009)

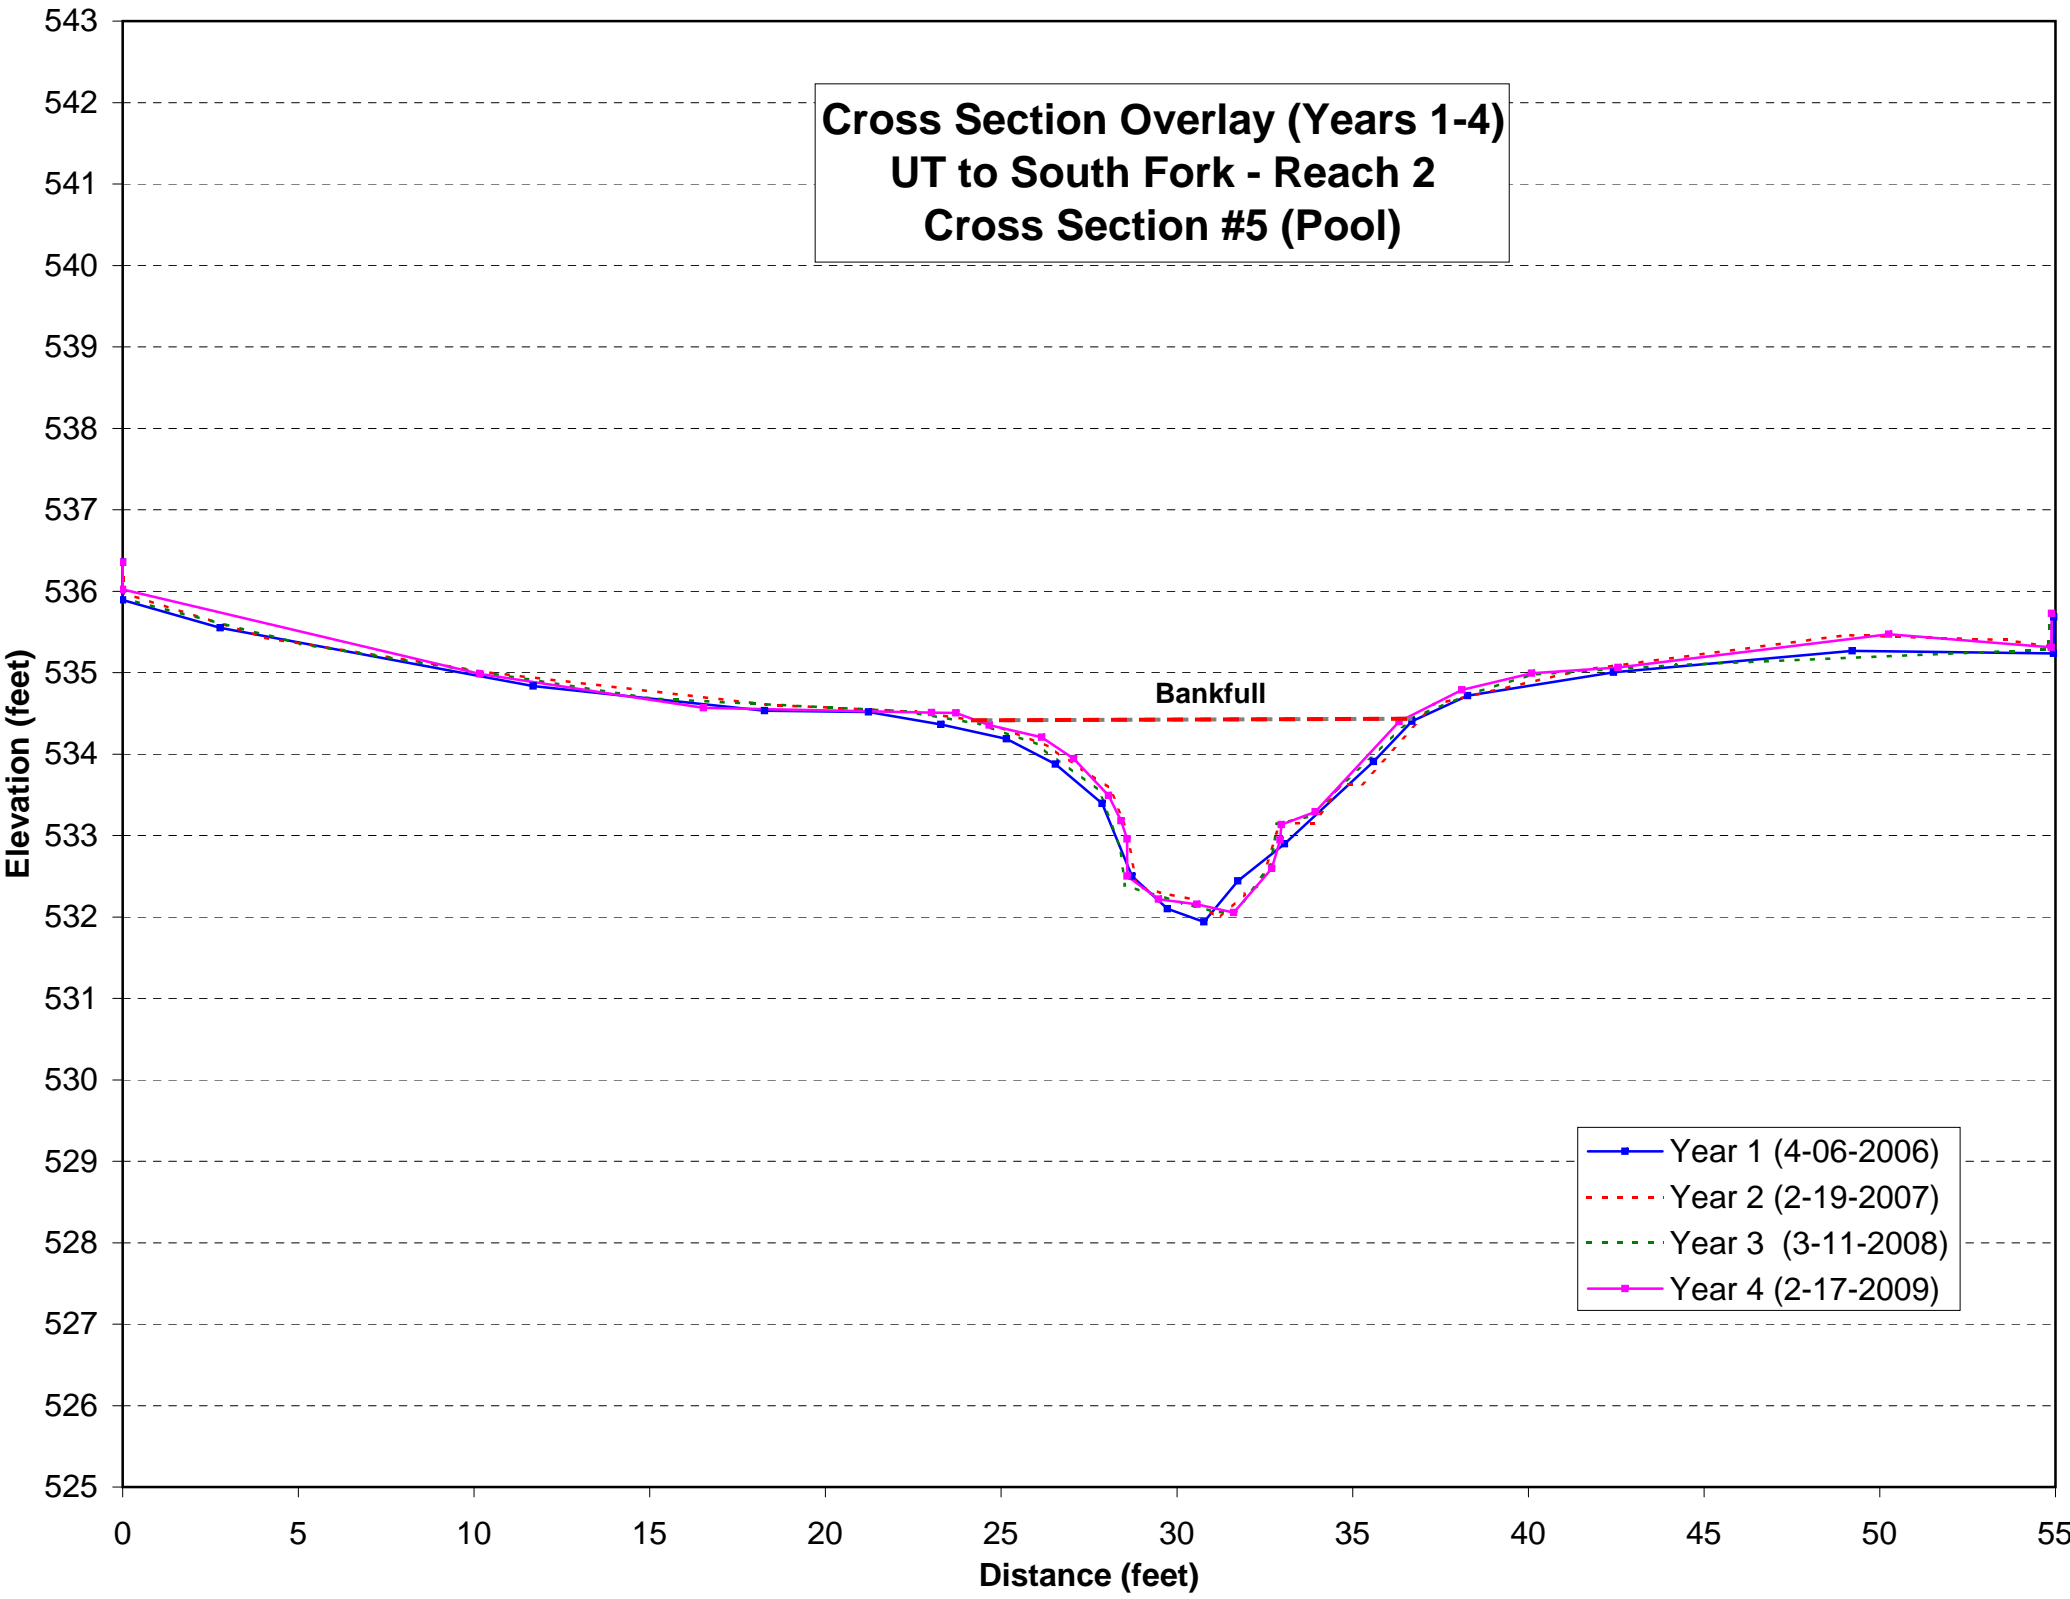
Cross Section Overlay (Years 1-4)
UT to South Fork - Reach 2
Cross Section #5 (Pool)

- Year 1 (4-06-2006)
- Year 2 (2-19-2007)
- Year 3 (3-11-2008)
- Year 4 (2-17-2009)

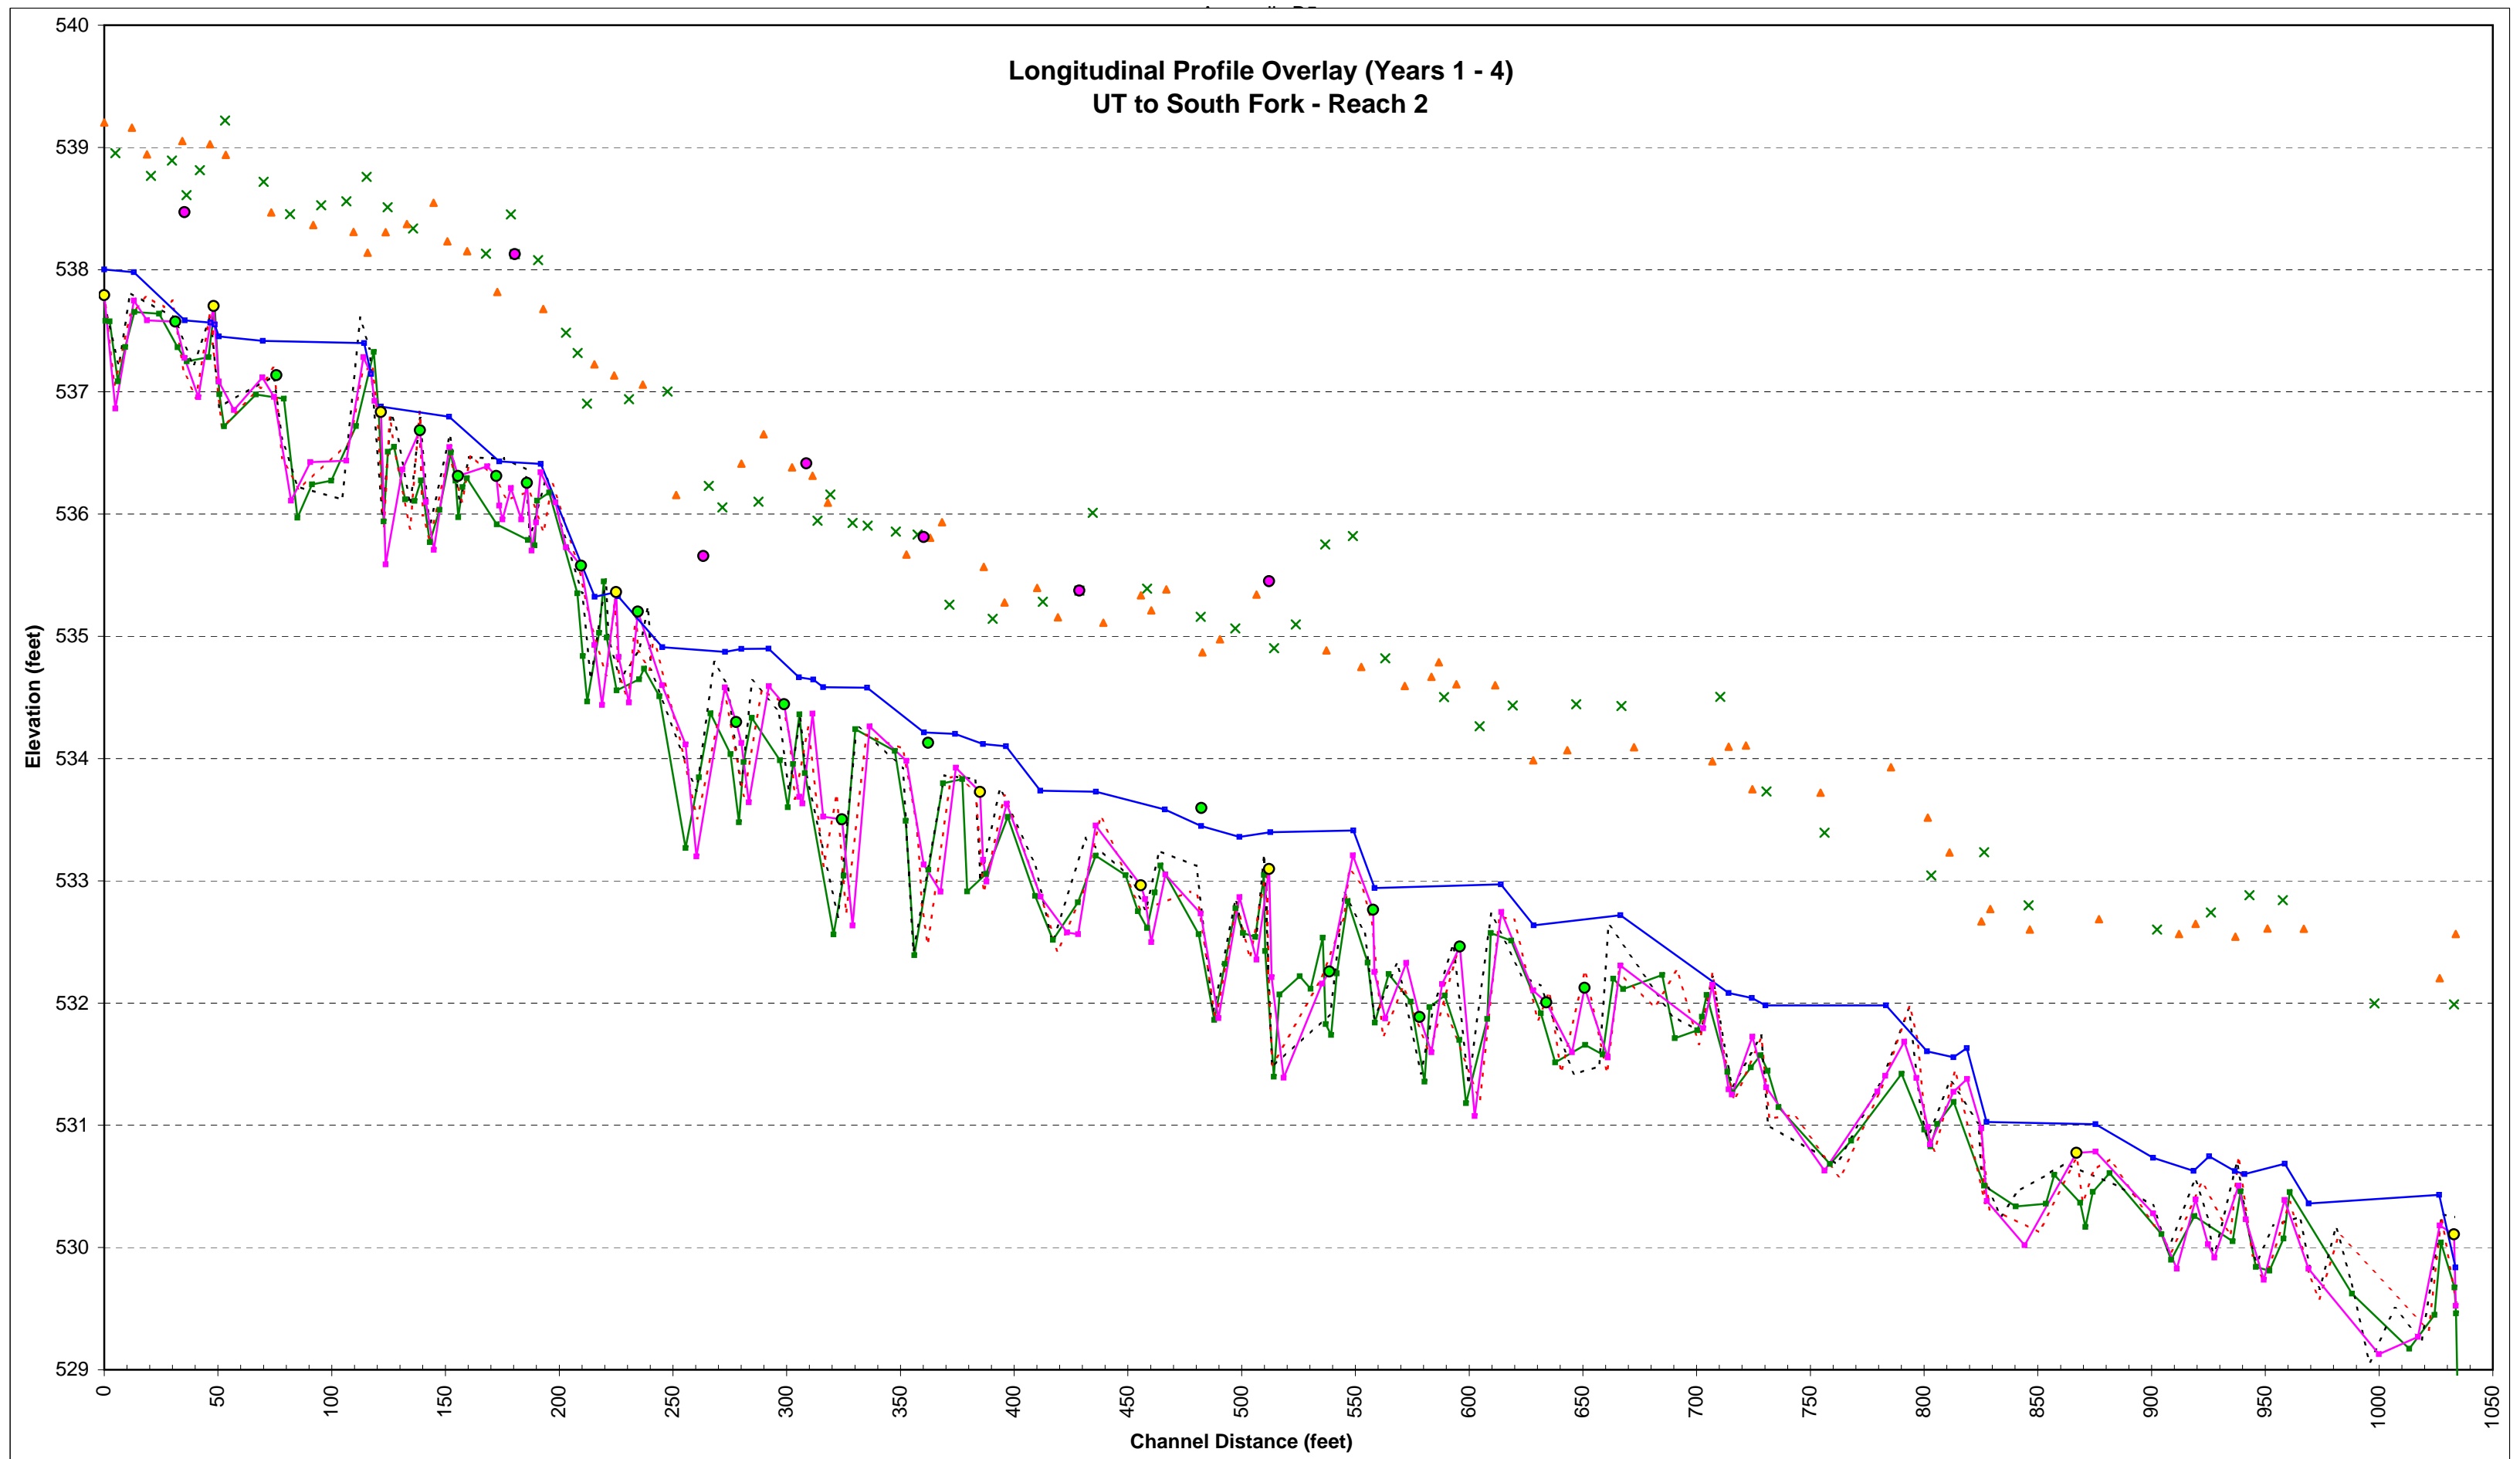
| Thalweg Year 1 (4-06-2006) | Thalweg Year 2 (2-19-2007) | Thalweg Year 3 (3-11-2008) | Thalweg Year 4 (2-17-2009) |

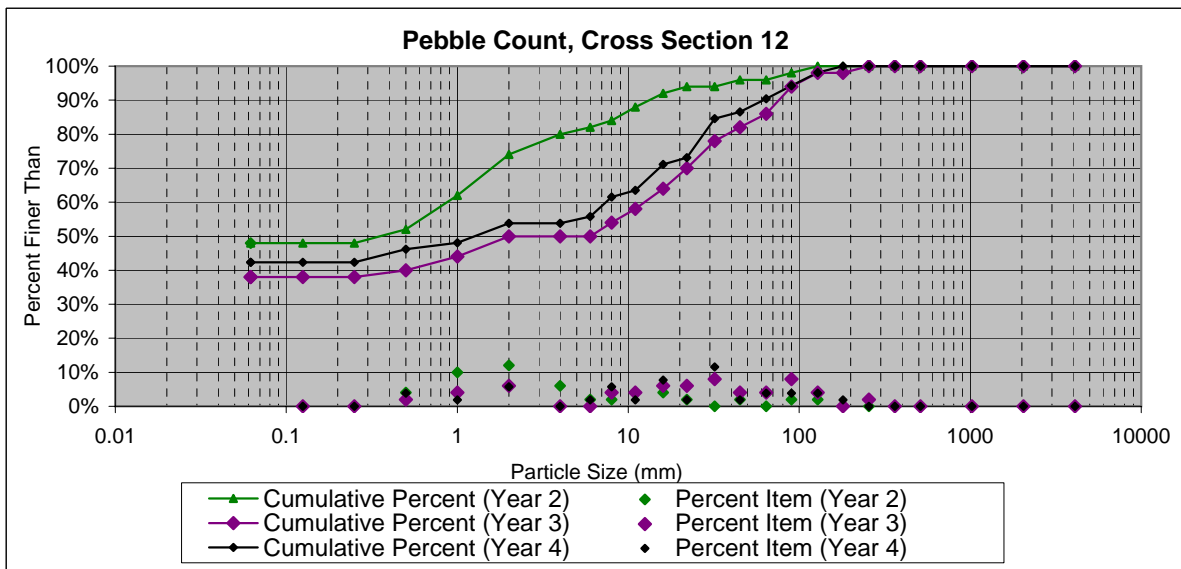
PEBBLE COUNT			SSEPI ENGINEERING GROUP				
Site: UT South Fork							
Party: IPJ & PDB							
Date: 10/08/09							
Inches	Particle	Millimeters					
			CS 12	TOT#	ITEM %	% CUM	
	Silt/Clay	< 0.062	S/C	22	22	42%	42%
	Very Fine	.062-.125	S A N D		0	0%	42%
	Fine	.125-.25			0	0%	42%
	Medium	.25-.50		2	2	4%	46%
	Coarse	.50-1.0		1	1	2%	48%
.04-.08	Very Coarse	1.0-2		3	3	6%	54%
.08-.16	Very Fine	2.0-4.0	G R A V E L		0	0%	54%
.16-.22	Fine	4-5.7		1	1	2%	56%
.22-.31	Fine	5.7-8		3	3	6%	62%
.31-.44	Medium	8-11.3		1	1	2%	63%
.44-.63	Medium	11.3-16		4	4	8%	71%
.63-.89	Coarse	16-22.6		1	1	2%	73%
.89-1.26	Coarse	22.6-32		6	6	12%	85%

1.26-1.77	Very Coarse	32-45		1	1	2%	87%
1.77-2.5	Very Coarse	45-64		2	2	4%	90%
2.5-3.5	Small	64-90	C O B B L E	2	2	4%	94%
3.5-5.0	Small	90-128		2	2	4%	98%

5.0-7.1	Large	128-180		1	1	2%	100%
7.1-10.1	Large	180-256			0	0%	100%
10.1-14.3	Small	256-362	B O U L D E R		0	0%	100%
14.3-20	Small	362-512			0	0%	100%
20-40	Medium	512-1024			0	0%	100%
40-80	Large	1024-2048			0	0%	100%
	Bedrock		BDRK		0	0%	100%
TOTALS →					52	100%	100%
