**UT TO SOUTH FORK
FINAL MONITORING REPORT
YEAR 5 OF 5
2010**

EEP Project #435
Alamance County, North Carolina

Project: Ut to South Fork (EEP #435) Year 5 (2010) Monitoring, Alamance County, North Carolina
June 2011

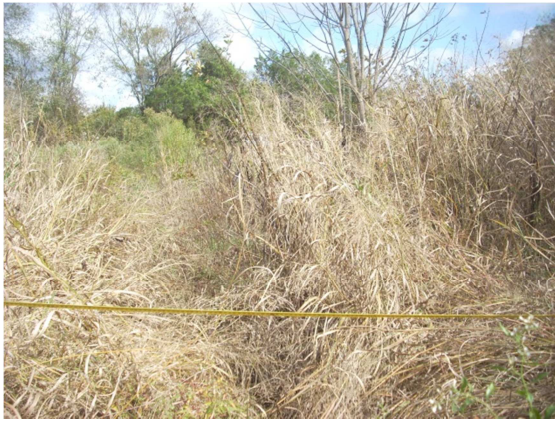
Cross-Section 1: View Upstream (10-27-2010)

Four permanent cross sections (two riffles and two pools) were surveyed at Monitoring Reach 1. Two permanent cross sections (one riffle and one pool) were surveyed at Monitoring Reach 2, and six permanent cross sections (3 riffles and 3 pools) were surveyed at Monitoring Reach 3. The beginning and end of each permanent cross section were originally marked with a wooden stake and metal conduit. Cross sections were installed perpendicular to the stream flow. Each survey noted all changes in slope, tops of both banks, left and right bankfull, edges of water, thalweg, and water surface. The cross sections were then plotted and overlain on the cross section surveys from all previous monitoring years. All dimension measurements (i.e. bankfull width, floodprone width, bankfull mean depth, cross sectional area, width-to-depth ratio, entrenchment ratio, bank height ratio, wetted perimeter, and hydraulic radius) were extracted from these plots and compared to data from all previous monitoring years.

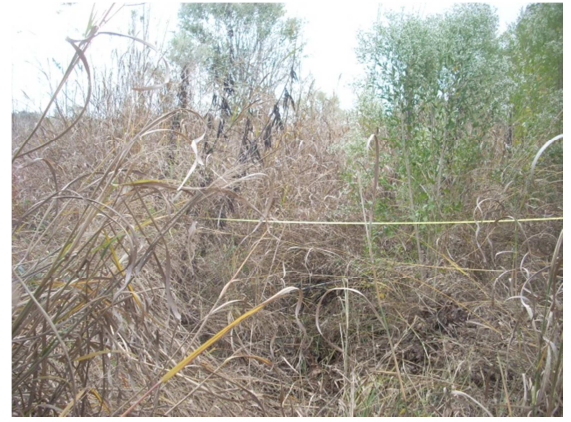
Cross-Section 1: View Downstream (10-27-2010)

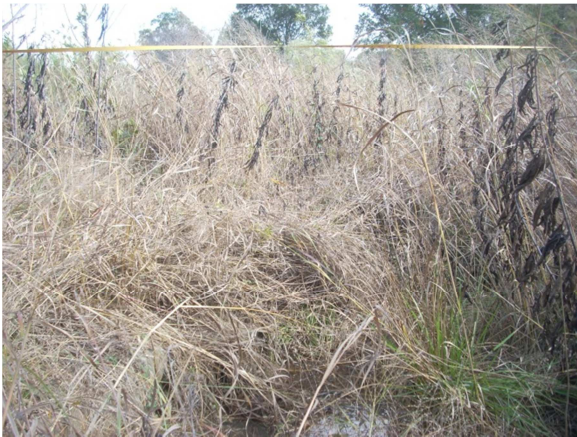
Cross-Section 2: View Upstream (10-27-2010)

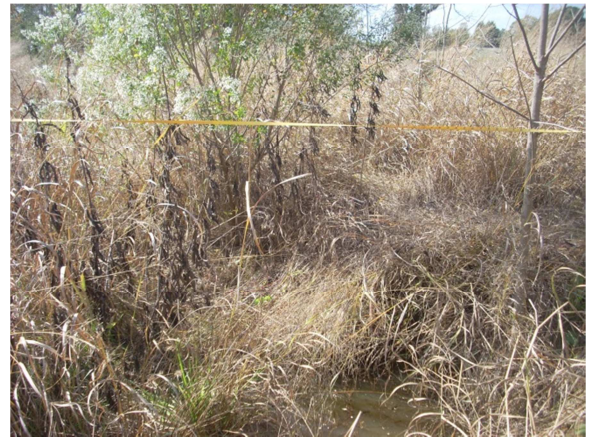
Cross-Section 2: View Downstream (10-27-2010)

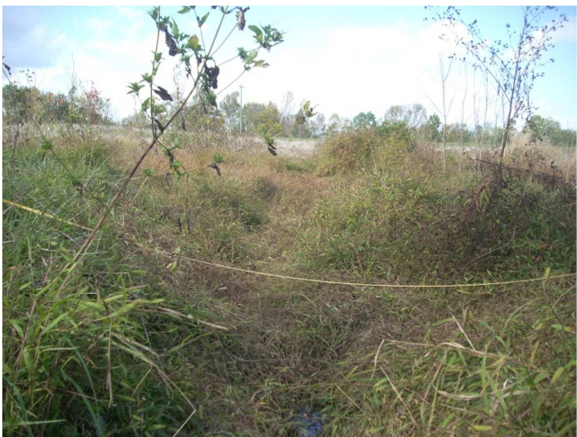
Cross-Section 3: View Upstream (10-27-2010)

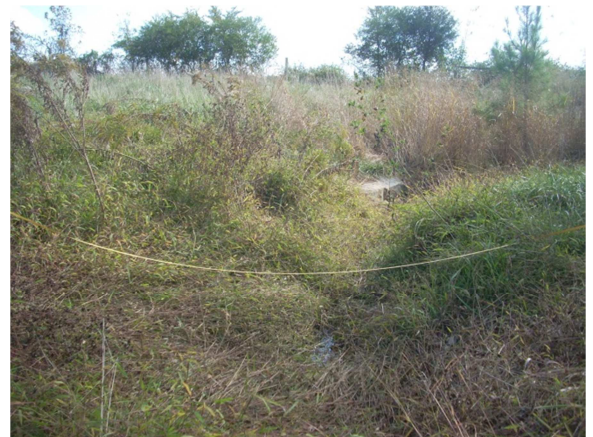
Cross-Section 3: View Downstream (10-27-2010)

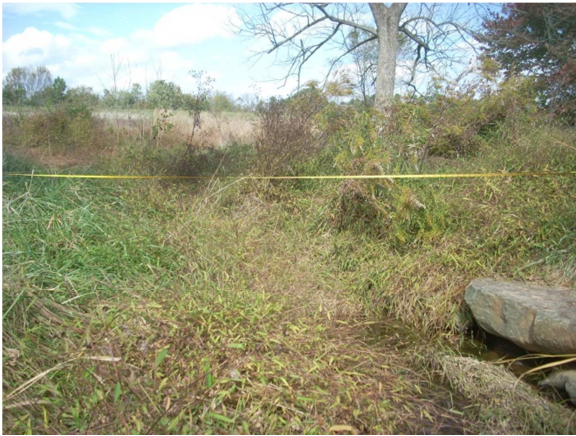
Cross-Section 4: View Upstream (10-27-2010)

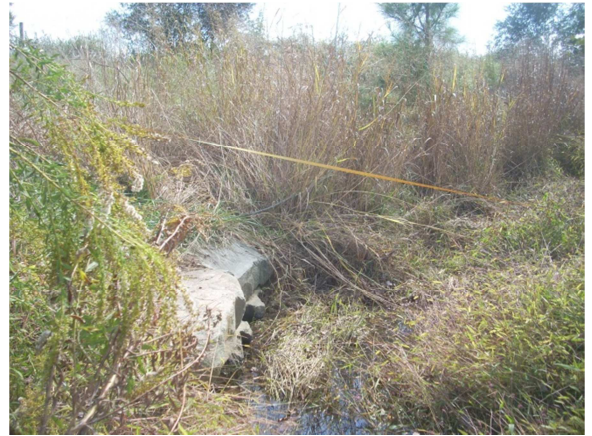
Cross-Section 4: View Downstream (10-27-2010)

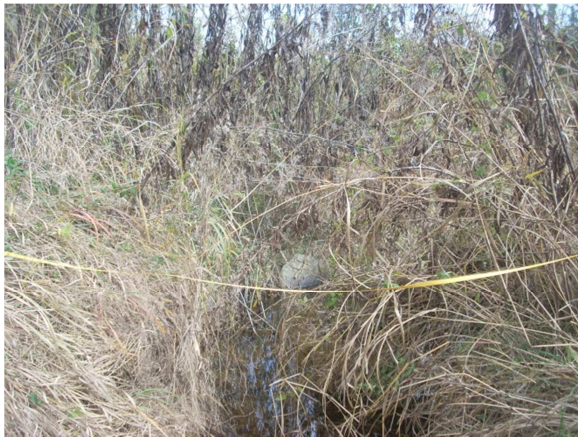
Cross-Section 5: View Upstream (10-28-2010)

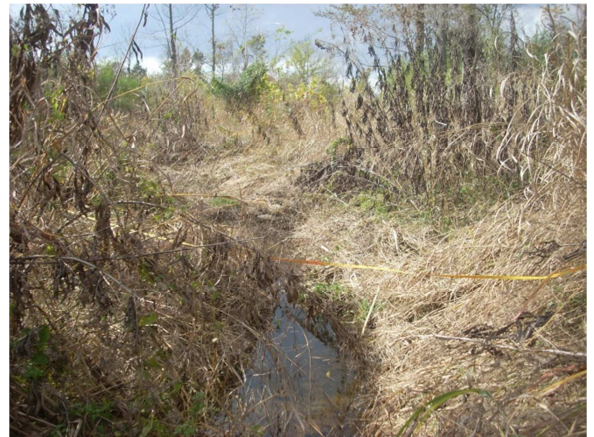
Cross-Section 5: View Downstream (10-28-2010)

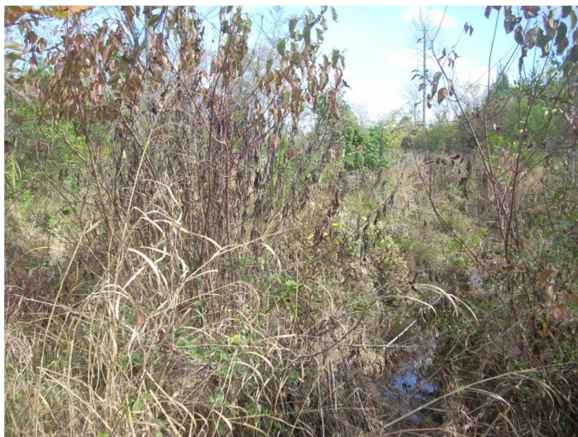
Cross-Section 6: View Upstream (10-28-2010)

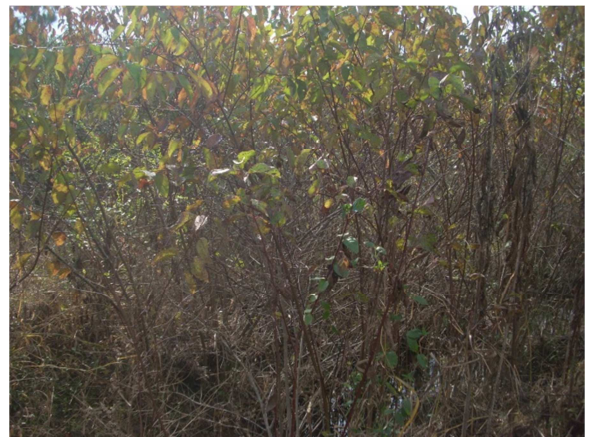
Cross-Section 6: View Downstream (10-28-2010)

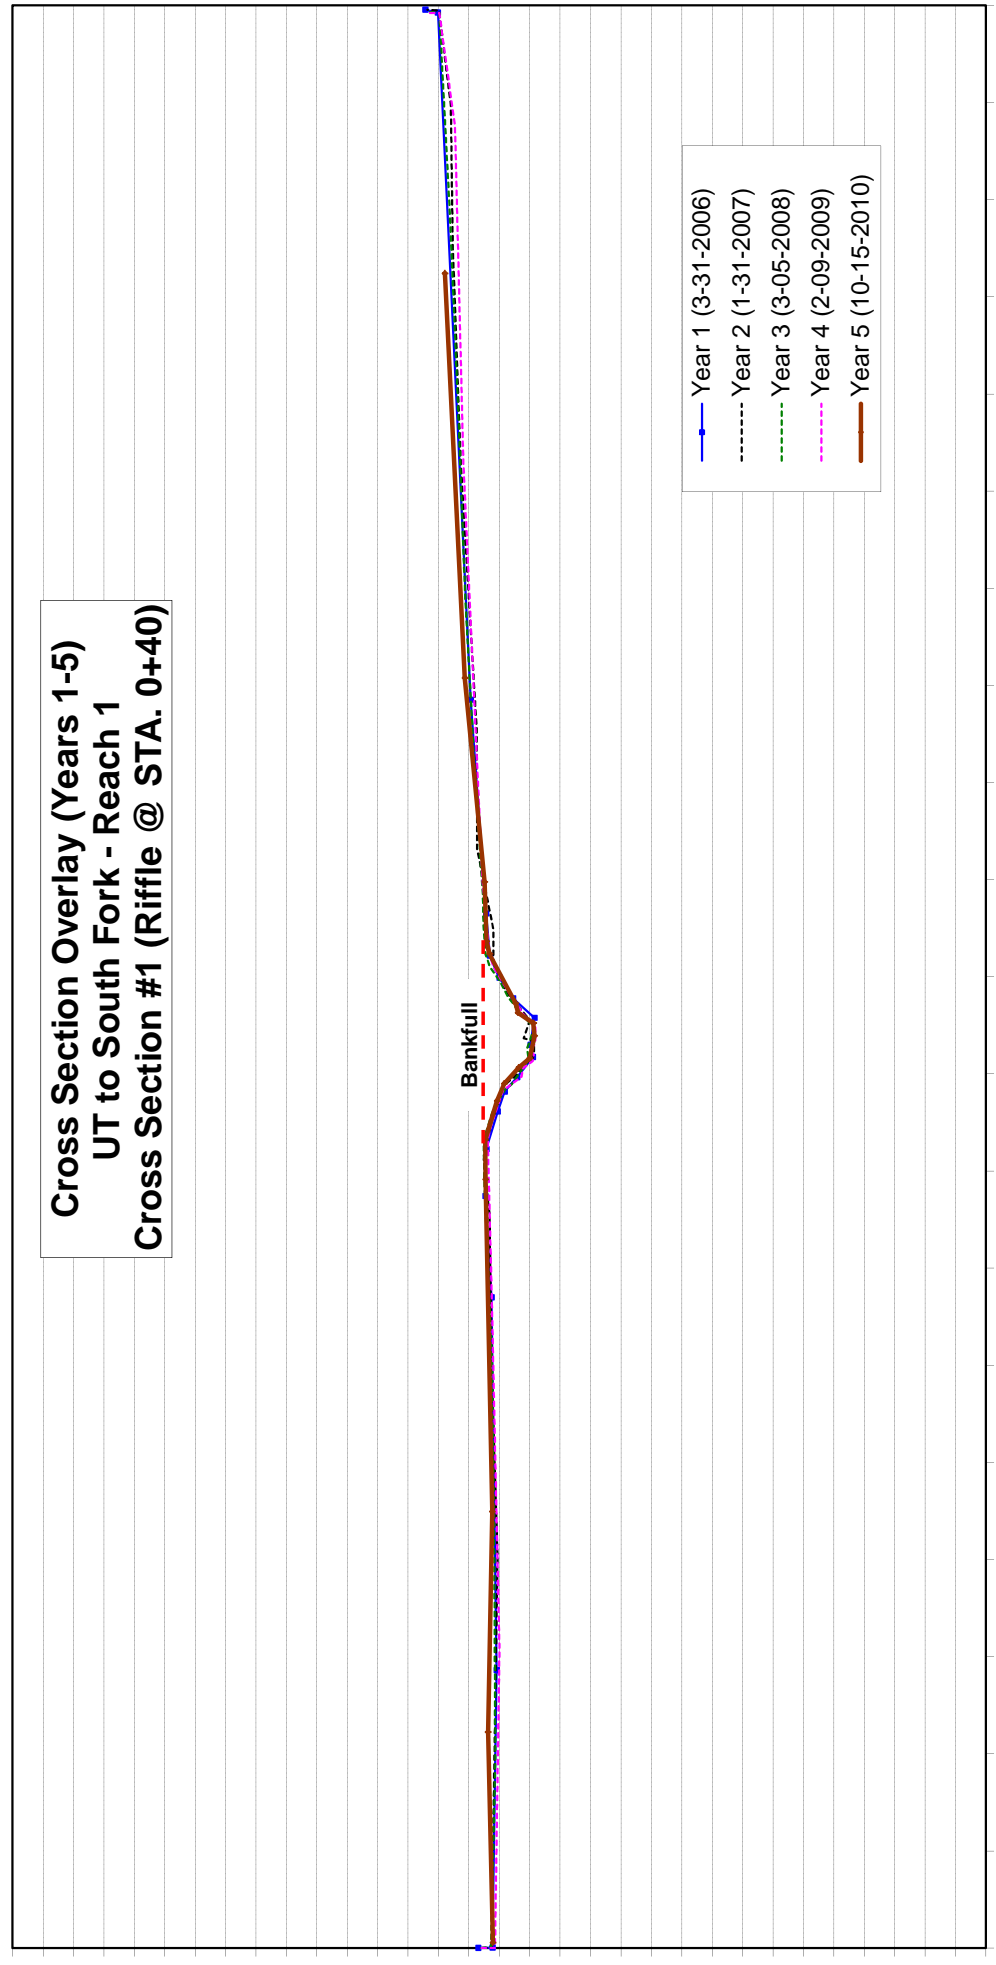
**Cross Section Overlay (Years 1-5)
UT to South Fork - Reach 1
Cross Section #1 (Riffle @ STA. 0+40)**

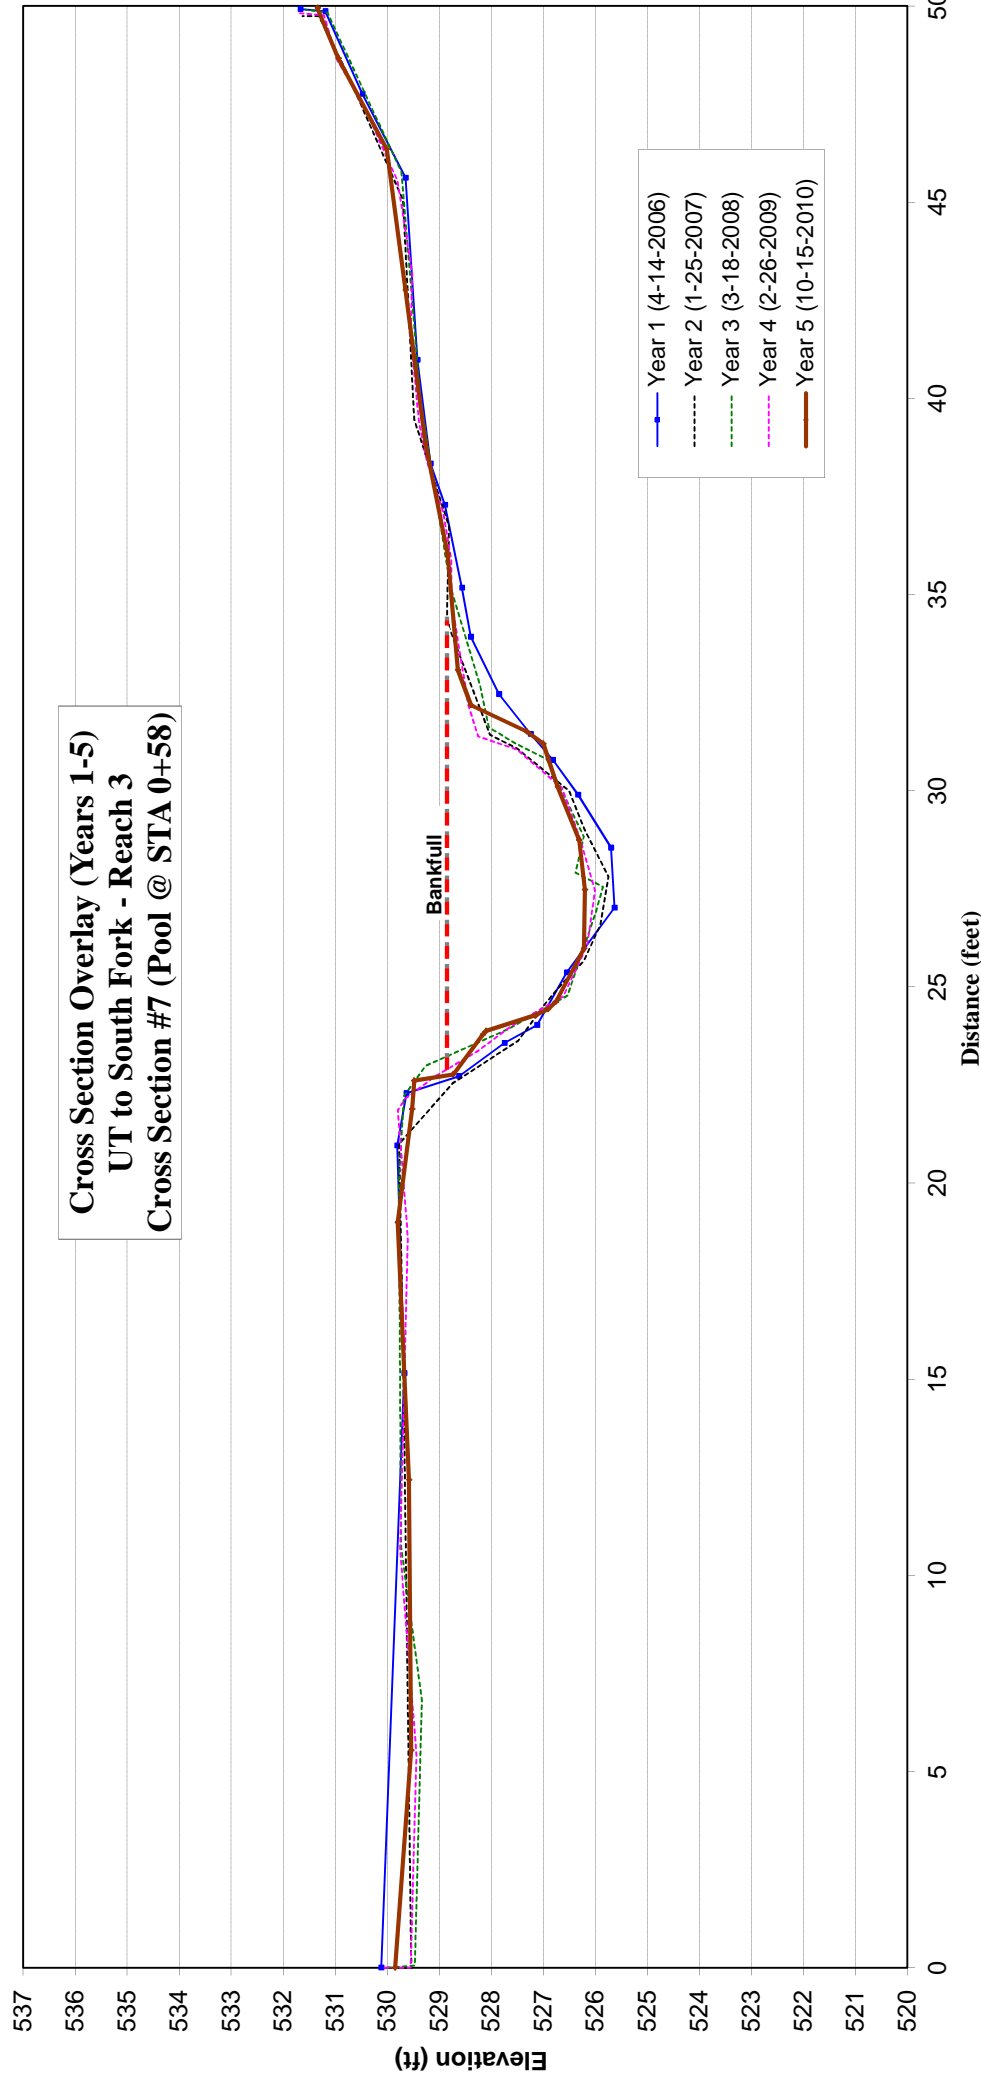
**Cross Section Overlay (Years 1-5)
UT to South Fork - Reach 3
Cross Section #7 (Pool @ STA 0+58)**

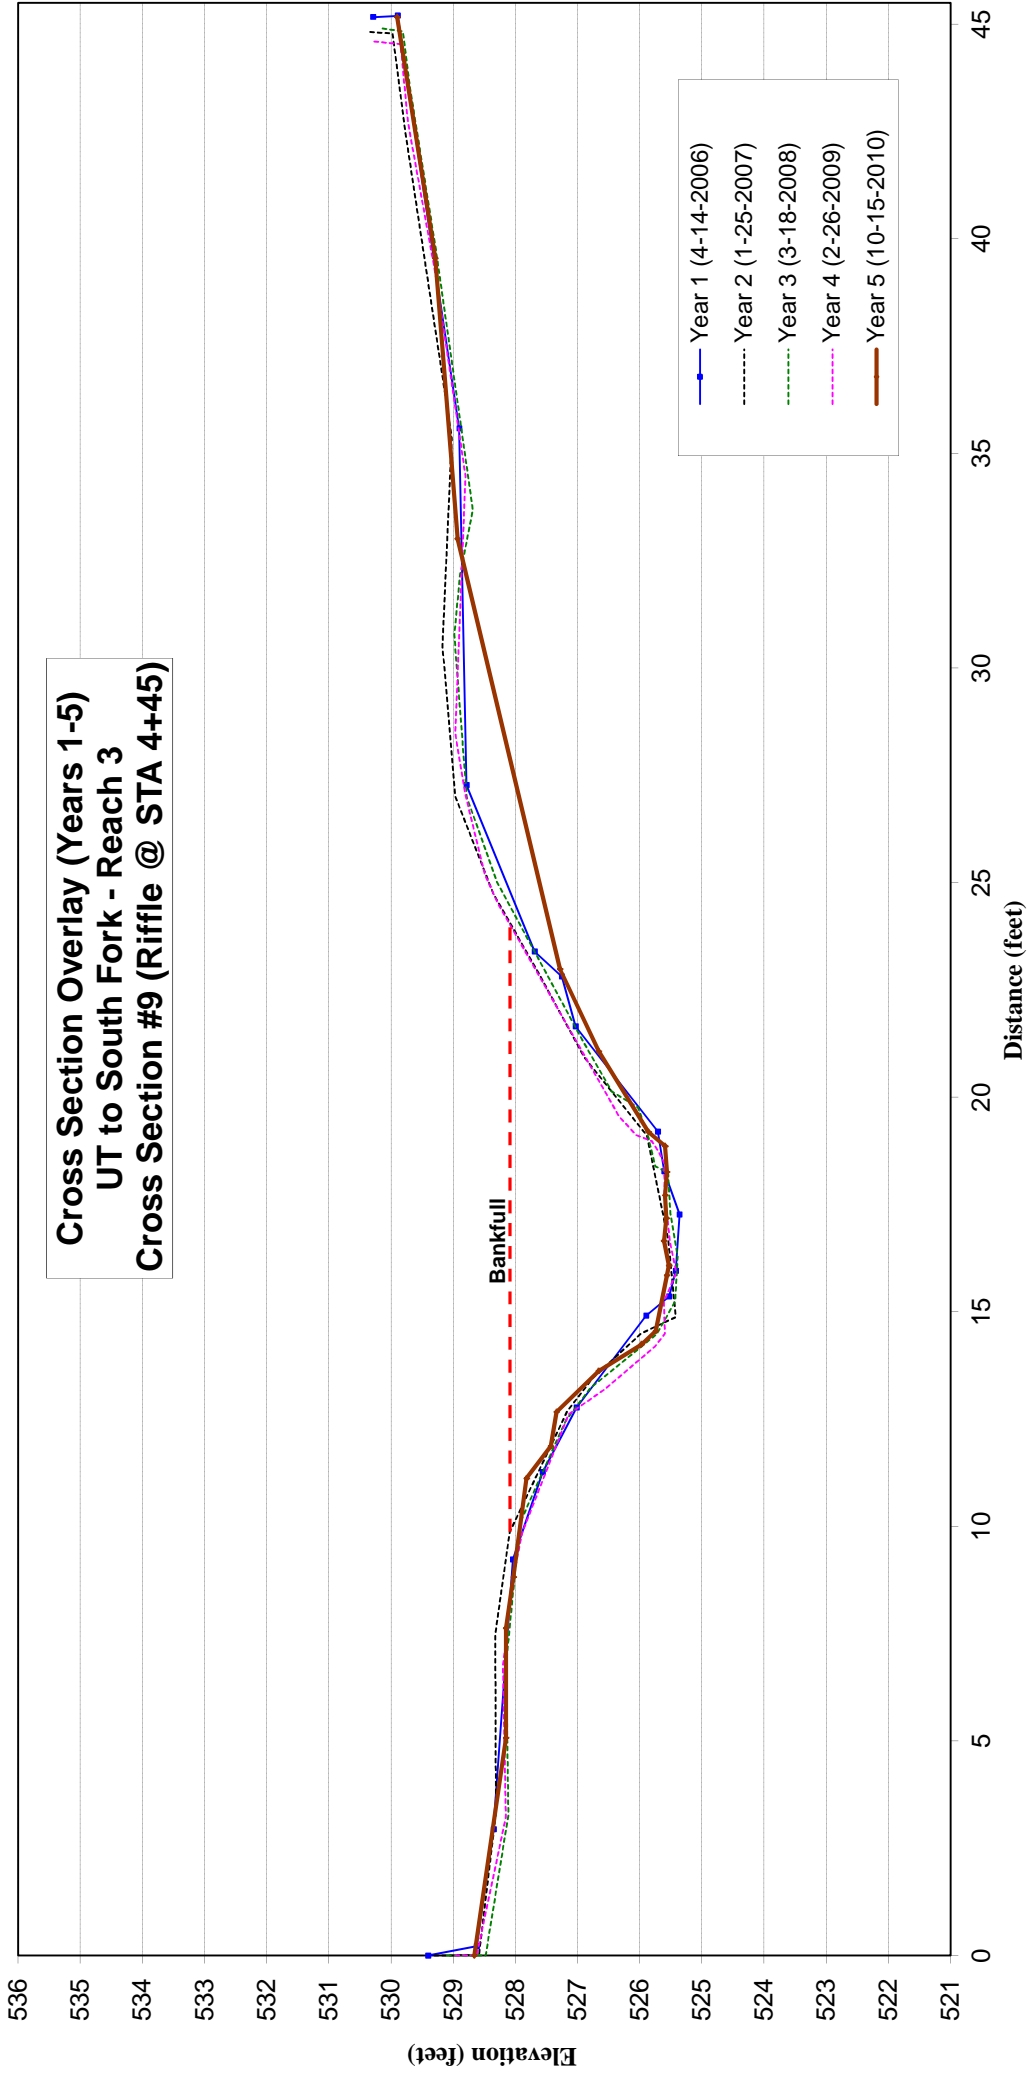
**Cross Section Overlay (Years 1-5)
UT to South Fork - Reach 3
Cross Section #9 (Riffle @ STA 4+45)**

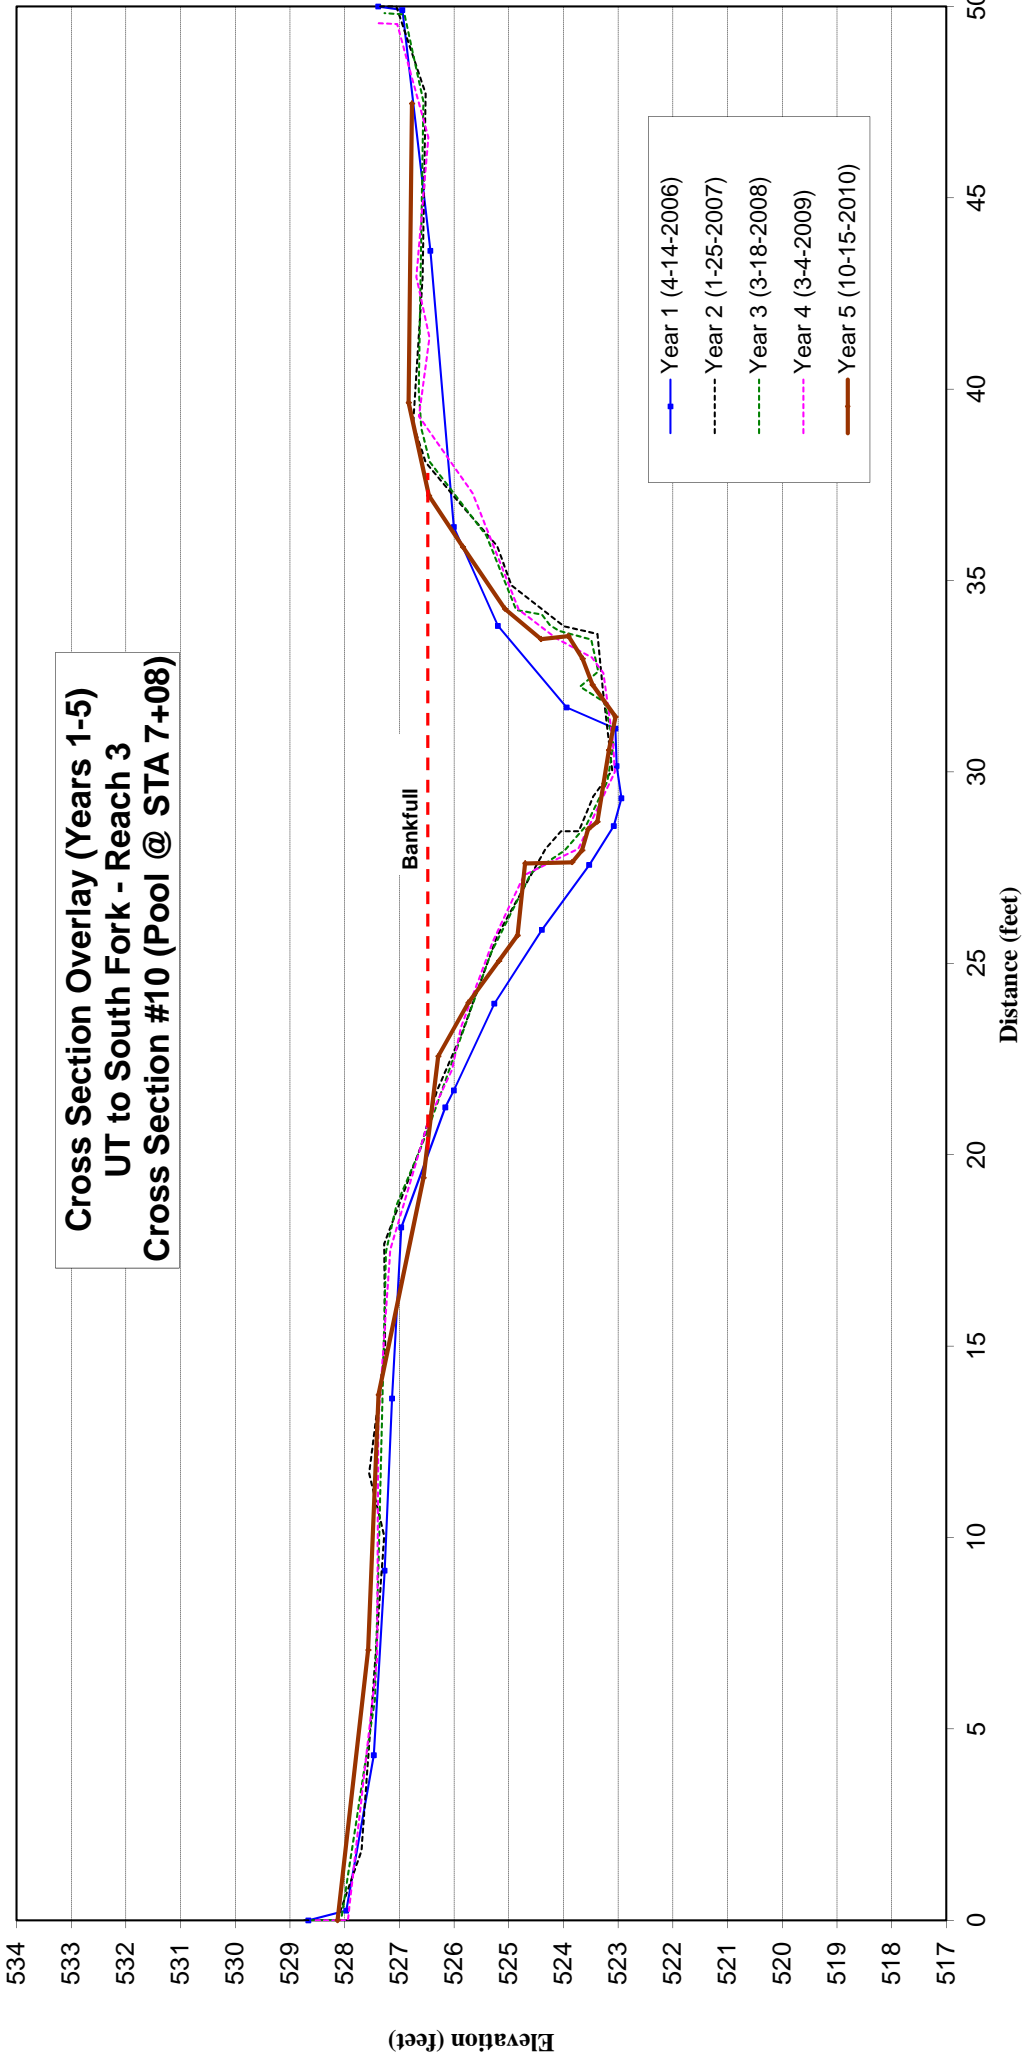
**Cross Section Overlay (Years 1-5)
 UT to South Fork - Reach 3
 Cross Section #10 (Pool @ STA 7+08)**

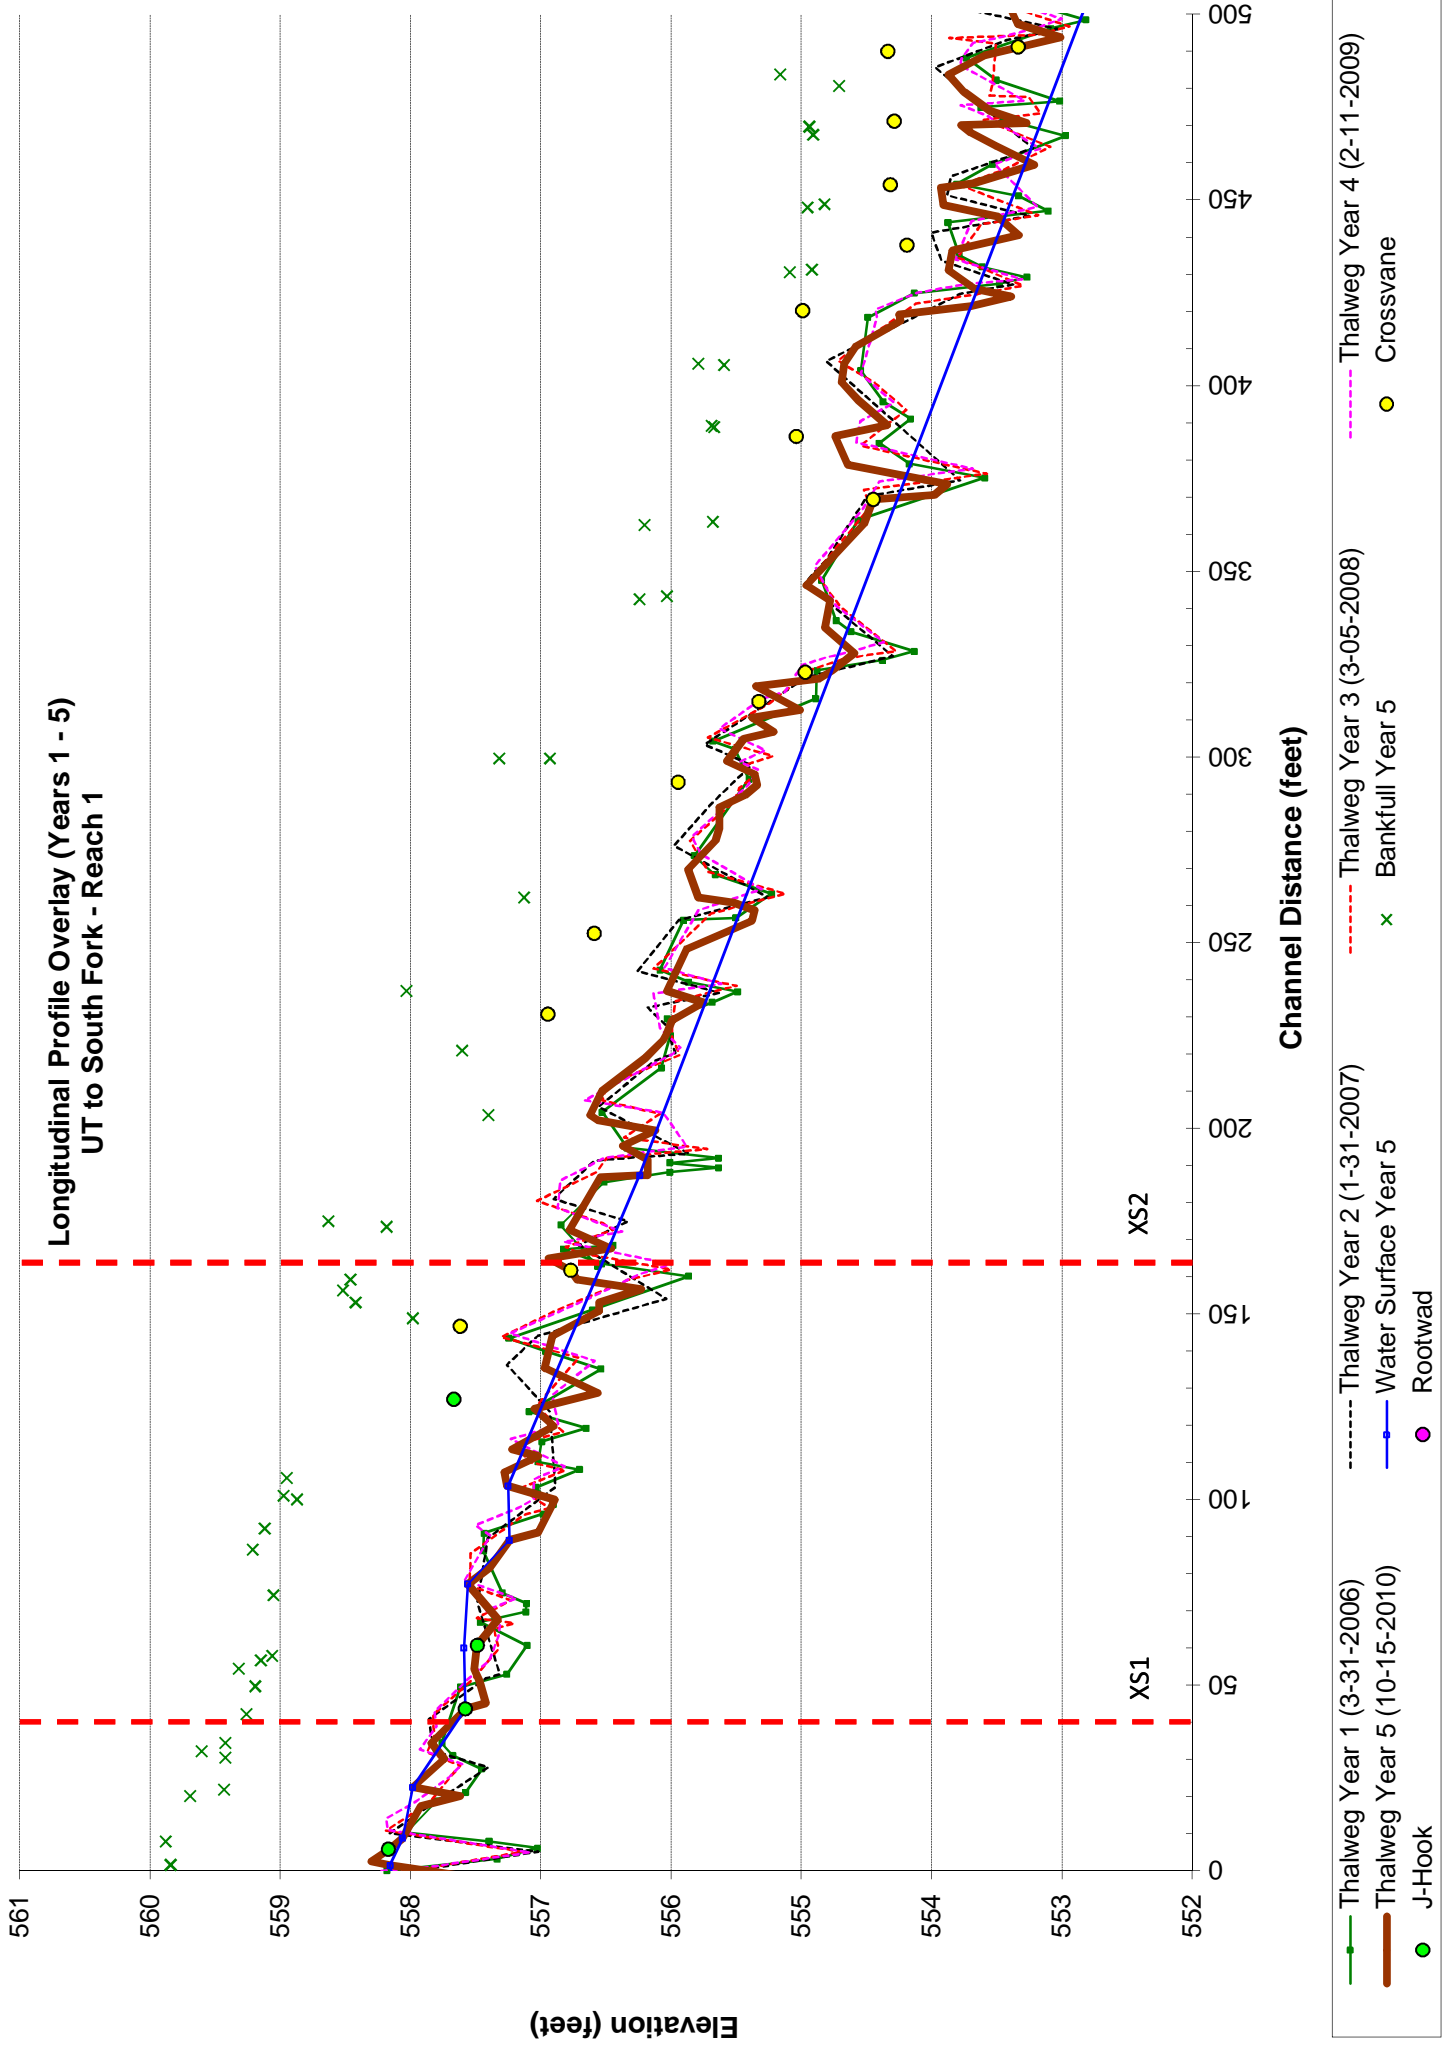
**Longitudinal Profile Overlay (Years 1 - 5)
UT to South Fork - Reach 1**

- Thalweg Year 1 (3-31-2006) —●—
- Thalweg Year 2 (1-31-2007) - - - - -
- Thalweg Year 3 (3-05-2008) - - - - -
- Thalweg Year 4 (2-11-2009) - - - - -
- Thalweg Year 5 (10-15-2010) - - - - -
- Bankfull Year 5 x
- Water Surface Year 5 —●—
- J-Hook ●
- Rootwad ●
- Crossvane ●

All Monitoring Year 5 profile and pattern parameters were consistent with Monitoring Year 4 values. Deposition in riffle sections remains a minor problem in monitoring reaches 1 and 2. The number of depositional areas and overall length of deposition identified decreased during Monitoring Year 5 for all monitoring reaches. Stream structures with problems were limited to Reaches 1 and 2. In monitoring reach 1, a total of 10 structures were found to have significant problems of concern out of 58 surveyed. One structure had significant problems of concern out of the 39 structures surveyed at monitoring reach 2. The most severe structural problem along monitoring reach 1 was a rootwad (Station 15+56) where the bank has caved in around the footing, leaving the footing almost completely exposed. There were small amounts of bank erosion in all monitoring reaches, but none were severe. Less than 1% of the banks in any of the reaches exhibited significant erosion. Evidence of recent beaver activity at the downstream end of Monitoring Reach 3 was observed during geomorphic survey during November 2010. No bank erosion was noted in the area and the impacted trees are species that have strong root systems that will resprout.

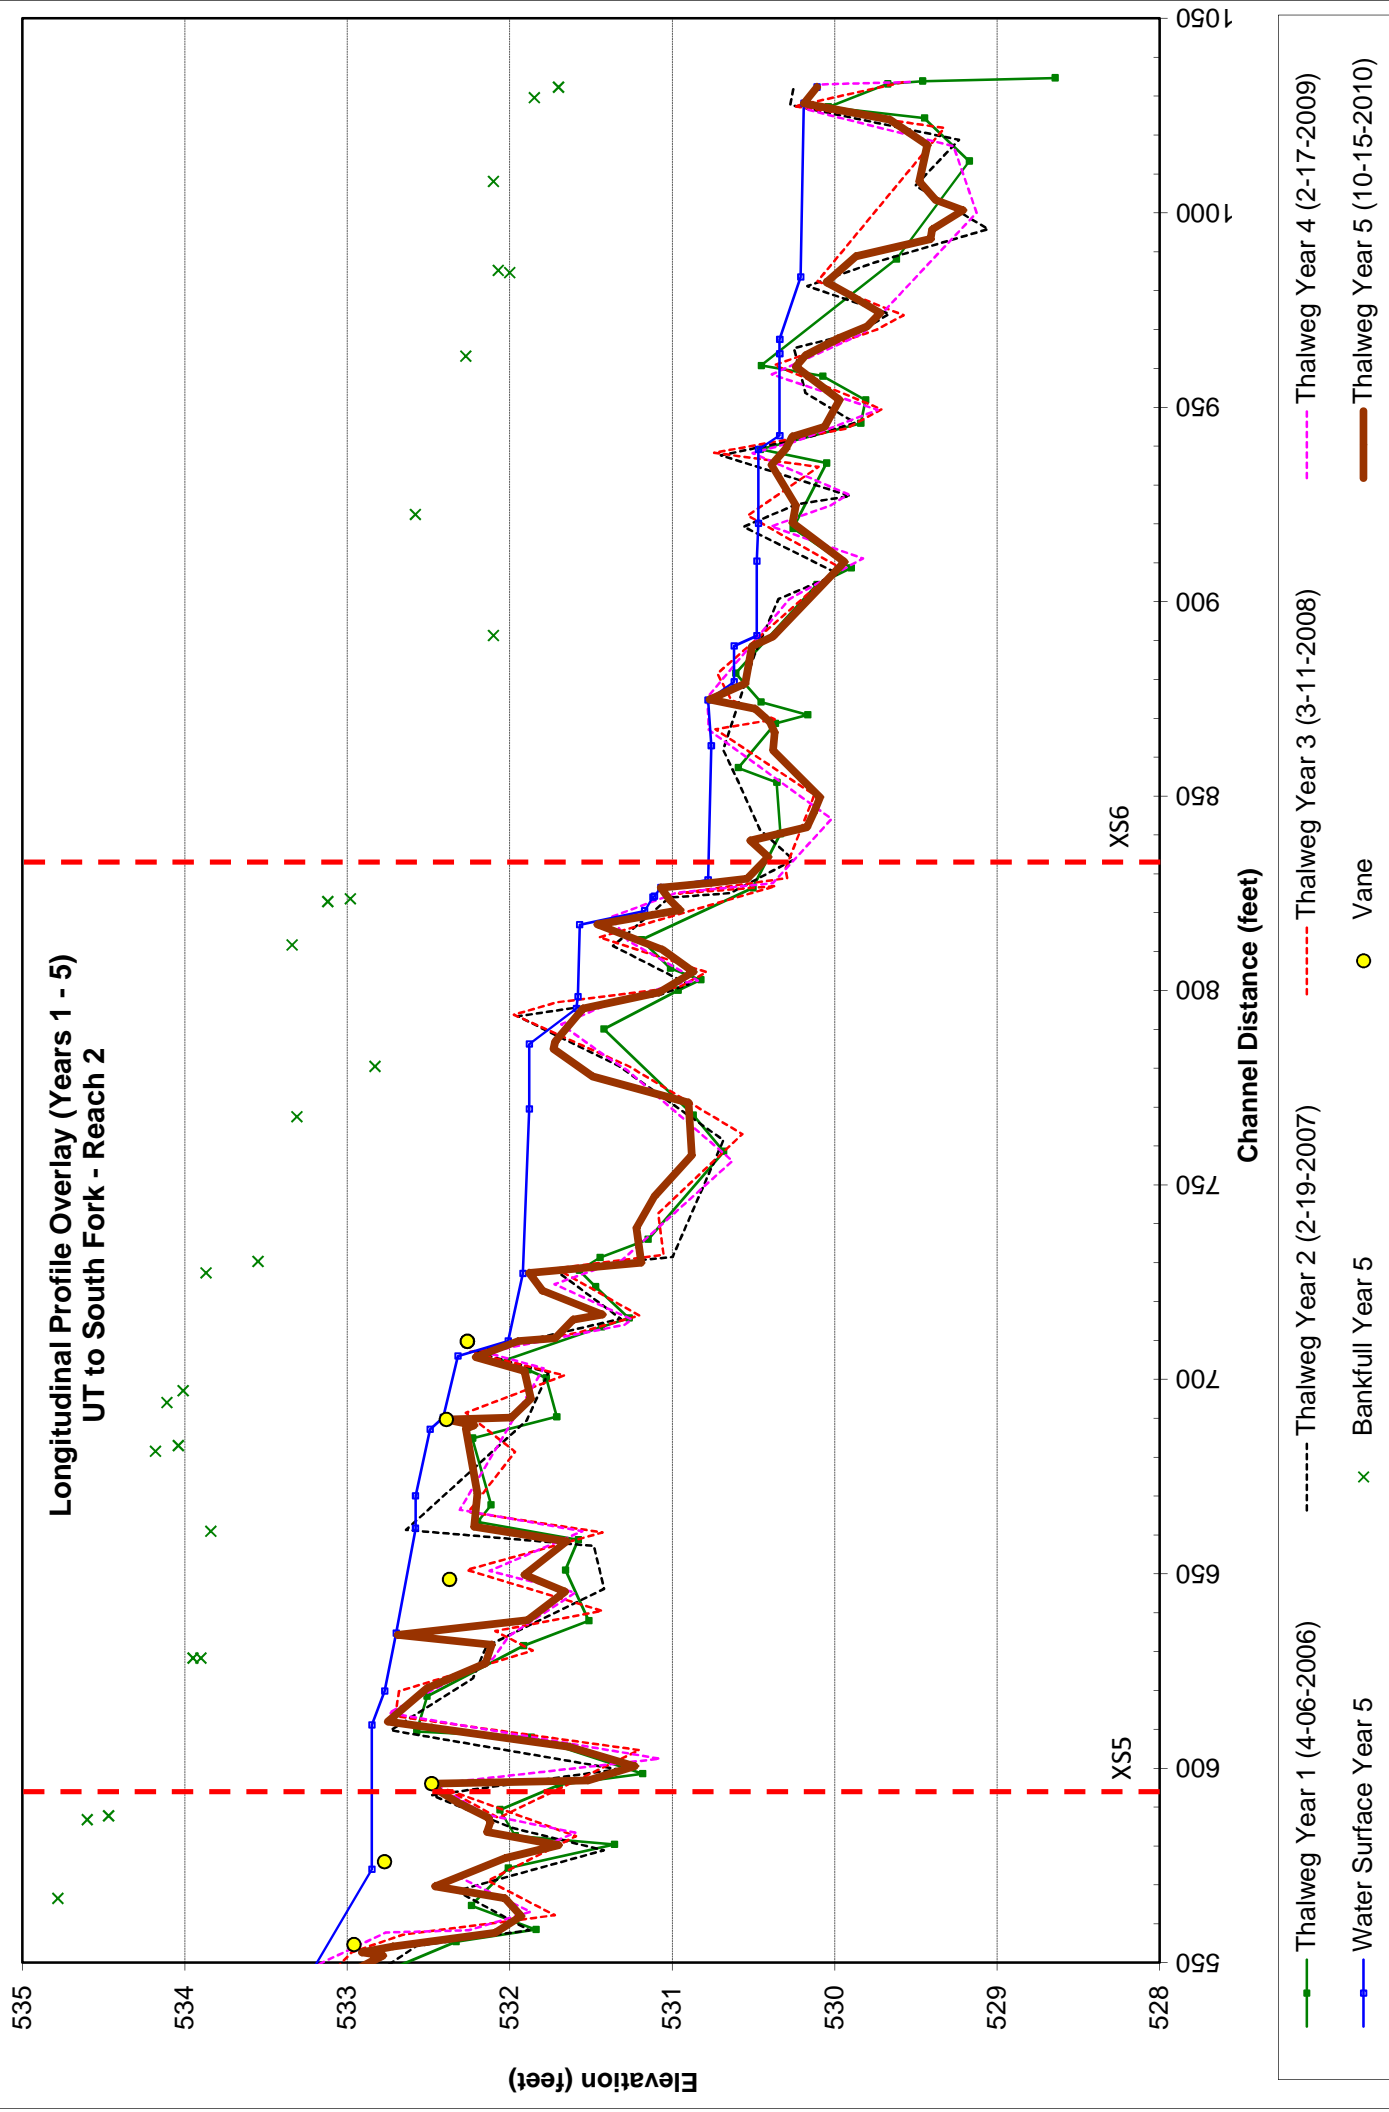
Longitudinal Profile Overlay (Years 1 - 5) UT to South Fork - Reach 2

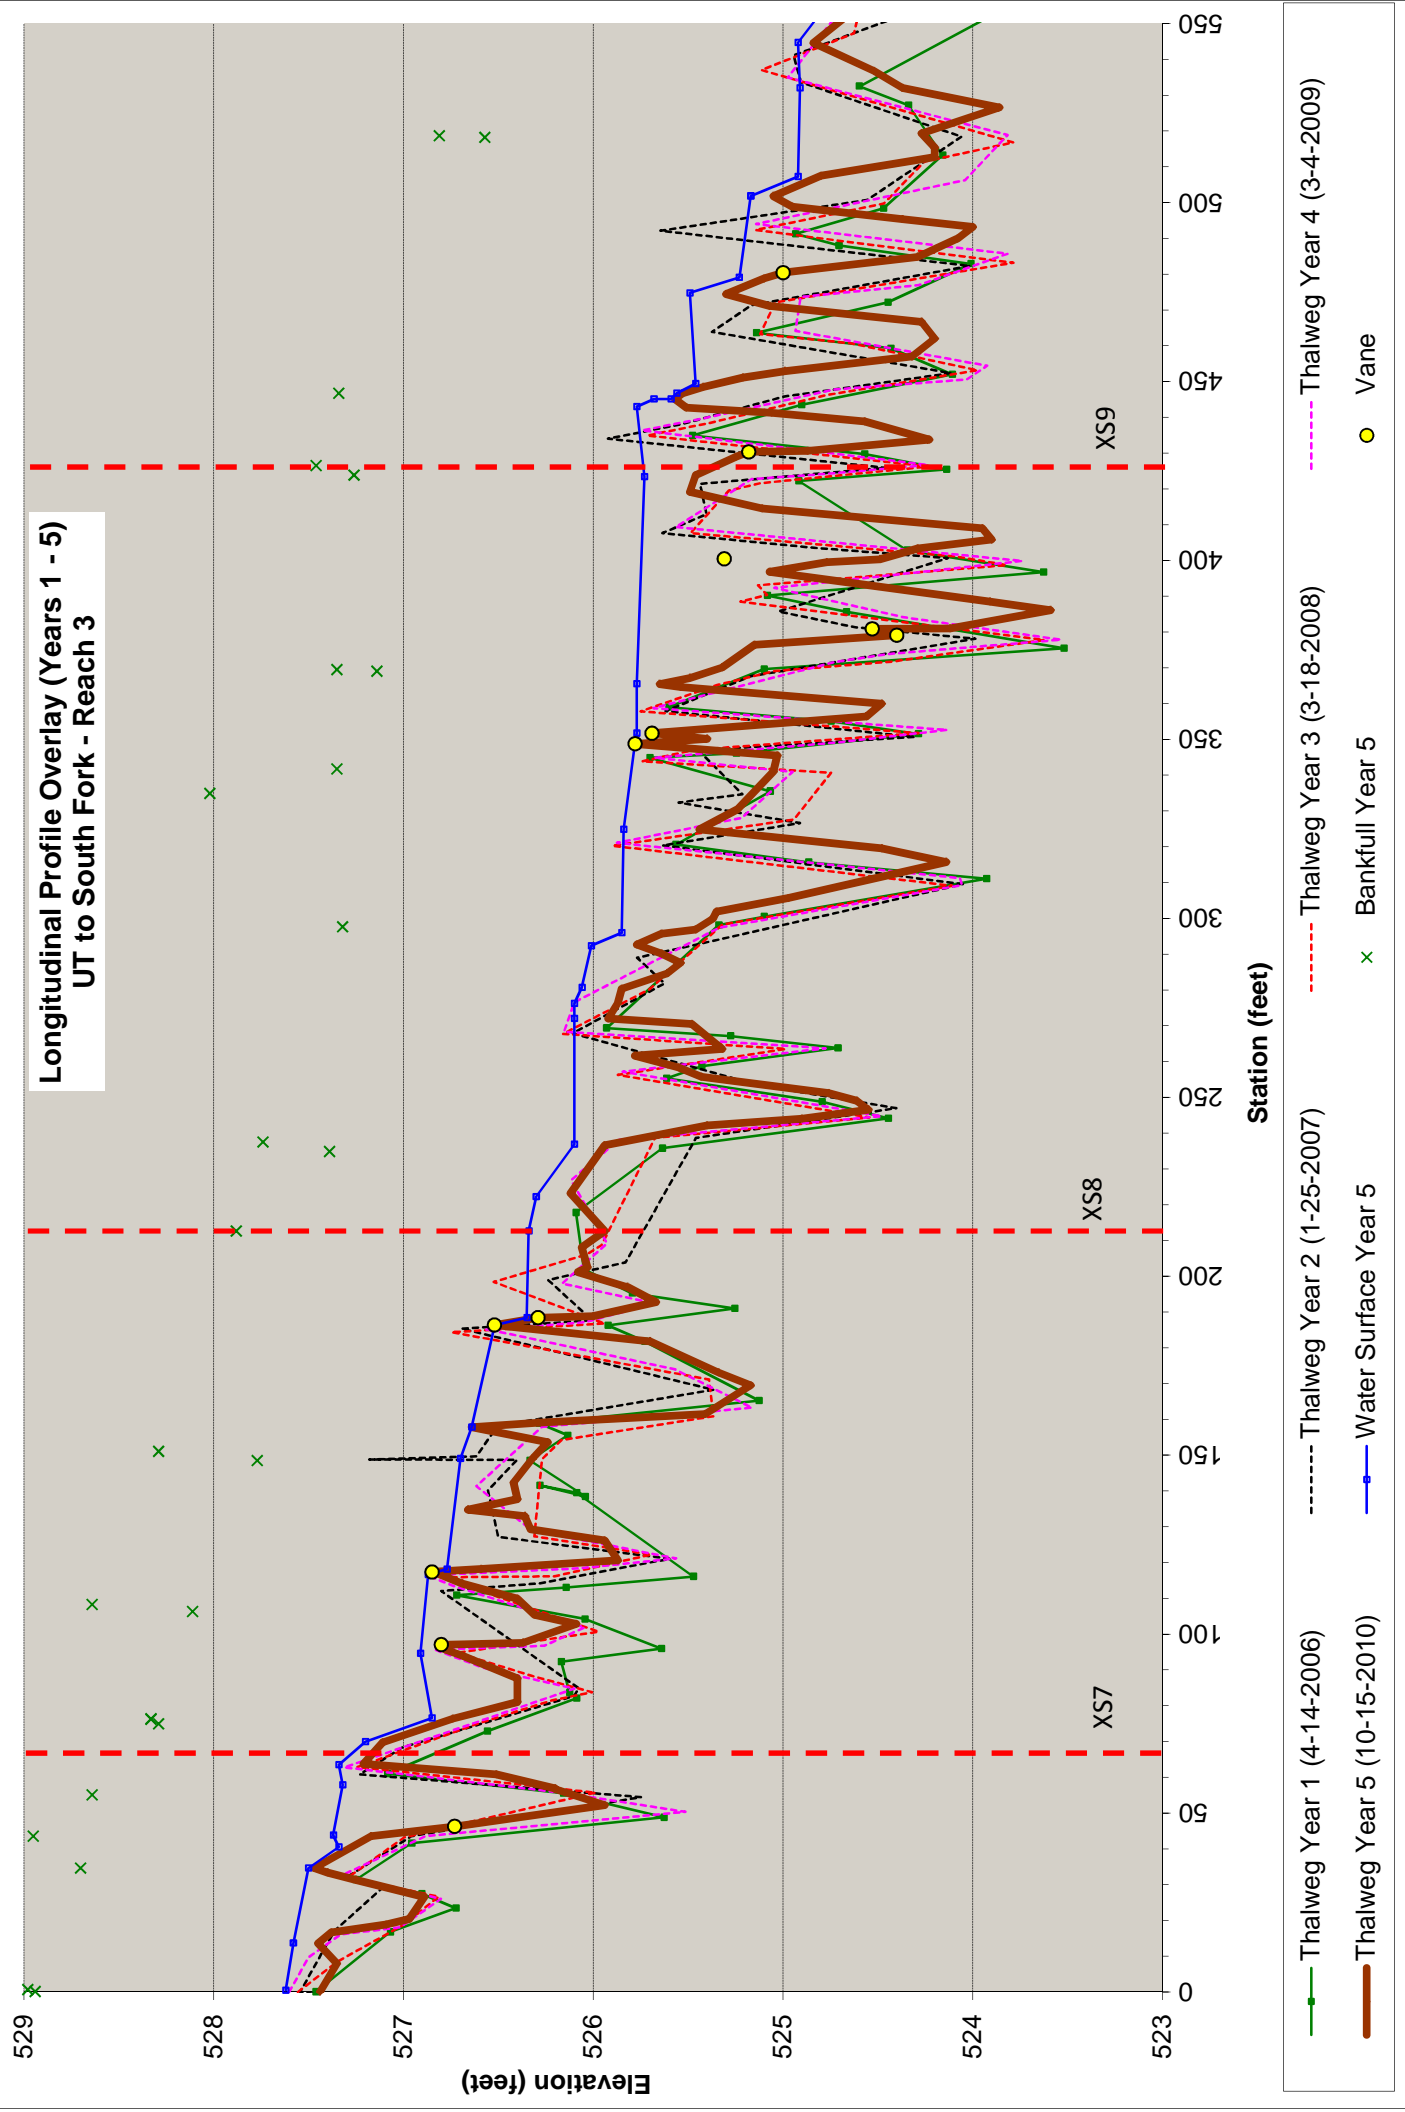
**Longitudinal Profile Overlay (Years 1 - 5)
UT to South Fork - Reach 3**
