**UT TO SOUTH FORK
FINAL MONITORING REPORT
YEAR 5 OF 5
2010**

EEP Project #435
Alamance County, North Carolina

Project: Ut to South Fork (EEP #435) Year 5 (2010) Monitoring, Alamance County, North Carolina
June 2011

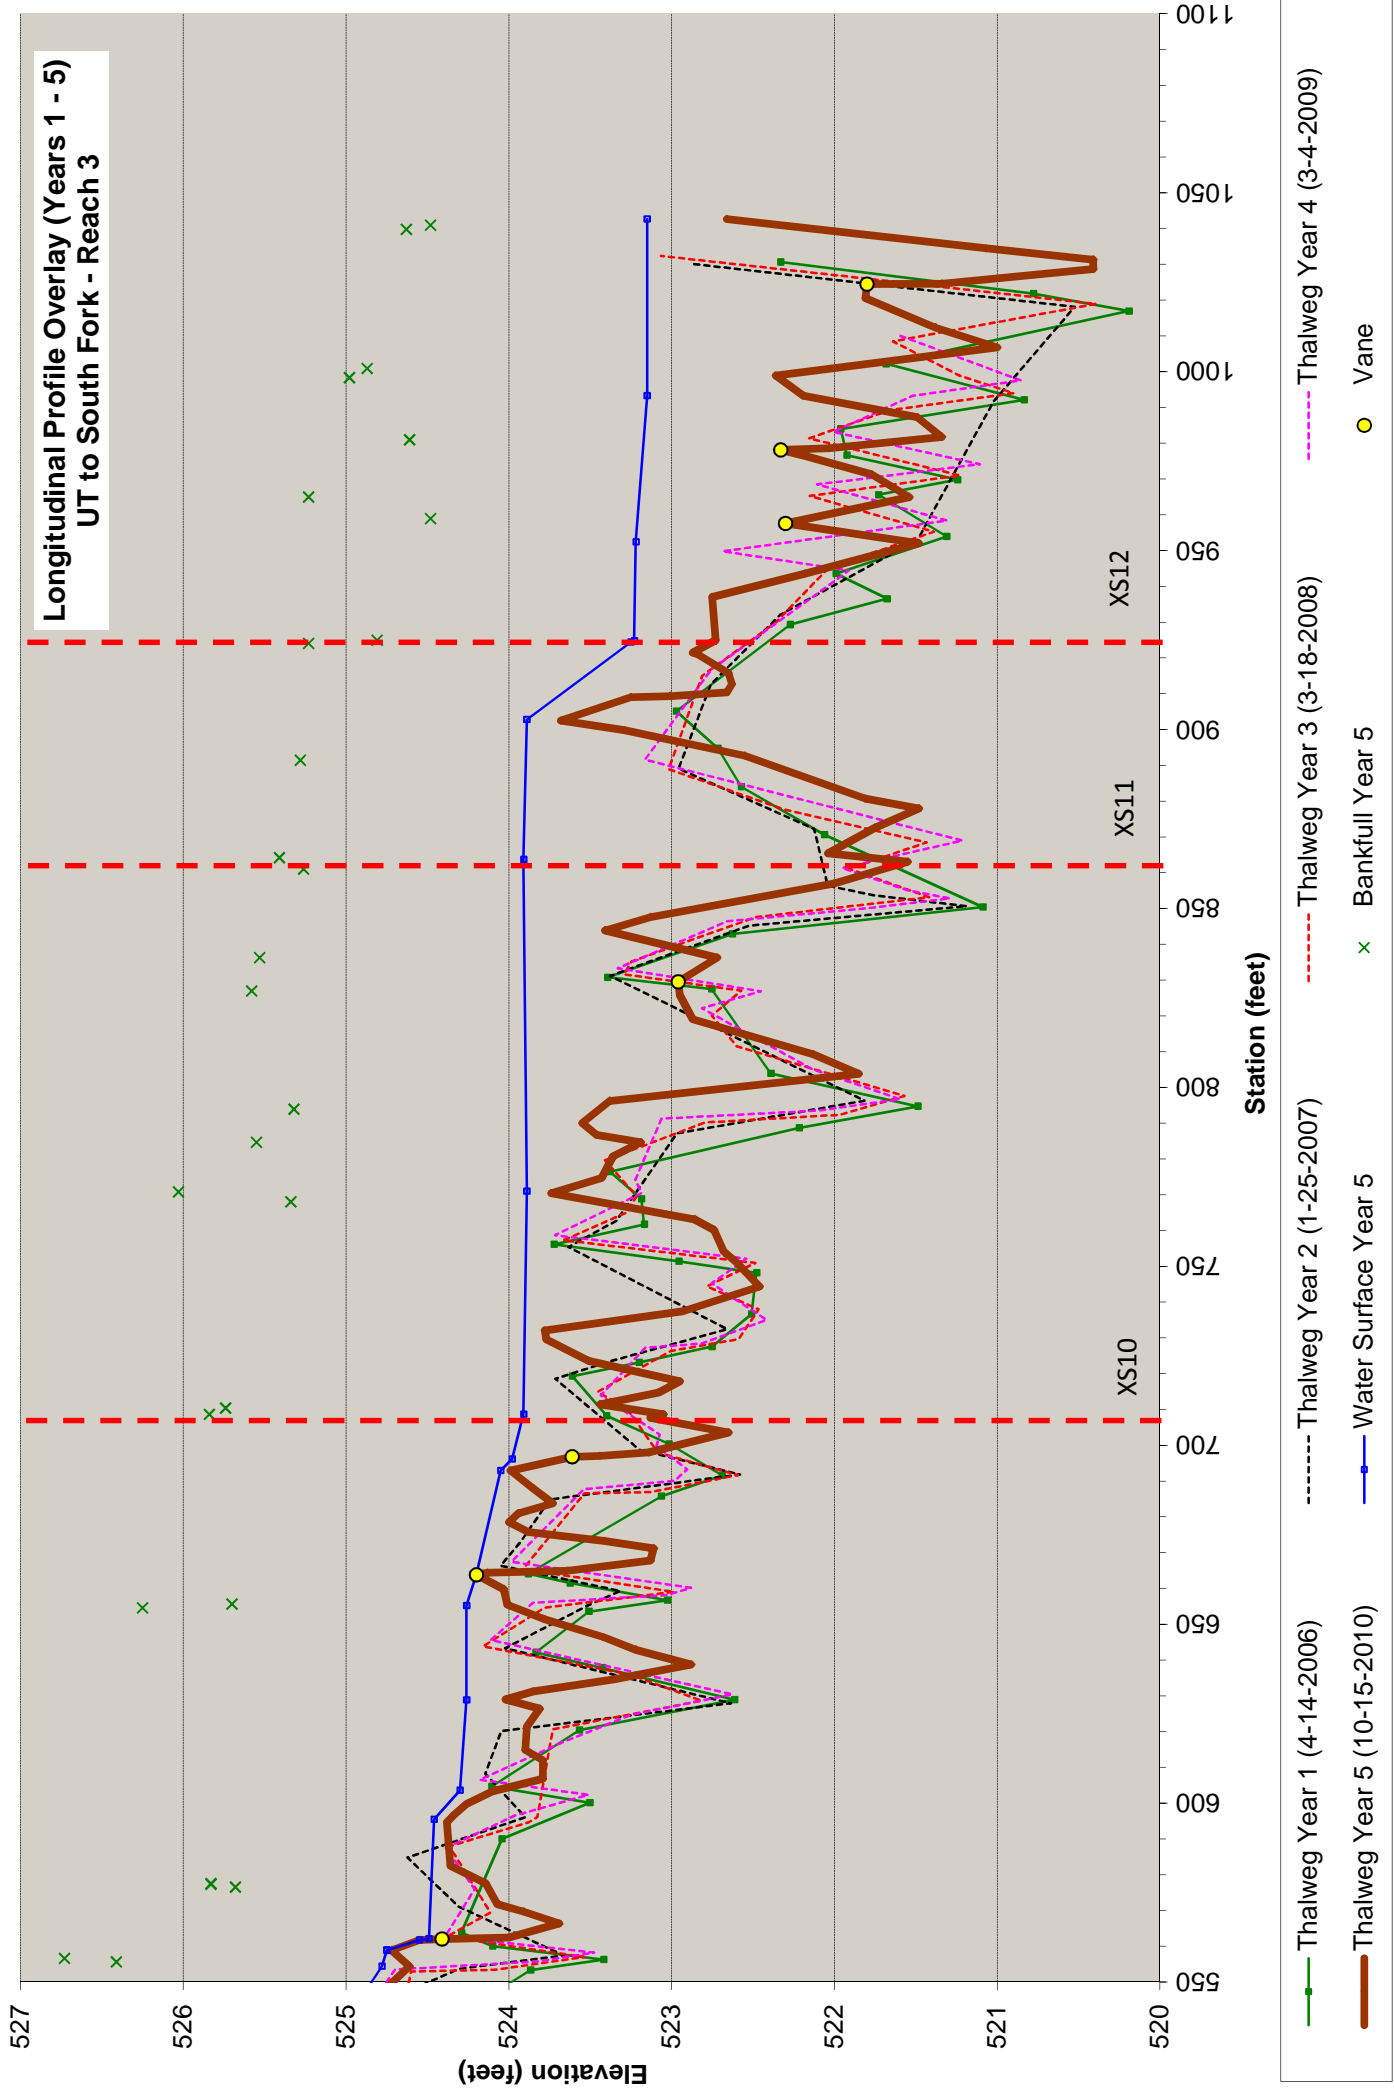
**Longitudinal Profile Overlay (Years 1 - 5)
UT to South Fork - Reach 3**

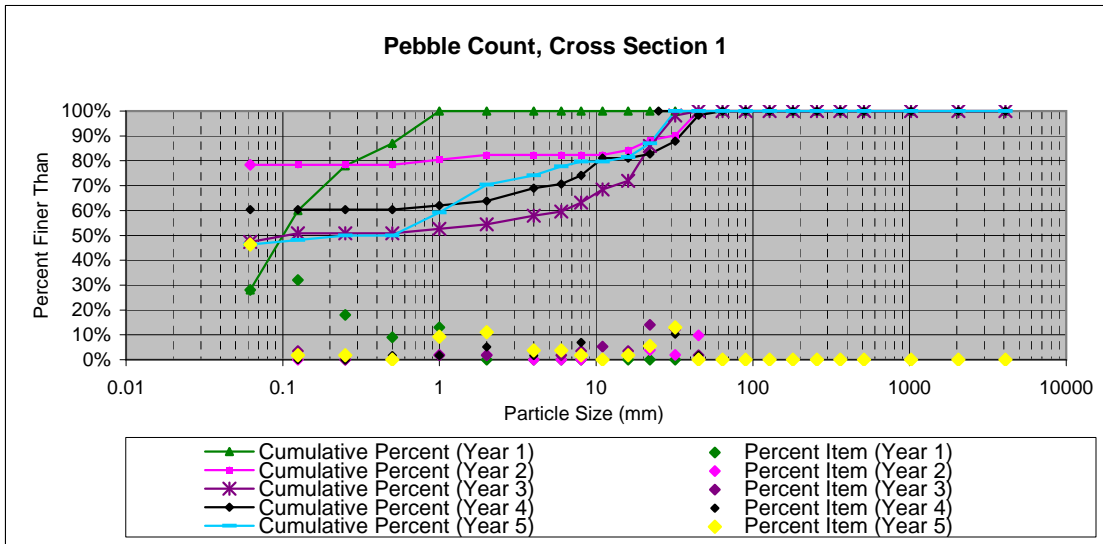
PEBBLE COUNT

Site: UT South Fork							
Party: PDB / JW							
Date: 11/11/2010							
			PARTICLE COUNT				
			CS 1				
Inches	Particle	Millimeters			TOT#	ITEM %	% CUM
	Silt/Clay	< 0.062	S/C	25	25	46%	46%
	Very Fine	.062-.125	S A N D	1	1	2%	48%
	Fine	.125-.25		1	1	2%	50%
	Medium	.25-.50		0	0	0%	50%
	Coarse	.50-1.0		5	5	9%	59%
.04-.08	Very Coarse	1.0-2		6	6	11%	70%
.08-.16	Very Fine	2.0-4.0	G R A V E L	2	2	4%	74%
.16-.22	Fine	4-5.7		2	2	4%	78%
.22-.31	Fine	5.7-8		1	1	2%	80%
.31-.44	Medium	8-11.3		0	0	0%	80%
.44-.63	Medium	11.3-16		1	1	2%	81%
.63-.89	Coarse	16-22.6		3	3	6%	87%
.89-1.26	Coarse	22.6-32		7	7	13%	100%

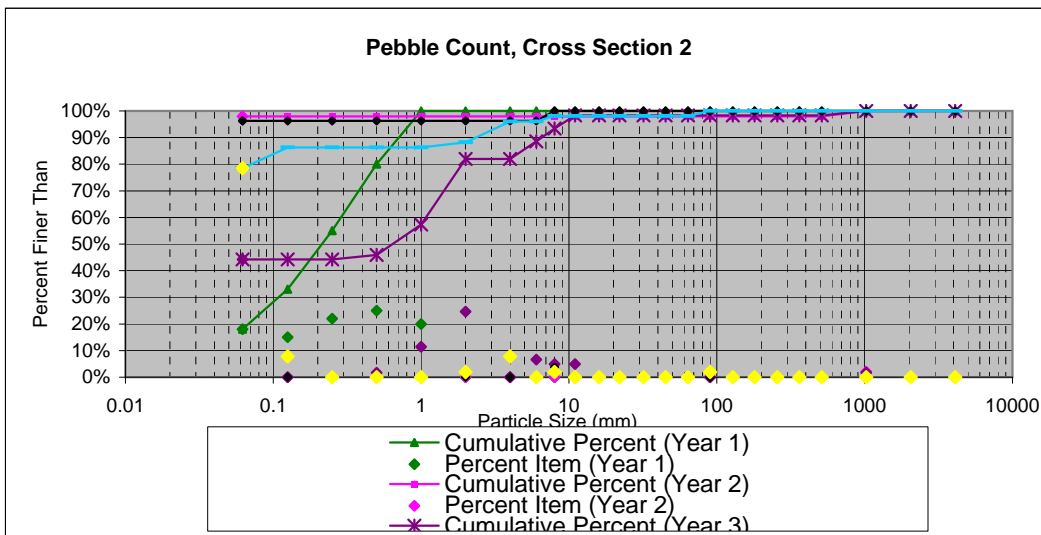
PEBBLE COUNT

Site: UT South Fork							
Party: PDB / JW							
Date: 11/11/2010							
			PARTICLE COUNT				
			CS 2				
Inches	Particle	Millimeters			TOT#	ITEM %	% CUM
	Silt/Clay	< 0.062	S/C	40	40	78%	78%
	Very Fine	.062-.125	S A N D	4	4	8%	86%
	Fine	.125-.25		0	0	0%	86%
	Medium	.25-.50		0	0	0%	86%
	Coarse	.50-1.0		0	0	0%	86%
.04-.08	Very Coarse	1.0-2		1	1	2%	88%
.08-.16	Very Fine	2.0-4.0	G R A V E L	4	4	8%	96%
.16-.22	Fine	4-5.7		0	0	0%	96%
.22-.31	Fine	5.7-8		1	1	2%	98%
.31-.44	Medium	8-11.3		0	0	0%	98%
.44-.63	Medium	11.3-16		0	0	0%	98%
.63-.89	Coarse	16-22.6		0	0	0%	98%
.89-1.26	Coarse	22.6-32		0	0	0%	98%

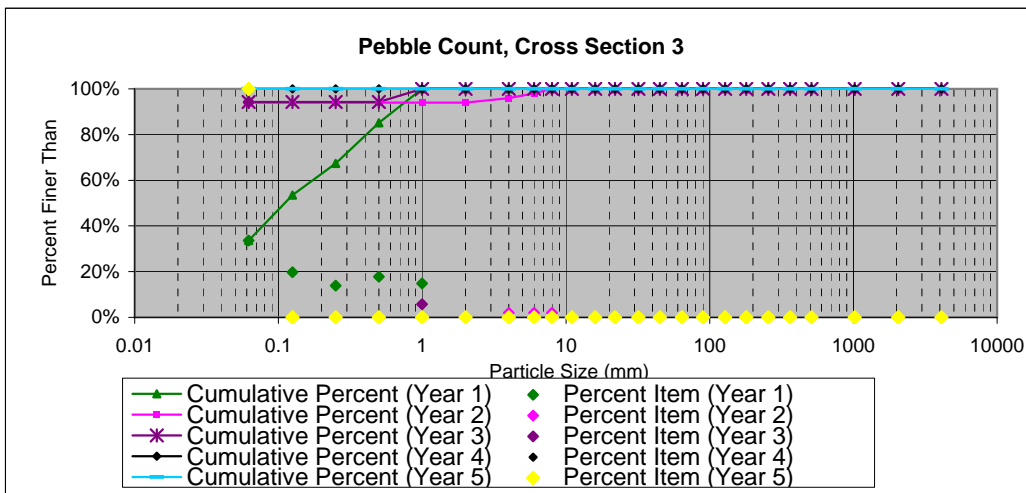
PEBBLE COUNT

Site: UT South Fork							
Party: PDB / JW							
Date: 11/11/2010							
			PARTICLE COUNT				
			CS 3		TOT#	ITEM %	% CUM
Inches	Particle	Millimeters	S/C	50	50	100%	100%
	Silt/Clay	< 0.062					
	Very Fine	.062-.125	S A N D		0	0%	100%
	Fine	.125-.25			0	0%	100%
	Medium	.25-.50			0	0%	100%
	Coarse	.50-1.0			0	0%	100%
.04-.08	Very Coarse	1.0-2			0	0%	100%
.08-.16	Very Fine	2.0-4.0	G R A V E L		0	0%	100%
.16-.22	Fine	4-5.7			0	0%	100%
.22-.31	Fine	5.7-8			0	0%	100%
.31-.44	Medium	8-11.3			0	0%	100%
.44-.63	Medium	11.3-16			0	0%	100%
.63-.89	Coarse	16-22.6			0	0%	100%
.89-1.26	Coarse	22.6-32			0	0%	100%
