FINAL
Baseline Monitoring Document and As-Built Baseline Report
UT to Town Creek Restoration Project – Option A

Stanly County, North Carolina

DMS Project ID No. 94648; NCDEQ Contract No. 003277

Data Collection Period – February – June 2016

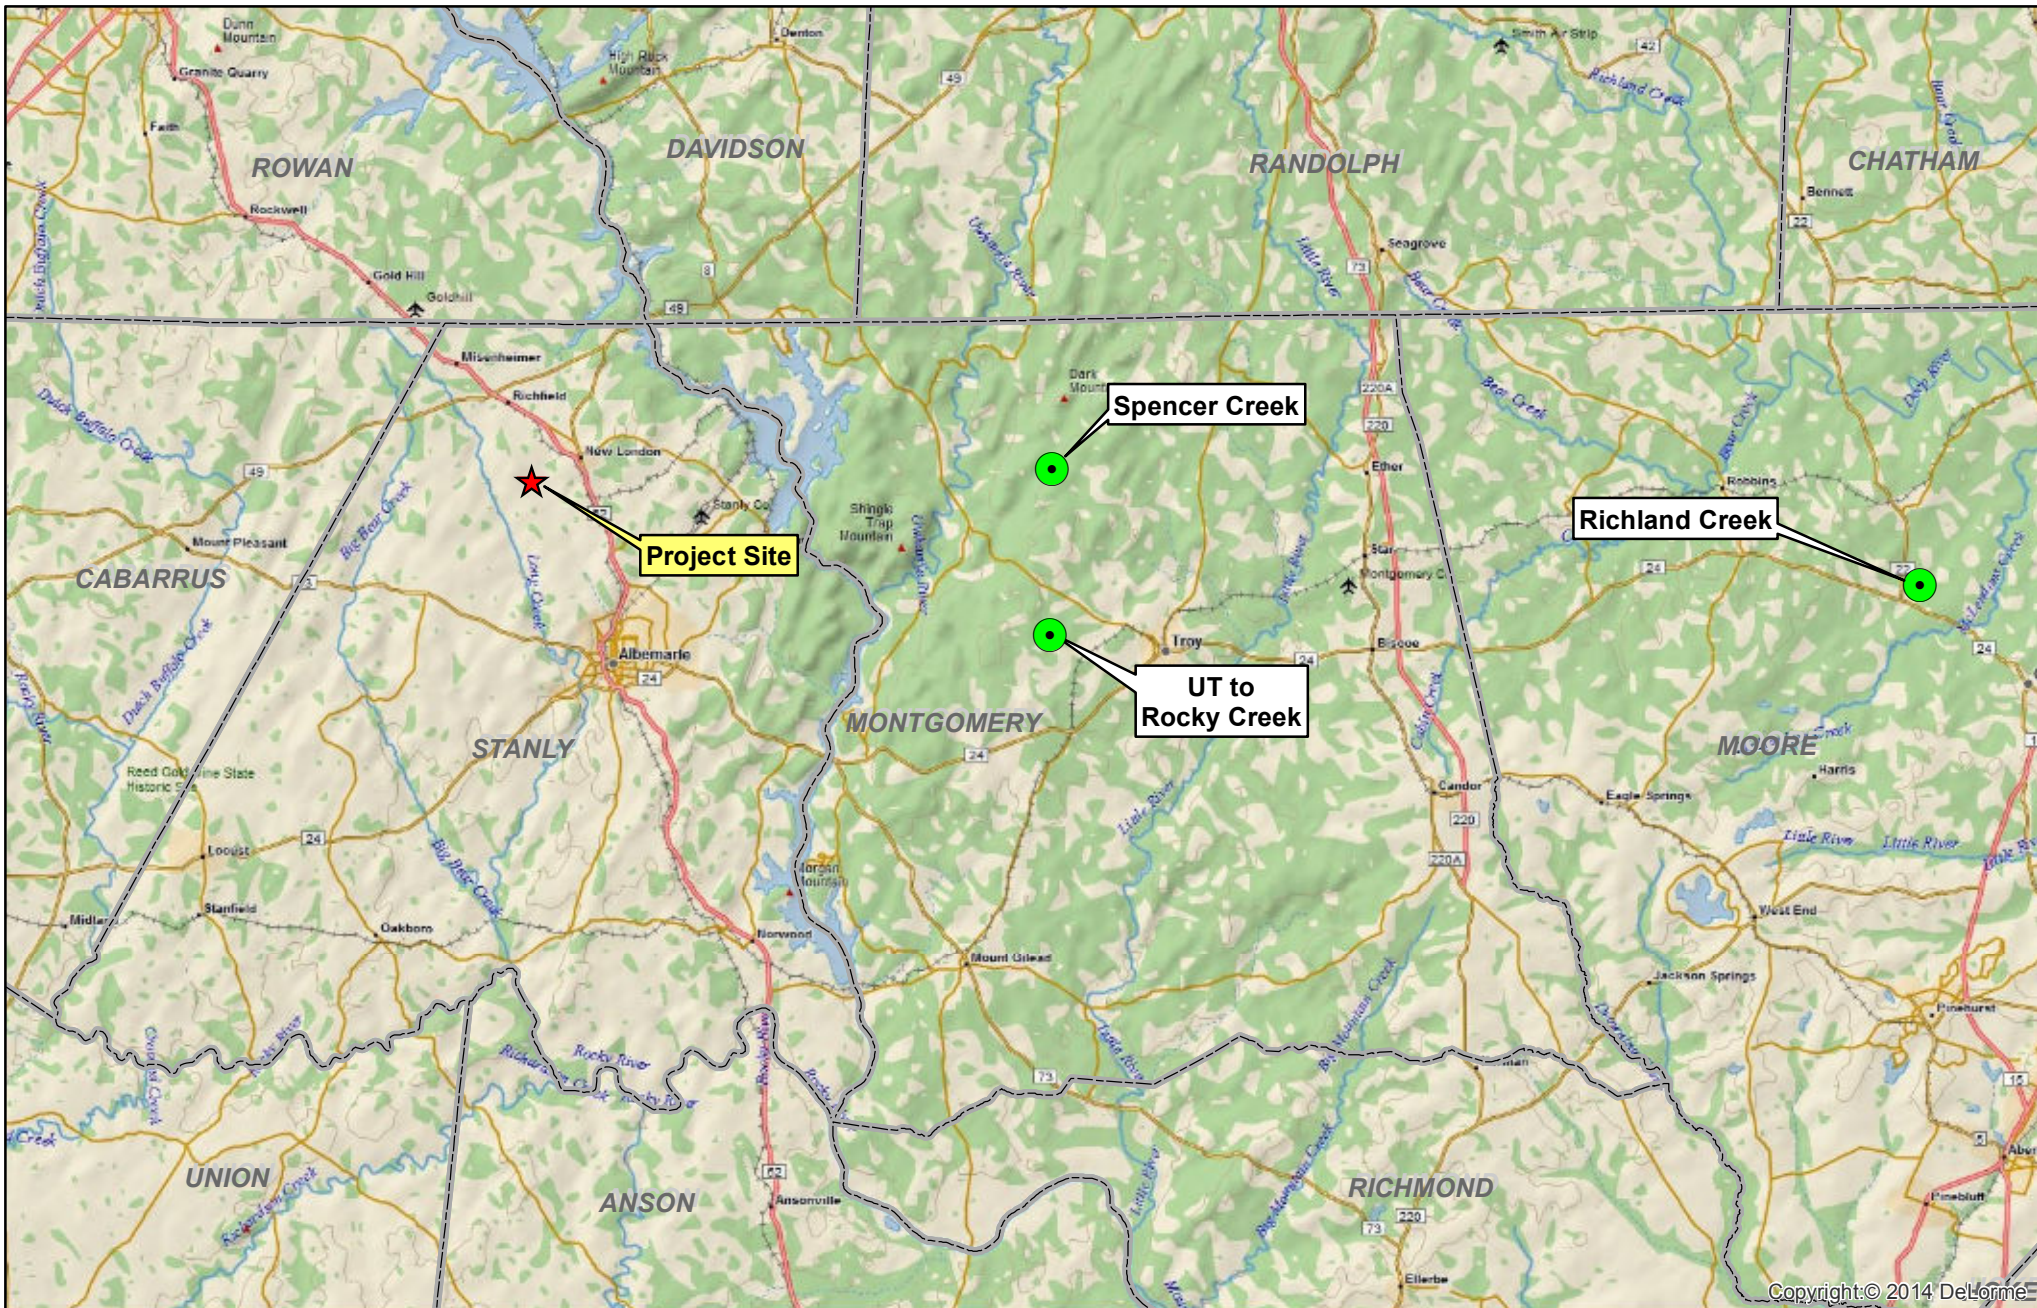
Figure 2. Mitigation Summary
UT to Town Creek
Restoration Project - Option A
Stanly County, NC

- LEGEND**
- Conservation Easement
 - Wetland Creation
 - Wetland Restoration
 - Restoration
 - Enhancement I
 - Enhancement II
 - Jurisdictional Wetlands
 - Wetland BMPs

The Site is located in Stanly County, NC, approximately 1.7 miles west of the Town of New London, as shown on the Vicinity Map (Figure 1). The Project is located within the Yadkin-Pee Dee River Basin and the North Carolina Division of Mitigation Services (NCDMS) - Targeted Local Watershed 03040105060040. The Project is located in the Piedmont physiographic region within the Carolina Slate Belt and includes an Unnamed Tributary (UT) to Town Creek, three of its headwater unnamed tributaries, and seven riparian wetlands. The four UTs were divided into seven individual Reaches (R1, R2, R3, R4, R5, R6, and R7) as shown in Figure 2.

The vegetative components of this Project included stream bank, floodplain, wetland, and transitional upland planting and described as the riparian buffer zone. The Site was planted with native species riparian buffer vegetation as shown in Table 8 and Table 9 (Appendix C) and now protected through a permanent conservation easement. Table 1 and Figure 2 (Appendix A) provide a summary of the Project components.

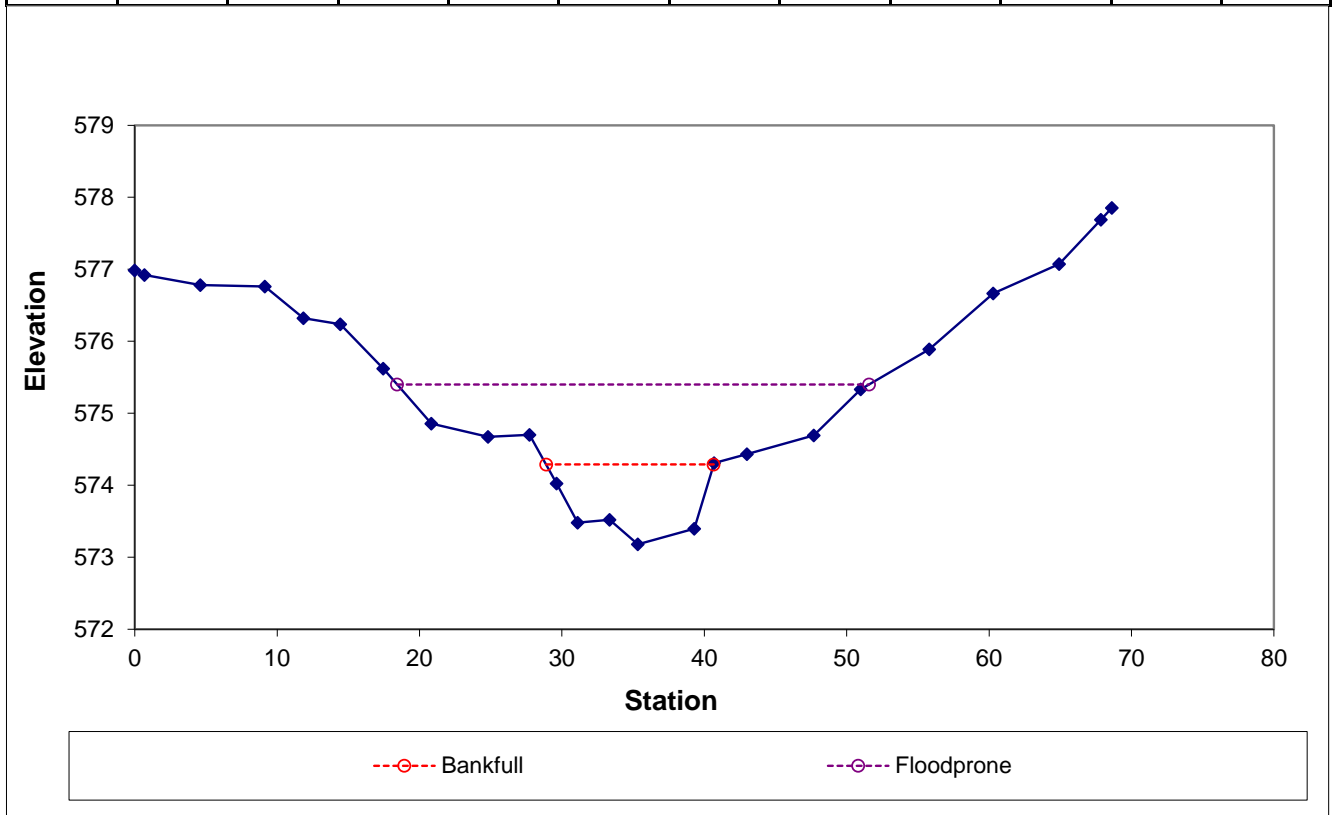
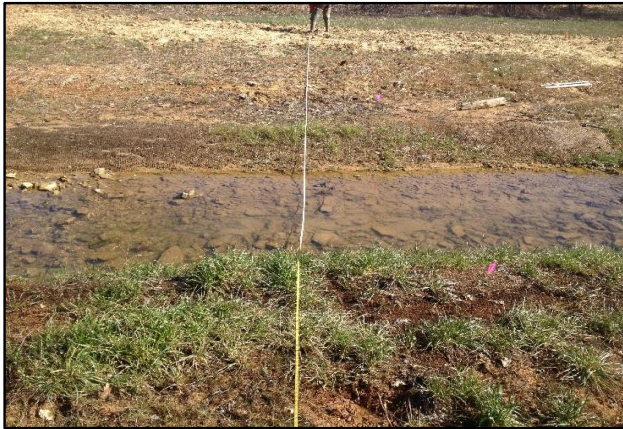
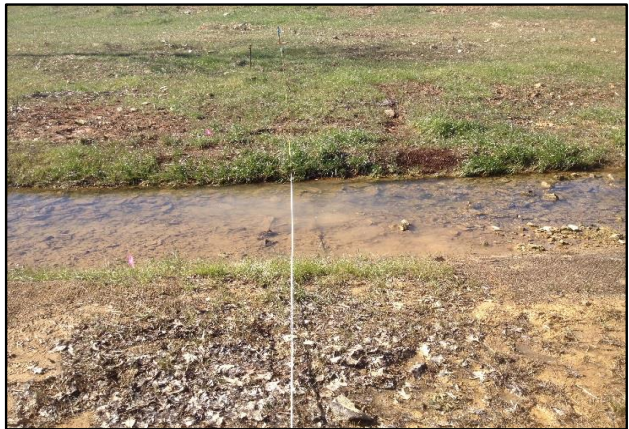
**Permanent Cross-section
X1 - Reach 1
(As-built Data - Collected April 2016)**

Feature	Stream Type	BKF Area	BKF Width	BKF Depth	Max BKF Depth	W/D	BH Ratio	ER	BKF Elev	TOB Elev	WFPA
Riffle	C	9.1	11.77	0.77	1.11	15.23	1	2.8	574.29	574.31	33.14

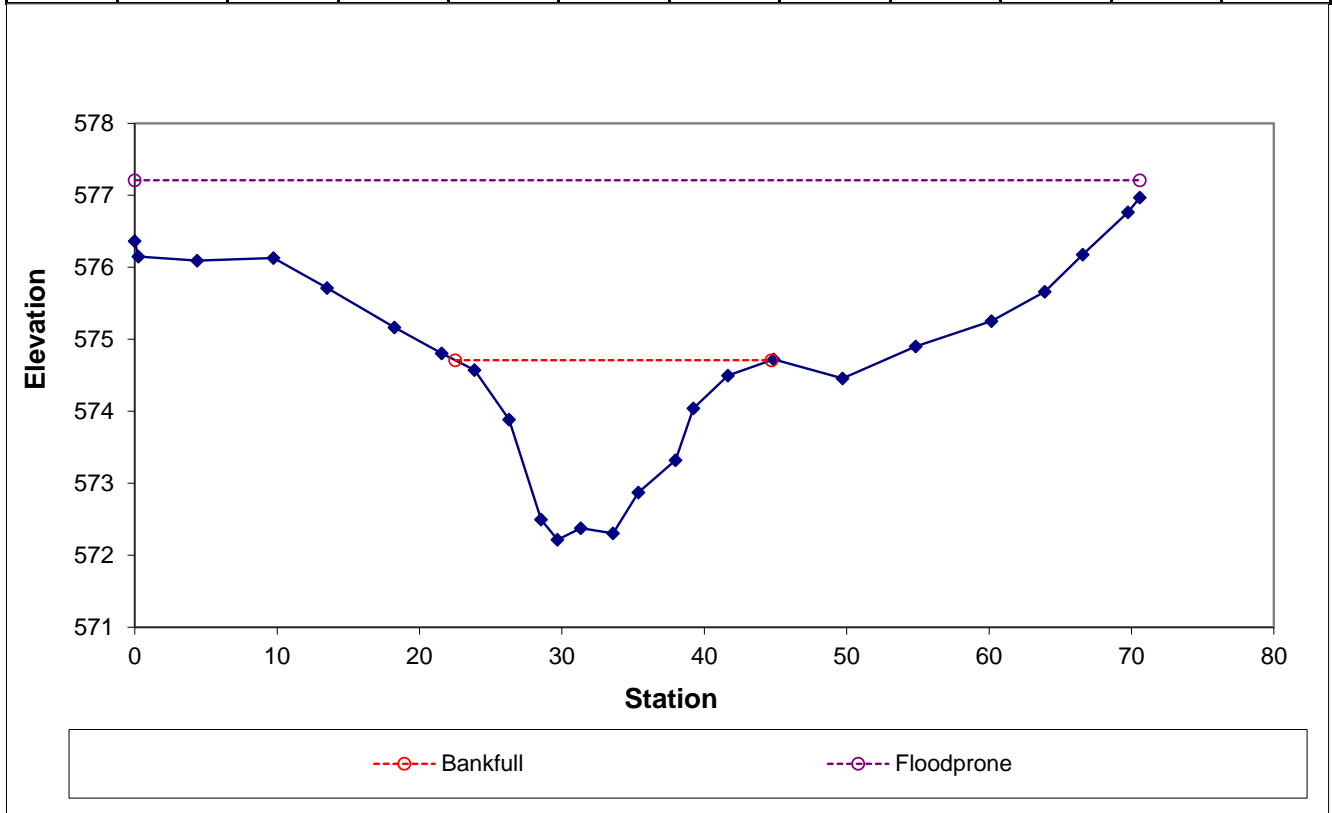
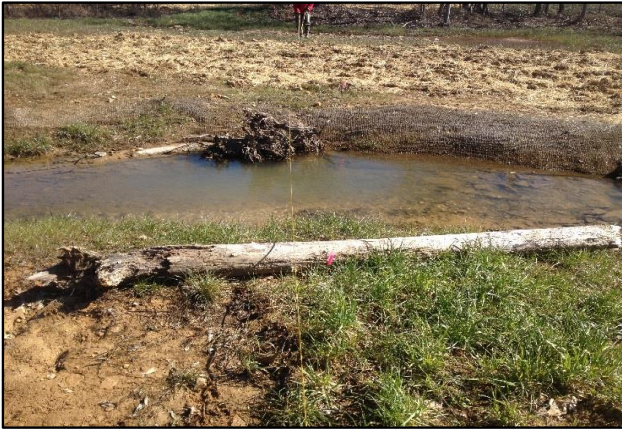
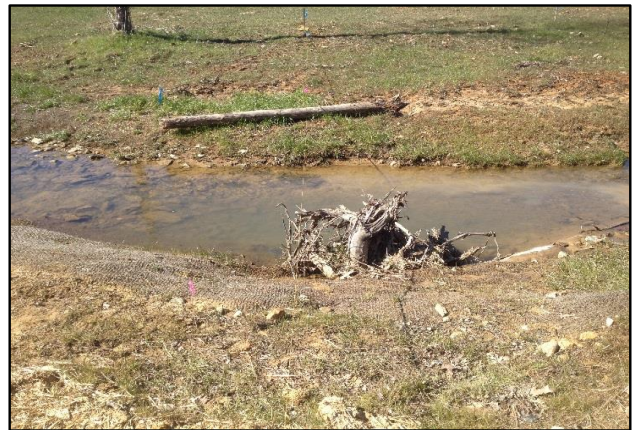
**Permanent Cross-section
X2 - Reach 1
(As-built Data - Collected April 2016)**

Feature	Stream Type	BKF Area	BKF Width	BKF Depth	Max BKF Depth	W/D	BH Ratio	ER	BKF Elev	TOB Elev	WFOA
Pool		27.4	22.22	1.23	2.5	18.03	1	3.2	574.71	574.72	70.59

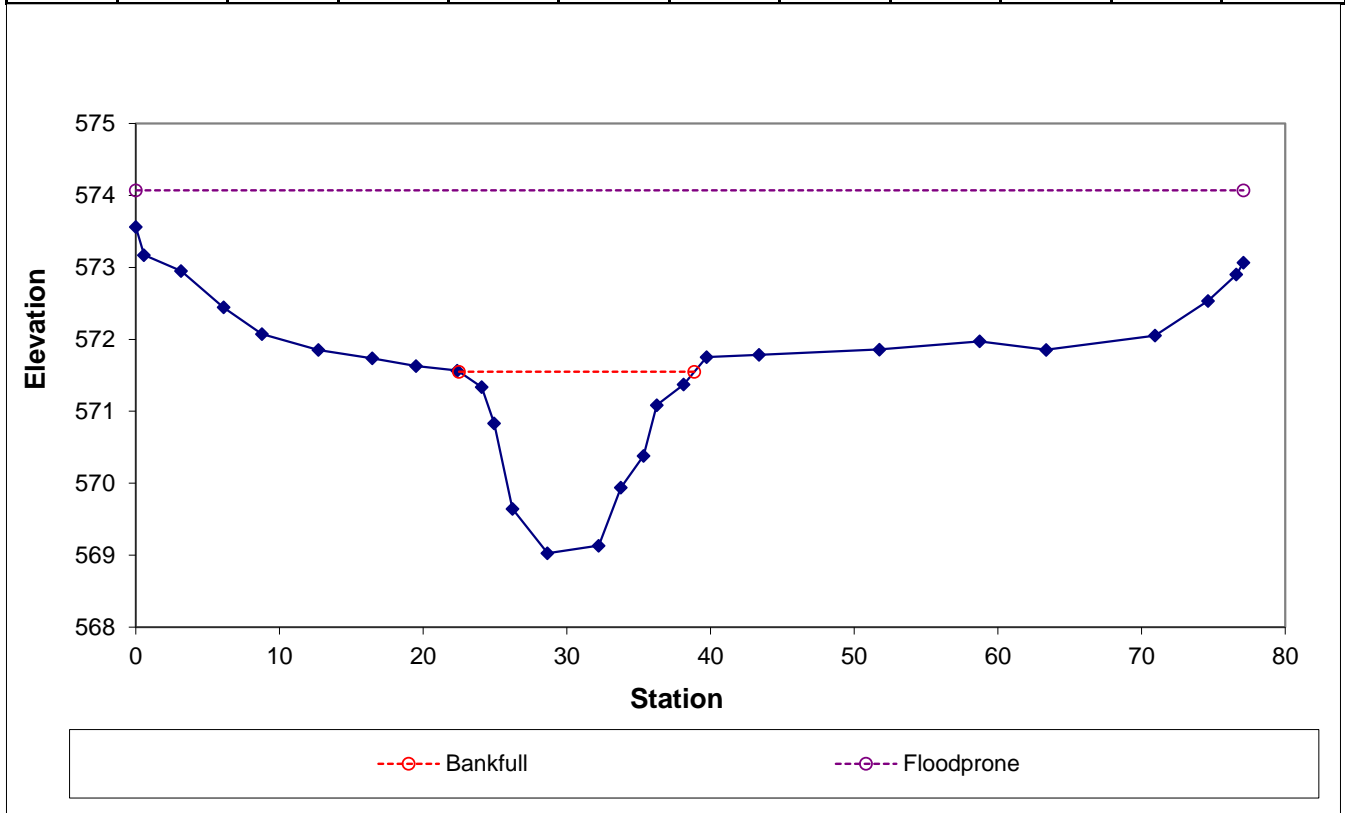
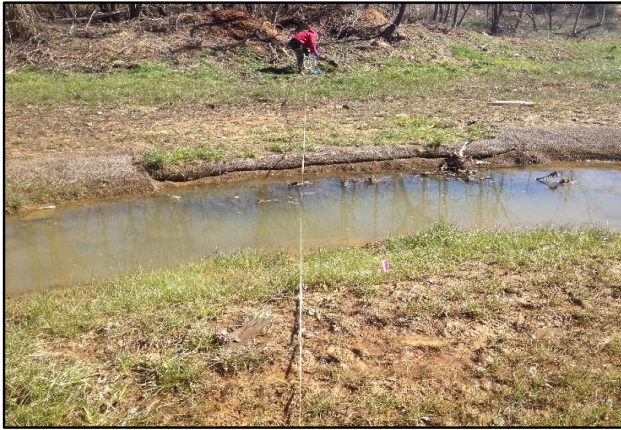
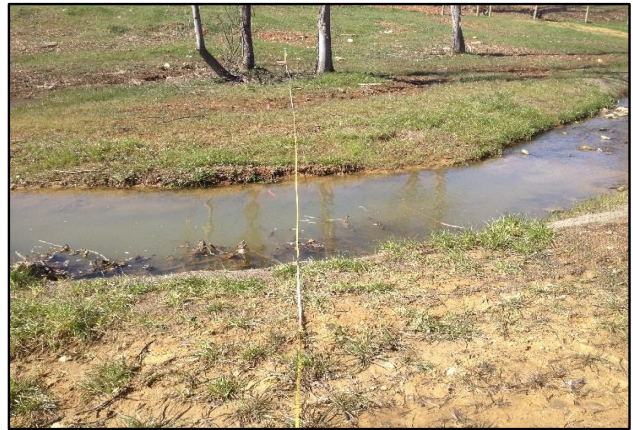
**Permanent Cross-section
X3 - Reach 1
(As-built Data - Collected April 2016)**

Feature	Stream Type	BKF Area	BKF Width	BKF Depth	Max BKF Depth	W/D	BH Ratio	ER	BKF Elev	TOB Elev	WFPA
Pool		23.2	16.38	1.41	2.52	11.59	1	4.7	571.55	571.57	77.09

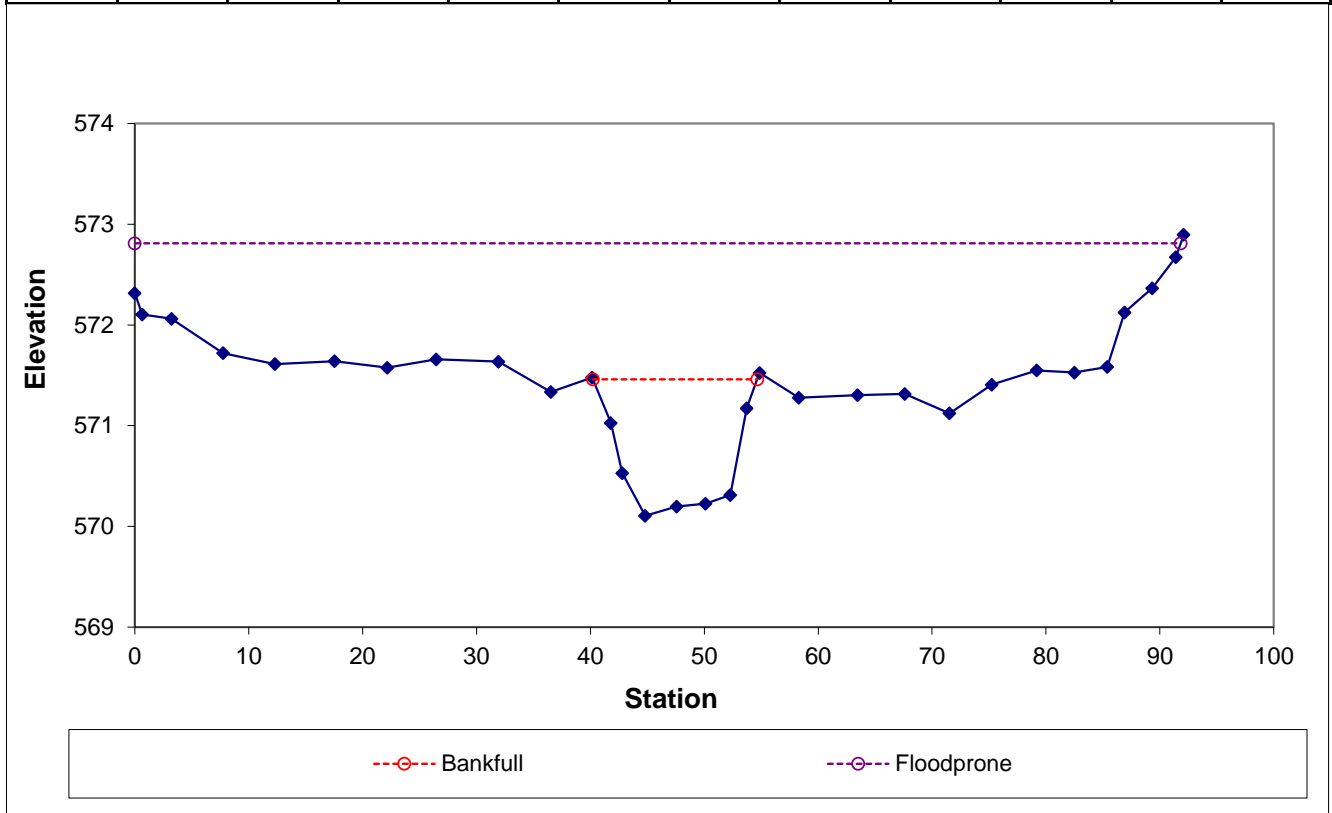
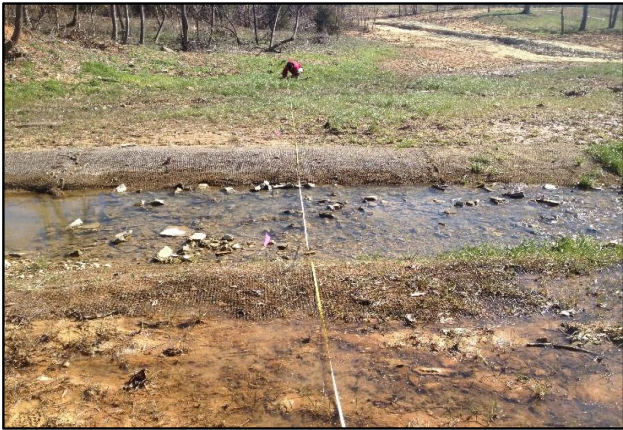
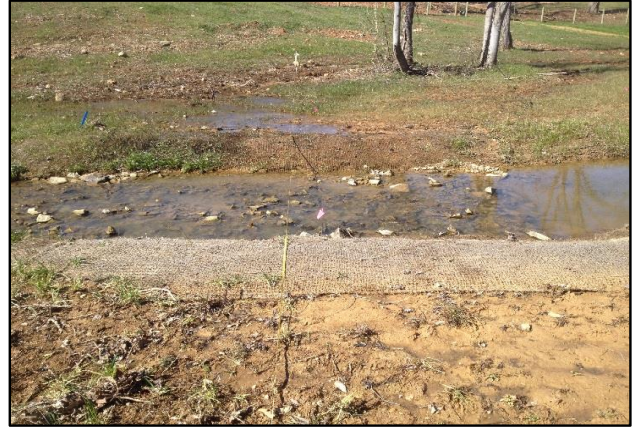
**Permanent Cross-section
X4 - Reach 1
(As-built Data - Collected April 2016)**

Feature	Stream Type	BKF Area	BKF Width	BKF Depth	Max BKF Depth	W/D	BH Ratio	ER	BKF Elev	TOB Elev	WFGPA
Riffle	C	13.9	14.44	0.96	1.35	15.04	1	6.4	571.46	571.48	91.83

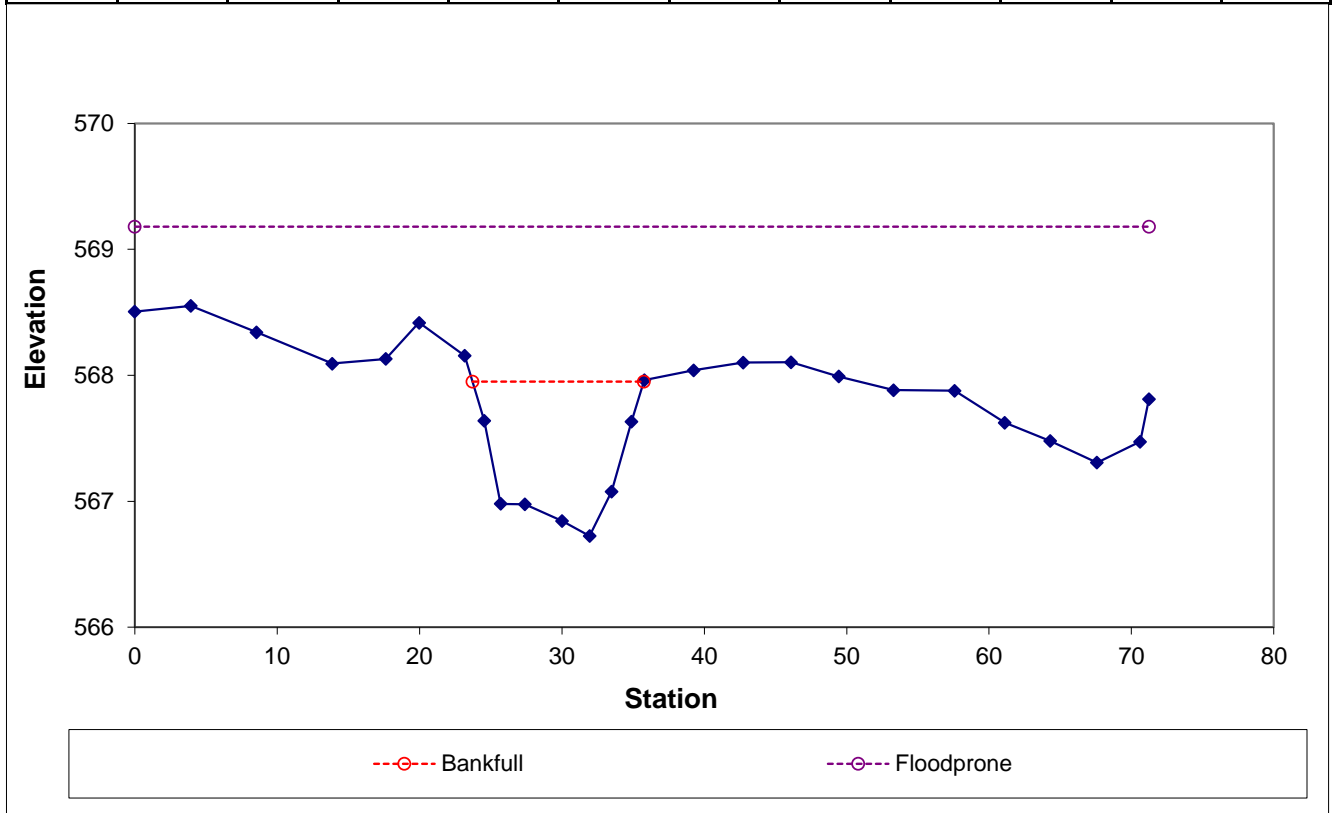
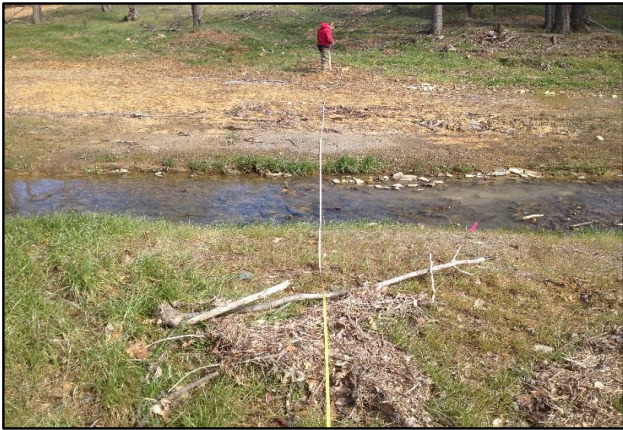
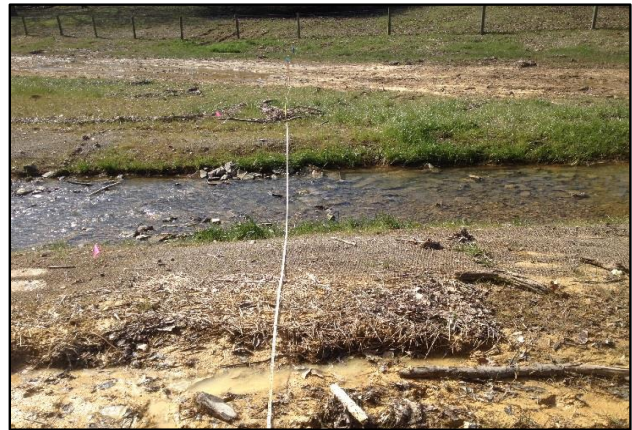
**Permanent Cross-section
X5 - Reach 1
(As-built Data - Collected April 2016)**

Feature	Stream Type	BKF Area	BKF Width	BKF Depth	Max BKF Depth	W/D	BH Ratio	ER	BKF Elev	TOB Elev	WFGPA
Riffle	C	10.1	12.05	0.84	1.23	14.4	1	5.9	567.95	567.96	71.23

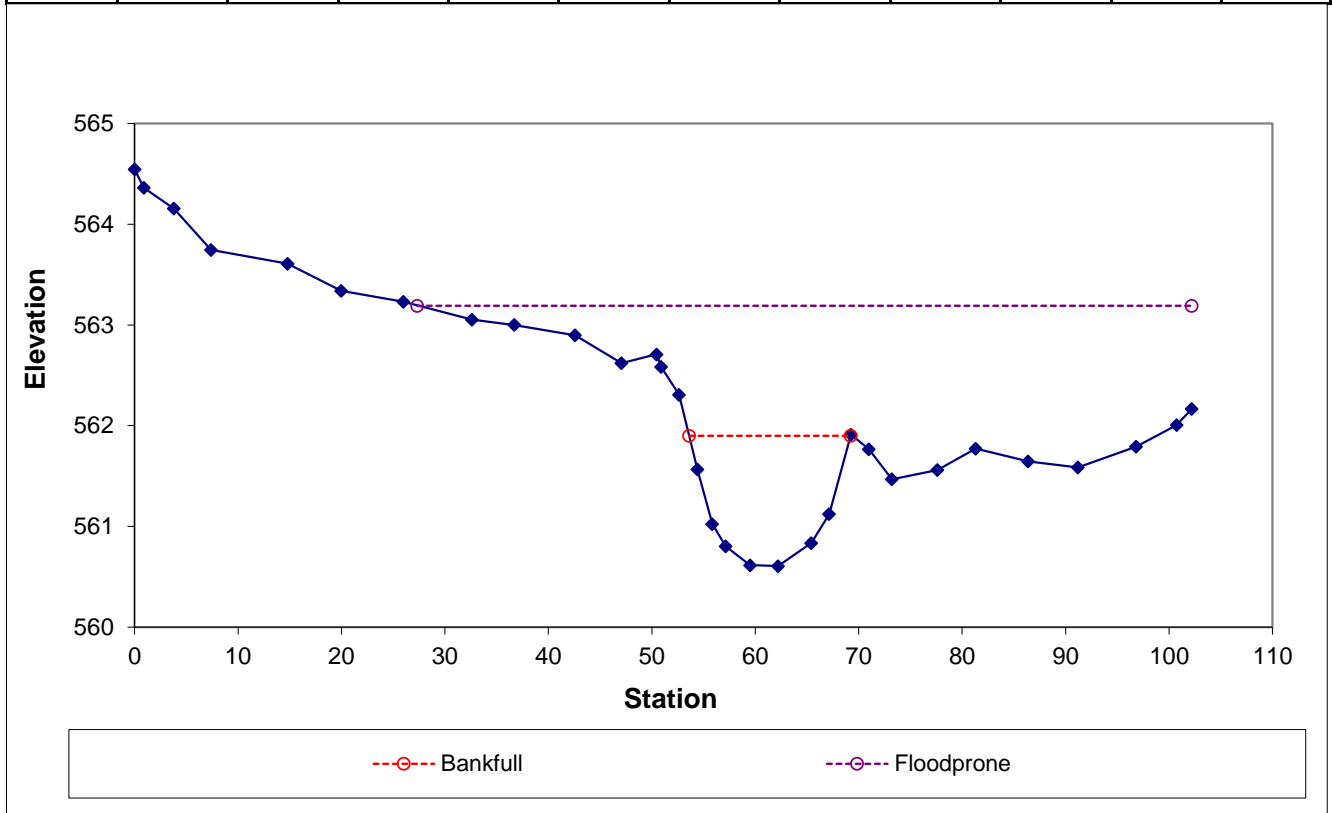
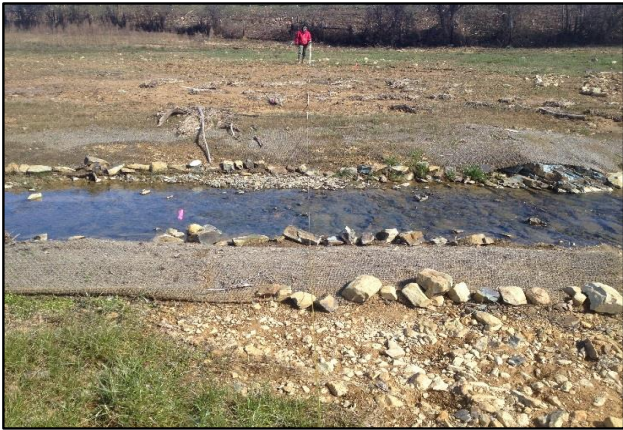
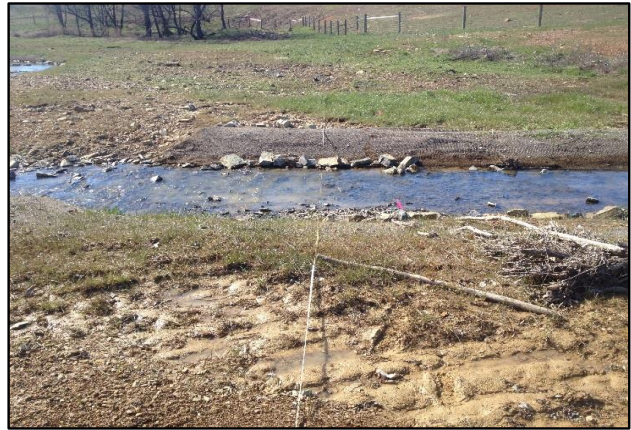
**Permanent Cross-section
X6 - Reach 2
(As-built Data - Collected April 2016)**

Feature	Stream Type	BKF Area	BKF Width	BKF Depth	Max BKF Depth	W/D	BH Ratio	ER	BKF Elev	TOB Elev	WFPA
Riffle	C	14.8	15.61	0.95	1.29	16.52	1	4.8	561.9	561.91	74.86

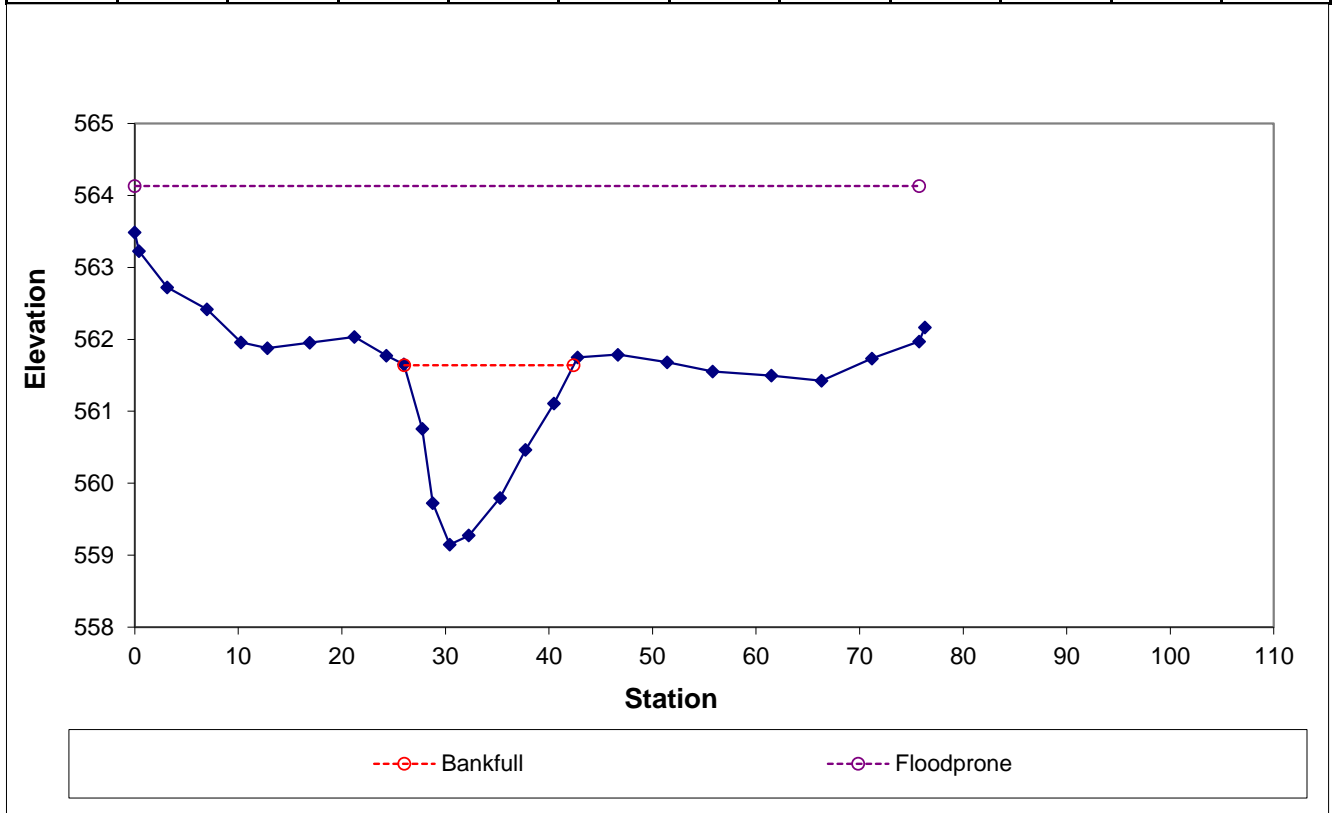
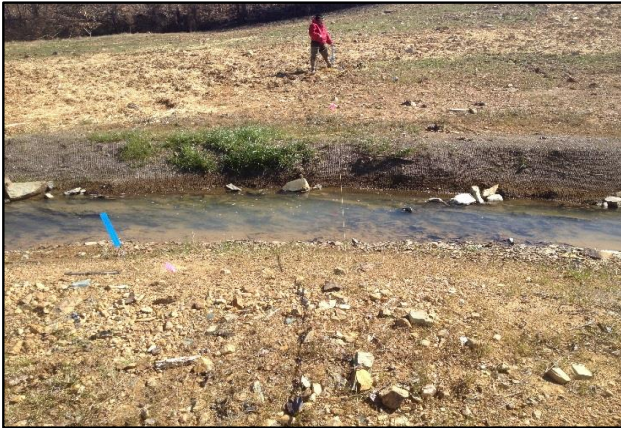
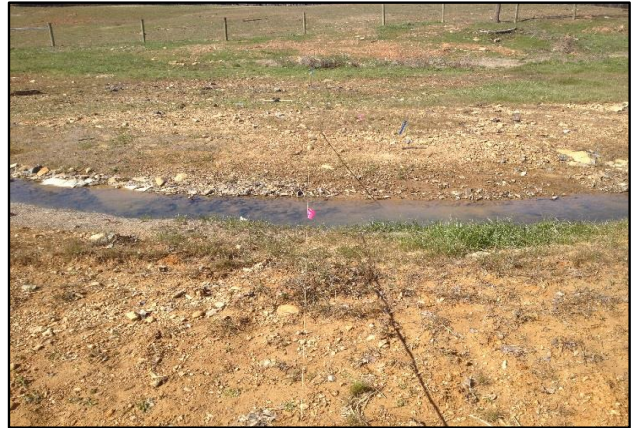
**Permanent Cross-section
X7 - Reach 2
(As-built Data - Collected April 2016)**

Feature	Stream Type	BKF Area	BKF Width	BKF Depth	Max BKF Depth	W/D	BH Ratio	ER	BKF Elev	TOB Elev	WFPA
Pool		23.2	16.34	1.42	2.49	11.52	1	4.6	561.64	561.65	75.75

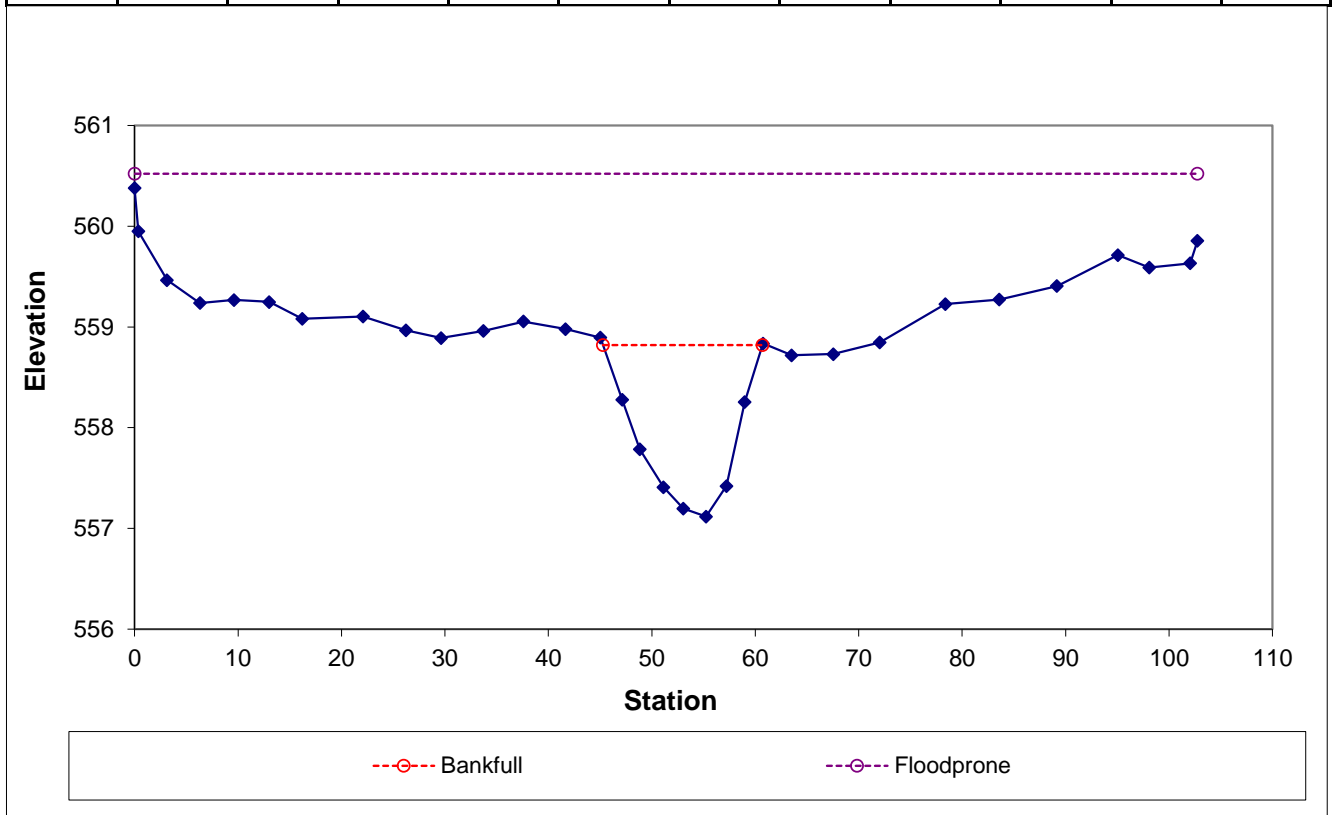
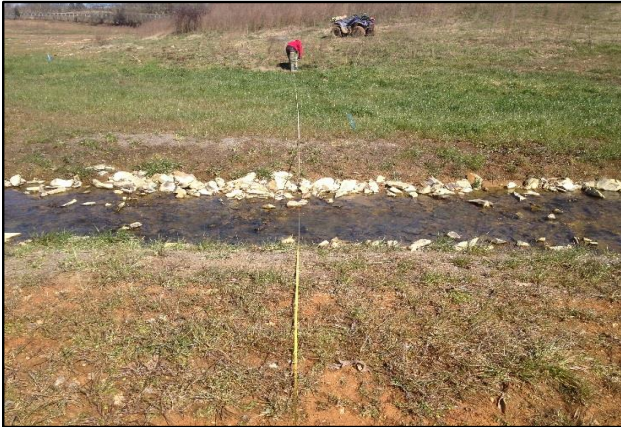
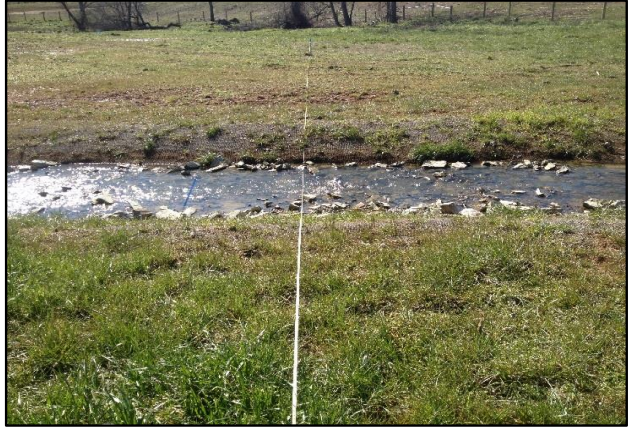
**Permanent Cross-section
X8 - Reach 2
(As-built Data - Collected April 2016)**

Feature	Stream Type	BKF Area	BKF Width	BKF Depth	Max BKF Depth	W/D	BH Ratio	ER	BKF Elev	TOB Elev	WFPA
Riffle	C	16.5	15.44	1.07	1.7	14.47	1	6.7	558.82	558.84	102.74

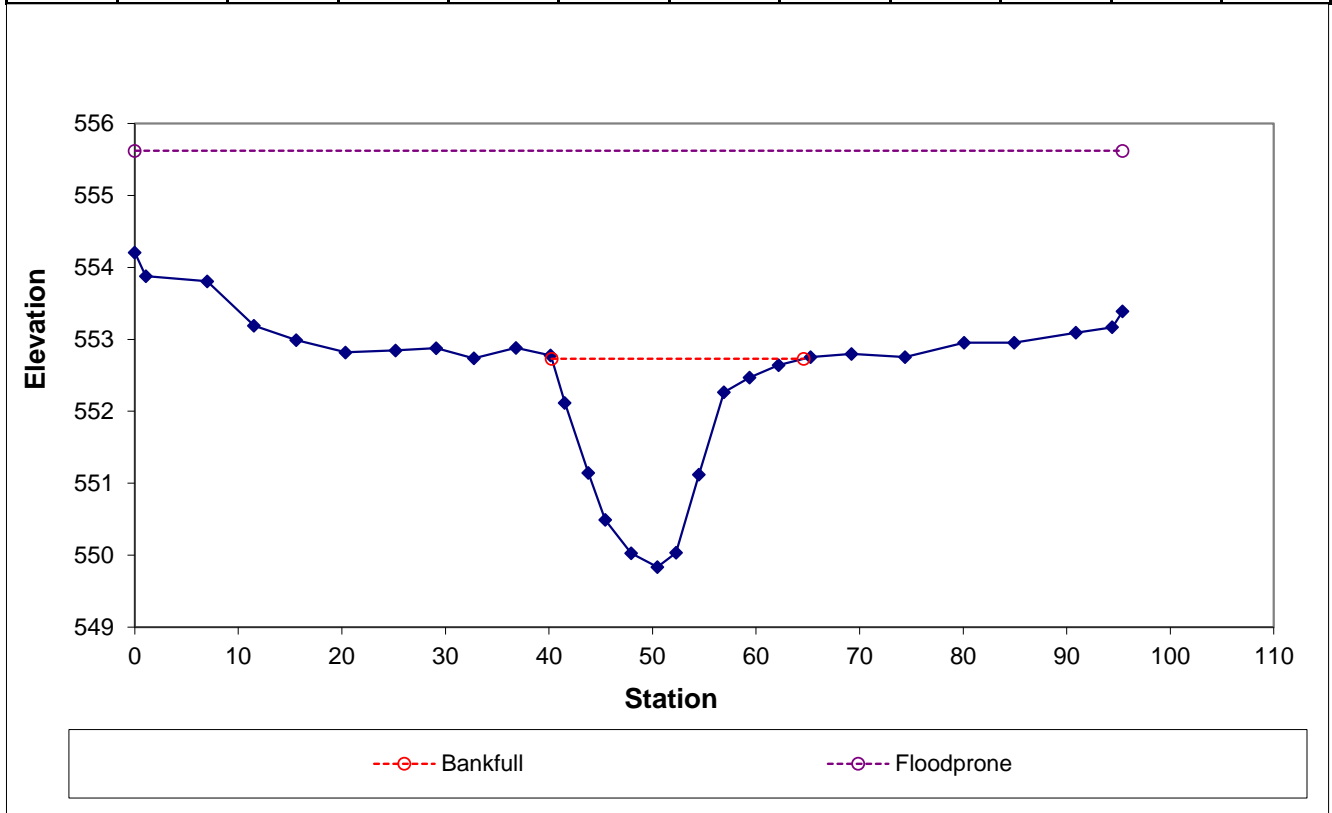
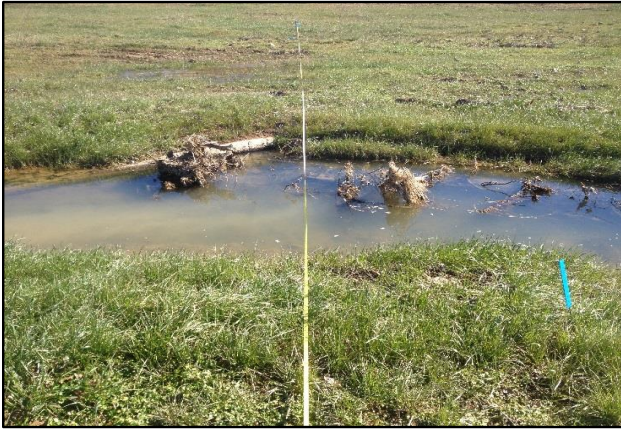
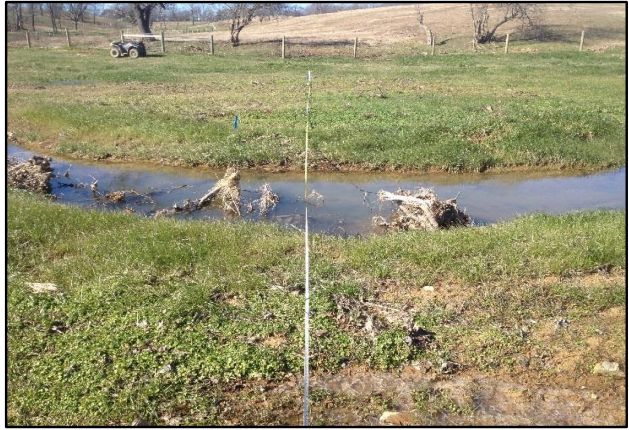
**Permanent Cross-section
X9 - Reach 2
(As-built Data - Collected April 2016)**

Feature	Stream Type	BKF Area	BKF Width	BKF Depth	Max BKF Depth	W/D	BH Ratio	ER	BKF Elev	TOB Elev	WSPA
Pool		33.1	24.33	1.36	2.89	17.9	1	3.9	552.73	552.76	95.4

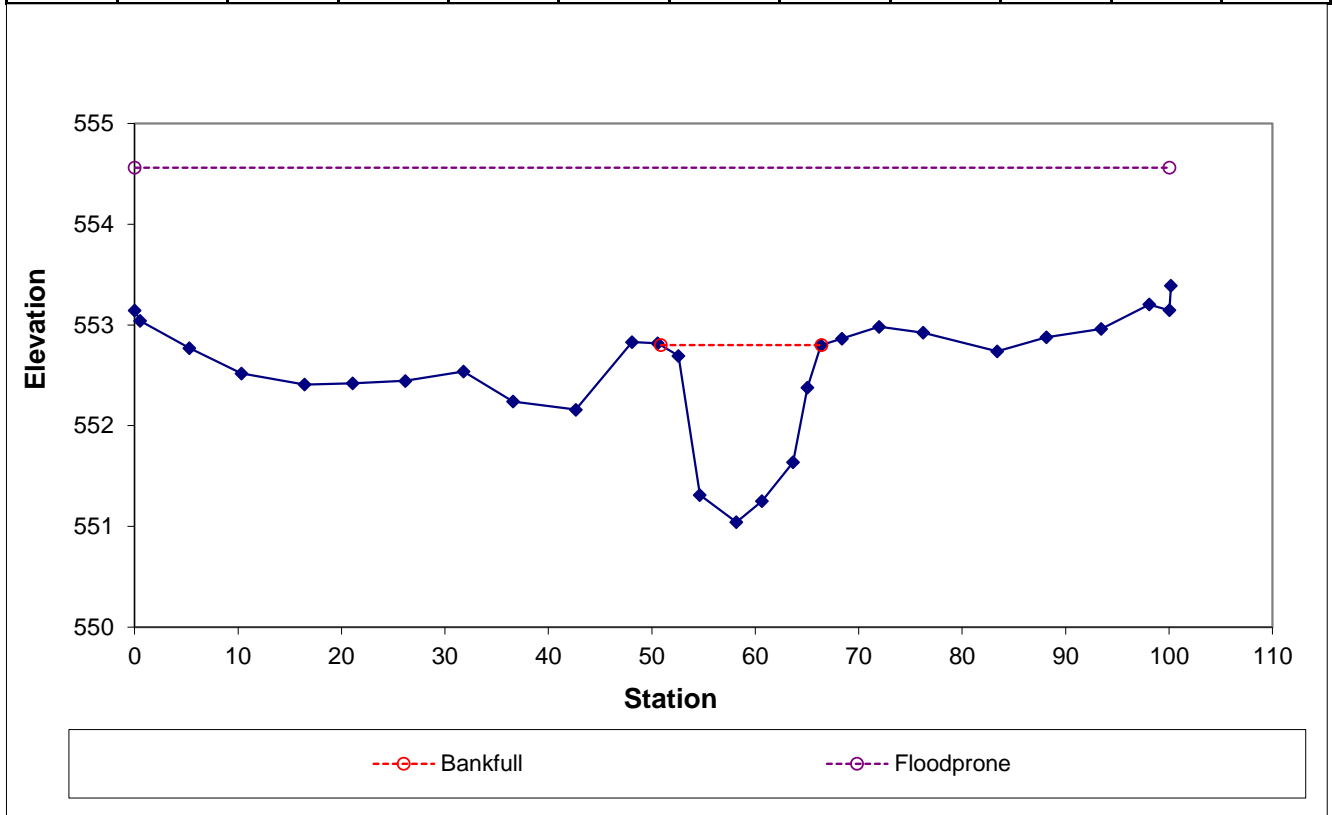
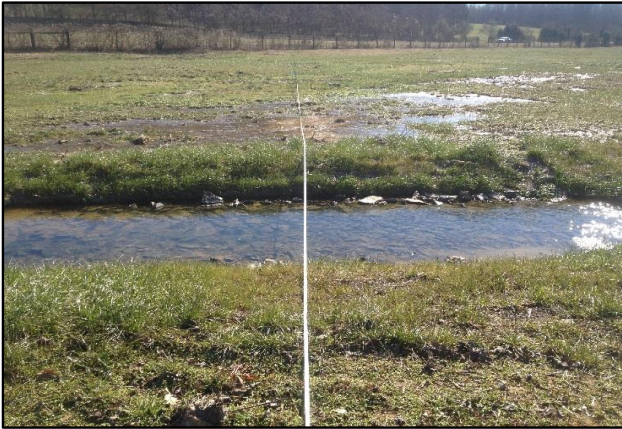
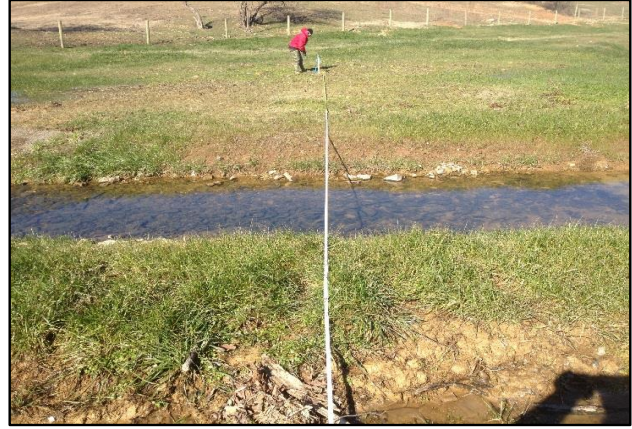
**Permanent Cross-section
X10 - Reach 2
(As-built Data - Collected April 2016)**

Feature	Stream Type	BKF Area	BKF Width	BKF Depth	Max BKF Depth	W/D	BH Ratio	ER	BKF Elev	TOB Elev	WFGPA
Riffle	C	17	15.54	1.1	1.76	14.19	1	6.4	552.8	552.8	100.03

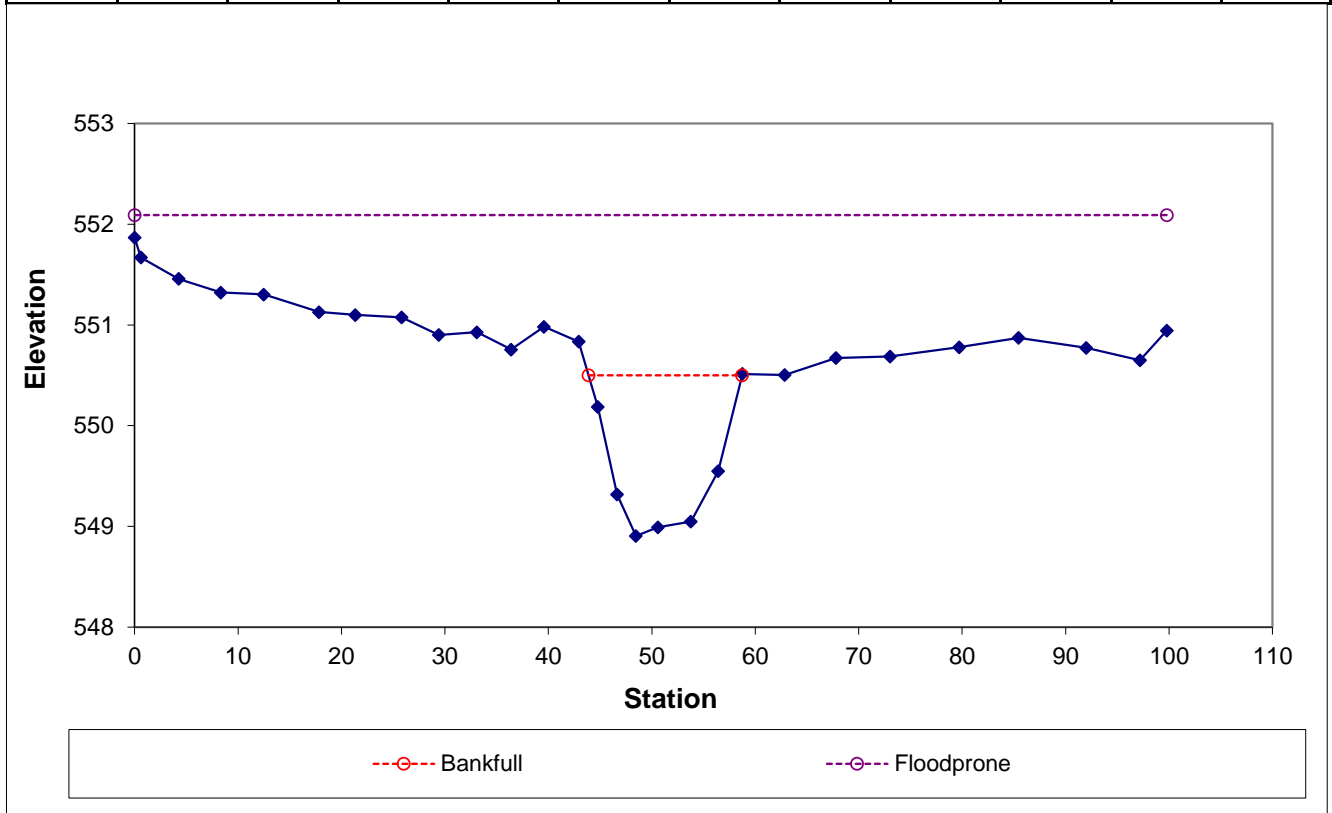
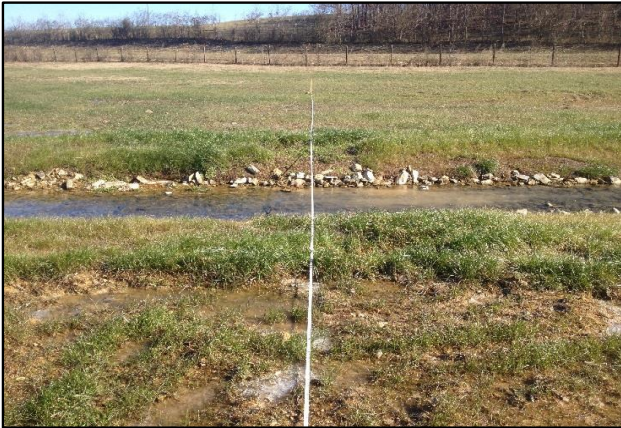
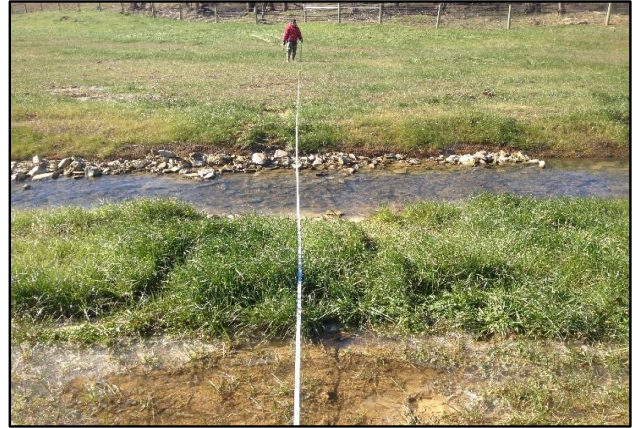
**Permanent Cross-section
X11 - Reach 3
(As-built Data - Collected April 2016)**

Feature	Stream Type	BKF Area	BKF Width	BKF Depth	Max BKF Depth	W/D	BH Ratio	ER	BKF Elev	TOB Elev	WFGPA
Riffle	C	16.3	14.85	1.1	1.59	13.49	1	6.7	550.5	550.51	99.8

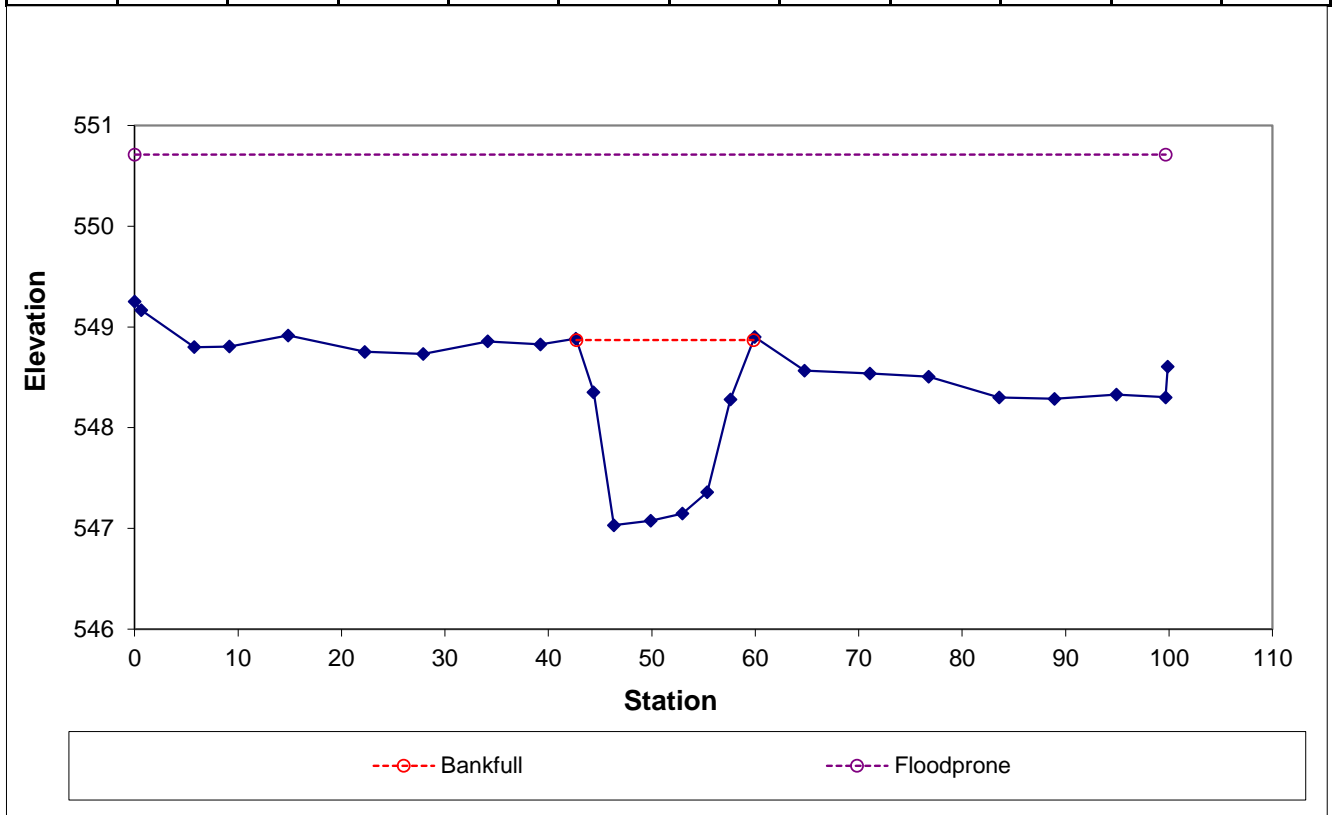
**Permanent Cross-section
X12 - Reach 3
(As-built Data - Collected April 2016)**

Feature	Stream Type	BKF Area	BKF Width	BKF Depth	Max BKF Depth	W/D	BH Ratio	ER	BKF Elev	TOB Elev	WFPA
Riffle	C	21.5	17.12	1.25	1.84	13.66	1	5.8	548.87	548.88	99.67

For monitoring stream success criteria, nineteen (19) permanent cross-sections were installed along Restoration and Enhancement I reaches throughout the Site. The permanent cross-sections will be used to monitor channel dimension and bank stability over time. One crest gauge was installed along Reach 3. The crest gauge will be used to document the occurrence of bankfull events. To provide a baseline for evaluating changes in bed conditions over time, a longitudinal survey was completed for each of the following stream reaches upon which Restoration and/or Enhancement I Mitigation was conducted: Reach 1, Reach 2, Reach 3, Reach 4, Reach 6, and Reach 7. The as-built permanent cross-sections (with photos) and the as-built longitudinal data, as well as the quantitative pre-construction, reference reach, and design data used to determine restoration approach are provided in Appendix B. In addition, the as-built reachwide bed material sampling data for Reach 1, Reach 2, Reach 3, and Reach 6 are included in Appendix B. As-built data will be used for comparison to post-construction monitoring data. The locations of the permanent cross-sections and the crest gauge are shown on the as-built plan sheets in Appendix D. Representative photographs from selected portions of each project reach are provided in Appendix E.
