FINAL
Baseline Monitoring Document and As-Built Baseline Report
UT to Town Creek Restoration Project – Option A

Stanly County, North Carolina

DMS Project ID No. 94648; NCDEQ Contract No. 003277

Data Collection Period – February – June 2016

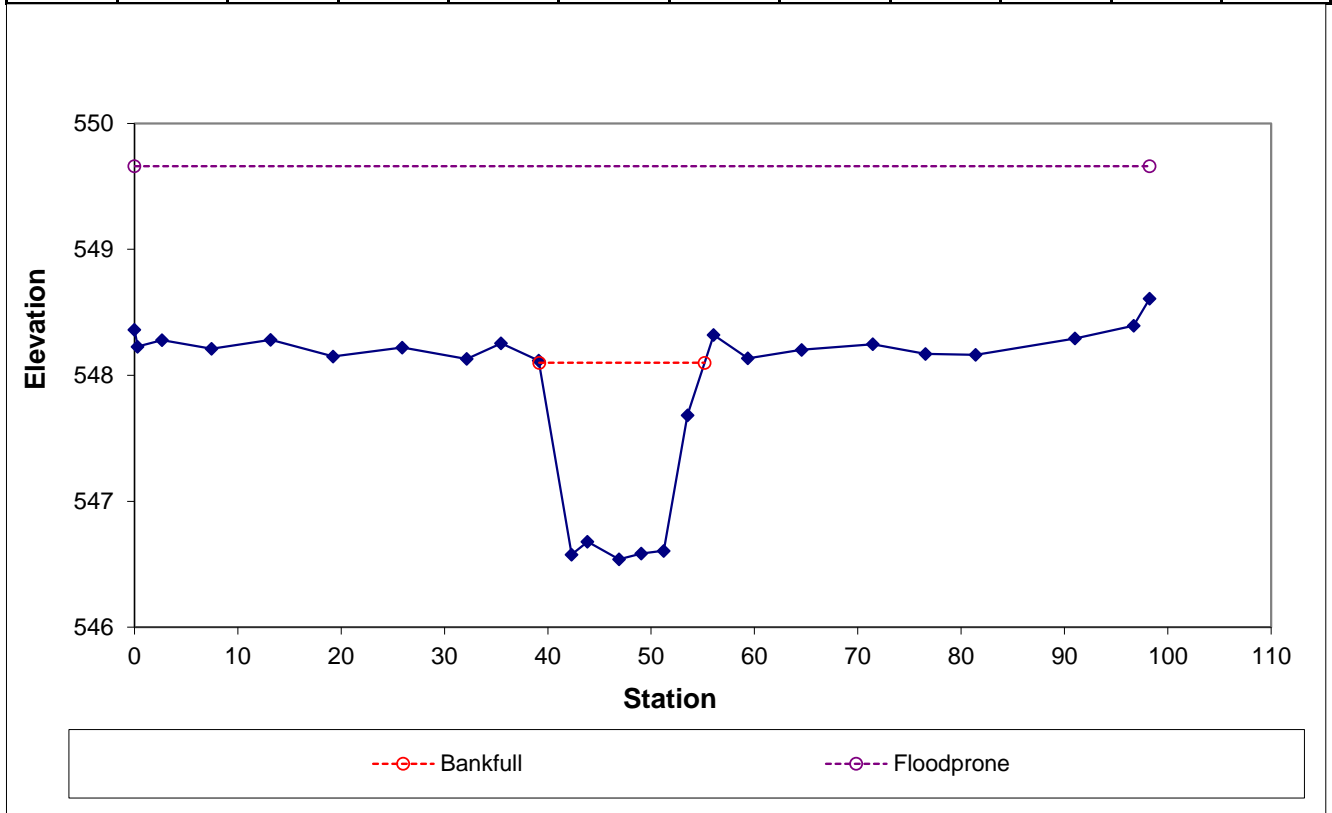
**Permanent Cross-section
X13 - Reach 3
(As-built Data - Collected April 2016)**

Feature	Stream Type	BKF Area	BKF Width	BKF Depth	Max BKF Depth	W/D	BH Ratio	ER	BKF Elev	TOB Elev	WFPA
Riffle	C	18.3	16	1.15	1.56	13.96	1	6.1	548.1	548.12	98.25

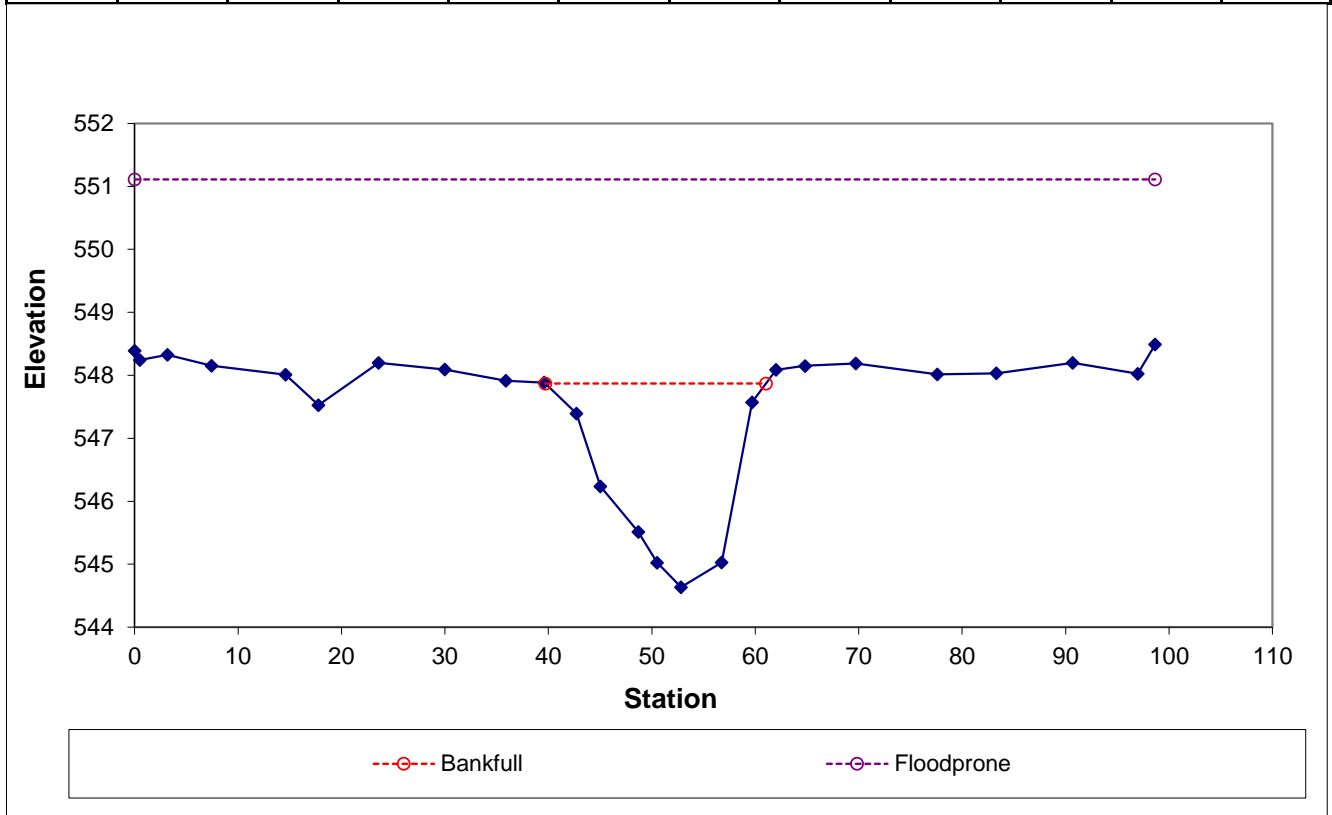
**Permanent Cross-section
X14 - Reach 3
(As-built Data - Collected April 2016)**

Feature	Stream Type	BKF Area	BKF Width	BKF Depth	Max BKF Depth	W/D	BH Ratio	ER	BKF Elev	TOB Elev	WFPA
Pool		39	21.33	1.83	3.24	11.67	1	4.6	547.87	547.89	98.66

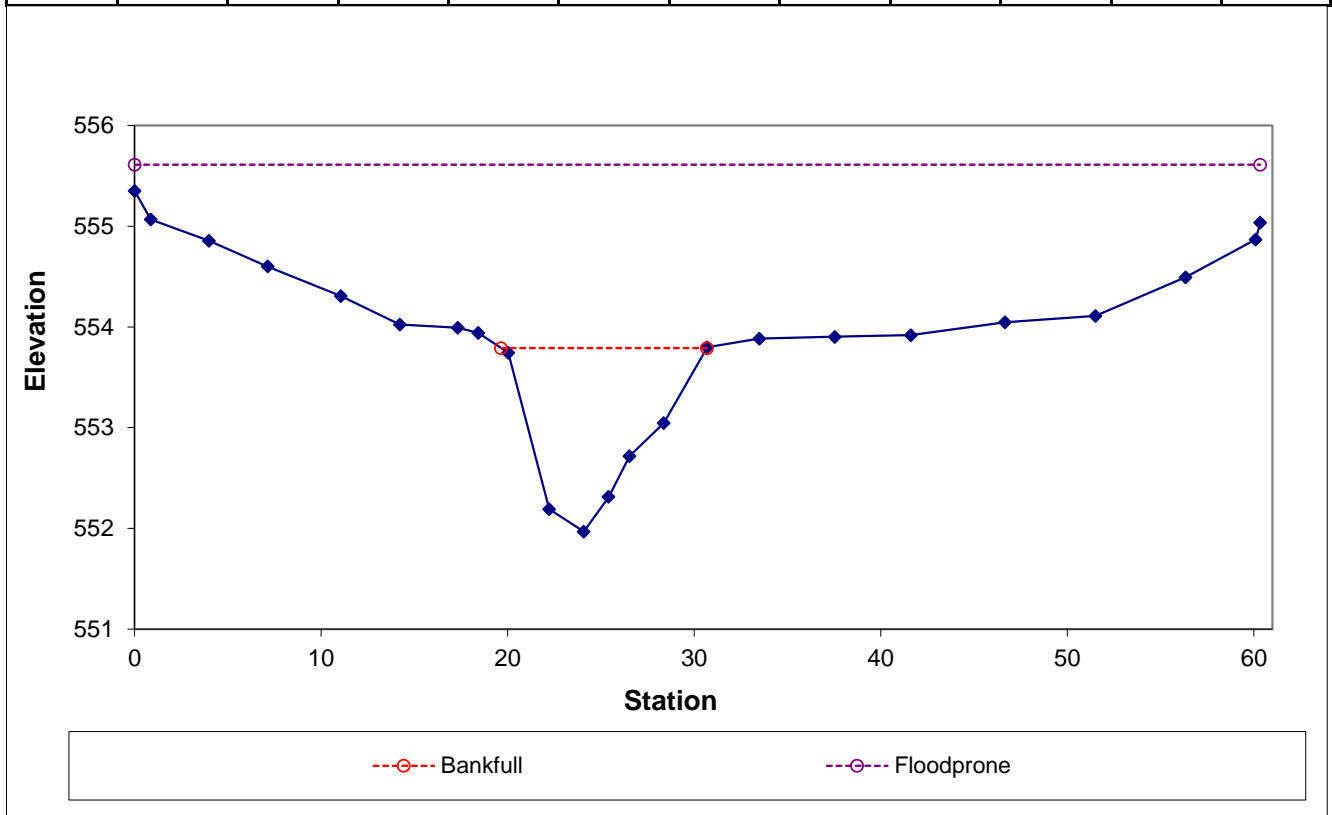
**Permanent Cross-section
X15 - Reach 6
(As-built Data - Collected April 2016)**

Feature	Stream Type	BKF Area	BKF Width	BKF Depth	Max BKF Depth	W/D	BH Ratio	ER	BKF Elev	TOB Elev	WFOA
Pool		11.1	11.02	1.01	1.82	10.91	1	5.5	553.79	553.8	60.34

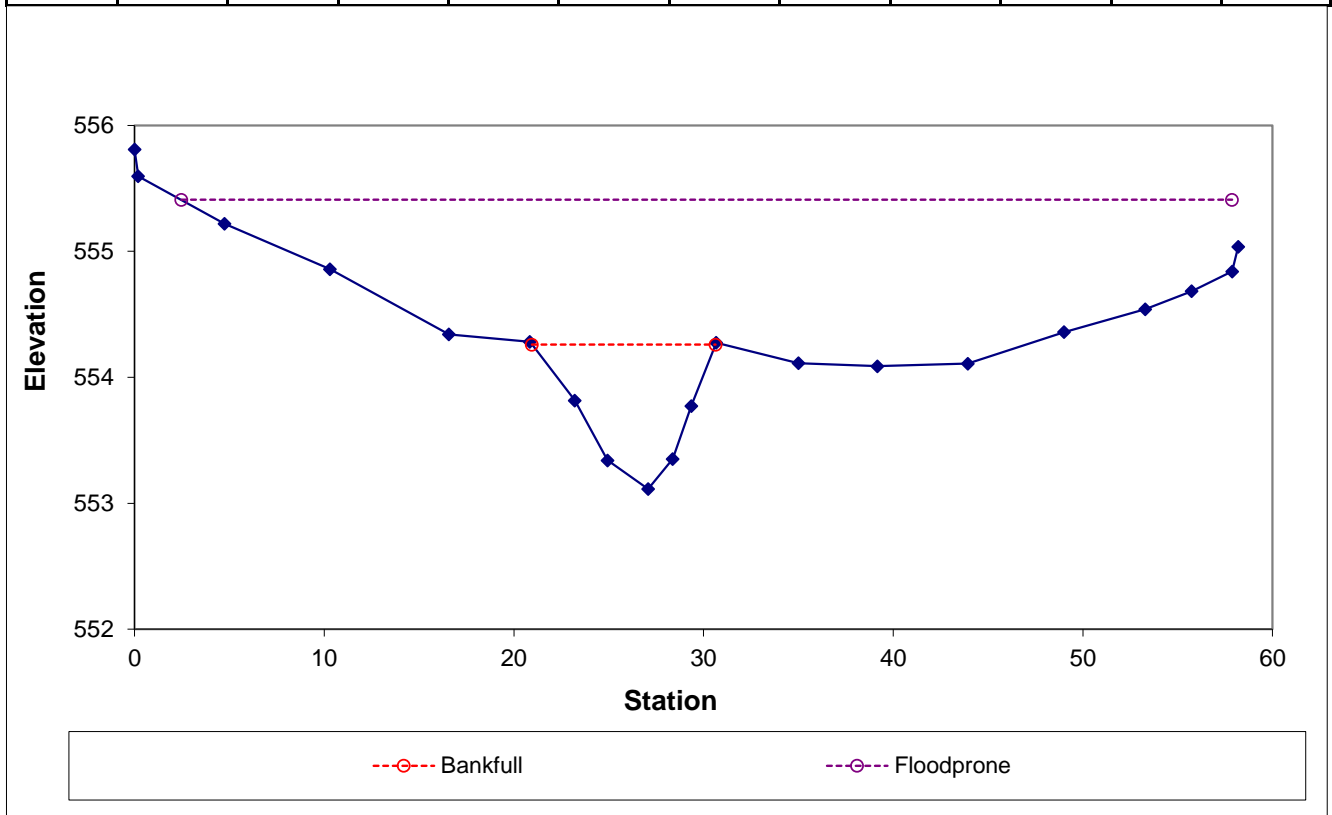
**Permanent Cross-section
X16 - Reach 6
(As-built Data - Collected April 2016)**

Feature	Stream Type	BKF Area	BKF Width	BKF Depth	Max BKF Depth	W/D	BH Ratio	ER	BKF Elev	TOB Elev	WFGPA
Riffle	C	6.2	9.68	0.64	1.15	15.08	1	5.7	554.26	554.27	55.4

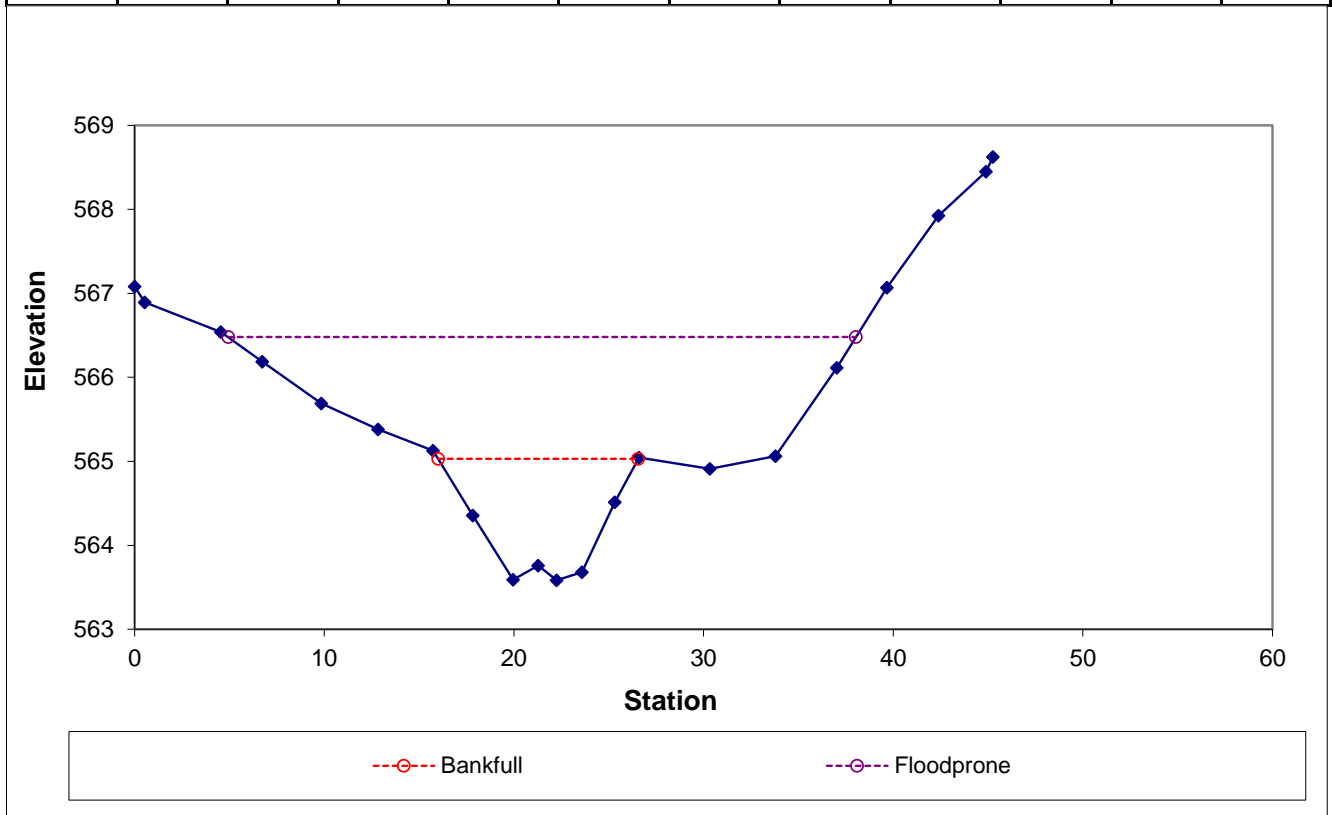
**Permanent Cross-section
X17 - Reach 6
(As-built Data - Collected April 2016)**

Feature	Stream Type	BKF Area	BKF Width	BKF Depth	Max BKF Depth	W/D	BH Ratio	ER	BKF Elev	TOB Elev	WFPA
Riffle	C	9.8	10.54	0.93	1.45	11.37	1	3.1	565.03	565.05	33.09

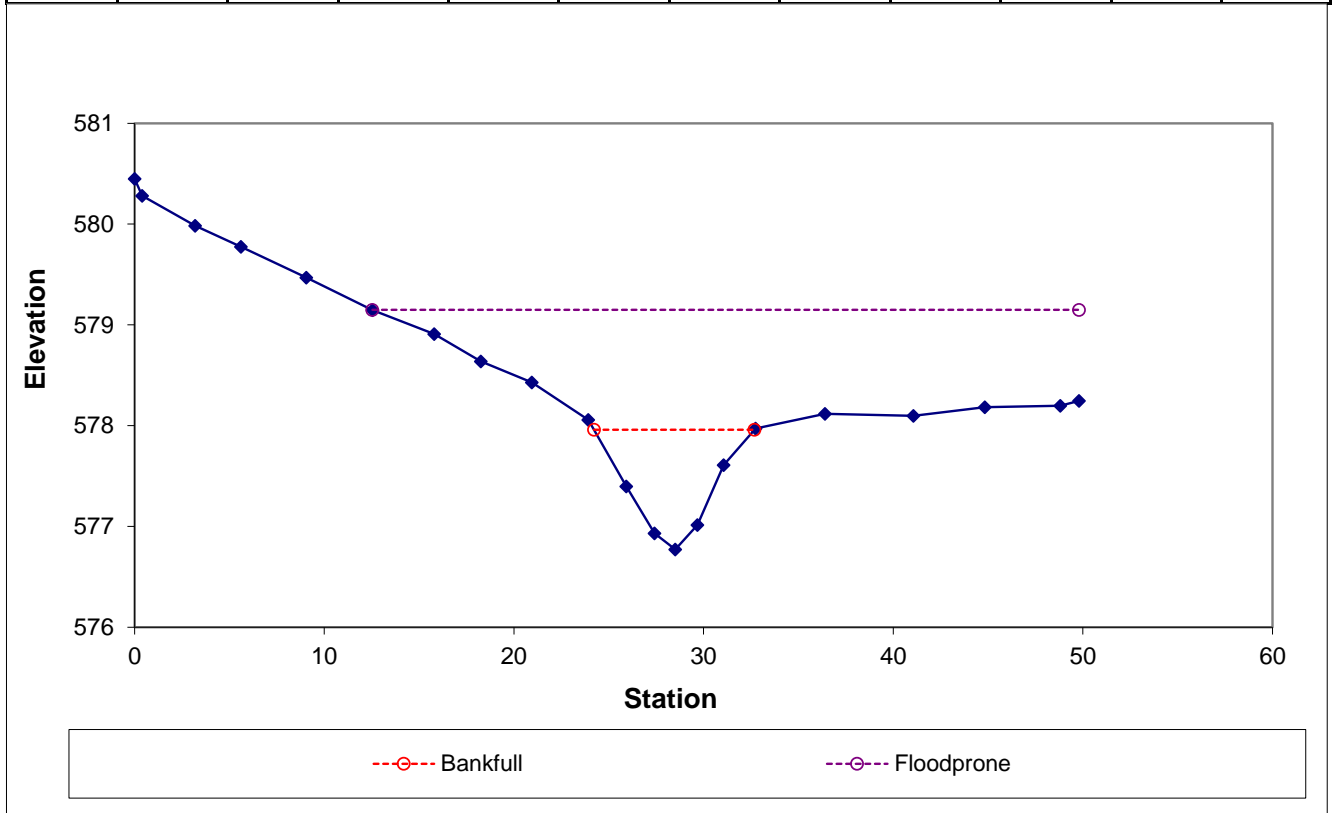
**Permanent Cross-section
X18 - Reach 6
(As-built Data - Collected April 2016)**

Feature	Stream Type	BKF Area	BKF Width	BKF Depth	Max BKF Depth	W/D	BH Ratio	ER	BKF Elev	TOB Elev	WFOA
Riffle	C	5.3	8.47	0.63	1.19	13.53	1	4.4	577.96	577.97	37.26

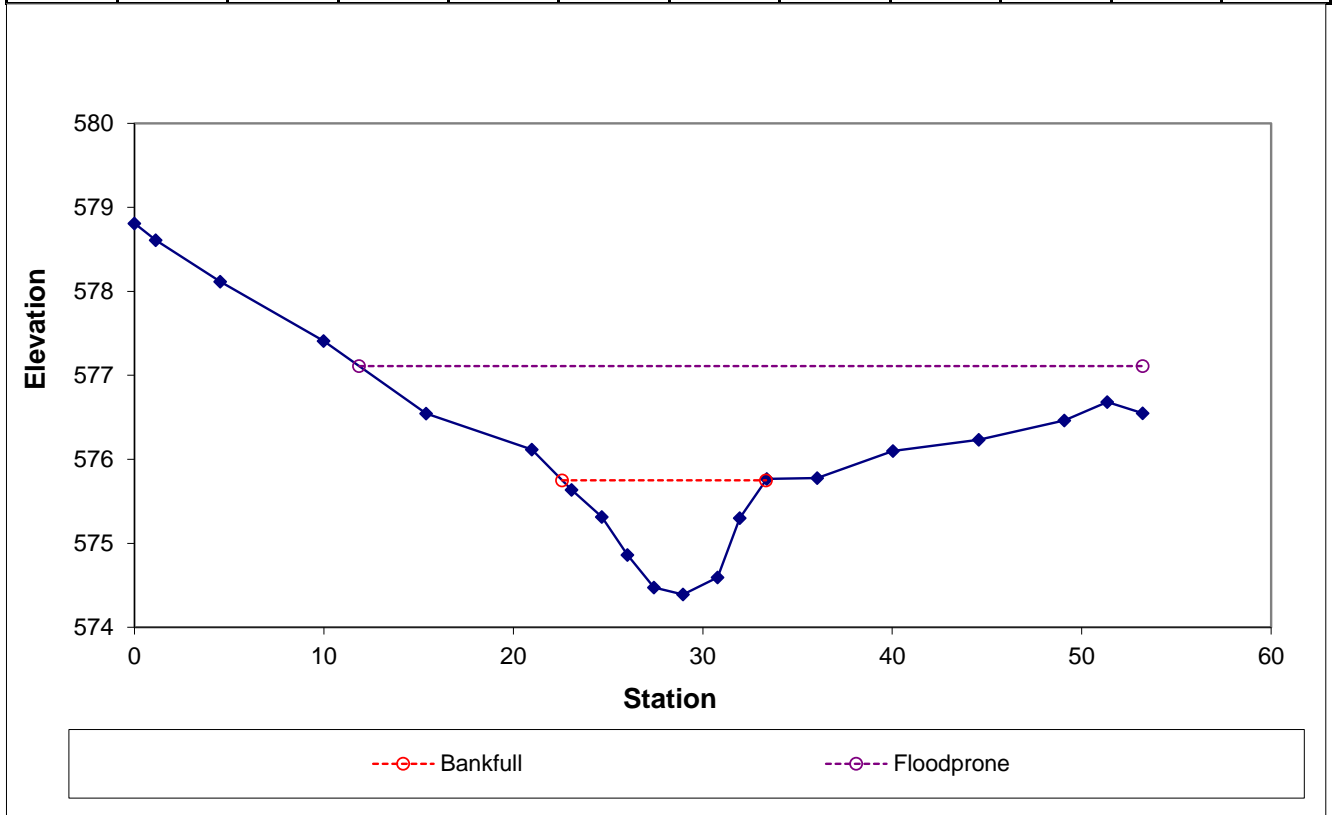
**Permanent Cross-section
X19 - Reach 6
(As-built Data - Collected April 2016)**

Feature	Stream Type	BKF Area	BKF Width	BKF Depth	Max BKF Depth	W/D	BH Ratio	ER	BKF Elev	TOB Elev	WFPA
Pool		8.4	10.76	0.78	1.36	13.73	1	3.8	575.75	575.77	41.36

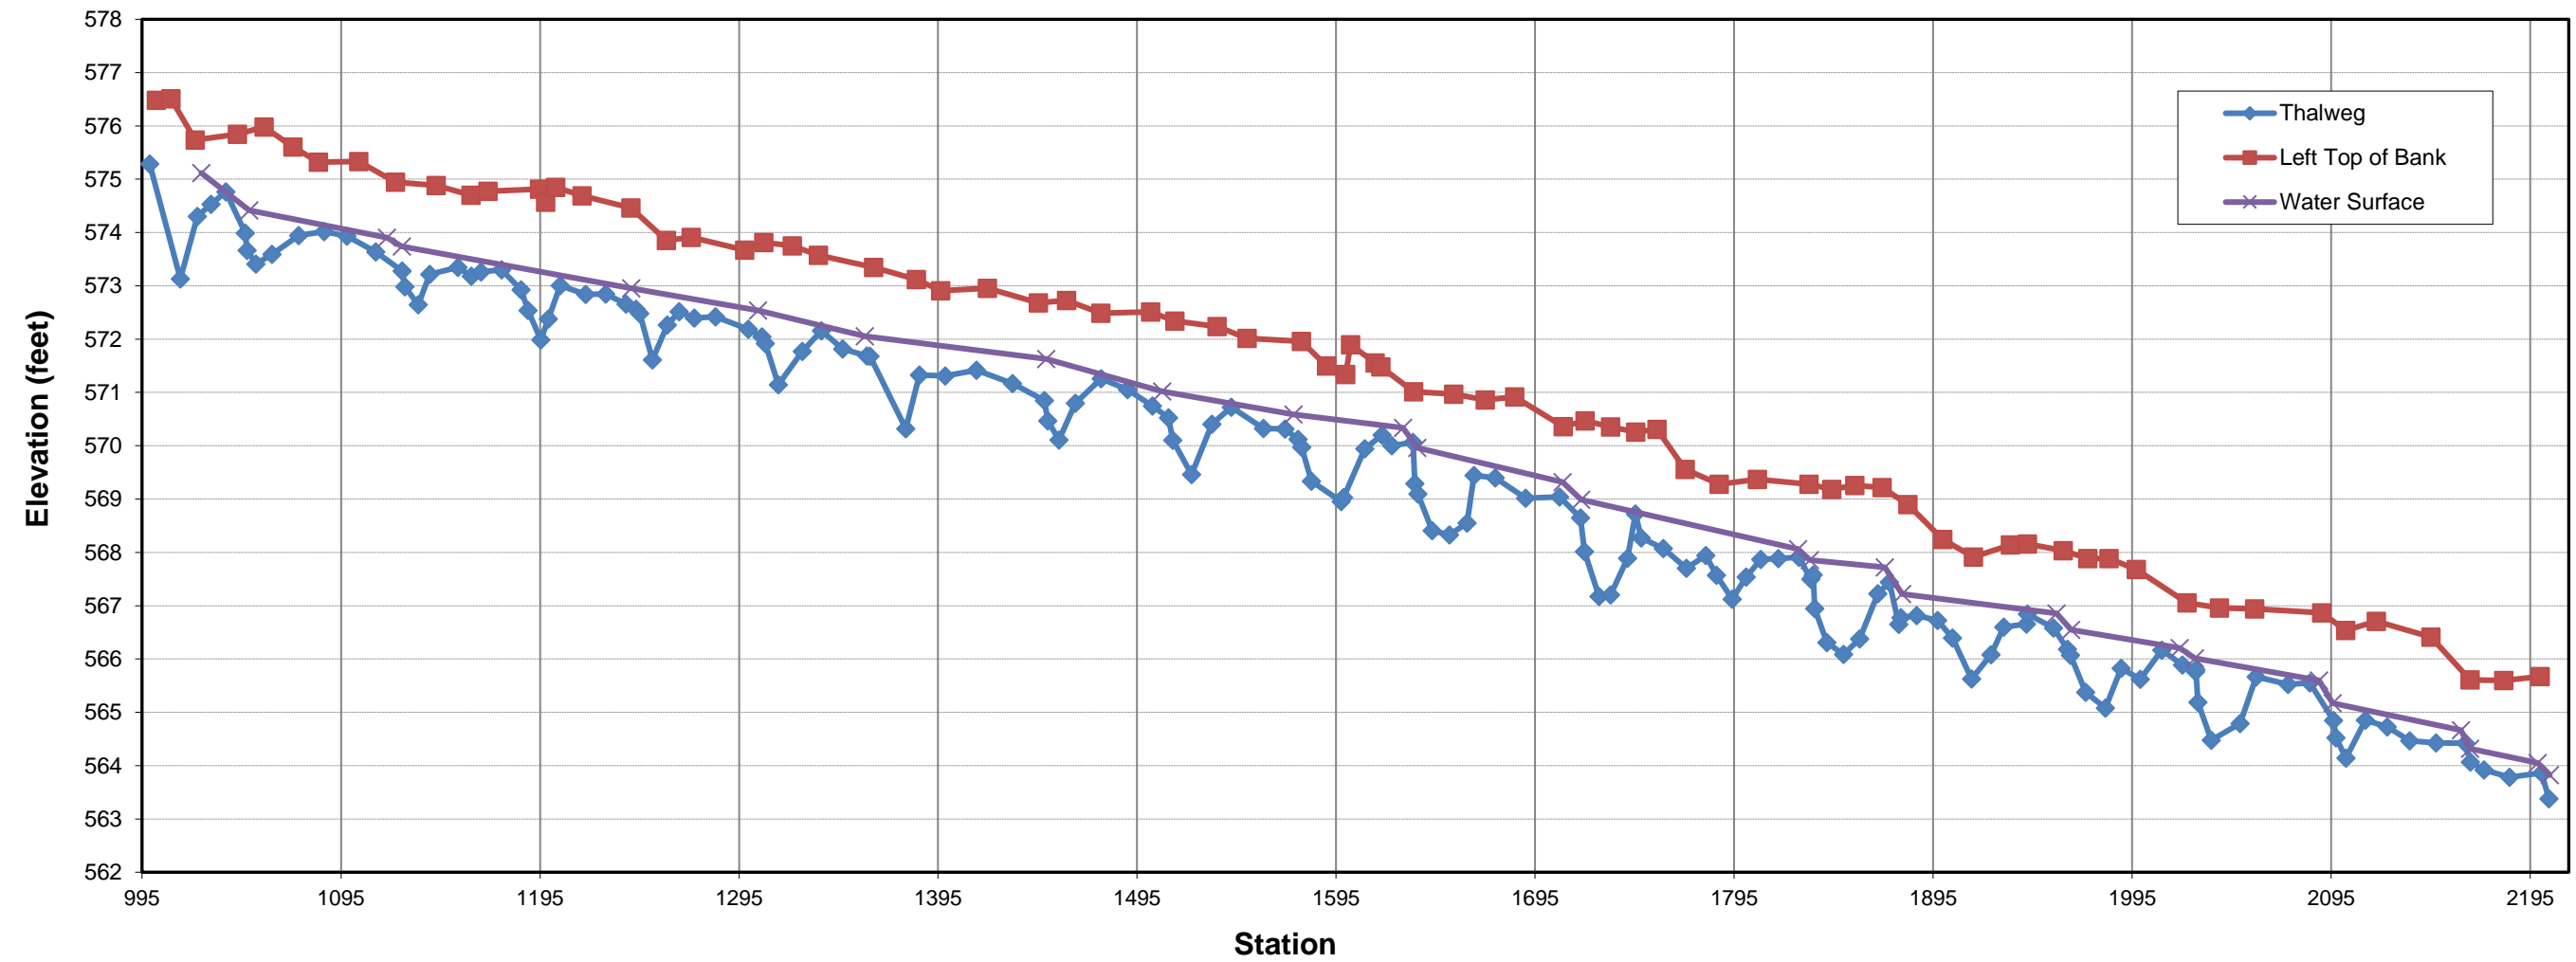
UT to Town Creek - Reach 1
As-built Stations 9+95 to 22+04
(Data Collected April 2016)

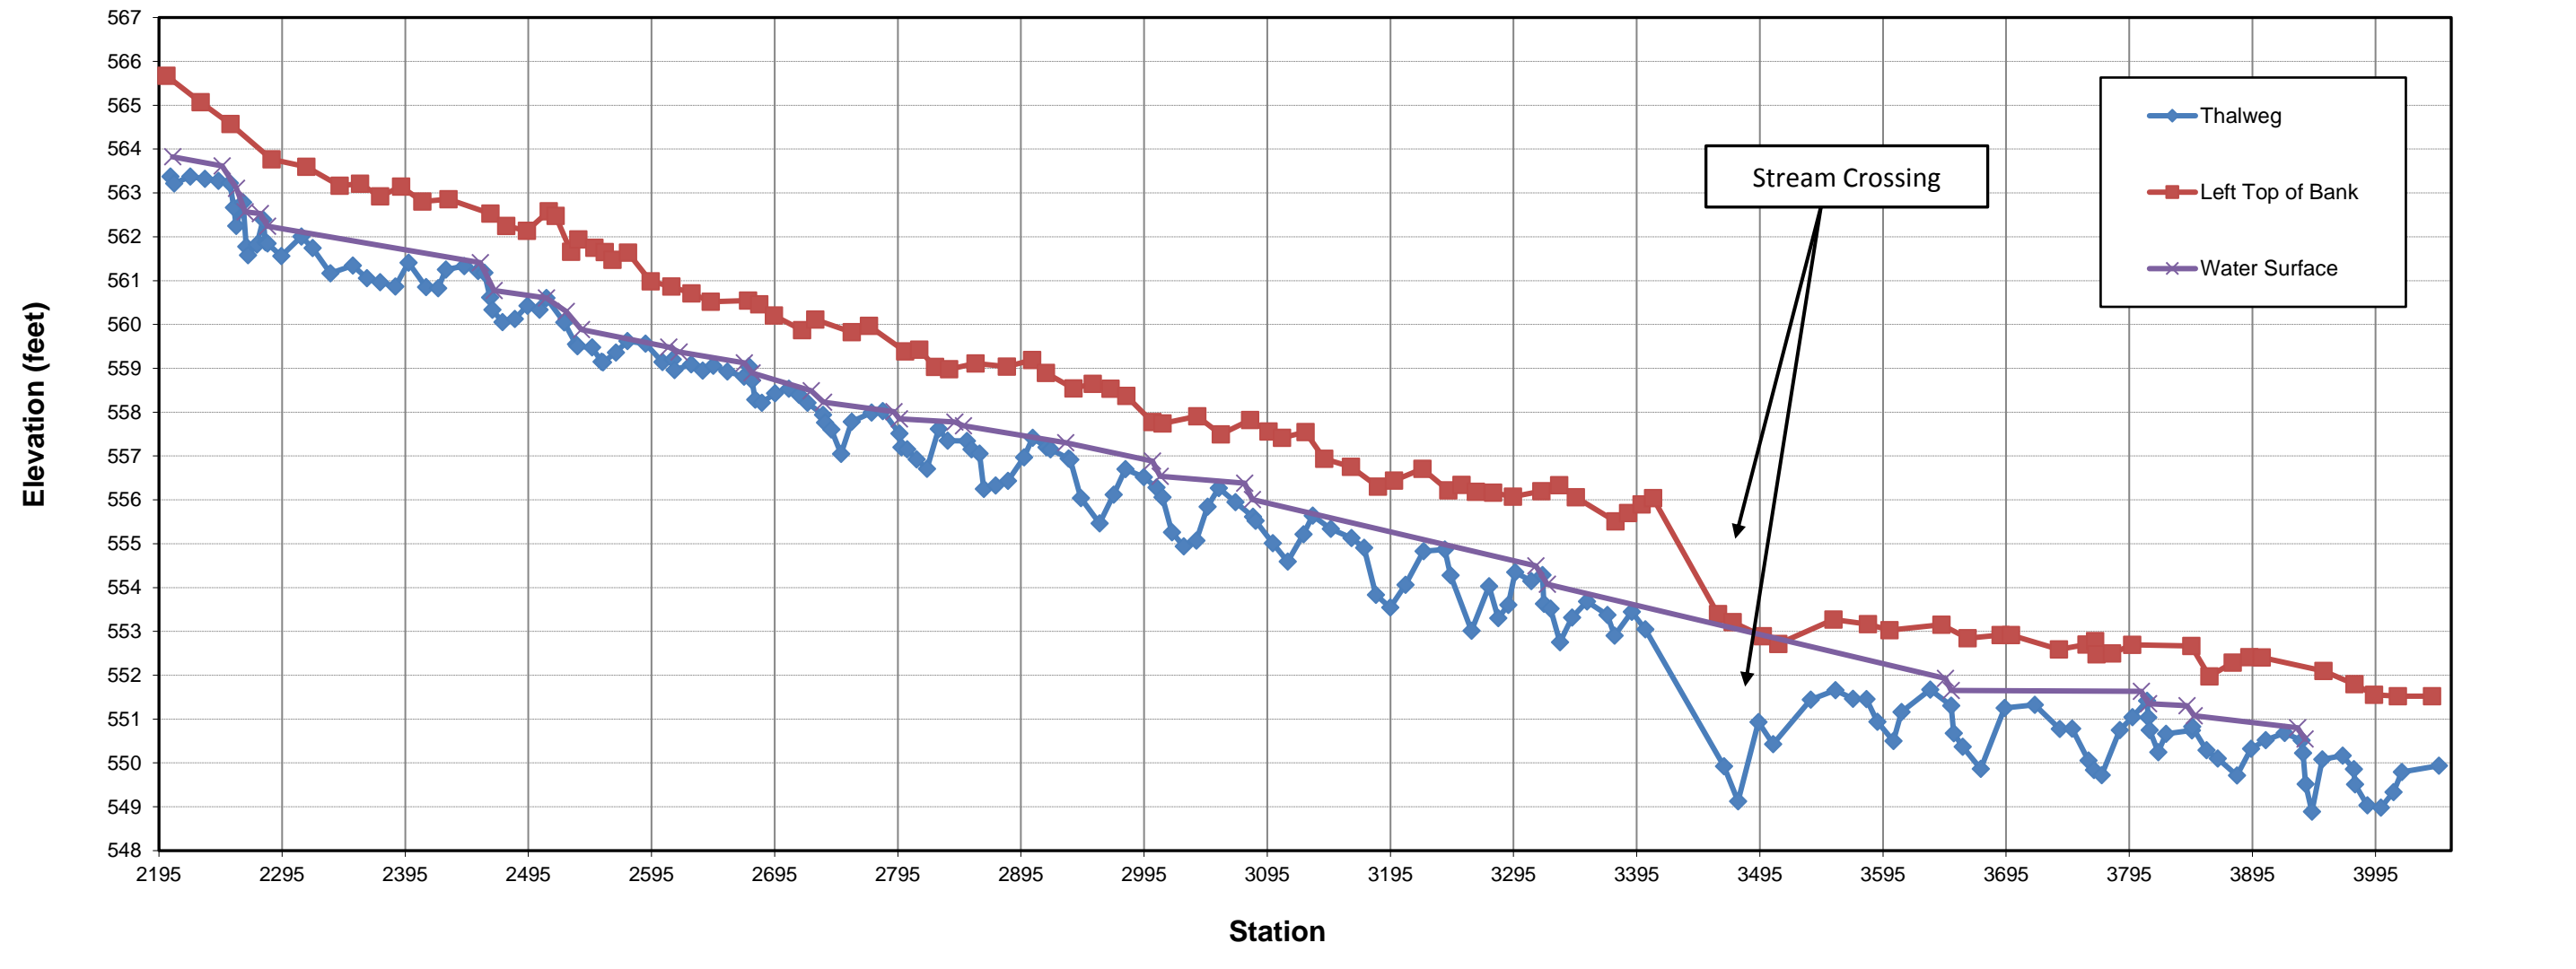
UT to Town Creek - Reach 2
As-Built Stations 22+04 to 40+46
(Data Collected April 2016)

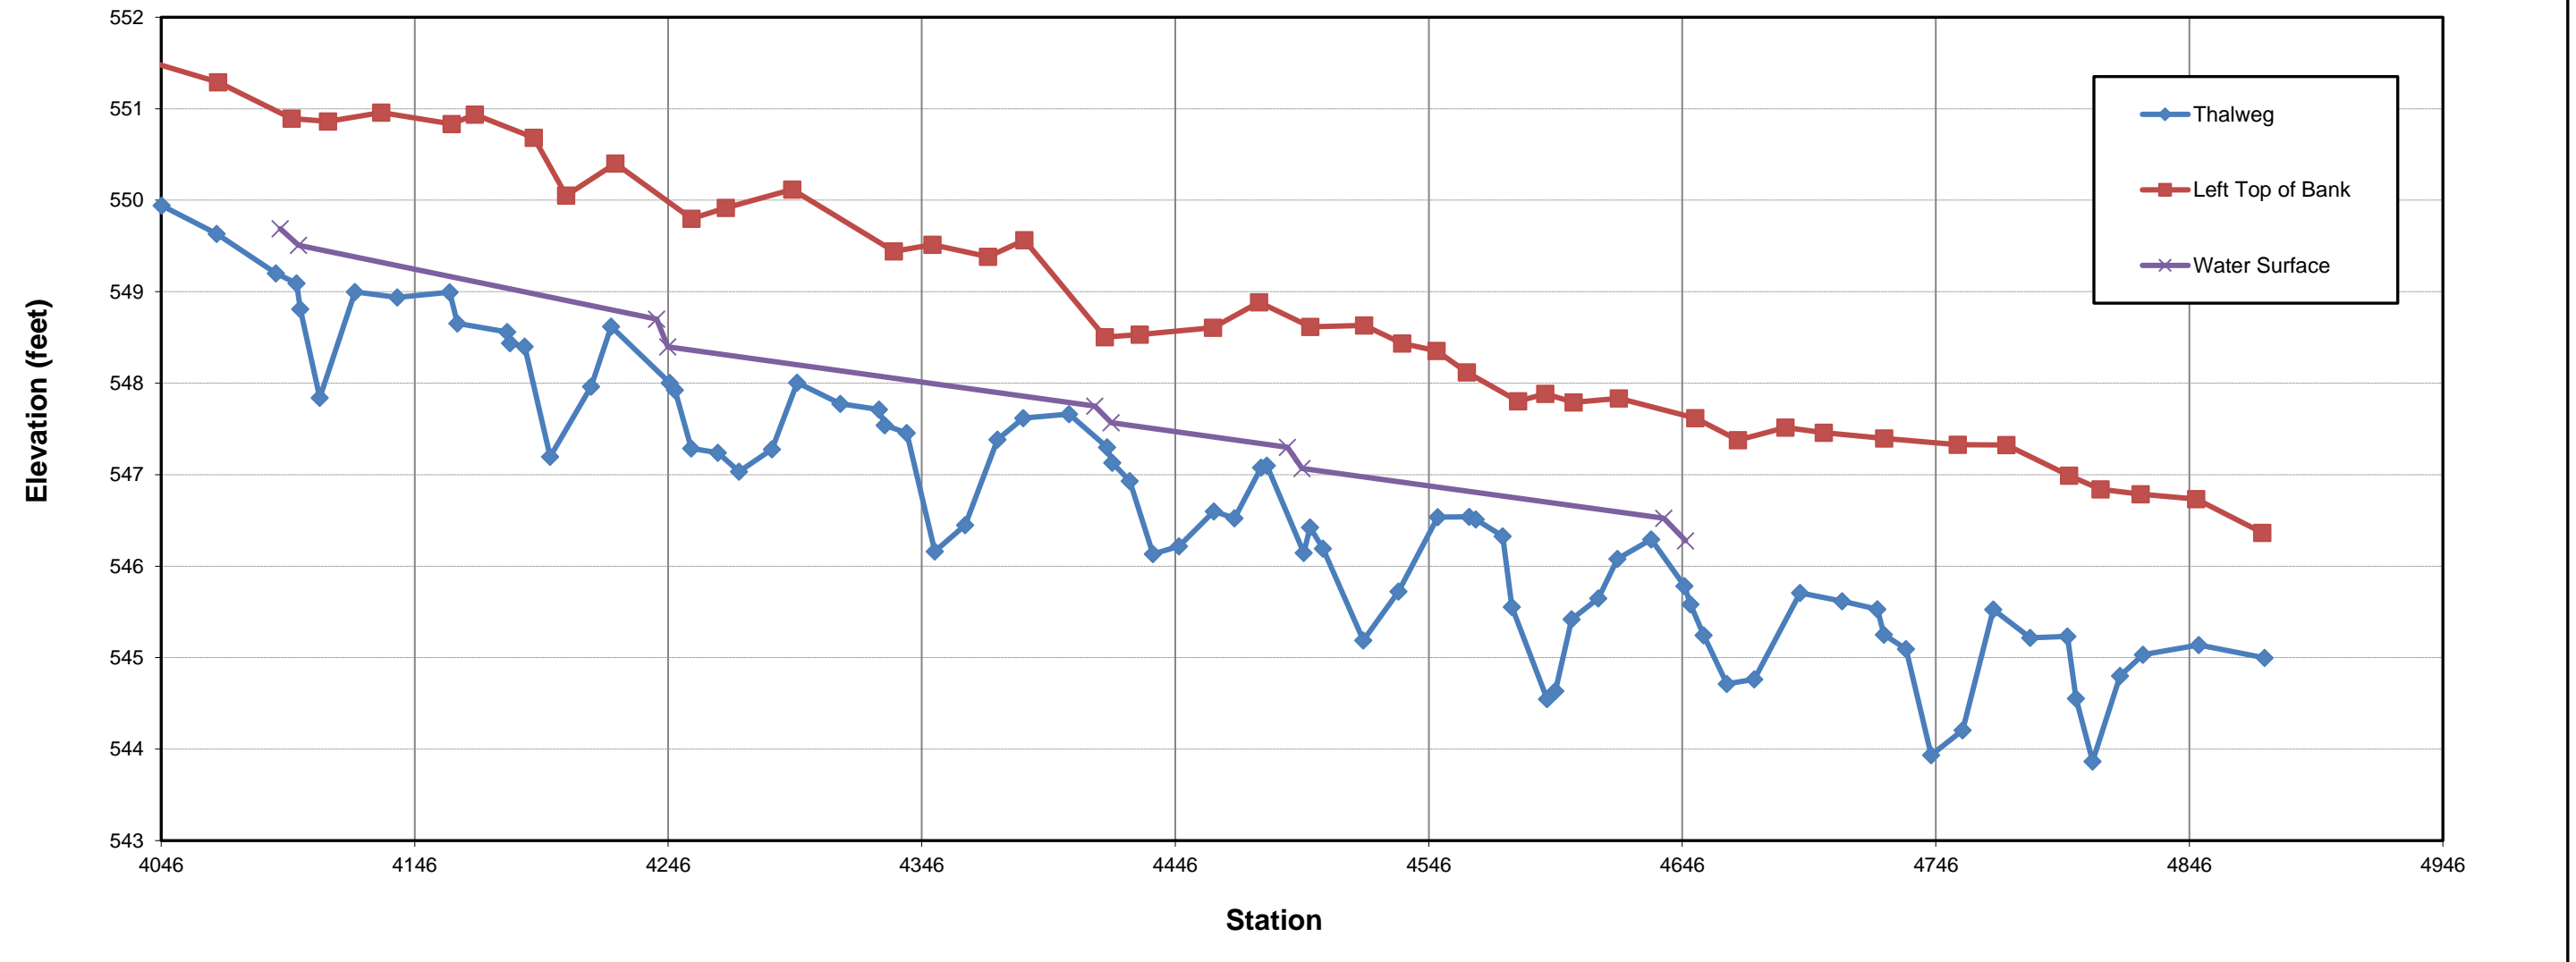
UT to Town Creek - Reach 3
As-Built Stations 40+46 to 48+75
(Data Collected April 2016)

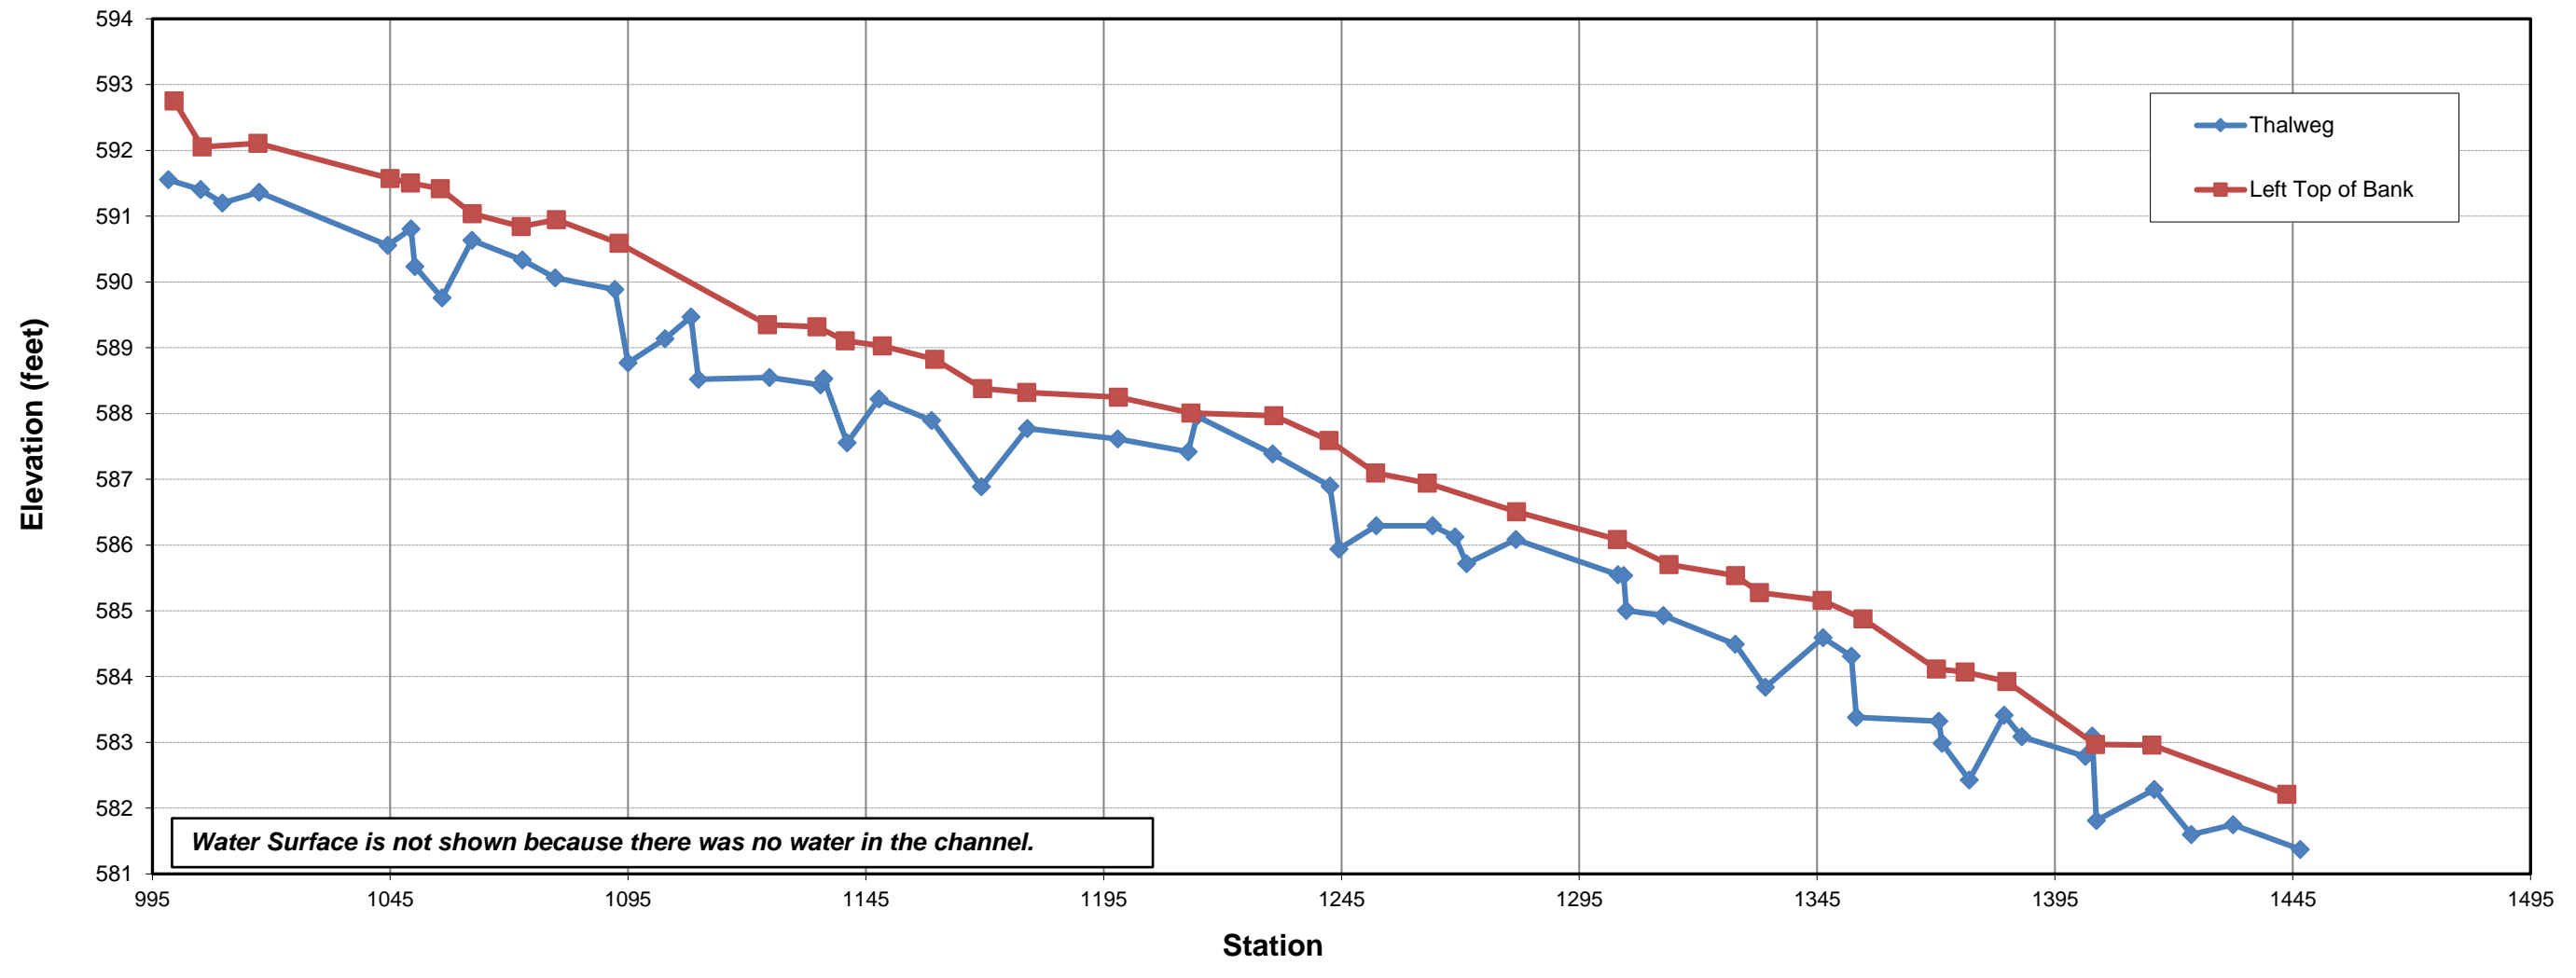
UT to Town Creek - Reach 4
As-built Stations 9+98 to 14+47
(Data Collected April 2016)

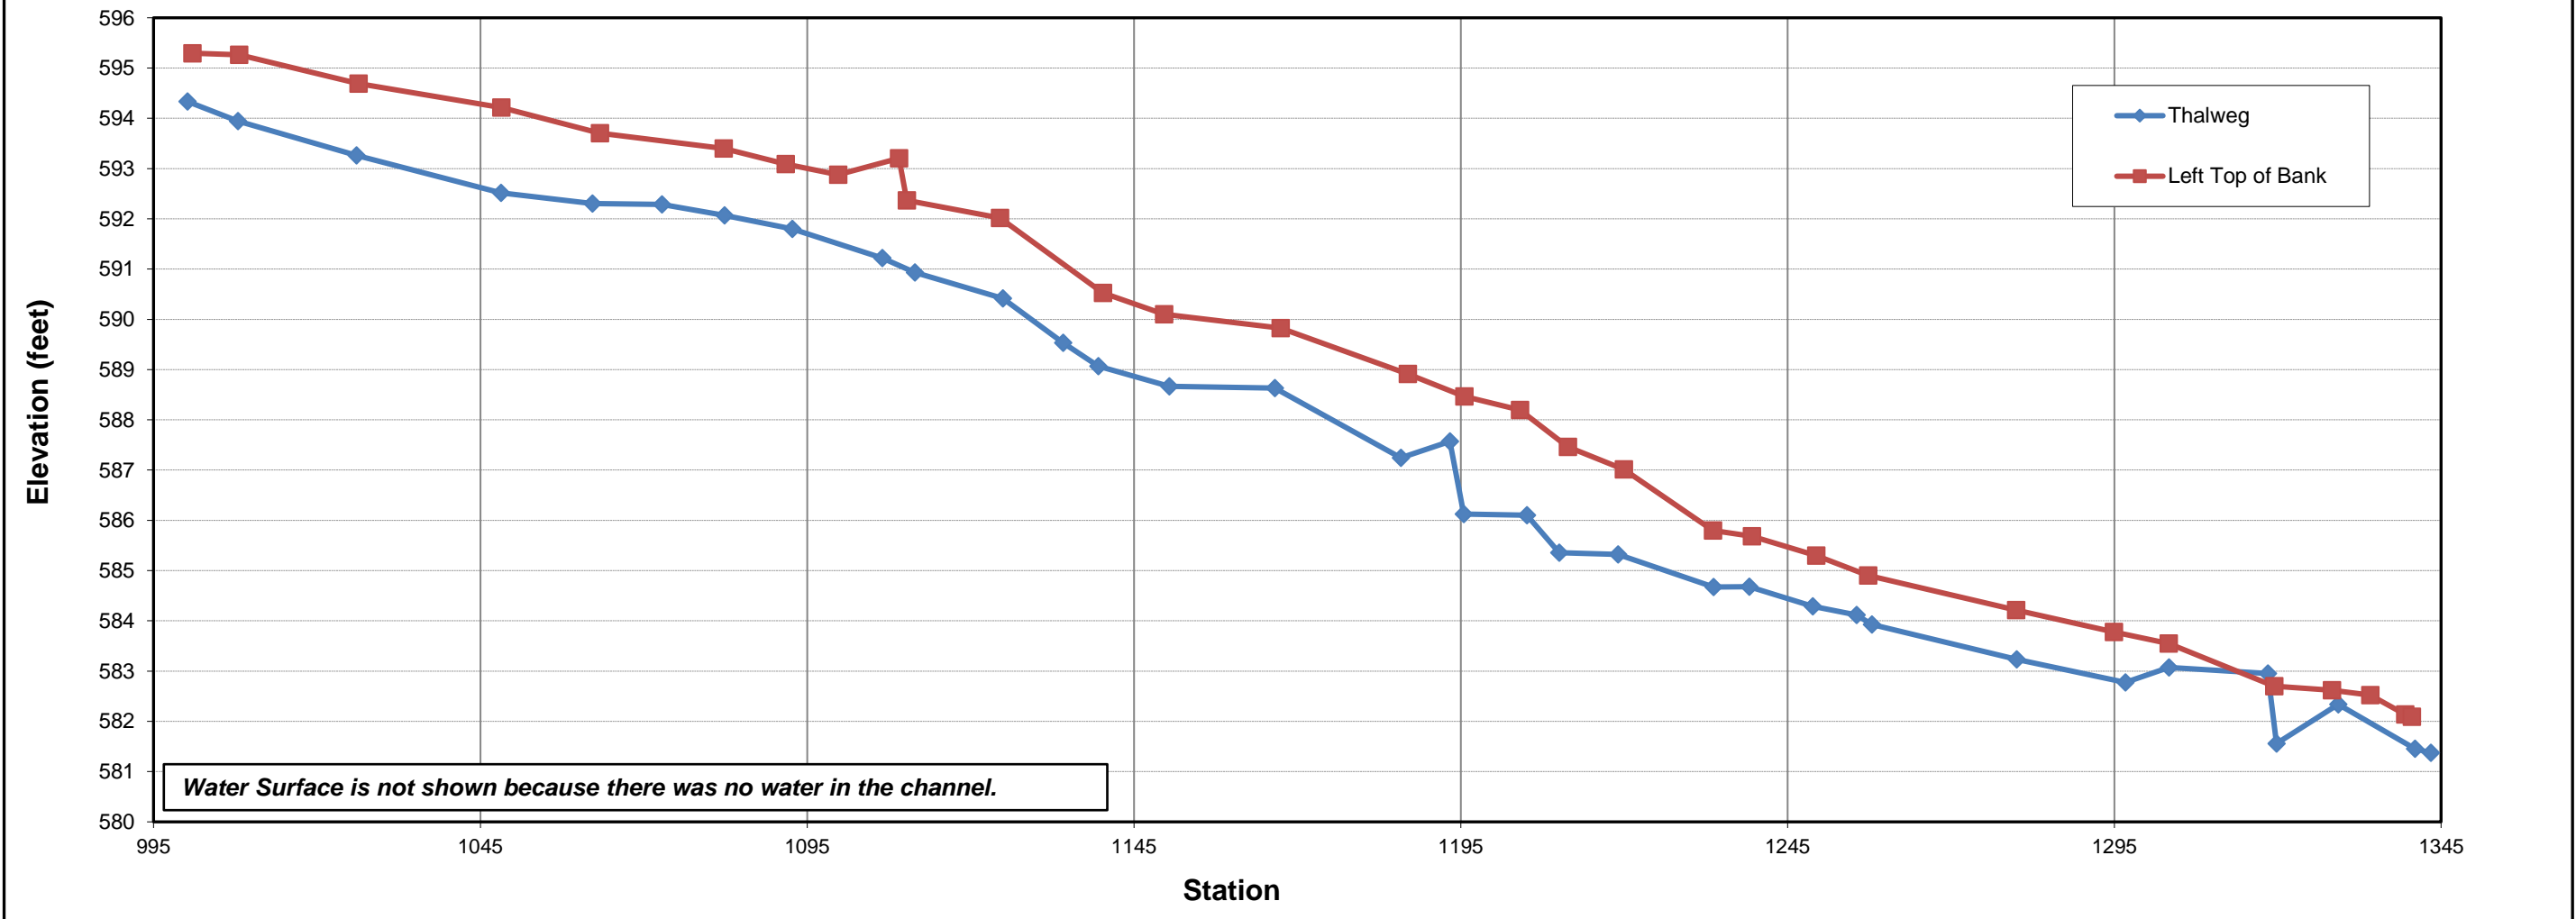
UT to Town Creek - Reach 5
As-built Stations 10+00 to 13+43
(Data Collected April 2016)

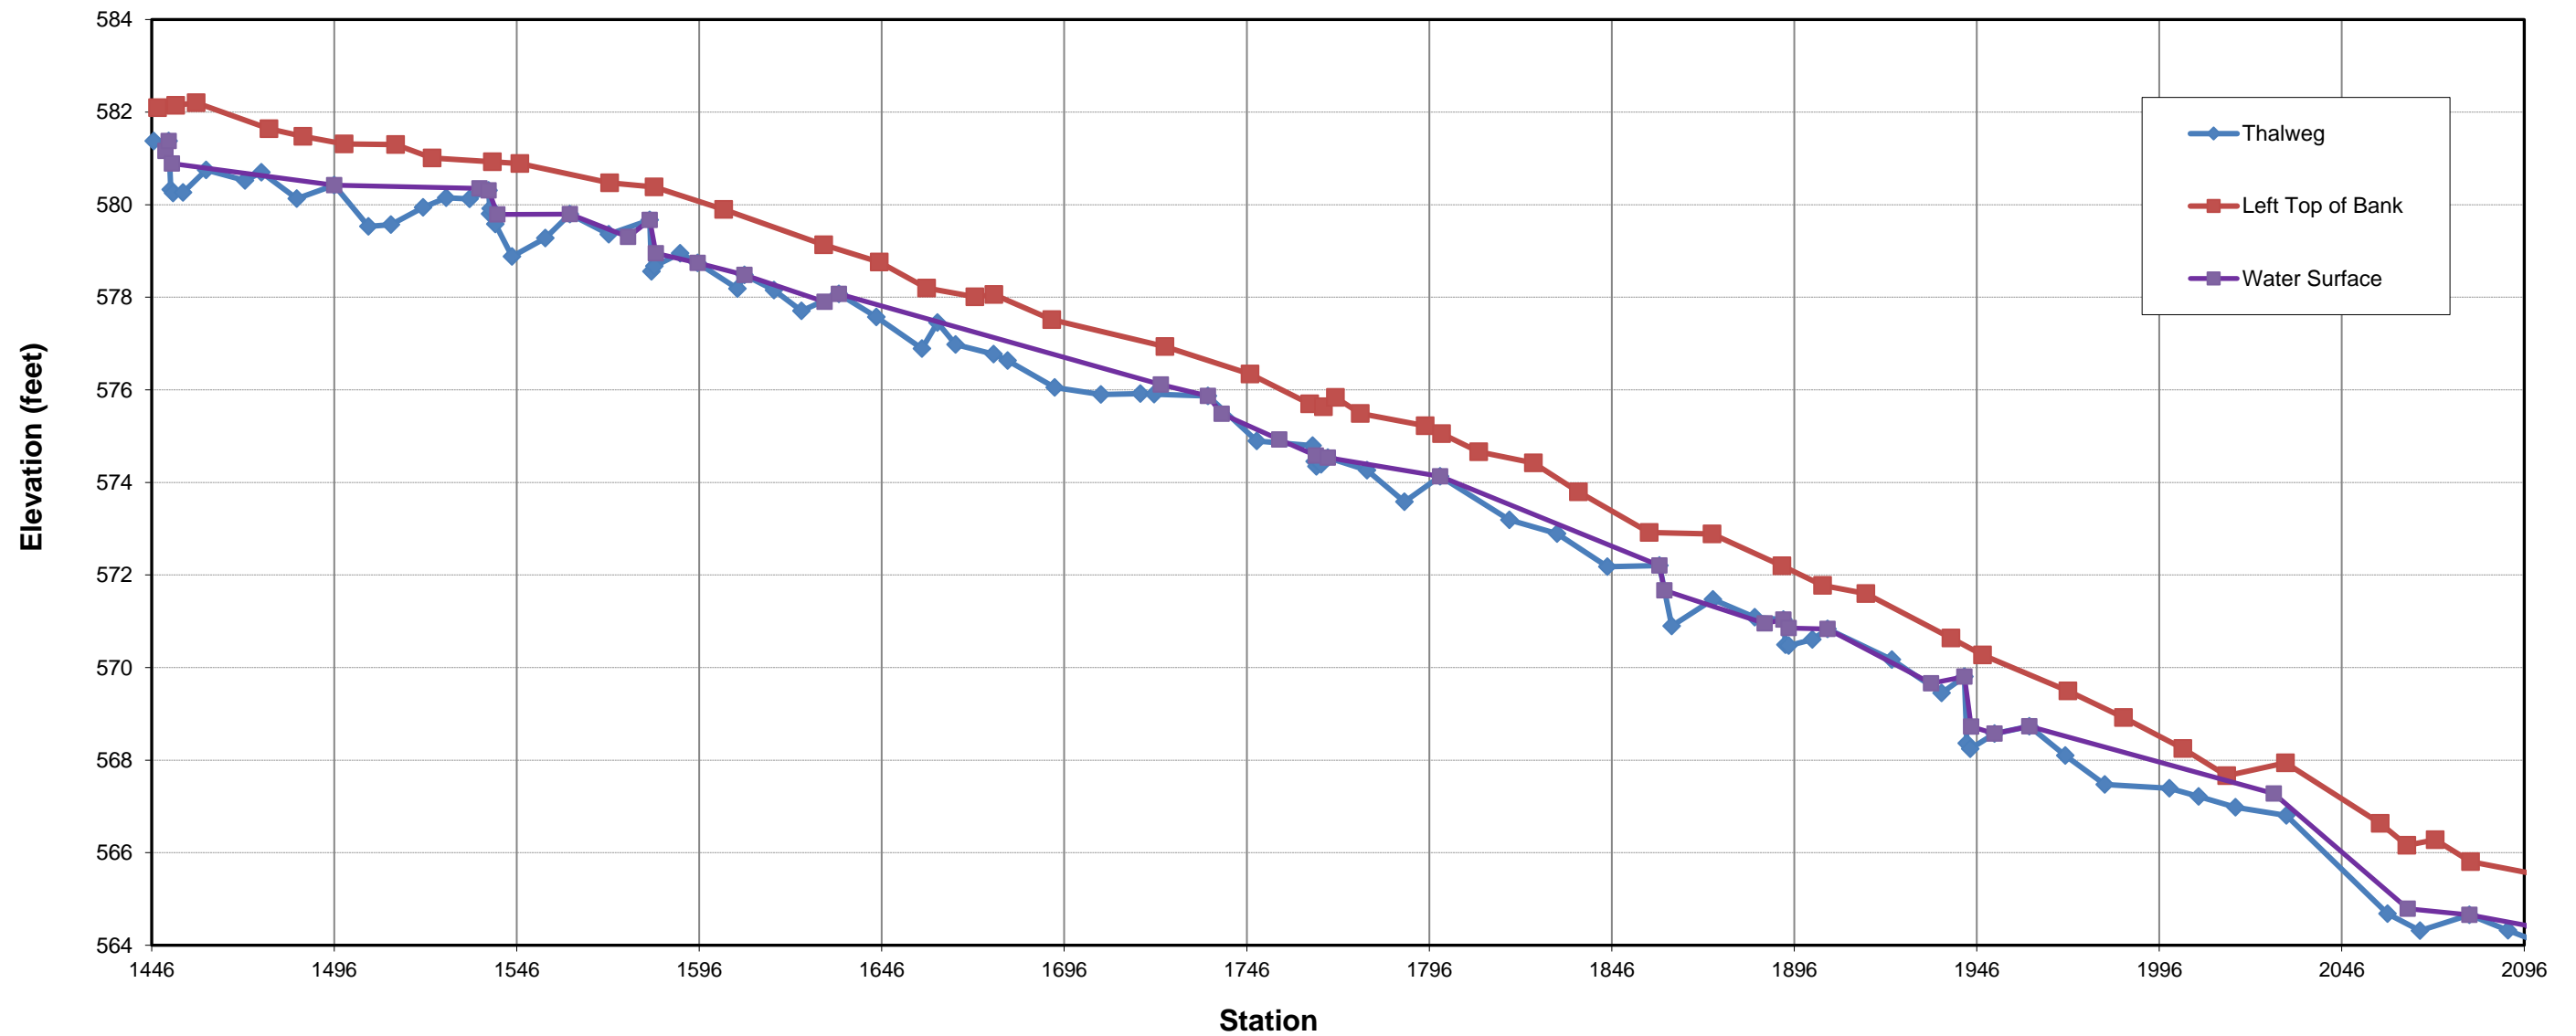
UT to Town Creek - Reach 6 (Upstream)
As-built Stations 14+46 to 20+96
(Data Collected April 2016)
