FINAL
Baseline Monitoring Document and As-Built Baseline Report
UT to Town Creek Restoration Project – Option A

Stanly County, North Carolina

DMS Project ID No. 94648; NCDEQ Contract No. 003277

Data Collection Period – February – June 2016

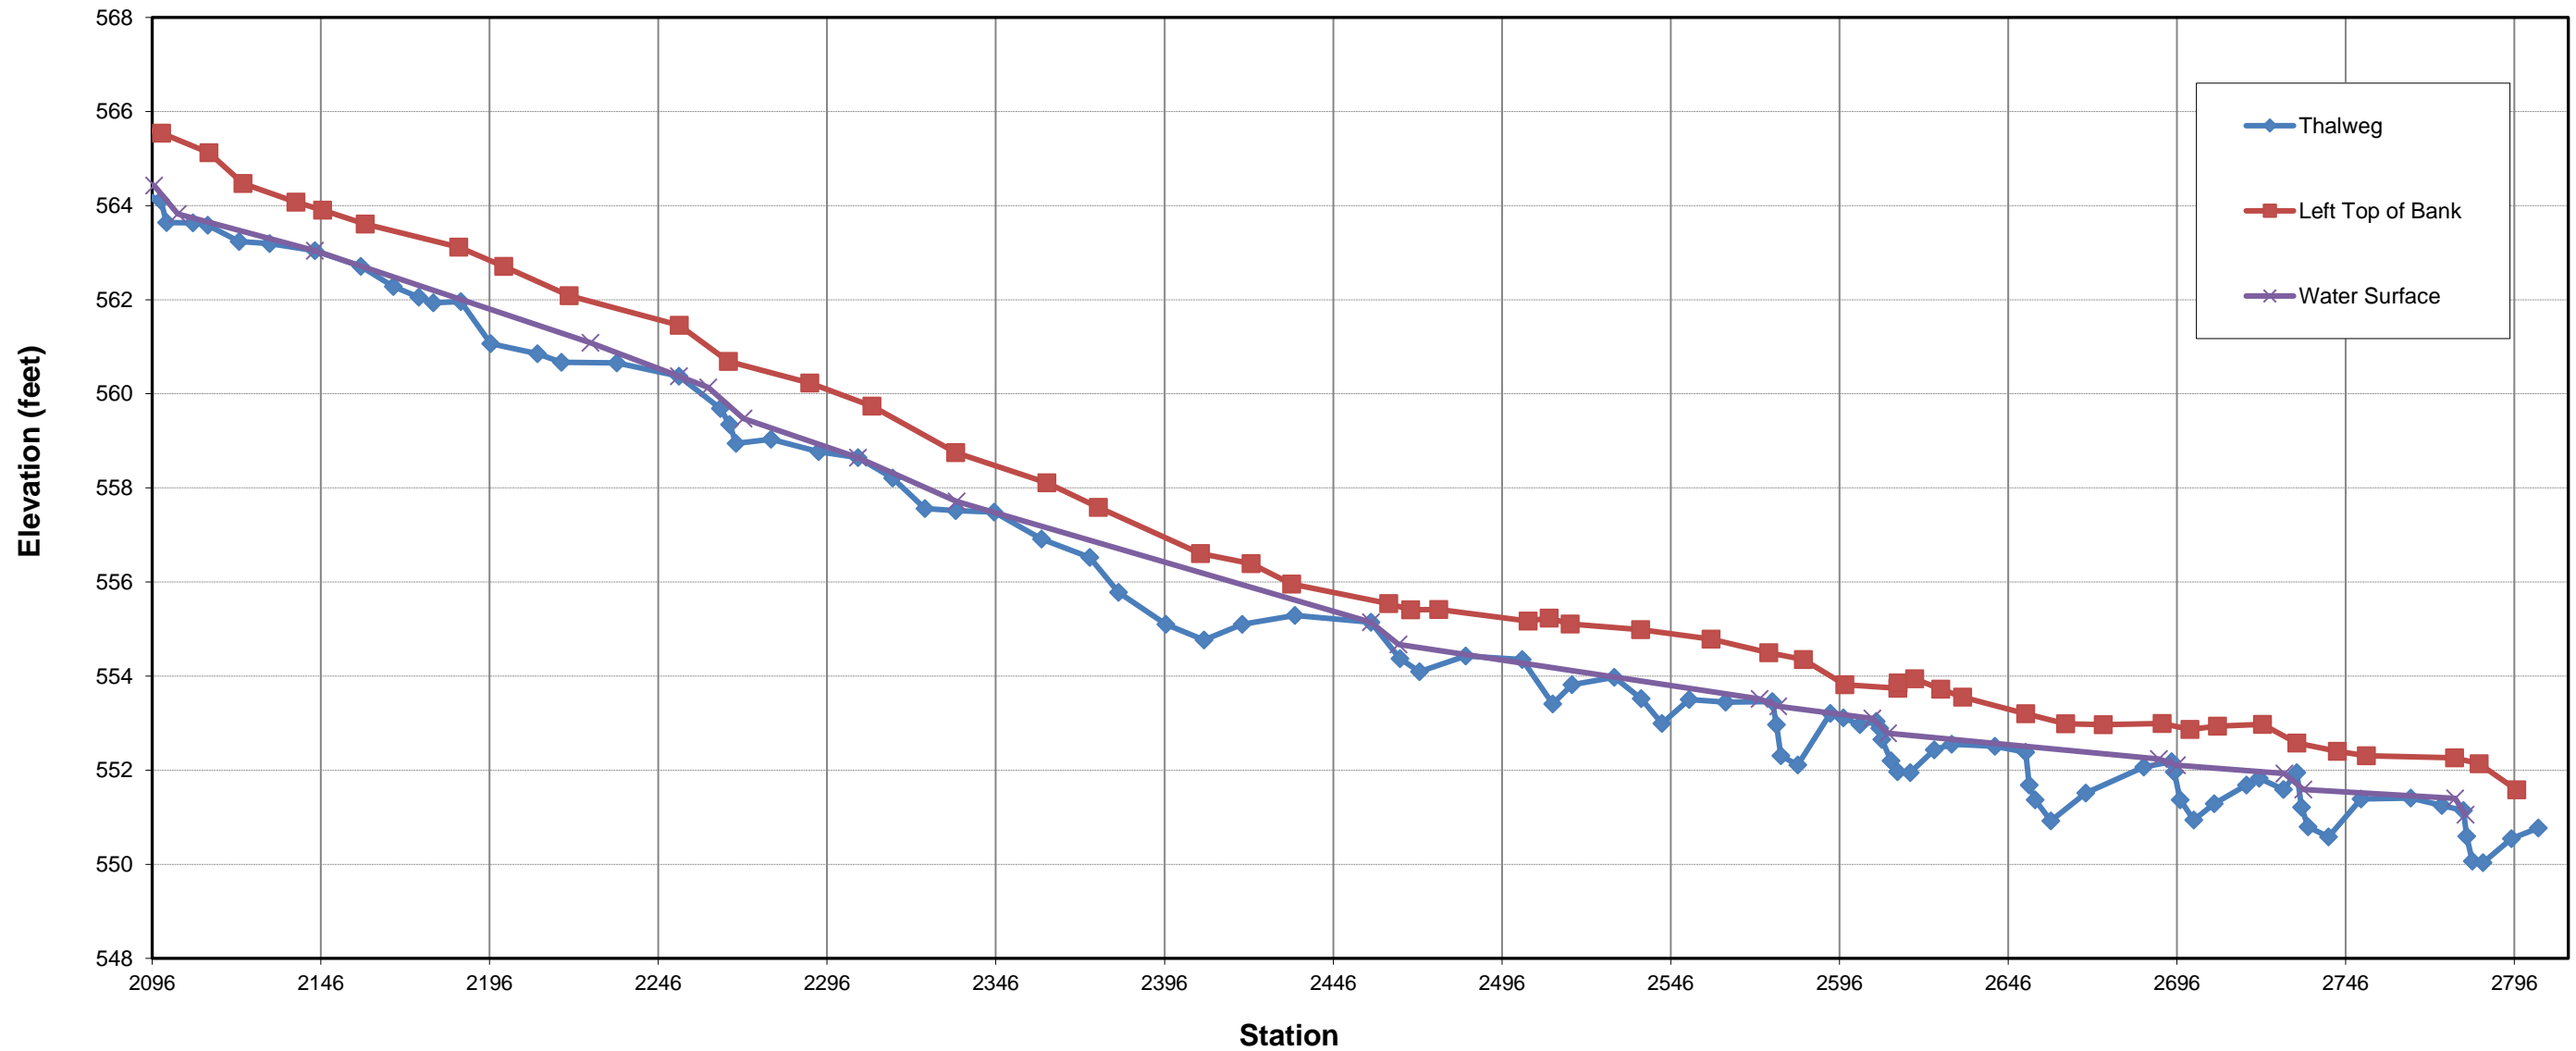
UT to Town Creek - Reach 6 (Downstream)
As-built Stations 20+96 to 28+13
(Data Collected April 2016)

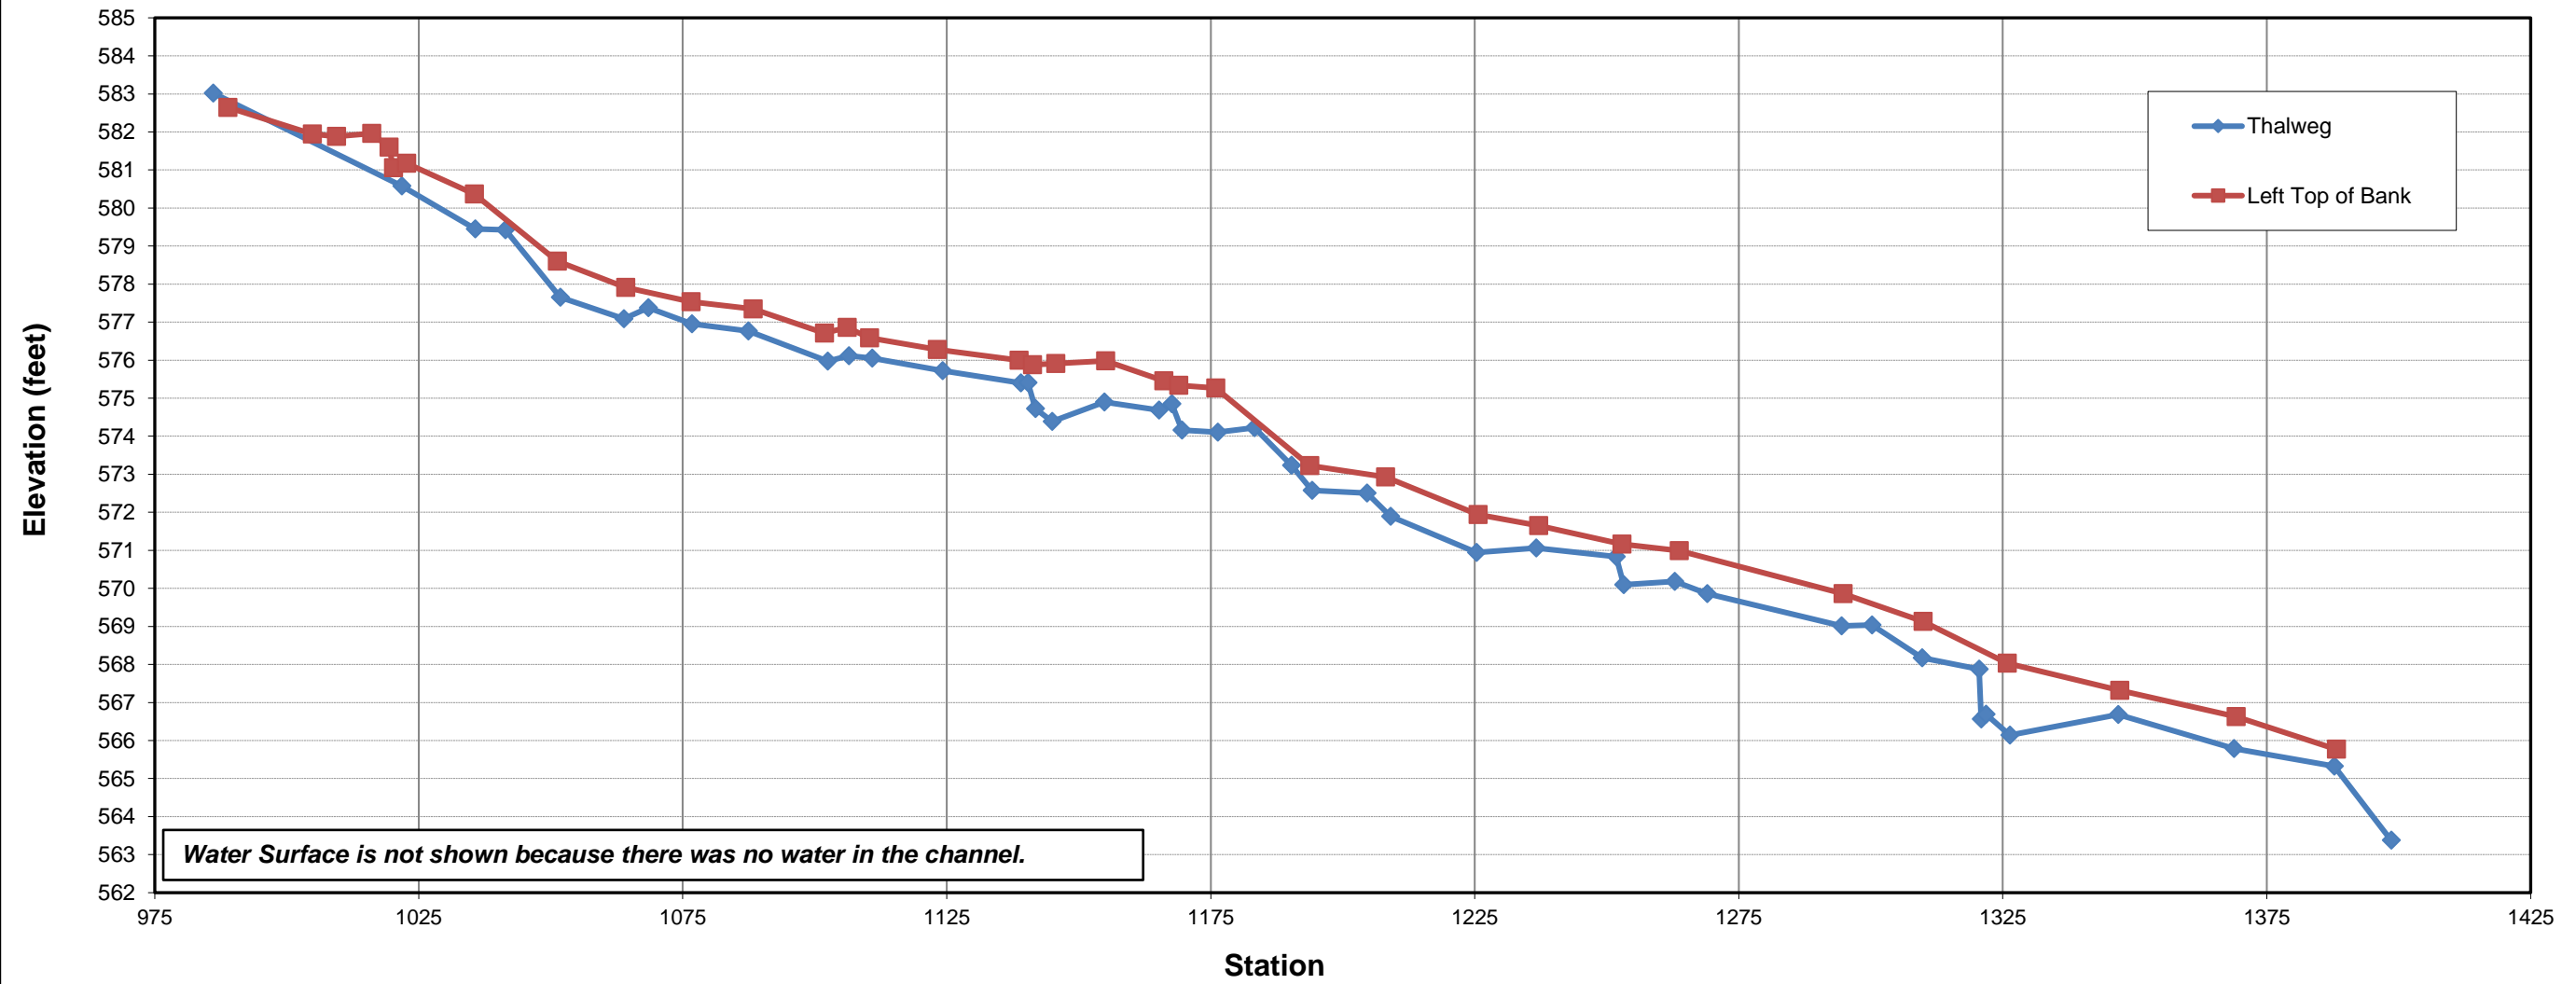
UT to Town Creek - Reach 7
As-built Stations 9+86 to 13+98
(Data Collected April 2016)

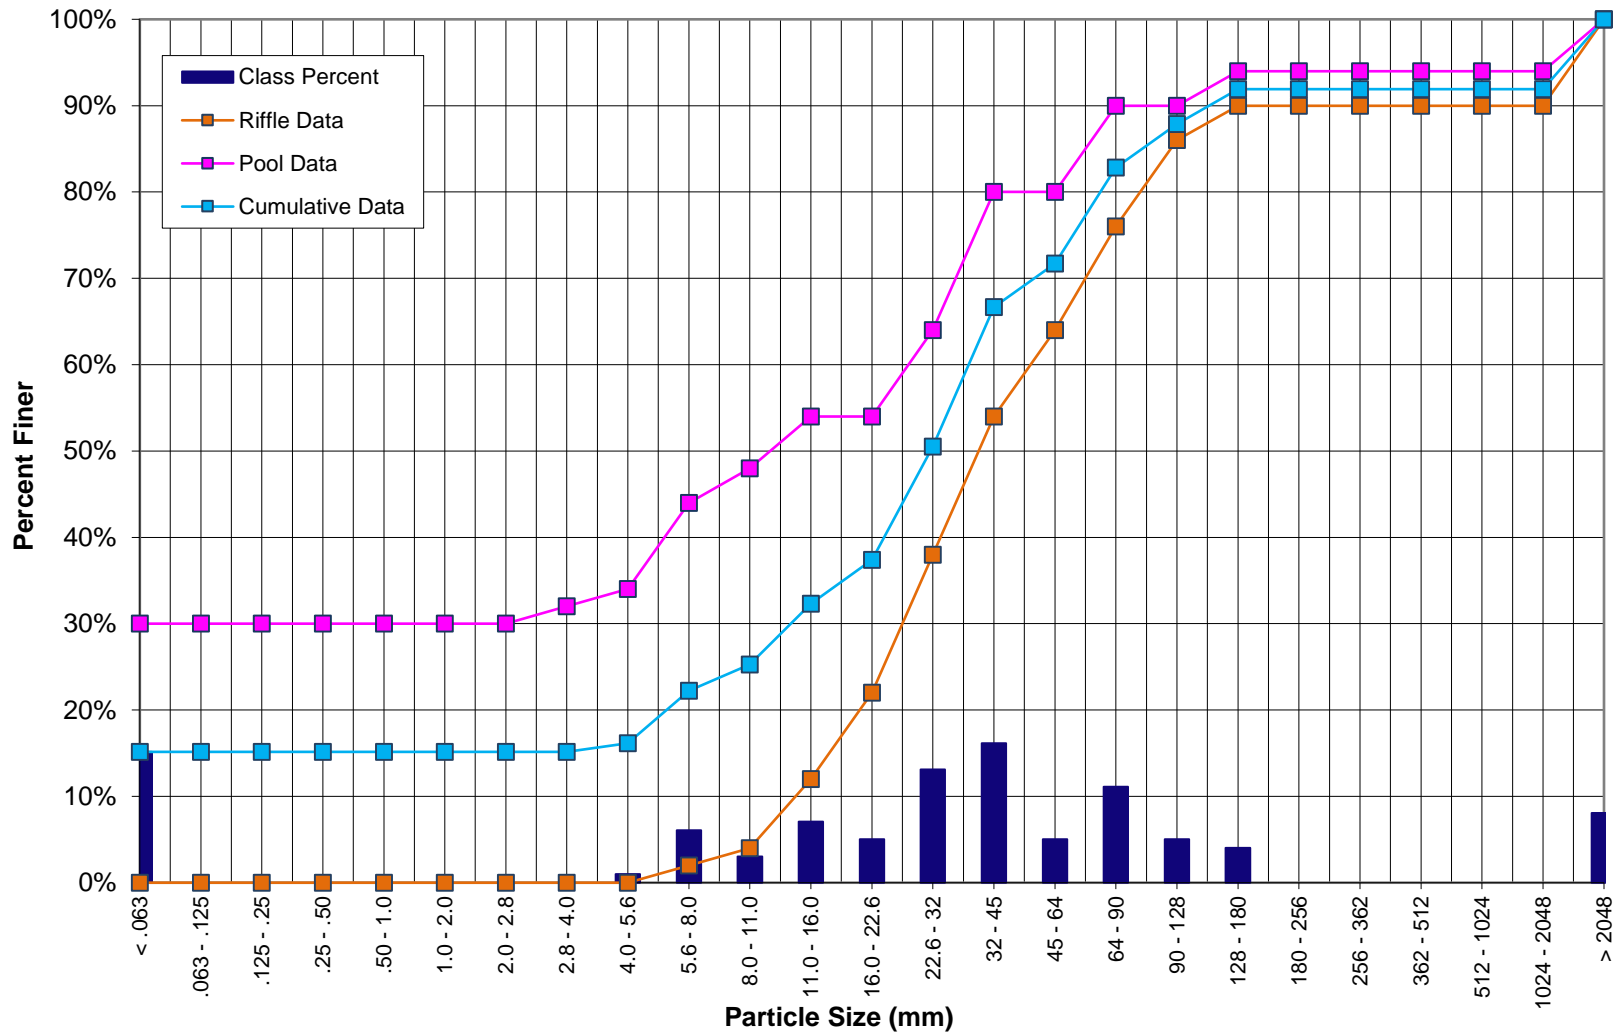
UT to Town Creek - Asbuilt Sediment Distribution - Active Bed Pebble Count Reachwide - Reach 1 (5 Riffles & 5 Pools)

Pool Channel materials	
D16 =	<0.063
D35 =	<0.063
D50 =	5.60
D84 =	36.68
D95 =	107.33
D100 =	> 2048

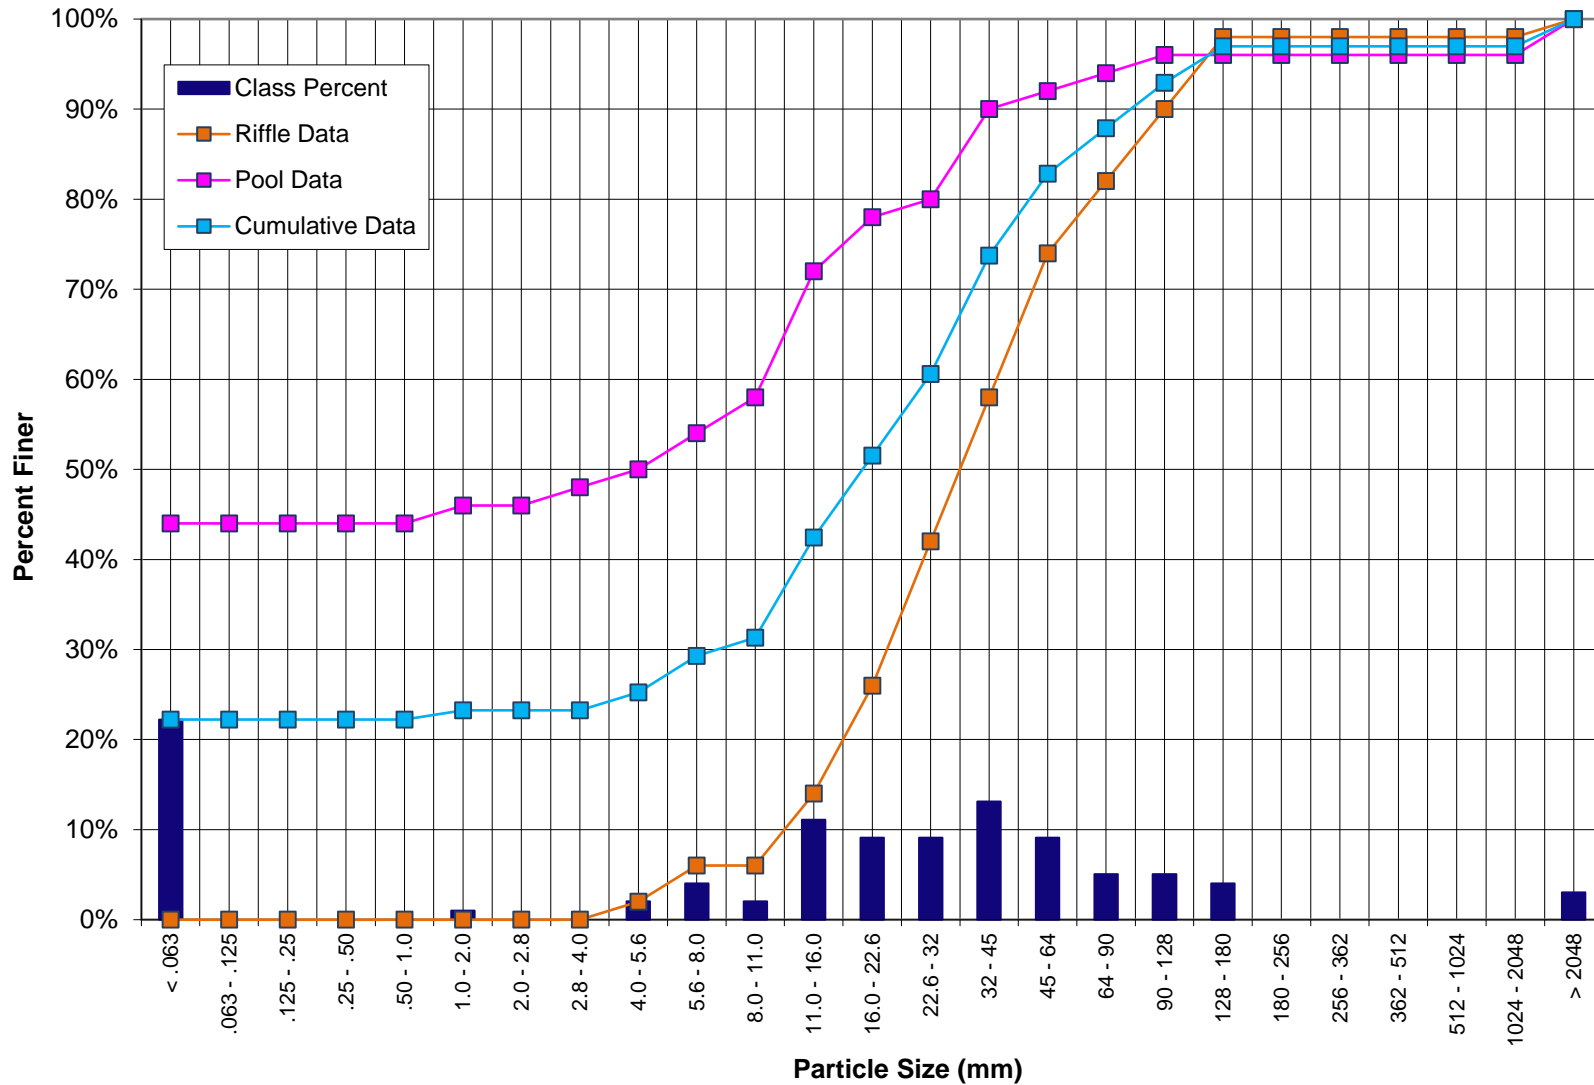
UT to Town Creek - Asbuilt Sediment Distribution - Active Bed Pebble Count Reachwide - Reach 2 (5 Riffles & 5 Pools)

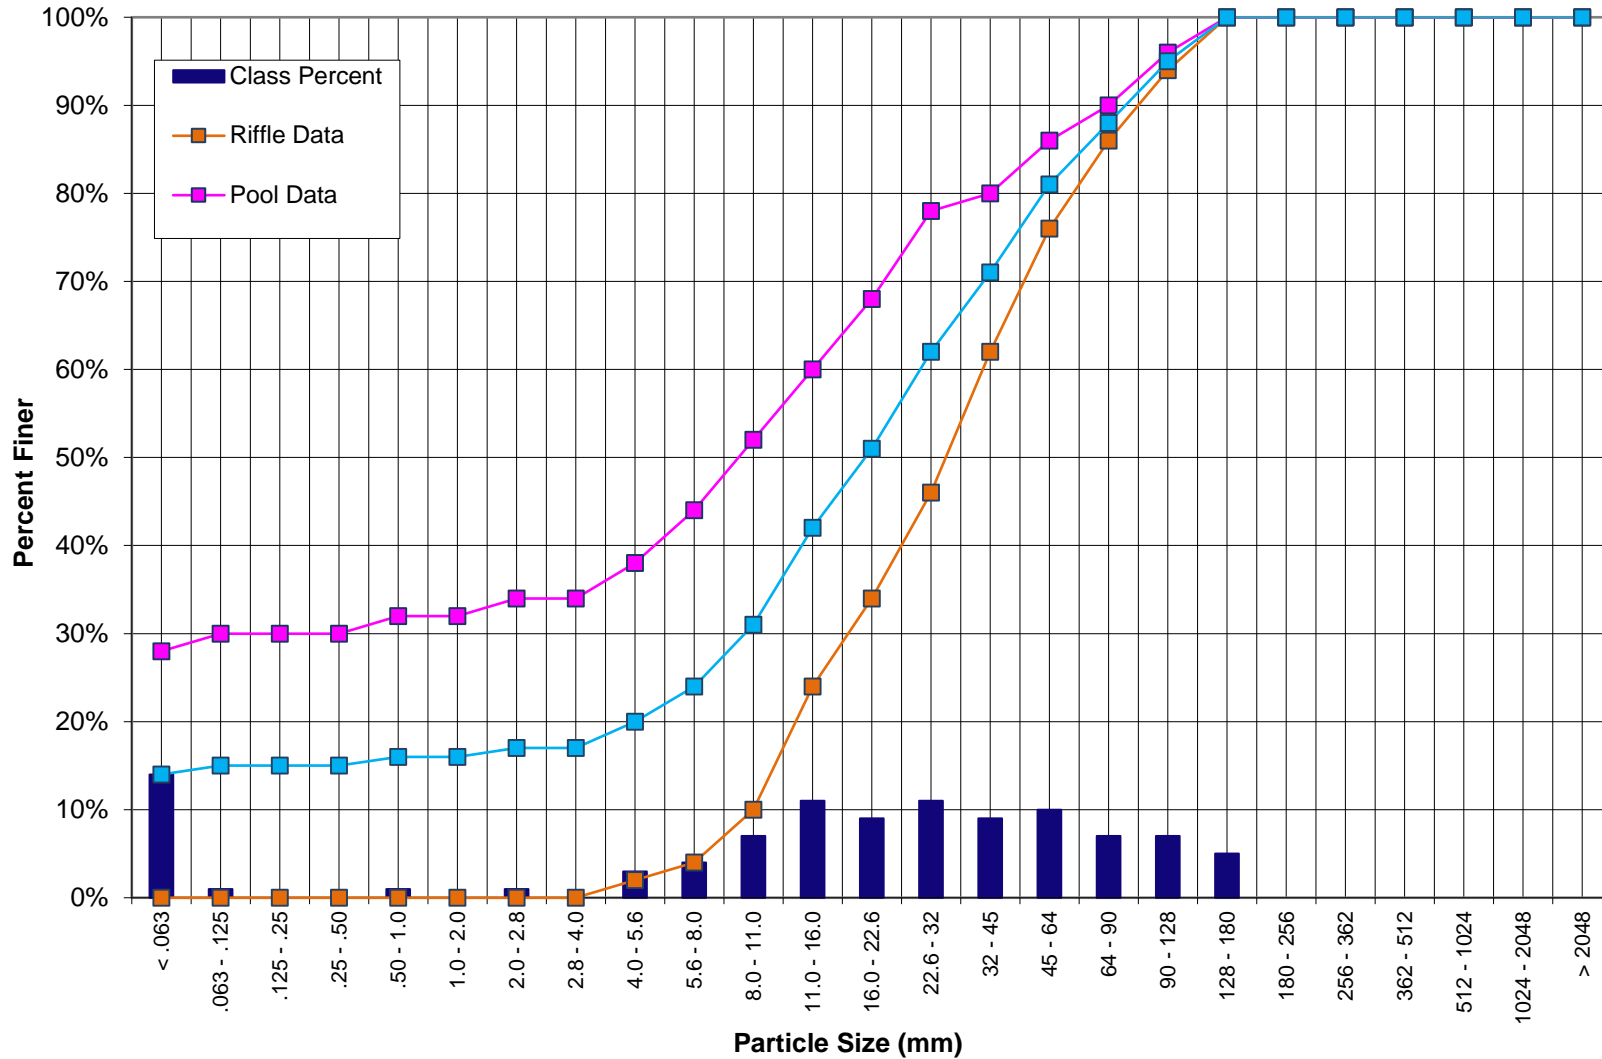
UT to Town Creek - Asbuilt
Sediment Distribution - Active Bed Pebble Count
Reachwide - Reach 3 (5 Riffles & 5 Pools)

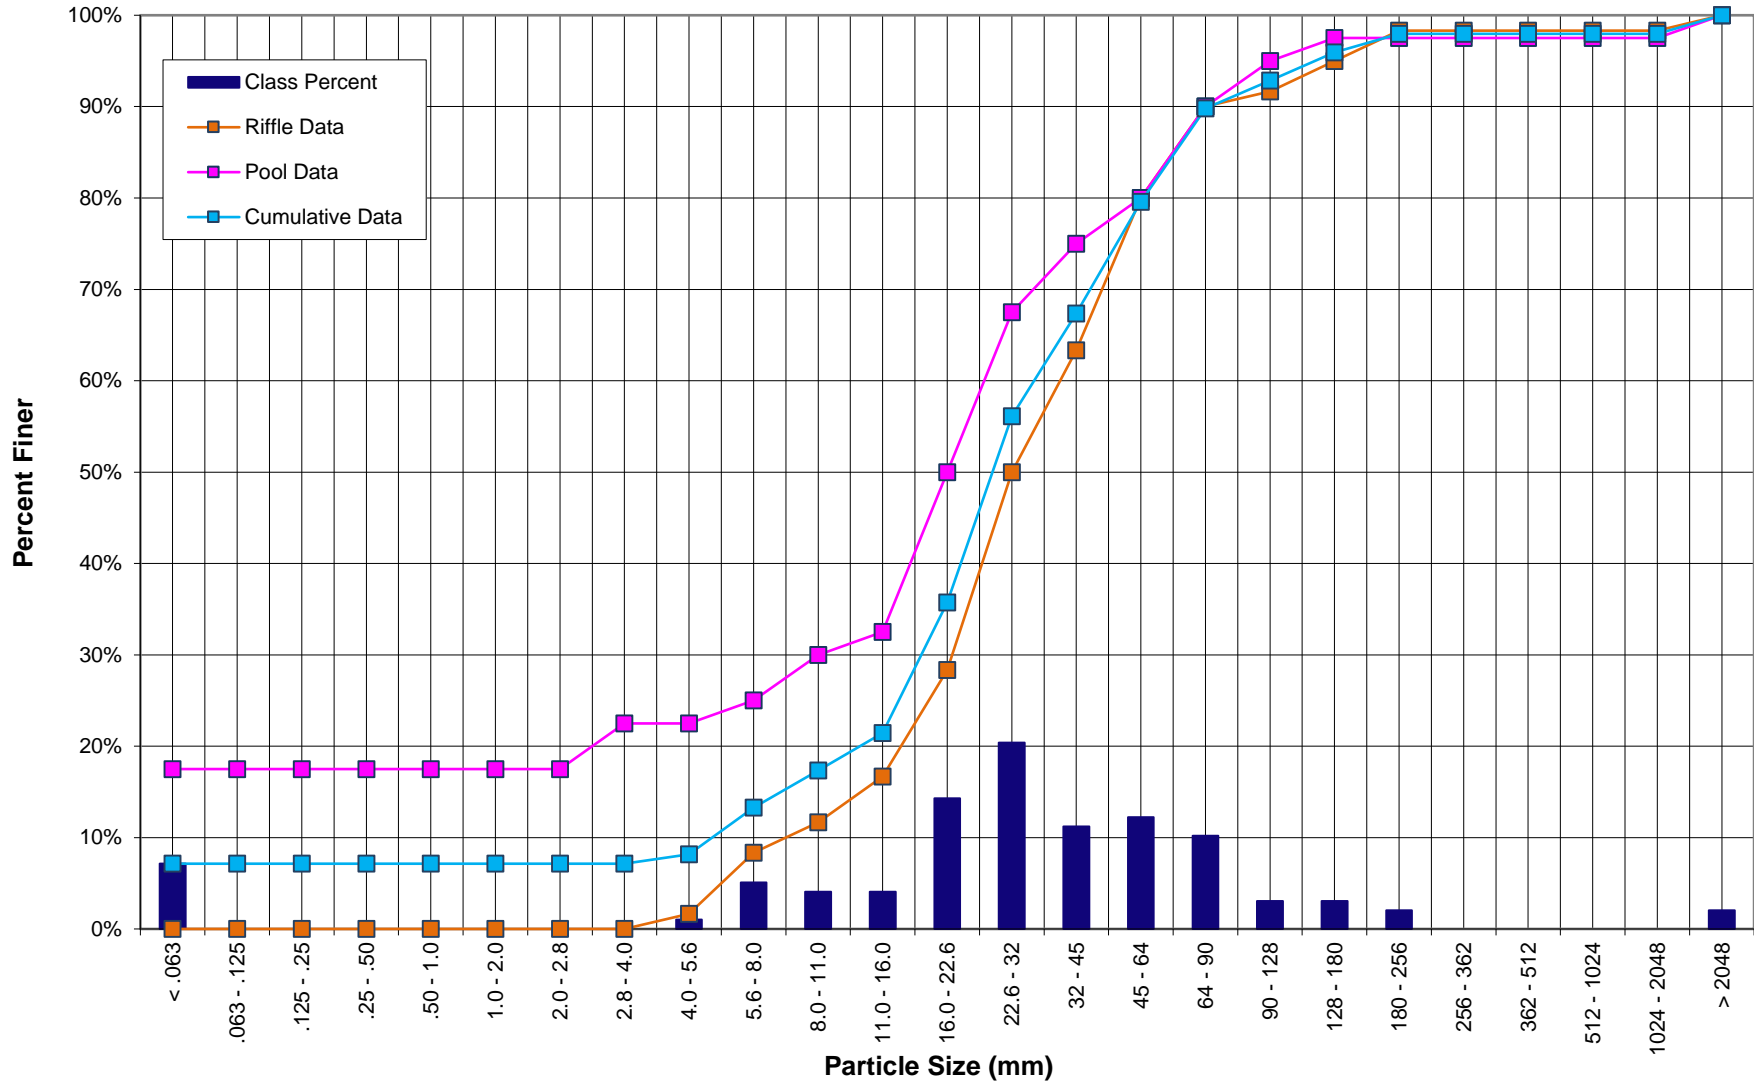
UT to Town Creek - Asbuilt
Sediment Distribution - Active Bed Pebble Count
Reachwide - Reach 6 (6 Riffles & 4 Pools)

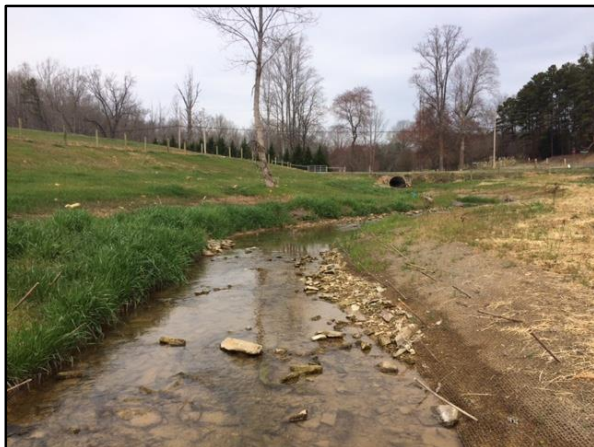
PID 5: Station 12+85 – Upstream (3/11/16)

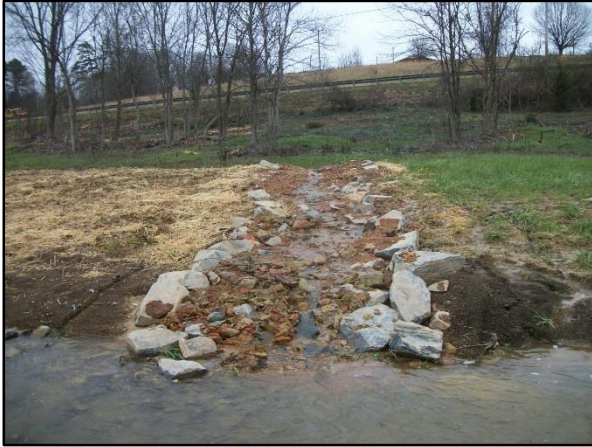
PID 6: Station 13+05 – Left Floodplain (2/4/16)

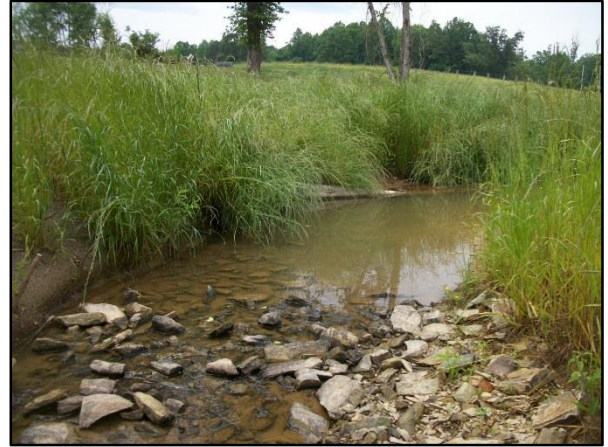
PID 7: Station 15+30 – Upstream (5/11/16)

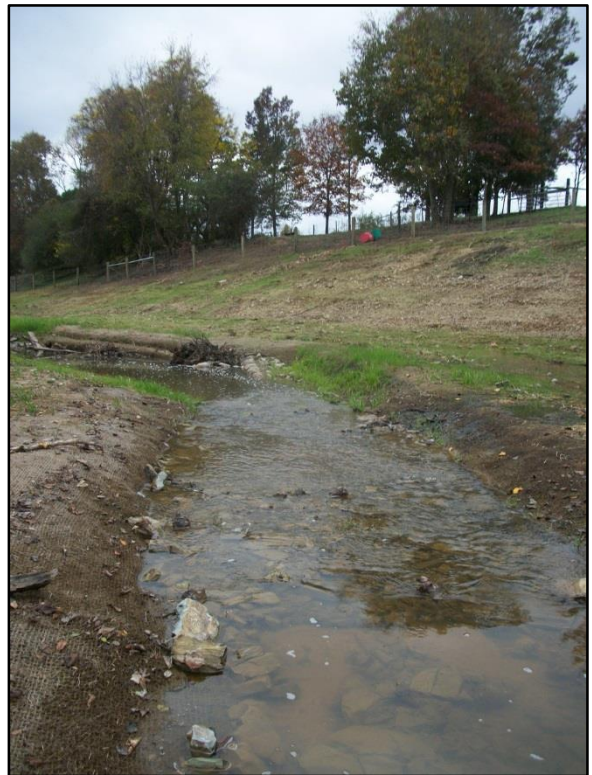
PID 8: Station 16+25 – Downstream (11/5/15)

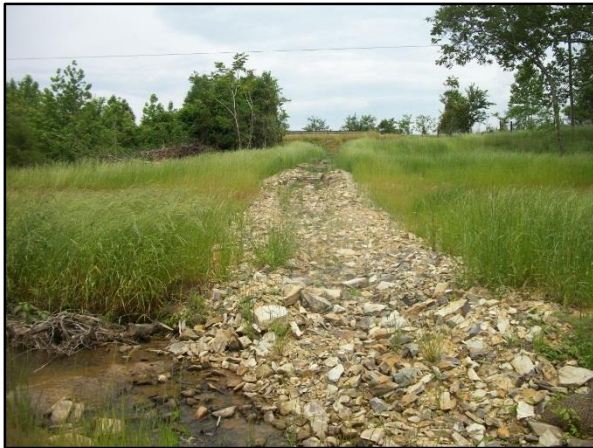
**PID 9: Station 17+75 – Left Floodplain
(5/11/16)**

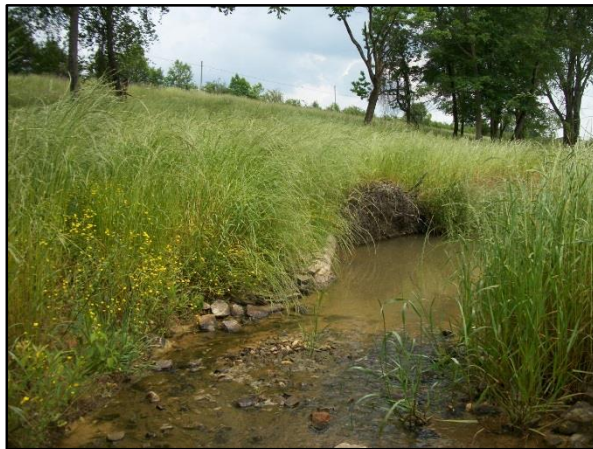
PID 10: Station 18+10 – Downstream (5/11/16)

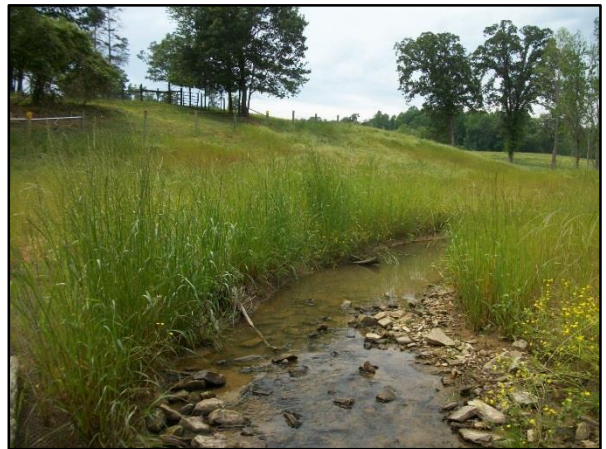
PID 11: Station 18+10 – Upstream (5/11/16)

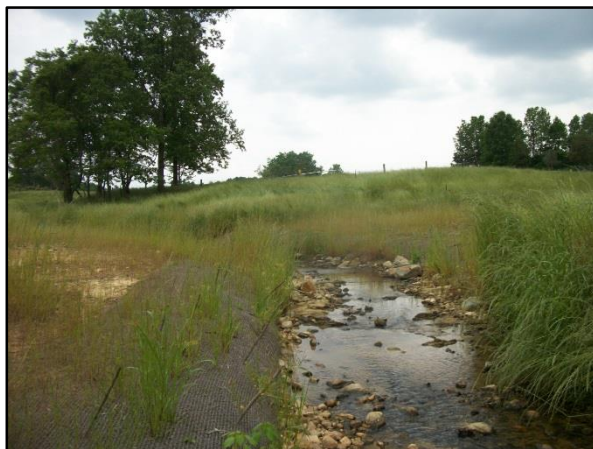
PID 12: Station 20+90 – Downstream (5/11/16)

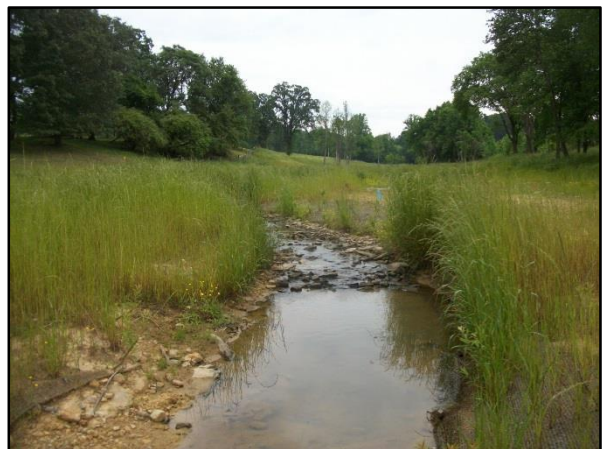
PID 13: Station 21+00 – Upstream (5/11/16)

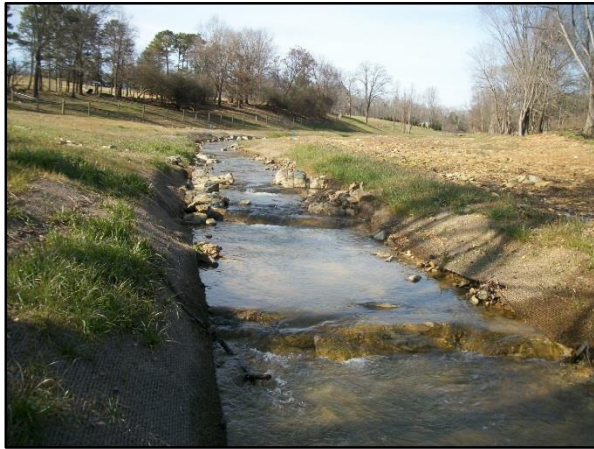
PID 14: Station 22+75 – Upstream (2/4/16)

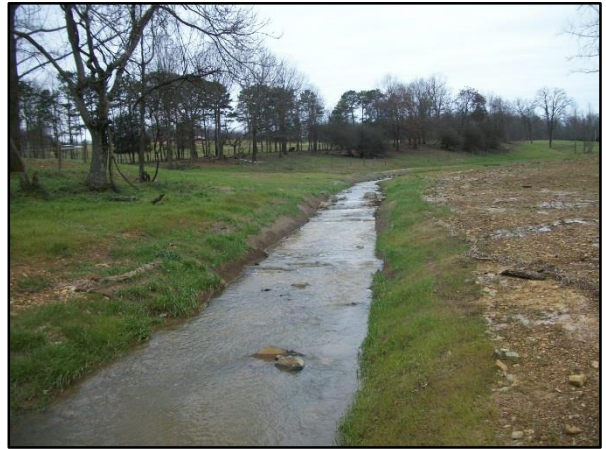
PID 15: Station 23+25 – Upstream (2/4/16)

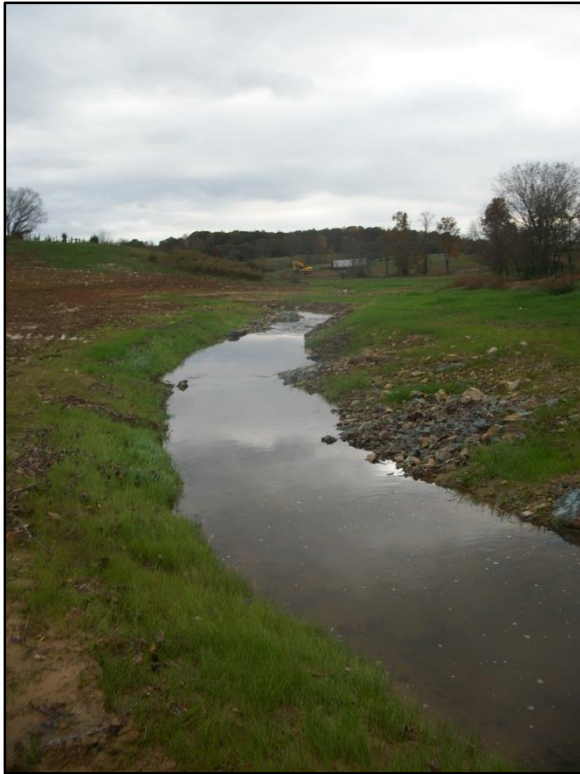
PID 16: Station 23+50 – Downstream (11/5/16)

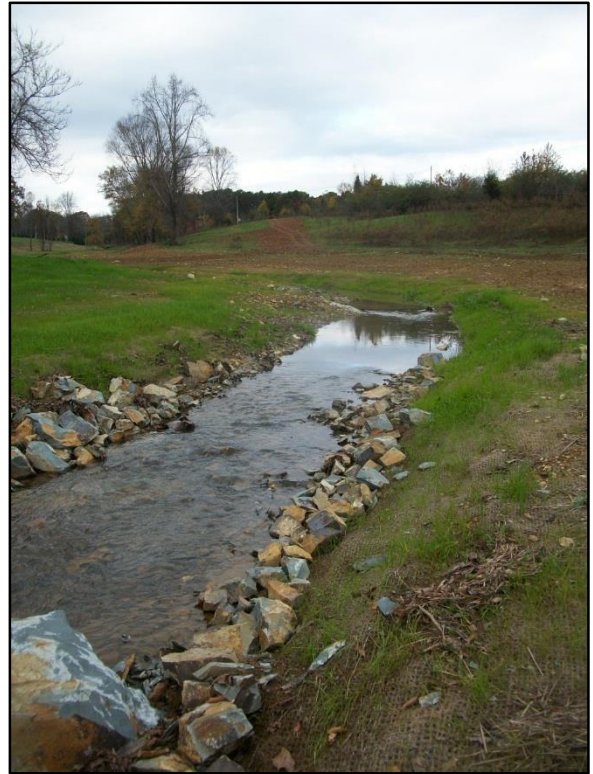
PID 17: Station 24+60 – Upstream (11/5/15)

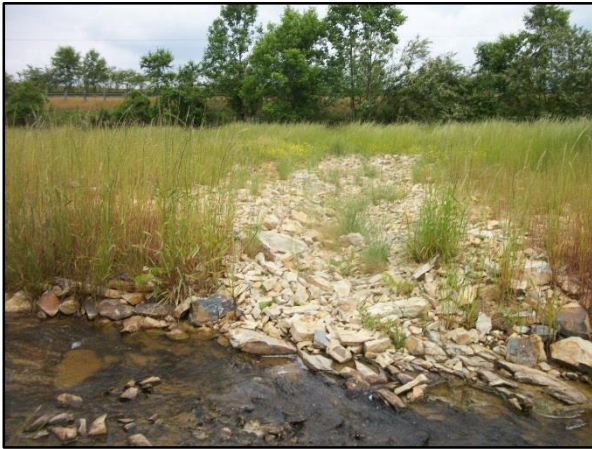
**PID 18: Station 25+30 – Left Floodplain
(5/11/16)**

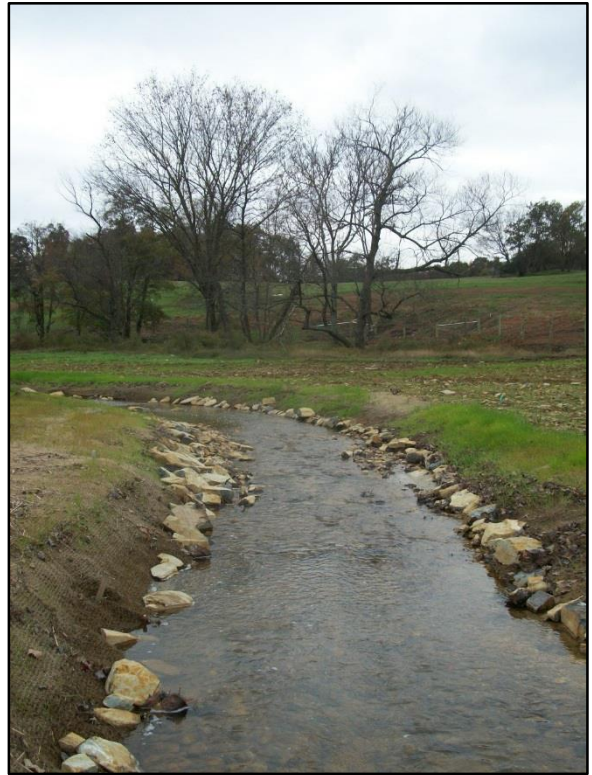
PID 19: Station 25+90 – Downstream (11/5/15)

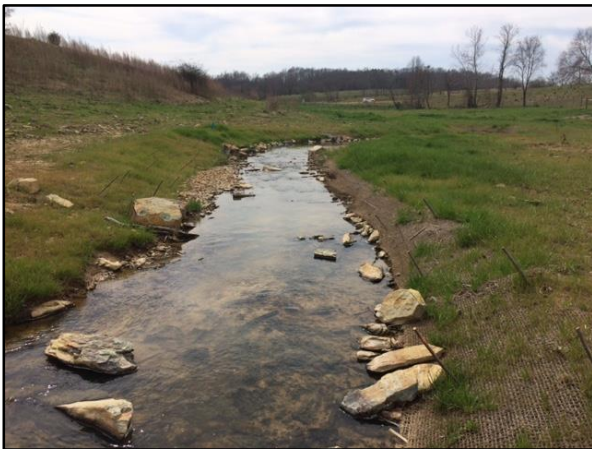
PID 20: Station 26+40 – Downstream (3/11/16)

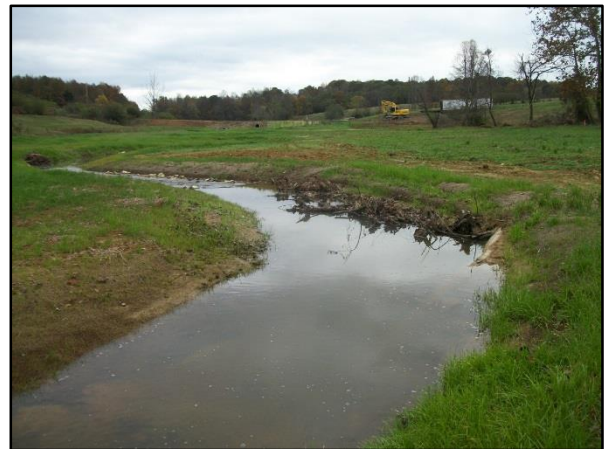
PID 21: Station 28+75 – Downstream (11/5/15)

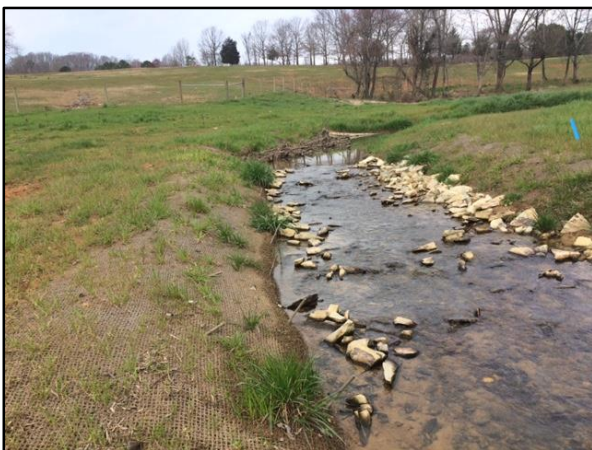
PID 22: Station 29+35 – Upstream (3/11/16)

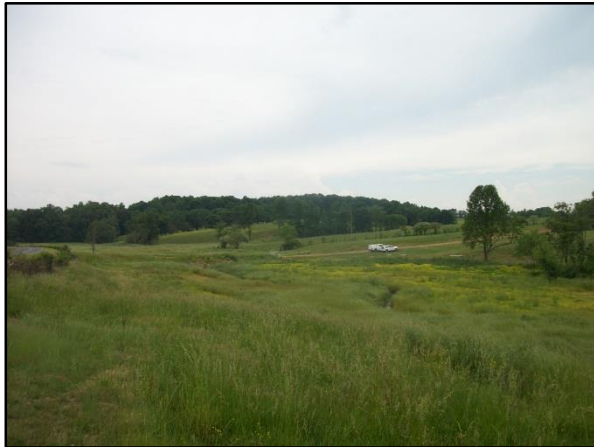
PID 23: Station 29+50 – Downstream Project View from Floodplain Knoll (5/11/16)

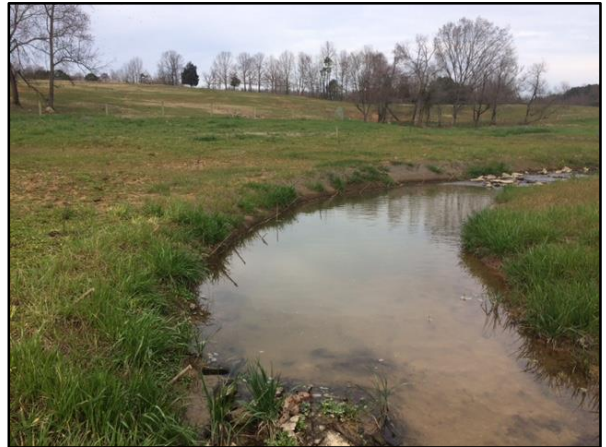
PID 24: Station 30+60 – Upstream (3/11/16)

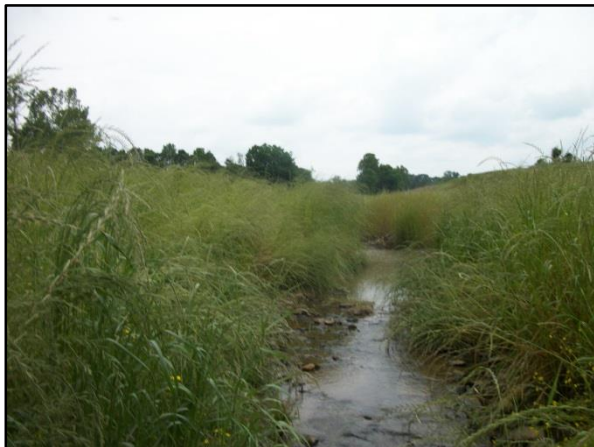
PID 25: Station 33+10 – Upstream (5/11/16)

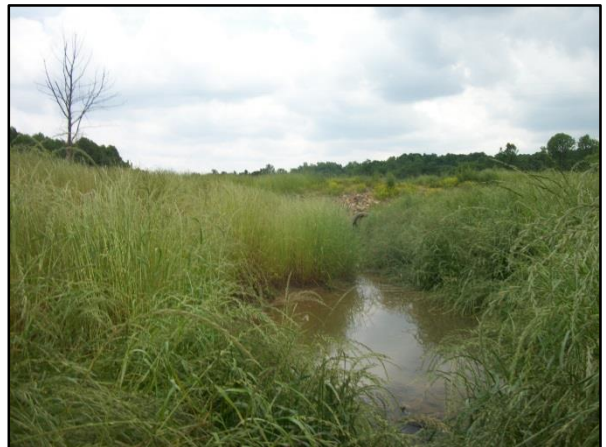
PID 26: Station 33+10 – Downstream (5/11/16)

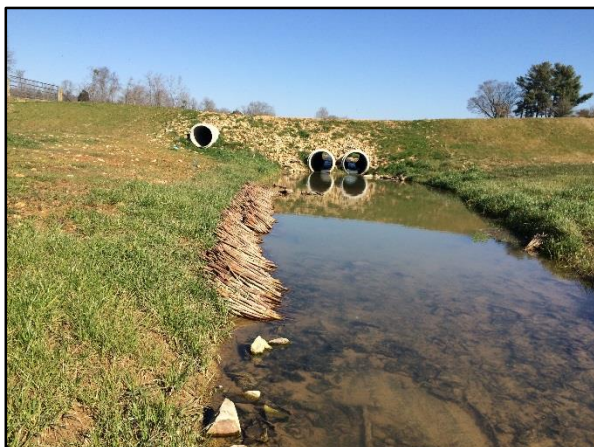
PID 27: Station 35+50 – Upstream (3/11/16)

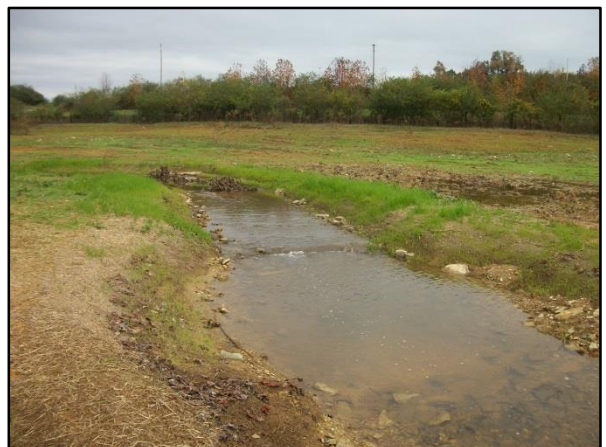
PID 28: Station 38+30 – Upstream (11/5/15)

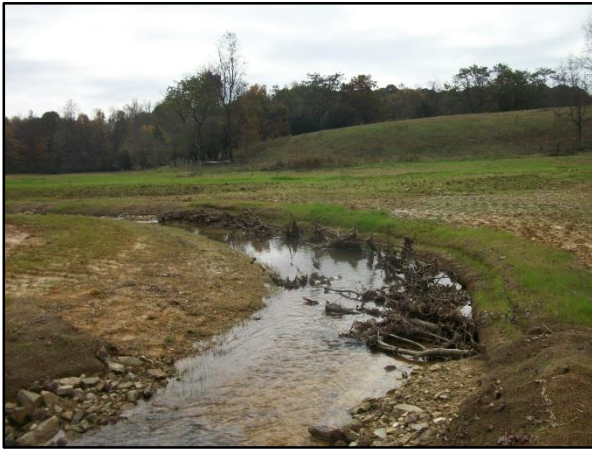
PID 29: Station 38+40 – Downstream (11/5/15)

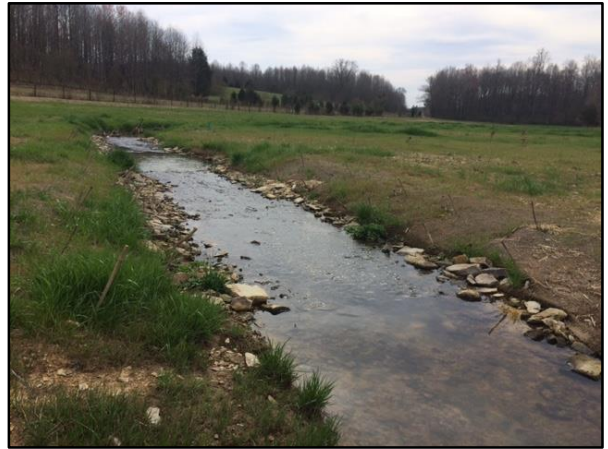
PID 30: Station 39+10 – Downstream (3/11/16)

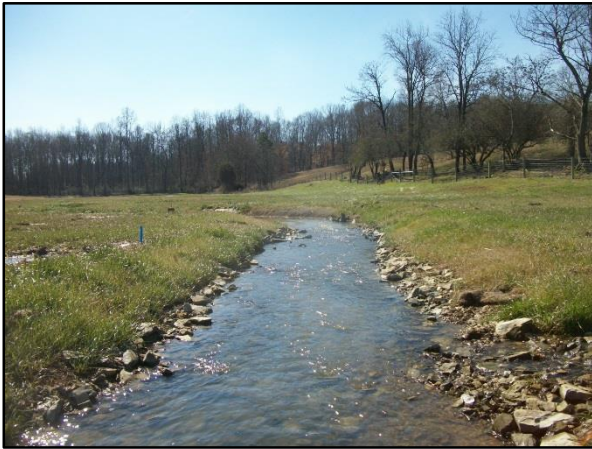
PID 31: Station 40+25 – Downstream (2/18/16)

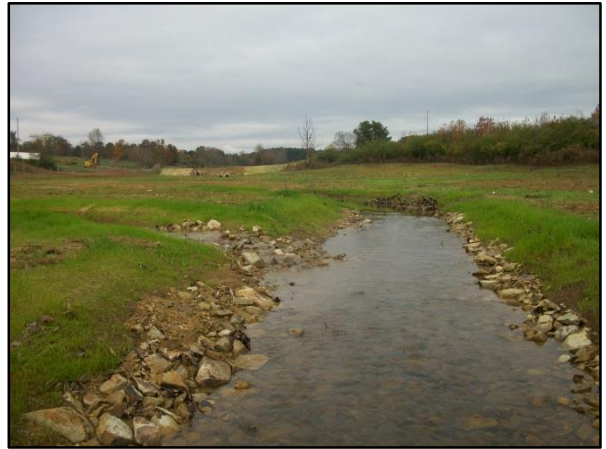
PID 32: Station 40+80 – Upstream (11/5/15)

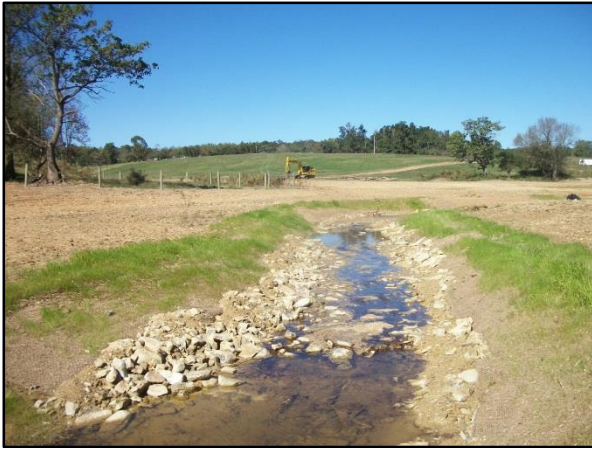
PID 33: Station 41+80 – Upstream (11/5/15)

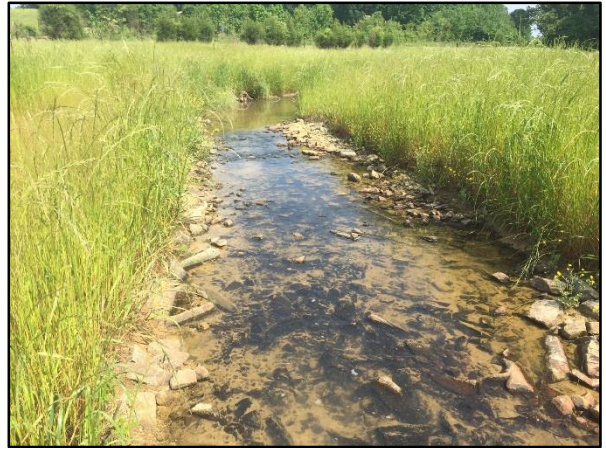
PID 34: Station 43+00 – Downstream (5/11/16)

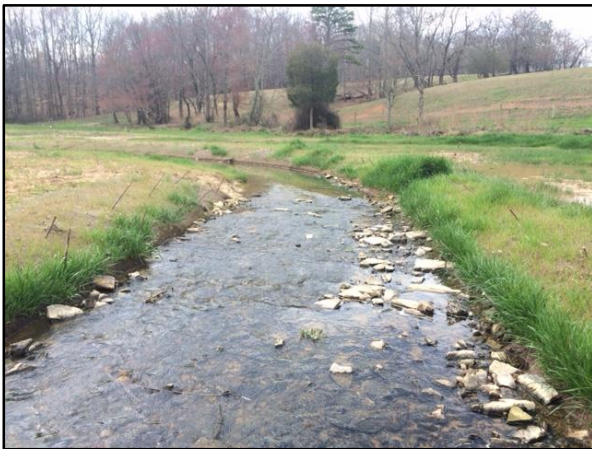
PID 35: Station 44+00 – Downstream (3/11/16)

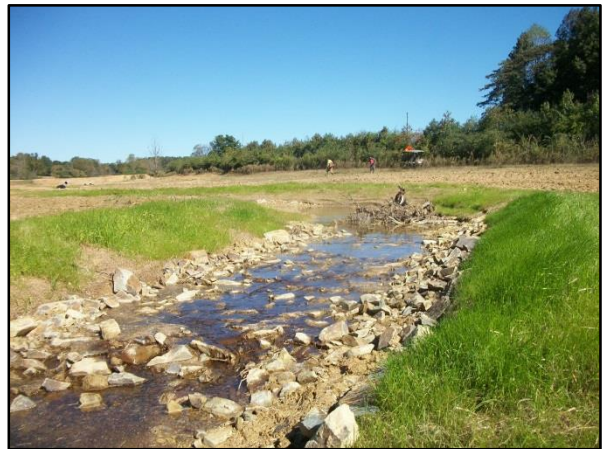
PID 36: Station 44+25 – Upstream (11/5/15)

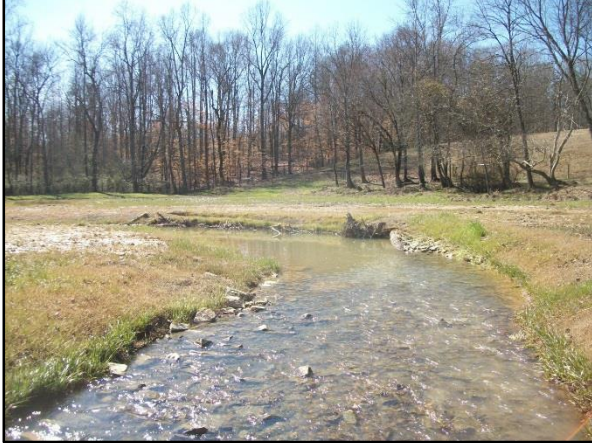
PID 37: Station 45+50 – Downstream (2/18/16)

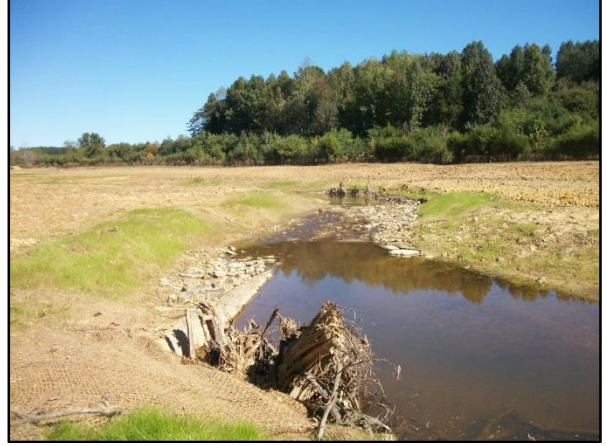
PID 38: Station 45+95 – Upstream (11/5/15)

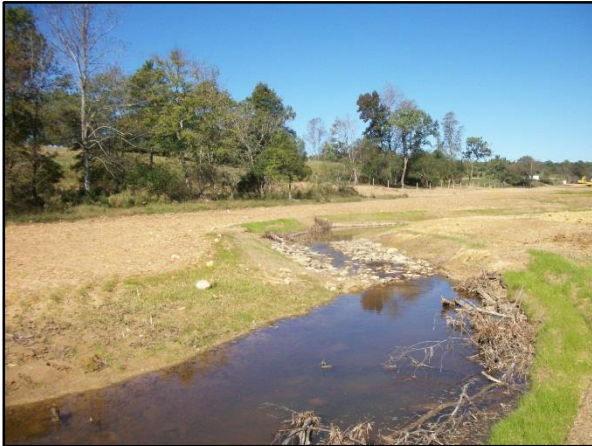
PID 39: Station 46+80 – Upstream (11/5/15)

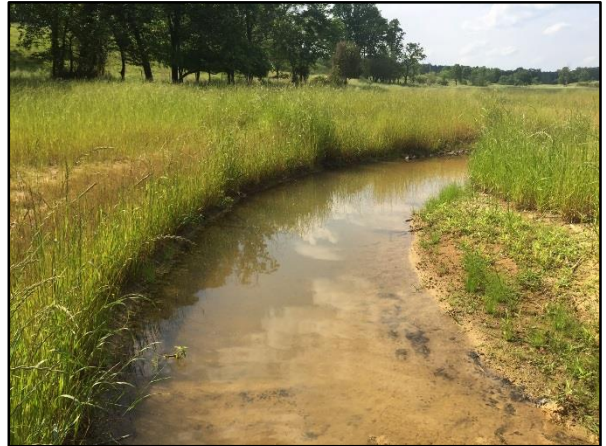
PID 40: Station 47+75 – Upstream (11/5/15)
