FINAL
Baseline Monitoring Document and As-Built Baseline Report
UT to Town Creek Restoration Project – Option A

Stanly County, North Carolina

DMS Project ID No. 94648; NCDEQ Contract No. 003277

Data Collection Period – February – June 2016

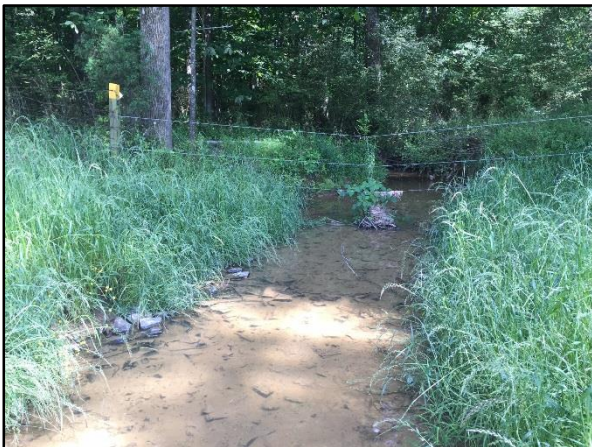
PID 41: Station 48+60 – Downstream (5/10/16)

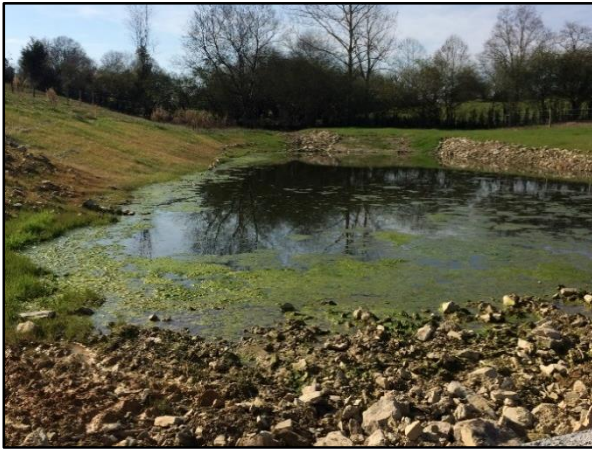
PID 1: Station 09+80 – Upstream (12/11/15)
