As-Built Baseline Monitoring Report

**UT WEST BRANCH ROCKY RIVER
RESTORATION SITE**

NCDMS Project #92684 (Contract # WBRR010521)
USACE Action ID: SAW-2017-00342 | NCDWR Project #18-1696

Mecklenburg County, North Carolina
Yadkin River Basin | HUC 03040105

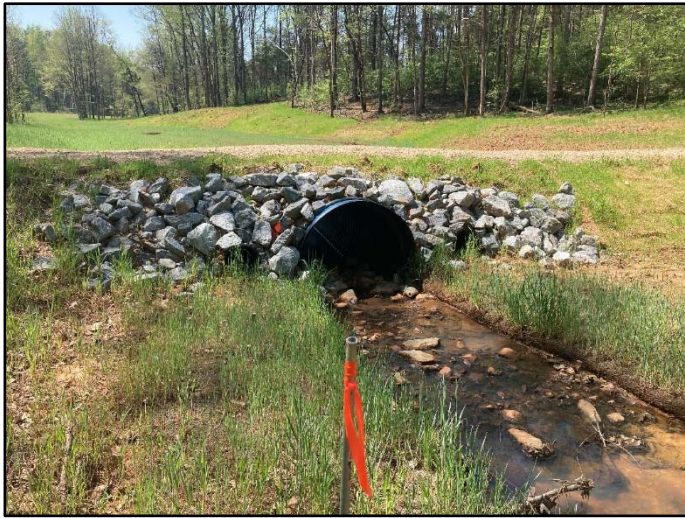
Photo Station 5
Crossing on UTWB-2 looking downstream

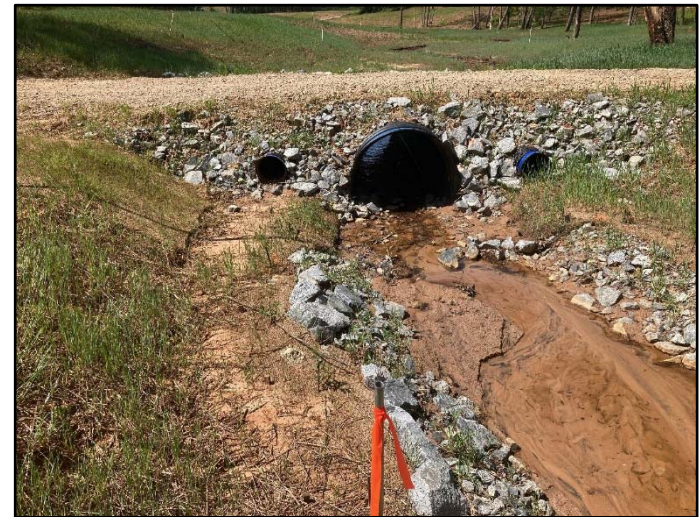
Photo Station 8
Crossing on UT2-2 looking downstream

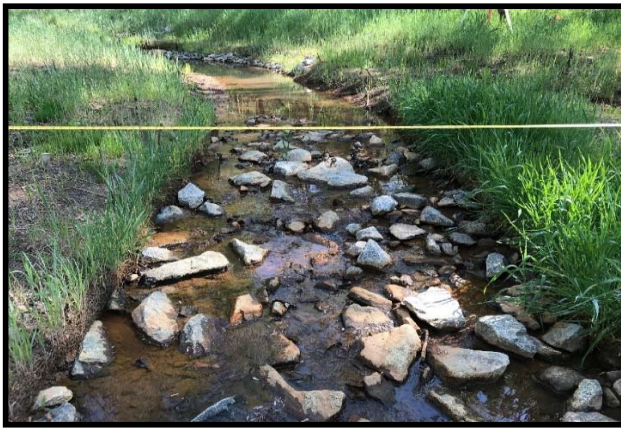
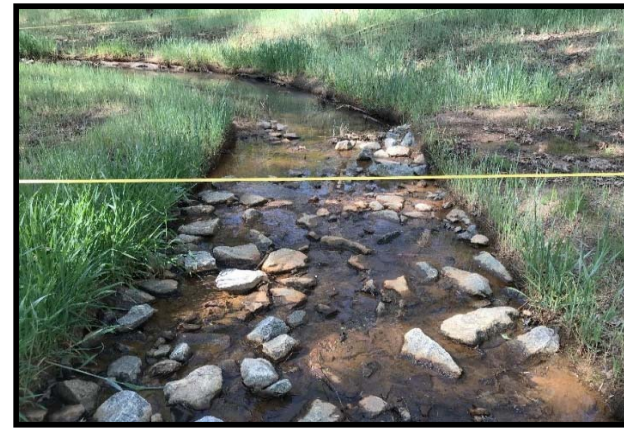
Upstream

Downstream

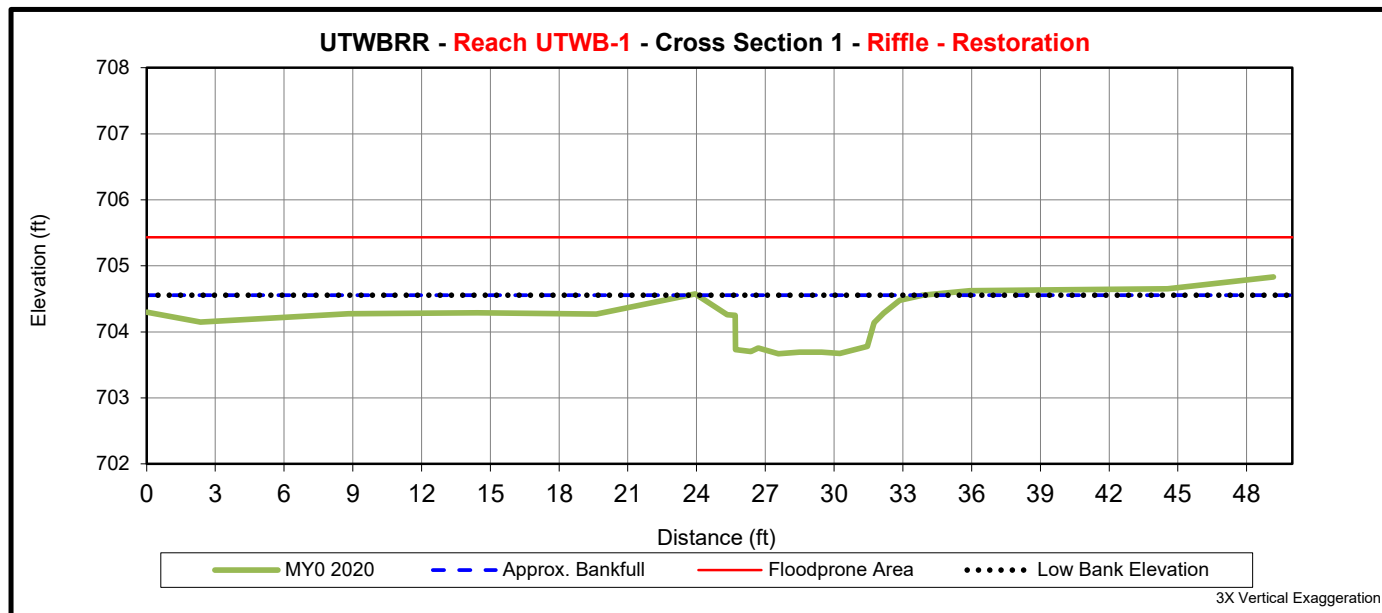
Cross Section 1 (Riffle)						
	MY0	MY1	MY2	MY3	MY5	MY7	MY+
Bankfull Elevation (ft) - Based on AB-XSA¹	704.56						
Bankfull Width (ft) ¹	9.8						
Floodprone Width (ft) ¹	>49.2						
Bankfull Max Depth (ft) ²	0.9						
Low Bank Elevation (ft)	704.56						
Bankfull Cross Sectional Area (ft ²) ²	5.7						
Bankfull Entrenchment Ratio ¹	>5						
Bankfull Bank Height Ratio ¹	1.0

A total of 14 cross sections were installed and geomorphology data collection (including longitudinal profile) for MY0 was conducted on April 14 and 15, 2021. Summary tables and cross section plots are in **Appendix D**. Overall the baseline cross sections and profile relatively match the proposed design. The as-built conditions show that shear stress and velocities have been reduced for the restoration reach. The reach was designed as a gravel bed channel and remain classified as a gravel bed channel post-construction.

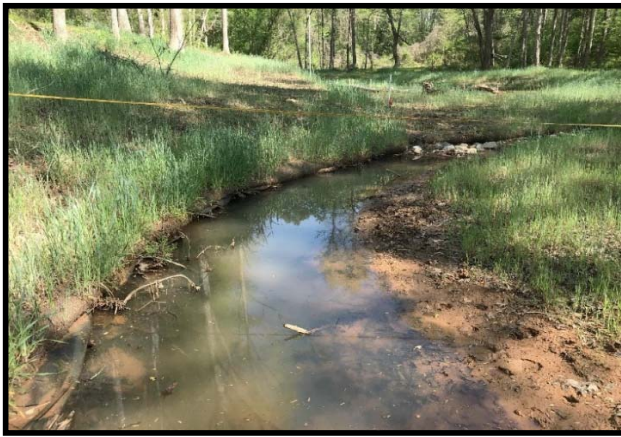
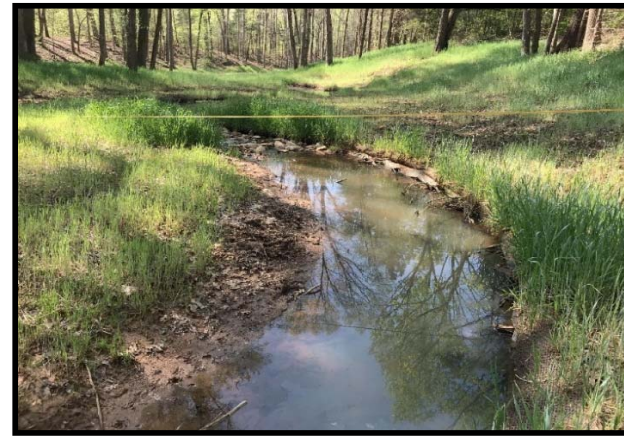
Upstream

Downstream

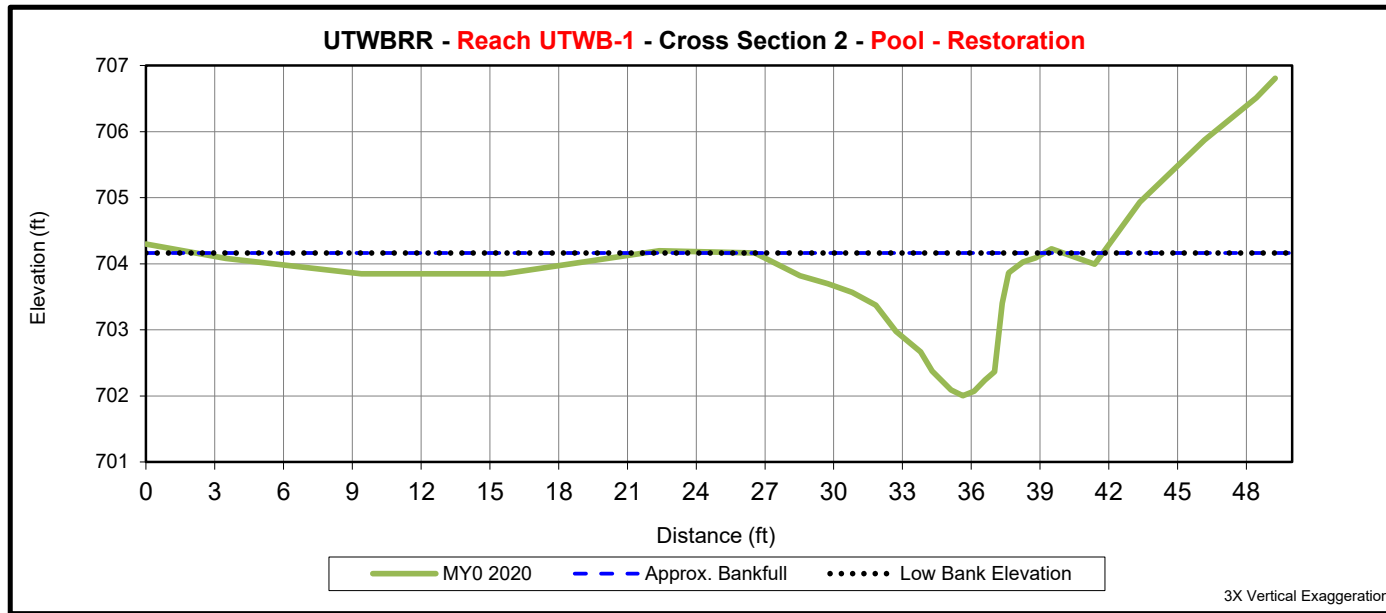
Cross Section 2 (Pool)						
	MY0	MY1	MY2	MY3	MY5	MY7	MY+
Bankfull Elevation (ft) - Based on AB-XSA¹	704.16						
Bankfull Width (ft) ¹	NA						
Floodprone Width (ft) ¹	NA						
Bankfull Max Depth (ft) ²	2.2						
Low Bank Elevation (ft)	704.16						
Bankfull Cross Sectional Area (ft ²) ²	11.5						
Bankfull Entrenchment Ratio ¹	NA						
Bankfull Bank Height Ratio ¹	NA

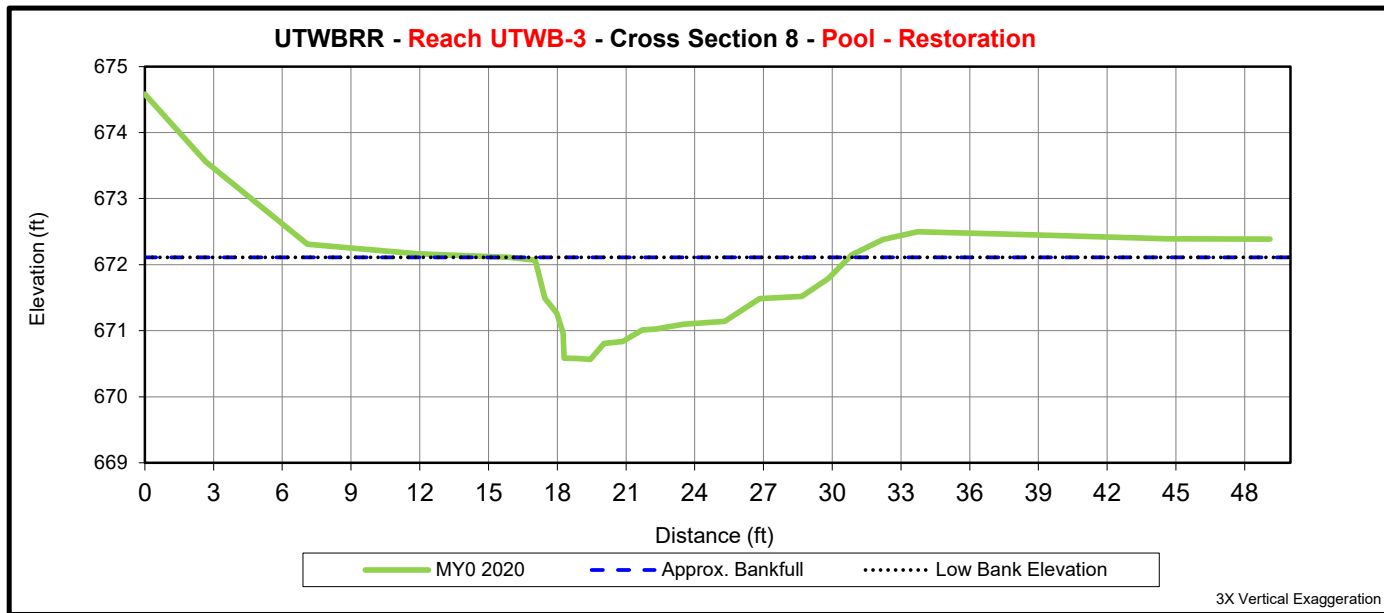
Cross Section 8 (Pool)						
	MY0	MY1	MY2	MY3	MY5	MY7	MY+
Bankfull Elevation (ft) - Based on AB-XSA¹	672.11						
Bankfull Width (ft) ¹	NA						
Floodprone Width (ft) ¹	NA						
Bankfull Max Depth (ft) ²	1.5						
Low Bank Elevation (ft)	672.11						
Bankfull Cross Sectional Area (ft ²) ²	12.3						
Bankfull Entrenchment Ratio ¹	NA						
Bankfull Bank Height Ratio ¹	NA

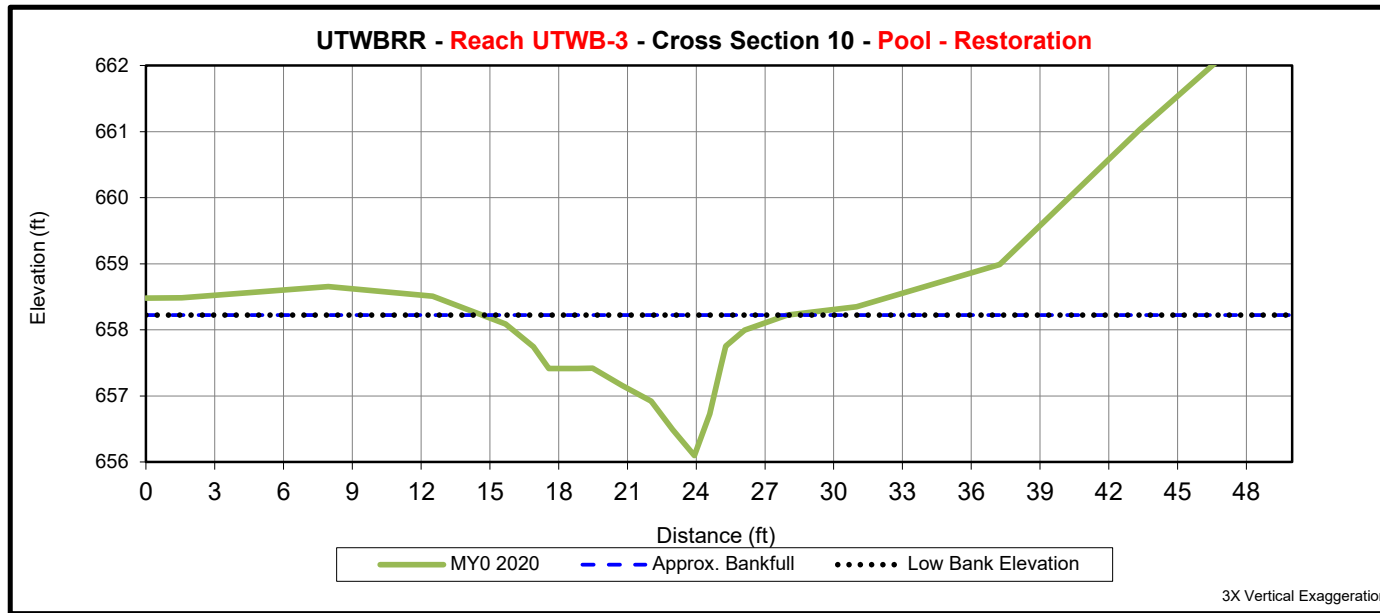
Cross Section 10 (Pool)						
	MY0	MY1	MY2	MY3	MY5	MY7	MY+
Bankfull Elevation (ft) - Based on AB-XSA¹	658.23						
Bankfull Width (ft) ¹	NA						
Floodprone Width (ft) ¹	NA						
Bankfull Max Depth (ft) ²	2.1						
Low Bank Elevation (ft)	658.23						
Bankfull Cross Sectional Area (ft ²) ²	10.8						
Bankfull Entrenchment Ratio ¹	NA						
Bankfull Bank Height Ratio ¹	NA

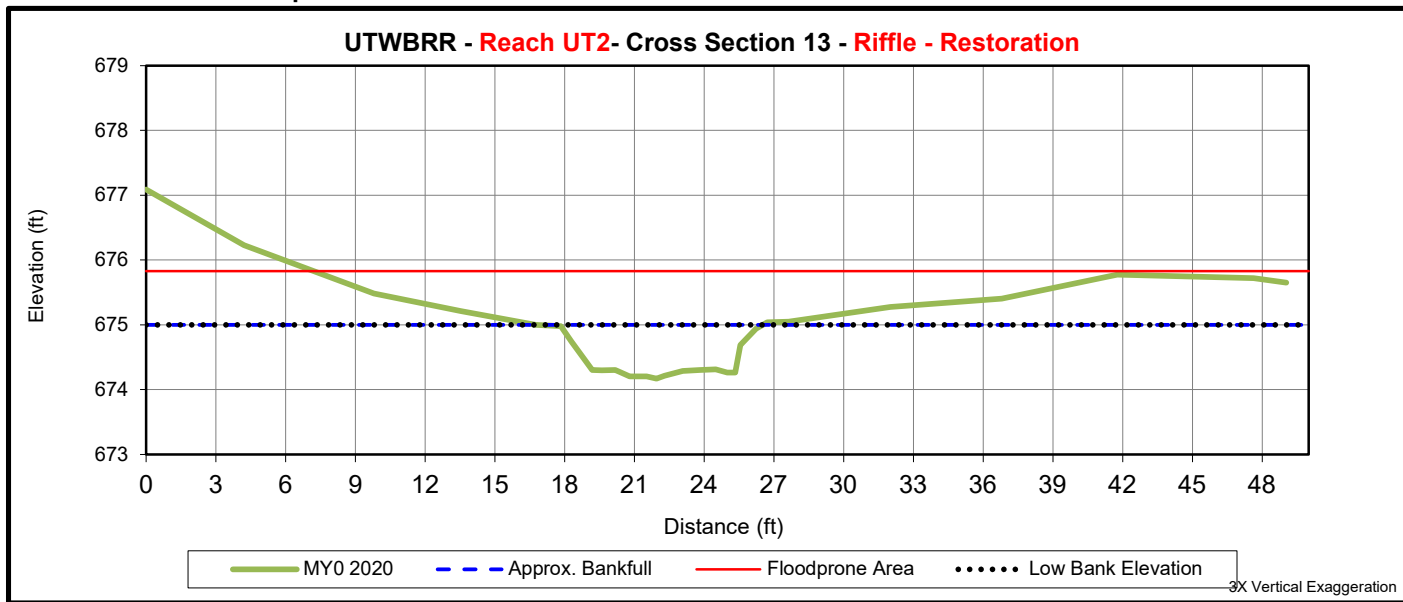
Cross Section 13 (Riffle)						
	MY0	MY1	MY2	MY3	MY5	MY7	MY+
Bankfull Elevation (ft) - Based on AB-XSA¹	675.00						
Bankfull Width (ft) ¹	9.8						
Floodprone Width (ft) ¹	>41.8						
Bankfull Max Depth (ft) ²	0.8						
Low Bank Elevation (ft)	675.00						
Bankfull Cross Sectional Area (ft ²) ²	5.3						
Bankfull Entrenchment Ratio ¹	>4.3						
Bankfull Bank Height Ratio ¹	1.0

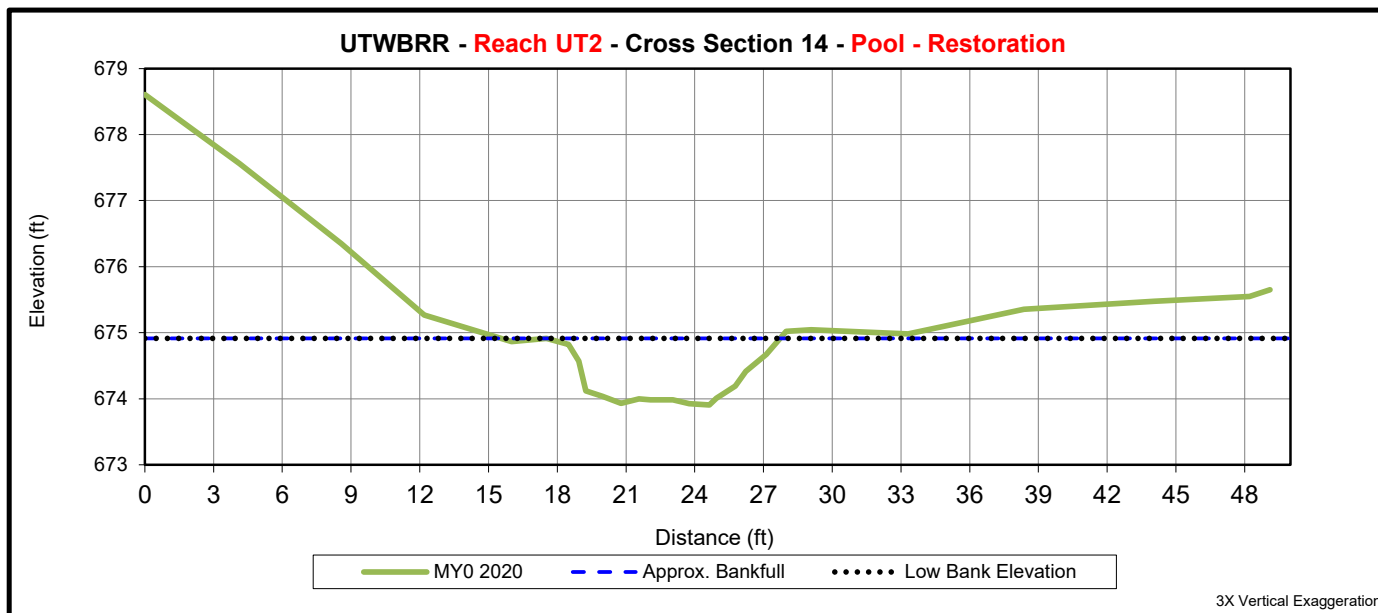
Cross Section 14 (Pool)						
	MY0	MY1	MY2	MY3	MY5	MY7	MY+
Bankfull Elevation (ft) - Based on AB-XSA¹	674.91						
Bankfull Width (ft) ¹	NA						
Floodprone Width (ft) ¹	NA						
Bankfull Max Depth (ft) ²	1.0						
Low Bank Elevation (ft)	674.91						
Bankfull Cross Sectional Area (ft ²) ²	7.0						
Bankfull Entrenchment Ratio ¹	NA						
Bankfull Bank Height Ratio ¹	NA

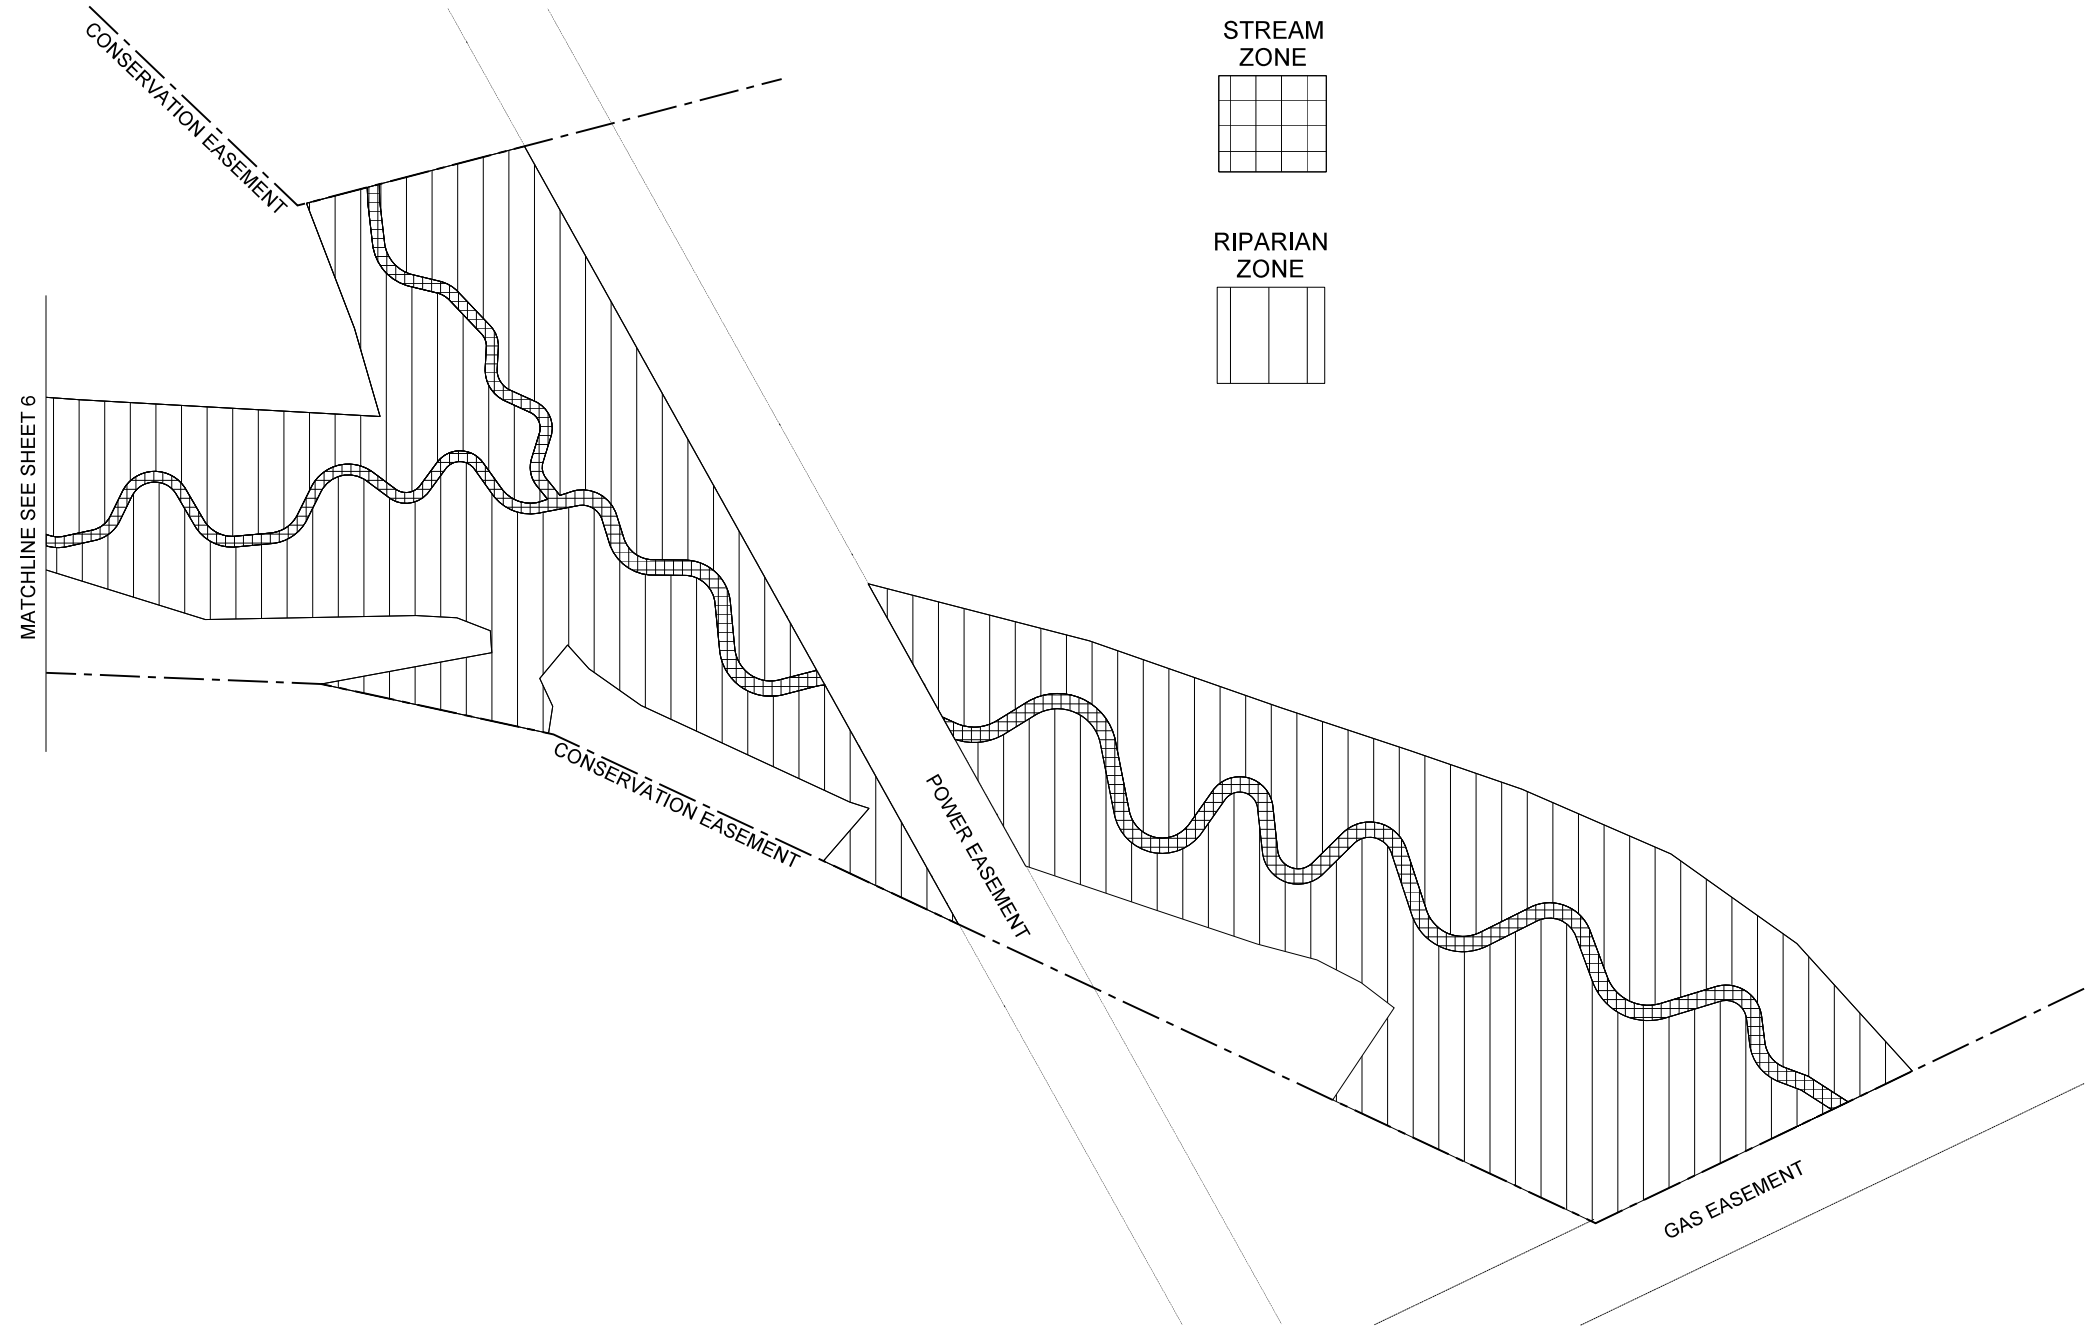
SHEET 7 OF 7

PLANTING
PLAN
