MONITORING YEAR 3 ANNUAL REPORT

VILE CREEK MITIGATION SITE

Alleghany County, NC
DEQ Contract No. 5999
DMS Project No. 96582

Data Collection Period: April – October 2019
Submission Date: December 19, 2019

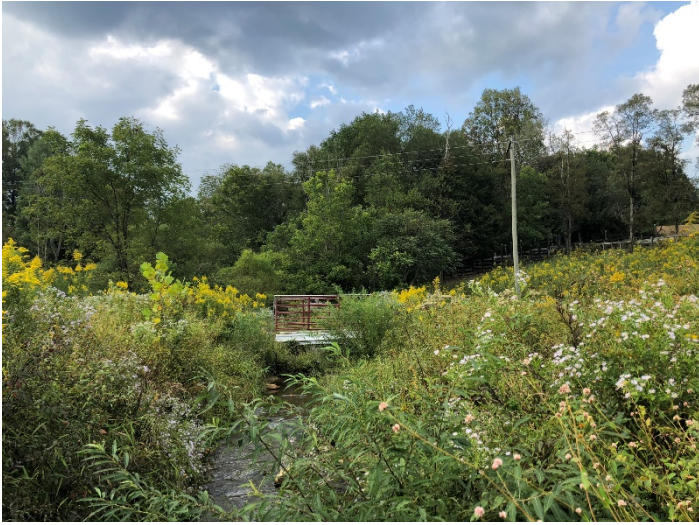
Photo Point 1 – view upstream Vile Creek R1 (9/17/2019)

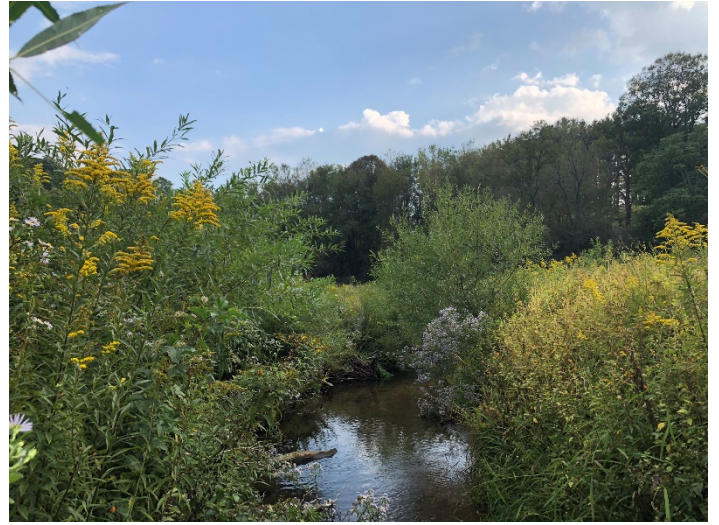
Photo Point 1 – view downstream Vile Creek R1 (9/17/2019)

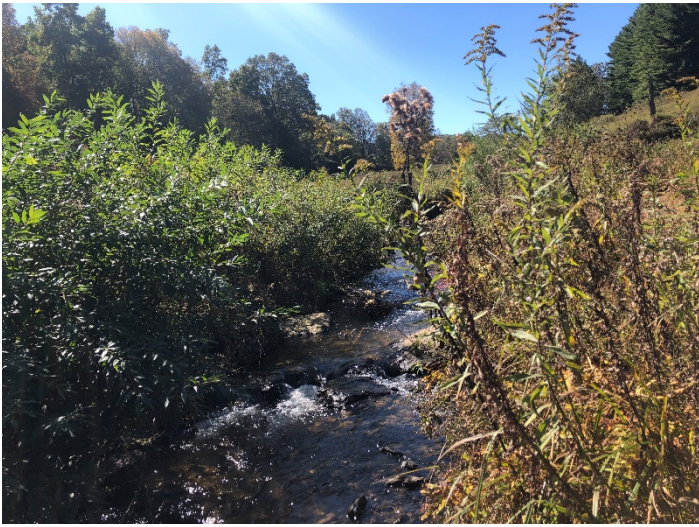
Photo Point 10 – view upstream Vile Creek R2 (10/14/2019)

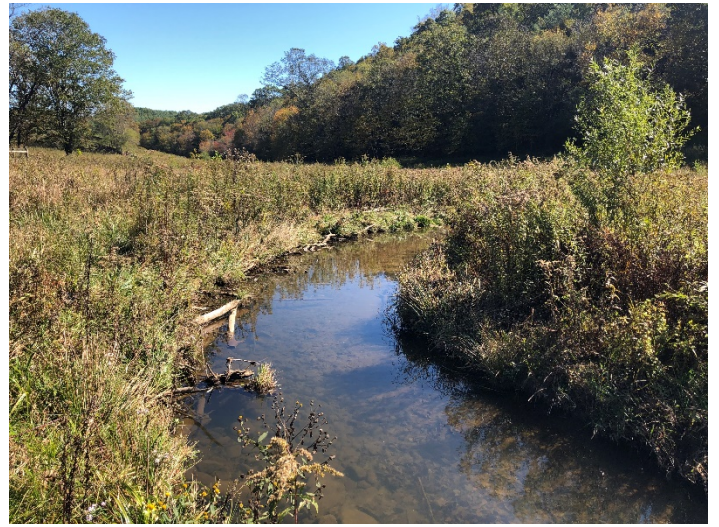
Photo Point 10 – view downstream Vile Creek R2 (10/14/2019)

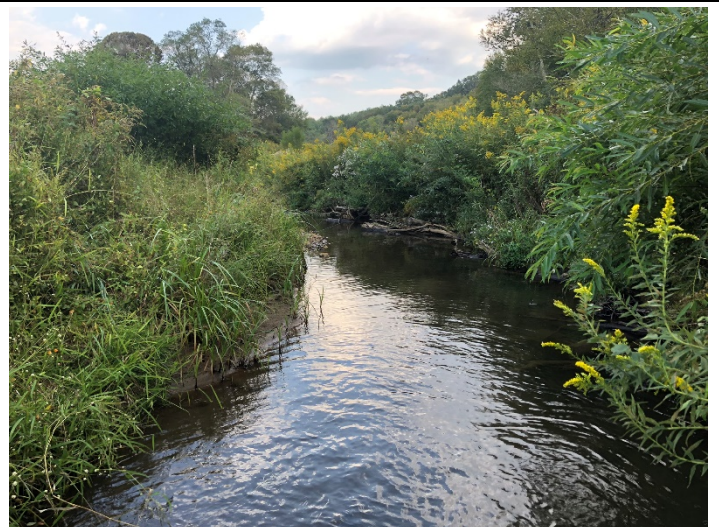
Photo Point 15 – view downstream Vile Creek R2 (9/17/2019)

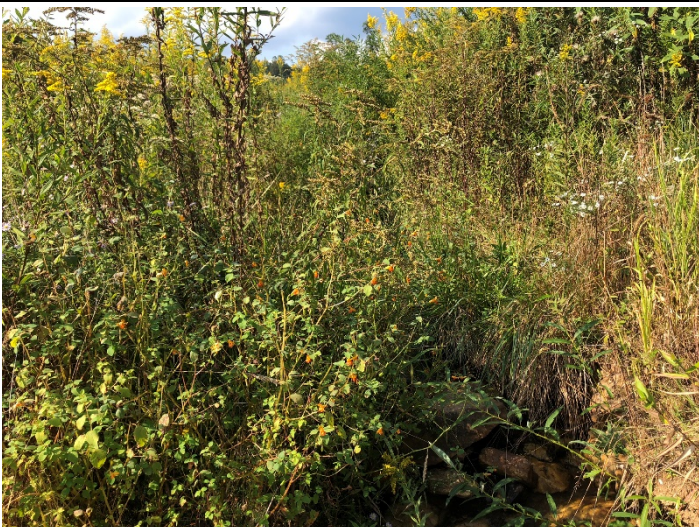
Photo Point 31 – view of UT2 BMP (9/17/2019)

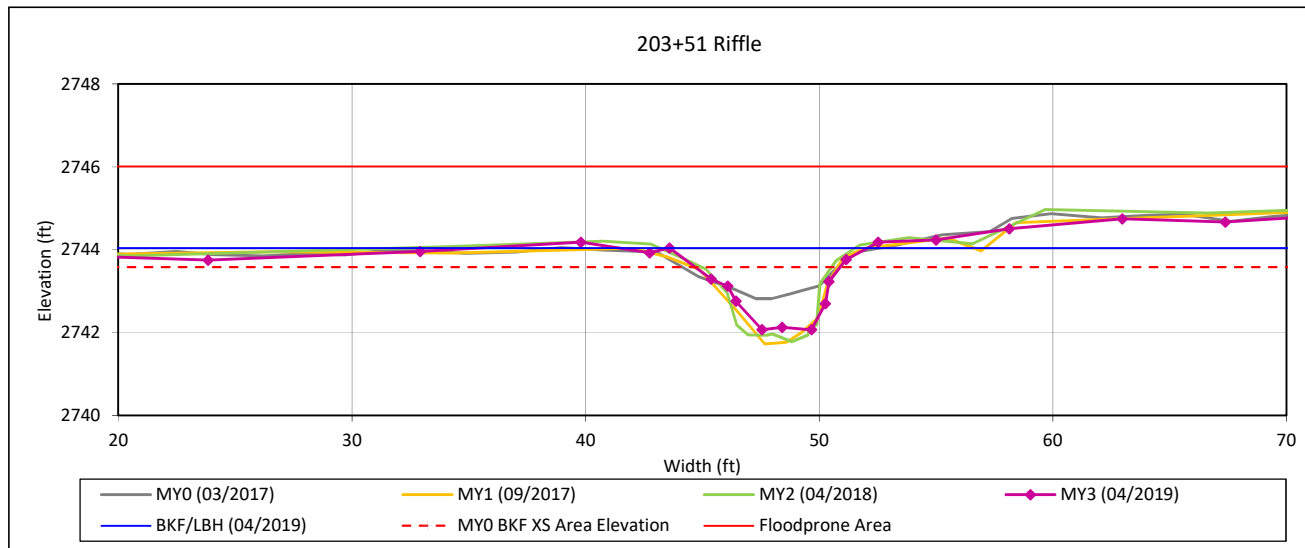
Cross-section 7 - UT1 Reach 1

9.3	x-section area (ft.sq.)
8.5	width (ft)
1.1	mean depth (ft)
2.0	max depth (ft)
9.9	wetted perimeter (ft)
0.9	hydraulic radius (ft)
7.8	width-depth ratio
85.5	W flood prone area (ft)
10.1	entrenchment ratio
1.3	low bank height ratio

In general, the cross-sections show little change in the bankfull area, maximum depth ratio, and width-to-depth ratio. All cross-sections fell within the parameters defined for channels of the appropriate stream type (Rosgen, 1994 & 1996). During MY3 cross-sections two and seven are exhibiting a bank height ratio greater than 1.2. Cross-section seven degraded during MY1 and has remained stable in subsequent years. Cross section two began to degrade in MY1 and has continued to degrade through MY3. The cross-section is located in between two logs in a rock and roll riffle. It's expected to see some deepening of a scour pool in this location of a rock and roll riffle. The degradation is not expected to affect the structures up and down stream. Wildlands will continue to watch these cross-sections in upcoming monitoring years.

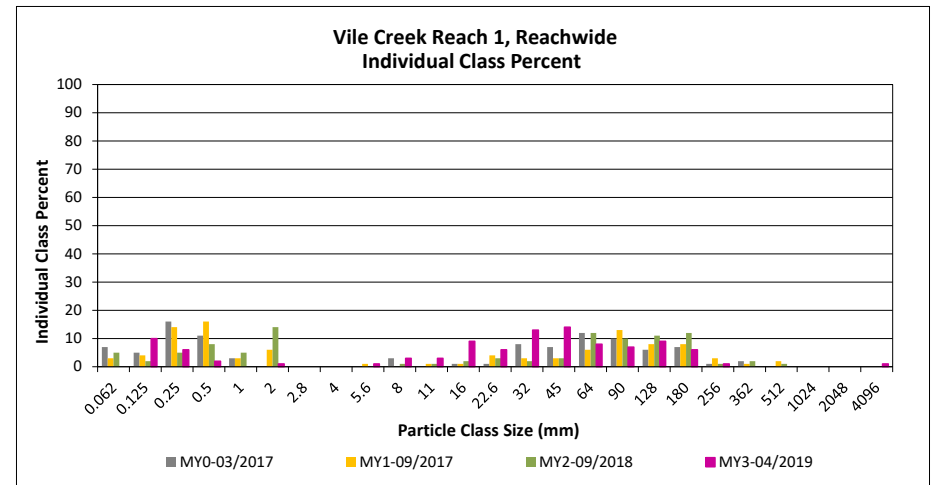
Reachwide Channel materials (mm)	
D ₁₆ =	0.3
D ₃₅ =	16.0
D ₅₀ =	28.8
D ₈₄ =	93.6
D ₉₅ =	151.8
D ₁₀₀ =	>2048

MY3 Pebble counts in UT1 and Vile Creek did not indicate a significant change in bed material compared to previous years. Refer to Appendix 2 for the visual stability assessment table, Current Condition Plan View (CCPV) maps, and reference photographs. Refer to Appendix 4 for the morphological data and plots.

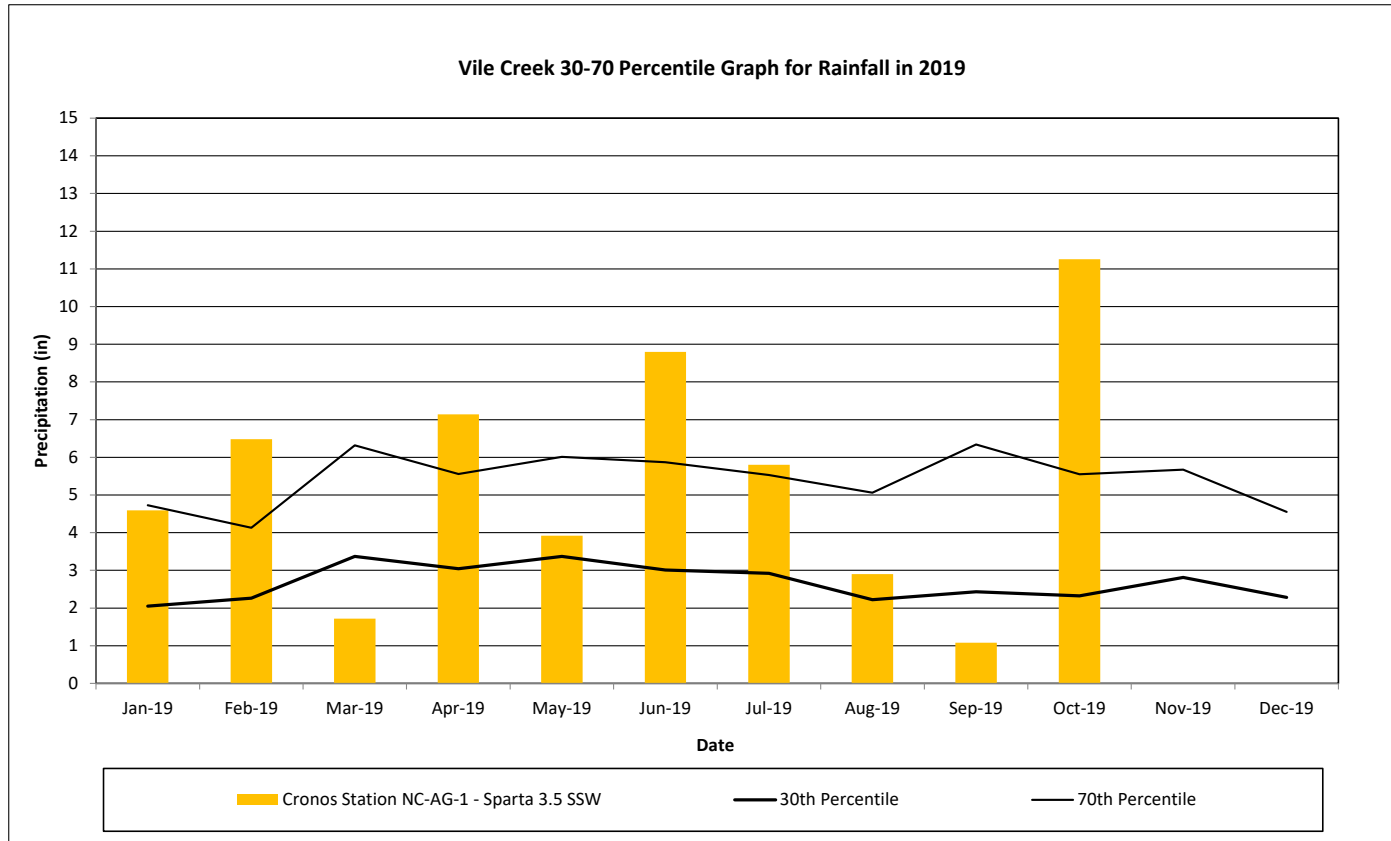
Monthly Rainfall Data

2019 rainfall collected by Cronos Station NC-AG-1 - Sparta 3.5 SSW

30th and 70th percentile rainfall data collected from Wets Station Sparta 3.5 SSW, NC (Years 1971 - 2019)
