# BIG WARRIOR STREAM RESTORATION MITIGATION PLAN

March 2005

Big Warrior Creek Restoration  
 Wilkes County, North Carolina  
 Biohabitats Project No. 02803.01

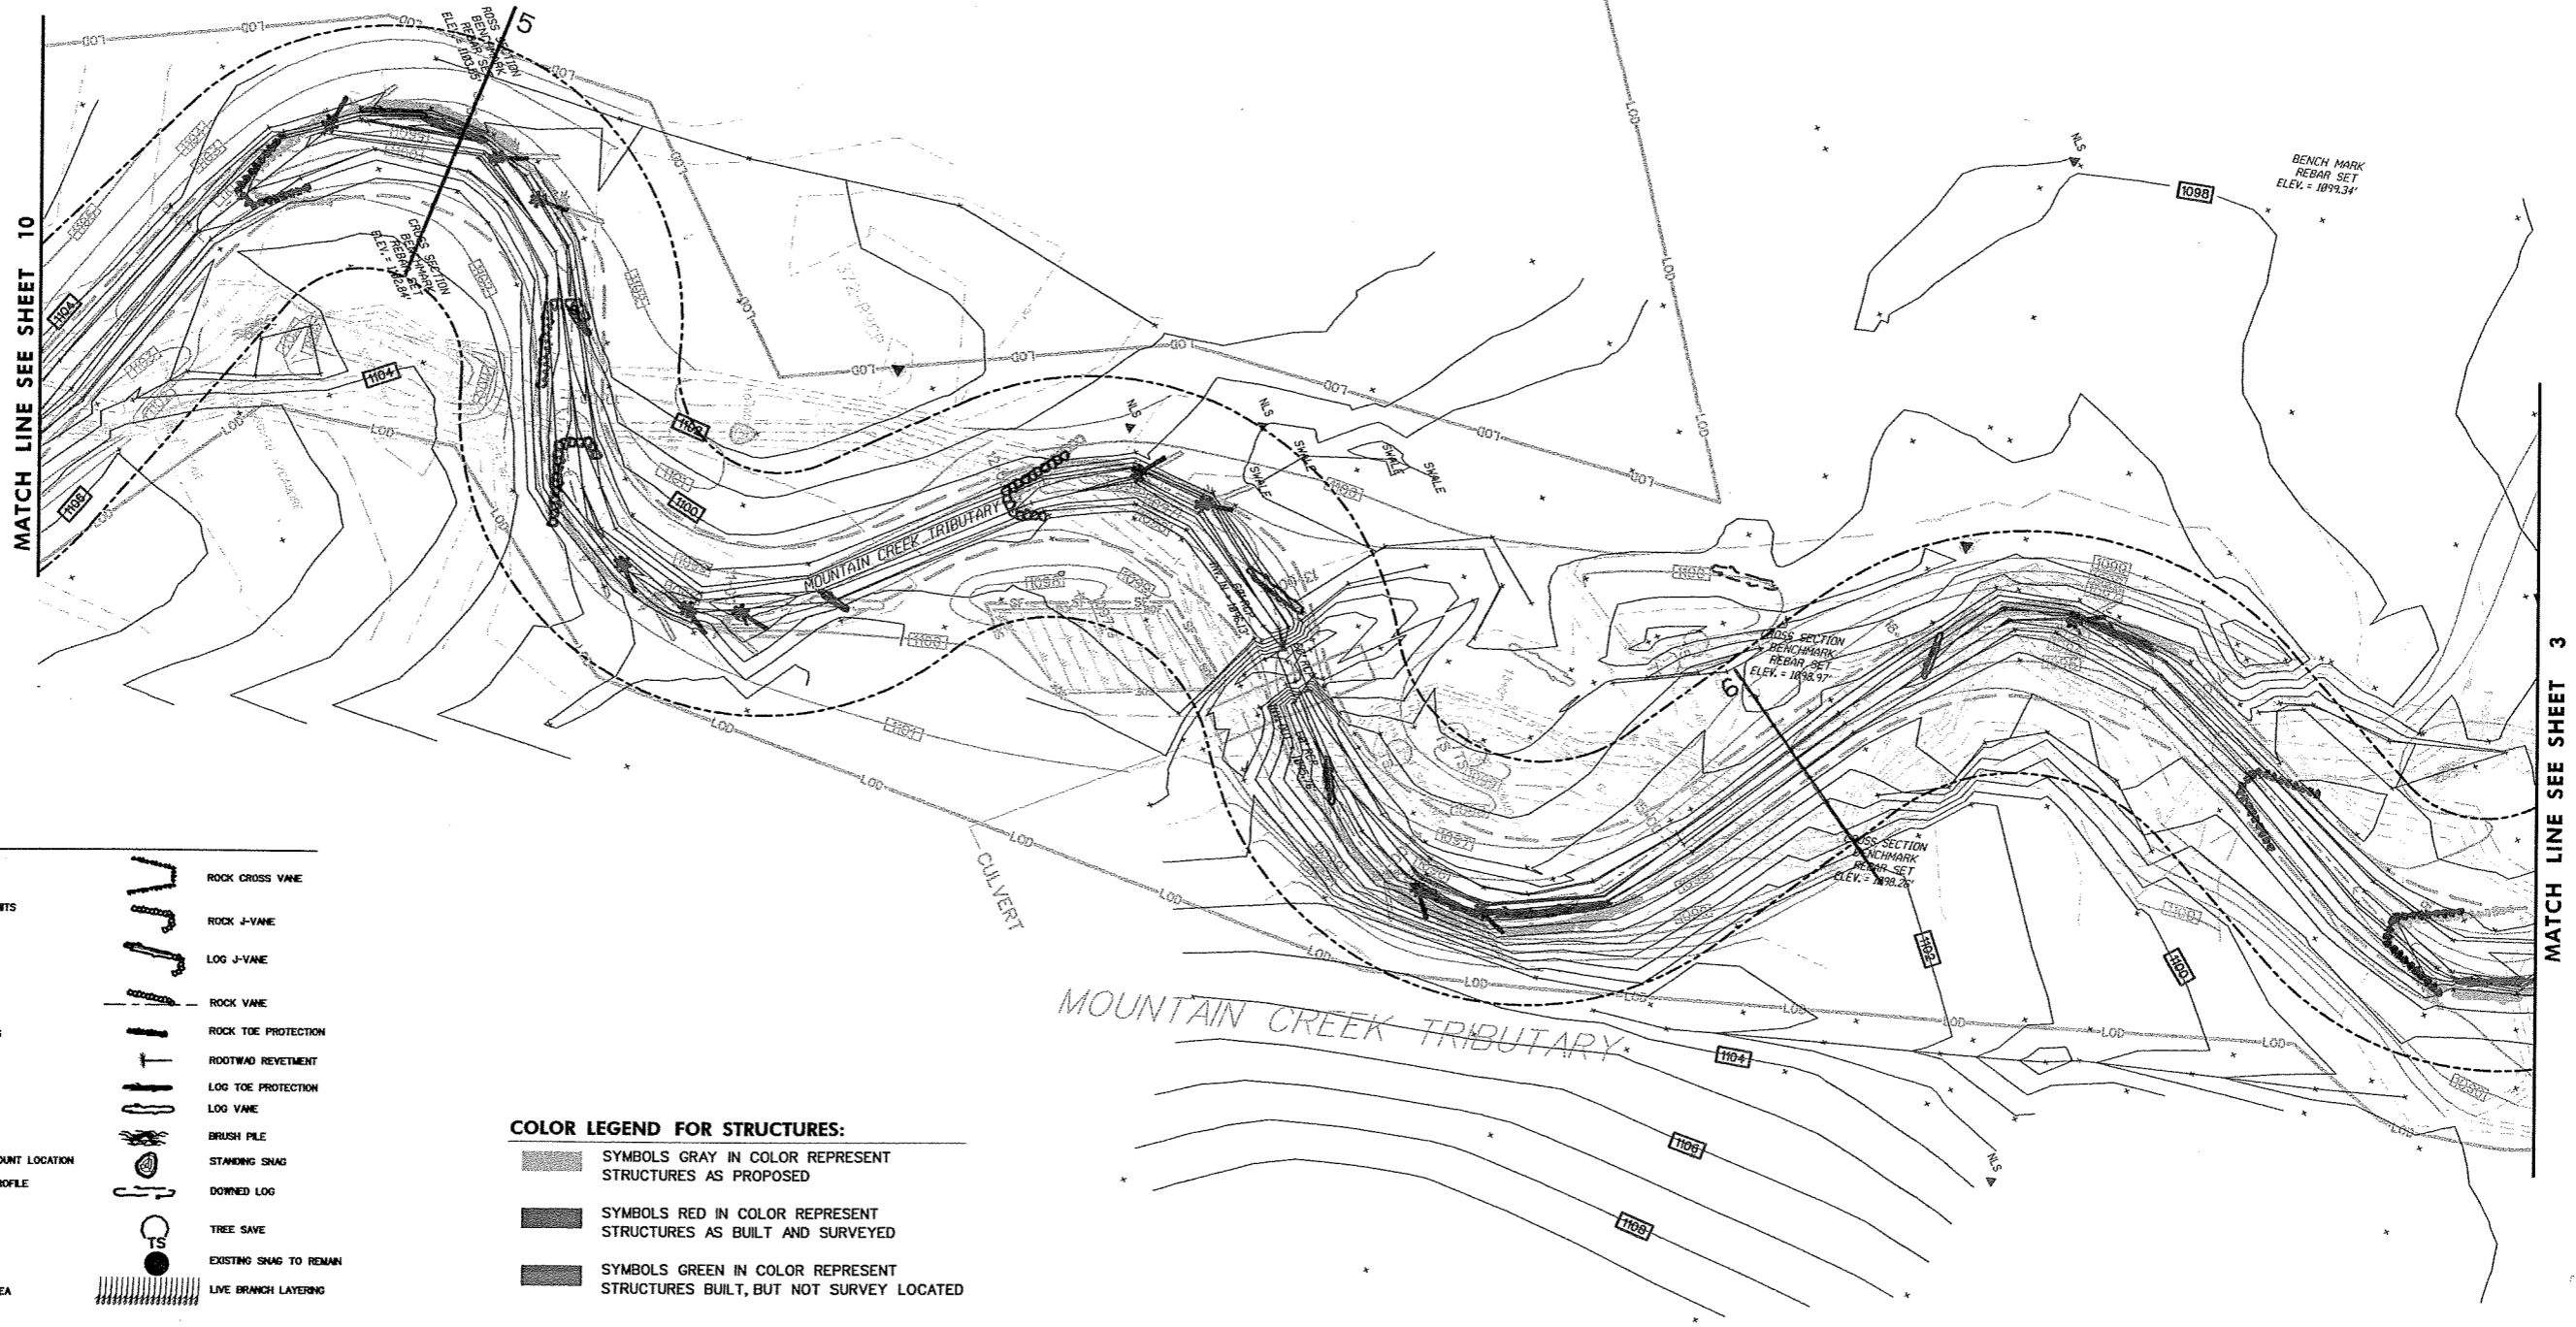
**AS BUILT SURVEY PLAN**  
 SCALE: 1" = 30'-0"  
 CONTRACT NO.   
 SHEET 9 OF 20

**BIG WARRIOR CREEK  
 STREAM RESTORATION**  
 WILKES COUNTY NORTH CAROLINA

Appendix A includes scaled 11" by 17" planform maps adapted from the as-built drawings to reflect monitoring locations. The plots show the as-built topography superimposed on the design plans for reference. The maps show the location of all in-stream structures, vegetation planting zones, vegetation sample plots, and the easement boundary. Final planting schedules corresponding with species planted by planting zone are shown in Appendix G. Many changes were made during construction in the field with the agreement of the Designer and the Contractor based on professional judgment of what would improve the installation.

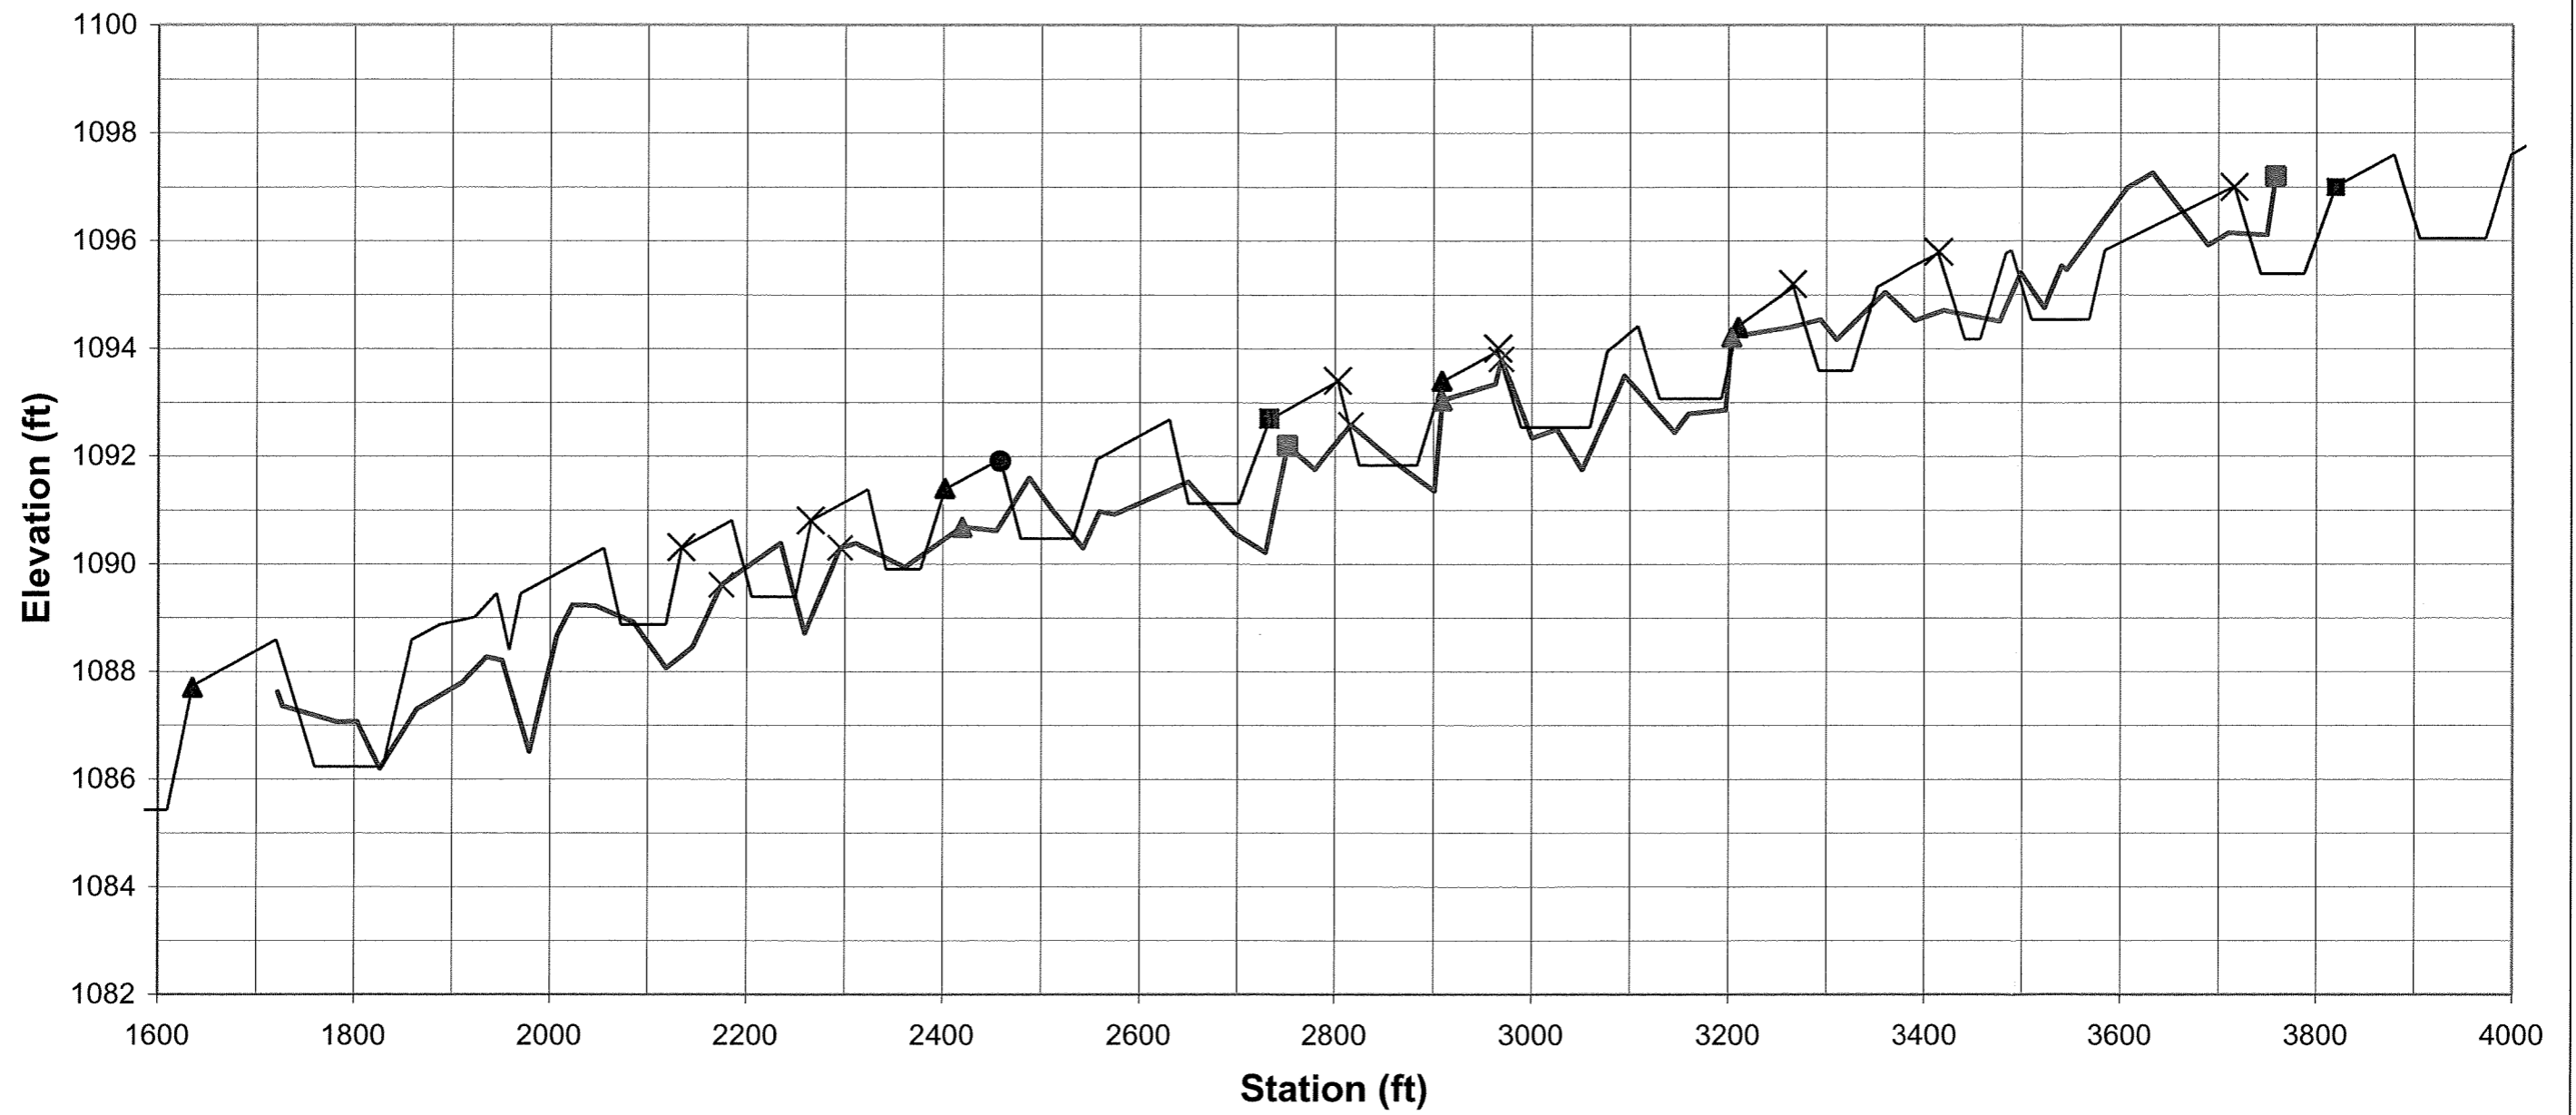
**LONGITUDINAL PROFILE**

- As-Built Surveyed Profile
- - - Design Profile
- Log Vane
- Rock Cross Vane
- X Rock Vane
- ▲ Rock J-Vane
- Rock Cross Vane
- X Rock Vane
- ▲ Rock J-Vane

**Baseline Monitoring Conditions  
Survey Date: December 7, 2004**

One continuous thalweg profile was surveyed through a 2,000+-foot section of the project reach to establish baseline streambed elevations. Features such as riffles and pools were noted in the survey. The location and elevation of flow deflection and grade control structures such as rock vanes and rock cross vanes were also surveyed. The extent of the field-surveyed longitudinal profile is shown by magenta line segments on Sheets 2 through 4 of Appendix A. The baseline longitudinal profile from December 2004 is shown in Appendix B.

To construct the baseline profile survey shown in Appendix B, measuring tapes were stretched end-to-end along the thalweg to record cumulative distance downstream. Because the thalweg will adjust slightly in planform from year to year, it should be expected that the total reach length will be somewhat different for each monitoring year. As a result, a point at a given distance on a

field-surveyed profile graph may not represent the same location shown on the as-built survey plan (Appendix A). The magnitude of the offset can, however, be evaluated by locally comparing the x-axis “distance” of a stationary in-stream structure (e.g., a cross vane) between years.

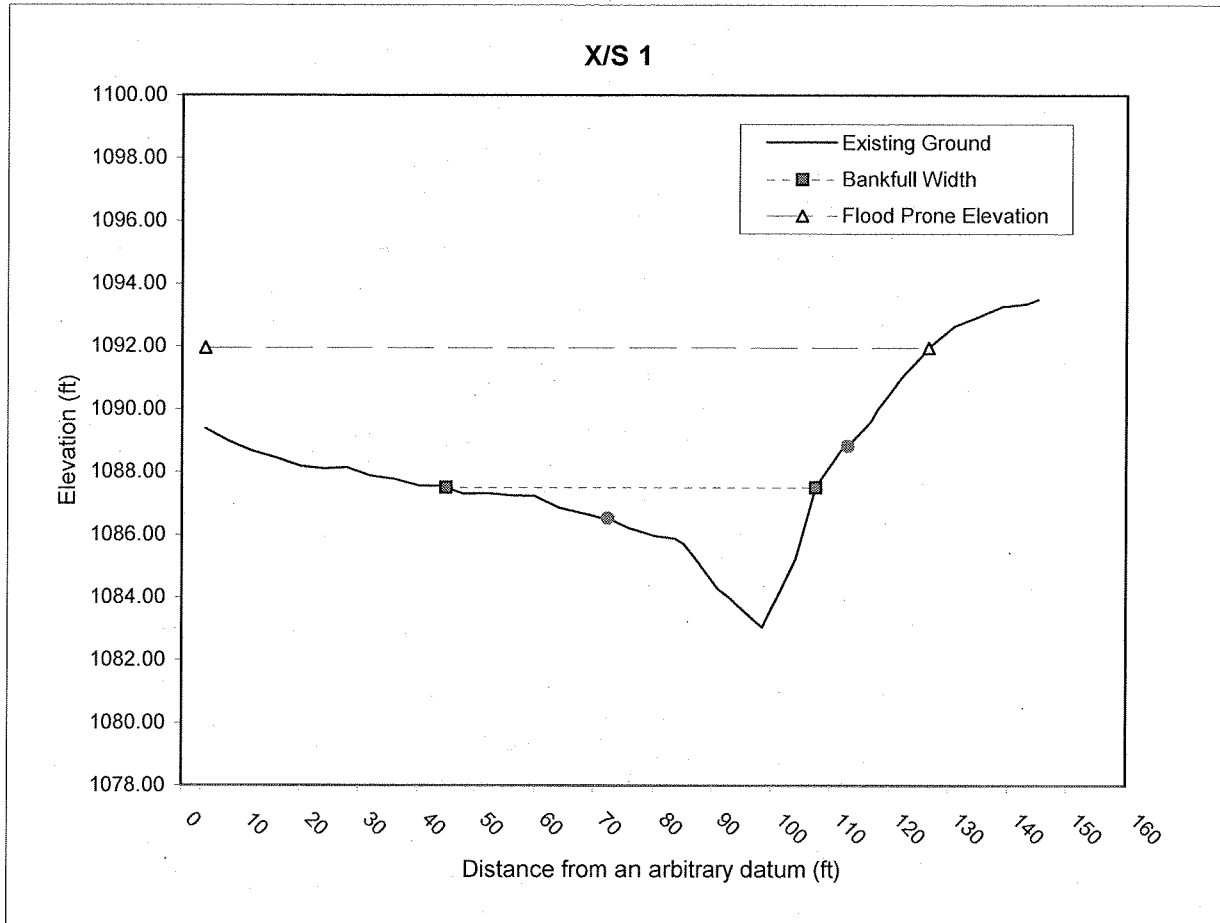
Rosgen Stream Type Classification	
Bankfull Width	62.62 (ft)
Entrenchment	>2.0 (ft/ft)
Width:Depth	41.05 (ft/ft)
Sinuousity	(ft/ft)
Slope	0.0040 (ft/ft)
D <sub>50</sub>	9 (mm)
Stream Type	C4

Flow Calculations	
Max BF Depth	4.45 (ft)
Mean BF Depth	1.53 (ft)
X/S Area	95.53 (ft <sup>2</sup> )
Manning's n	0.0350
BF Ave. Velocity	3.52 (ft/s)
Discharge	335.83 (cfs)
Shear Stress	0.37 (lb/ft <sup>2</sup> )

Following installation of the rebar monuments, the eight cross sections were surveyed with a standard survey level, survey rod and measuring tapes. Baseline cross-sectional measurements are intended to document a range of future adjustments in channel geometry. Cross-sectional features measured during the surveying efforts included monumented cross-sectional endpoints (capped rebar), topographic breaks in slope, bankfull indicators, edge of water at time of survey, and channel features that may influence the direction and/or speed of flow in the channel. The locations of monumented cross sections are shown by numbered, dark blue line segments in Appendix A. Results from the baseline cross-sectional measurements are shown in Appendix C. Two of the cross sections (#2 and #3) overlap the longitudinal profile.

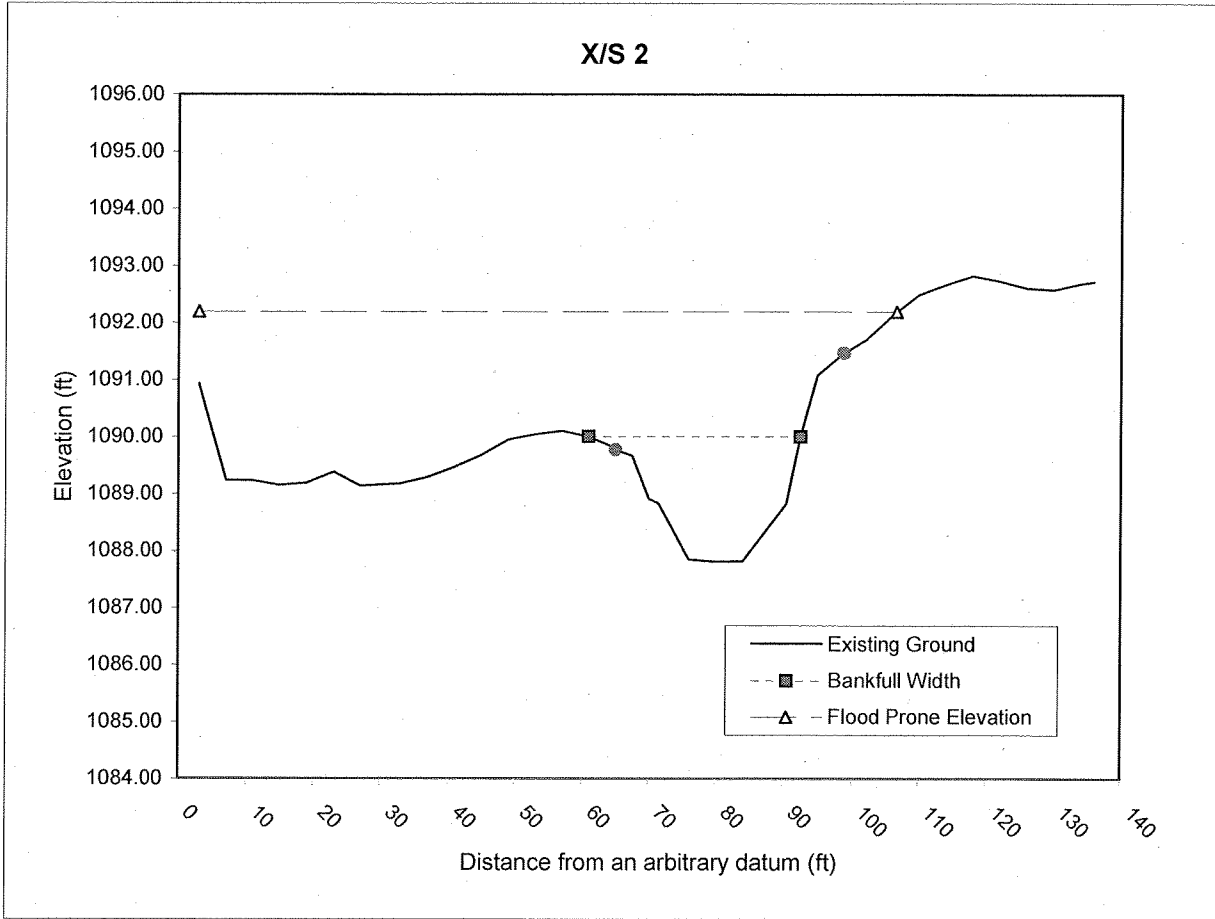
Rosgen Stream Type Classification	
Bankfull Width	31.57 (ft)
Entrenchment	>3.3 (ft/ft)
Width:Depth	23.96 (ft/ft)
Sinuousity	(ft/ft)
Slope	0.0040 (ft/ft)
D <sub>50</sub>	<2 (mm)
Stream Type	C4

Flow Calculations	
Max BF Depth	2.19 (ft)
Mean BF Depth	1.32 (ft)
X/S Area	41.59 (ft <sup>2</sup> )
Manning's n	0.0350
BF Ave. Velocity	3.19 (ft/s)
Discharge	132.78 (cfs)
Shear Stress	0.32 (lb/ft <sup>2</sup> )

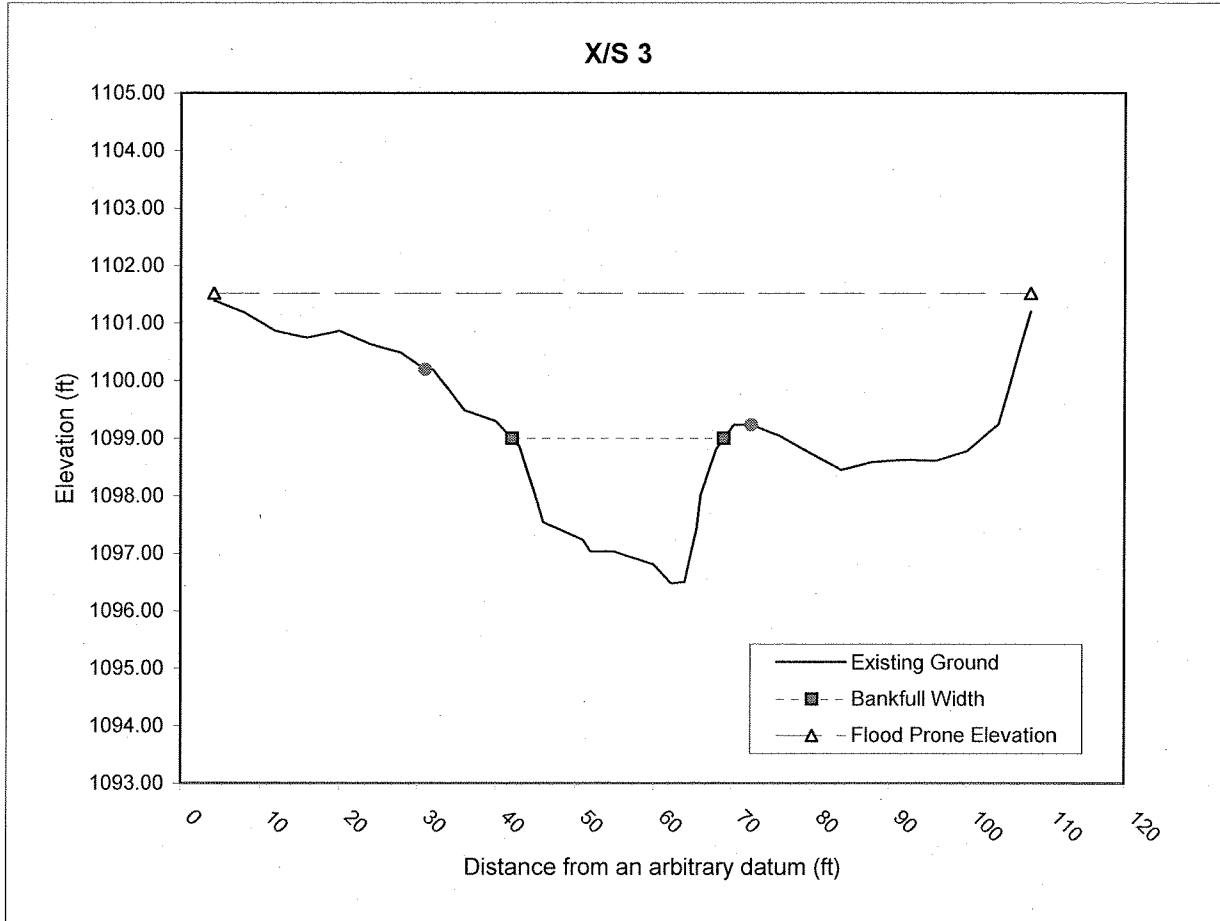
Rosgen Stream Type Classification	
Bankfull Width	26.97 (ft)
Entrenchment	>2.3 (ft/ft)
Width:Depth	16.79 (ft/ft)
Sinuousity	(ft/ft)
Slope	0.0040 (ft/ft)
D <sub>50</sub>	<2 (mm)
Stream Type	C4

Flow Calculations	
Max BF Depth	2.52 (ft)
Mean BF Depth	1.61 (ft)
X/S Area	43.32 (ft <sup>2</sup> )
Manning's n	0.0350
BF Ave. Velocity	3.60 (ft/s)
Discharge	155.99 (cfs)
Shear Stress	0.39 (lb/ft <sup>2</sup> )

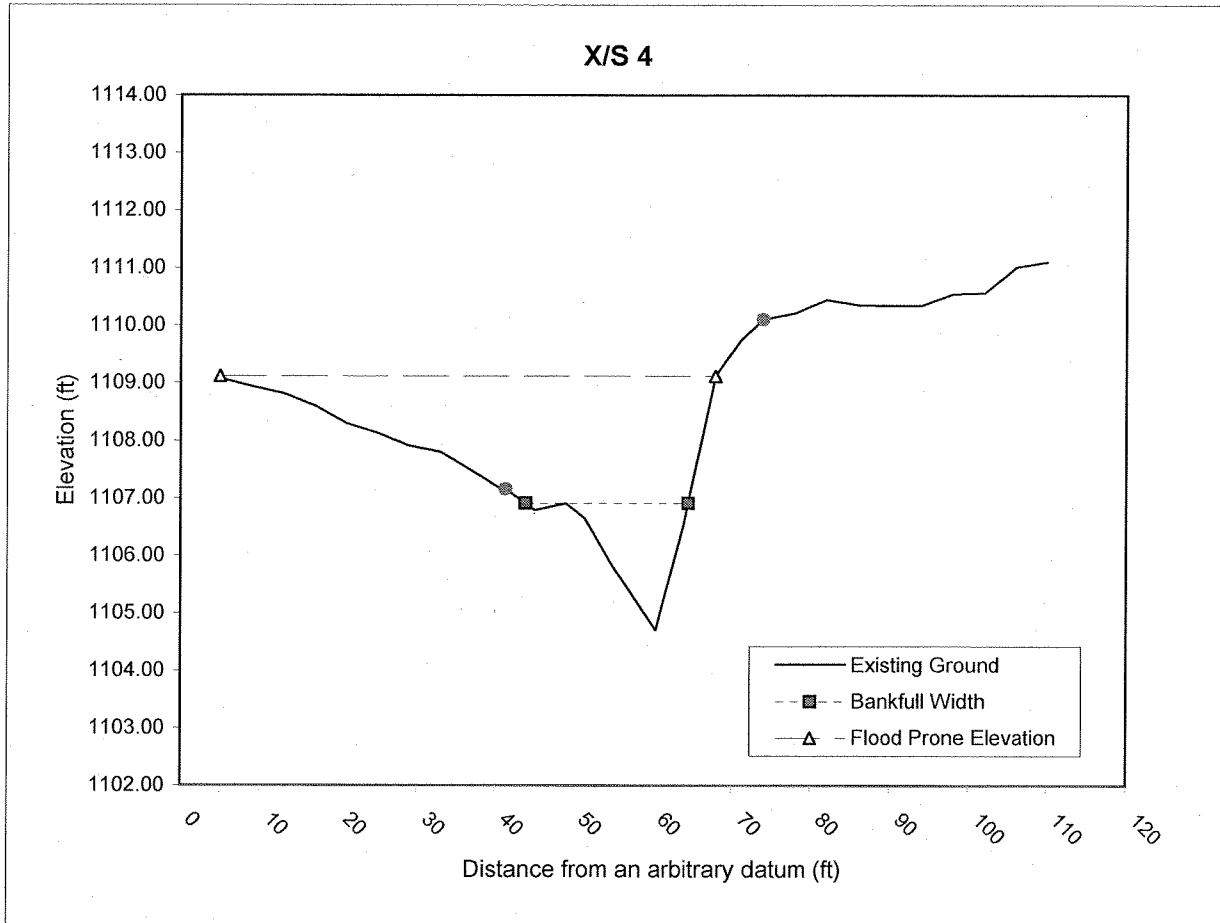
Rosgen Stream Type Classification	
Bankfull Width	20.79 (ft)
Entrenchment	3.03 (ft/ft)
Width:Depth	25.78 (ft/ft)
Sinosity	(ft/ft)
Slope	0.0040 (ft/ft)
D <sub>50</sub>	3 (mm)
Stream Type	C4

Flow Calculations	
Max BF Depth	2.21 (ft)
Mean BF Depth	0.81 (ft)
X/S Area	16.76 (ft <sup>2</sup> )
Manning's n	0.0350
BF Ave. Velocity	2.28 (ft/s)
Discharge	38.14 (cfs)
Shear Stress	0.19 (lb/ft <sup>2</sup> )

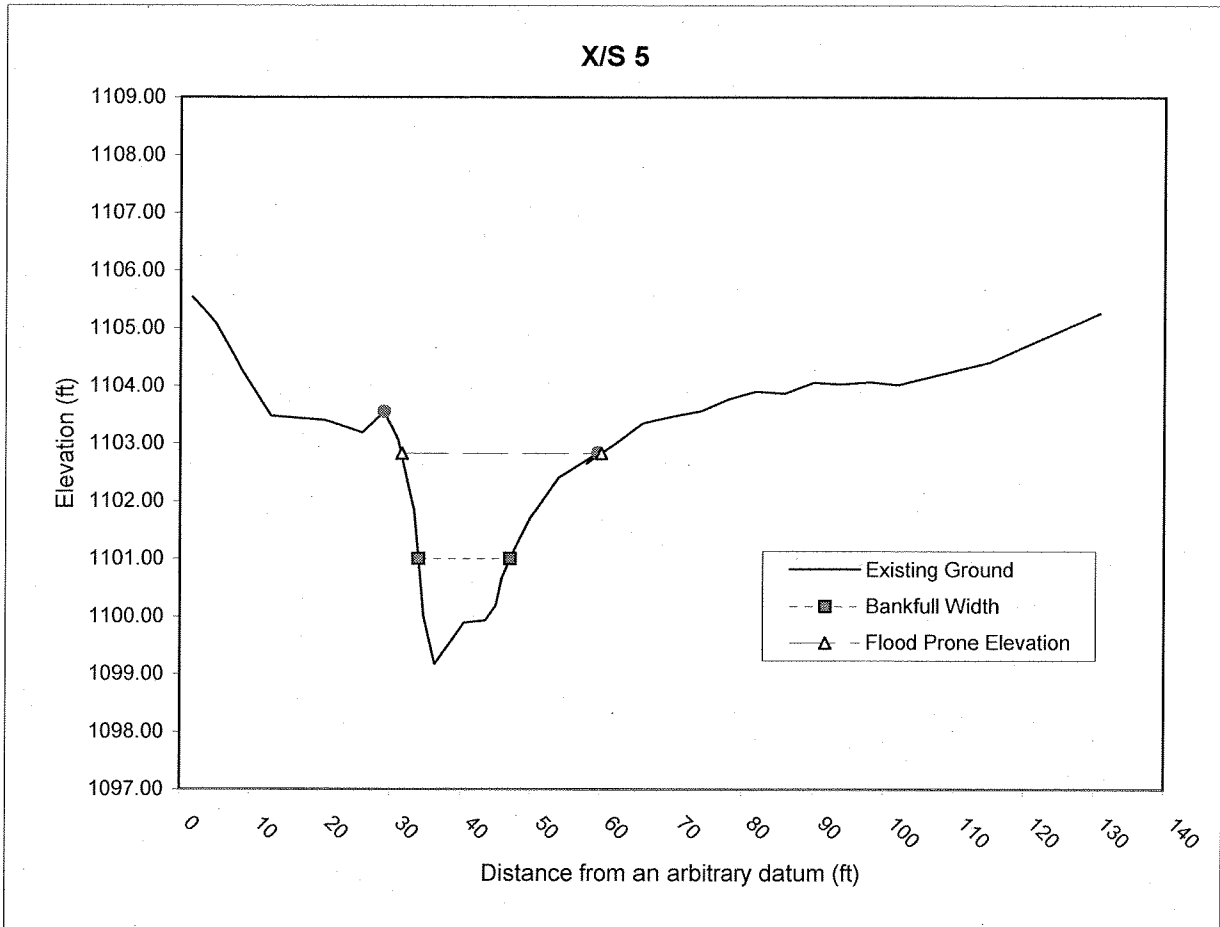
Rosgen Stream Type Classification	
Bankfull Width	13.15 (ft)
Entrenchment	2.18 (ft/ft)
Width:Depth	12.09 (ft/ft)
Sinuousity	(ft/ft)
Slope	0.0080 (ft/ft)
D <sub>50</sub>	20 (mm)
Stream Type	C4

Flow Calculations	
Max BF Depth	1.83 (ft)
Mean BF Depth	1.09 (ft)
X/S Area	14.31 (ft <sup>2</sup> )
Manning's n	0.0350
BF Ave. Velocity	3.84 (ft/s)
Discharge	54.92 (cfs)
Shear Stress	0.51 (lb/ft <sup>2</sup> )

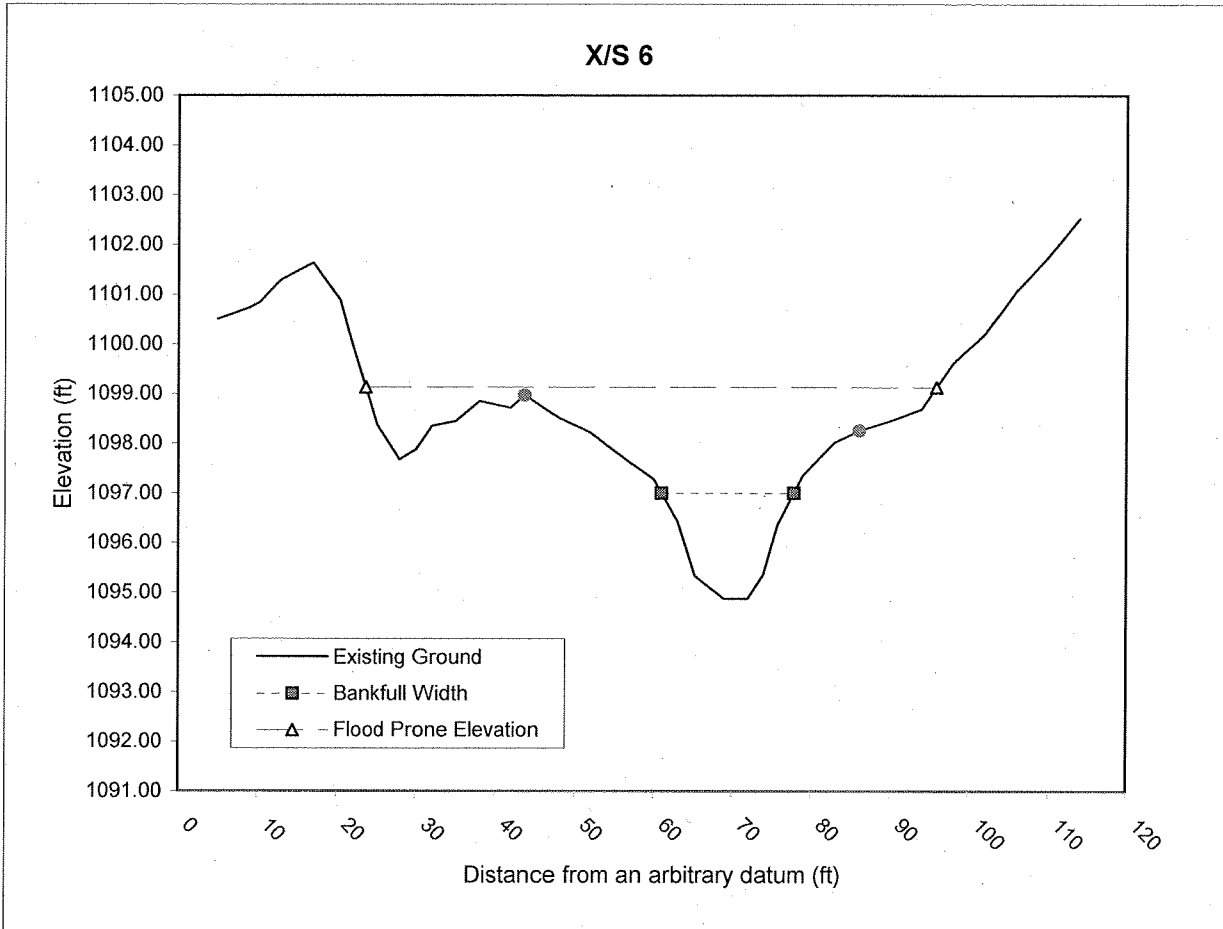
Rosgen Stream Type Classification	
Bankfull Width	16.83 (ft)
Entrenchment	4.29 (ft/ft)
Width:Depth	12.37 (ft/ft)
Sinuousity	(ft/ft)
Slope	0.0080 (ft/ft)
D <sub>50</sub>	17 (mm)
Stream Type	C4

Flow Calculations	
Max BF Depth	2.13 (ft)
Mean BF Depth	1.36 (ft)
X/S Area	22.89 (ft <sup>2</sup> )
Manning's n	0.0350
BF Ave. Velocity	4.54 (ft/s)
Discharge	103.86 (cfs)
Shear Stress	0.65 (lb/ft <sup>2</sup> )

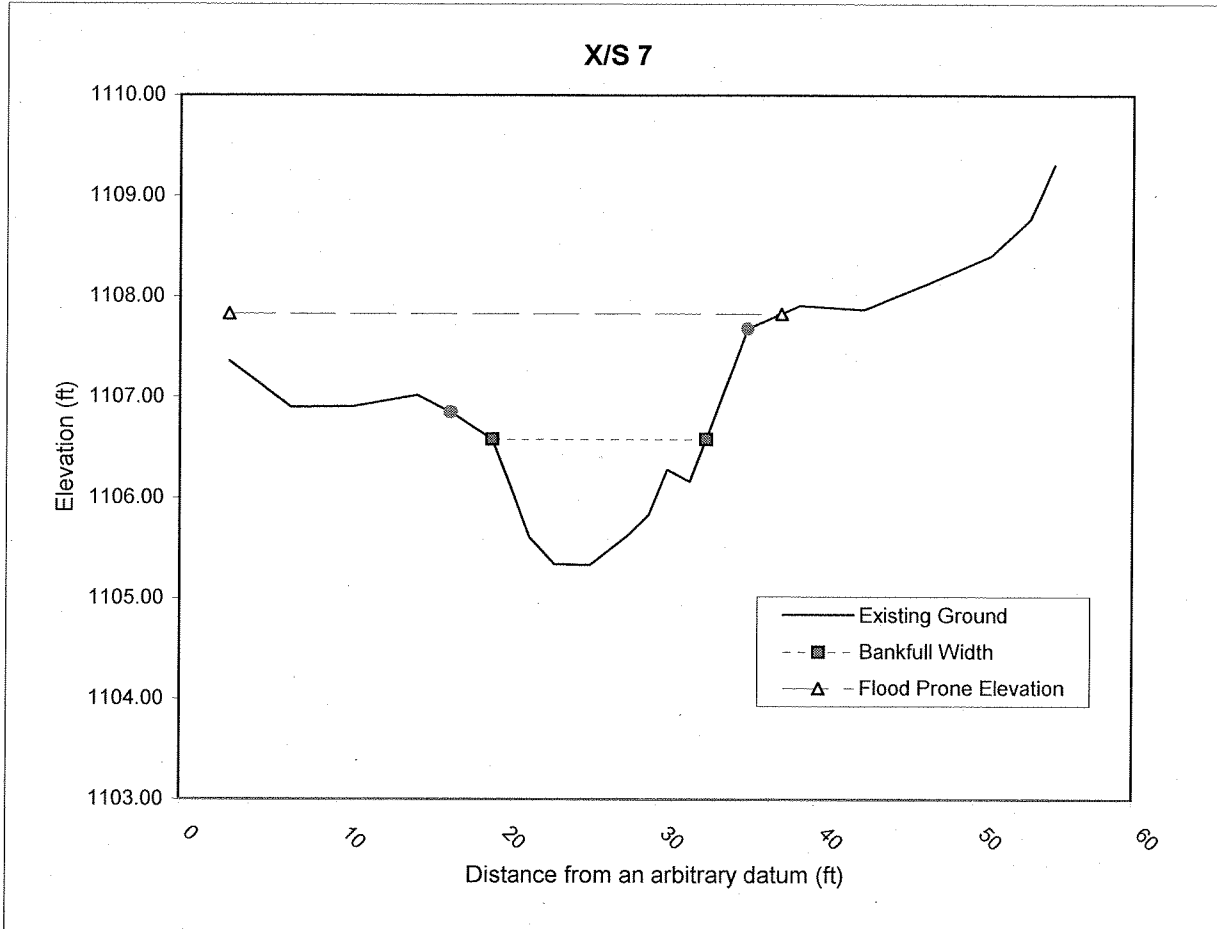
Rosgen Stream Type Classification	
Bankfull Width	13.49 (ft)
Entrenchment	>2.6 (ft/ft)
Width:Depth	16.93 (ft/ft)
Sinosity	(ft/ft)
Slope	0.0140 (ft/ft)
D <sub>50</sub>	8 (mm)
Stream Type	C4

Flow Calculations	
Max BF Depth	1.25 (ft)
Mean BF Depth	0.80 (ft)
X/S Area	10.76 (ft <sup>2</sup> )
Manning's n	0.0350
BF Ave. Velocity	4.24 (ft/s)
Discharge	45.66 (cfs)
Shear Stress	0.68 (lb/ft <sup>2</sup> )

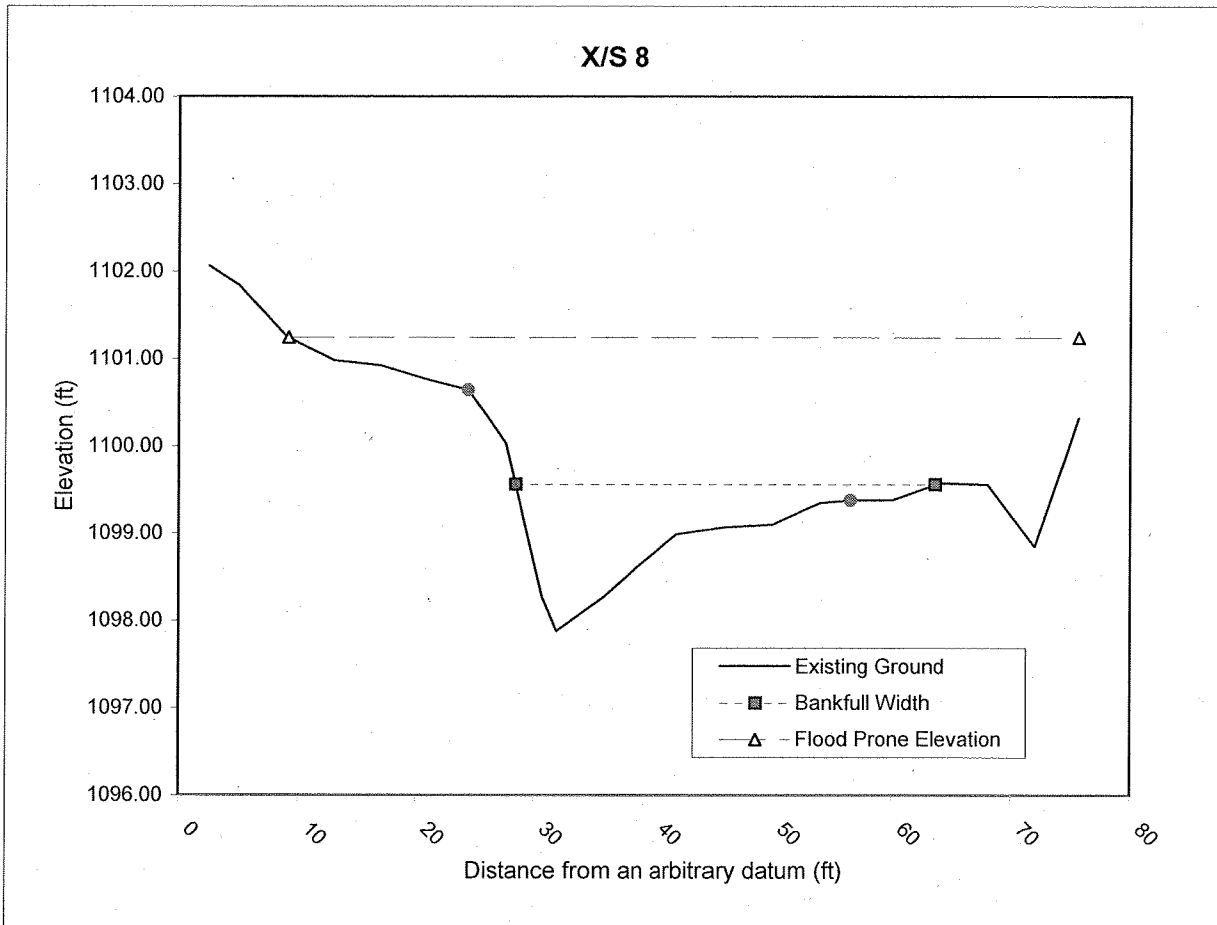
Rosgen Stream Type Classification	
Bankfull Width	35.17 (ft)
Entrenchment	>1.5 (ft/ft)
Width:Depth	57.58 (ft/ft)
Sinuousity	(ft/ft)
Slope	0.0140 (ft/ft)
D <sub>50</sub>	13 (mm)
Stream Type	C4

Flow Calculations	
Max BF Depth	1.68 (ft)
Mean BF Depth	0.61 (ft)
X/S Area	21.48 (ft <sup>2</sup> )
Manning's n	0.0350
BF Ave. Velocity	3.59 (ft/s)
Discharge	77.19 (cfs)
Shear Stress	0.53 (lb/ft <sup>2</sup> )

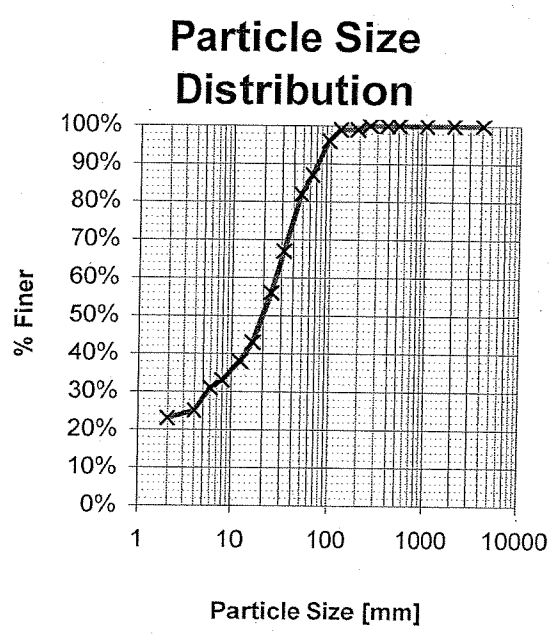
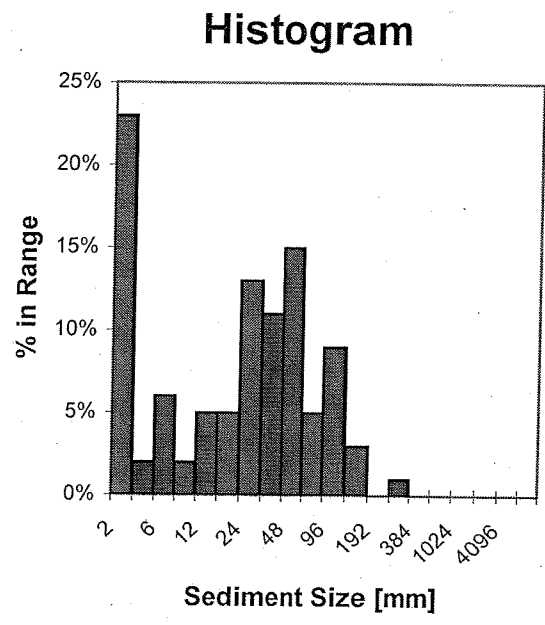
Site Name:	Big Warrior Creek	Biohabitats, Inc
Project No:	02803.01	Pebble Count Data Sheet
Date:	12/7/2004	Cross Section #5 (Pool)

Particle Size [mm]	Total #	% in Range	% Cumulative
Sand and Silt	< 2	23	23%	23%
	2 - 4	2	2%	25%
Gravels	4 - 6	6	6%	31%
	6 - 8	2	2%	33%
	8 - 12	5	5%	38%
	12 - 16	5	5%	43%
	16 - 24	13	13%	56%
	24 - 32	11	11%	67%
	32 - 48	15	15%	82%
Cobbles	48 - 64	5	5%	87%
	64 - 96	9	9%	96%
	96 - 128	3	3%	99%
	128 - 192	0	0%	99%
Boulders	192 - 256	1	1%	100%
	256 - 384		0%	100%
	384 - 512		0%	100%
	512 - 1024		0%	100%
	1024 - 2048		0%	100%
Bedrock	2048 - 4096		0%	100%
			0%	100%
TOTALS:		100	100%

D<sub>50</sub> = 20.3

D<sub>84</sub> = 54.4

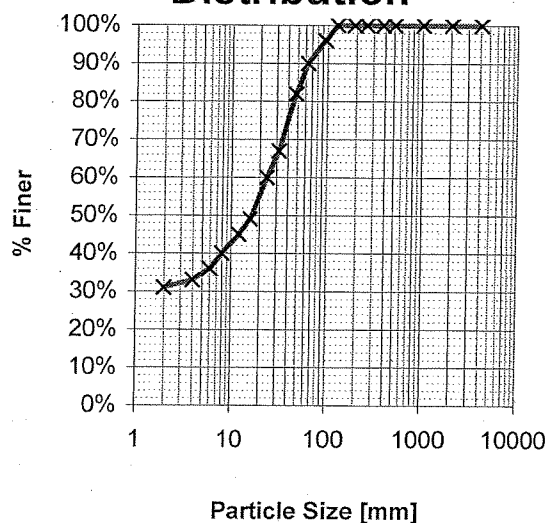
**Particle Size Distribution**

Site Name:	Big Warrior Creek	Biohabitats, Inc.
Project No:	02803.01	Pebble Count Data Sheet
Date:	12/7/2004	Cross Section #6 (Riffle)

Particle Size [mm]	Total #	% in Range	% Cumulative
Sand and Silt	< 2	31	31%	31%
Gravels	2 - 4	2	2%	33%
	4 - 6	3	3%	36%
	6 - 8	4	4%	40%
	8 - 12	5	5%	45%
	12 - 16	4	4%	49%
	16 - 24	11	11%	60%
	24 - 32	7	7%	67%
	32 - 48	15	15%	82%
Cobbles	48 - 64	8	8%	90%
	64 - 96	6	6%	96%
	96 - 128	4	4%	100%
	128 - 192		0%	100%
Boulders	192 - 256		0%	100%
	256 - 384		0%	100%
	384 - 512		0%	100%
	512 - 1024		0%	100%
	1024 - 2048		0%	100%
Bedrock	2048 - 4096		0%	100%
			0%	100%
TOTALS:		100	100%

D<sub>50</sub>= 16.7

D<sub>84</sub>= 52.0

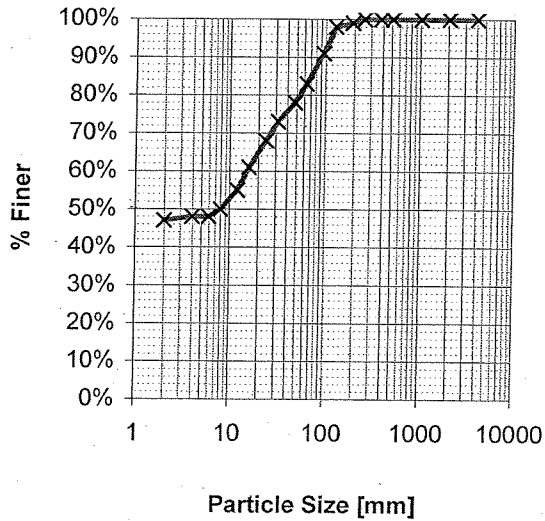
**Particle Size Distribution**

Site Name:	Big Warrior Creek	Biohabitats, Inc.
Project No.:	02803.01	Pebble Count Data Sheet
Date:	12/7/2004	Cross Section #7 (Riffle)

Particle Size [mm]	Total #	% in Range	% Cumulative
Sand and Silt	< 2	47	47%	47%
	2 - 4	1	1%	48%
Gravels	4 - 6	0	0%	48%
	6 - 8	2	2%	50%
	8 - 12	5	5%	55%
	12 - 16	6	6%	61%
	16 - 24	7	7%	68%
	24 - 32	5	5%	73%
	32 - 48	5	5%	78%
	48 - 64	5	5%	83%
Cobbles	64 - 96	8	8%	91%
	96 - 128	7	7%	98%
	128 - 192	1	1%	99%
	192 - 256	1	1%	100%
Boulders	256 - 384		0%	100%
	384 - 512		0%	100%
	512 - 1024		0%	100%
	1024 - 2048		0%	100%
	2048 - 4096		0%	100%
Bedrock			0%	100%
TOTALS:		100	100%

D<sub>50</sub> = 8.0

D<sub>84</sub> = 68.0

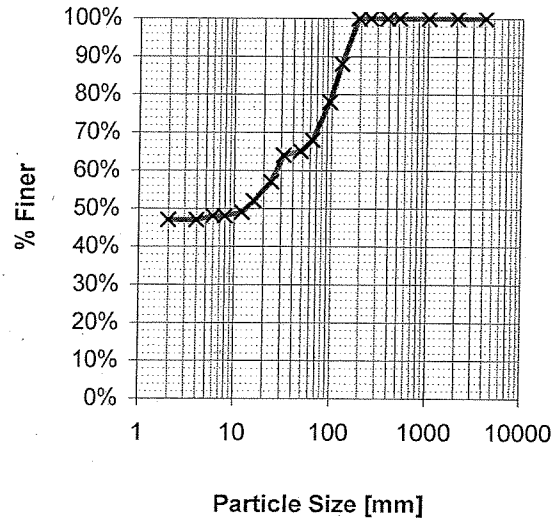
**Particle Size Distribution**

Site Name:	Big Warrior Creek	Biohabitats, Inc.
Project No:	02803.01	Pebble Count Data Sheet
Date:	12/7/2004	Cross Section #8 (Pool)

Particle Size [mm]	Total #	% in Range	% Cumulative
Sand and Silt	< 2	47	47%	47%
	2 - 4	0	0%	47%
Gravels	4 - 6	1	1%	48%
	6 - 8	0	0%	48%
	8 - 12	1	1%	49%
	12 - 16	3	3%	52%
	16 - 24	5	5%	57%
	24 - 32	7	7%	64%
	32 - 48	1	1%	65%
	48 - 64	3	3%	68%
Cobbles	64 - 96	10	10%	78%
	96 - 128	10	10%	88%
	128 - 192	12	12%	100%
	192 - 256		0%	100%
Boulders	256 - 384		0%	100%
	384 - 512		0%	100%
	512 - 1024		0%	100%
	1024 - 2048		0%	100%
	2048 - 4096		0%	100%
Bedrock			0%	100%
TOTALS:		100	100%

D<sub>84</sub> = 115.2

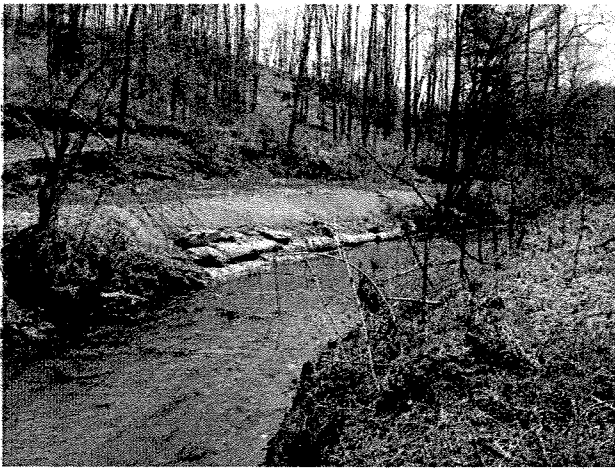
Photograph 1. Looking upstream from culvert at log toe protection installed on banks of existing MS channel at upstream end of project area. (4/7/04)

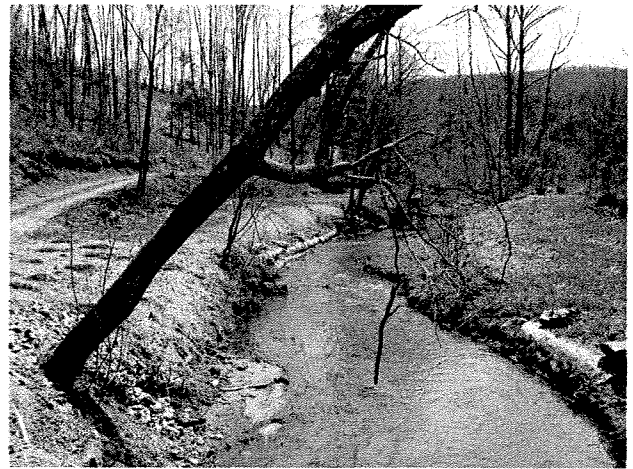
Photograph 2. Looking upstream from culvert at log toe protection installed on banks of existing MS channel at upstream end of project area. (4/7/04)

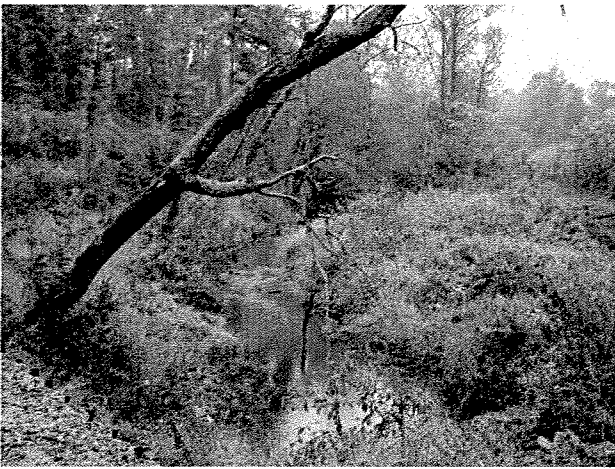
Photograph 3. Looking upstream from culvert at log toe protection installed on banks of existing MS channel at upstream end of project area. (9/27/04)

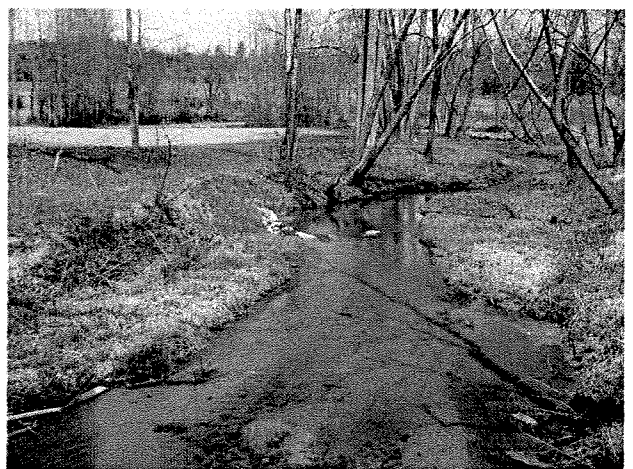
Photograph 4. Looking downstream from culvert at rock J vane installed in existing MS channel. (4/7/04)

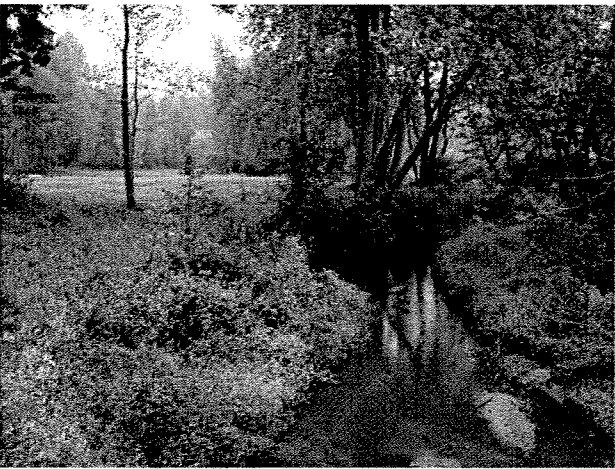
Photograph 5. Looking downstream from culvert at rock J vane installed in existing MS channel. (9/27/04)

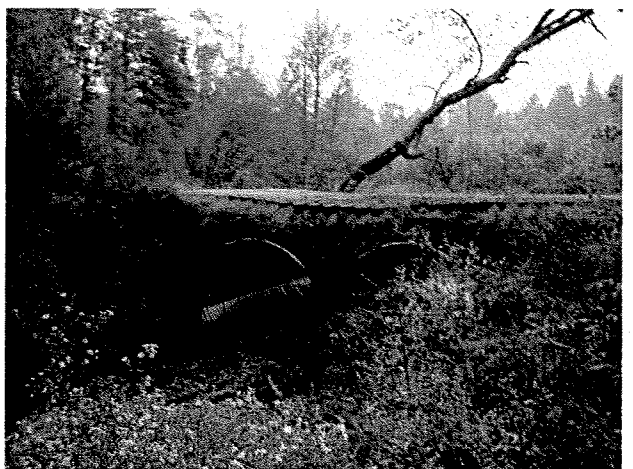
Photograph 6. Downstream face of culvert installed at upstream end of project area. (9/27/04)

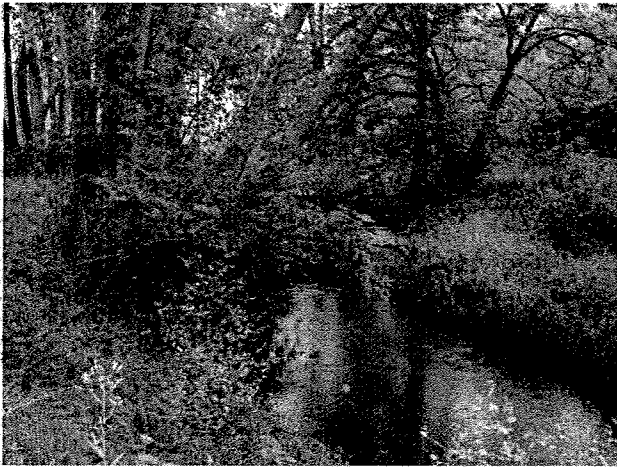
Photograph 7. Looking downstream from rock J vane installed in existing MS channel. (9/27/04)

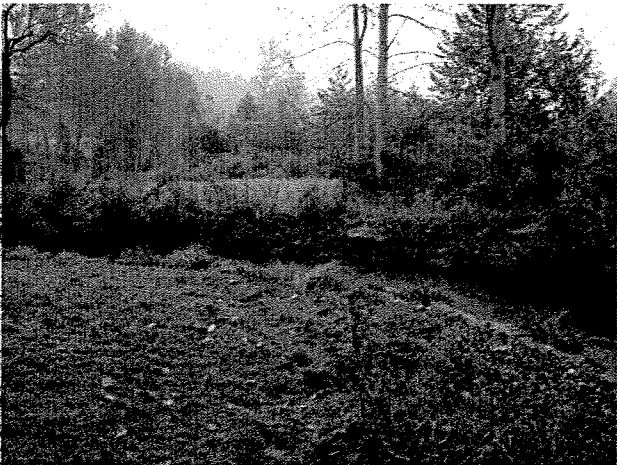
Photograph 9. Looking downstream at log toe protection and root wads installed around bend at MS Station 66+00. (9/27/04)

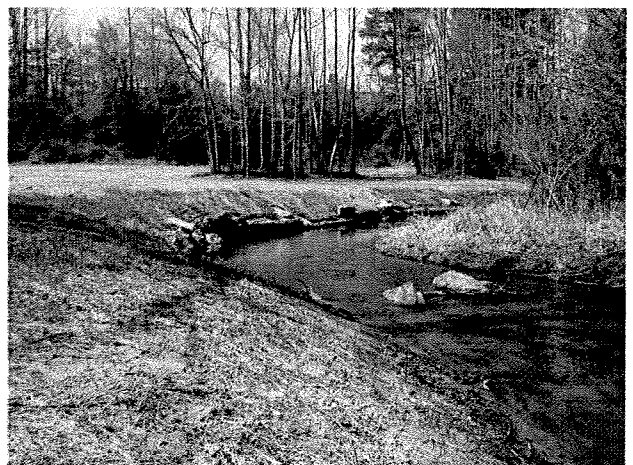
Photograph 10. Looking downstream from MS Station 65+50 at rock J vane, log toe protection, and root wad. (4/7/04)

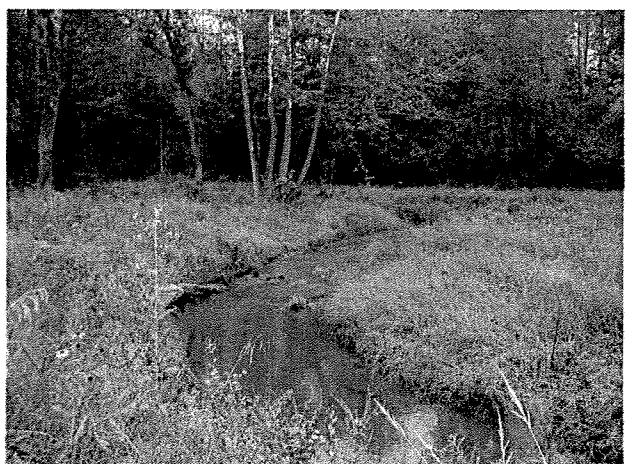
Photograph 12. Looking upstream at rock J vane installed at MS Station 62+44. (9/27/04)

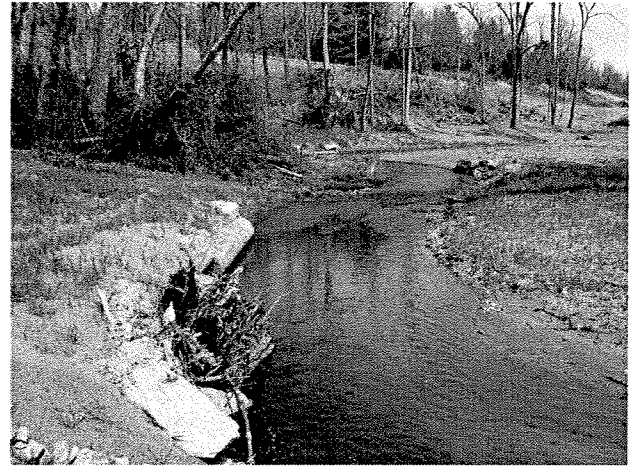
Photograph 14. Looking downstream from MS Station 60+50 at root wad and log toe protection. (4/7/04)
