# BIG WARRIOR STREAM RESTORATION MITIGATION PLAN

March 2005

Big Warrior Creek Restoration  
 Wilkes County, North Carolina  
 Biohabitats Project No. 02803.01

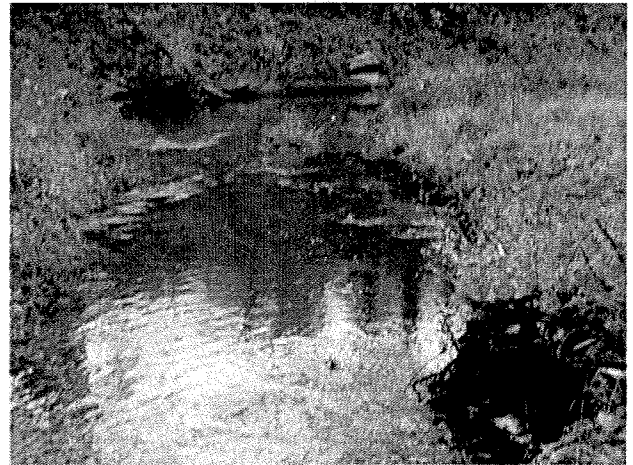
Photograph 16. Looking downstream from root wad at MS Station 59+50 at log vane and log toe protection. (9/27/04)

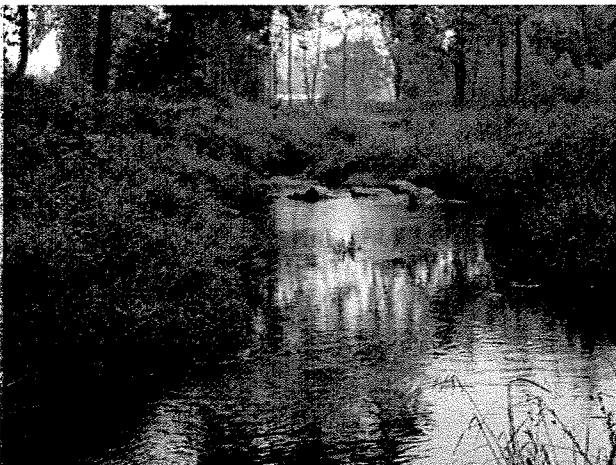
Photograph 17. Looking downstream from MS Station 58+75 at Station 58+44 rock J vane. (9/27/04)

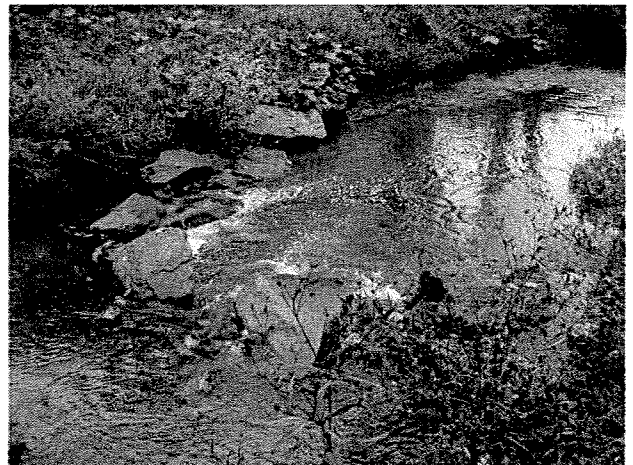
Photograph 18. Rock J vane installed at MS Station 57+66. (9/27/04)

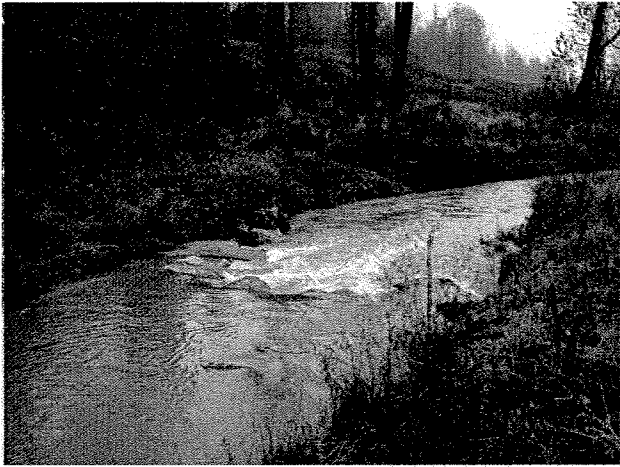
Photograph 19. Rock J vane installed at MS Station 57+66 during storm event. (11/12/04)

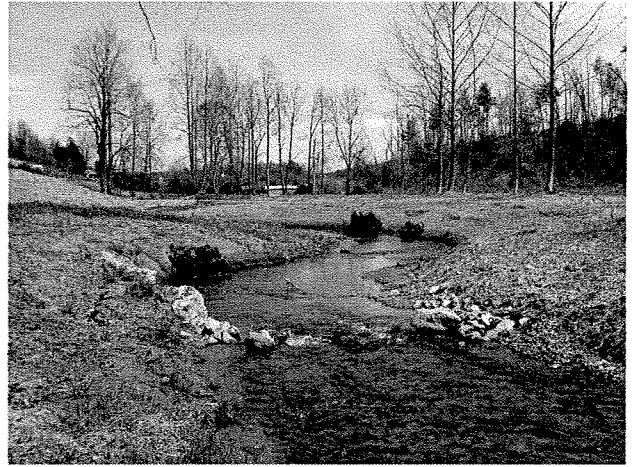
Photograph 20. Rock J vane installed at MS Station 56+19. (4/7/04)

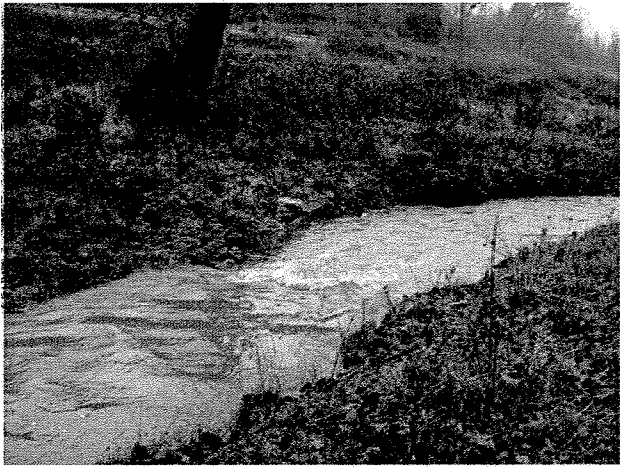
Photograph 21. Rock J vane installed at MS Station 56+19 during storm event. (11/12/04)

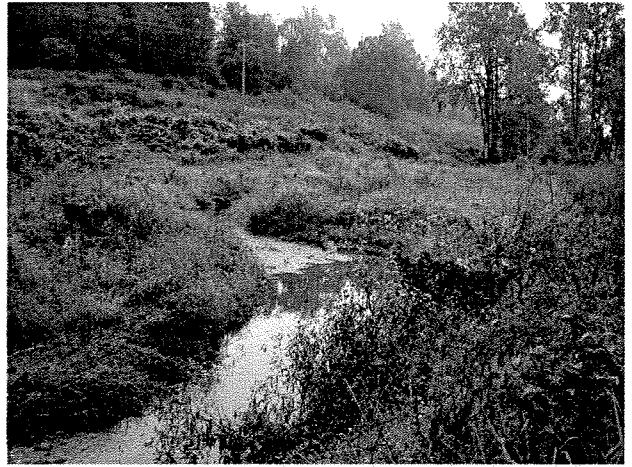
Photograph 22. Looking downstream at root wads and log vane installed at MS Station 55+08. (9/27/04)

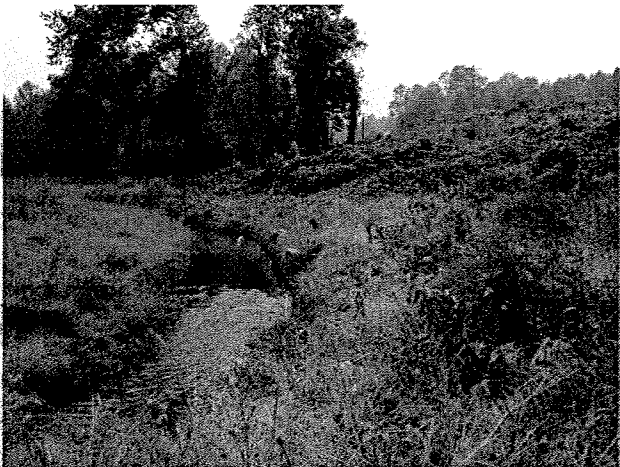
Photograph 23. Looking upstream from MS Station 53+50 at log toe protection. (9/27/04)

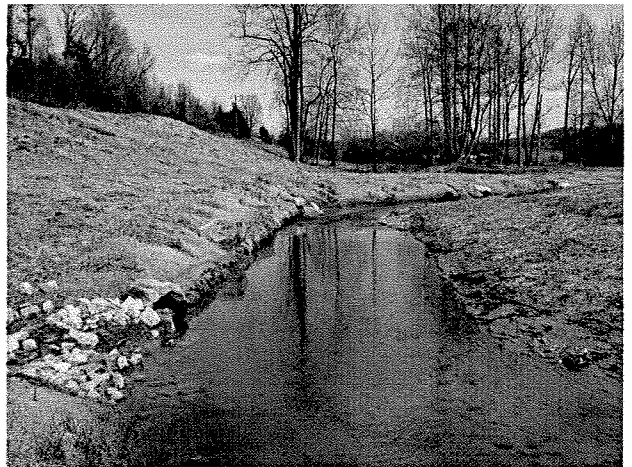
Photograph 24. Looking downstream at log toe protection and MS Station 53+96 rock vane. (4/7/04)

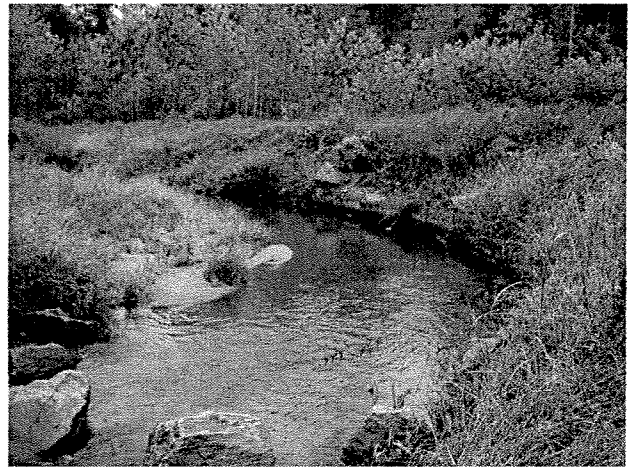
Photograph 26. Looking downstream at rock J vane installed at MS Station 53+01 and downstream log toe protection/root wad. (9/27/04)

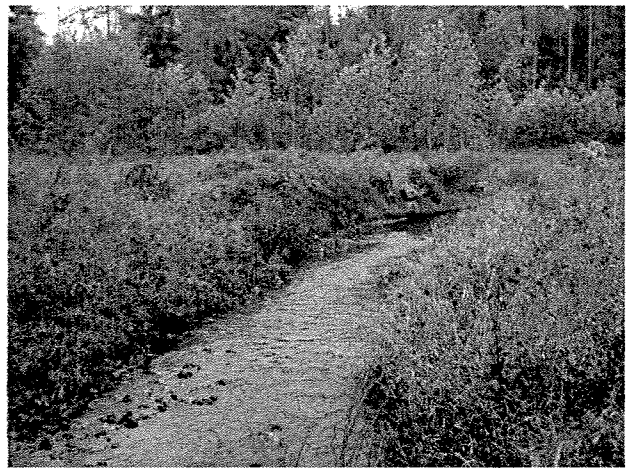
Photograph 28. Looking upstream at log toe protection and log vane installed at MS Station 51+93. (9/27/04)

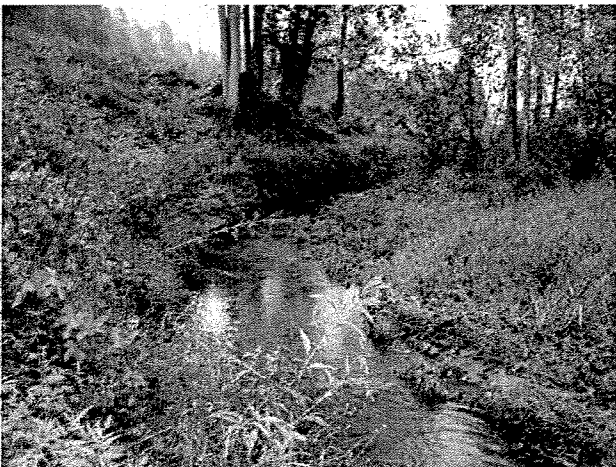
Photograph 29. Looking downstream from MS Station 51+25 at log toe protection, root wads, and live branch layering (left bank). (9/27/04)

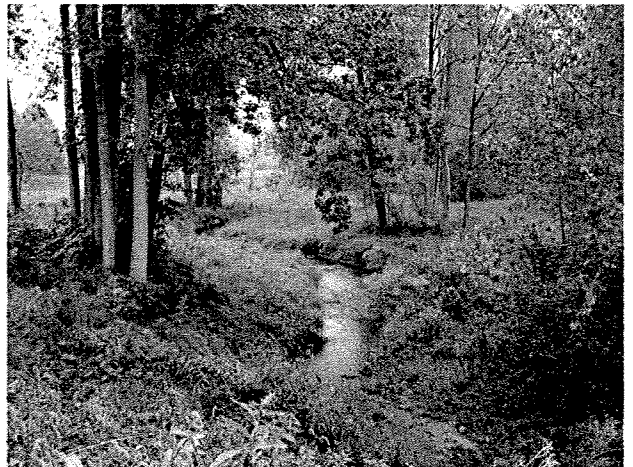
Photograph 30. Looking downstream from MS Station 50+50 at root wads and log toe protection. Preserved wetland on right bank. (9/27/04)

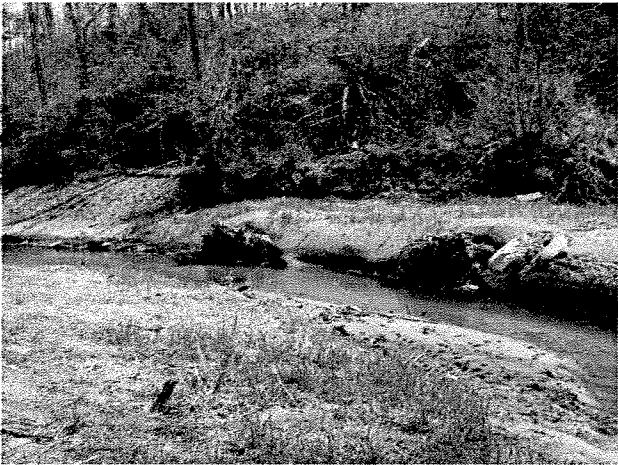
Photograph 33. Looking downstream at root wads between MS Stations 47+50 and 47+00. (4/7/04)

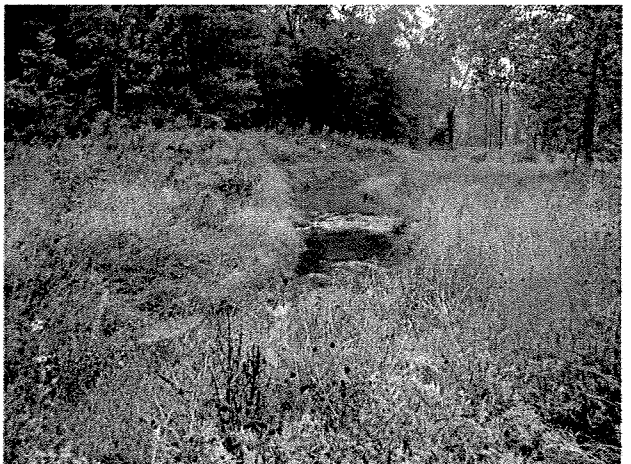
Photograph 36. Looking upstream at rock cross vane installed at MS Station 44+38. (9/27/04)

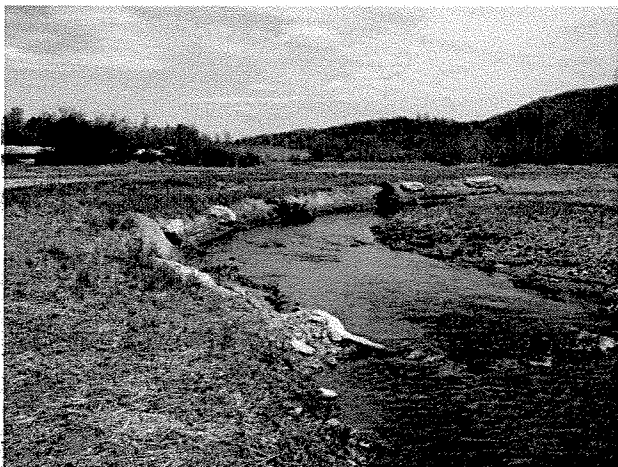
Photograph 37. Looking downstream at rock cross vane installed at MS Station 44+38 and root wads/log toe protection. (4/7/04)

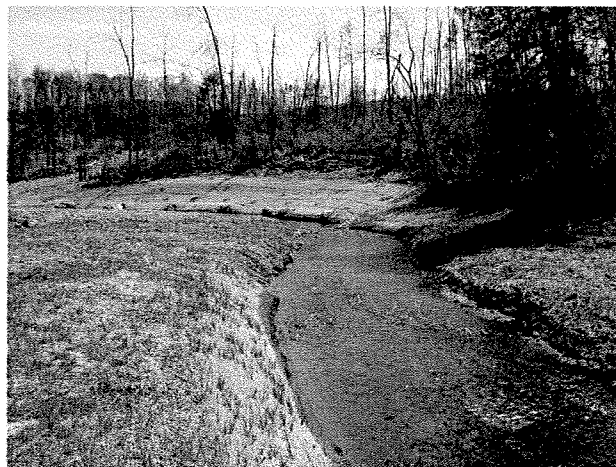
Photograph 38. Looking downstream from MS Station 43+00 at rock vane installed at MS Station 42+32 and log toe protection/root wads. (4/7/04)

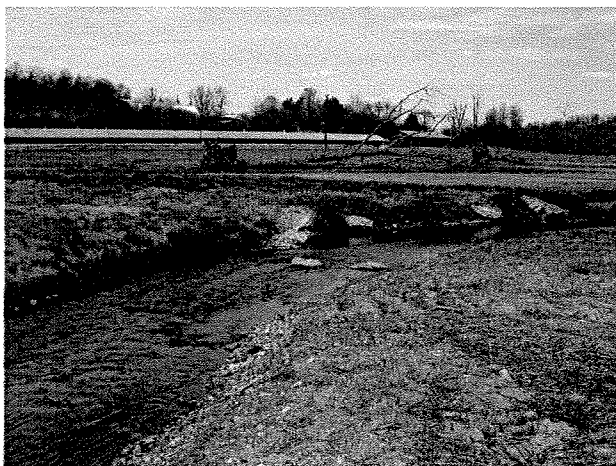
Photograph 42. Looking downstream from MS Station 40+50 at rock J vane installed at MS Station 39+98 and log toe protection/root wads. (4/7/04)

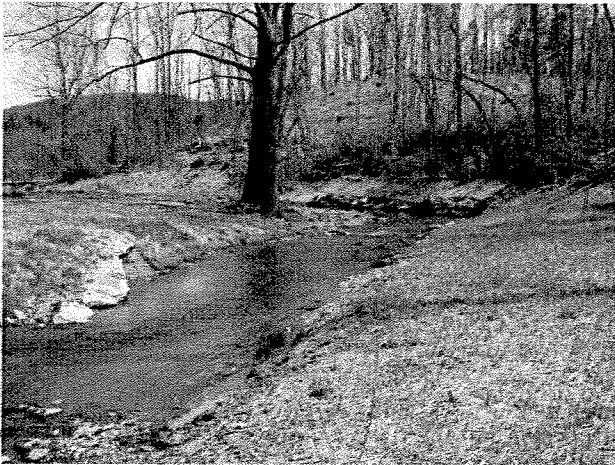
Photograph 45. Looking downstream at rock vane installed at MS Station 38+80. (4/7/04)

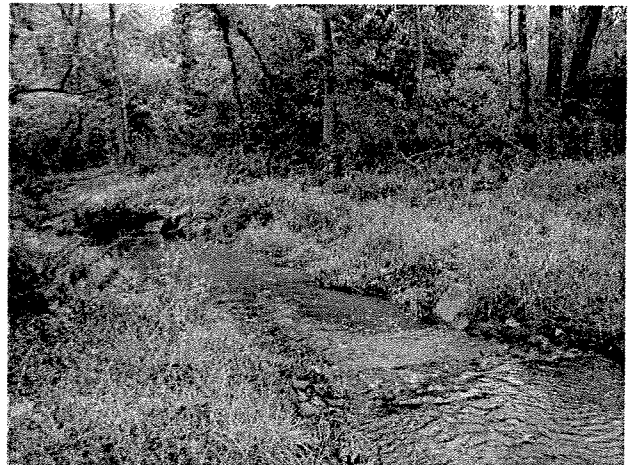
Photograph 46. Looking downstream at rock cross vane installed at MS Station 38+20. (9/27/04)

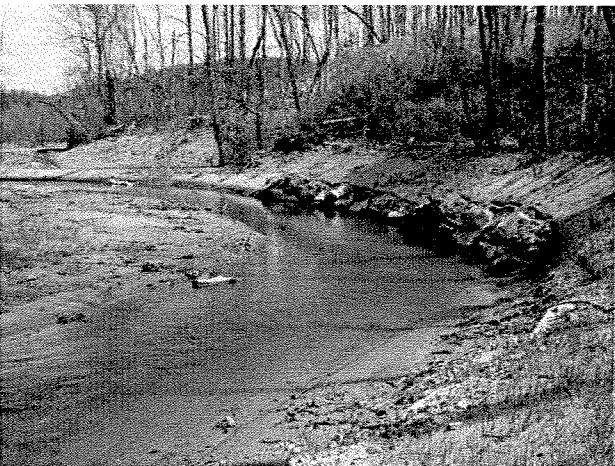
Photograph 47. Looking downstream from MS Station 38+00 at rock toe protection/root wad and rock vane installed at MS Station 37+17. (4/7/04)

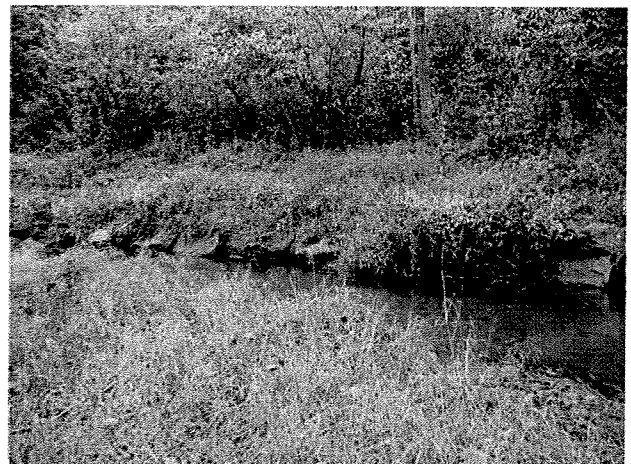
Photograph 48. Looking downstream at rock toe protection installed between MS Station 37+80 and 37+25. (9/27/04)

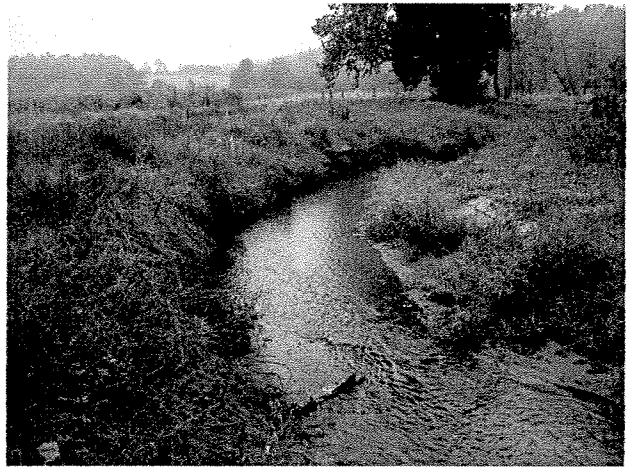
Photograph 50. Looking downstream from MS Station 36+50 at log toe protection and root wads. (9/27/04)

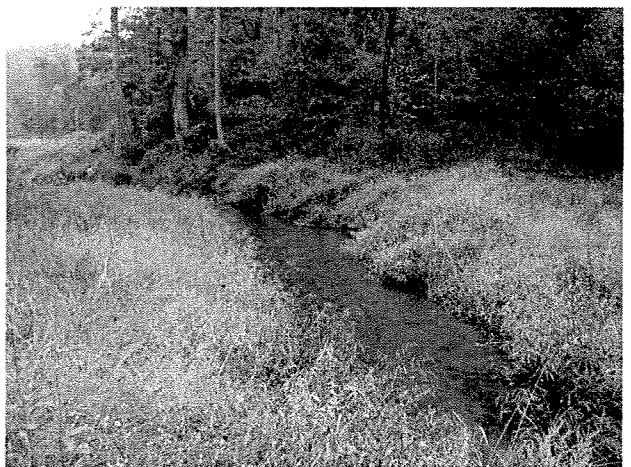
Photograph 52. Looking downstream from MS Station 35+00 at installed rock toe protection and root wads. (9/27/04)

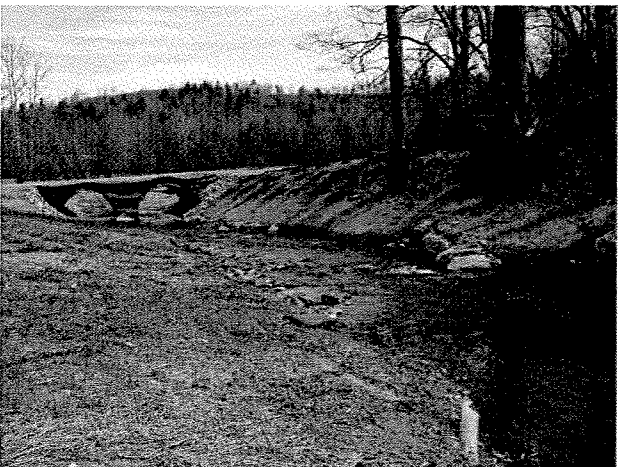
Photograph 53. Looking downstream at rock vane installed at MS Station 34+15. (4/7/04)

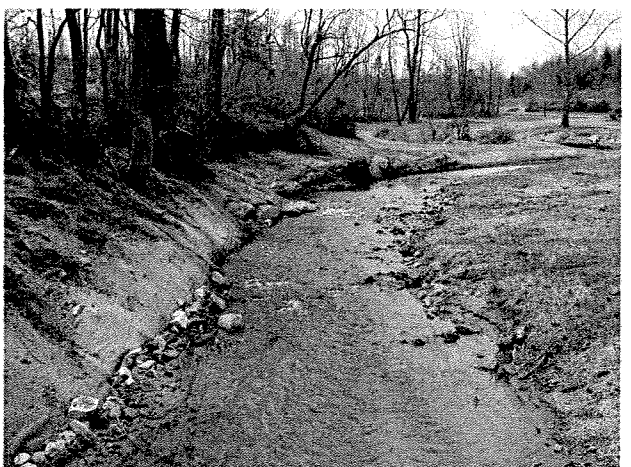
Photograph 54. Looking upstream at rock toe protection, root wads, and rock vane installed between MS Stations 34+75 and 33+75. (4/7/04)

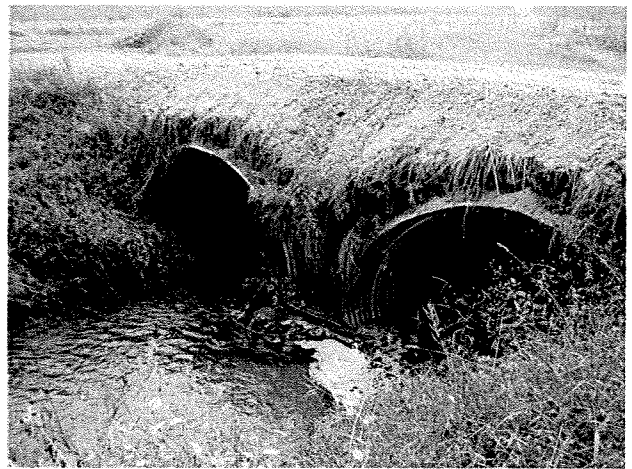
Photograph 56. Upstream face of culvert installed at MS Station 33+00. (9/27/04)

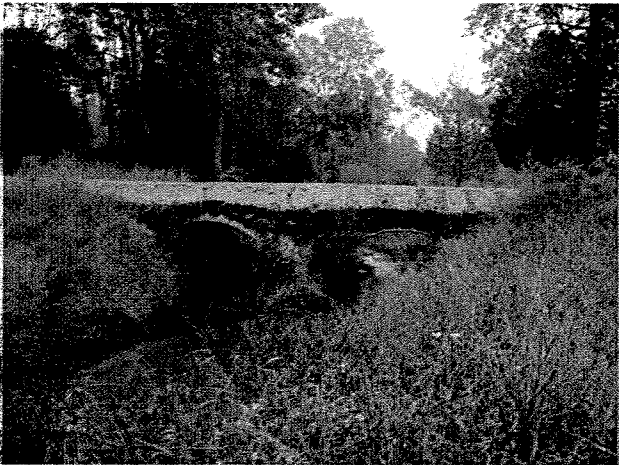
Photograph 57. Downstream face of culvert installed at MS Station 33+00. (9/27/04)

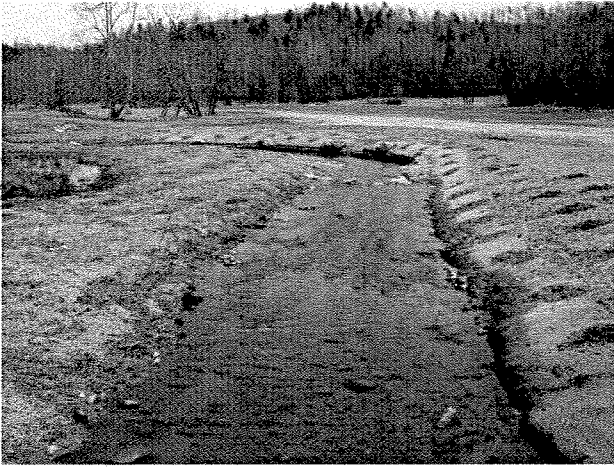
Photograph 61. Looking downstream at rock J vane, log toe protection, and root wads installed between MS Stations 32+50 and 31+50. (4/7/04)

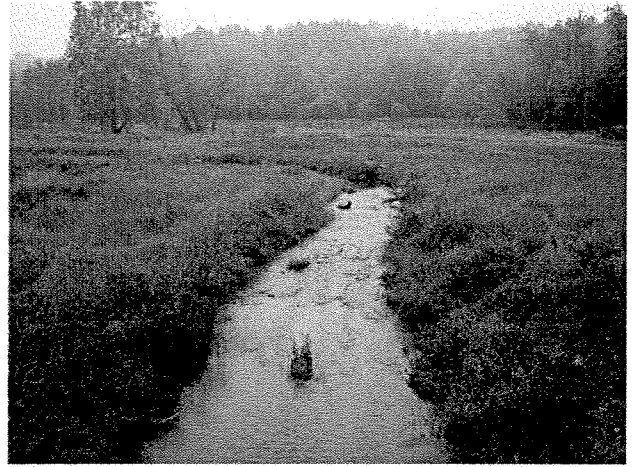
Photograph 62. Looking downstream at rock J vane, log toe protection, and root wads installed between MS Stations 32+50 and 31+50. (9/27/04)

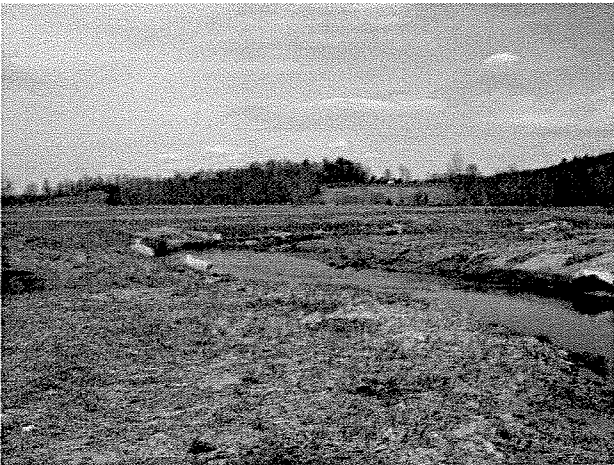
Photograph 63. Looking downstream at log toe protection and root wads installed between MS Stations 30+80 and 30+00. (4/7/04)

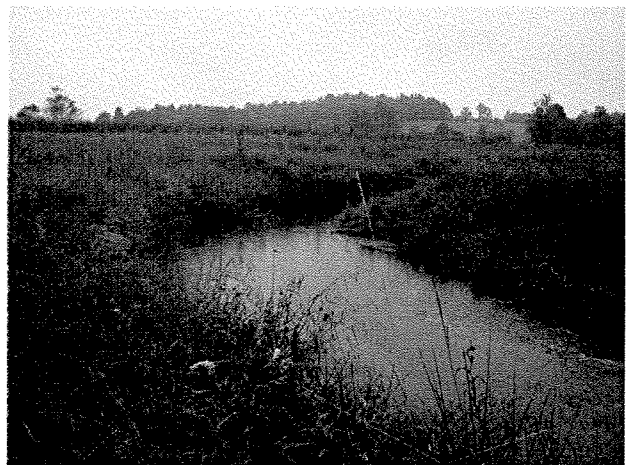
Photograph 64. Looking downstream at log toe protection and root wads installed between MS Stations 30+80 and 30+00. (9/27/04)

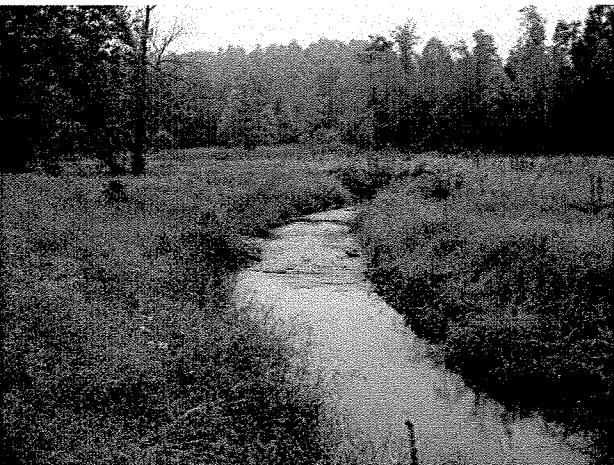
Photograph 65. Looking downstream at rock vane installed at MS Station 29+67. (9/27/04)

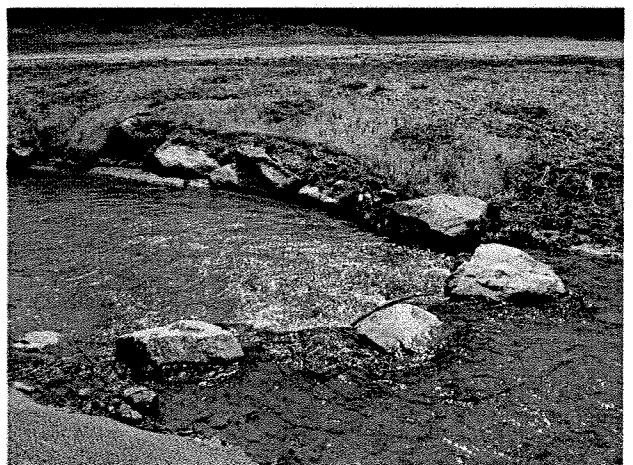
Photograph 66. Rock J vane installed at MS Station 29+10. (4/7/04)

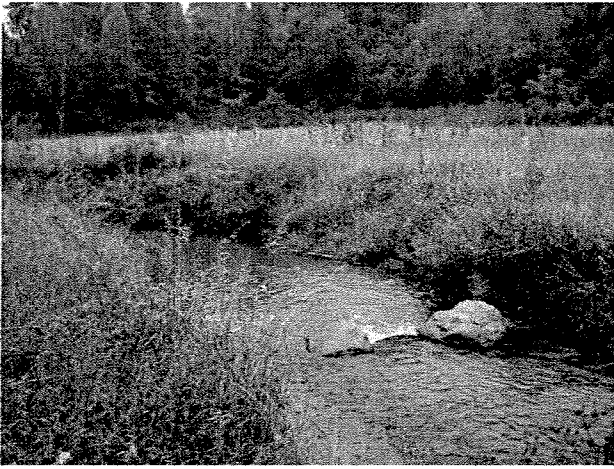
Photograph 67. Looking downstream at rock J vane installed at MS Station 29+10. (9/27/04)

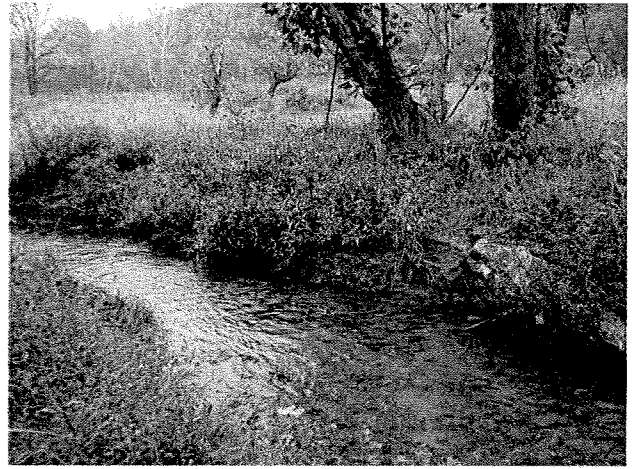
Photograph 68. Rock vane installed at MS Station 28+04. (9/27/04)

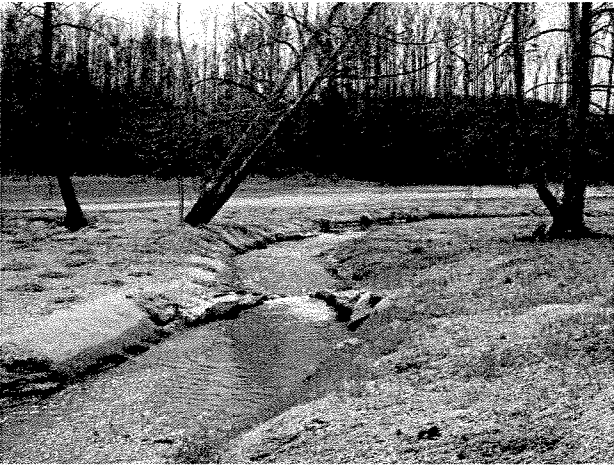
Photograph 69. Looking upstream at rock cross vane installed at MS Station 27+33. (4/7/04)

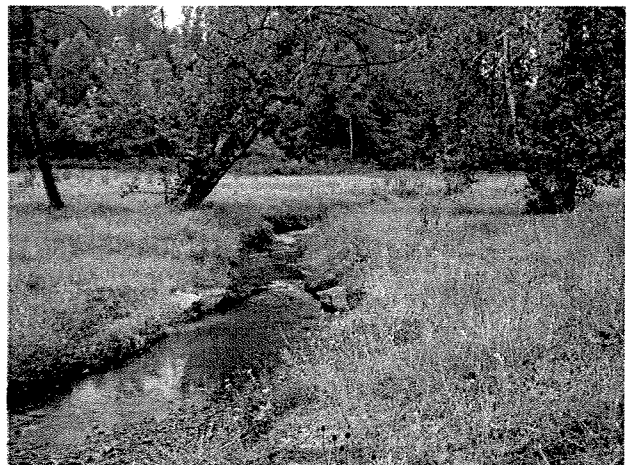
Photograph 70. Looking upstream at rock cross vane installed at MS Station 27+33. (9/27/04)

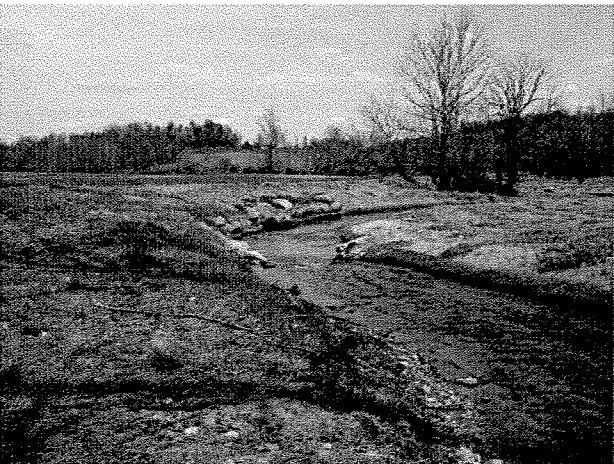
Photograph 71. Looking downstream at rock cross vane, log toe protection, and root wad installed between MS Stations 27+33 and 26+25. (4/7/04)

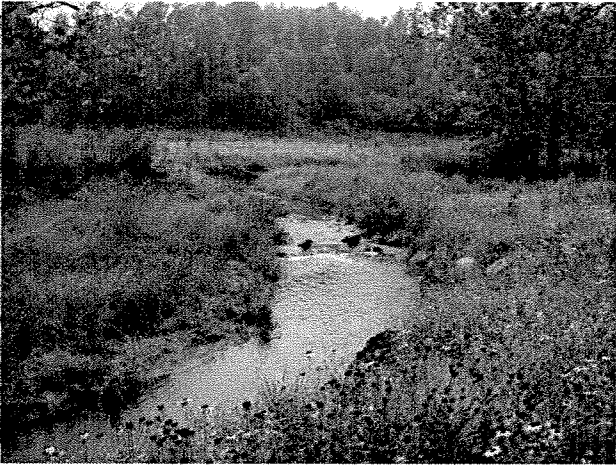
Photograph 74. Looking downstream from log vane installed at MS Station 24+59. (9/27/04)

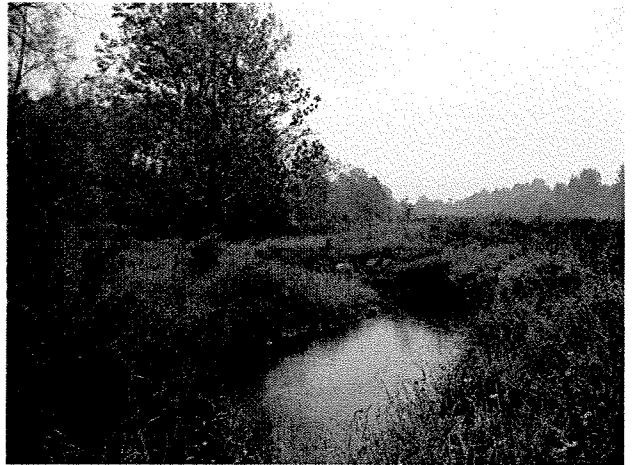
Photograph 75. Looking upstream at rock J vane installed at MS Station 24+03. (9/27/04)

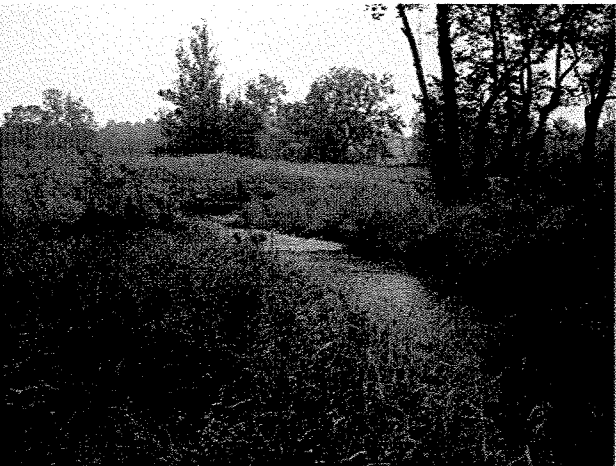
Photograph 76. Looking upstream at log toe protection and root wad installed between MS Stations 23+50 and 23+00 area. (9/27/04)

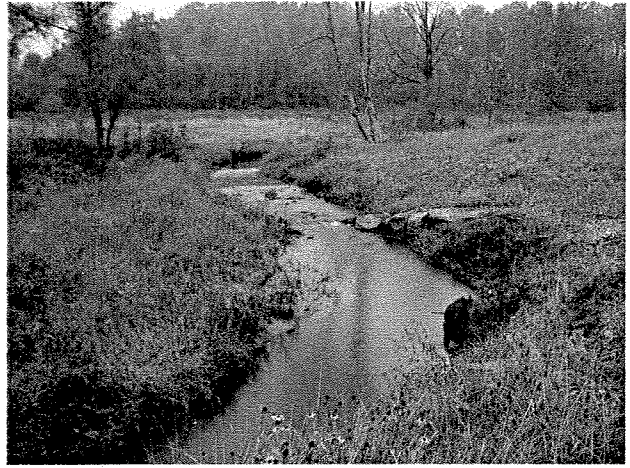
Photograph 79. Looking upstream at rock vane installed at MS Station 21+34. (9/27/04)

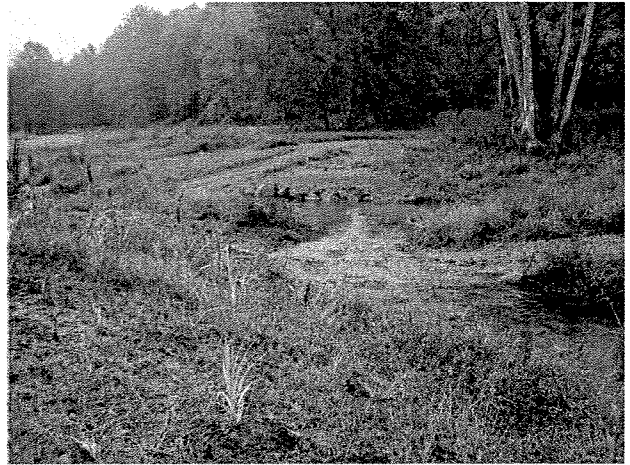
Photograph 81. Looking upstream at root wad and log toe protection installed between MS Stations 20+90 and 20+60. (9/27/04)

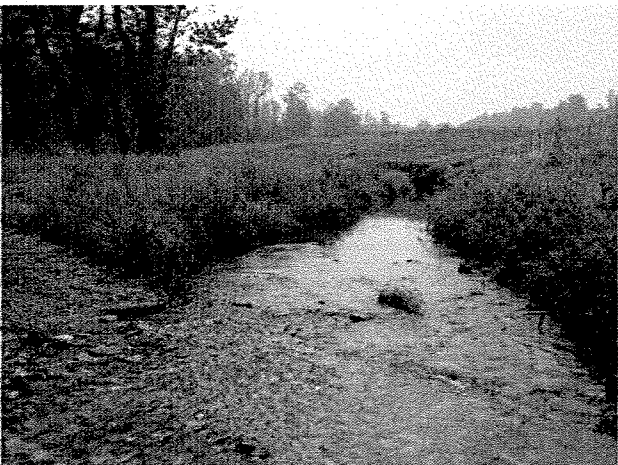
Photograph 82. Looking downstream at ford stream crossings near confluence of Mountain Creek tributary and main stem. (9/27/04)

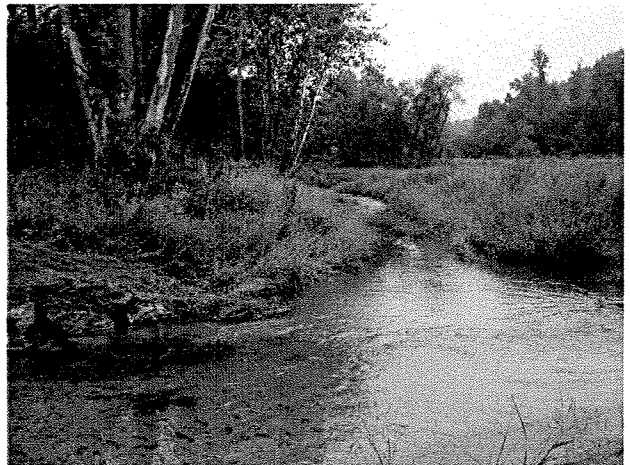
Photograph 83. Looking upstream from ford stream crossing installed at MS Station 19+75. (9/27/04)

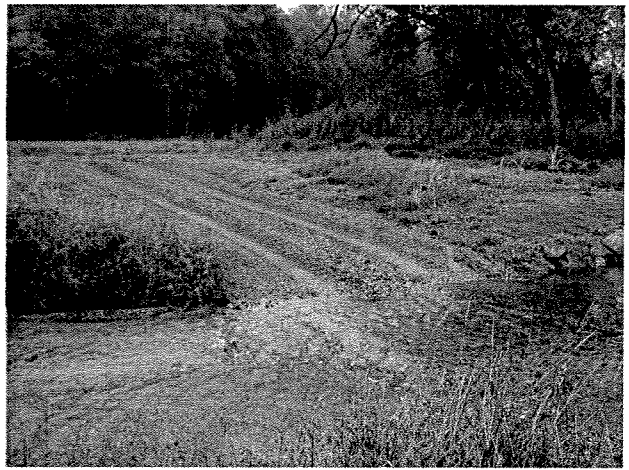
Photograph 85. Rock toe protection installed between MS Stations 19+25 and 18+80 upstream of ford crossing. (9/27/04)

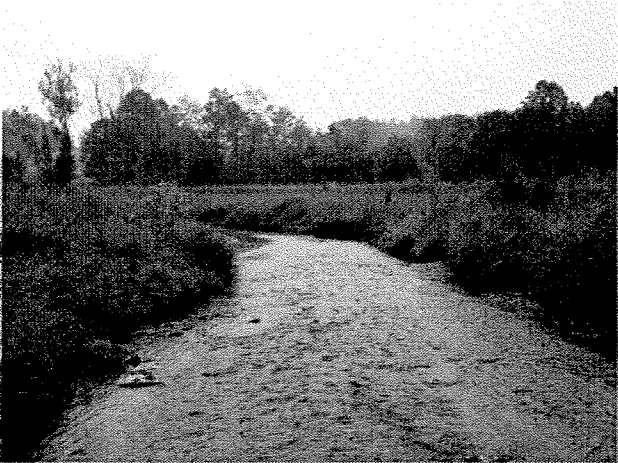
Photograph 86. Ford stream crossing installed at MS Station 18+75. (9/27/04)

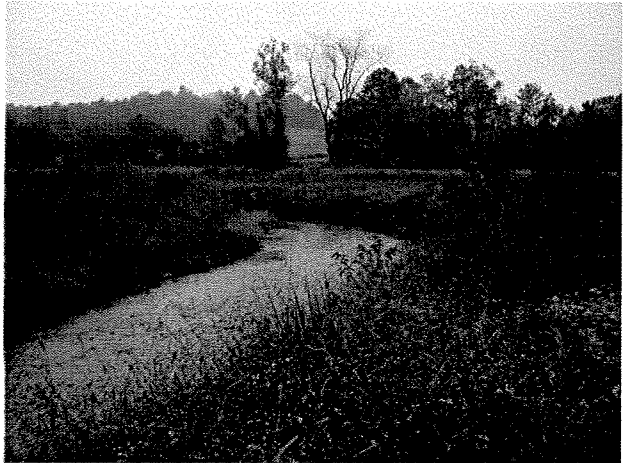
Photograph 87. Looking downstream from ford stream crossing (MS Station 18+75). (9/27/04)

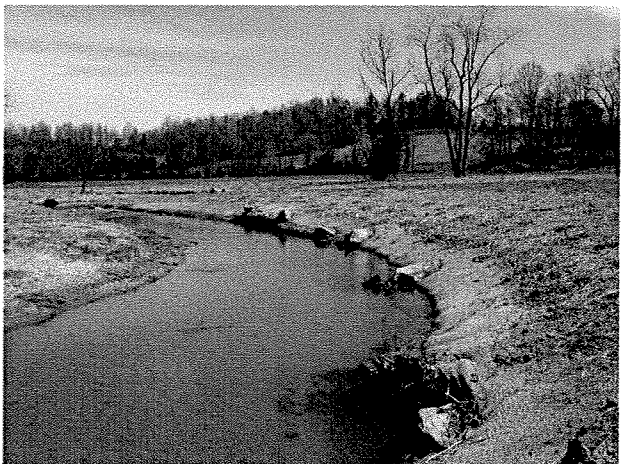
Photograph 89. Looking downstream at log toe protection and root wads installed between MS Stations 18+25 and 17+50. (9/27/04)

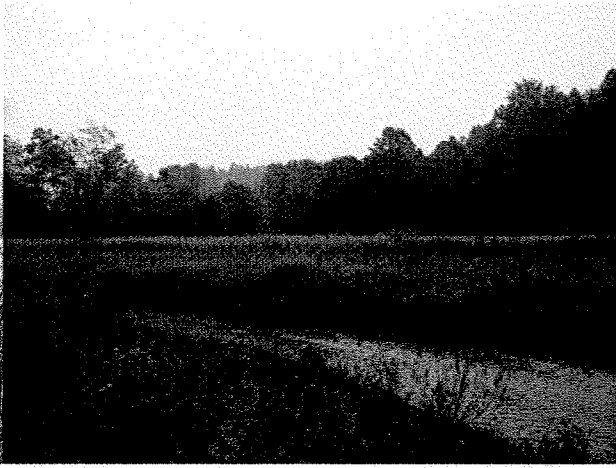
Photograph 90. Looking downstream at log toe protection and root wads installed between MS Stations 18+00 and 17+00. (4/7/04)

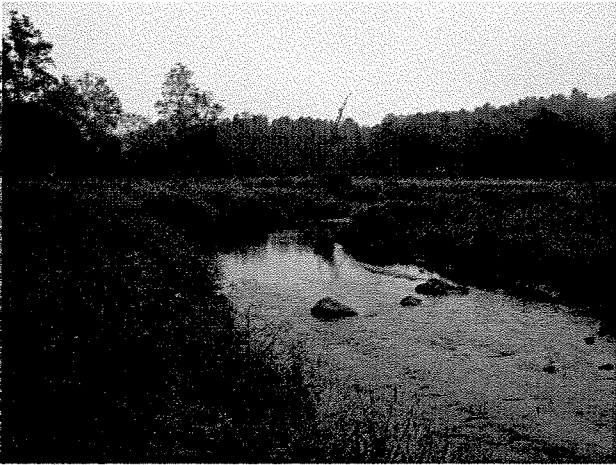
Photograph 92. Looking downstream at rock J vane and root wads installed between MS Stations 16+35 and 15+50. (4/7/04)

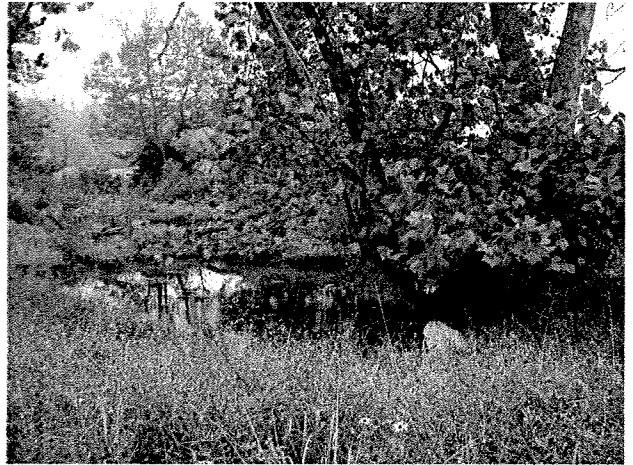
Photograph 93. Looking downstream at rock J vane installed at MS Station 16+35. (9/27/04)

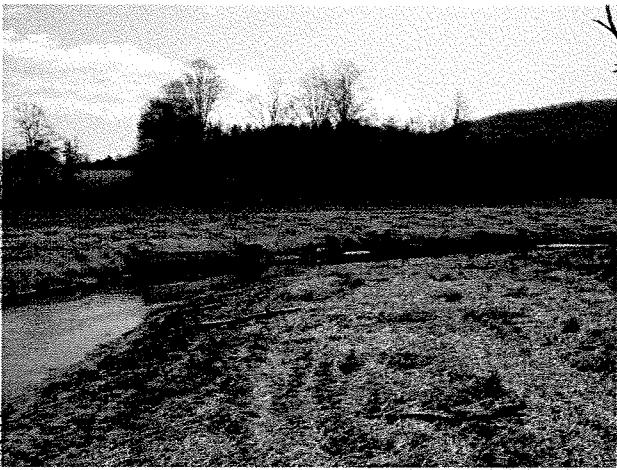
Photograph 96. Log toe protection and root wads installed around bend between MS Stations 14+55 and 13+90 (preserved snag on left bank). (4/7/04)

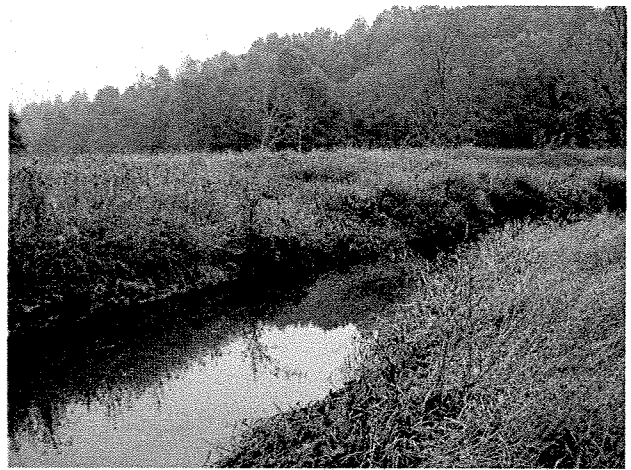
Photograph 97. Looking upstream at log toe protection and root wads installed around bend between MS Stations 14+10 and 13+45. (4/7/04)

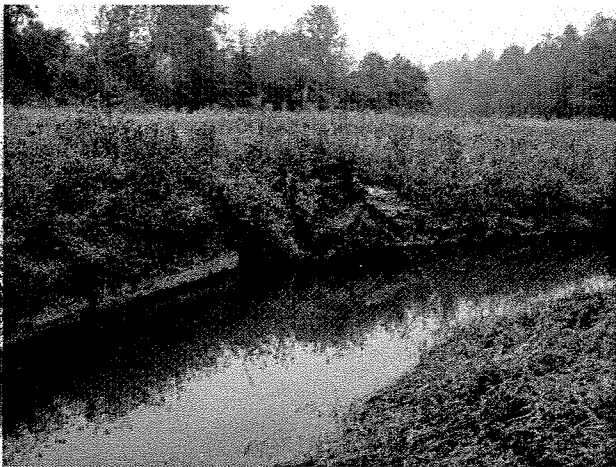
Photograph 98. Looking upstream from left bank at log toe protection and root wads installed between MS Stations 14+25 to 13+90. (9/27/04)

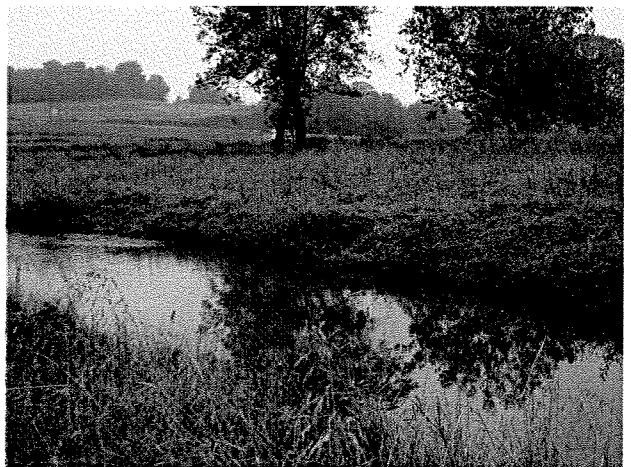
Photograph 99. Looking upstream from left bank at log toe protection and root wads installed between MS Stations 14+15 to 13+70. (9/27/04)

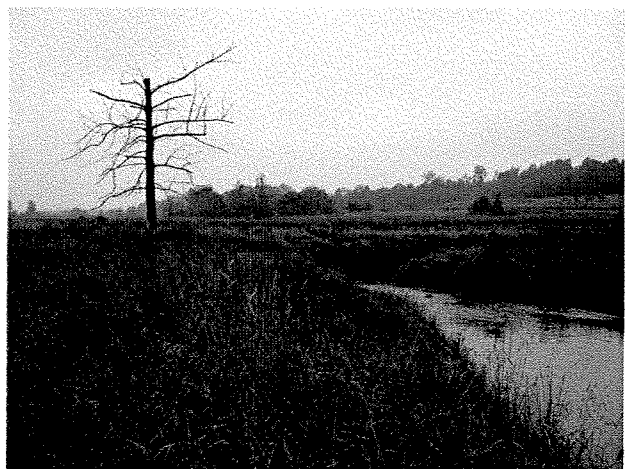
Photograph 101. Looking upstream at rock J vane installed at MS Station 13+00. (4/7/04)

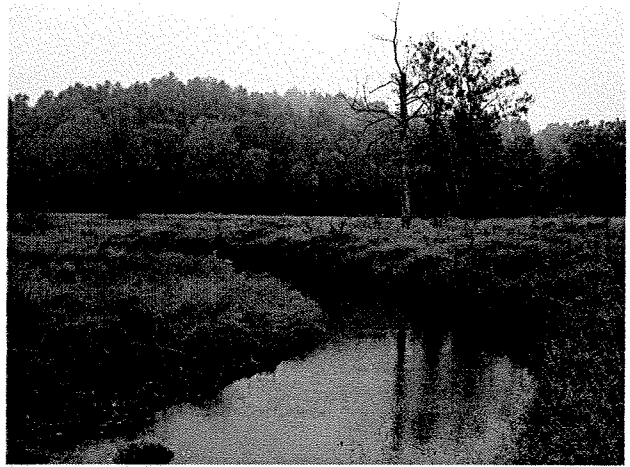
Photograph 103. Looking upstream at log toe protection and root wads installed between MS Stations 12+65 and 11+15. (4/7/04)

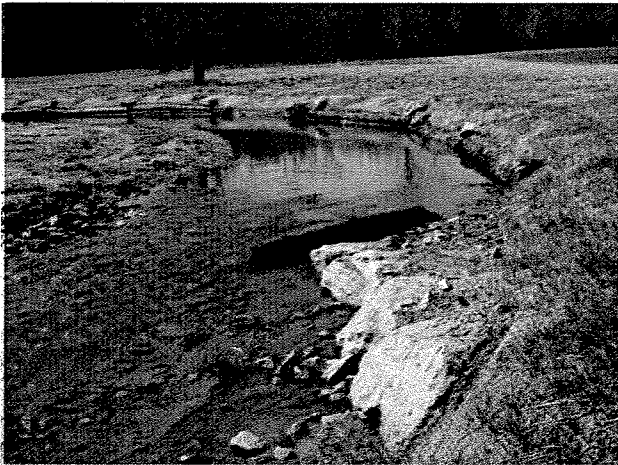
Photograph 104. Looking upstream at log toe protection and root wads installed between MS Stations 12+65 and 11+15. (9/27/04)

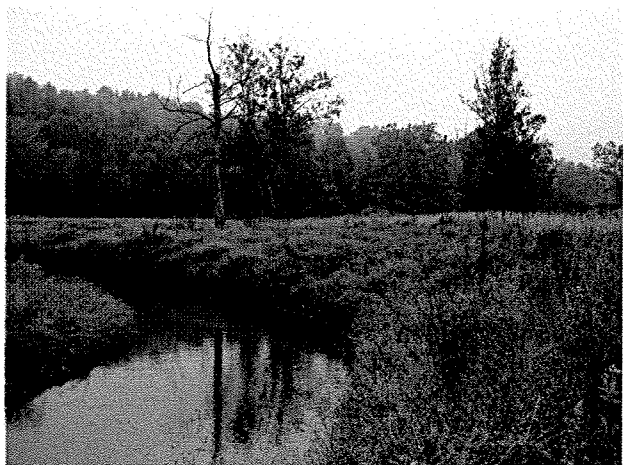
Photograph 105. Looking upstream at rock vane installed at MS Station 11+10. (4/7/04)

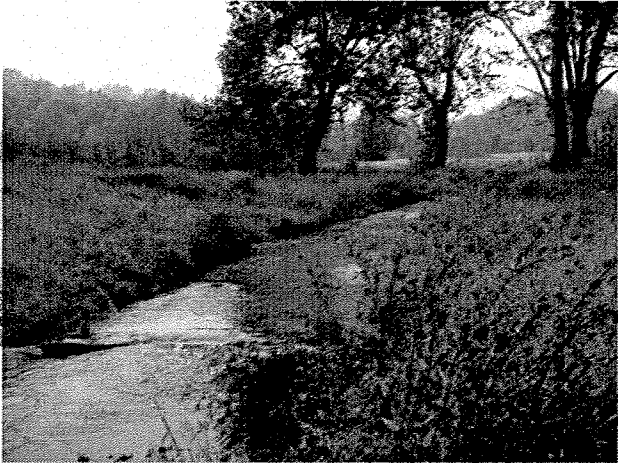
Photograph 110. Rock cross vane installed at MS Station 9+04. (4/7/04)

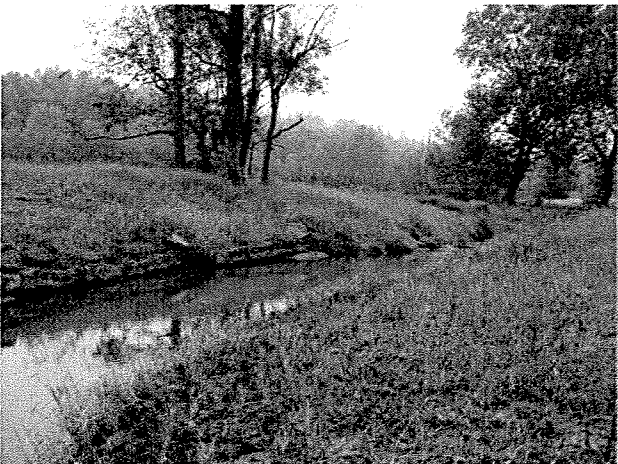
Photograph 113. Looking upstream at log toe protection installed between MS Stations 8+70 and 8+30. (9/27/04)

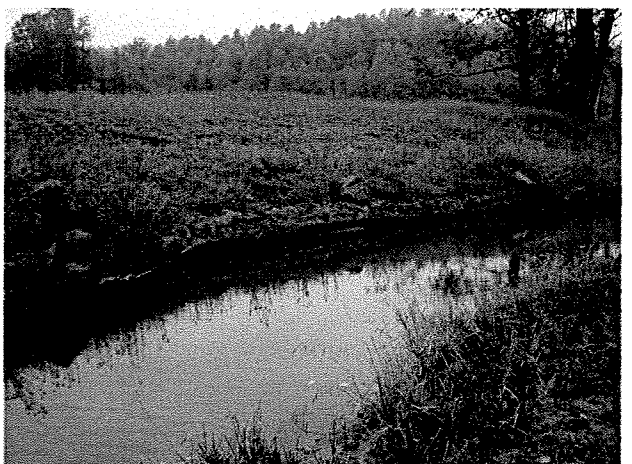
Photograph 114. Looking upstream at log toe protection installed between MS Stations 8+50 and 8+00. (9/27/04)

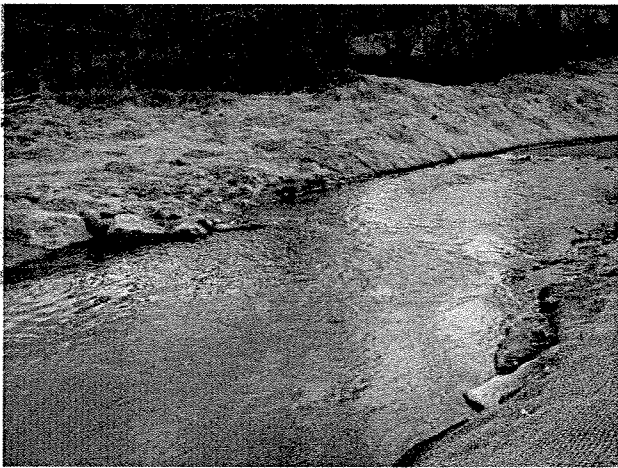
Photograph 115. Rock cross vane installed at MS Station 6+58. (4/7/04)

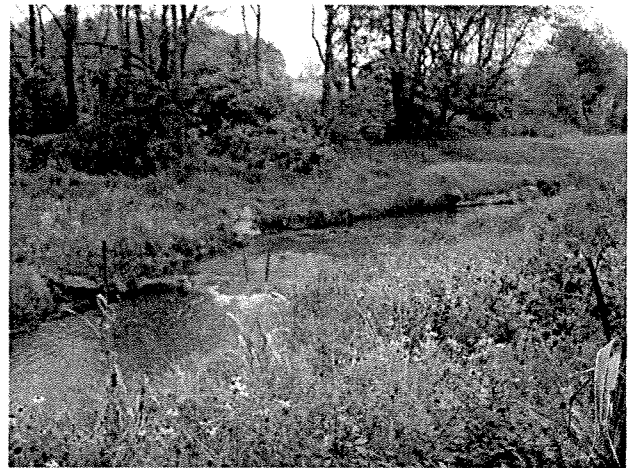
Photograph 116. Rock cross vane installed at MS Station 6+58. (9/27/04)

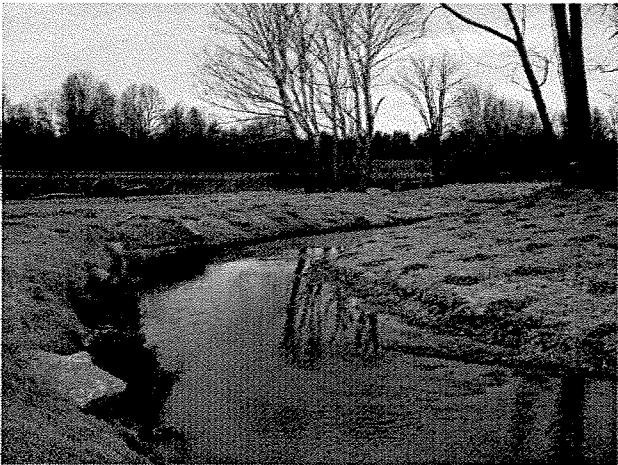
Photograph 117. Looking downstream at root wads and log toe protection installed between MS Stations 6+10 and 5+40. (4/7/04)

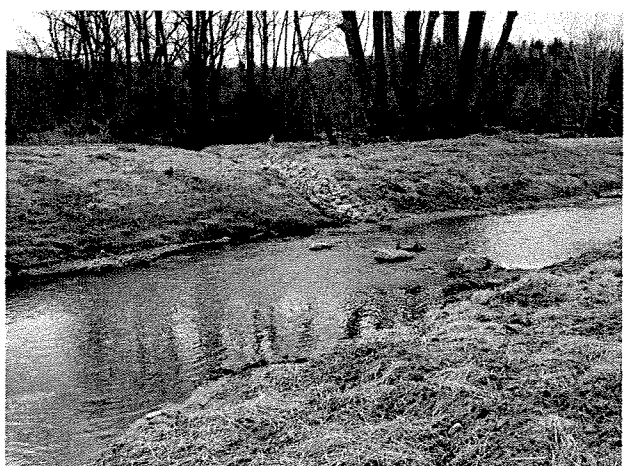
Photograph 120. Looking upstream at rock J vane installed at MS Station 4+72 (existing ditch in background). (4/7/04)

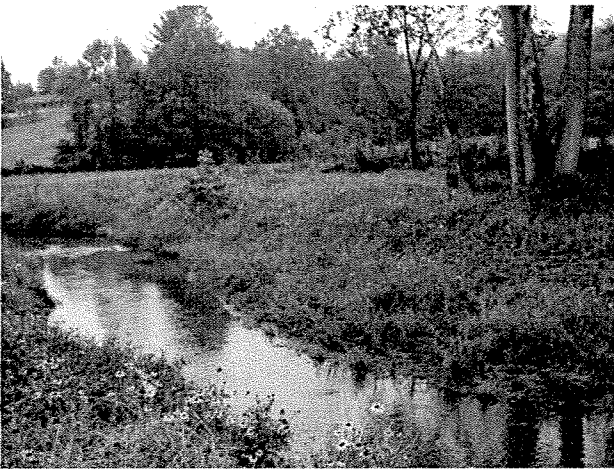
Photograph 121. Looking downstream from MS Station 5+25 at rock J vane. (9/27/04)

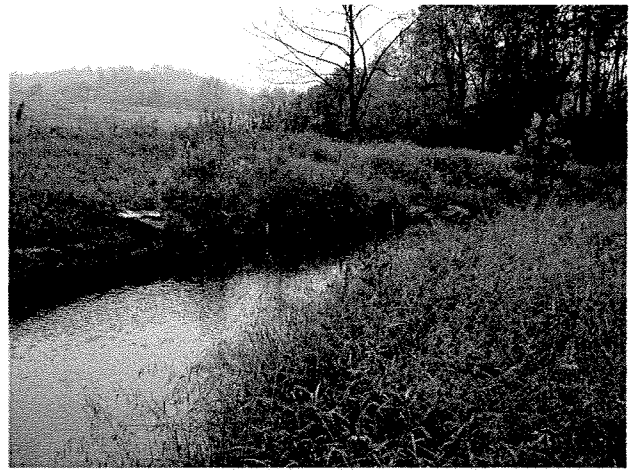
Photograph 122. Looking upstream at root wads and log toe protection installed between MS Stations 4+35 and 3+90. (9/27/04)

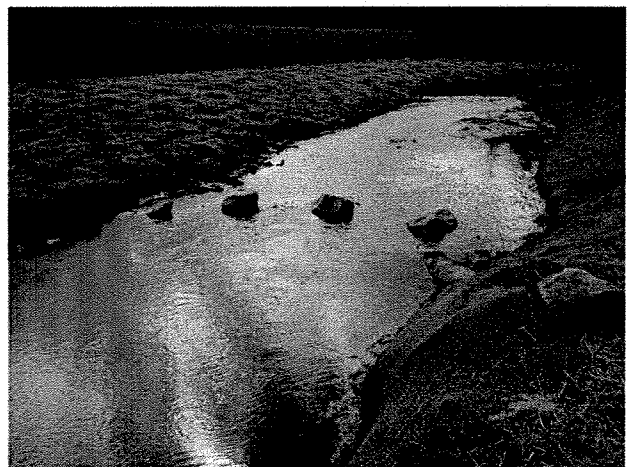
Photograph 124. Looking upstream at log J vane installed at MS Station 3+53. (4/7/04)

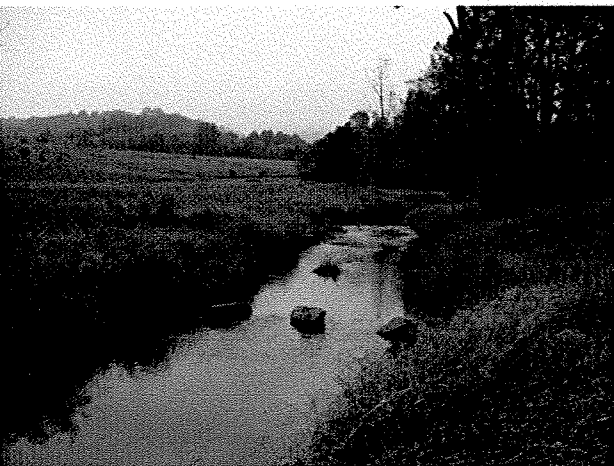
Photograph 125. Looking upstream at log J vane installed at MS Station 3+53. (9/27/04)
