# BIG WARRIOR STREAM RESTORATION MITIGATION PLAN

March 2005

Big Warrior Creek Restoration  
 Wilkes County, North Carolina  
 Biohabitats Project No. 02803.01

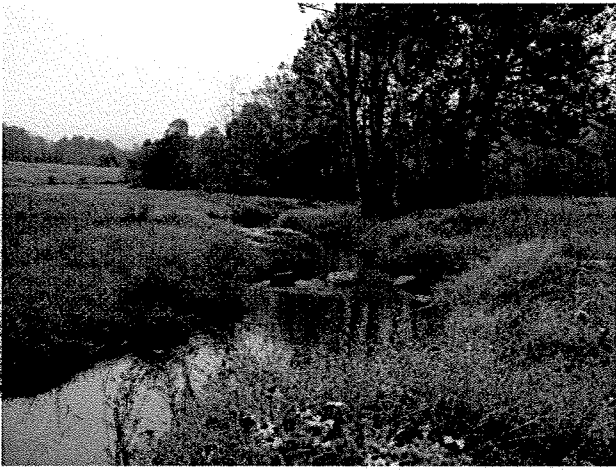
Photograph 127. Looking upstream from MS Station 2+90 at log J vane installed at MS Station 3+53. (9/27/04)

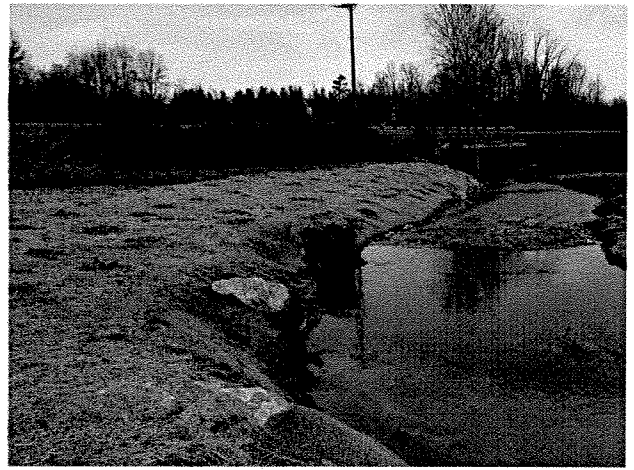
Photograph 128. Looking downstream at root wads installed between MS Stations 3+10 and 2+80. (4/7/04)

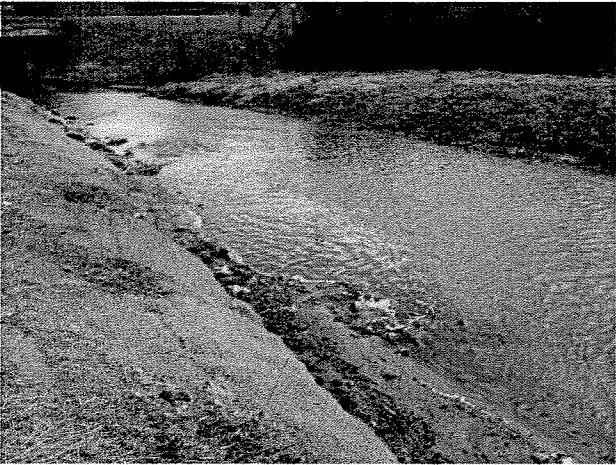
Photograph 129. Looking downstream from rock cross vane installed at MS Station 1+50 area. (4/7/04)

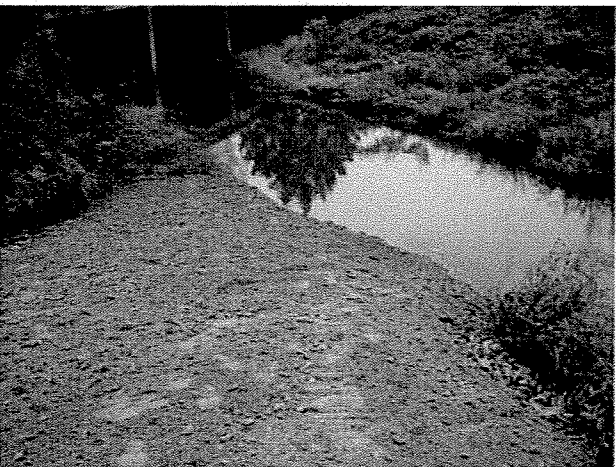
Photograph 131. Gravel path installed at downstream end of main stem for cattle access to NC 18 culvert. (9/27/04)

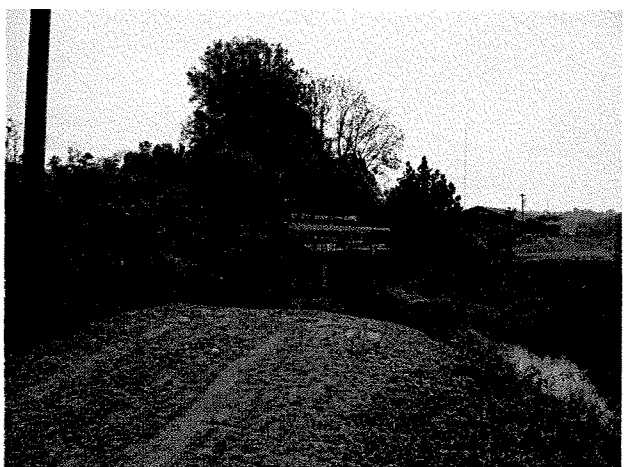
Photograph 132. Gravel path installed at downstream end of main stem for cattle access to NC 18 culvert. (9/27/04)

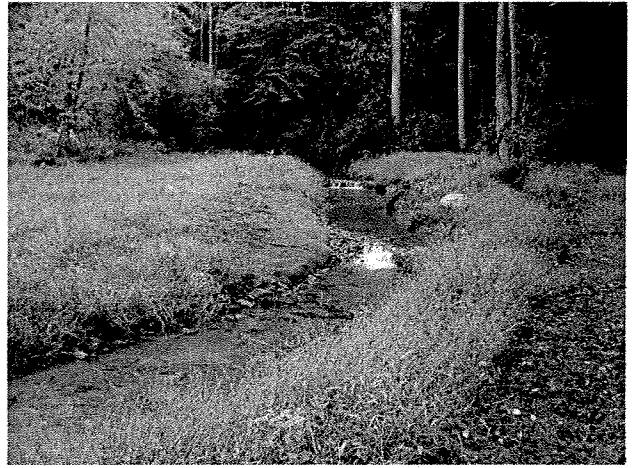
Photograph 2. Looking upstream at rock cross vane, log toe protection, root wads, and log vane installed between MC Stations 0+12 and 1+08. (9/27/04)

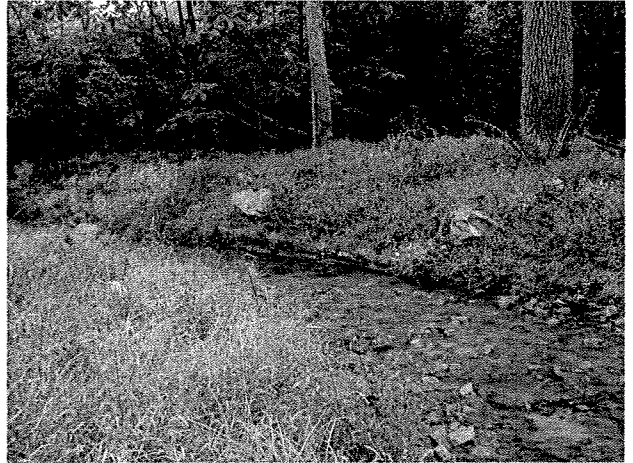
Photograph 4. Looking downstream at log toe protection installed between LT Stations 1+50 and 1+90 to protect large trees. (9/27/04)

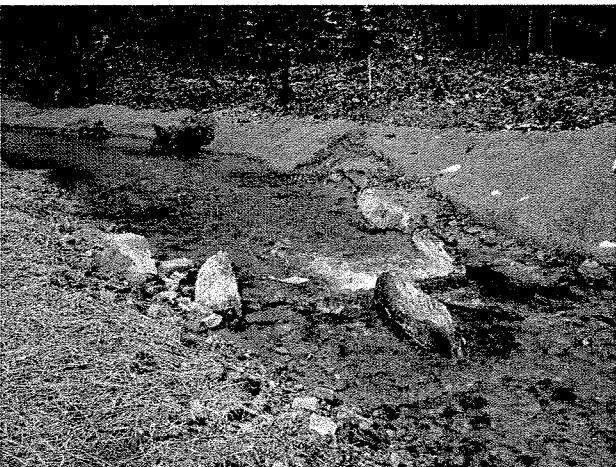
Photograph 5. Rock J vane installed at MC Station 1+93. (12/18/03)

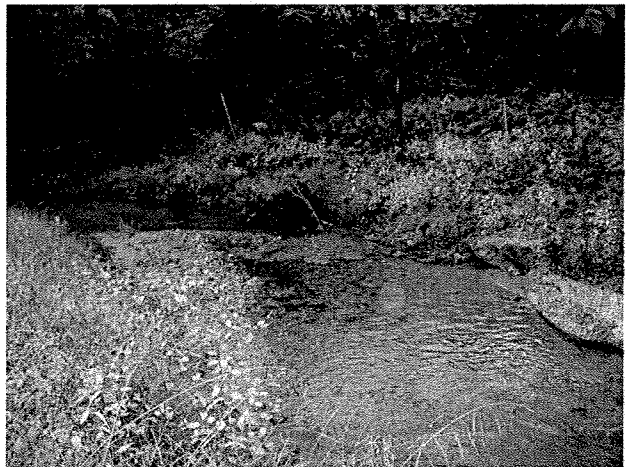
Photograph 6. Looking downstream from rock J vane at root wads and log vane installed between MC Stations 2+20 and 2+57. (9/27/04)

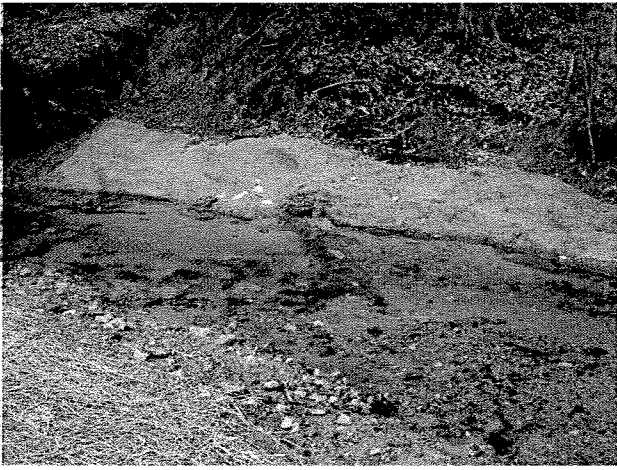
Photograph 7. Log vane installed at MC Station 2+57. (12/18/03)

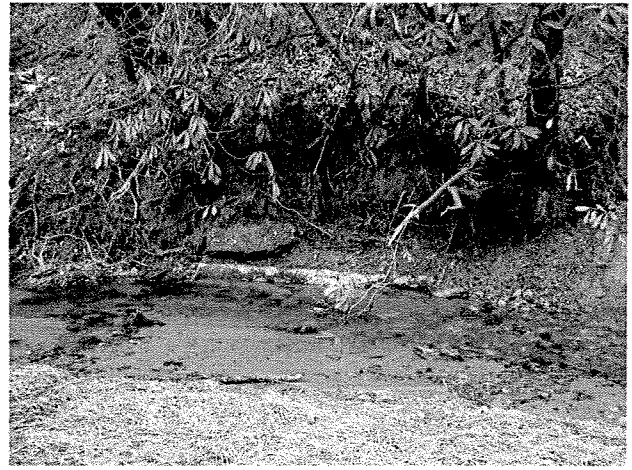
Photograph 8. Log toe protection installed between MC Stations 2+85 and 3+05. (12/18/03)

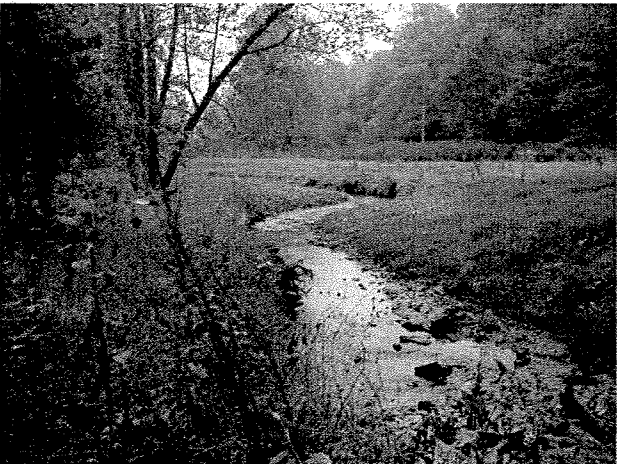
Photograph 11. Looking downstream from MC Station 4+65 at log toe protection and root wads installed on left bank between MC Stations 5+05 and 5+70. (9/27/04)

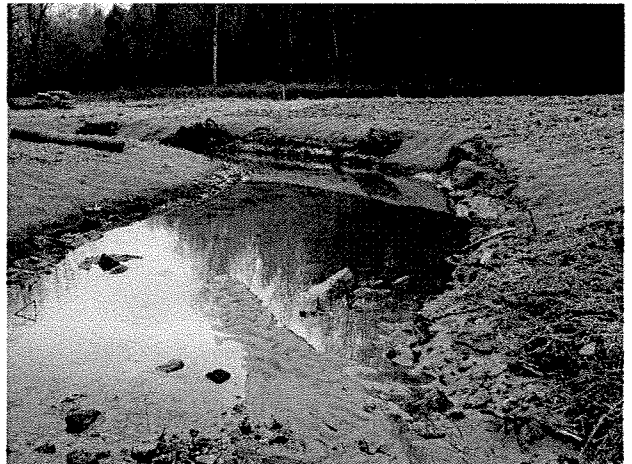
Photograph 12. Looking downstream at rock J vane installed at MC Station 5+86 and log toe protection and root wads installed between MC Stations 6+20 and 6+55. (12/18/03)

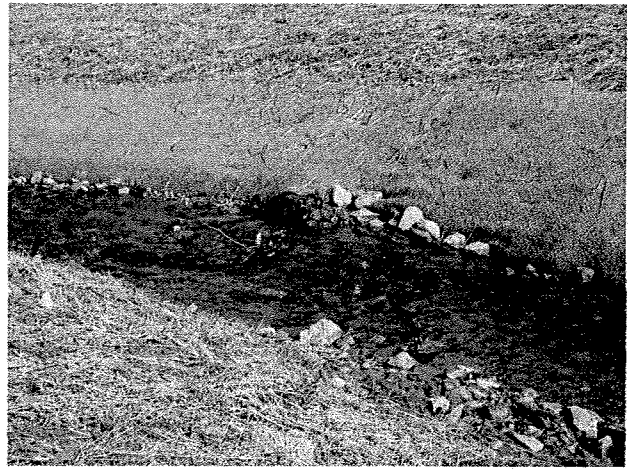
Photograph 14. Log vane installed at MC Station 6+86. (1/16/04)

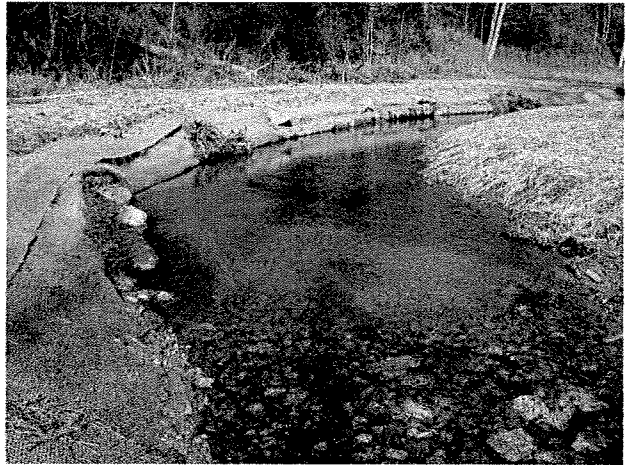
Photograph 16. Looking downstream at rock cross vane installed at MC Station 8+25 and root wads and log toe protection installed between MC Stations 8+70 and 9+20. (1/16/04)

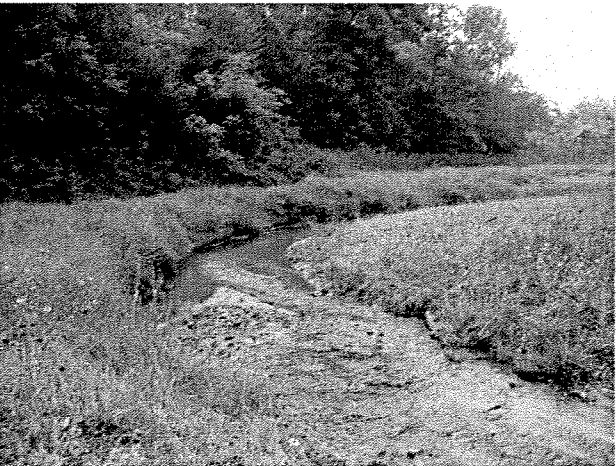
Photograph 17. Looking downstream at rock cross vane installed at MC Station 8+25 and root wads and log toe protection installed between MC Stations 8+70 and 9+20. (9/27/04)

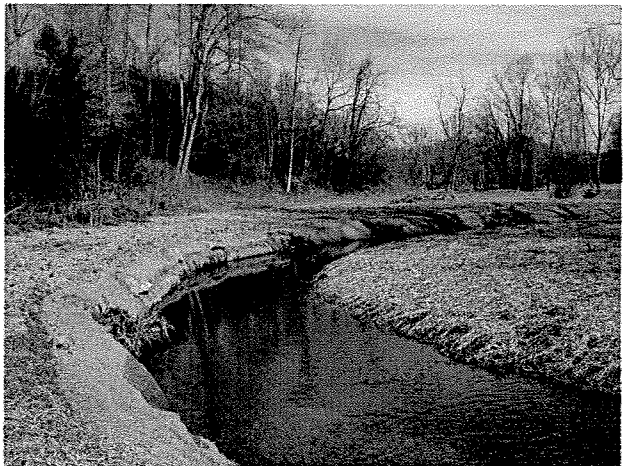
Photograph 18. Looking downstream at root wads and log toe protection installed between MC Stations 8+70 and 9+40. (1/16/04)

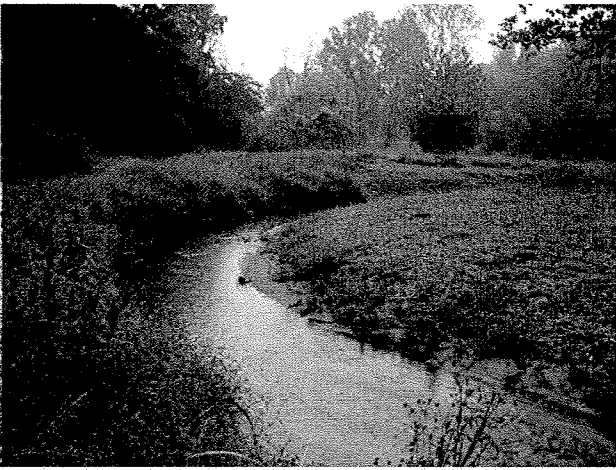
Photograph 19. Looking downstream at root wads and log toe protection installed between MC Stations 8+70 and 9+40. (9/27/04)

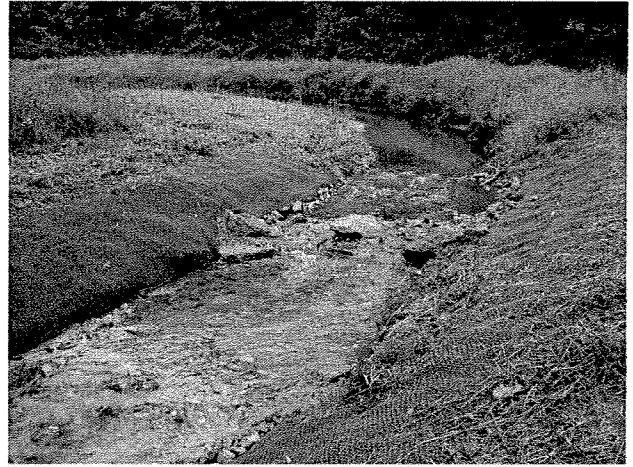
Photograph 20. Looking upstream at rock J vane installed at MC Station 9+72. (9/27/04)

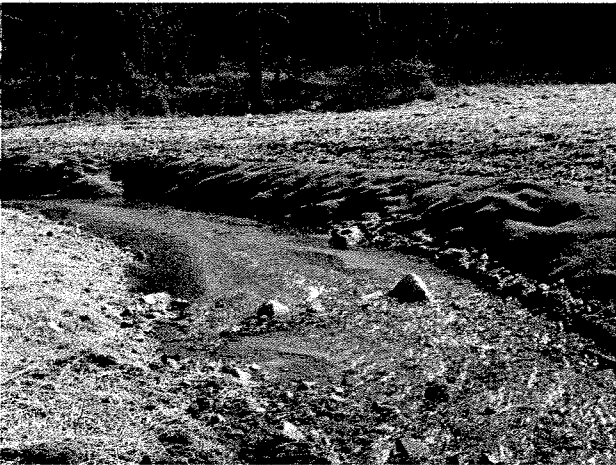
Photograph 21. Looking downstream at rock J vane installed at MC Station 10+14. (1/16/04)

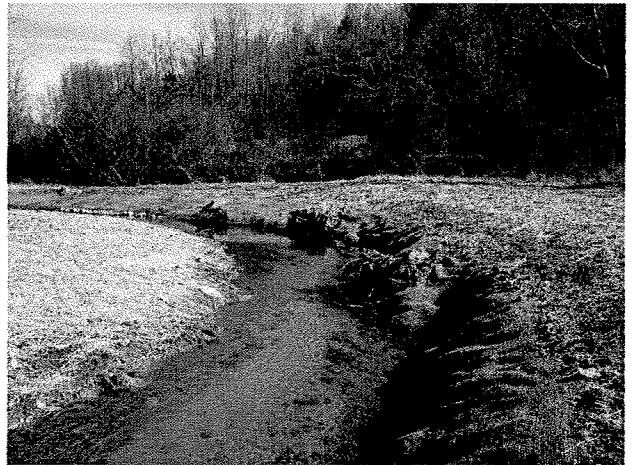
Photograph 22. Looking downstream at root wads installed between MC Stations 10+50 and 11+00. (1/16/04)

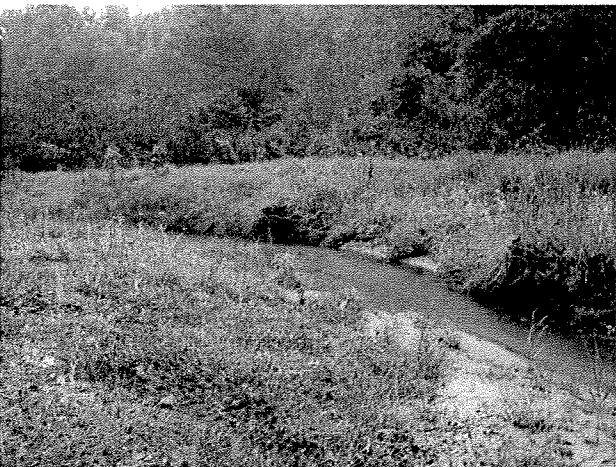
Photograph 23. Looking downstream at root wads installed between MC Stations 10+50 and 11+00. (9/27/04)

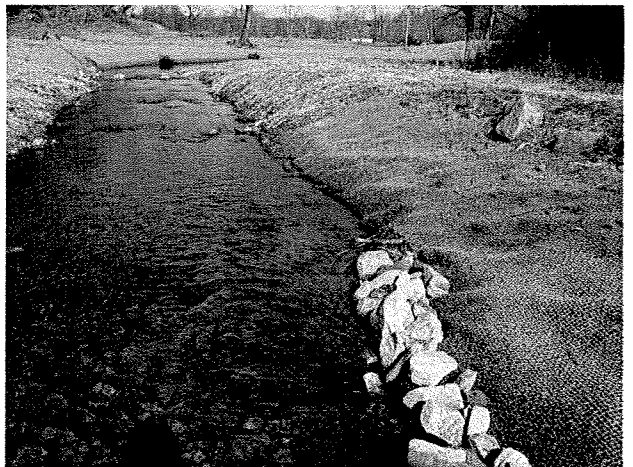
Photograph 24. Log vane installed at MC Station 11+26. (1/16/04)

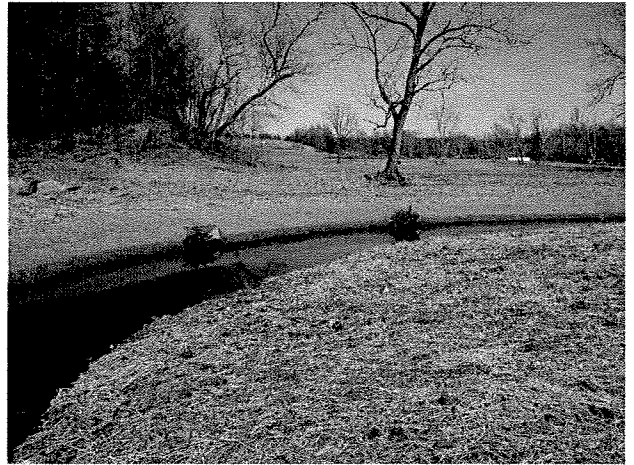
Photograph 28. Looking downstream at root wads installed between MC Stations 12+45 and 12+65. (1/16/04)

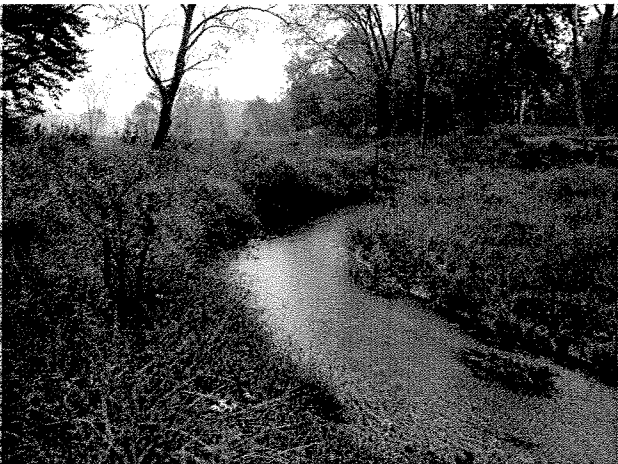
Photograph 29. Looking downstream from LT Station 12+10 at root wads installed between MC Stations 12+45 and 12+65. (9/27/04)

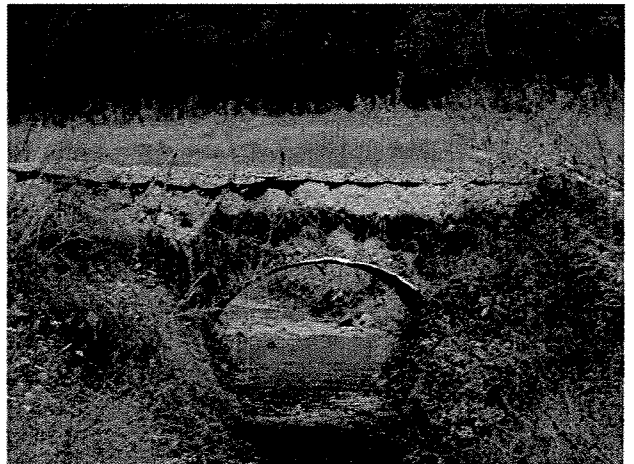
Photograph 30. Upstream face of culvert installed at MC Station 13+29. (9/27/04)

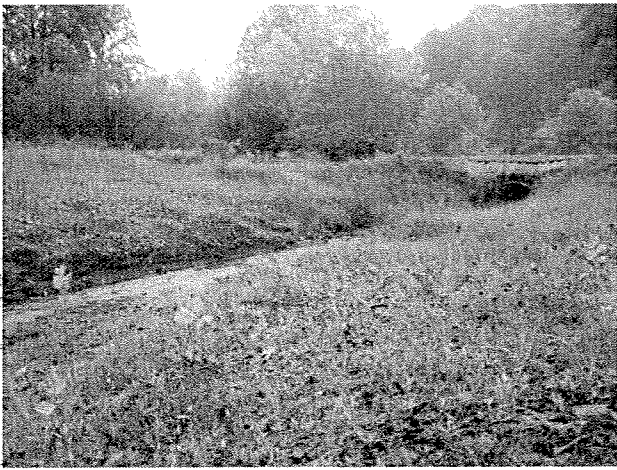
Photograph 31. Downstream face of culvert installed at MC Station 13+29. (9/27/04)

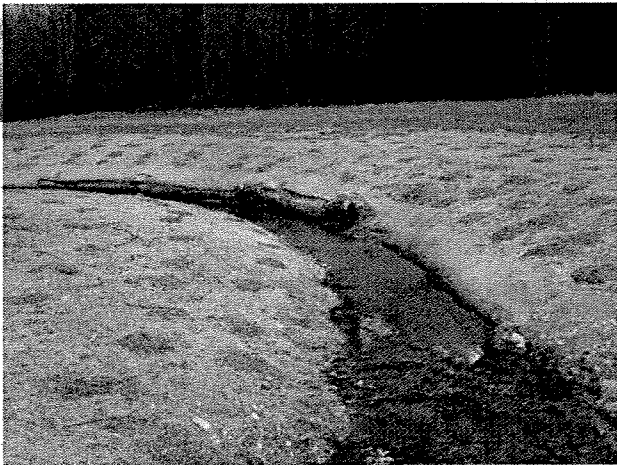
Photograph 33. Looking downstream from culvert at log vane, root wads, and log toe protection installed between MC Stations 13+66 and 15+85. (4/7/04)

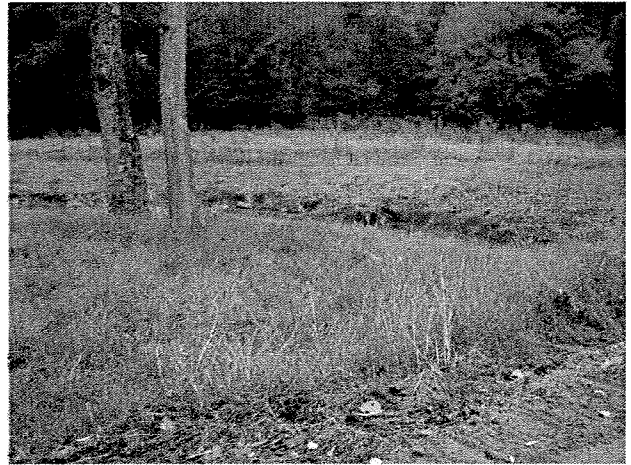
Photograph 34. Looking across culvert at root wads and log toe protection installed on right bank between MC Stations 14+00 and 14+70. (9/27/04)

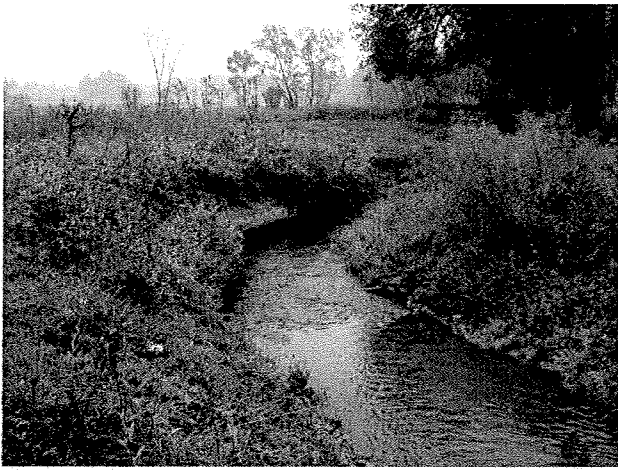
Photograph 37. Looking downstream at log vane, log toe protection, and root wad installed between MC Stations 16+03 and 16+55. (9/27/04)

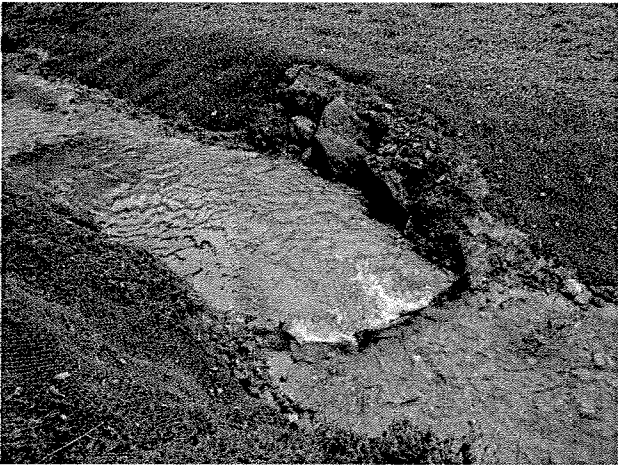
Photograph 39. Rock cross vane installed at MC Station 17+25. (9/27/04)

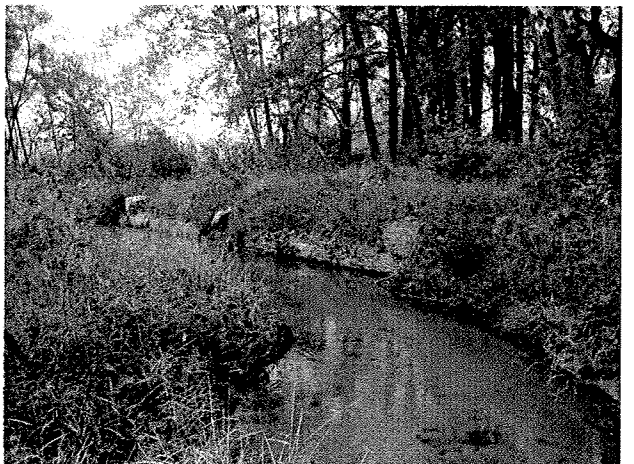
Photograph 42. Looking downstream from MC Station 17+98 at log toe protection and root wads installed between MC Stations 18+25 and 19+25. (9/27/04)

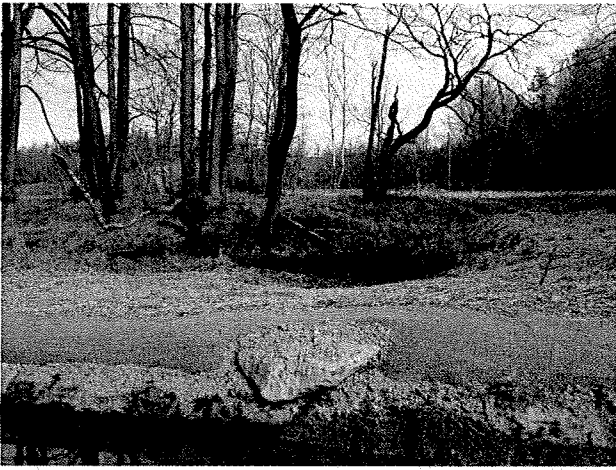
Photograph 43. Wetland created from relic channel in MC Station 18+75 area. (1/16/04)

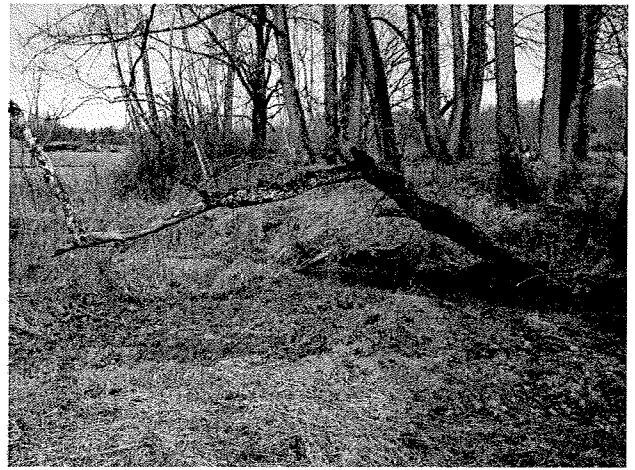
Photograph 44. Wetland created from relic channel in MC Station 19+50 area. (1/16/04)

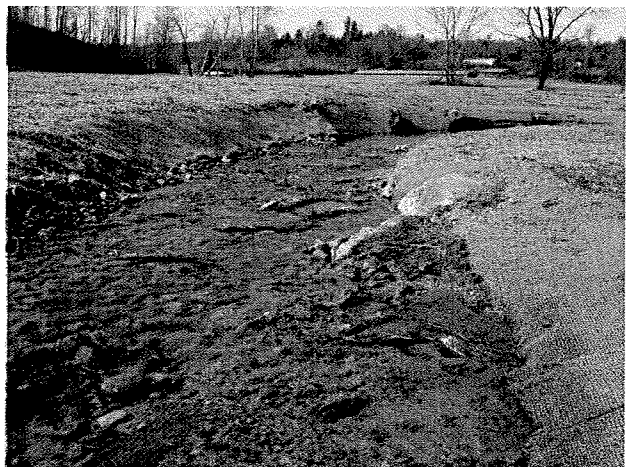
Photograph 46. Looking downstream at rock vane installed at MC Station 19+20. (1/16/04)

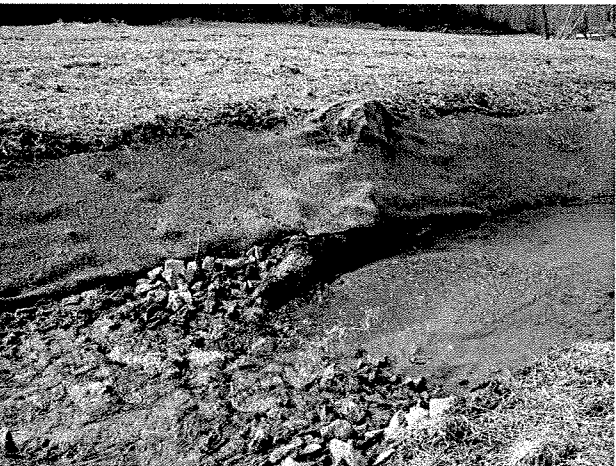
Photograph 47. Looking downstream at log vane installed at MC Station 19+97. (1/16/04)

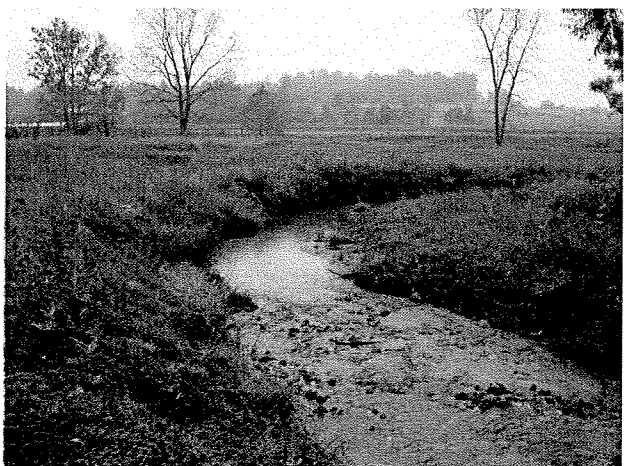
Photograph 48. Looking downstream at log vane, root wads, and log toe protection installed between MC Stations 19+97 and 20+75. (9/27/04)

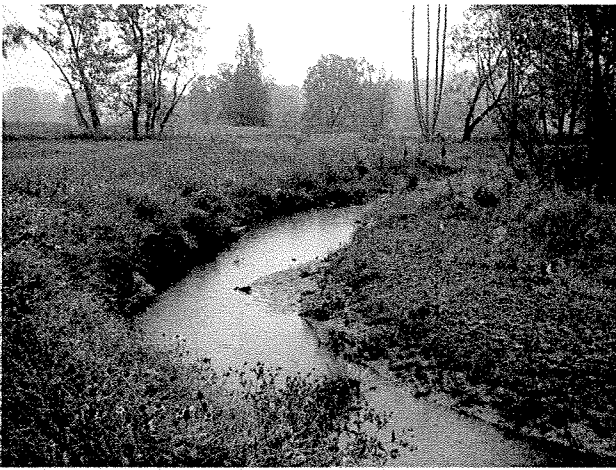
Photograph 49. Looking downstream at log toe protection and root wad installed between MC Stations 20+60 and 21+00. (9/27/04)

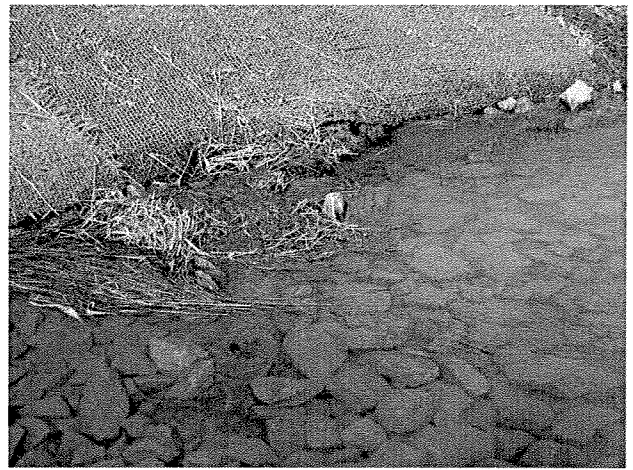
Photograph 50. Log vane installed at MC Station 21+11. (1/16/04)

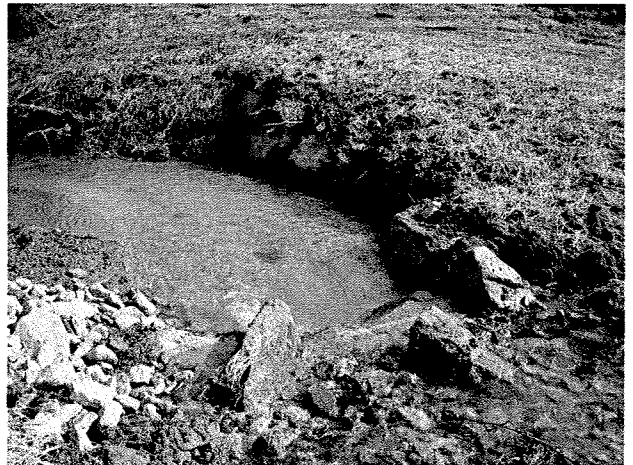
Photograph 52. Rock J vane installed at MC Station 21+63. (1/16/04)

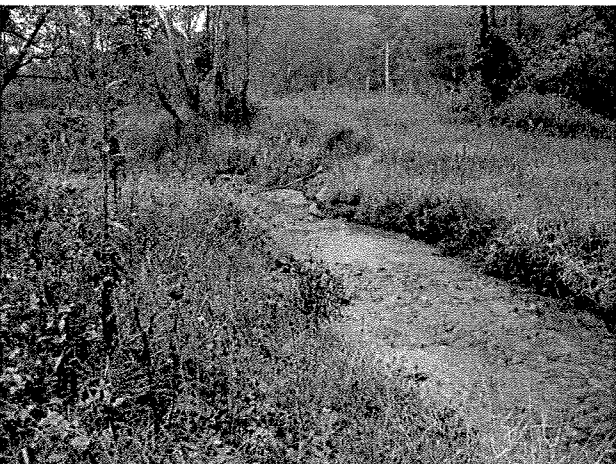
Photograph 53. Looking downstream at rock J vane installed at MC Station 21+63. (9/27/04)

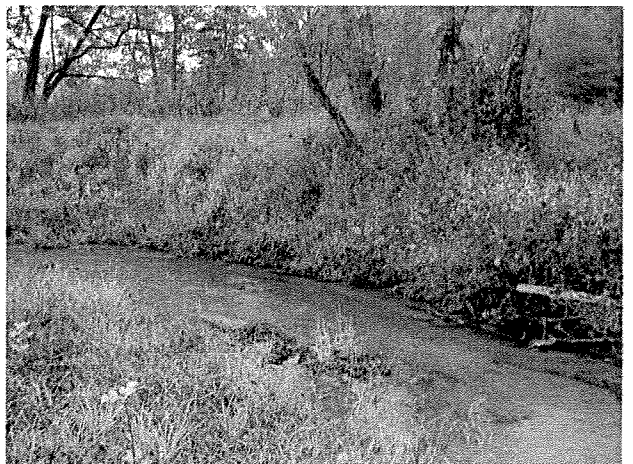
Photograph 54. Looking downstream at root wad installed at MC Station 22+05. (9/27/04)

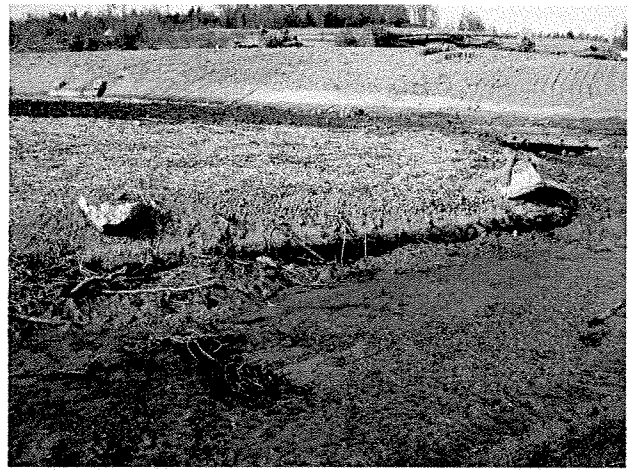
Photograph 56. Log toe protection installed on left bank between MC Stations 23+50 and 23+70. (1/16/04)

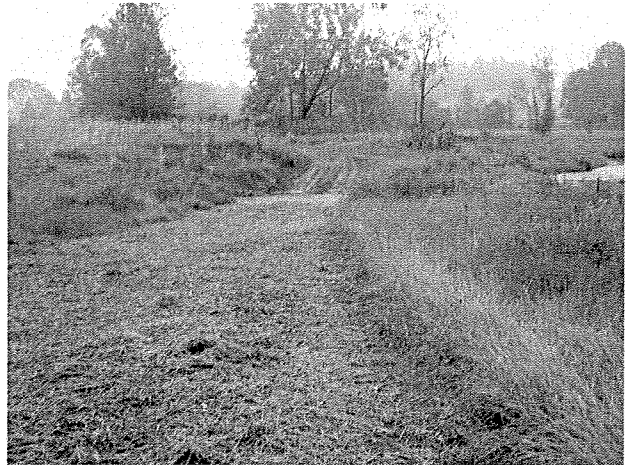
Photograph 58. Ford crossing replaced at Mountain Creek tributary confluence with main stem (left bank of Mountain Creek tributary). (9/27/04)

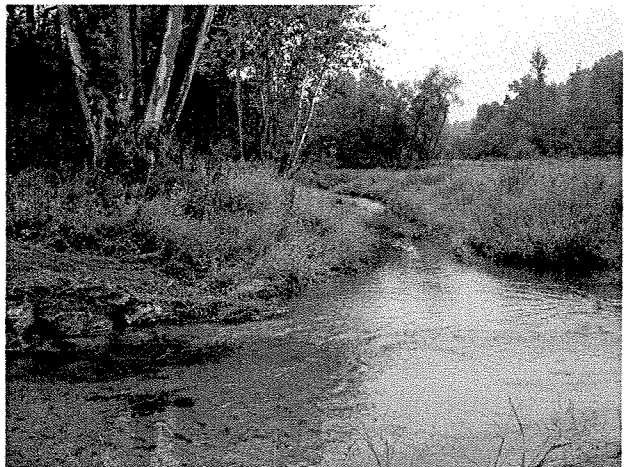
Photograph 60. Looking upstream at Mountain Creek tributary confluence with main stem. (9/27/04)

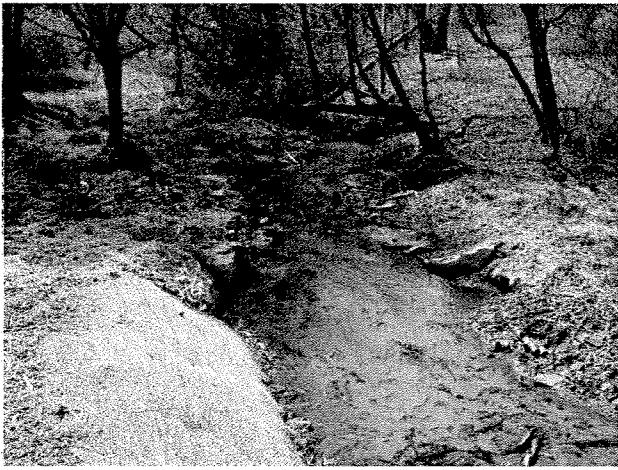
Photograph 1. Rock cross vane installed at LT Station 0+00 (upstream end of restoration area). (4/7/04)

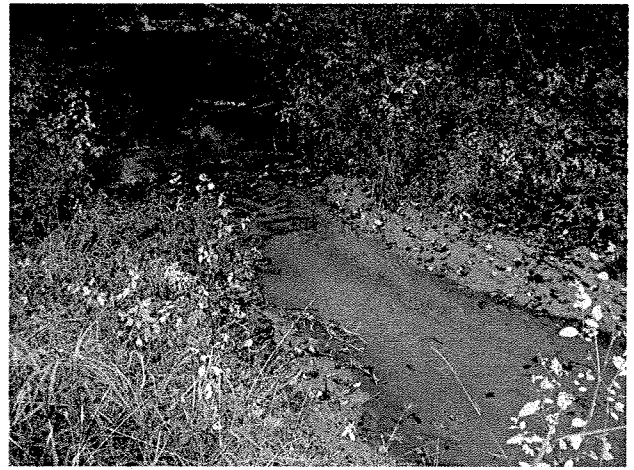
Photograph 2. Rock cross vane installed at LT Station 0+00 (upstream end of restoration area). (9/27/04)

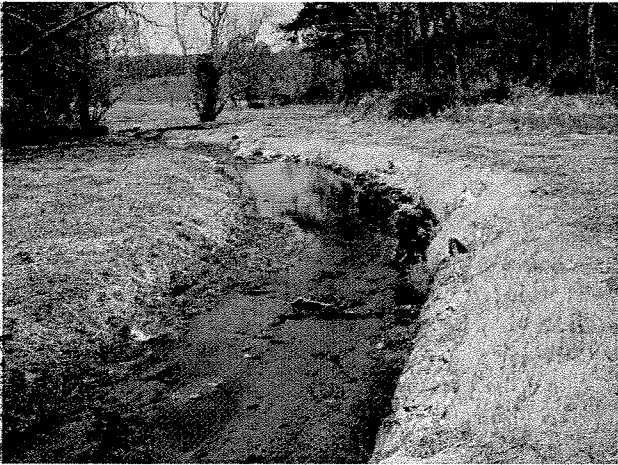
Photograph 3. Looking downstream at log toe protection and root wads installed between LT Stations 0+25 and 0+95. (4/7/04)

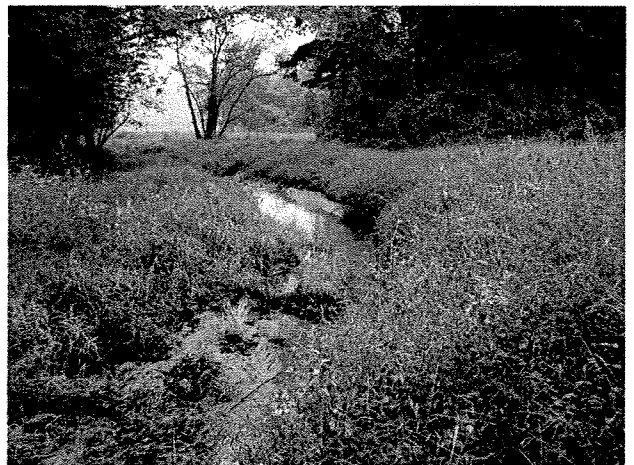
Photograph 4. Looking downstream at log toe protection and root wads installed between LT Stations 0+25 and 0+95. (9/27/04)

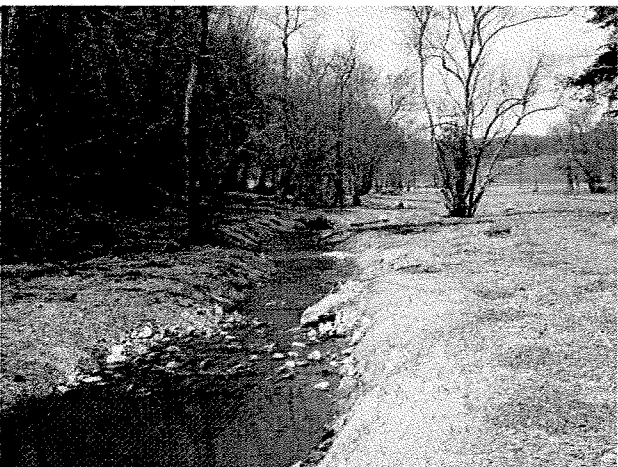
Photograph 5. Looking downstream at rock vane installed at LT Station 0+94. (4/7/04)

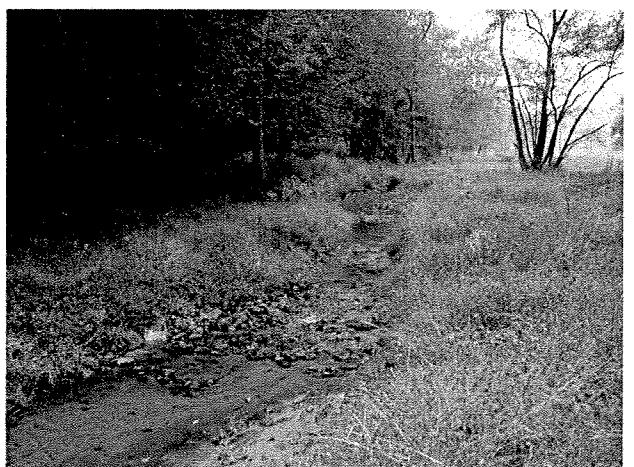
Photograph 6. Looking downstream at rock vane installed at LT Station 0+94. (9/27/04)

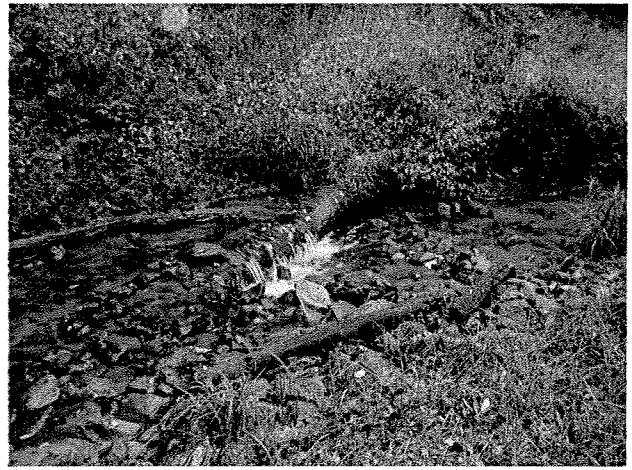
Photograph 8. Log vane installed at LT Station 1+80. (9/27/04)

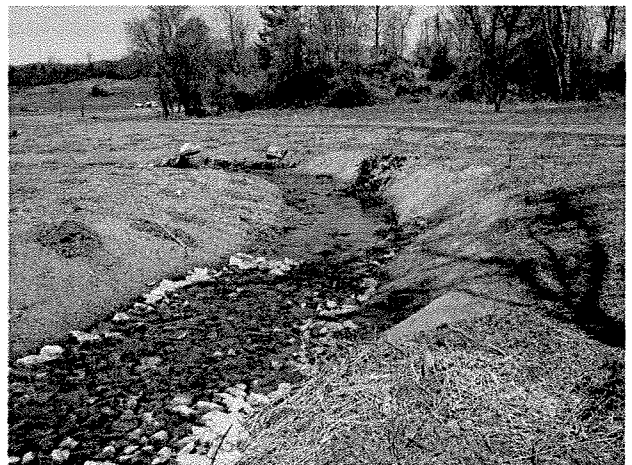
Photograph 10. Looking downstream at log vane, root wad, and log toe protection installed between LT Stations 2+65 and 3+20. (4/7/04)

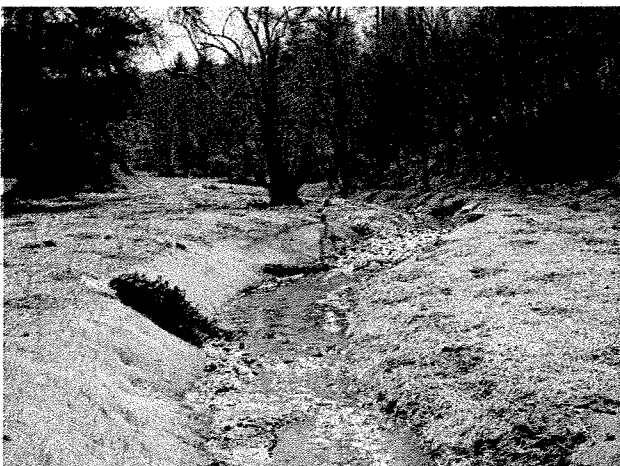
Photograph 11. Looking upstream at log vane and root wad installed between LT Stations 2+65 and 2+90. (4/7/04)

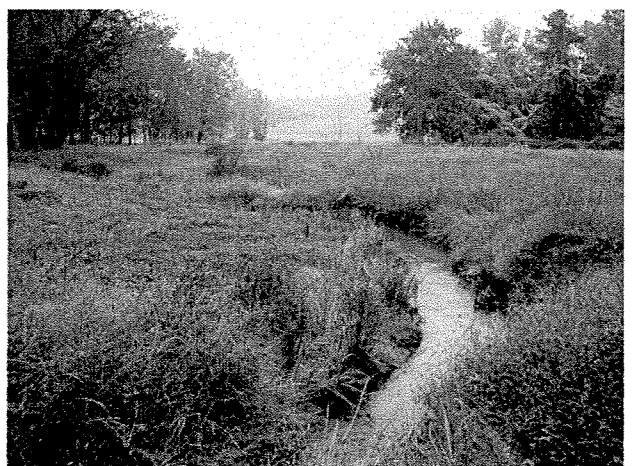
Photograph 12. Looking downstream at log vane, root wad, and log toe protection installed between LT Stations 2+65 and 3+20. (9/27/04)

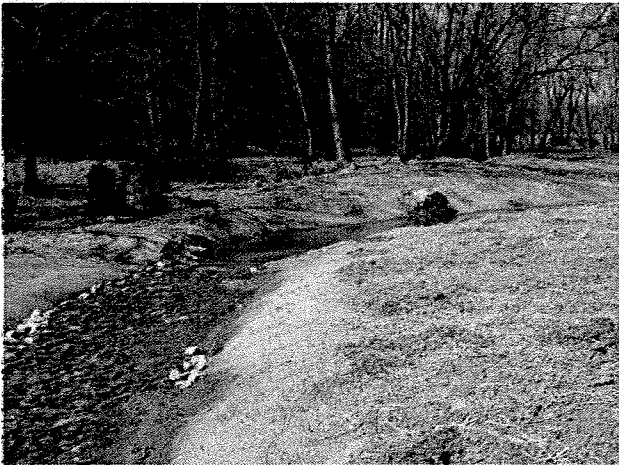
Photograph 15. Looking downstream at rock cross vane and root wad installed between LT Stations 3+58 and 3+90. (4/7/04)

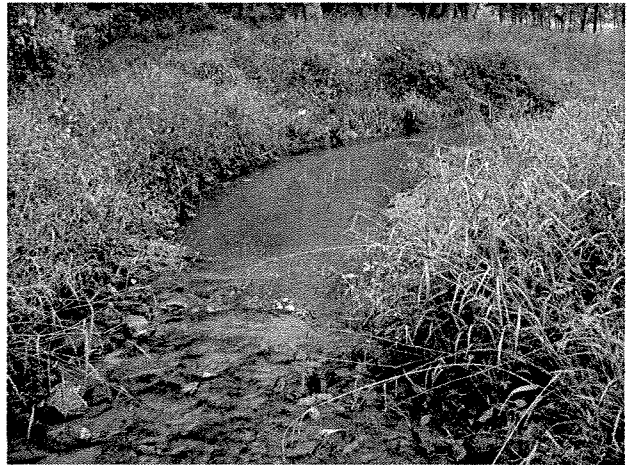
Photograph 16. Looking downstream at rock cross vane and root wad installed between LT Stations 3+58 and 3+90. (9/27/04)

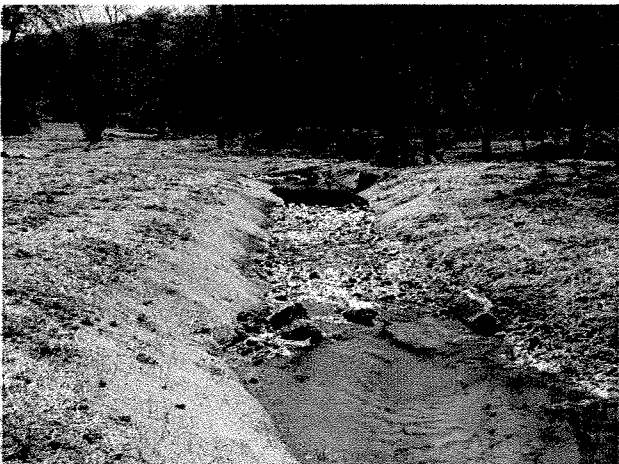
Photograph 17. Rock J vane installed at LT Station 4+33. (4/7/04)

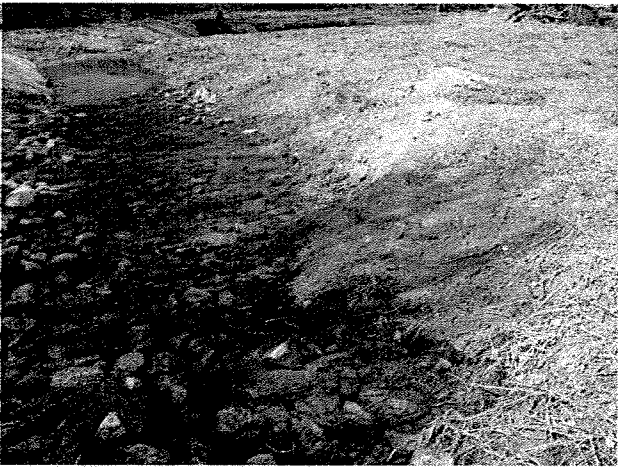
Photograph 21. Log vane installed at LT Station 5+01. (4/7/04)

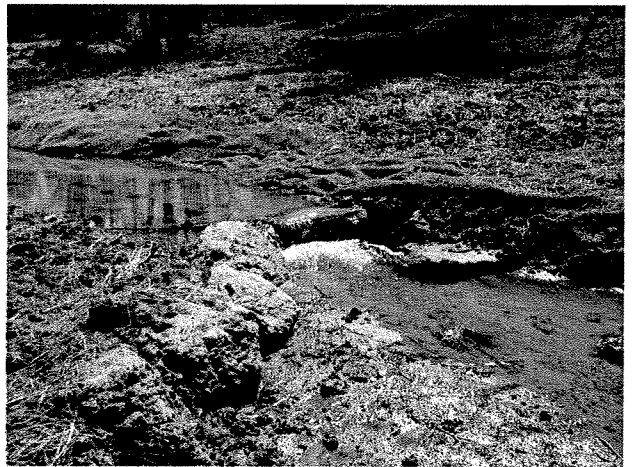
Photograph 22. Cross vane installed at LT Station 5+90. (4/7/04)

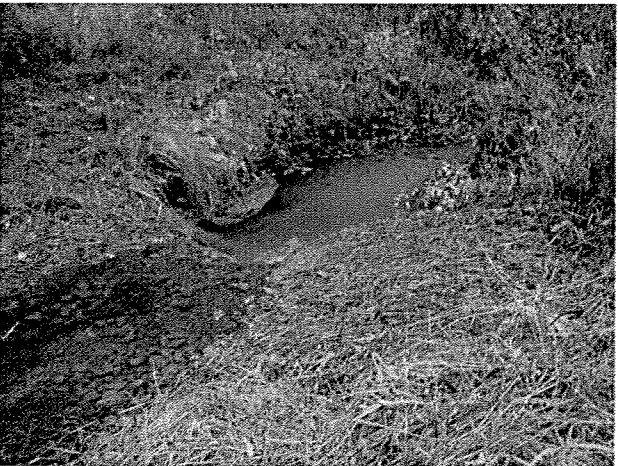
Photograph 23. Looking downstream at cross vane installed at LT Station 5+90. (9/27/04)

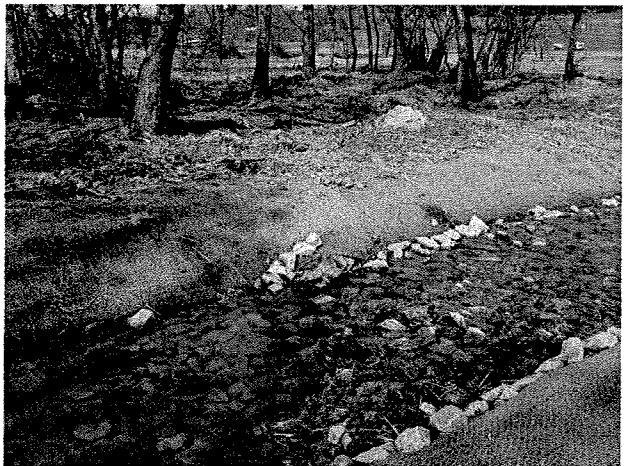
Photograph 24. Log vane installed at LT Station 6+57. (4/7/04)

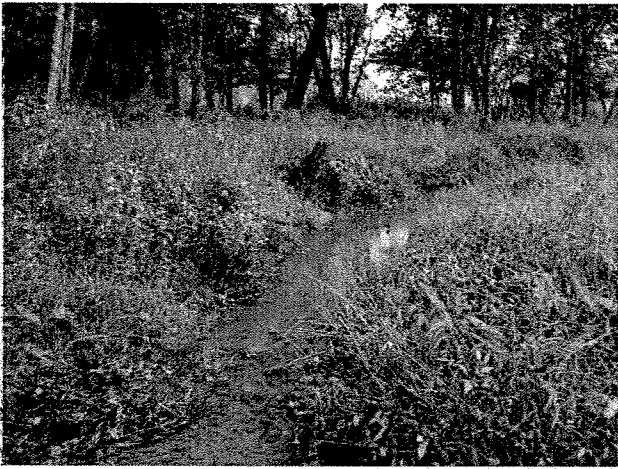
Photograph 25. Looking downstream at root wad and log toe protection installed between LT Stations 6+25 and 6+60. (9/27/04)

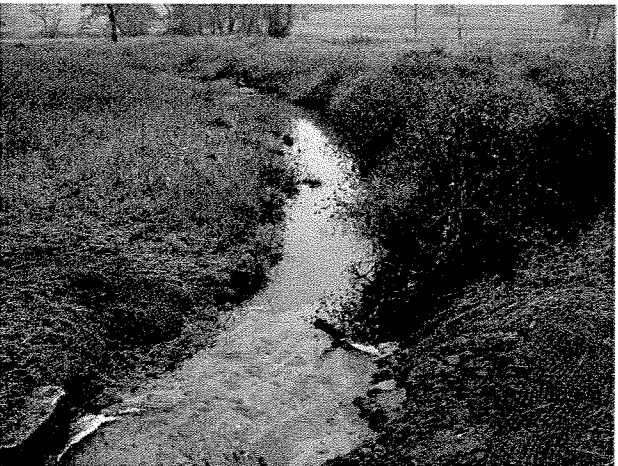
Photograph 29. Looking downstream from LT Station 7+85 at root wad and log toe protection installed between LT Stations 7+75 and 8+25. (9/27/04)

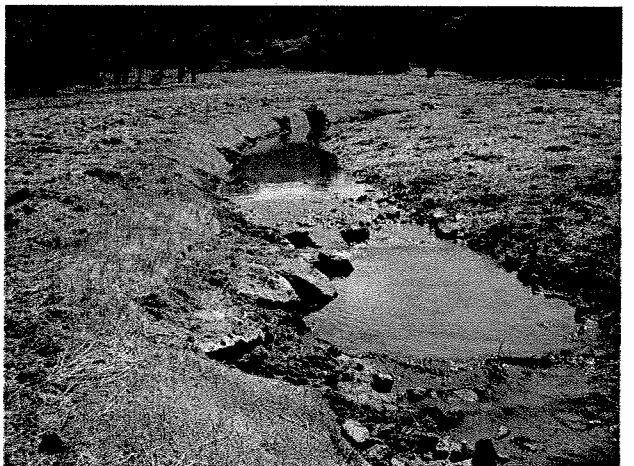
Photograph 30. Looking upstream at rock J vane installed at LT Station 8+38 (4/7/04)

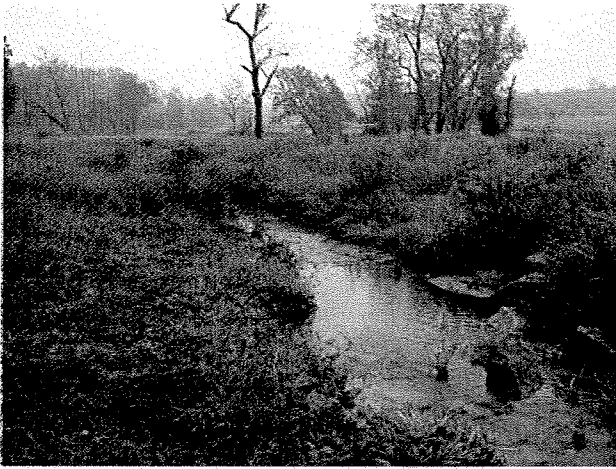
Photograph 31. Looking downstream from rock J vane installed at LT Station 8+38. (9/27/04)

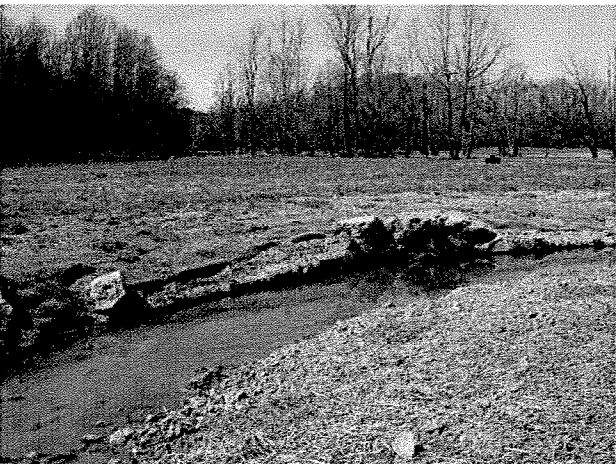
Photograph 35. Looking downstream at log toe protection and root wad installed between LT Stations 10+60 and 10+80. (4/7/04)

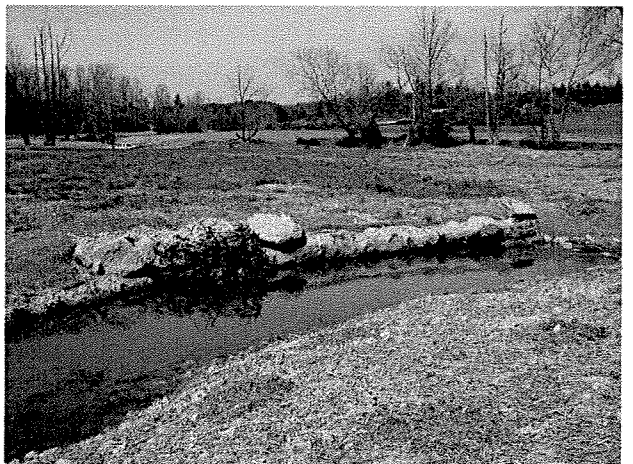
Photograph 36. Looking downstream at root wad and log toe protection installed between LT Stations 10+10 and 10+30. (4/7/04)

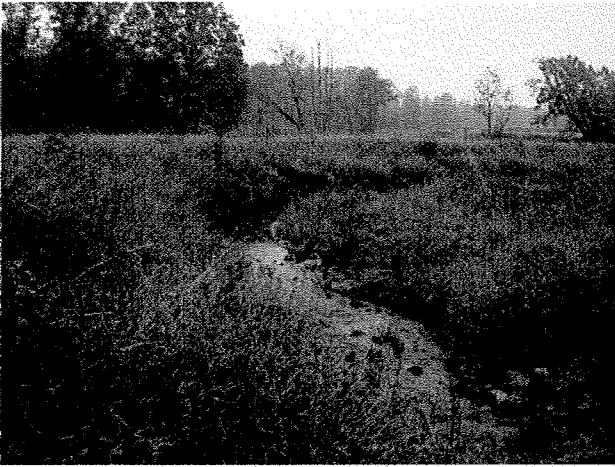
Photograph 37. Looking downstream at log vane, root wads, and log toe protection installed between LT Stations 9+44 and 10+30. (9/27/04)

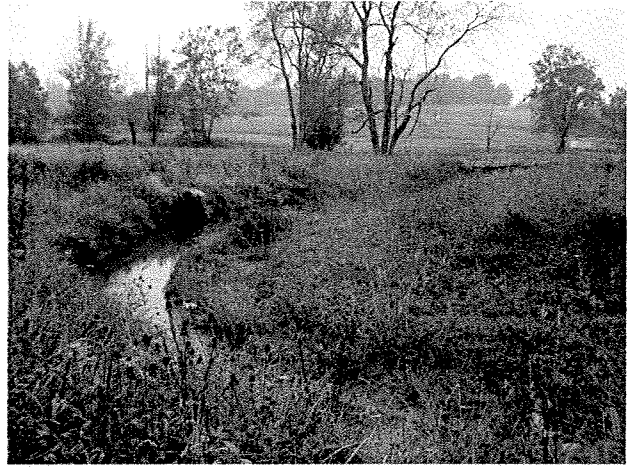
Photograph 38. Looking downstream at log vane, root wads, and log toe protection installed between LT Stations 9+44 and 10+30. (9/27/04)

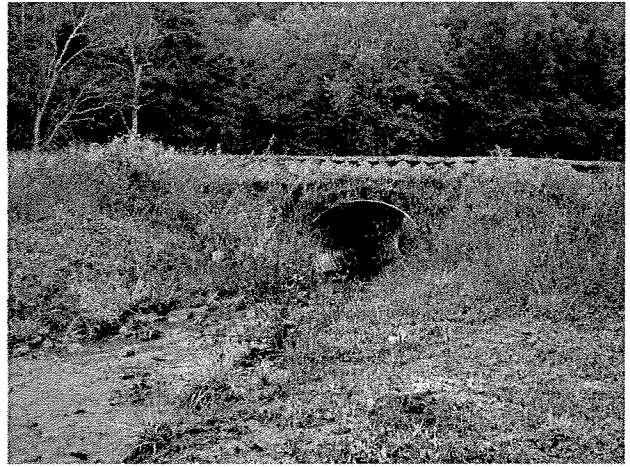
Photograph 40. Downstream face of culvert installed at LT Station 10+38. (9/27/04)
