# BIG WARRIOR STREAM RESTORATION MITIGATION PLAN

March 2005

Big Warrior Creek Restoration  
 Wilkes County, North Carolina  
 Biohabitats Project No. 02803.01

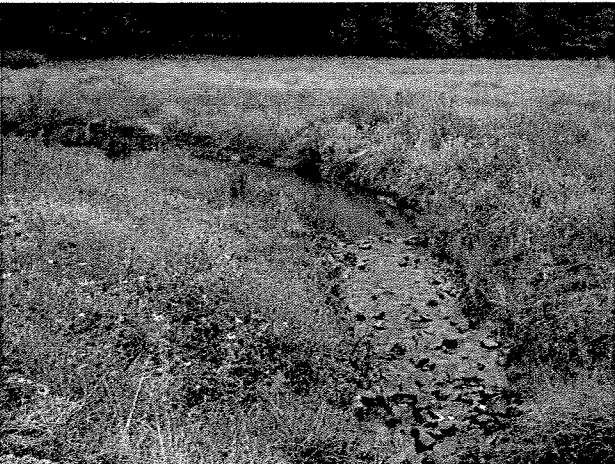
Photograph 41. Looking upstream from culvert at log toe protection and root wads installed between LT Stations 9+65 and 10+30. (9/27/04)

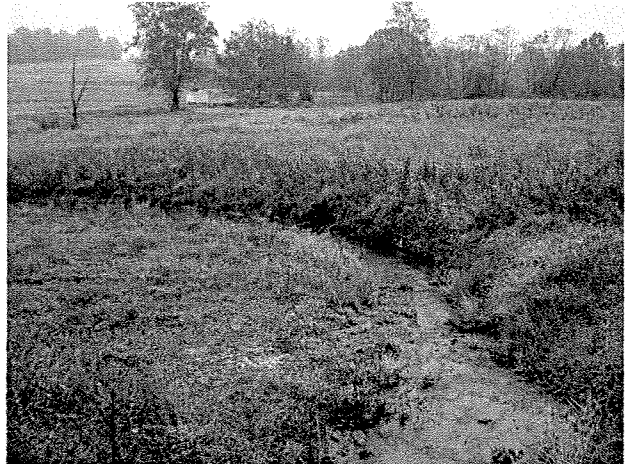
Photograph 42. Looking downstream from culvert at log vane, log toe protection, and root wads installed between LT Stations 10+87 and 11+85. (9/27/04)

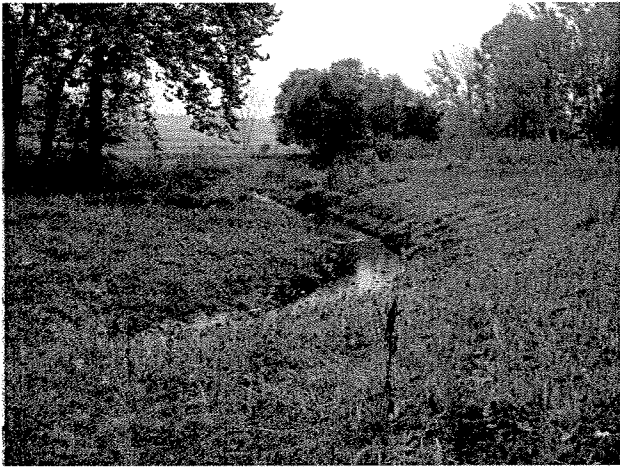
Photograph 43. Looking downstream from right bank near LT Station 10+75. (9/27/04)

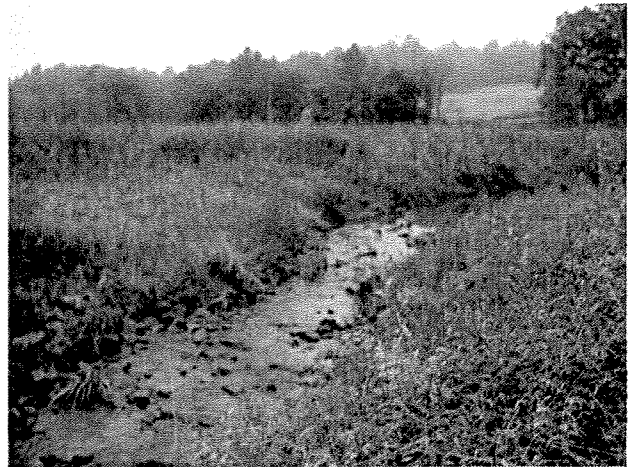
Photograph 44. Looking upstream from rock cross vane installed at LT Station 12+44. (9/27/04)

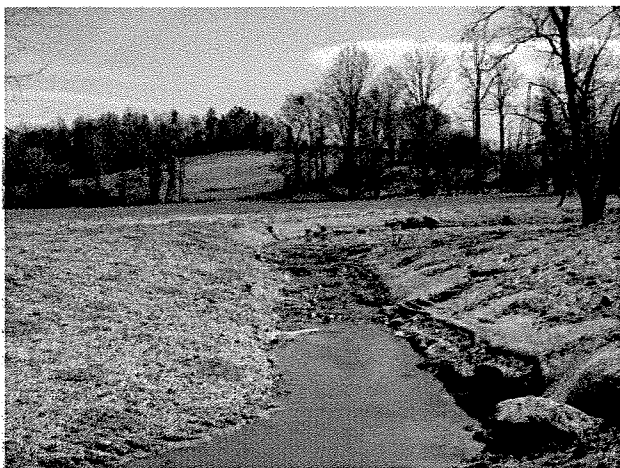
Photograph 45. Looking upstream at rock cross vane installed at LT Station 12+44. (4/7/04)

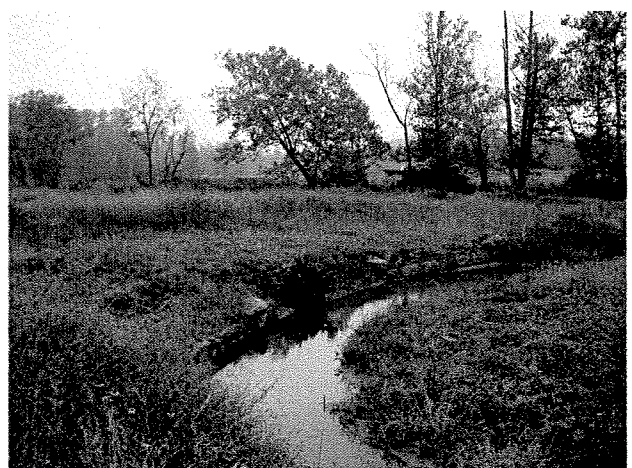
Photograph 46. Looking downstream at log toe protection, root wad, and log vane installed between LT Stations 12+60 and 13+23. (9/27/04)

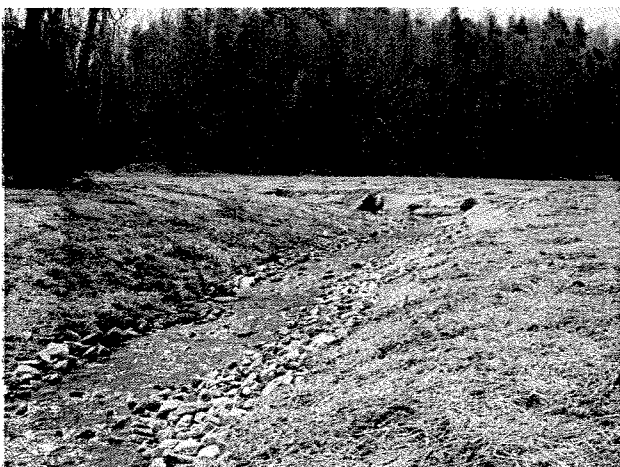
Photograph 47. Looking upstream at Lower tributary near confluence with main stem between LT Stations 12+60 and 14+00. (4/7/04)

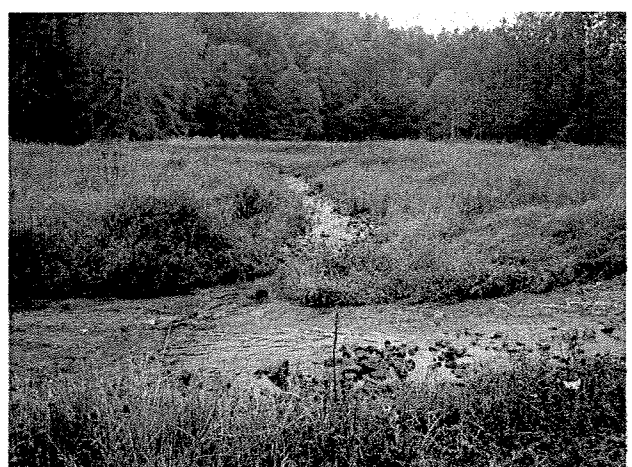
Photograph 48. Looking upstream at Lower tributary confluence with main stem (LT Stations 13+25 and 14+35). (9/27/04)
