Allen Steam Station Ash Basin

Plan for Identification of New Discharges

NPDES Permit NC0004979

September 30, 2014

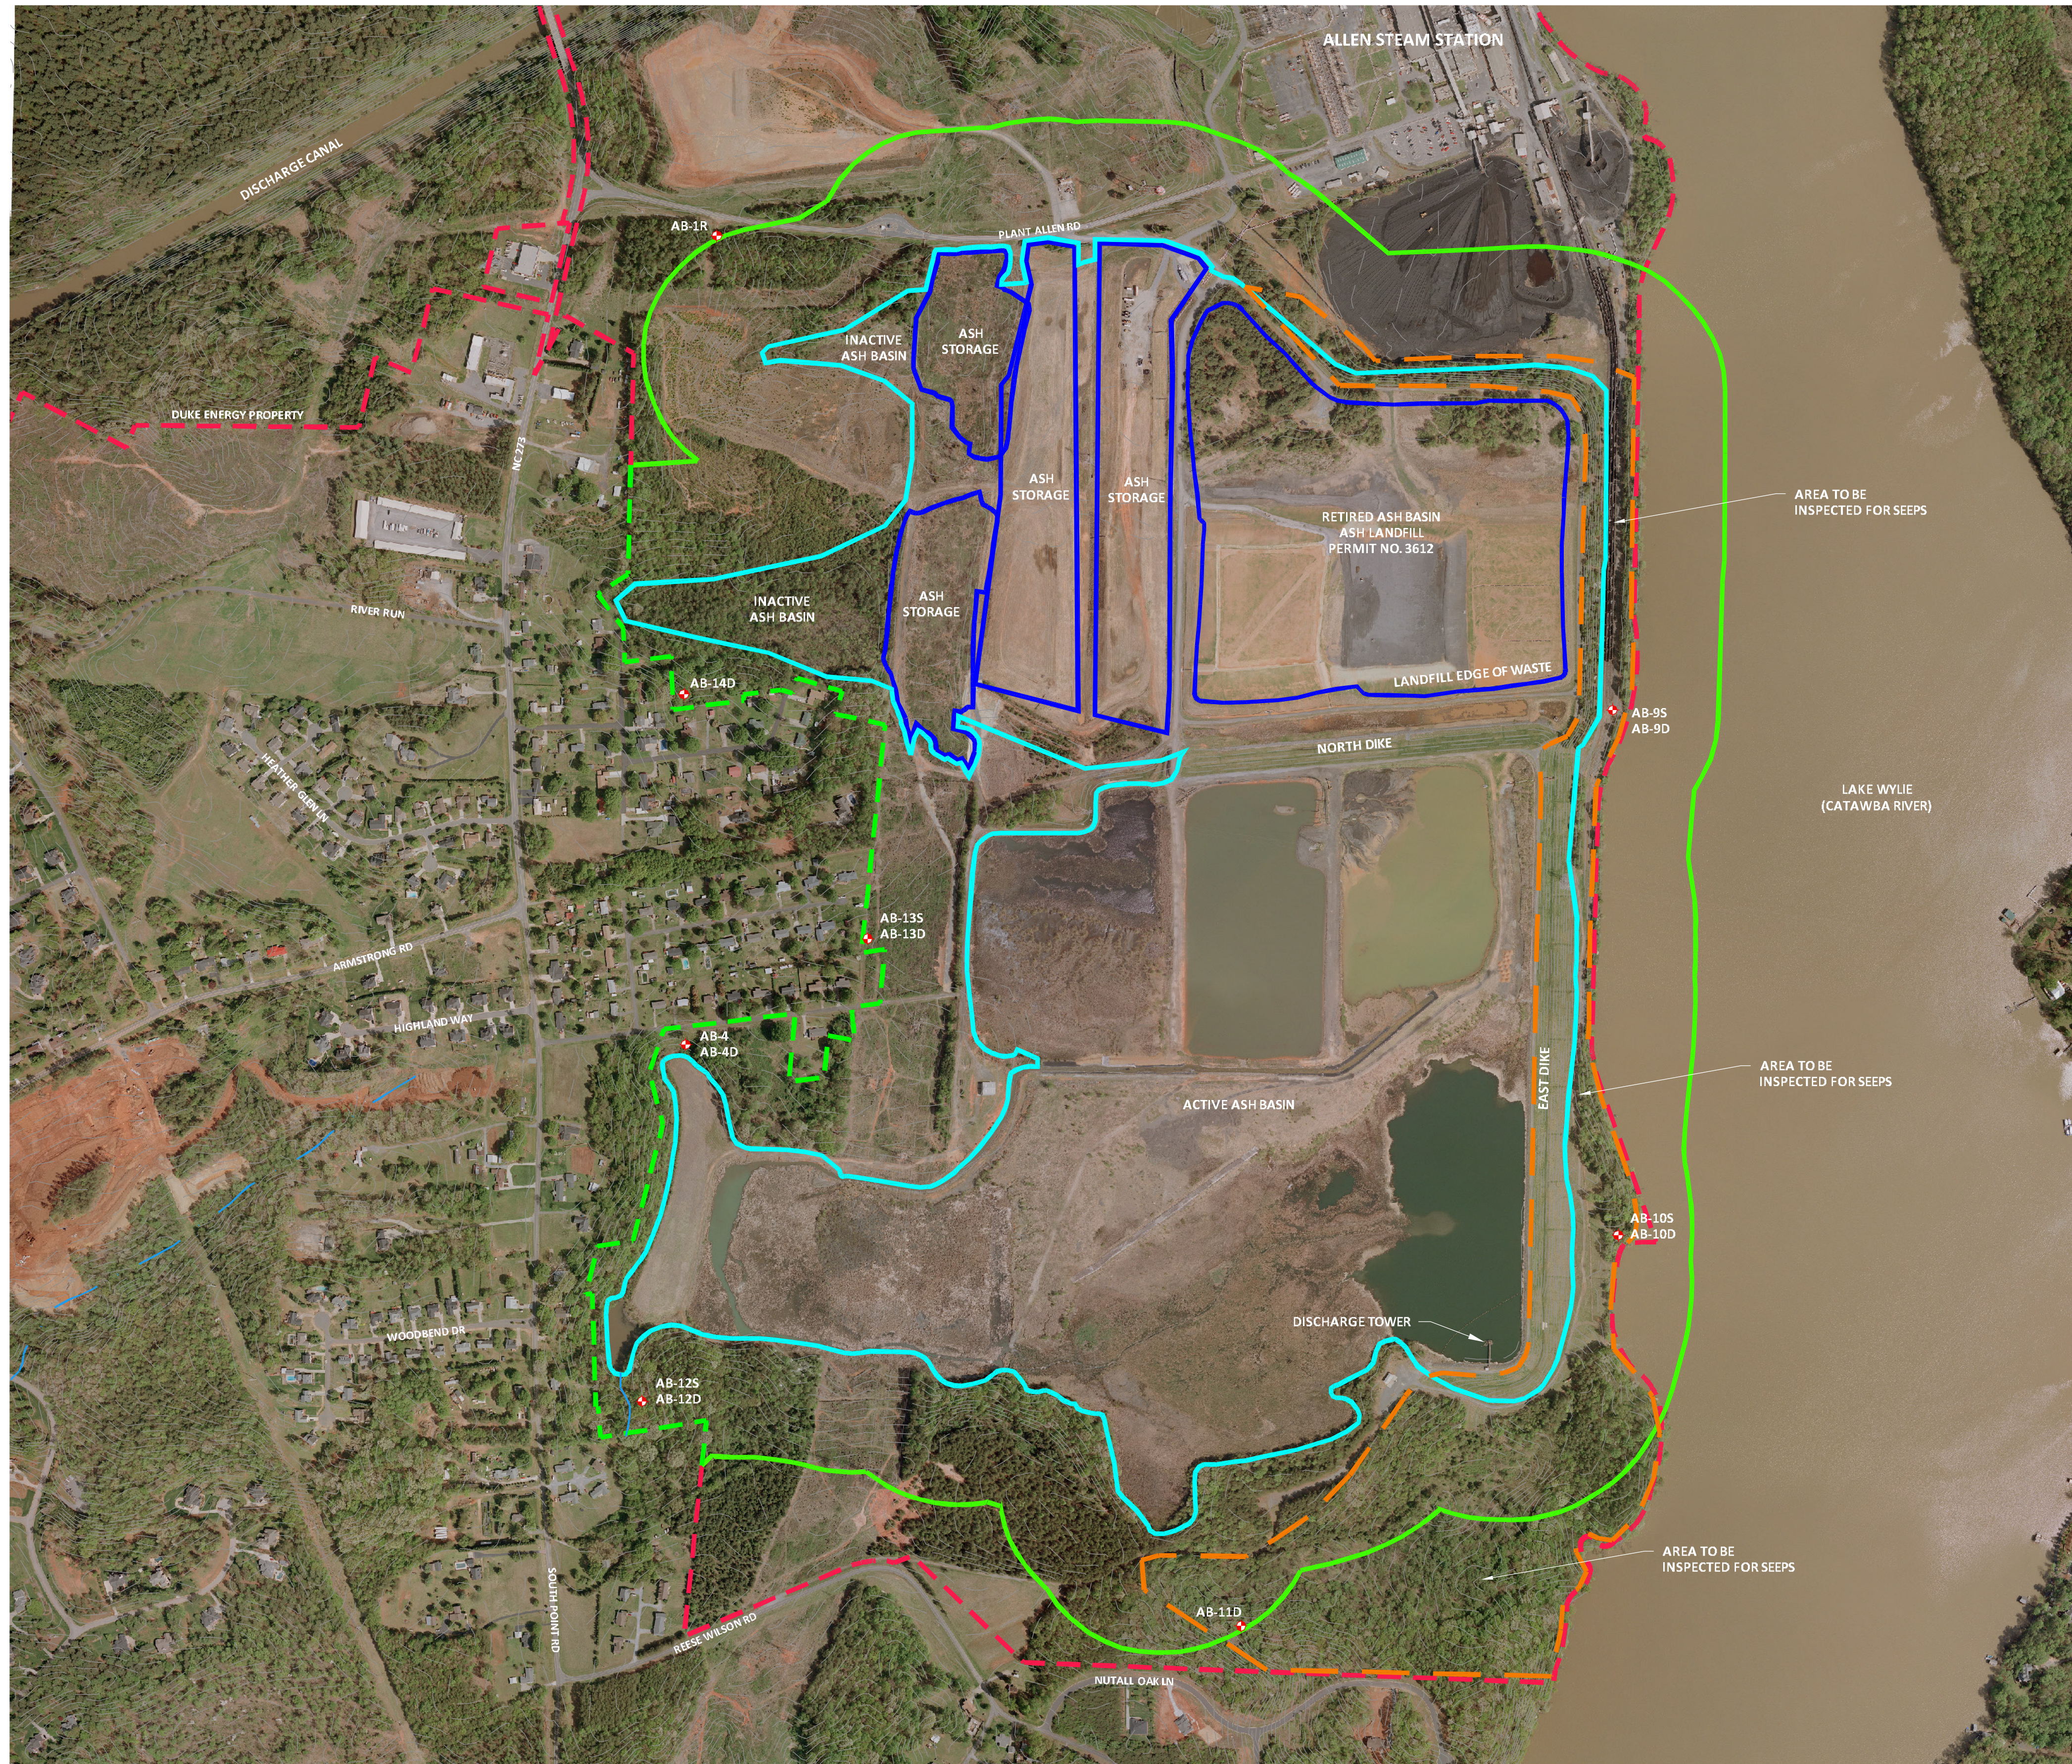
AREAS TO BE INSEPECTED FOR SEEPS
DUKE ENERGY CAROLINAS, LLC
ALLEN STEAM STATION ASH BASIN
NPDES PERMIT NO. NC0004979
 GASTON COUNTY, NORTH CAROLINA

- LEGEND:**
- DUKE ENERGY PROPERTY BOUNDARY
 - ASH BASIN WASTE BOUNDARY
 - ASH STORAGE AREA BOUNDARY
 - ASH BASIN COMPLIANCE BOUNDARY
 - ASH BASIN COMPLIANCE BOUNDARY COINCIDENT WITH DUKE PROPERTY BOUNDARY
 - STREAM
 - TOPOGRAPHIC CONTOUR (4-FT INTERVAL)*
 - AREA TO BE INSPECTED FOR SEEPS
 - ◆ ASH BASIN COMPLIANCE GROUNDWATER MONITORING WELL

Allen has an active ash basin and an inactive ash basin. The active ash basin was commissioned in 1973 and is currently in operation. The inactive ash basin is located to the north of the active ash basin and is not in operation. A large portion of the inactive ash basin is permitted as an industrial landfill by the NCDENR Division of Waste Management (DWM) (Permit No. 3612). See Figure 2.

The Allen ash basin is generally bounded to the north by the inactive ash basin (Figure 2). Lake Wylie is located to the east of the ash basin and lies along the toe of the East Dike. To the south, the ash basin is generally bounded by a surface water divide located north of Reese Wilson Road. This divide drops in elevation to the east toward Lake Wylie. The ash basin is generally bounded to the west by a surface water divide that runs approximately along the alignment of South Point Road (NC 273) and upland areas east of South Point Road. The geological/groundwater conditions at the site are expected to be generally consistent with the characteristics of the conceptual groundwater model developed by LeGrand for the Piedmont region. The surface water divide along South Point Road likely functions as a groundwater divide. The predominant direction of groundwater flow from the ash basin is likely in an easterly direction, generally from South Point Road towards Lake Wylie.

The areas to be inspected for new discharges and indicators of potential new discharges are the areas of the site where water contained in the ash basin might infiltrate into the underlying residual material and be expressed as seepage. This would include the earthen embankment which impounds the ash basin and certain adjacent areas.

The extent of the areas to be inspected was determined based on the generalized LeGrand conceptual model and the concept of the slope-aquifer system and the site topography. In this generalization, flow of water from the ash basin would be expected to be located within the slope-aquifer compartment and to be below the full pond elevation of the ash basin. The area to be inspected for new discharges is shown on Figure 2.
