Cliffside Steam Station Ash Basin

# Plan for Identification of New Discharges

NPDES Permit NC0005088

September 30, 2014

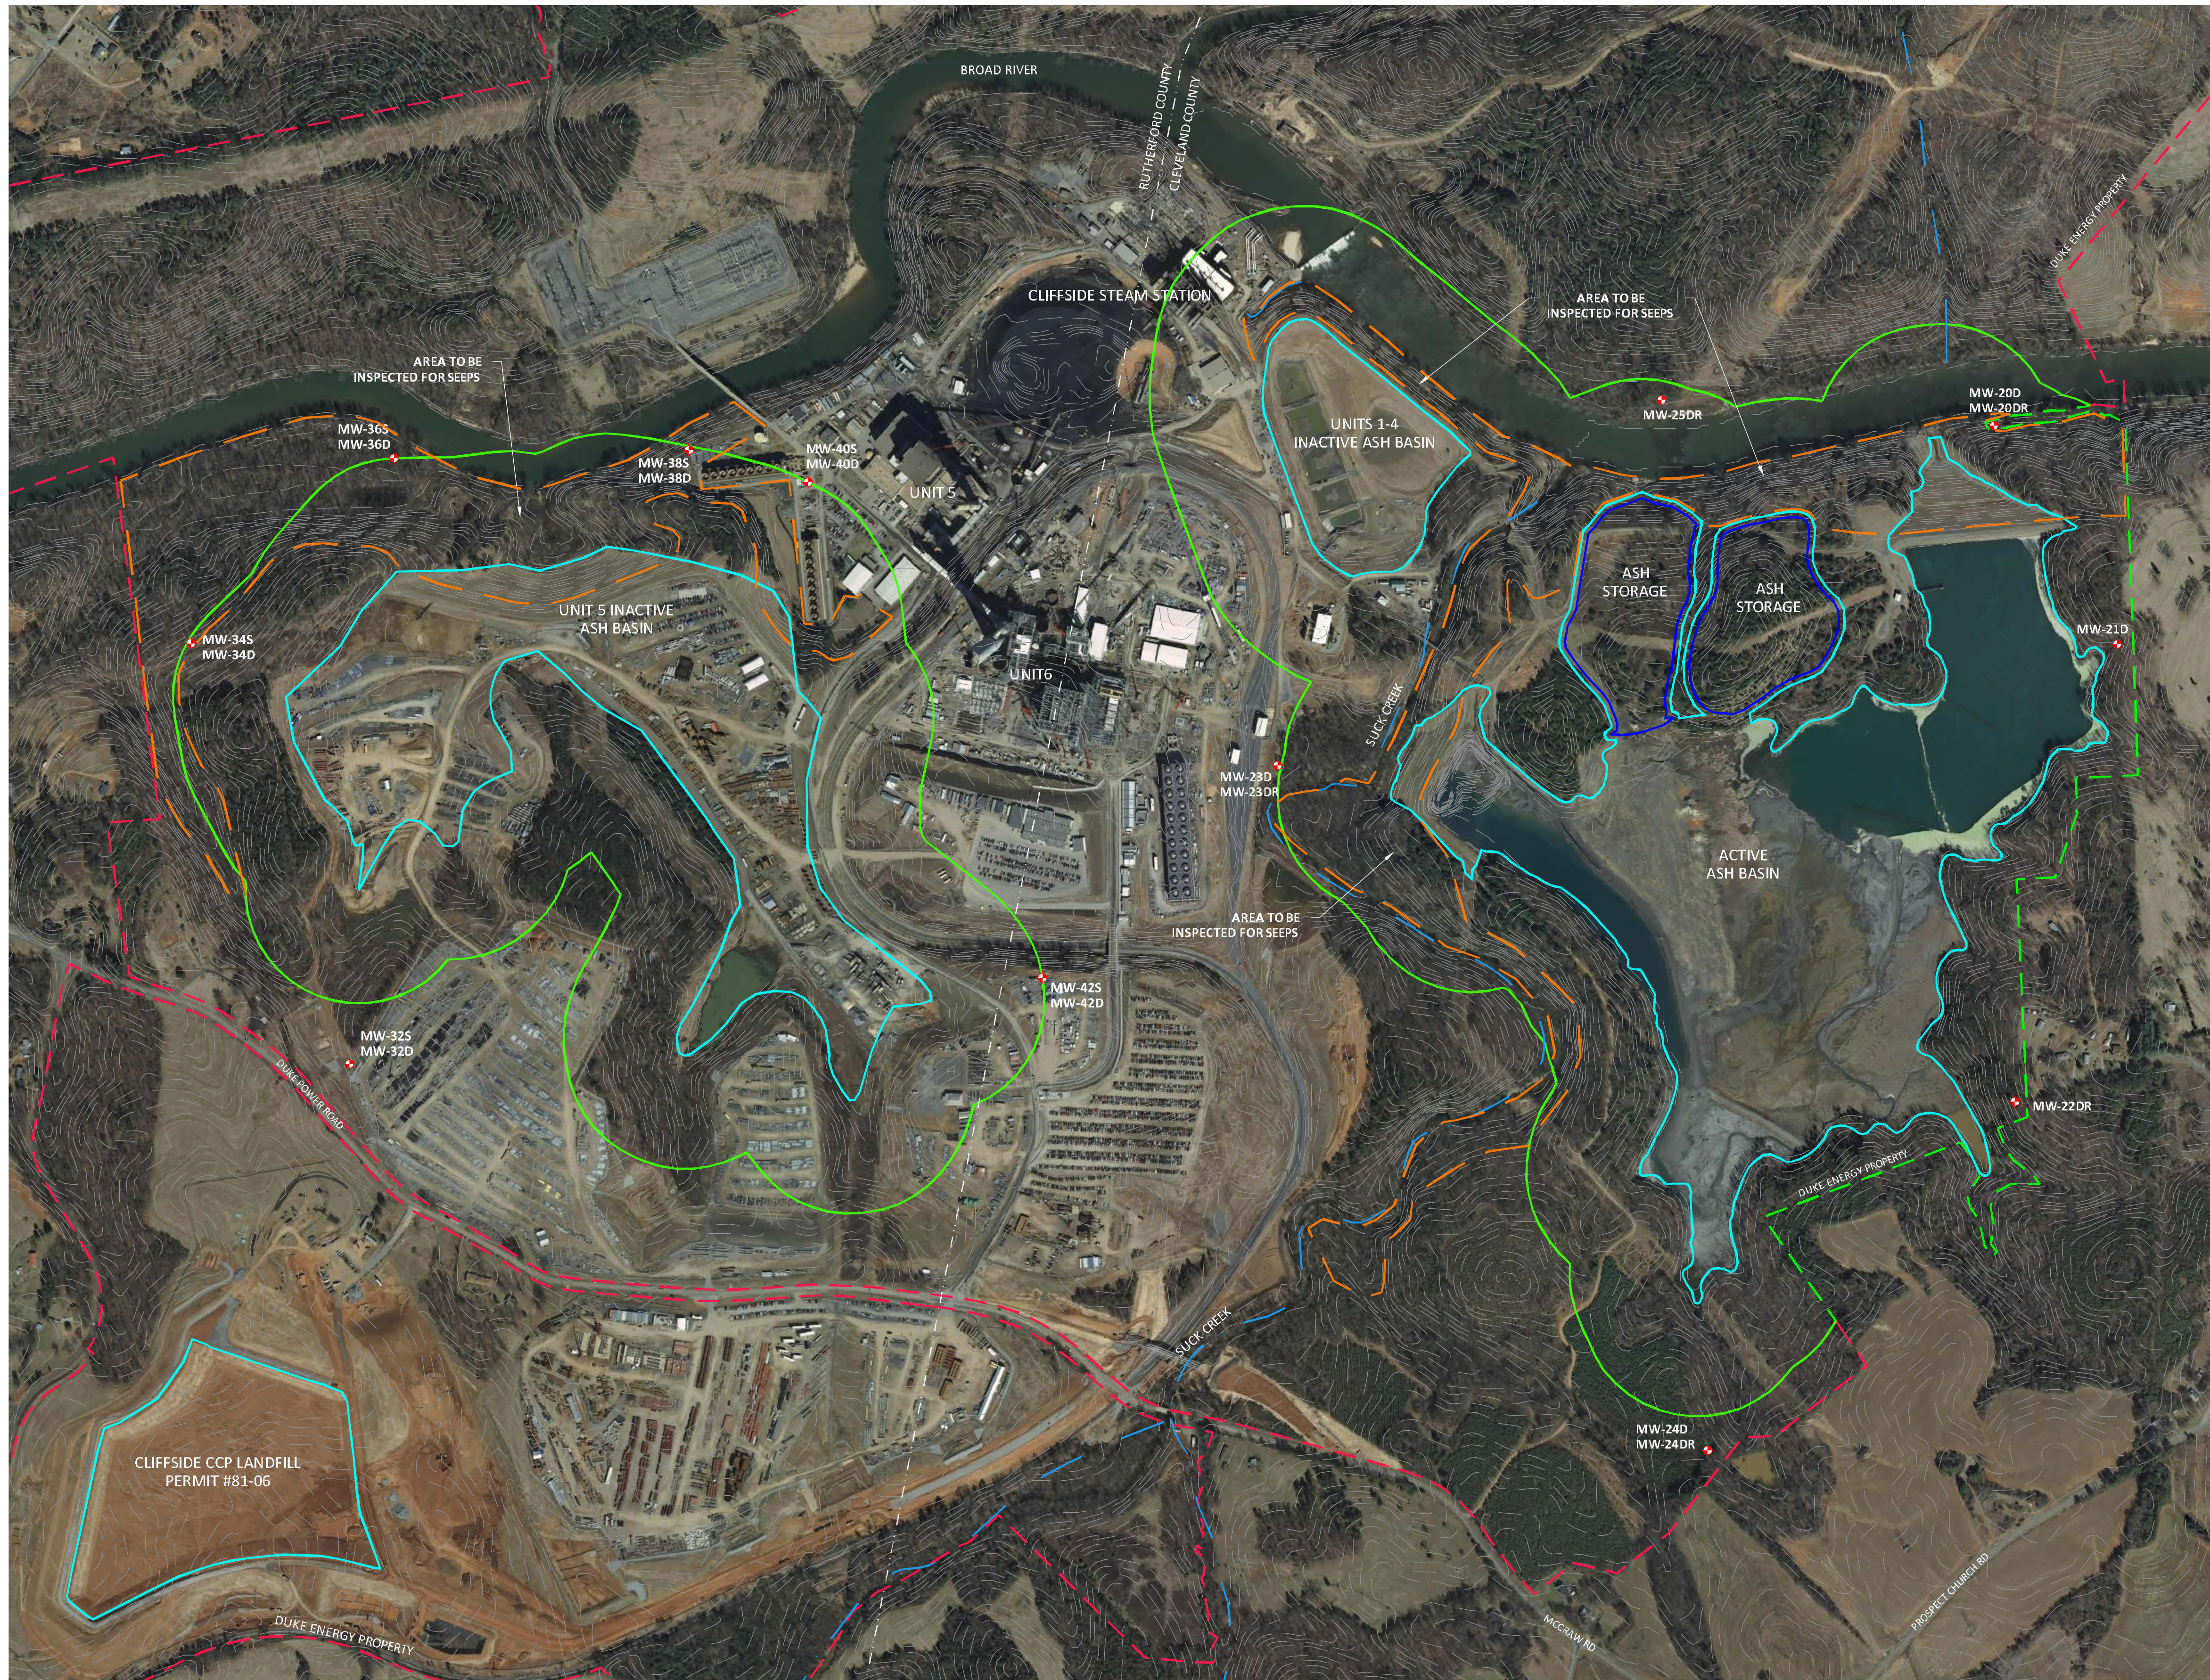
DATE  
 9/30/2014  
 FIGURE  
 2

**AREAS TO BE INSPECTED FOR SEEPS**  
**DUKE ENERGY CAROLINAS, LLC**  
**CLIFFSIDE STEAM STATION ASH BASIN**  
**NPDES PERMIT NO. NC0005088**  
 CLEVELAND COUNTY, NORTH CAROLINA

The active ash basin is located approximately 1,700 feet to the east-southeast of CSS adjacent to the Broad River as shown on Figure 2. The active ash basin is impounded by earthen dikes located between the west portion of the basin and Suck Creek and between the northeast portion of the basin and the Broad River. The approximate maximum pond elevation of the active ash basin is 765 feet.

The Units 1-4 inactive ash basin is located approximately 400 feet to the southeast of the retired Units 1-4 and approximately 1,300 feet to the northeast of Unit 6, adjacent to the Broad River (Figure 2). The Units 1-4 inactive ash basin is impounded by an earthen dike located along the north and northeast sides of the basin. The waste boundary associated with the Units 1-4 inactive ash basin is approximately 14.5 acres in area.

The Unit 5 inactive ash basin is located approximately 1,000 feet to the southwest of Unit 5 and approximately 1,000 feet west of Unit 6, south of the Broad River (Figure 2). The Unit 5 inactive ash basin is impounded by two earthen dikes located along the north and northeast sides of the basin.

The extent of the areas to be inspected was determined based on the generalized LeGrand conceptual model, the concept of the slope-aquifer system, and the site topography. In this generalization, flow of water from the ash basins would be expected to be located within the slope-aquifer compartments and to be below the full pond elevations of the ash basins. The area to be inspected is shown on Figure 2.

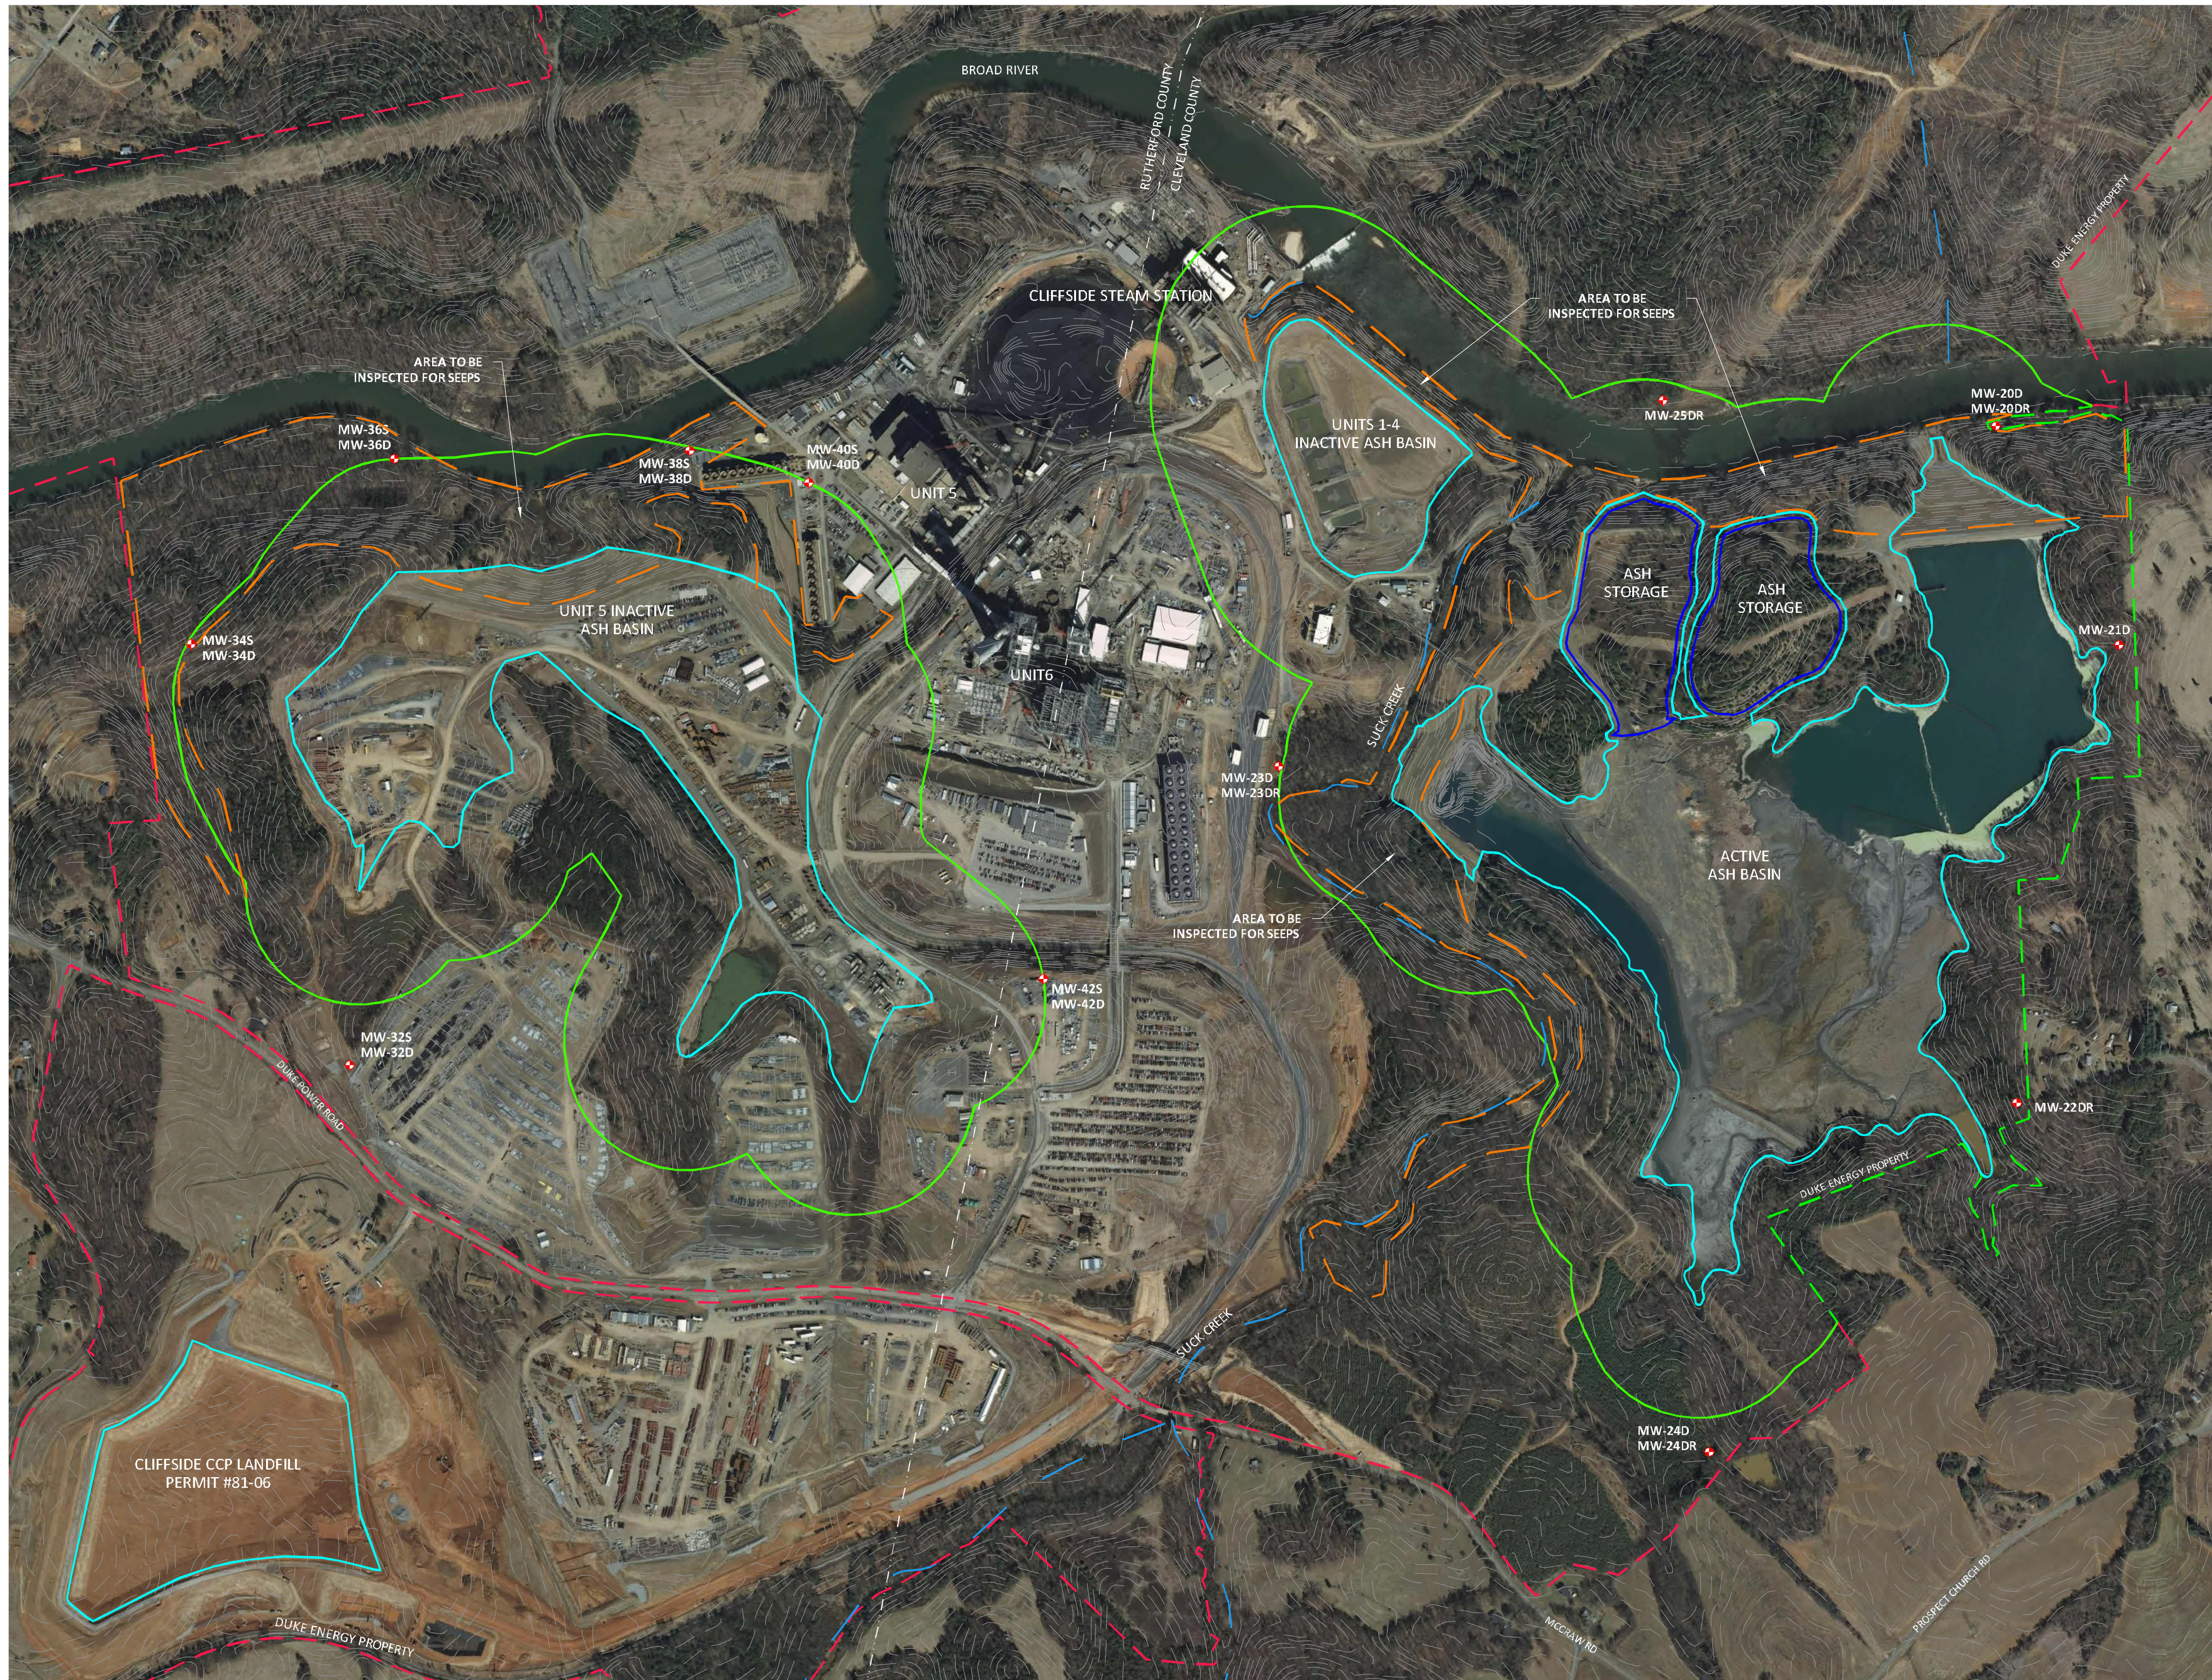
DATE  
 9/30/2014  
 FIGURE  
 A-2

**AREAS TO BE INSPECTED FOR SEEPS**  
**DUKE ENERGY CAROLINAS, LLC**  
**CLIFFSIDE STEAM STATION ASH BASIN**  
**NPDES PERMIT NO. NC0005088**  
 CLEVELAND COUNTY, NORTH CAROLINA
