VII. Potential Locations

A. Literature Review of Existing Terminal Groin Sites

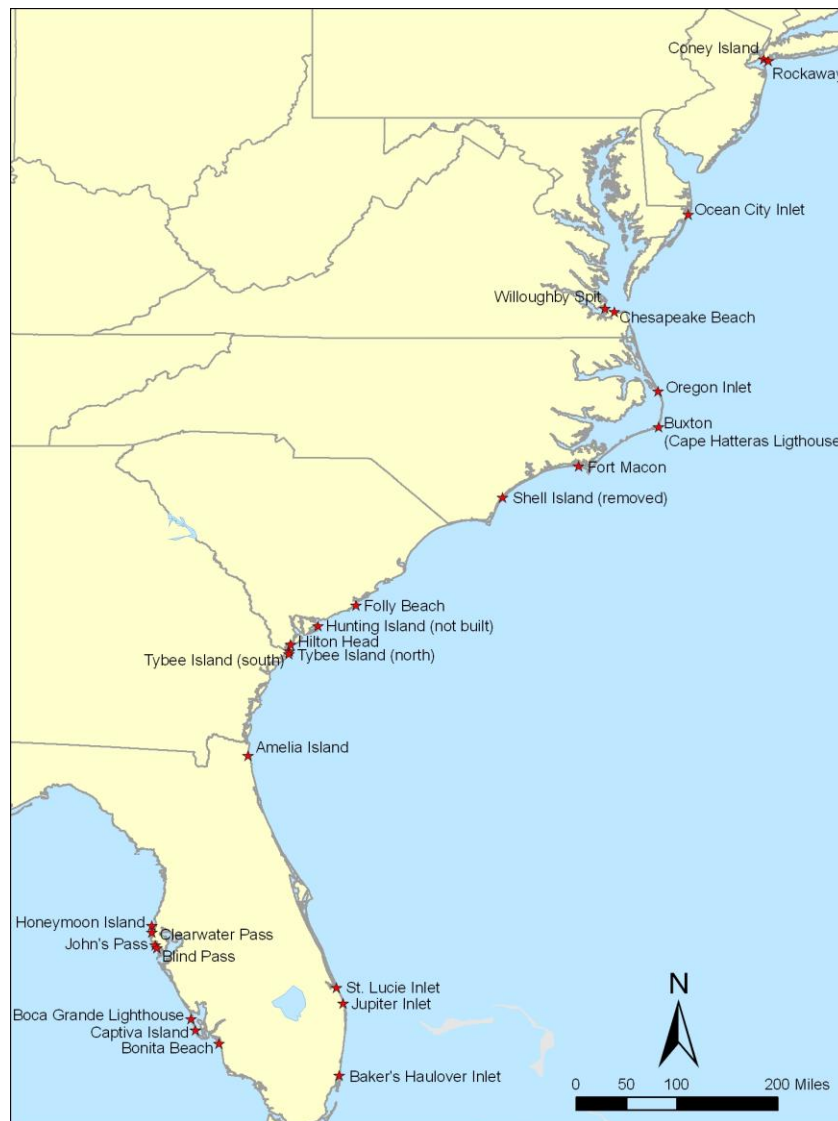
Figure VII-1. Potential Study Sites

One of the first steps completed for this study was the documentation of terminal groin sites along the East and Gulf Coasts (Figure VII-1). After an exhaustive review of the literature and multiple contacts with leading coastal experts, the following list of terminal structures was developed (Table VII-1).
