SEDIMENTS

Newsletter of the North Carolina Sedimentation Control Commission

Monitoring Sediment Export During Construction of the I-40 Bypass in Greensboro

By Dan Line, NCSU Water Quality Group, Department of Biological & Agricultural Engineering, Raleigh, NC

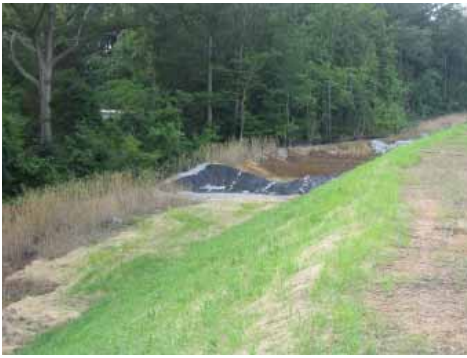
Fig. 2. Highway road bank and example sediment control basin.

The construction contractors, under the supervision of NC DOT, installed many erosion and sediment control measures to reduce sediment export from the highway corridor. These included sediment basins with skimmer (floating pipe to drain the basin from near the top of the water column) outlets and coir baffles, sediment traps, rock dams, accelerated seeding and mulching, slope drains, silt fence, and flocculant applications on selected areas (fig. 2, pg 2). In addition, floating silt or turbidity curtains were installed around the inlets of the two major tributaries to the Sedgefield Lake. These two silt curtains were effective (fig. 3, pg 2) for relatively small storm events occurring shortly after their installation; however, visual observation indicated

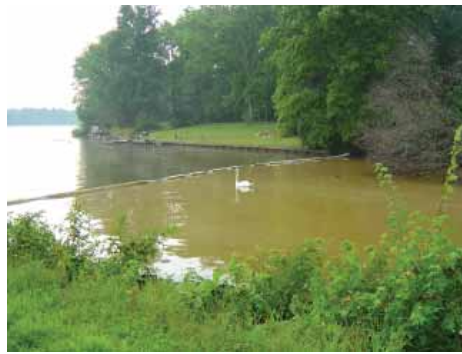
Fig. 3. Sedgefield Lake with turbidity curtain.

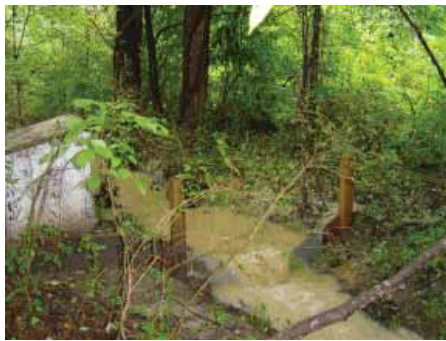
Fig. 4. Ellery-up monitoring station.

The water quality monitoring program consisted of installing 6 continuous monitoring stations: 4 in the Sedgefield Lakes watershed and 2 in the King's Mill watershed. In Sedgefield Lakes two stations, Ellery-up (fig. 4, p.3) and Tilly-up were located on tributary streams immediately downstream of the highway corridor and two stations Ellery-down and Tilly-down were located on the same tributaries just upstream of the lake. For the upstream stations the highway corridor comprised at least 26% of the total drainage with the rest of the area being wooded or residential homes with established lawns and landscape. The intent was that sediment loading to the upstream

Sediment loss rate at the Ellery-up site increased from 0.04 ton/ac-yr before construction to 4.7 ton/ac-yr during construction. This increase was about half that of Tilly-up

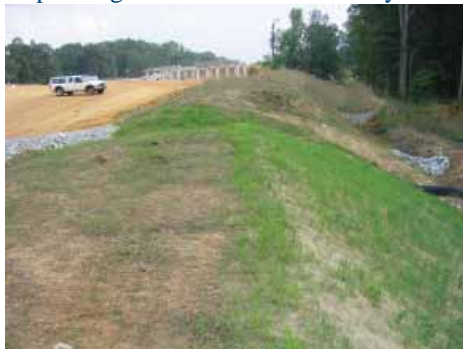
Fig. 5. Road section showing bank created by fill.

This project highlights the difficulty in controlling sediment export resulting from large storm events that occur at time of high erosion vulnerability as was the case for the Tilly-up drainage area. Further, the Tilly-up drainage area included a large fill section of highway, which is particularly susceptible to erosion given the steep roadbanks. The project also documents the rapid drop in sediment export associated with the completion of highway construction. In addition, the continued cooperation and coordination with local residents helped identify and mitigate erosion and sediment control
