North Carolina Department of Environment and Natural Resources  
**Division Energy, Mineral, and Land Resources**  
**Land Quality Section**

Subject: Sedimentation and Erosion Control Local Program Review

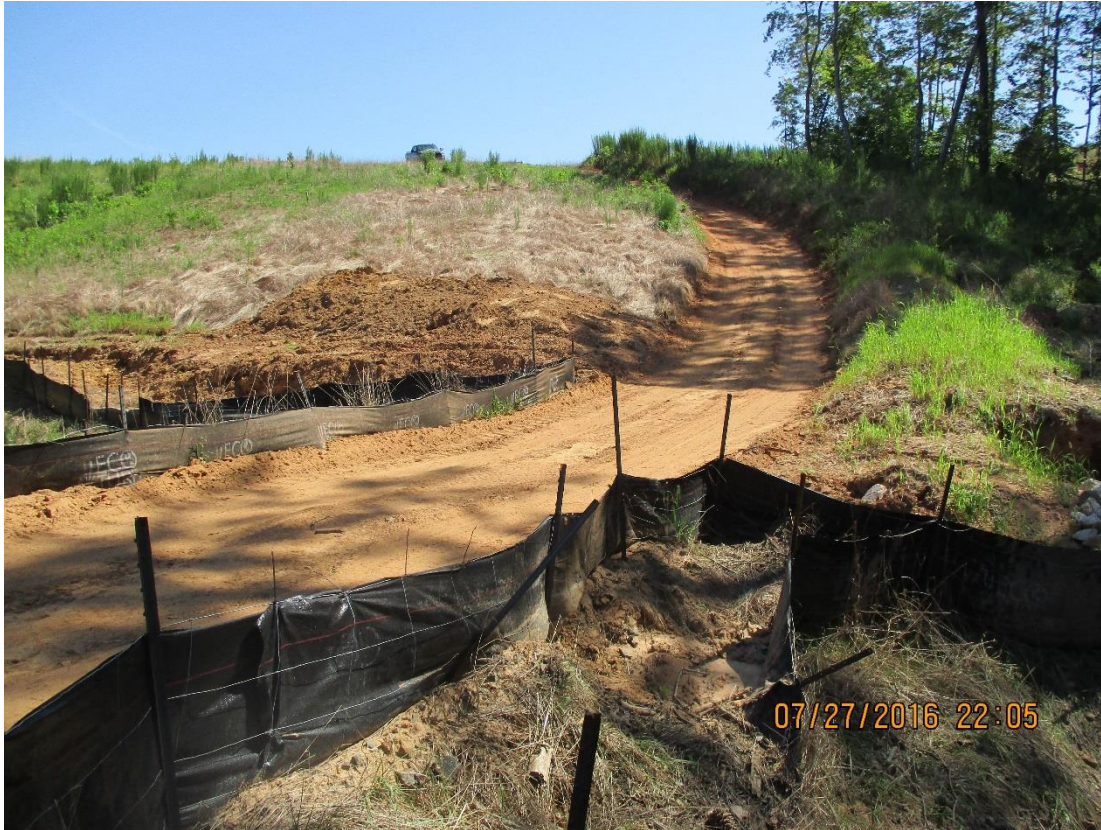
This site is a 150.6 acre residential project. The file for this project did contain adequate documentation. The erosion and sediment control plan was approved and was not adequate. Per our previous review, additional sediment controls needed for site, phased erosion control needed, additional runoff conveyance and basins needed for clearing and grubbing phase, no information shown on the plans for existing streams to be crossed, and no calculations for supporting erosion and sediment control measures. The site was last inspected on 6/21/16 and was found out of compliance. The site was under a Notice of Continuing Violations at time of inspection with DWR, DEMLR, and Durham County. The site was not active at the time of the inspection and was **out** of compliance. The violations found were: failure to follow approved plan, failure to take all reasonable measures, insufficient measures to retain sediment on site, inadequate buffer zone, and failure to maintain erosion control measures.

Site 1 – Stream crossing needs additional upstream runoff conveyance and sediment storage.

Corrective Actions: 1) A revised plan is needed to provide a phased erosion and sediment control plan with additional runoff conveyance and sediment control/storage. Additional conveyances provided should outlet into a sediment basin prior to leaving site. 2) Additional groundcover is needed on site. Repair and stabilize bare and eroded areas around site. 3) Removal of sediment from stream and buffer zones should be accomplished to the satisfaction of DWR. Removal of

offsite sediment. 4) Maintenance and repair of perimeter sediment silt fence and check dams is needed. 5) Continue slope drains to the toe of the slope.

Comments: Provide adequate ground cover on all bare and inactive areas. A revised plan is needed immediately to prevent further offsite deposition to adjacent properties and stream. Additional sediment controls need to be installed immediately to prevent further offsite deposition. Corrective actions have been taken including sediment removal from a stream location. Sub-contractor onsite making repairs during our site visit. This site has a high potential for additional offsite sediment.

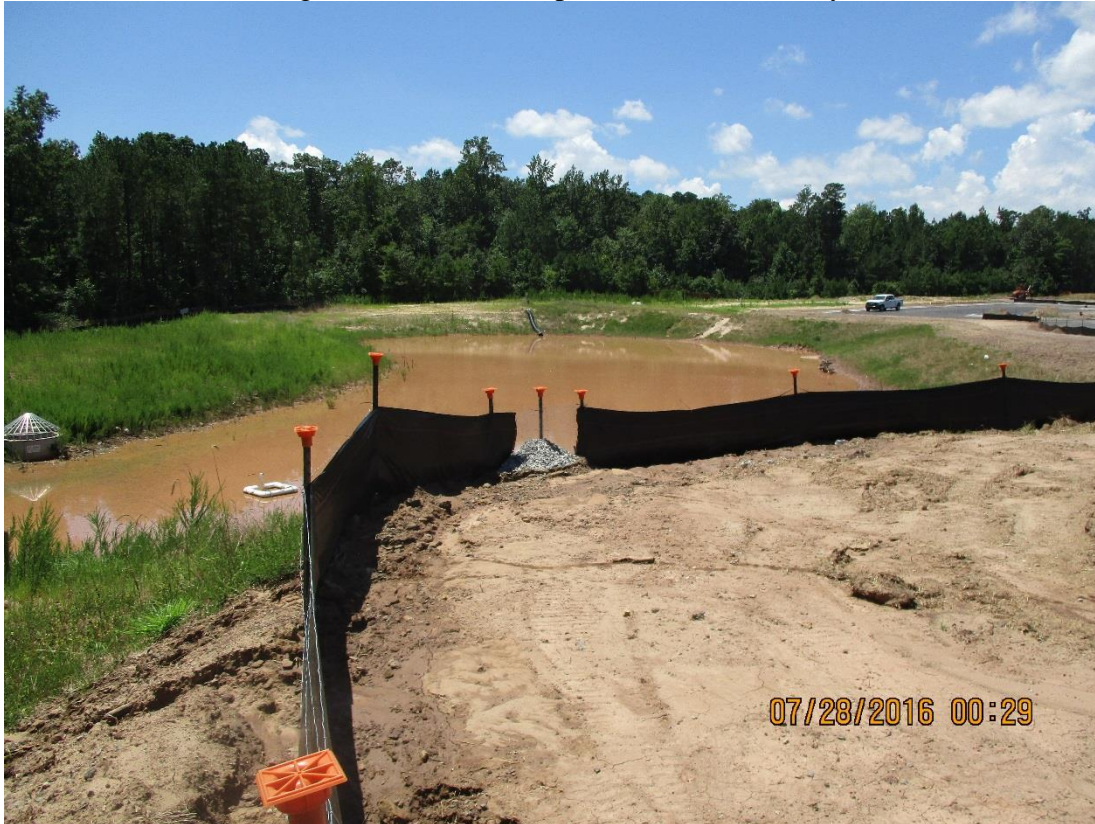
This site is a 31.85 acre commercial project. The file for this project did include adequate documentation. The erosion and sediment control plan was approved and appeared adequate. The last inspection was conducted on 7/25/16 and the site was not in compliance and an NOV was to be drafted based on this inspection. The site has received a Notice of Violations previously. The site was active at the time of the inspection and was **out** of compliance. The violations found were: failure to follow approved plan, insufficient measures to retain sediment on site, failure to take all reasonable measures, and failure to maintain erosion control measures.

Site 2 – Silt fence undermined causing erosion on downstream slope.

Corrective Actions: 1) Maintain and repair silt fence and silt fence outlets and sediment basin located along perimeter of site. Provide check dam type silt fence outlet downstream of sediment basin outlet. 2) Provide groundcover on slopes of sediment basin and other areas on site. 3) Use concrete washout area located onsite. 3) Removal of sediment from stream and buffer zones should be accomplished to the satisfaction of DWR.

Comment: Overseed sparsely vegetated areas. Provide ground cover on all bare and inactive areas.

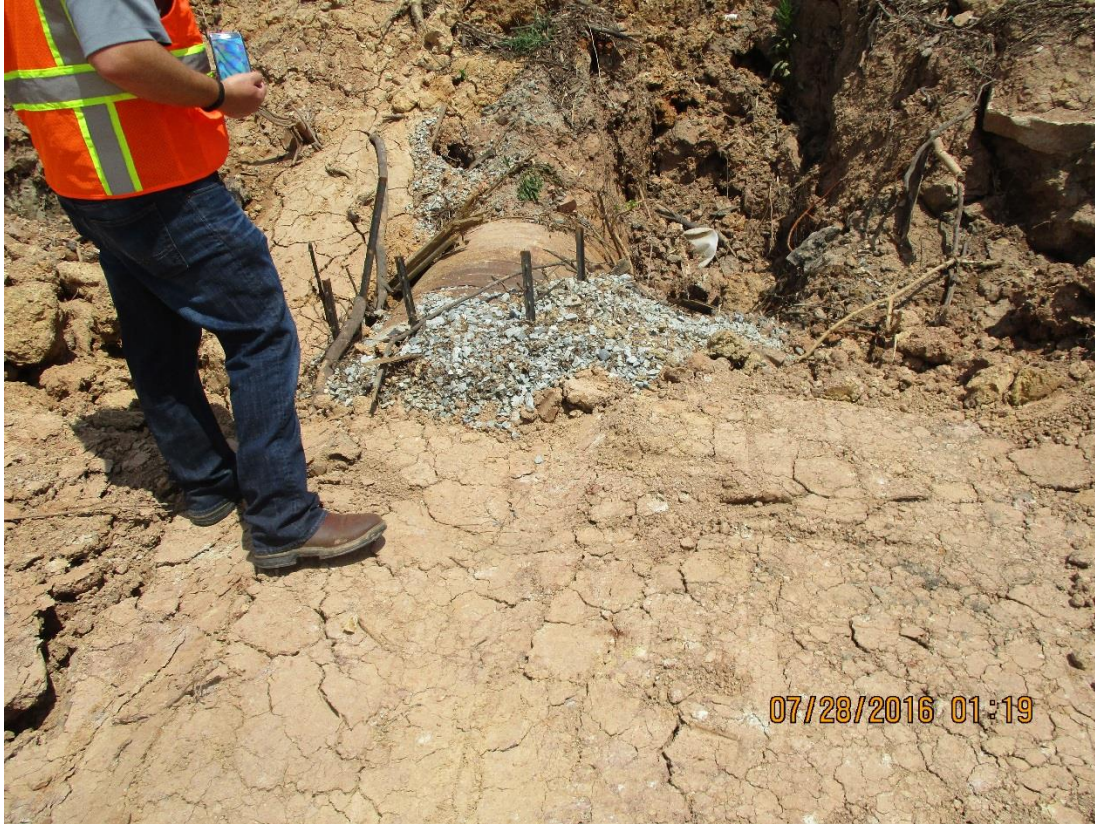
This site is a 4.3 acre commercial project. The file for this project did contain adequate documentation. The erosion and sediment control plan was approved and was adequate. Site has no previous inspections and has not received a Notice of Violations. The site was active at the time of the inspection and was **out** of compliance. The violations found were: failure to follow approved plan, failure to take all reasonable measures, and failure to maintain erosion control measures.

Site 3 – Inlet protection blocked with compacted fill.

Corrective Actions: 1) Install basins and diversions. 2) Install adequate inlet protection.

Comments: Provide adequate ground cover on all bare and inactive areas. Site is denuded. Construction started recently.

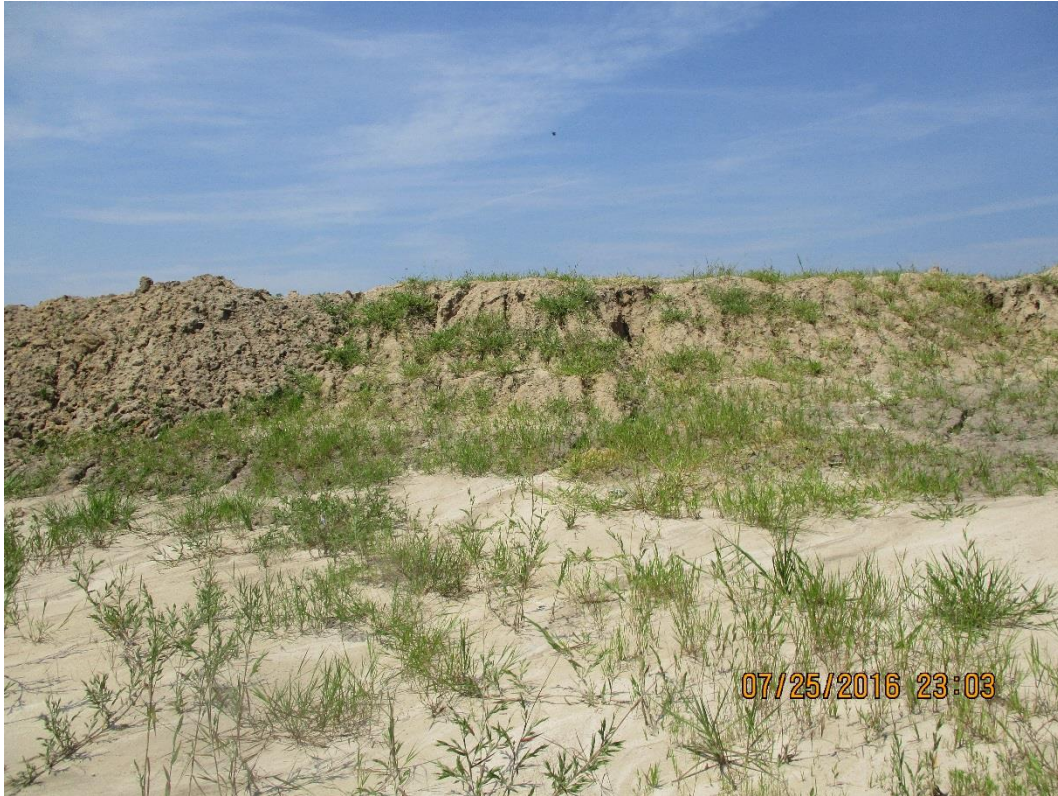
This site is a 19.5 acre multi-family residential project. The file for this project included adequate documentation. The erosion and sediment control plan was approved and was not adequate. Some details were not shown on the drawings for planned sediment and erosion control measures, also NPDES requirements not shown including concrete washout areas, stockpiles, groundcover stabilization timeframes. The last inspection was conducted on 1/27/16 and the site was out of compliance and received a Notice of Violations. The site was active at the time of the inspection and was **out** of compliance. The violations found were: failure to follow approved plan, failure to submit a revised plan, failure to provide groundcover; failure to take all reasonable measures, unprotected exposed slopes, and failure to maintain erosion control measures.

Site 1 – Poor groundcover observed on eroding stockpile areas.

Corrective Actions: 1) Maintain construction entrance, additional clean stone is needed. 2) Provide groundcover on stockpiles. Remove stockpile located within 50 ft of curb or yard inlets. 3) Maintain perimeter silt fence and provide additional silt fence upstream of sediment basin along tree line. 4) Additional clean stone needed at yard inlets, especially in ditch adjacent to construction entrance. 5) Provide revised plan to include concrete washout area and ditch disturbance. 6) Provide copy of NPDES/Self-Inspection records.

Comment: Provide adequate ground cover on all bare and inactive areas. A revised plan is needed to show lined concrete washout with detail. Site has a high potential for offsite sediment.

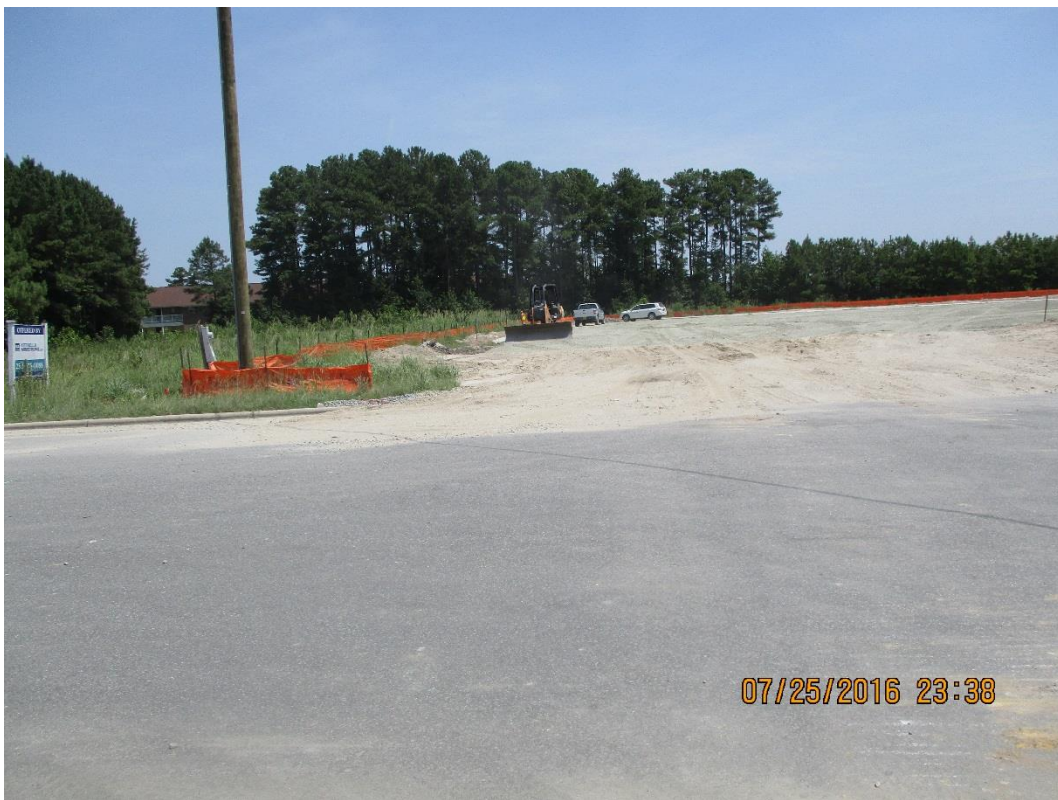
This site is an 8.2 acre commercial project. The file for this project was missing the deed and the easement for utility installation. The erosion and sediment control plan was approved and was adequate. No inspections were documented in the file. The site has not received a Notice of Violations. The site was not active at the time of the inspection and was **in** compliance.

Site 2 – Sediment in street at construction entrance.

Corrective Actions: 1) Maintain and add clean stone at construction entrance and yard inlets. 2) Repair breach in silt fence.

Comments: Provide adequate ground cover on all bare and inactive areas.

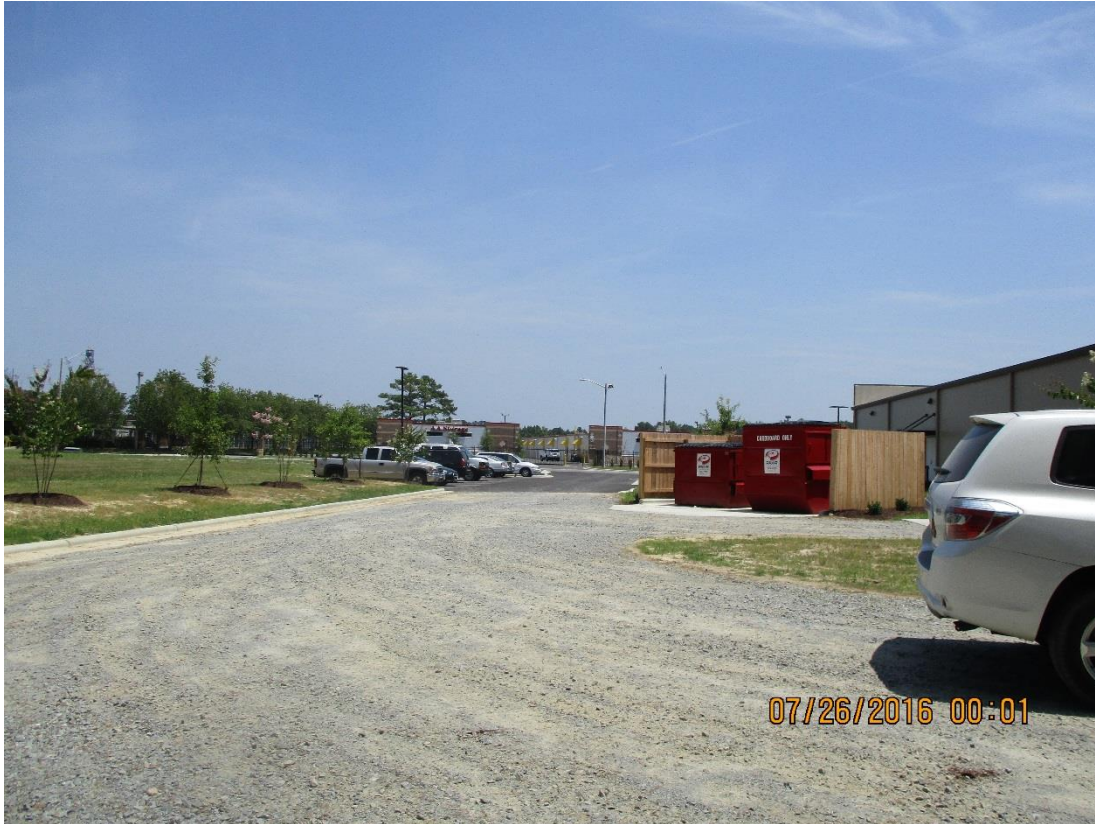
This site is a 1.4 acre commercial project. The file for this project did contain adequate documentation. The erosion and sediment control plan was approved and was adequate. No recent inspections were documented in the file. The site has not received a Notice of Violations. The site was not active at the time of the inspection and was **in** compliance.

Site 3 – Groundcover establishment underway on completed site.

Comments: Project is completed. Continue to overseed sparsely vegetated areas until dense groundcover is achieved.
