*Review of
Erosion and Sedimentation Program
Delegation to the North Carolina Department
Of Transportation, Division of Highways*

February 4, 2016

NCDEQ
*North Carolina Department of Environmental Quality
Division of Energy, Mineral, and Land Resources
Land Quality Section*

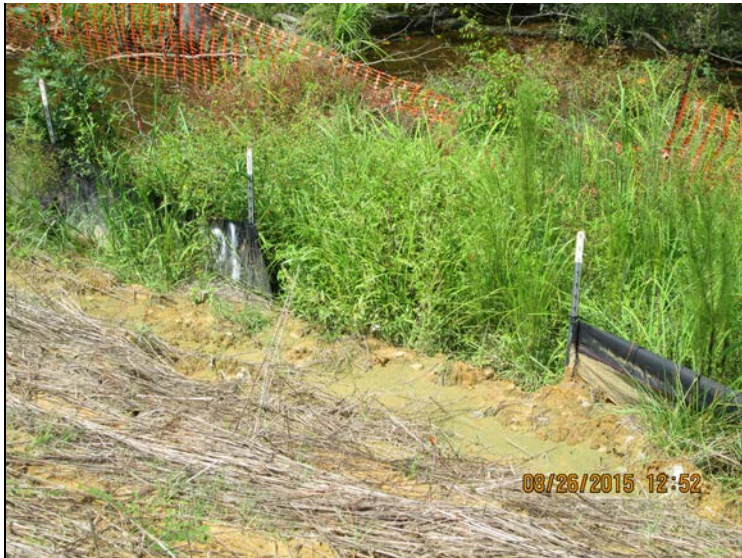
This is a 3.333 mile project with a budget of \$8,614,907.10. This project was approximately 40% complete at the time of inspection. The plan appeared to be adequate and measures were installed; however, maintenance of measures was an issue throughout. Problems were noted with silt fence not being toed in near a jurisdictional stream, silt fence outlets/wattles needing replacement / maintenance, proper installation and maintenance of slope drains and outlets, and stabilization of inactive and bare areas. Records (self-inspections and Roadside Environmental Unit inspection reports) were available for review and were (in general) complete. However, inspections within 24 hours of a ½ inch rain event needed to be performed/documented and all corrective actions taken needed to be documented.

Silt fence outlet needing maintenance (additional wattle(s))

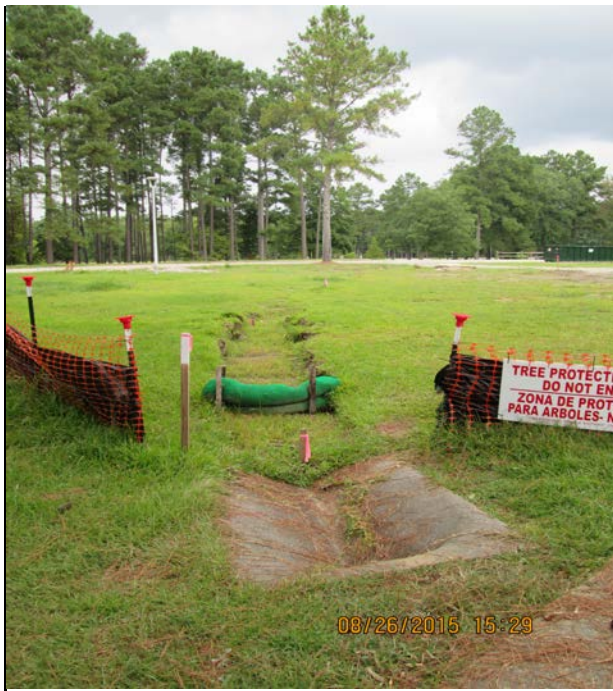
This is was a less than 1 acre vertical construction project (approximately 0.5 miles) with a budget of \$905,711.66 and which had recently begun demolition. Although not required, an E&SC plan was designed and implemented. NPDES requirements did not apply since the site was less than 1 acre. The project was early in construction – adequate erosion and sedimentation control measures had been installed and demolition was ongoing. Recordkeeping for this project was well maintained.

Minor measures needed on a less than 1 acre Rest Area project in Craven County

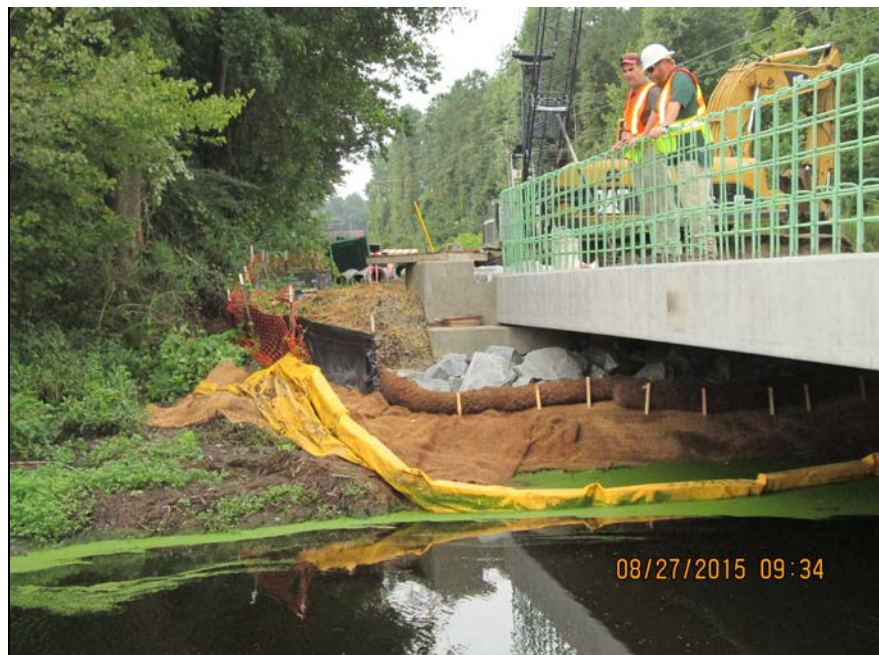
This is a bridge project with a total budget of \$1,004,585.82. This part of the project (Bridge 23) was approximately 85% complete. Bridge 23 is a 0.1 mile project with a budget of \$502,292.91. Construction of Bridge 24 had not yet started. The approved plan appeared adequate and had been implemented properly. Minor field adjustments had been made to the plan and documented properly. Overall, the site appeared well contained and protected. Recordkeeping (self-inspections and Roadside Environmental Unit inspection reports) for this project was very good.

*Silt fence, Matting, Coir
Logs, Riprap, and Turbidity
Curtains being used for
protection during bridge
construction*

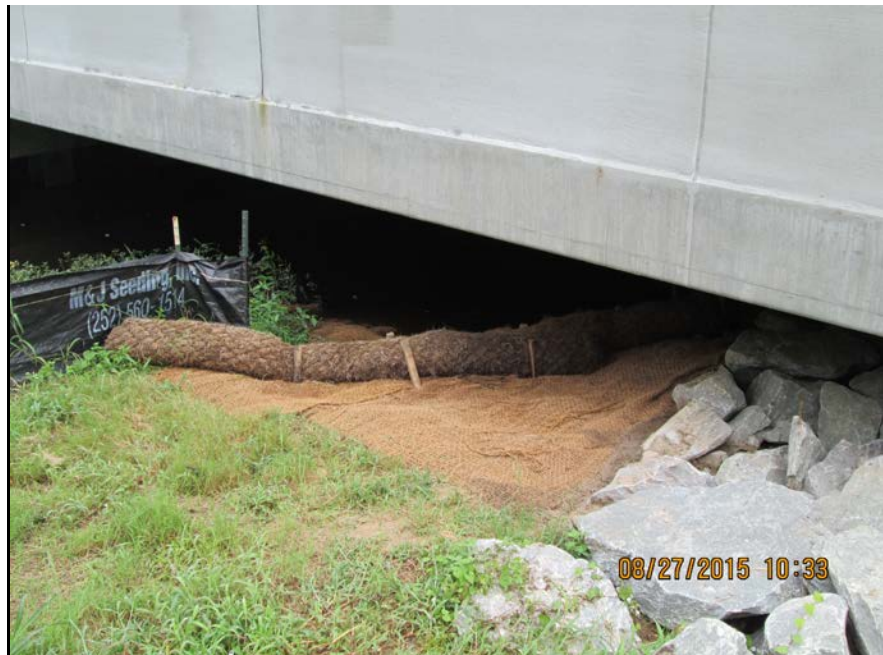
This is a 0.1 mile bridge project with a budget of \$516,800.00. This project was approximately 95% complete and was primarily waiting on the establishment of permanent groundcover. The approved plan appeared adequate and had been implemented properly. It was recommended to add matting under one side of the new bridge. Existing wattles were providing containment and the area had been seeded and mulched with straw. Recordkeeping for this project was well maintained. Minor issues had been noted in the past, but were corrected in a reasonable timeframe and all relevant information was properly documented.

Good efforts at stabilization under one side of the bridge

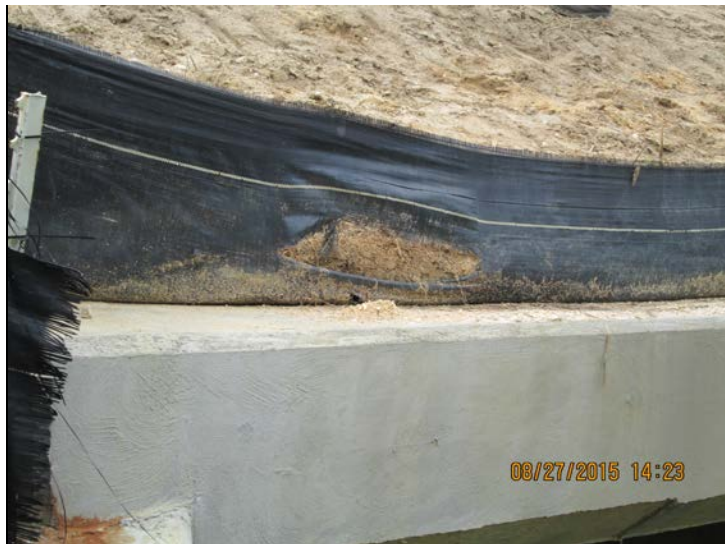
Overall the project appeared to be improved over the previous year's inspection, and no offsite sedimentation was noted. However, there were several areas where maintenance of measures was needed and groundcover had not been established in a timely manner. Several slopes were bare/minimally covered and had developed rills and gullies. As a result, there was a potential for offsite sediment. Recordkeeping for this project was well maintained.

Unmaintained silt fence below bare slope and above stream; High potential for offsite sedimentation

Many of the issues with sites noted on this year's review were the result of inadequate maintenance of measures. DOT should focus on maintenance issues during their regular inspections and make it a priority to obtain compliance from the contractor on this item. Several projects noted maintenance issues repeatedly that were ultimately corrected, but not in a timely manner. If compliance with maintenance requirements is not obtained within a reasonable timeframe, then DOT should consider using other tools, including the issuance of ICAs, in order to gain compliance.

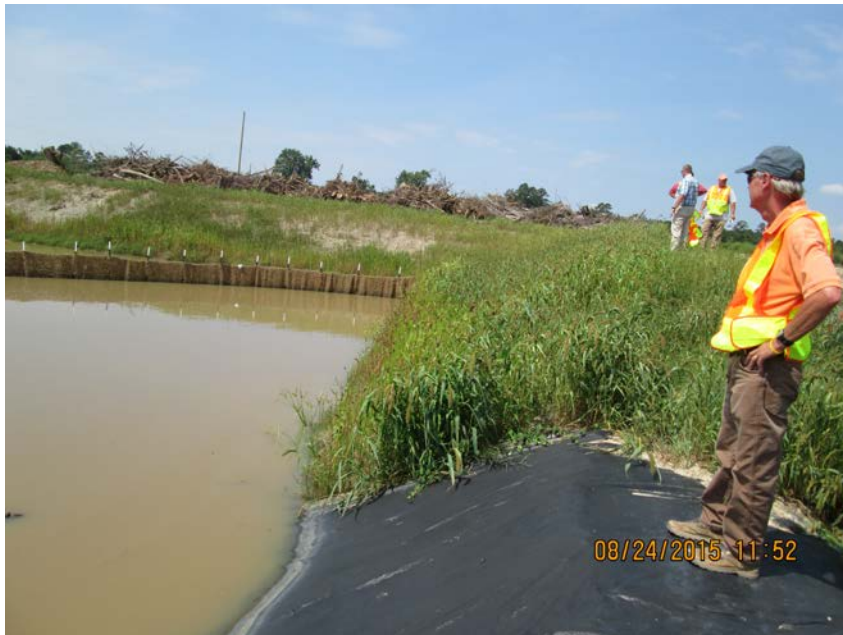
Temporary groundcover establishment is underway on this newly constructed temporary skimmer basin.

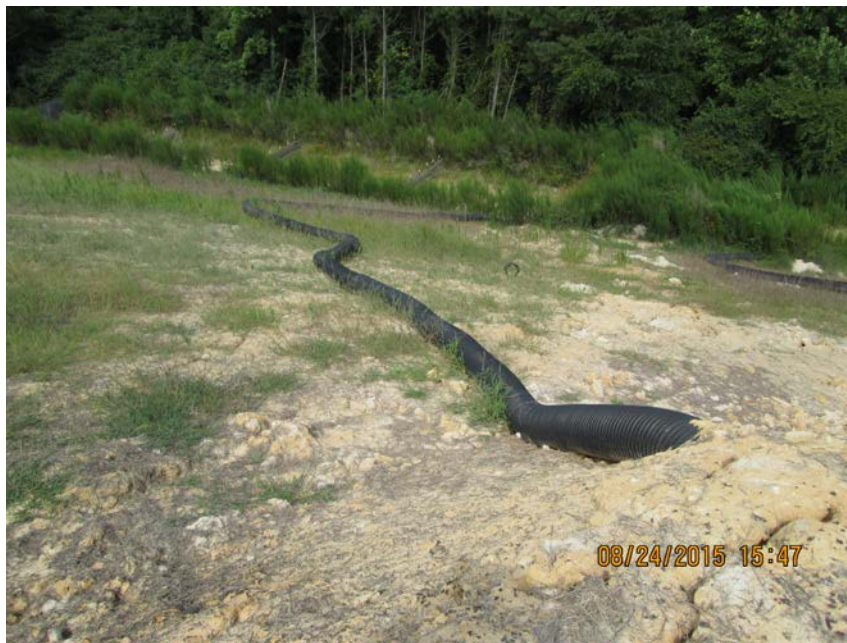
This is a 12.5 mile road project with a budget of \$104,414,724.30. This project was about 82% complete. The approved plan appeared to be adequate and was properly implemented. Revisions were made to the plan that required approval from Roadside Environmental Unit prior to our site visit. This plan has been revised 7 times throughout construction. An Immediate Corrective Action (ICA) was issued for this project that was not inspected by the Washington Regional Office. Maintenance and groundcover were needed throughout site. Several stockpiles were located temporarily by yard inlets within the construction corridor. The recordkeeping via self-inspections for this project was not good. The Roadside Environmental Unit inspection reports for this project were good.

Temporary slope drain was not anchored well and the joints leaked contributed to deposition at the silt fence.

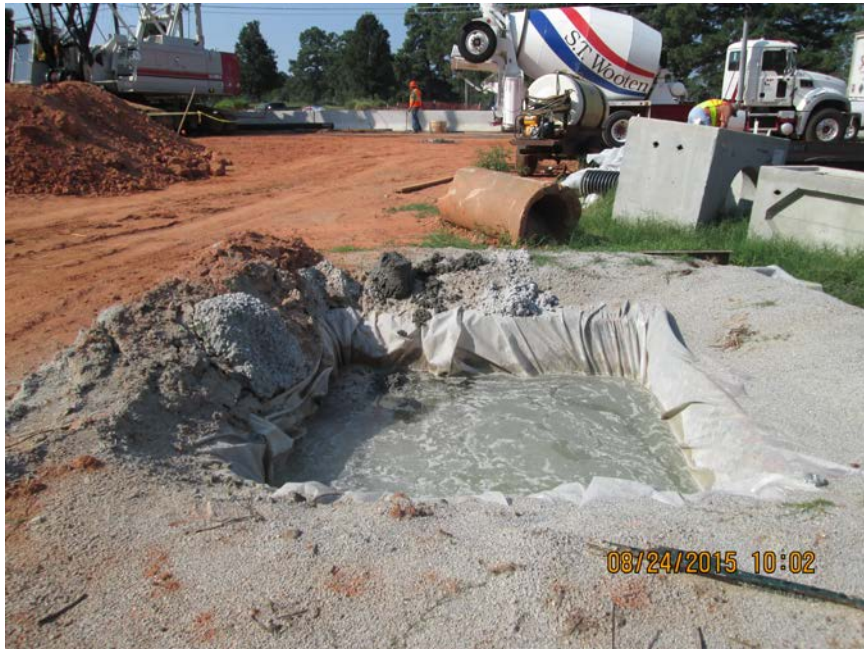
Designated concrete washout area near bridge where contractor is actively working.

Improvement in the installation of concrete washouts onsite was noted throughout this year's review. However, DOT staff and contractors need to be reminded to use the washouts – there were several instances of improperly installed, maintained, or used concrete washout pits during this review. DOT is actively working toward finding solutions to some of their more difficult concrete projects. They have identified possible alternative designs for concrete washouts and are seeking approval from the Stormwater program.

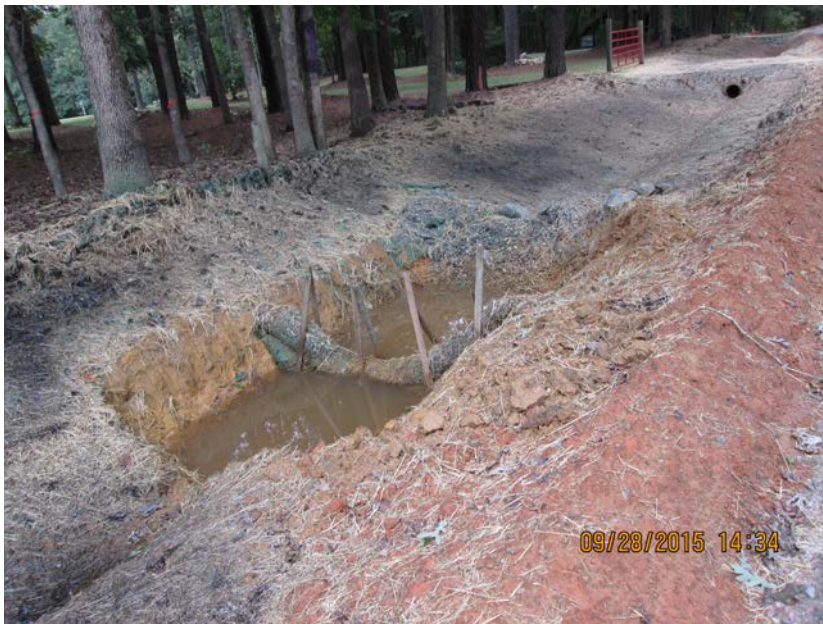
Smaller Sediment control measures such as this Silt Basin type B prove to be effective on linear project as shown here where it contained the previous day's rainfall event.

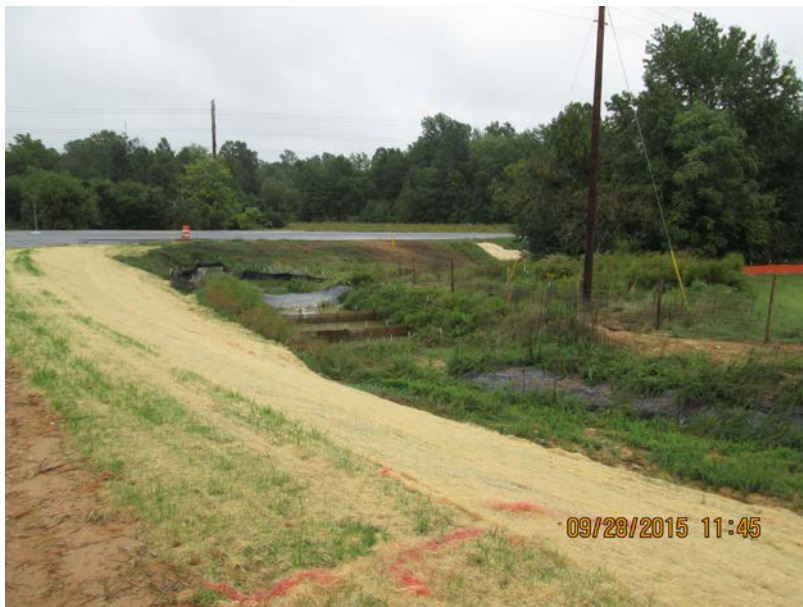
Great use of rolled erosion control product and groundcover in the construction corridor.

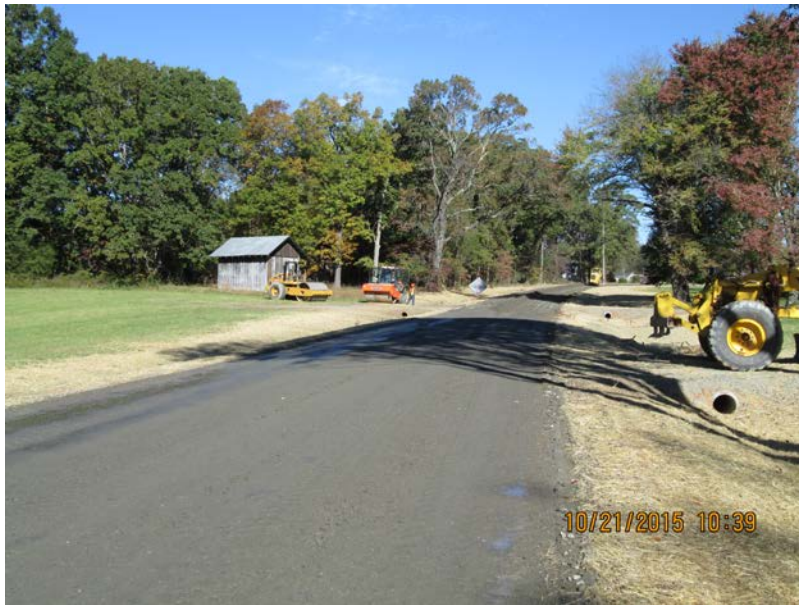
This is a 1.6 mile maintenance project with a budget of \$650,000.00, which was approximately 90% complete at the time of inspection. This project was a good example of phased construction done properly – one section was cleared and grubbed, graded, and stabilized prior to the next section being opened up. The site was originally a dirt road which was being upgraded to a paved road. The plan was adequate and properly implemented; minor field adjustments had been made to the plan to add additional measures where needed. In many areas, DOT had enough right of way (60 feet) that the existing ditchline did not have to be disturbed. Recordkeeping (self-inspections and Roadside Environmental Unit inspection reports) for this project was excellent.

Phased Construction on a Road Maintenance Project, Guilford County

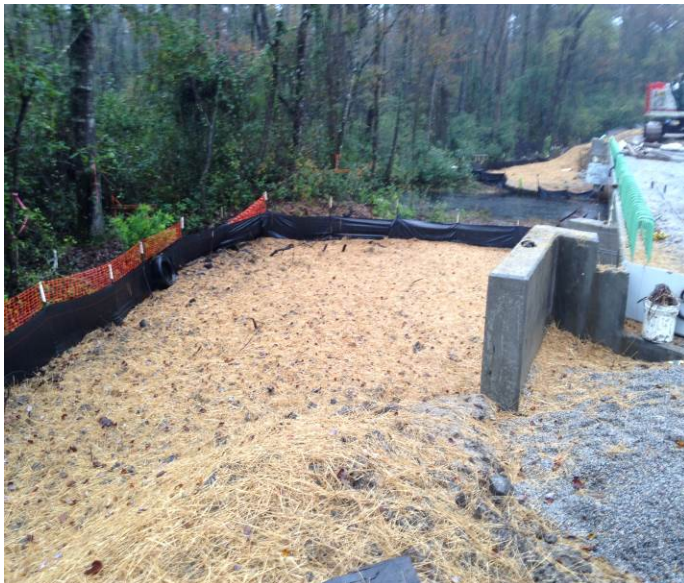
Stabilized area along wingwall, left

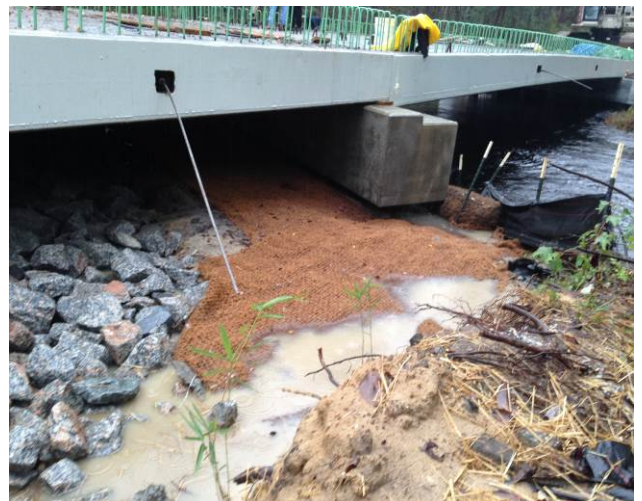
Slope protected with coir fiber matting and wattles, below

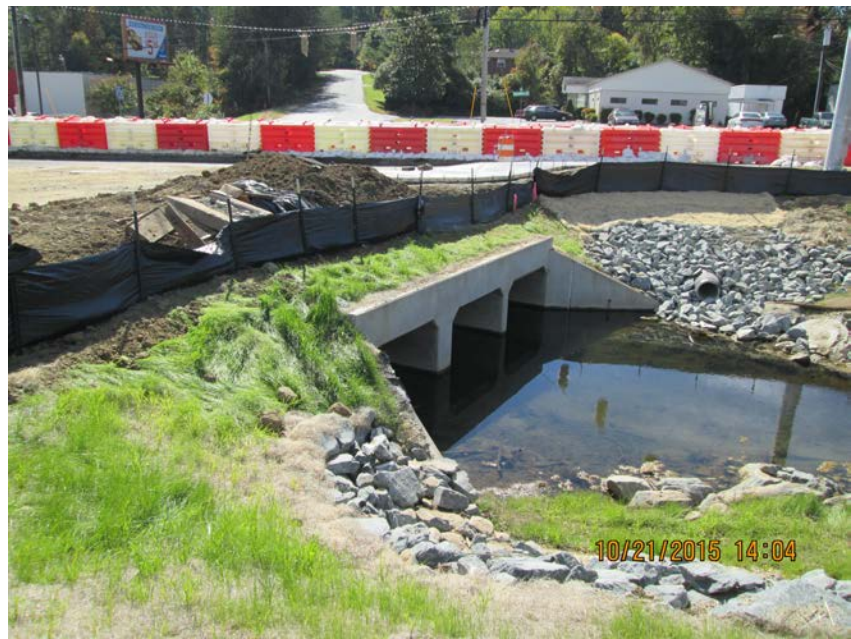
This is a 0.1 mile safety improvement project with a budget of \$782,588.60 and was approximately 80% complete at the time of inspection. This project involved a culvert extension, curb and gutter construction, grading work, and the removal of an existing culvert on the abandoned alignment. The plan was adequate and properly implemented, although minor silt fence maintenance was needed in a few areas. It was suggested to place a wattle perpendicular to the silt fence at the private driveway at the end of each workday. In addition, concrete was being washed out in a designated area but a lined pit was needed. Contaminated soil from a known (old) gas station had been stockpiled and covered appropriately. Recordkeeping (self-inspections and Roadside Environmental Unit inspection reports) for this project was adequate.

Culvert work at Reynolda Road/Winona Street project, Forsyth County

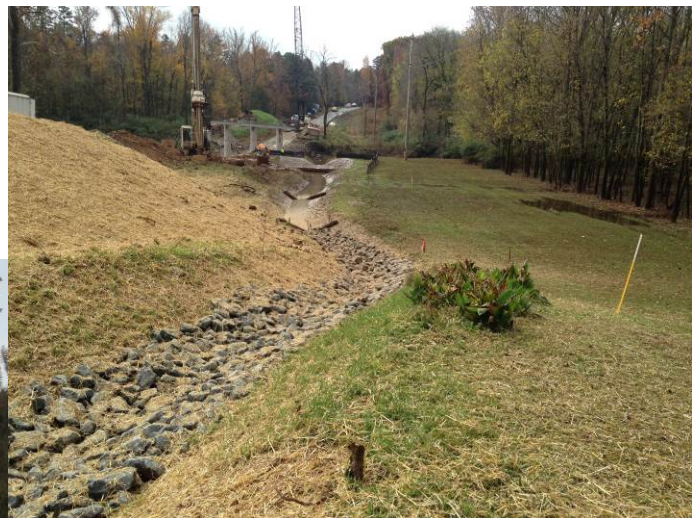
Temporary silt ditch lined with riprap and wattles, right

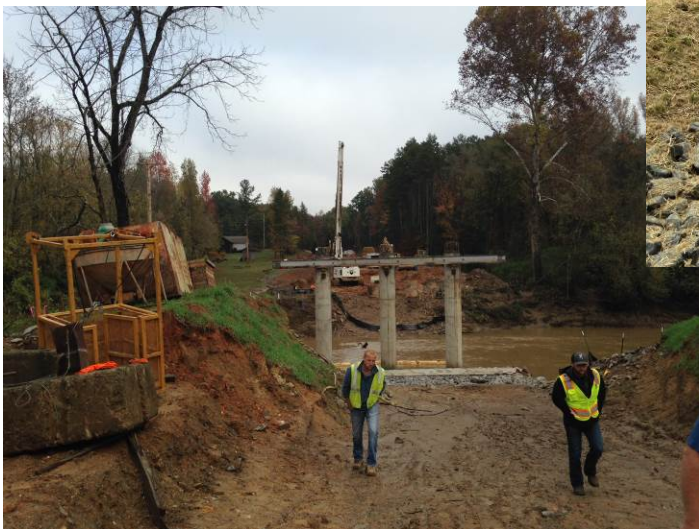
Bridge approach leading to Rocky River, below

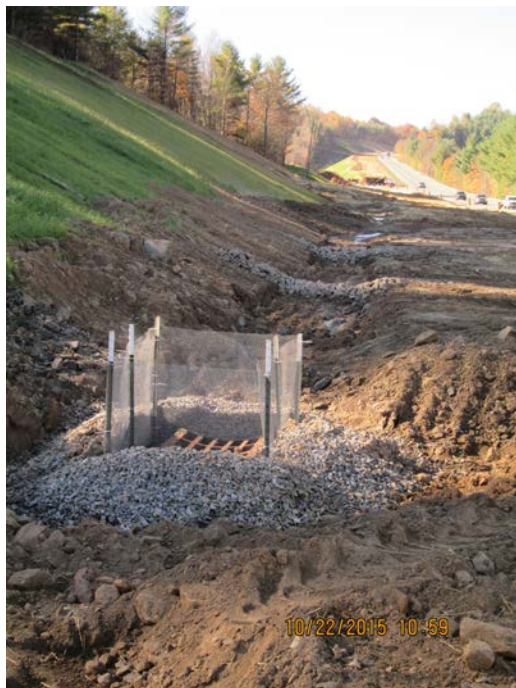
Measures in ditchline, left

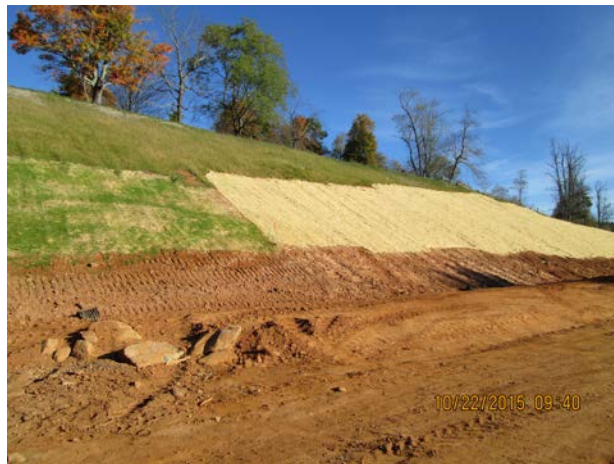
*Stabilization of slopes,
below*

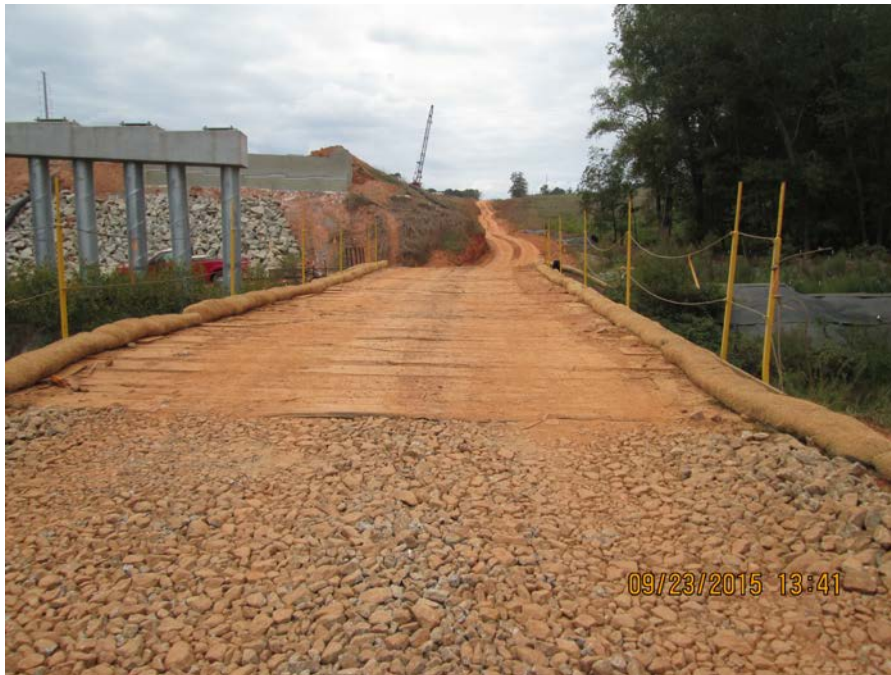
Innovative stream crossing with riprap approaches, geotextile underlayment, and wattles to minimize deposition from the sides.

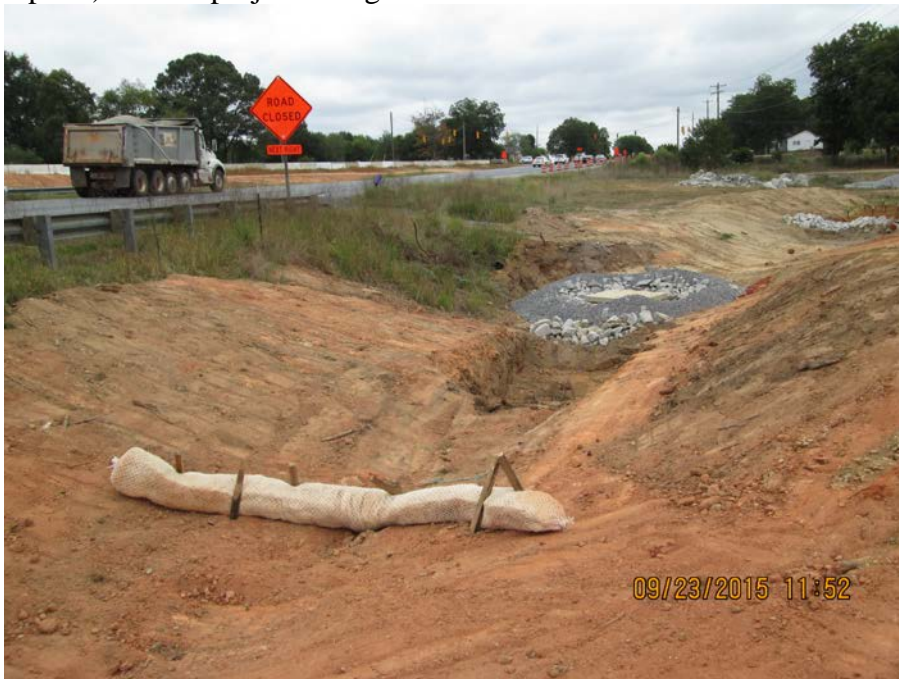
Installation of inline sediment and erosion control measures under way.

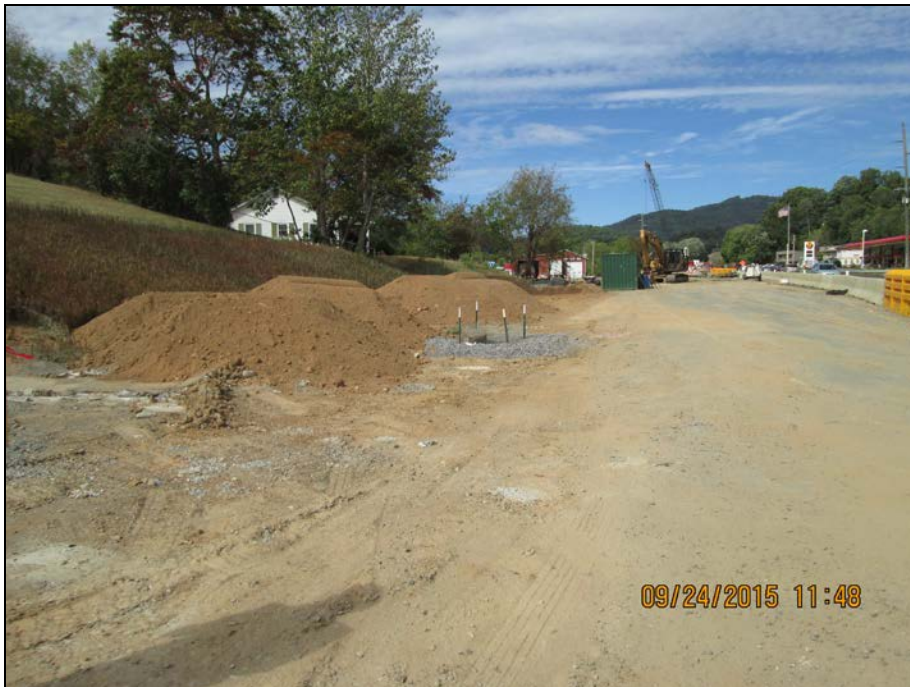
This is part of an 11.92 mile project with a budget of \$41,527,279.98. This project was approximately 70% complete and began in 2012. The plan approved was under the previous NCG01000. The approved plan appeared to be adequate and was properly implemented. Minor field adjustments were made to the plan and documented properly. Smaller soil stockpiles were being placed within 50 feet of yard/curb inlets. Great containment of sedimentation bag for stream pump around operation. Overall the disturbed area was adequately maintained and the recordkeeping (self-inspections and Roadside Environmental Unit inspection reports) for this project was good.

Several stockpiles were located less than 50 ft from surface inlets.

Good site management can increase the potential for success of erosion and sedimentation control. Several sites had issues with stockpiles being placed (for over 24 hours) along inadequately protected inlets without additional erosion and sedimentation control measures. Relying on one downstream measure to protect the site is not always sound practice. In the case of the Goldsboro Bypass project, the Roadside Environmental Unit inspector had noted concerns about these stockpiles and requested corrective actions be taken by the contractor to minimize this sedimentation potential. During our initial inspection, staff noted the same issues. In addition, inlet protections called for on the plan were not installed, and one of the basins being relied upon as the sole protection had already been converted to a stormwater pond and was no longer functioning as an erosion and sedimentation control basin.

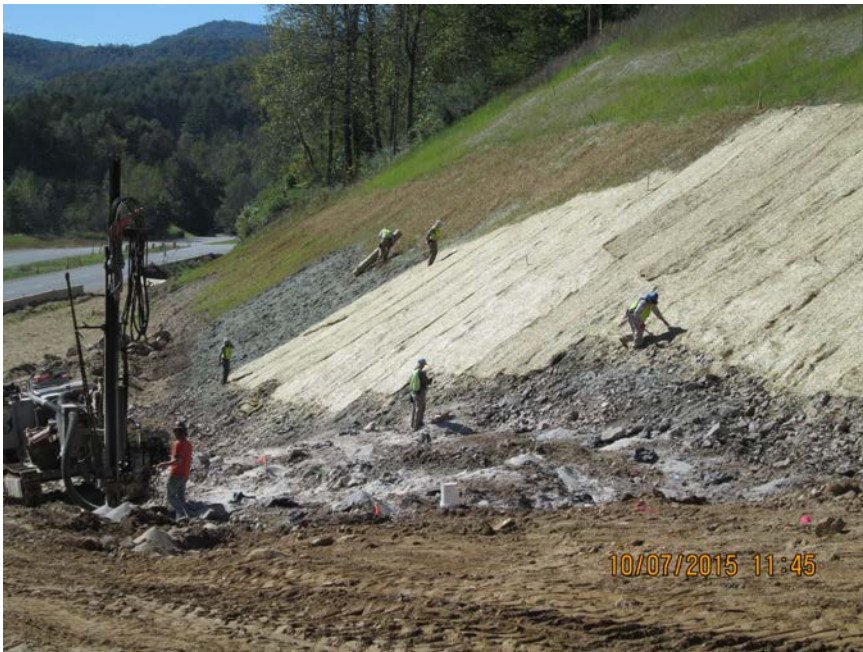
*Slope Stabilization
Efforts Underway*
