Asheville Steam Electric Plant Ash Basin

# Topographic Map and Discharge Assessment Plan

NPDES Permit NC0000396

December 30, 2014

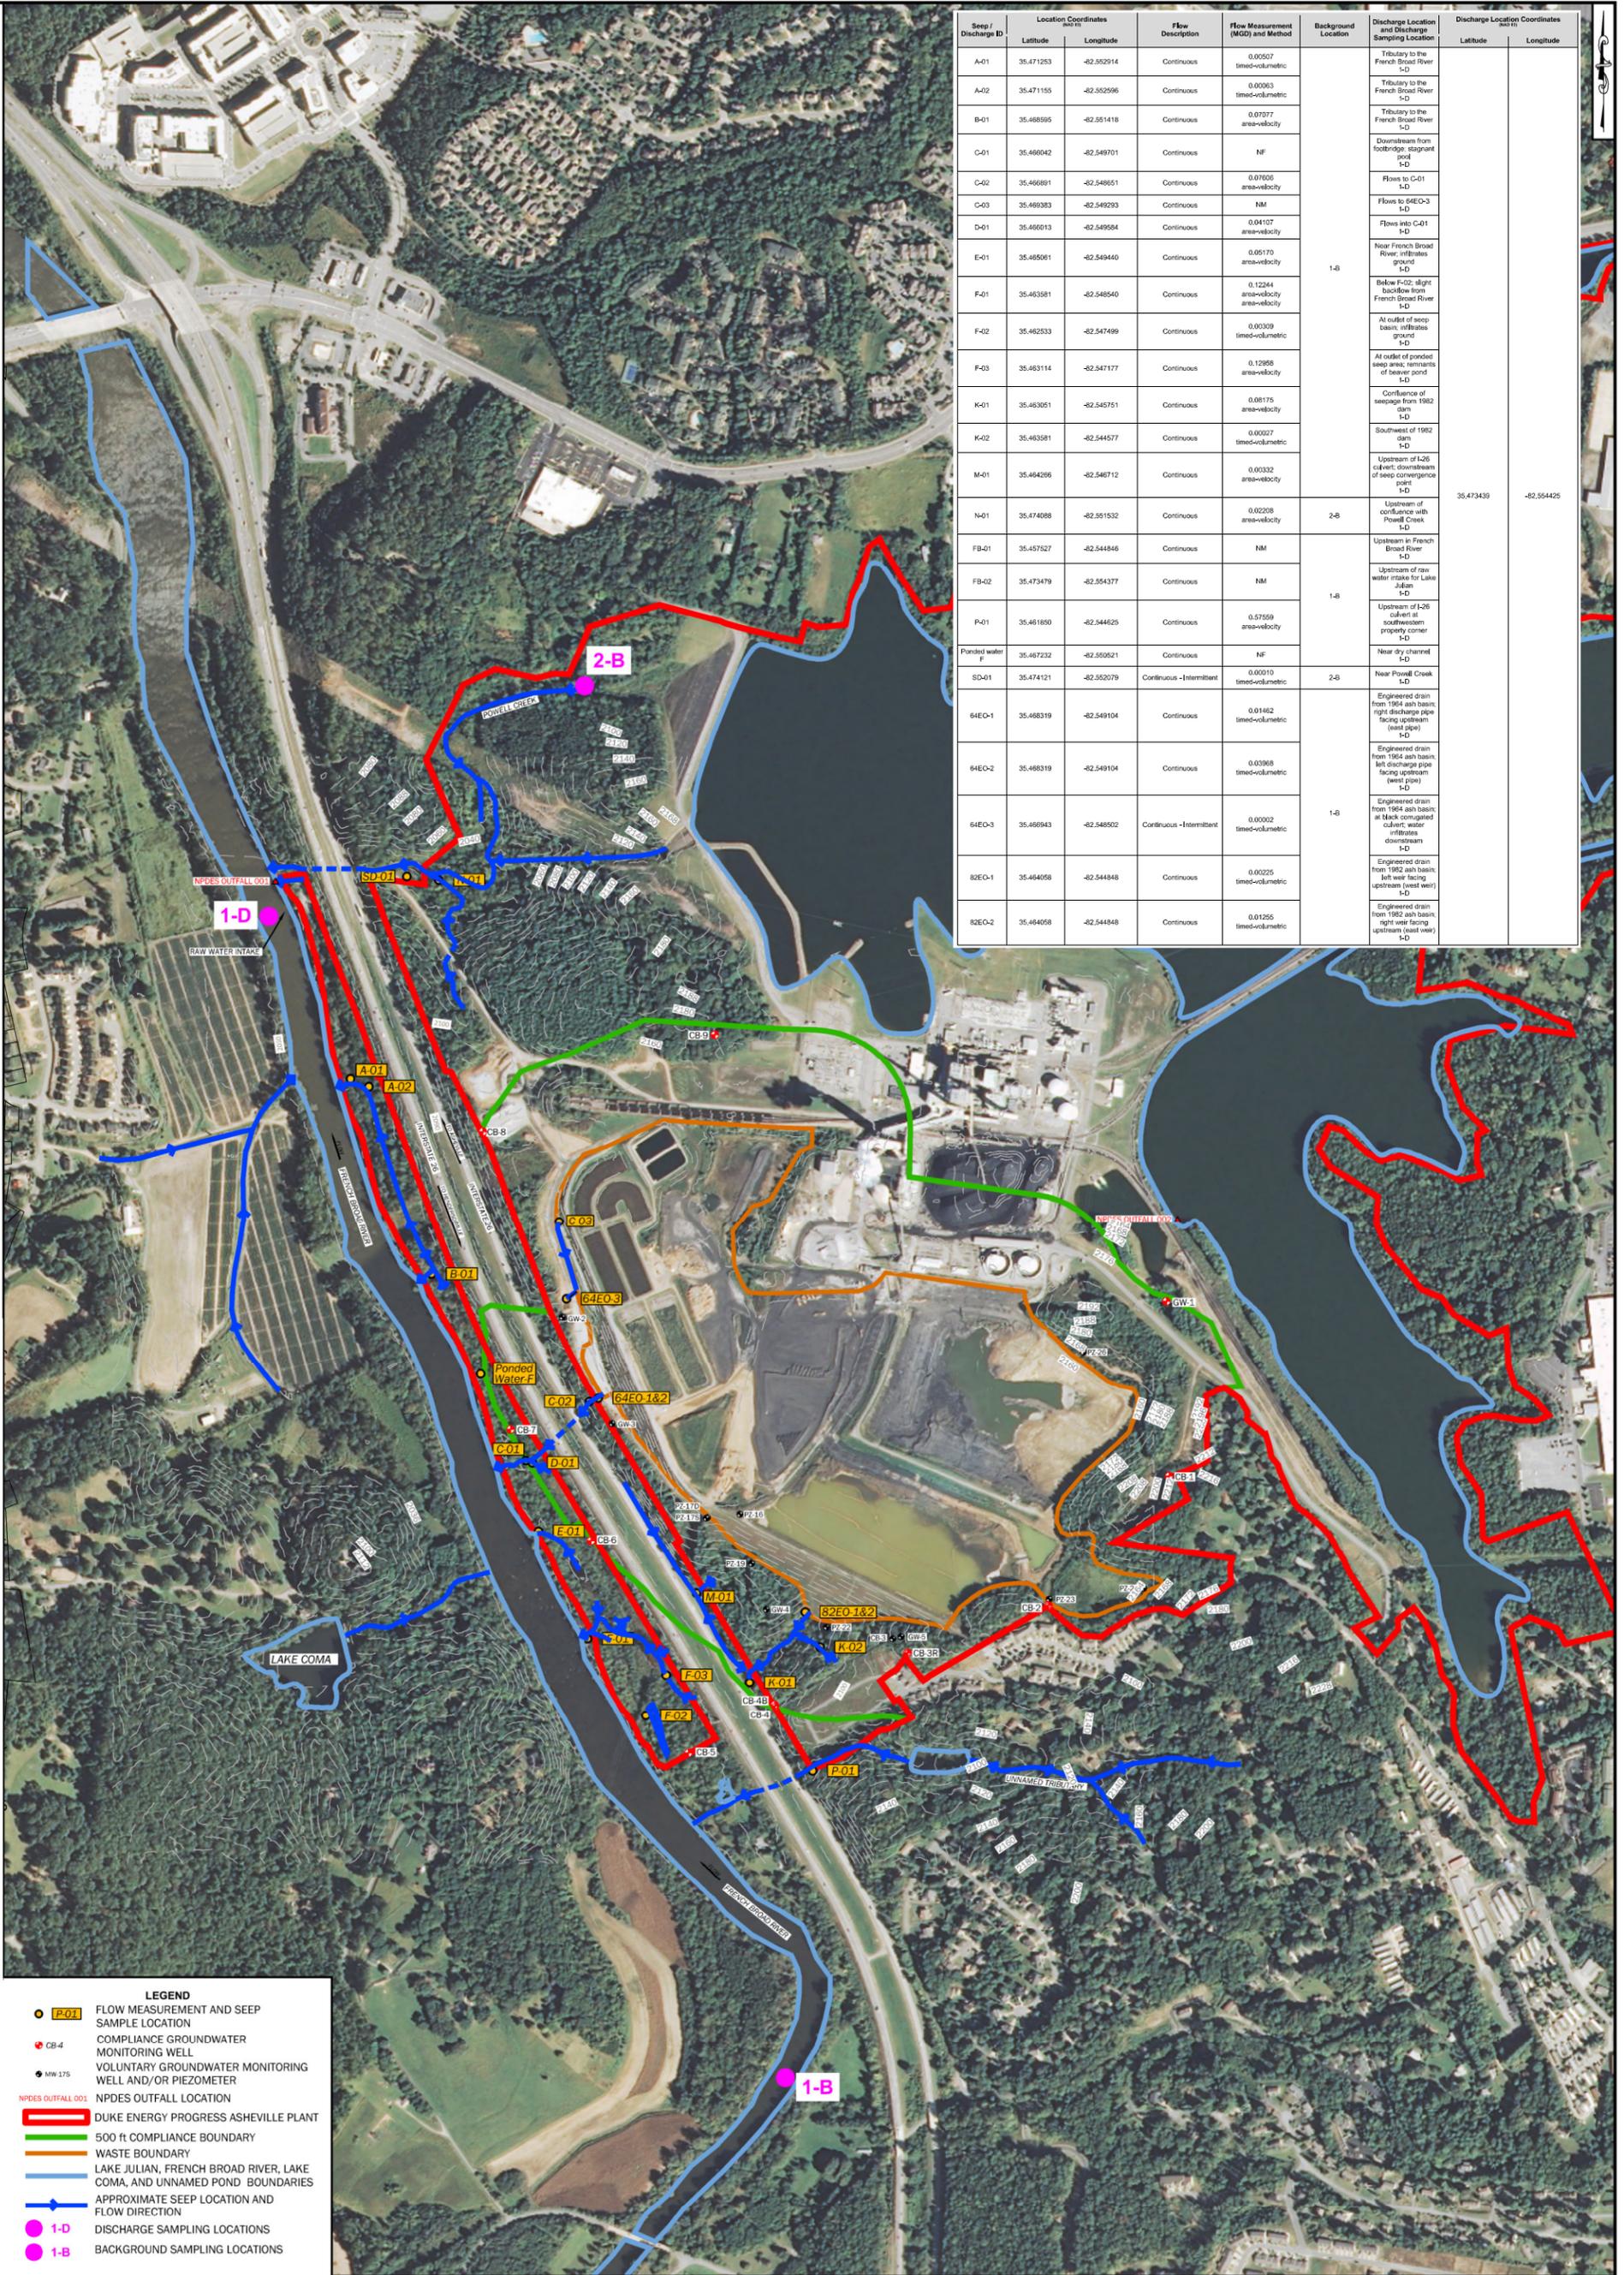
DATE: DECEMBER 2014  
FIGURE: 2

A topographic map is presented in Figure 2 to meet the requirements of GS 130A-309.210(a) in the identification of outfalls from engineered channels, as well as seeps and weeps. Seepage is the movement of wastewater from the ash basin through the ash basin embankment, the embankment foundation, the embankment abutments, basin rim, through residual material in areas adjacent to the ash basin. A seep is defined in this document as an expression of seepage at the ground surface. A weep is understood to have the same meaning as a seep.

Locations of seepage at the ground surface adjacent to the ash basin have been identified and are shown in Figure 2. These areas include the earthen embankment(s) which impound the ash

TOPOGRAPHIC MAP WITH IDENTIFIED SEEPS AND OUTFALLS  
DUKE ENERGY CAROLINAS, LLC  
ASHEVILLE PLANT  
ARDEN, NORTH CAROLINA  
NPDES PERMIT #NC0000396

Engineered drains at the base of the 1964 ash pond collect water into two PVC pipes where flow rates can be measured. A section of the 1964 dam seeps into a swale along the dam access road. The point where the seep is consolidated to flow under the road can be used to measure flow. The engineered drains at the base of the 1982 ash pond are collected in a weir box. The engineered drainage system features, or outfalls, associated with the ash basin dam are shown as required by GS 130A-309.210(a)(2)(i) on Figure 2.

Topographic maps of the site were reviewed to identify regions of the site where there was a potential for ash basin related seepage to be present. These regions were determined by comparing ash basin full pond elevations to adjacent topography with ground surface elevations lower than the ash basin full pond elevation. Synterra staff performed site observations within these identified areas as part of NPDES inspections during the reapplication process during June 2014 and documented locations where seepage was apparent at the time of the site visit. These seeps are identified as required by GS 130A-309.210(a)(2)(ii) on Figure 2.

Figure 2 and Table 1 present the background and downstream sampling locations to be considered as part of this Discharge Assessment Plan (DAP). These locations may be assessed by comparing surface water sampling analytical results of the associated background location with the corresponding downstream location. For discharges located at the toe of a dam, an upstream location within the channel may not have been possible to isolate for comparison given the proximity to the ash basin, which would have the same chemical composition as the discharge itself. As such, the upstream location was established upstream of the ash basin and is considered “background.” For discharges located a distance from the ash basin, an identified upstream, or “background” location for sampling may be compared to the downstream portion of the discharge channel. The background and downstream sampling locations are shown on Figure 2 with “B” and “D” identifiers, respectively, and the corresponding Seep locations associated with the sampling locations are indicated on Table 1.
