ANNUAL REPORT FOR 2002

Croatan Wetland Mitigation Bank

Craven County

Natural Systems Unit & Roadside Environmental Unit
North Carolina Department of Transportation
January 2003

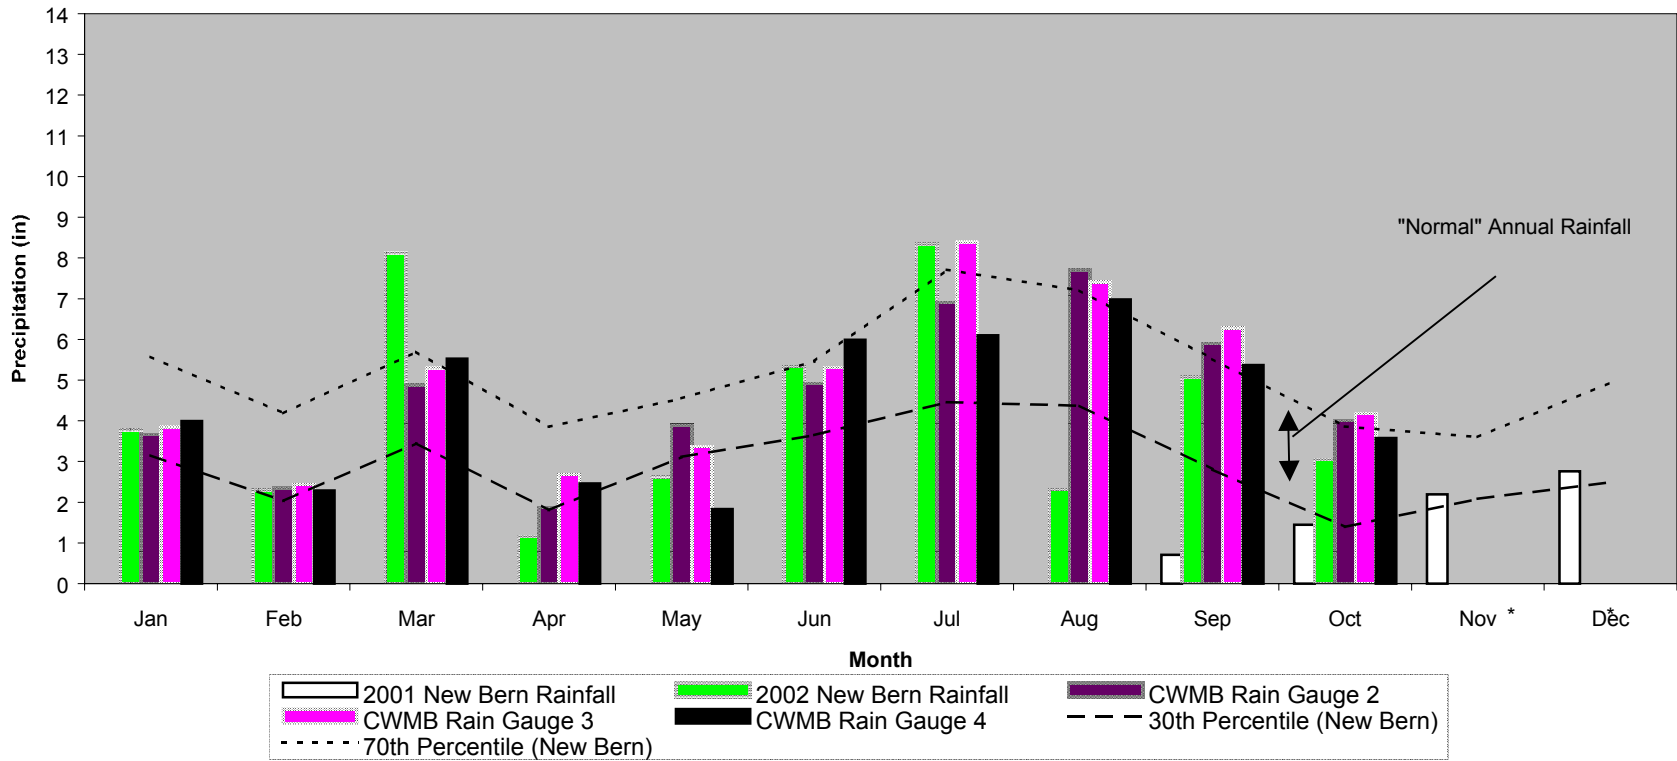
Figure 4. Croatan WMB 30-70 Percentile Graph

Figure 4 is a comparison of 2002 monthly rainfall to historical precipitation for the area. The two lines represent the 30th and 70th percentiles of monthly precipitation for Craven County, North Carolina. The bars are monthly rainfall totals for 2002 growing season as well as the rainfall for September through December of 2001. The historical data was collected from the North Carolina State Climate Office rain gauge in Craven County, North Carolina. Three onsite rain gauges provided 2002 rainfall data.

Overall, rainfall for the 2002 growing season was normal, but low going into the beginning of the growing season. Rainfall was trending on the lower end of normal from September 2001 through May 2002, and trending on the higher end of normal from June 2002 through October 2002.

The low rate of hydrologic success criteria achievement for Phase I at the end of the first growing season is attributed to low rainfall and dry site conditions during late 2001 and early 2002, the period during which the Phase was constructed. Overall, the rainfall for the 2002 growing season was normal, but low going into the beginning of the growing season. Rainfall was well below normal in September and October 2001 and trending on the lower end of normal from November 2001 through February 2002 and April and May 2002; rainfall was trending on the higher end of normal in March 2002 and from June through October 2002. Phase I has shown trends towards re-hydration compared to baseline conditions (1998-2000 data). Assuming normal rainfall conditions, this trend is expected to continue into the 2003 growing season as the surficial aquifer is recharged.

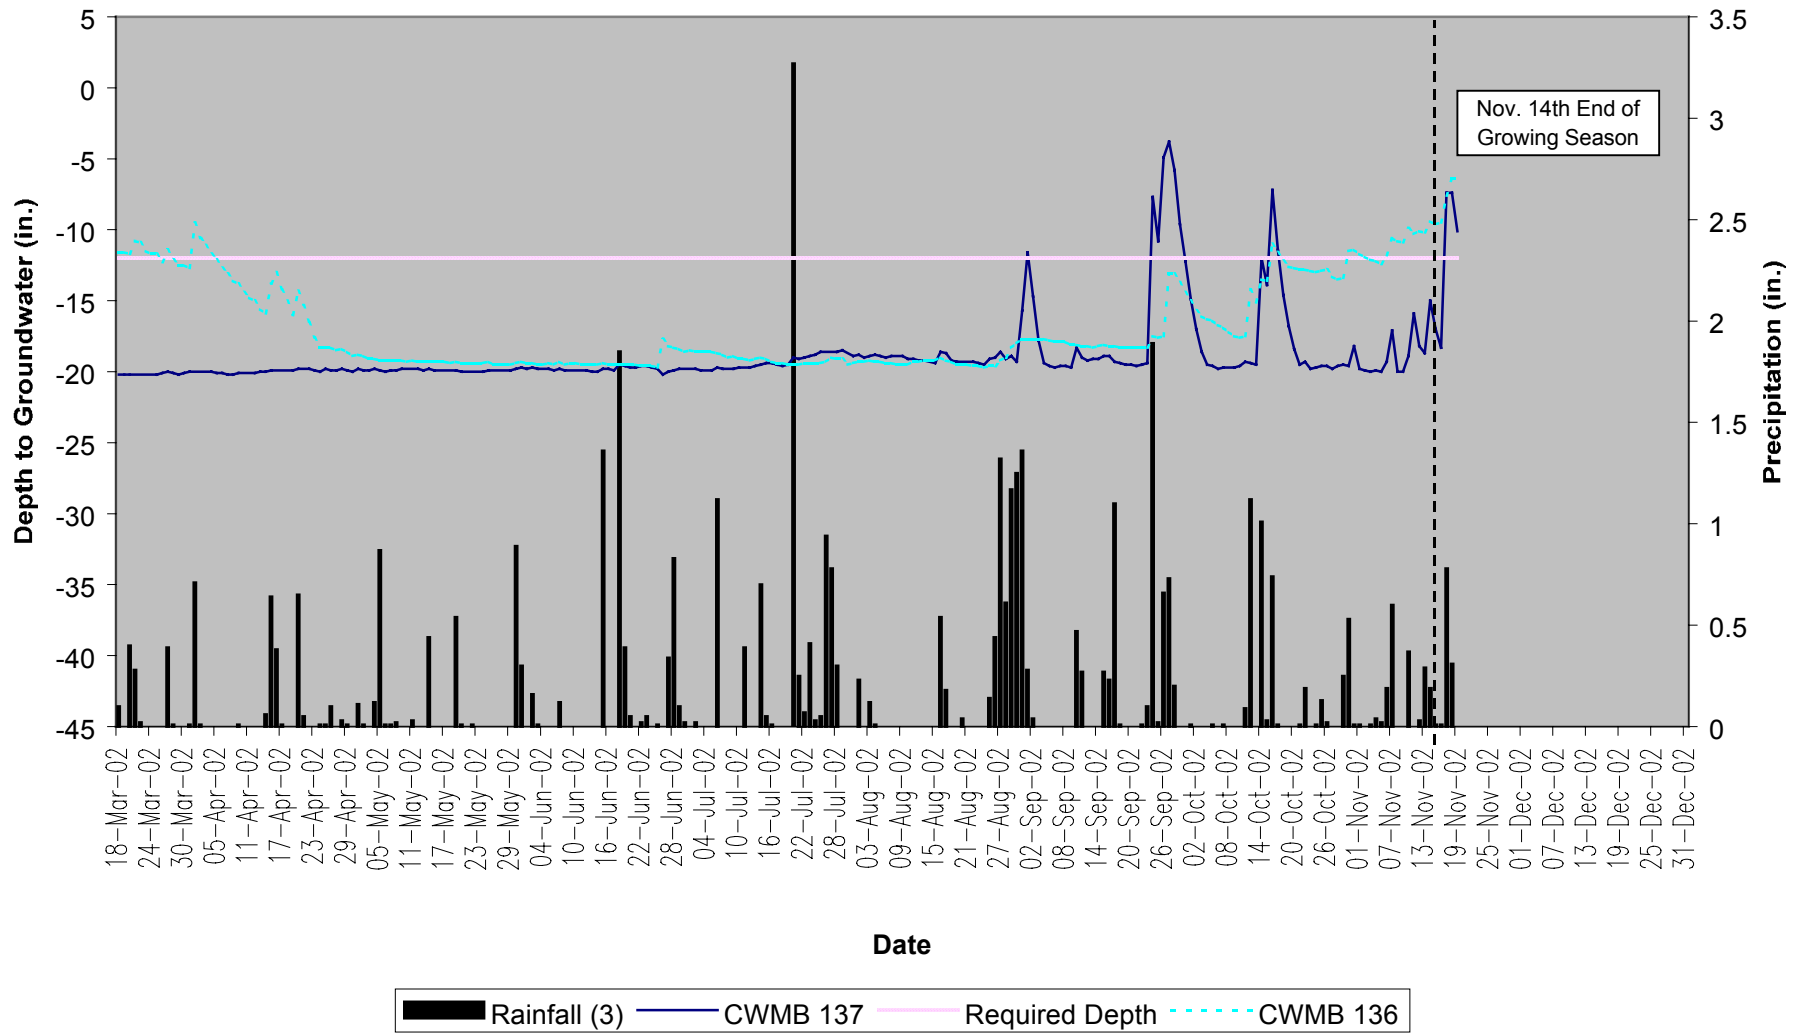
**Croatan WMB
136 & 137
Murville**

Three of the six gauges in MU 12A met both of their expected hydrologic success criteria. Gauges 136, 137, and 180 did not meet either of their expected hydrologic success criteria.

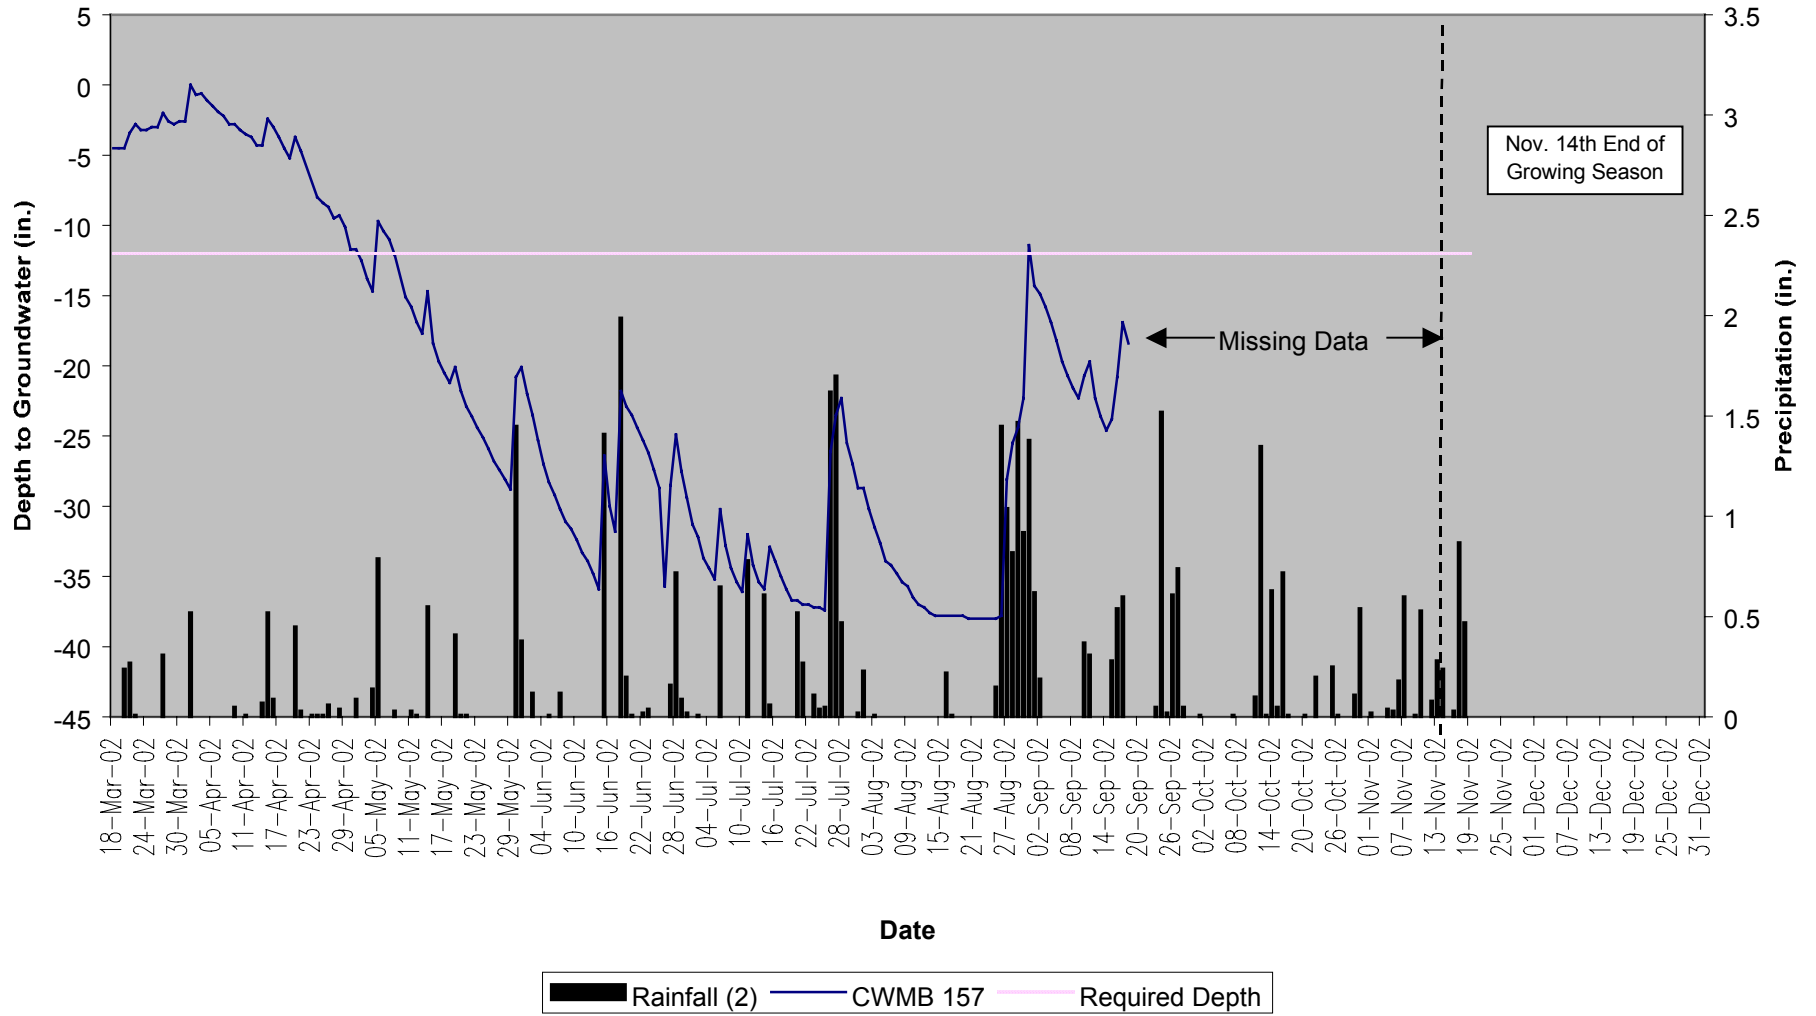
Croatan WMB 157 Croatan

Three (Gauges 36, 38, and 197) of the thirteen monitoring gauges in MU 12B met both of their expected hydrologic success criteria. Gauge 157 was within 50% of reference (Success Criterion 2) and met jurisdictional hydrology (12.5% of the growing season), but did not meet Success Criterion 1 (25% of the growing season). The remaining nine gauges in MU 12B did not meet either of their respective success criteria.

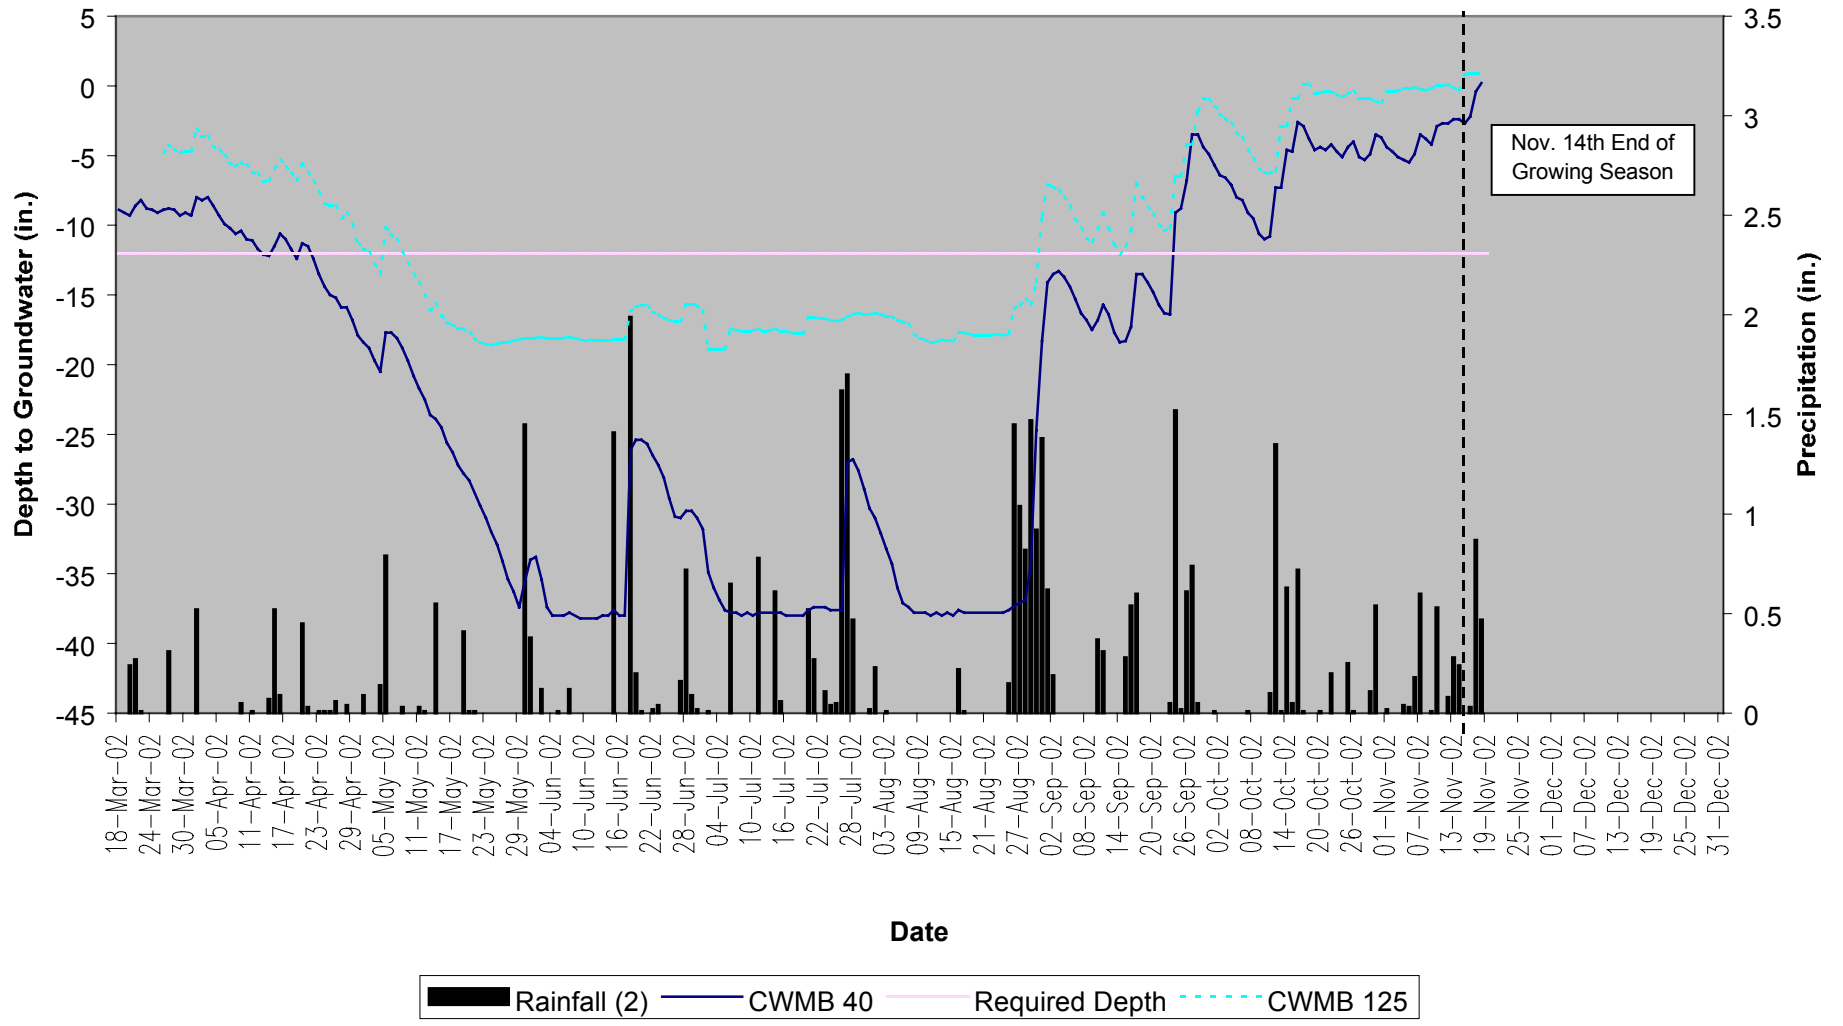
**Croatan WMB
40 & 125
Croatan**

Eight of the twelve monitoring gauges in MU 13A met both of their expected hydrologic success criteria. Gauges 40 and 126 were within 50% of the reference range for Croatan soil, and therefore met Success Criterion 2. Both gauges 40 and 126 met jurisdictional hydrology, but they did not meet jurisdictional hydrology for 25% of the growing season required for organic soils to achieve Success Criterion 1. Gauge 127 met jurisdictional hydrology, but it did not make jurisdictional hydrology for 25% of the growing season to achieve Success Criterion 1. Gauge 142 did not meet either of its respective hydrologic success criteria.

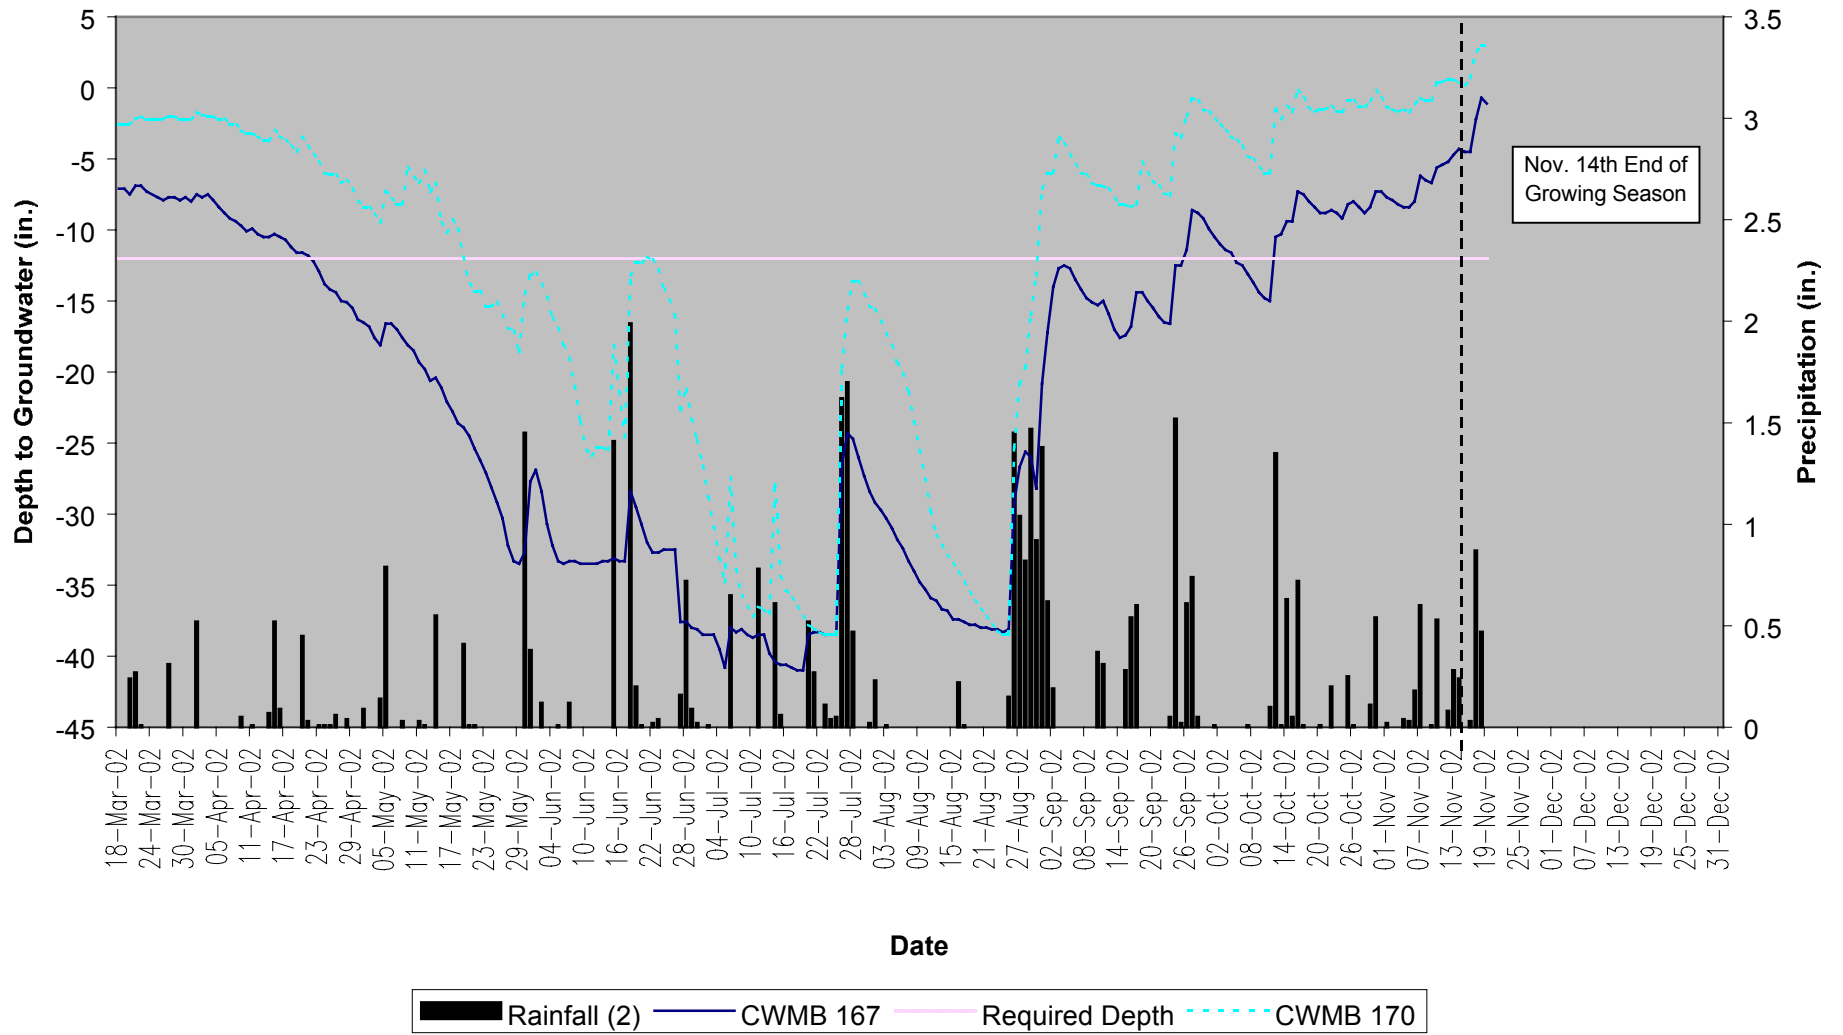
**Croatan WMB
167 & 170
Croatan**

Nine of the ten monitoring gauges in MU 15 met both of their expected hydrologic success criteria. Gauge 167 met jurisdictional hydrology, but did not make jurisdictional hydrology for 25% of the growing season required for organic soils to achieve Success Criterion 1 and was not within 50% of the reference range.

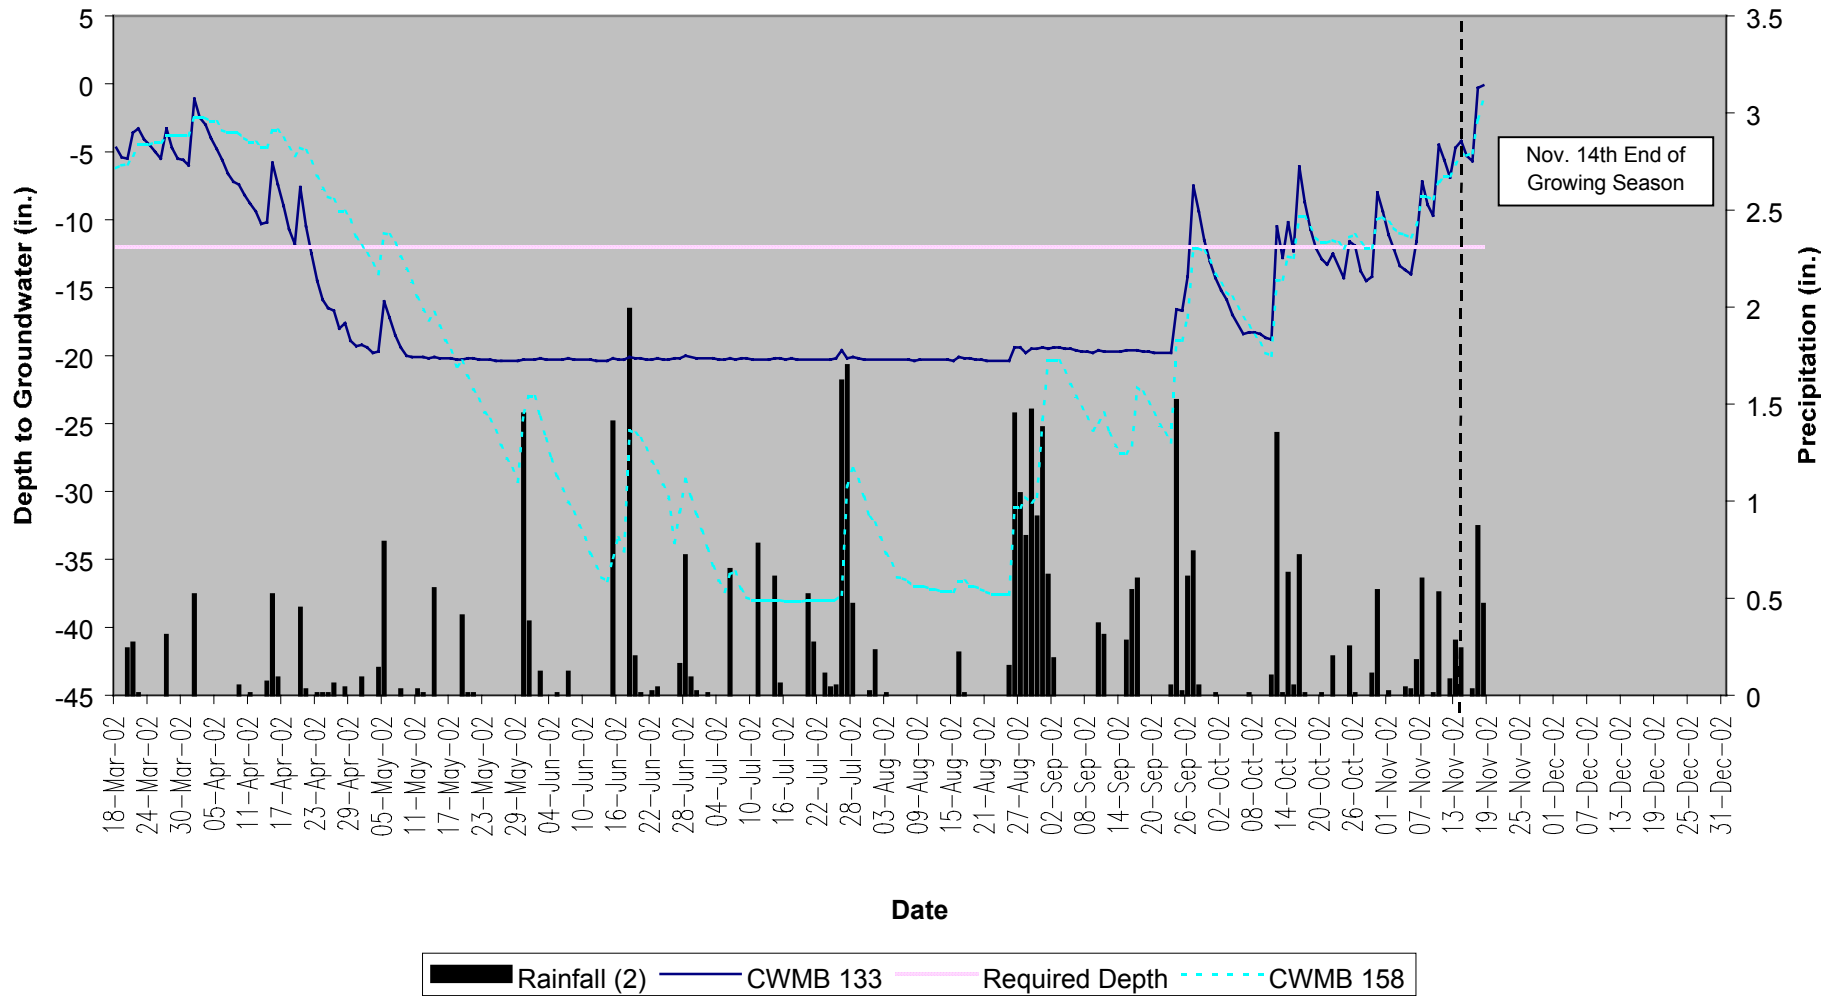
**Croatan WMB
133 & 158
Croatan**

Two of the seven monitoring gauges in MU 18 met their expected hydrologic success criteria. Gauges 158 and 159 were within 50% of the reference range for Croatan soils, therefore meeting Success Criterion 2. Both gauges met jurisdictional hydrology, but did not make jurisdictional hydrology for 25% of the growing season required for organic soils to achieve Success Criterion 1. Gauge 184 met Success Criterion 2 (within 50% of the reference range for Leon soils), but did not make jurisdictional hydrology for 12.5% of the growing season required for mineral soils to achieve Success Criterion 1. The remaining two monitoring gauges in MU 18 did not meet either of their expected hydrologic success criteria.
