W. H. Weatherspoon Power Plant Ash Basin

Topographic Map and Discharge Assessment Plan

NPDES Permit NC0005363

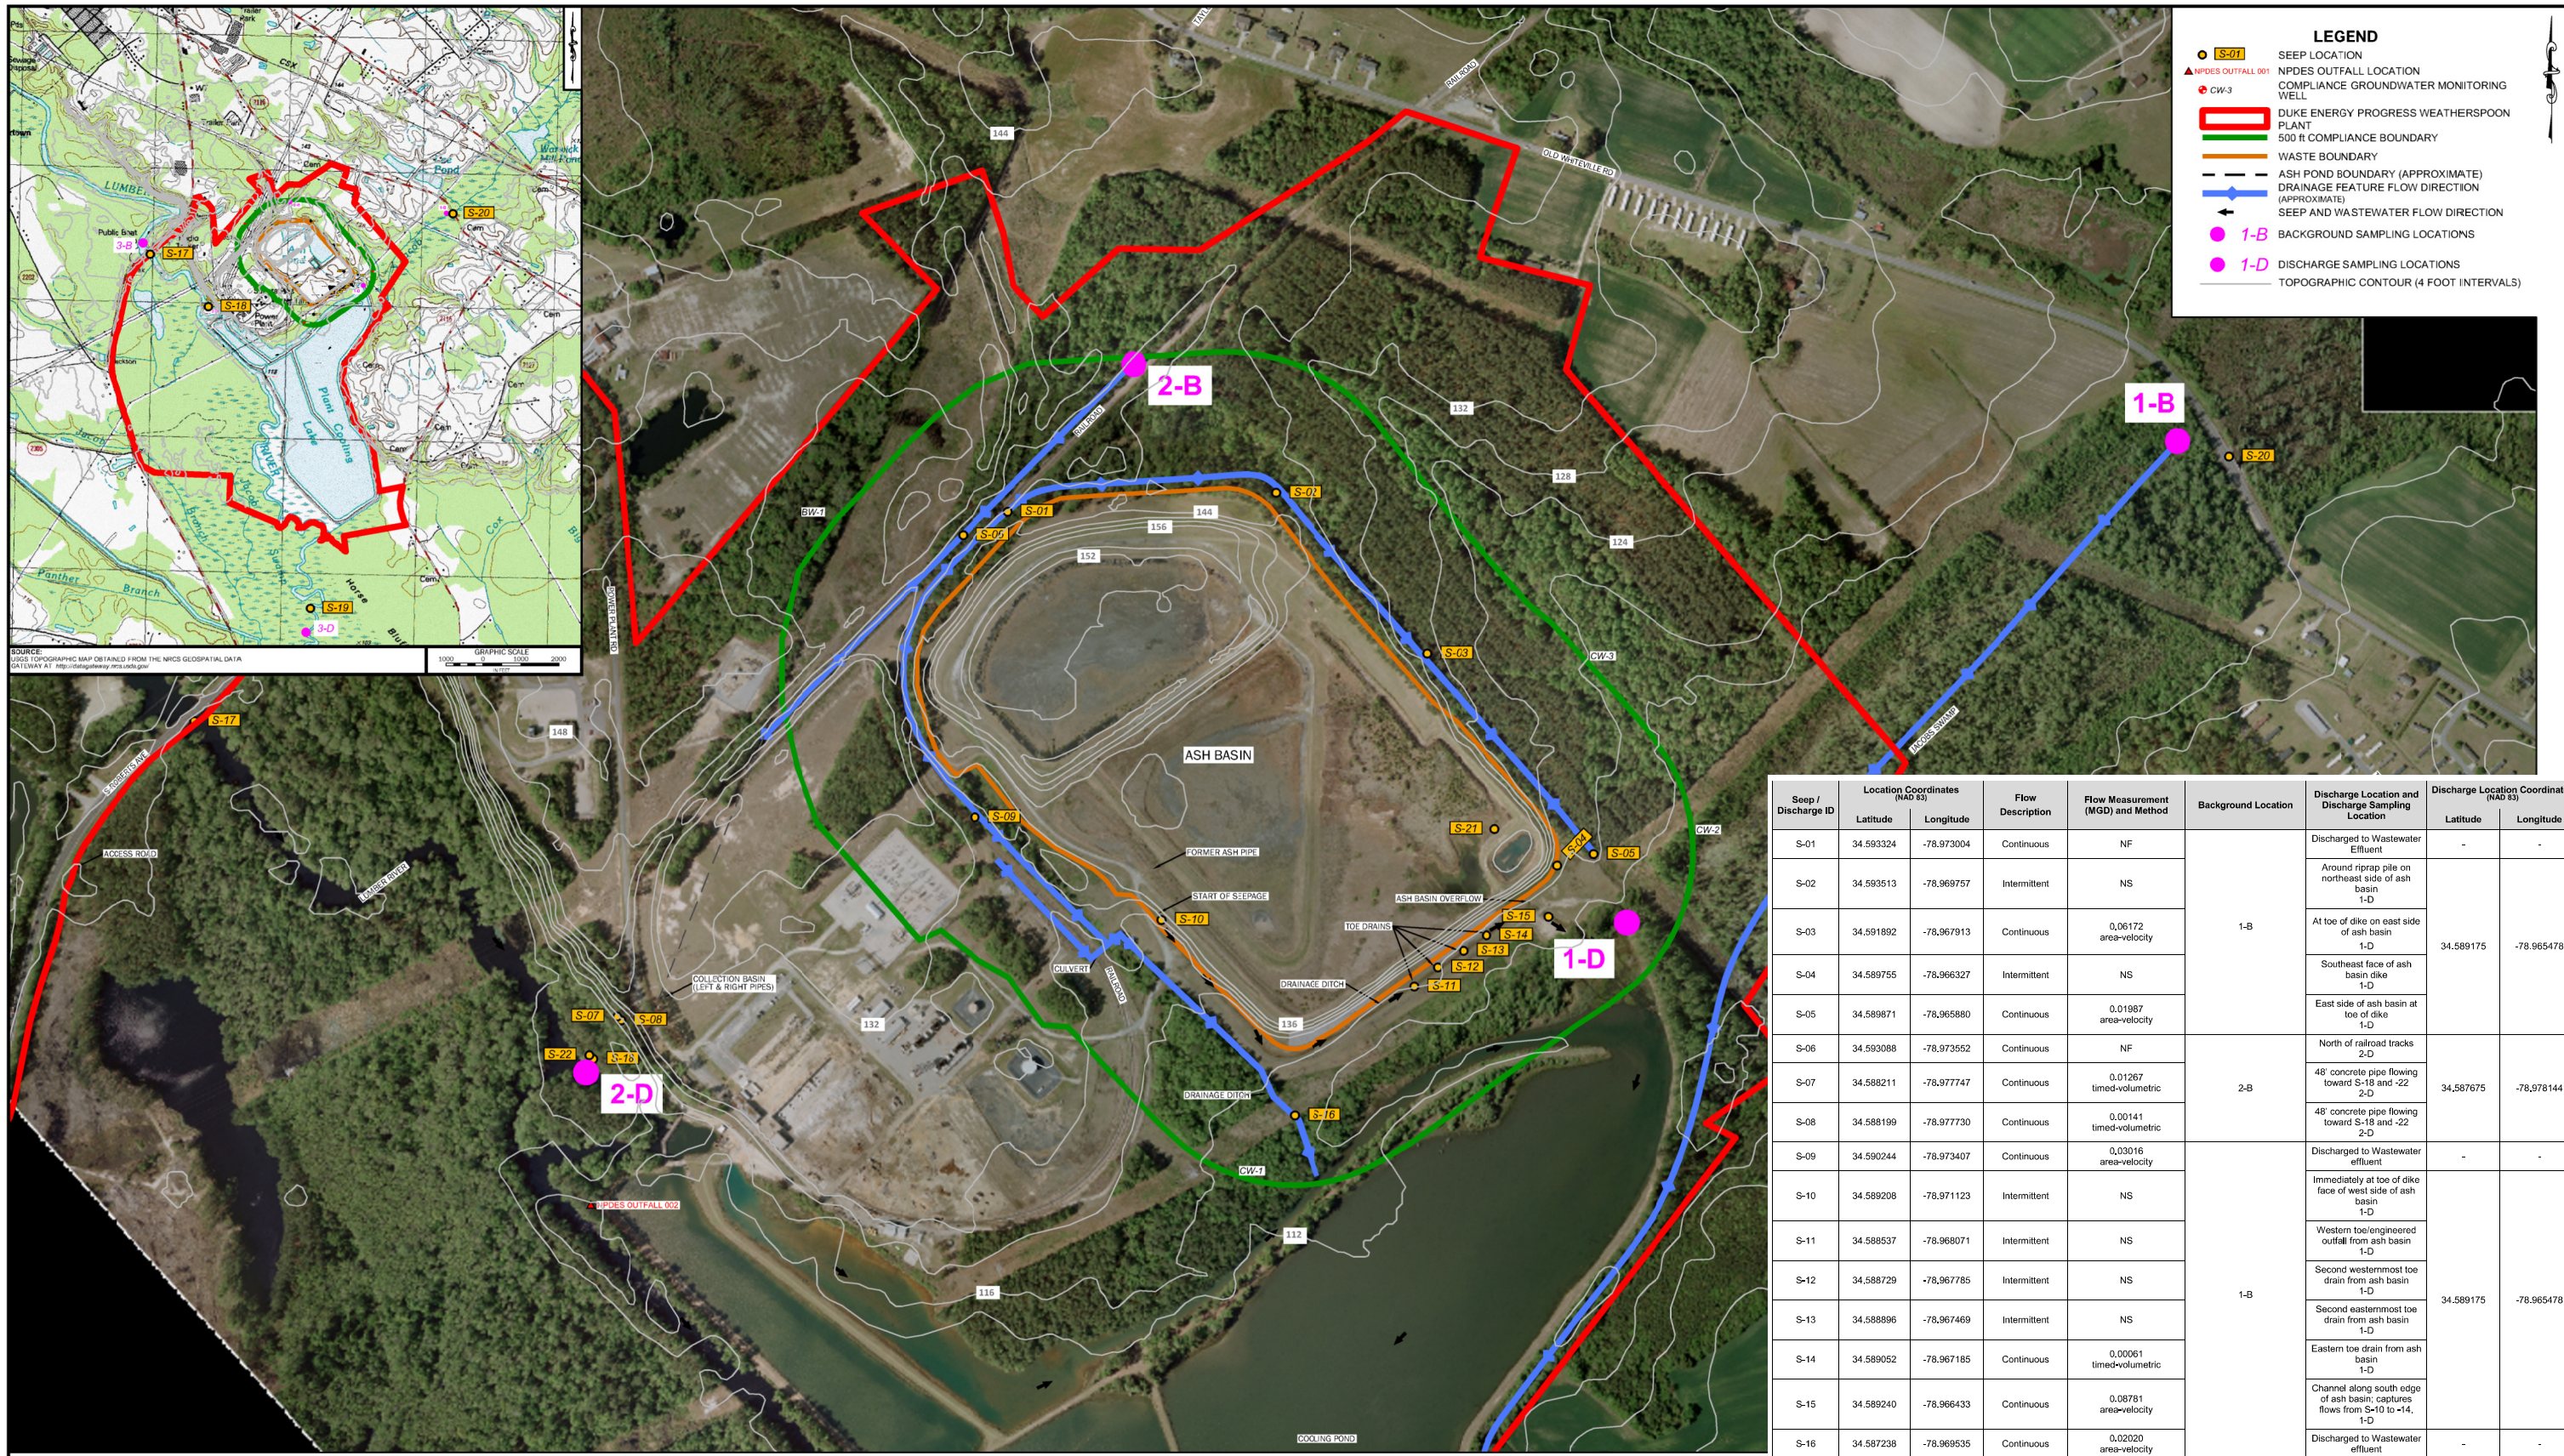
DATE
 DECEMBER 2014
 FIGURE
 2

A topographic map is presented in Figure 2 to meet the requirements of GS 130A-309.210(a) in the identification of outfalls from engineered channels, as well as seeps and weeps.

Locations of seepage at the ground surface adjacent to the ash basin have been identified and are shown in Figure 2. These areas include the earthen embankments which impound the ash basin as well as adjacent areas where water from the ash basin may have infiltrated into the underlying residual materials and expressed as seepage.

TOPOGRAPHIC MAP WITH IDENTIFIED SEEPS AND OUTFALLS
 DUKE ENERGY CAROLINAS, LLC
 WEATHERSPOON POWER PLANT
 NPDES PERMIT #NC0005363
 LUMBERTON, NORTH CAROLINA

The Weatherspoon Ash Basin Dam was constructed with a drainage system, such as toe drains, or outfalls, associated with the ash basin dam, which are shown as required by GS 130A-309.210(a)(2)(i) on Figure 2.

Topographic maps of the site were reviewed to identify regions of the site where there was a potential for ash basin related seepage to be present. These regions were determined by comparing ash basin full pond elevations to adjacent topography with ground surface elevations lower than the ash basin full pond elevation. Synterra staff performed site observations within these identified areas as part of NPDES inspections during the reapplication process during August 2014 and documented locations where seepage was apparent at the time of the site visit. These seeps are identified as required by GS 130A-309.210(a)(2)(ii) on Figure 2.

Figure 2 and Table 1 present the background and downstream sampling locations to be considered as part of this Discharge Assessment Plan (DAP). These locations may be assessed by comparing surface water sampling analytical results of the associated background location with the corresponding downstream location. For discharges located at the toe of a dam, an upstream location within the channel may not have been possible to isolate for comparison given the proximity to the ash basin, which would have the same chemical composition as the discharge itself. As such, the upstream location was established upstream of the ash basin and is considered “background.” For discharges located a distance from the ash basin, an identified upstream, or “background” location for sampling may be compared to the downstream portion of the discharge channel. The background and downstream sampling locations are shown on Figure 2 with “B” and “D” identifiers, respectively, and the corresponding seep locations associated with the sampling locations are indicated on Table 1.
