YEAR 7 (2021) MONITORING REPORT

**ABBAY LAMM
STREAM AND WETLAND MITIGATION SITE**

Alamance County, North Carolina
Full Delivery Contract No. 5790
DMS Project No. 96311
NCDWR Project No. 20140336
USACE Action ID No. SAW-2014-01710

December 2021

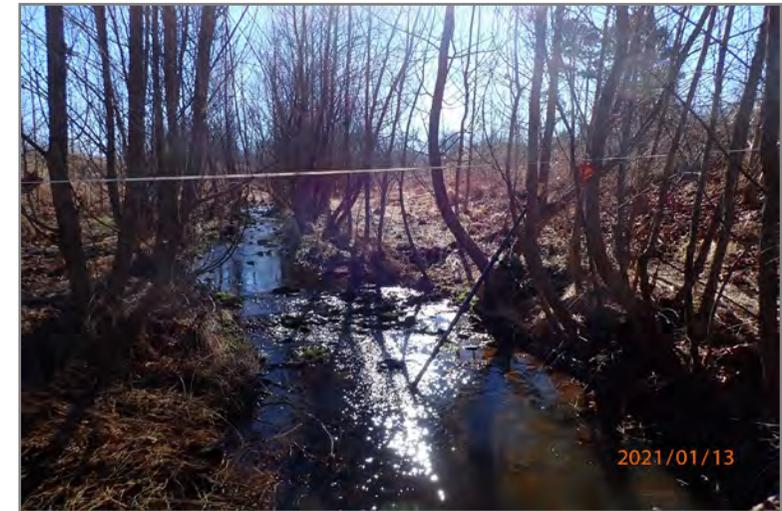
SUMMARY DATA	
Bankfull Elevation:	73.1
Bankfull Cross-Sectional Area:	11.2
Bankfull Width:	11.7
Flood Prone Area Elevation:	NA
Flood Prone Width:	NA
Max Depth at Bankfull:	1.6
Low Bank Height:	1.6
Mean Depth at Bankfull:	1.0
W / D Ratio:	NA
Entrenchment Ratio:	NA
Bank Height Ratio:	1.0

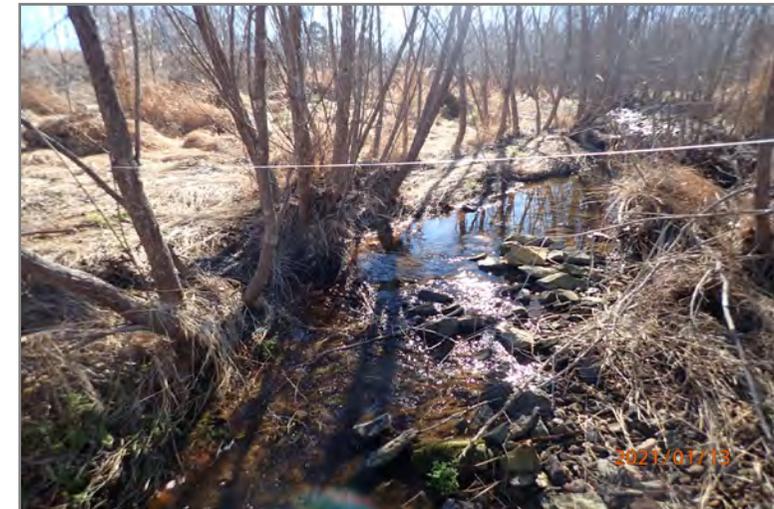
Site	Abbey Lamm
Watershed:	Cape Fear, 0303002
XS ID	Main Channel XS - 5, Pool
Feature	Pool
Date:	1/13/2021
Field Crew:	Perkinson, Harris

SUMMARY DATA	
Bankfull Elevation:	76.7
Bankfull Cross-Sectional Area:	11.8
Bankfull Width:	19.4
Flood Prone Area Elevation:	NA
Flood Prone Width:	NA
Max Depth at Bankfull:	1.3
Low Bank Height:	1.5
Mean Depth at Bankfull:	0.6
W / D Ratio:	NA
Entrenchment Ratio:	NA
Bank Height Ratio:	1.1

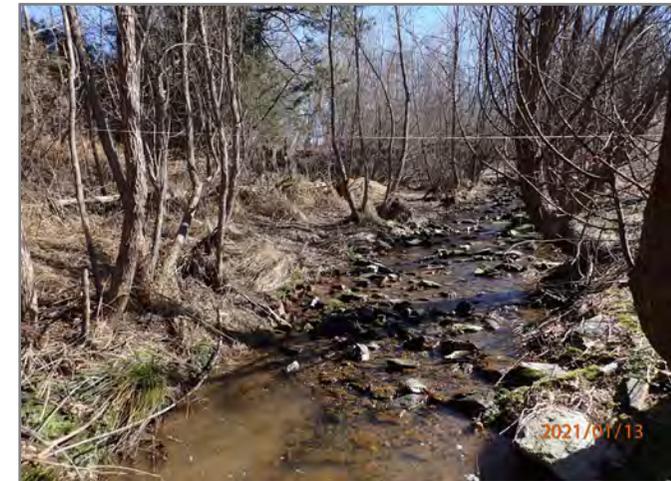
SUMMARY DATA	
Bankfull Elevation:	84.7
Bankfull Cross-Sectional Area:	9.8
Bankfull Width:	11.2
Flood Prone Area Elevation:	NA
Flood Prone Width:	NA
Max Depth at Bankfull:	1.4
Low Bank Height:	1.4
Mean Depth at Bankfull:	0.9
W / D Ratio:	NA
Entrenchment Ratio:	NA
Bank Height Ratio:	1.0

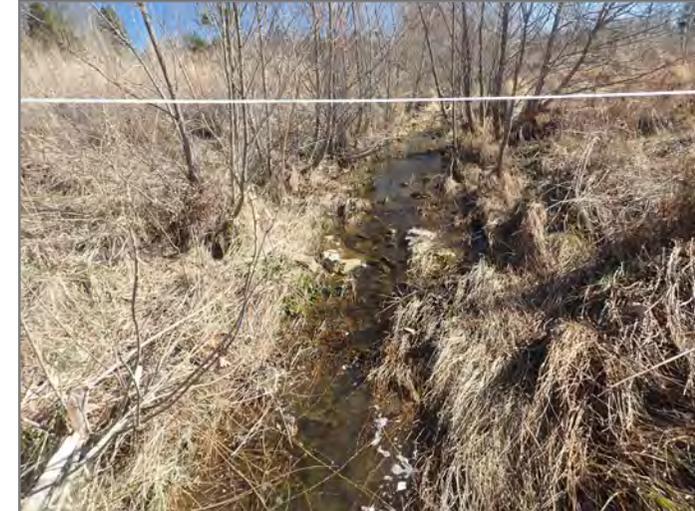
SUMMARY DATA	
Bankfull Elevation:	107.1
Bankfull Cross-Sectional Area:	13.1
Bankfull Width:	15.2
Flood Prone Area Elevation:	NA
Flood Prone Width:	NA
Max Depth at Bankfull:	1.7
Low Bank Height:	1.8
Mean Depth at Bankfull:	0.9
W / D Ratio:	NA
Entrenchment Ratio:	NA
Bank Height Ratio:	1.1

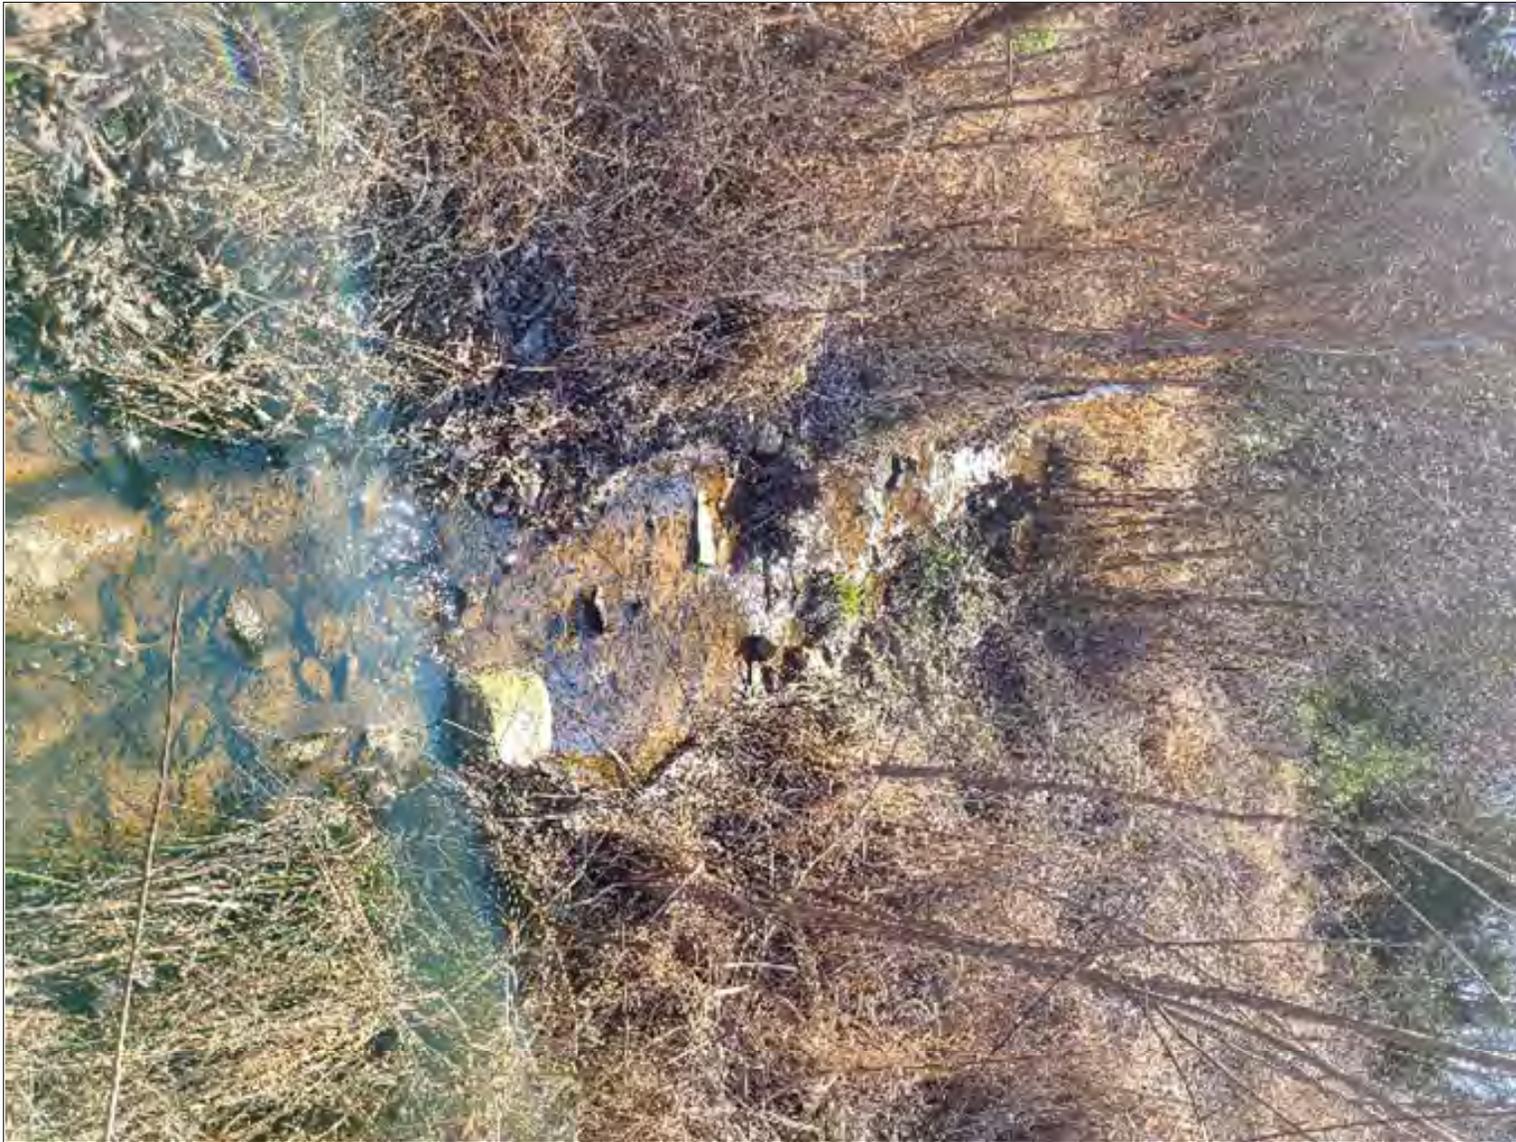
UT-1 channel formation at the stream

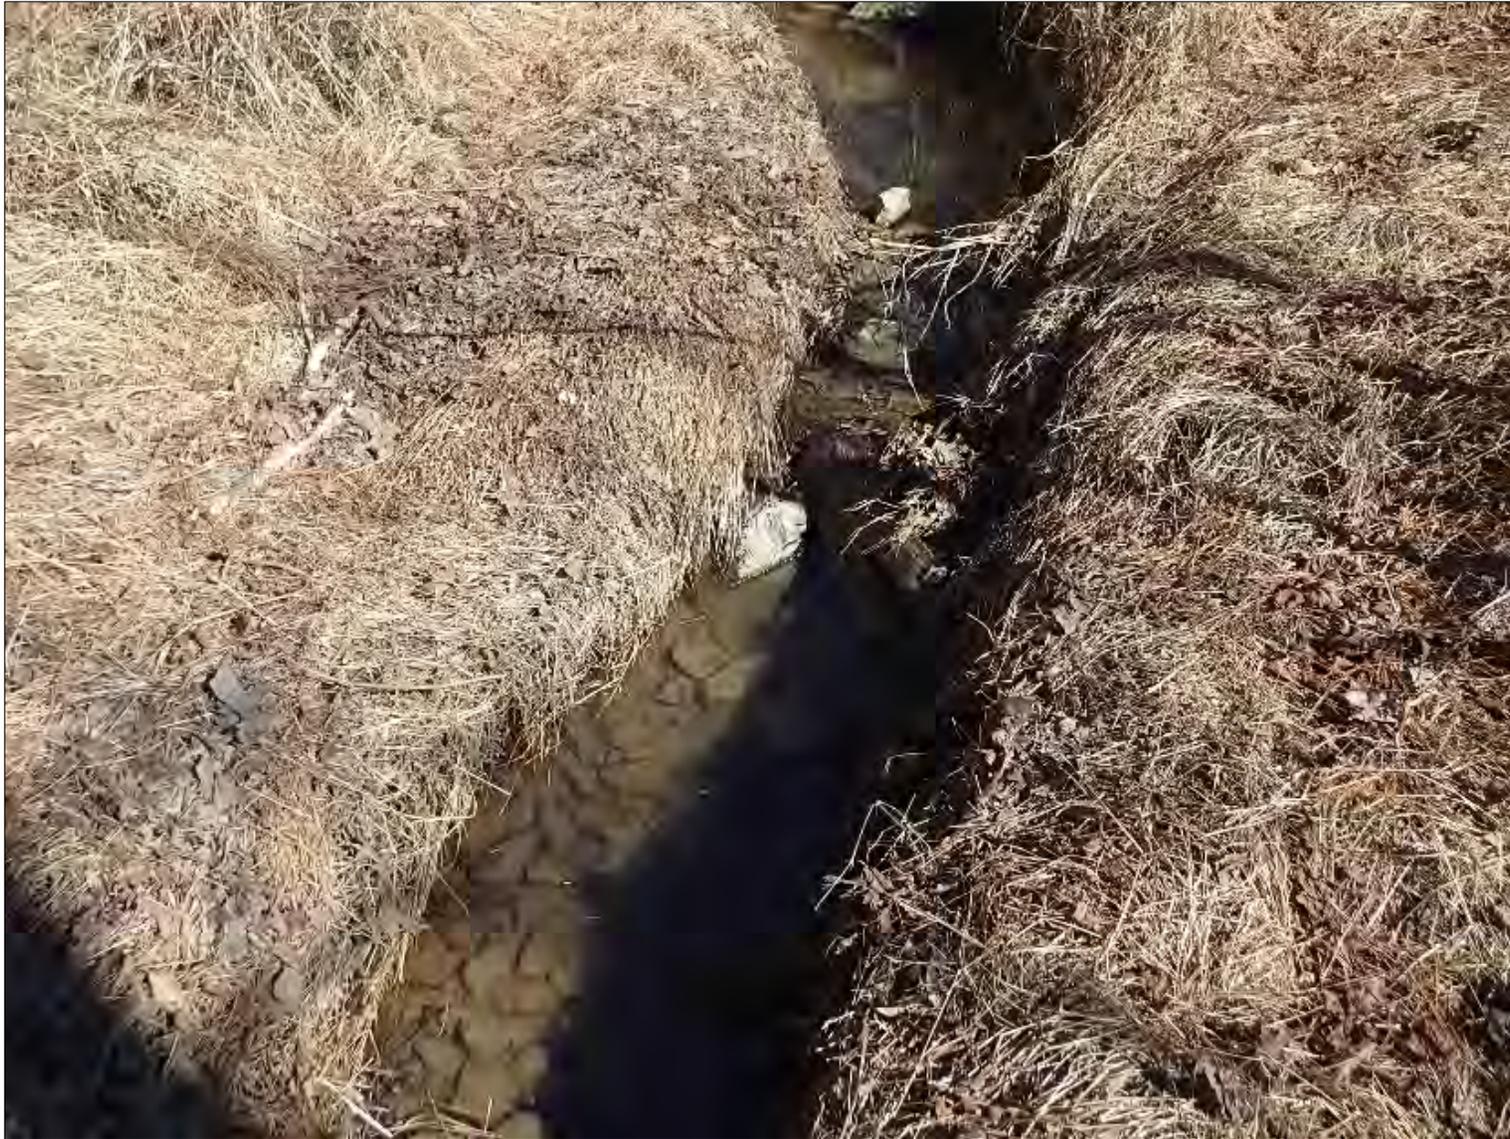
UT-3 channel formation at the stream

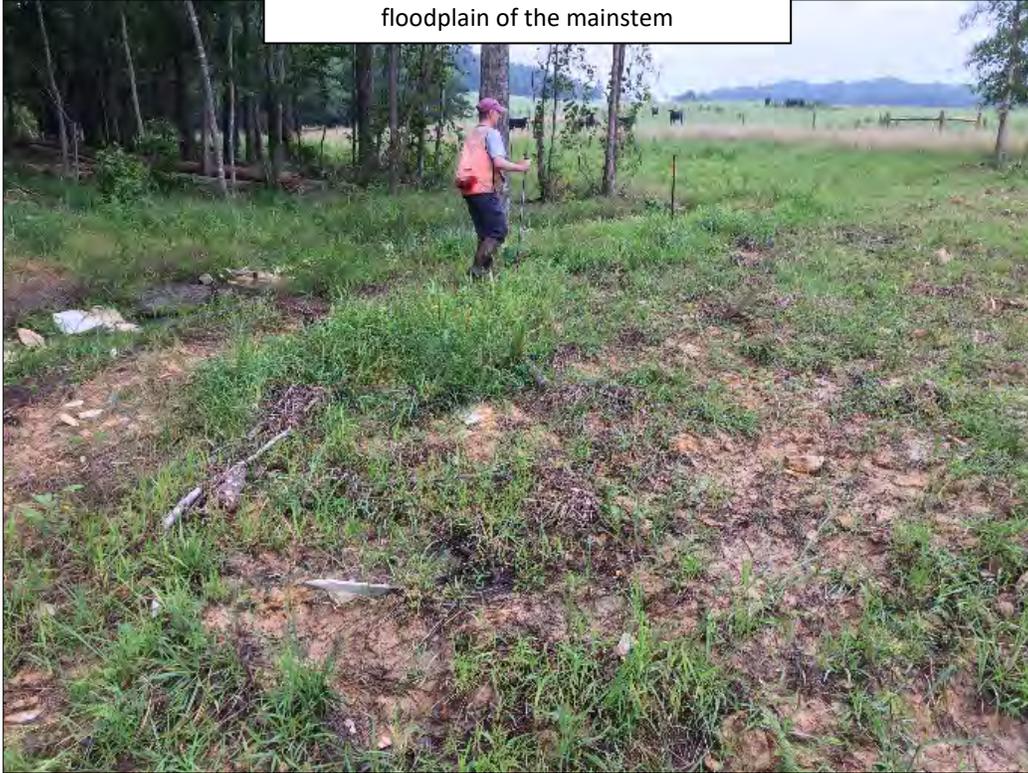
Bankfull Photo 1: Wrack and sediment in the floodplain of the mainstem

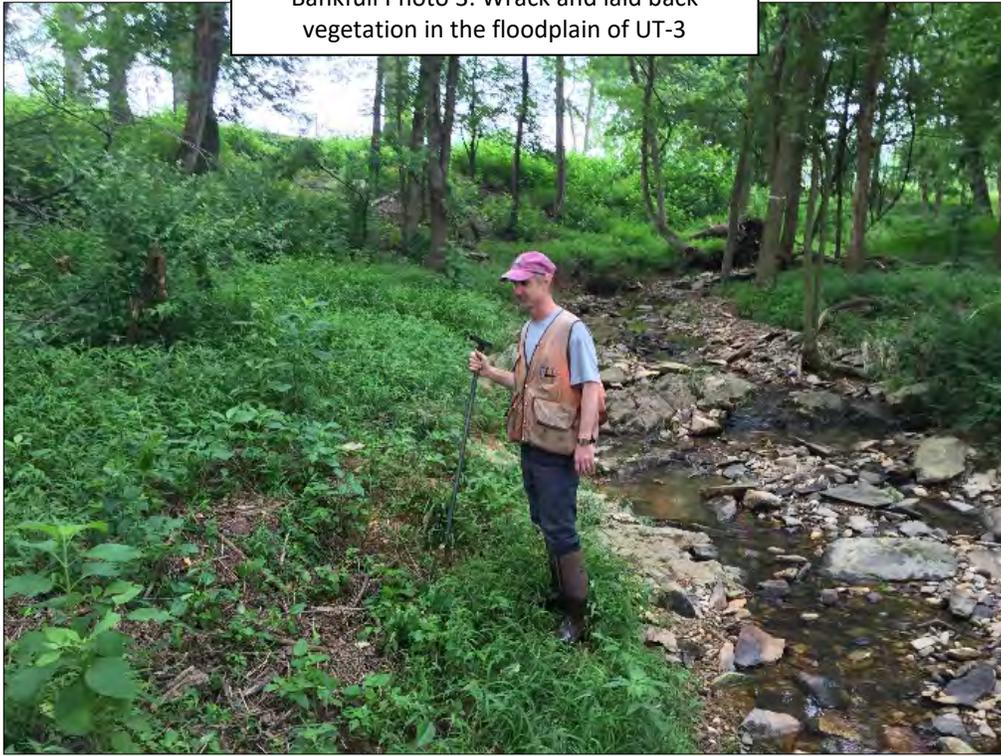
Bankfull Photo 3: Wrack and laid back vegetation in the floodplain of UT-3

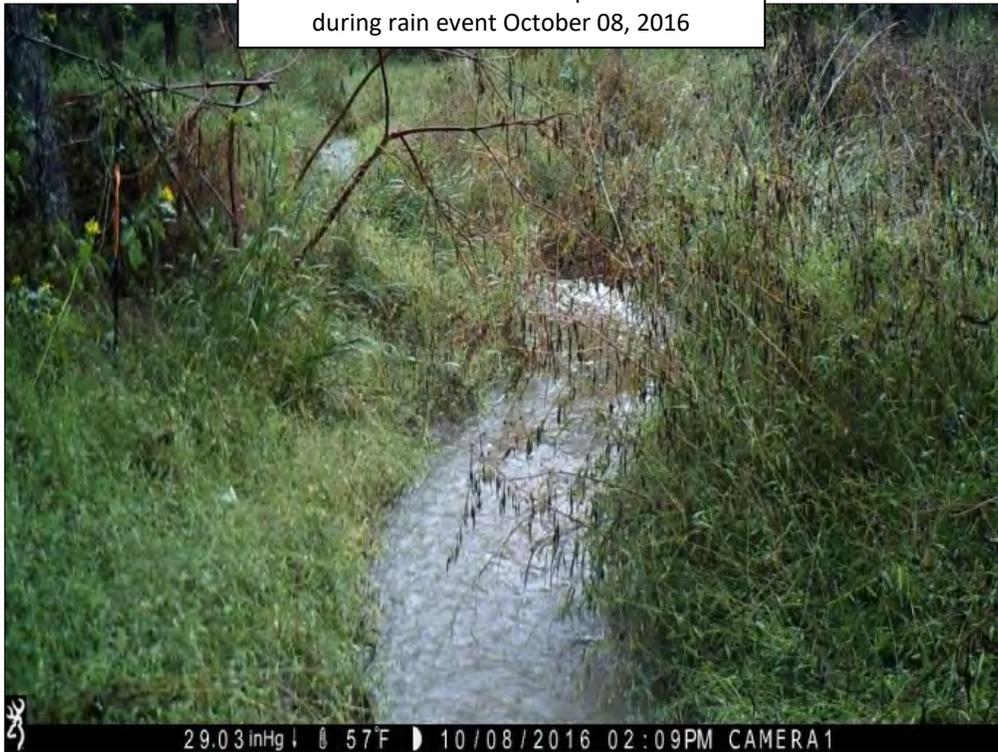
Bankfull Photo 4: Trail Cam photo of UT-3 during rain event October 08, 2016

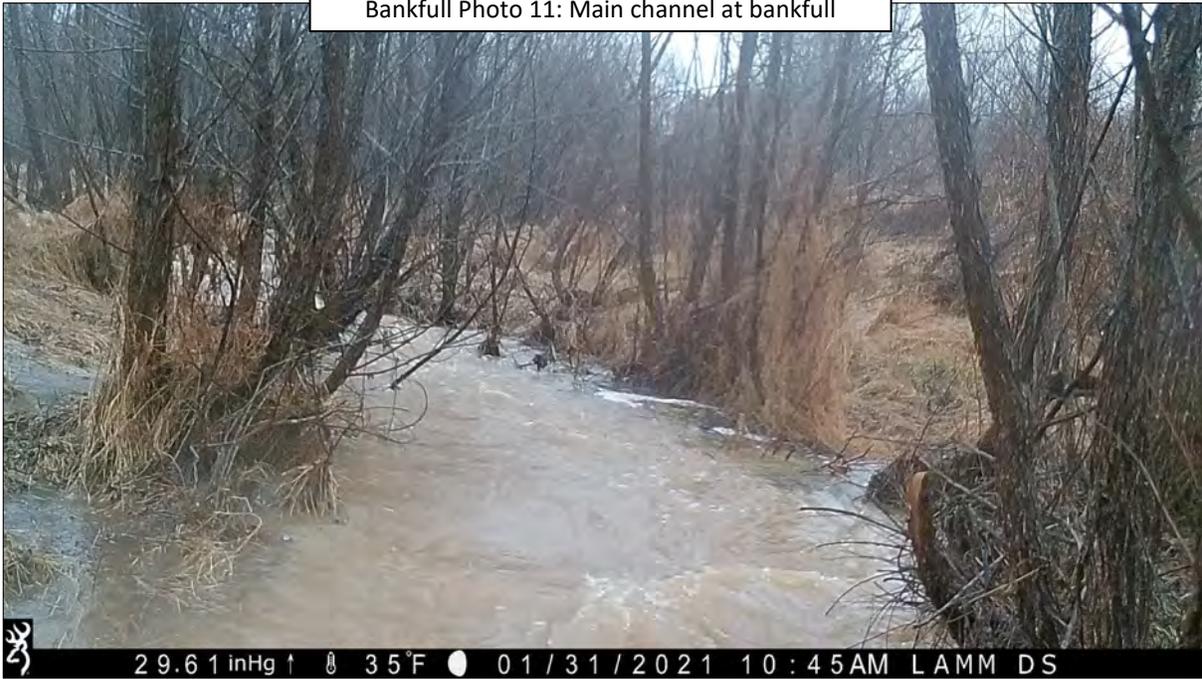
July 21, 2020	June 11, 2020	Wrack in trees in the floodplain indicate a bankfull event occurred after 4.23 inches of rain was documented on June 11, 2020 at an on-site rain gauge.	10
February 15, 2021	January 31, 2021	Trail cameras captured the main stem and UT-1 at bankfull on January 31, 2021 after 0.89 inches of rain was documented at an on-site rain gauge.	11-12

Bankfull Photo 11: Main channel at bankfull

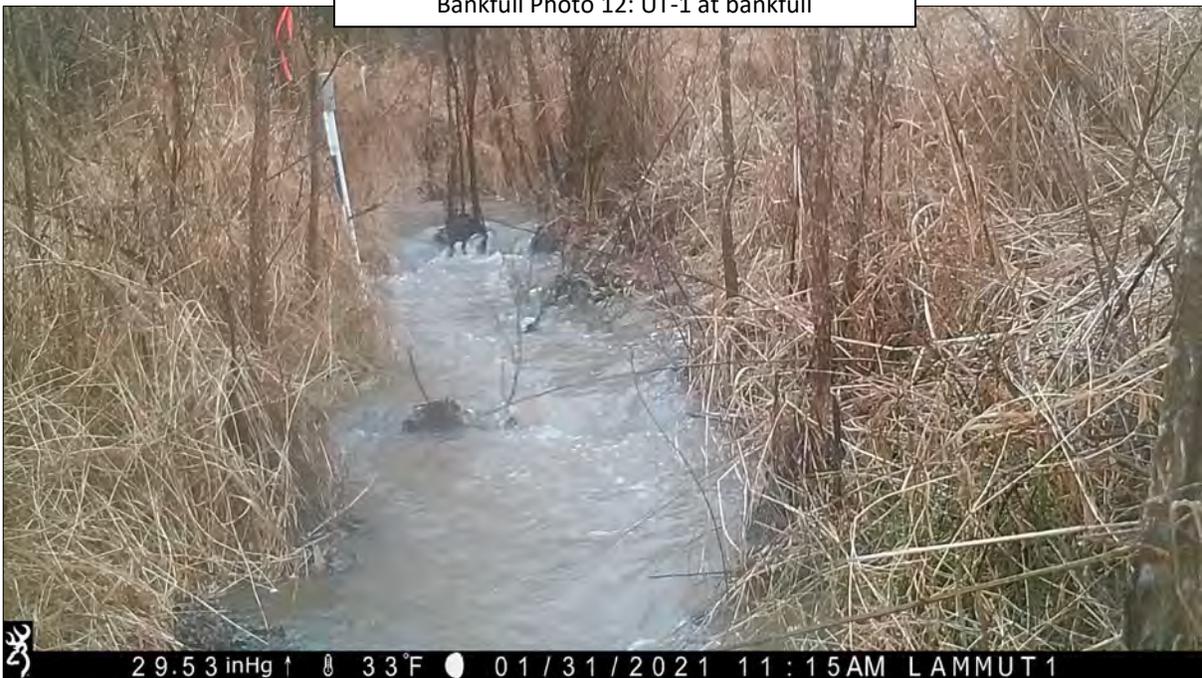
Bankfull Photo 12: UT-1 at bankfull
