**Year 1 Monitoring Report**

**MATTHEW SITE**

NCDMS Project #100043 (Contract #7419)  
USACE Action ID: SAW-2017-00055  
DWR Project #2017-0624

Johnston County, North Carolina  
Neuse River Basin  
HUC 03020201

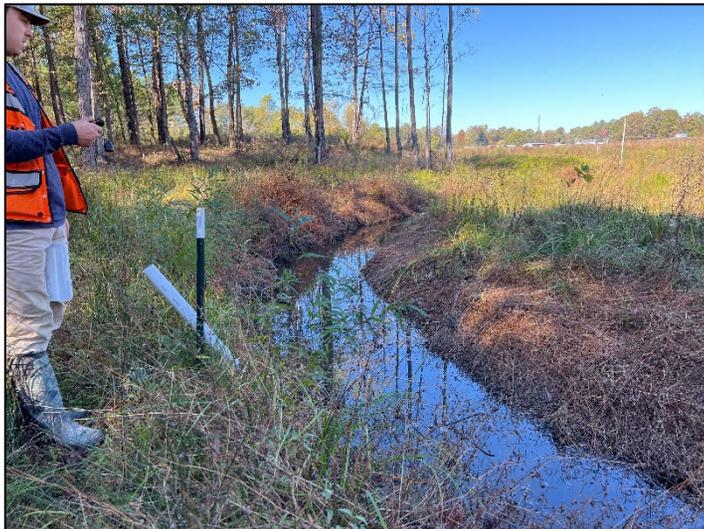
Stage Recorder RL1-A

Two stage recorders are currently recording bankfull events on reaches RL1-A and RL2. The stage recorder on RL1-A recorded 15 bankfull events in MY1 with the highest reading being 2.11 feet above the top of bank. The stage recorder on RL2 recorded 11 bankfull events in MY1 with the highest reading being 2.78 feet above the top of bank. Stage recorder locations can be found on **Figure 2**, photos are in **Appendix B**, and hydrology data are in **Appendix E**.

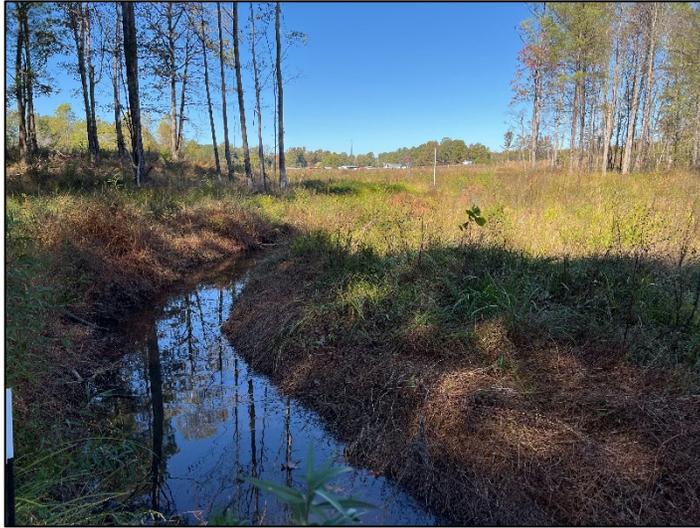
RL1-A looking upstream (11/9/2021)

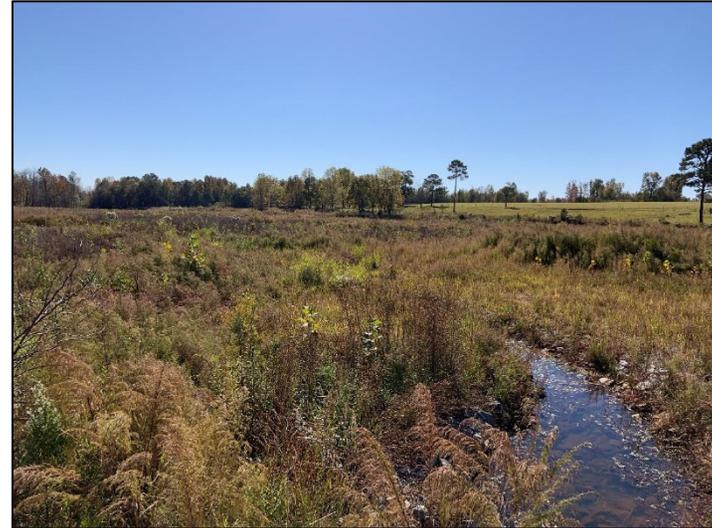
RL2 looking downstream from pond outlet (11/9/2021)
