**MONITORING YEAR 1
ANNUAL REPORT**
Final

PERRY HILL MITIGATION SITE

Orange County, NC
Neuse River Basin
HUC 03020201

DMS Project No. 100093
DMS Contract No. 7744
DMS RFP No. 16-007576
USACE Action ID No. 2019-00125
DWR Project No. 2019-0157

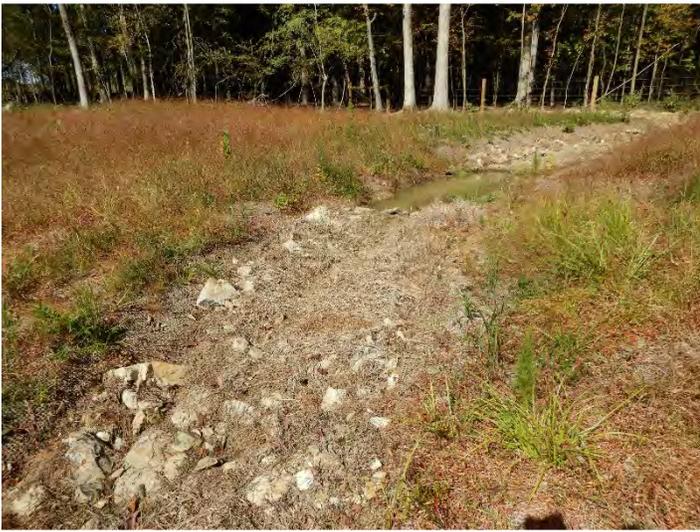
PHOTO POINT 1 Perry Branch R1 – upstream (10/21/2021)

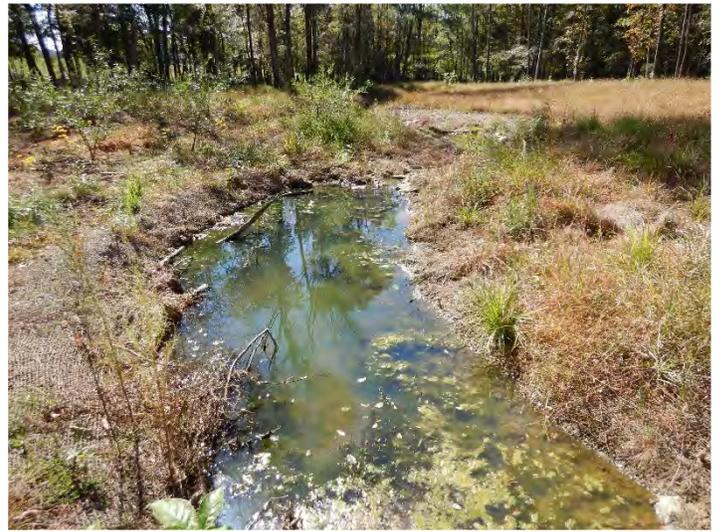
PHOTO POINT 1 Perry Branch R1 – downstream (10/21/2021)

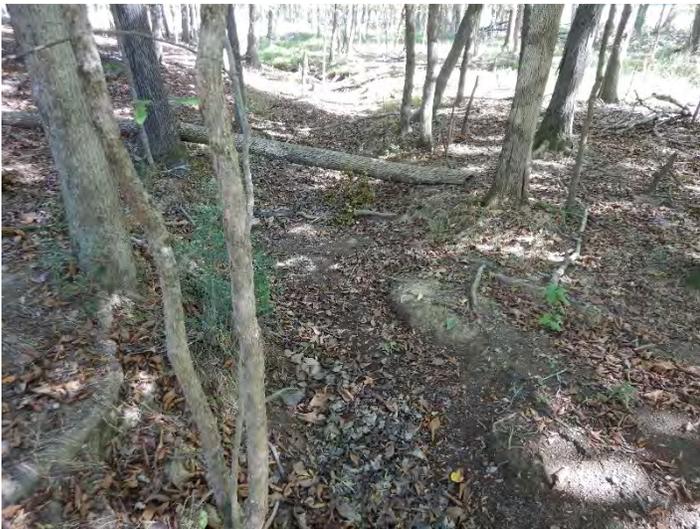
PHOTO POINT 2 Perry Branch R2 – upstream (10/21/2021)

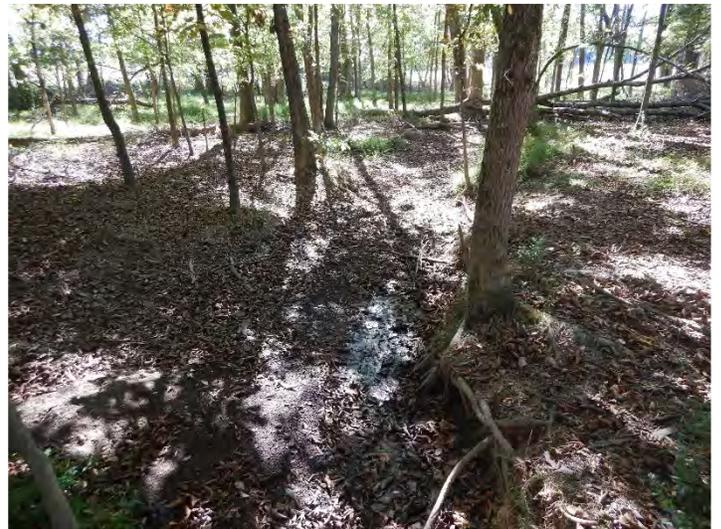
PHOTO POINT 2 Perry Branch R2 – downstream (10/21/2021)

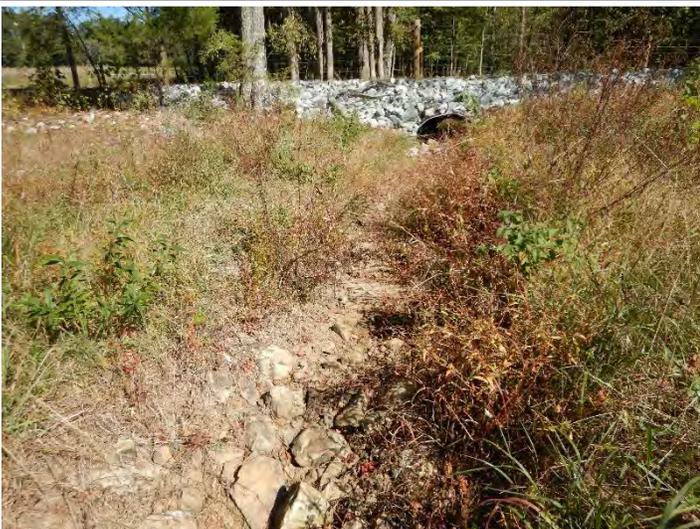
PHOTO POINT 3 Perry Branch R3 – upstream (10/21/2021)

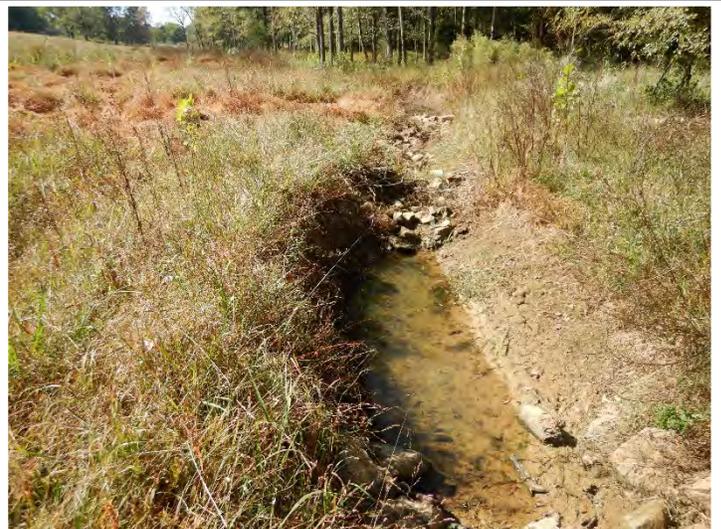
PHOTO POINT 3 Perry Branch R3 – downstream (10/21/2021)

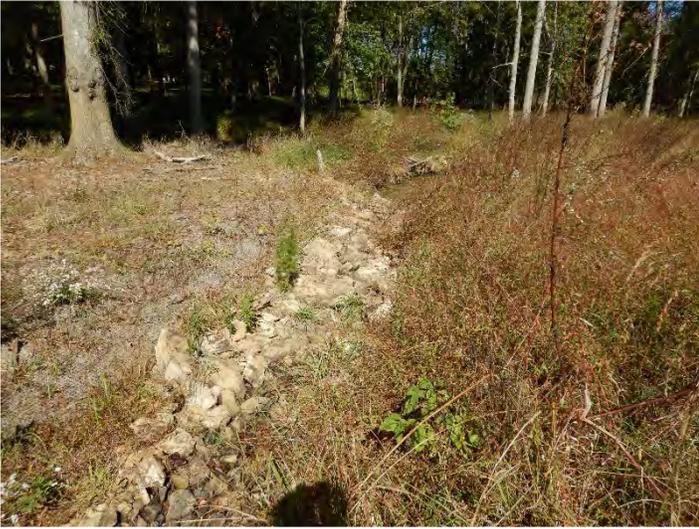
PHOTO POINT 4 Perry Branch R3 – upstream (10/21/2021)

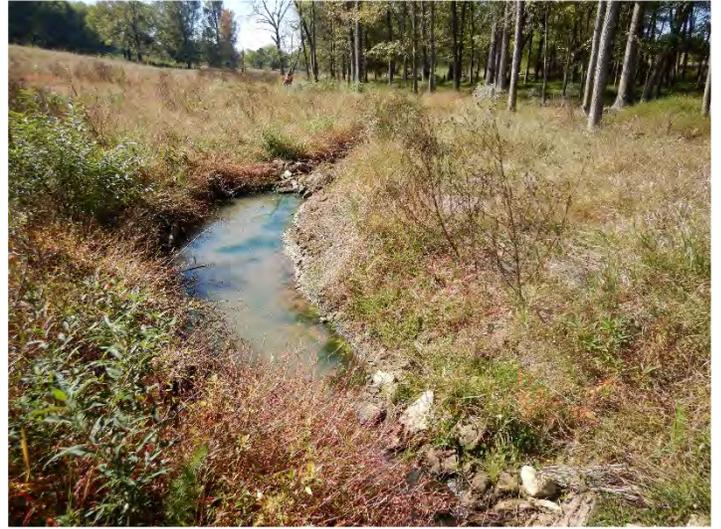
PHOTO POINT 4 Perry Branch R3 – downstream (10/21/2021)

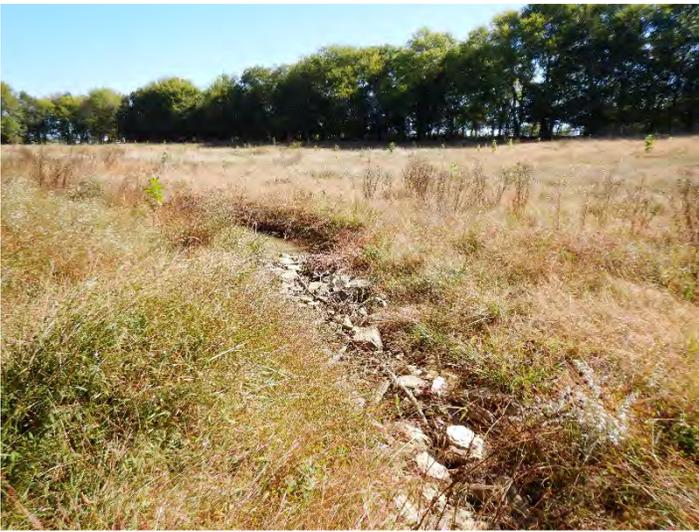
PHOTO POINT 5 Perry Branch R3 – upstream (10/21/2021)

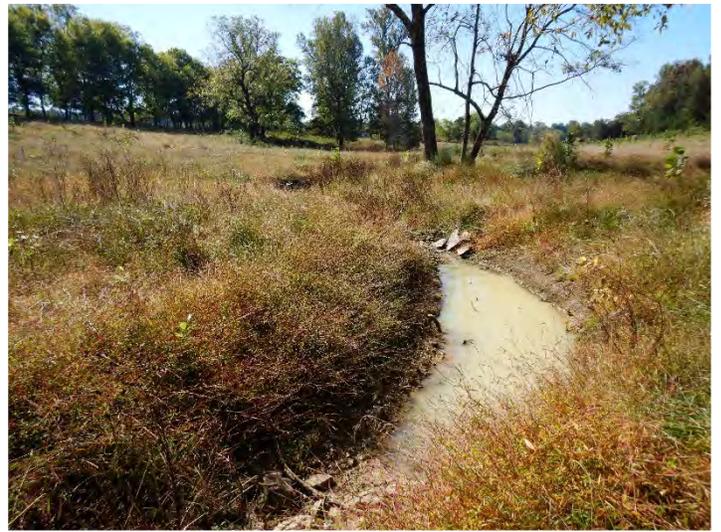
PHOTO POINT 5 Perry Branch R3 – downstream (10/21/2021)

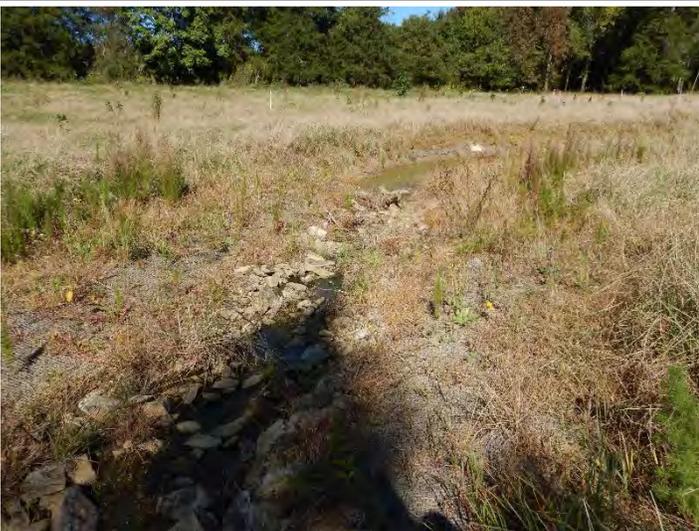
PHOTO POINT 6 Perry Branch R4 – upstream (10/21/2021)

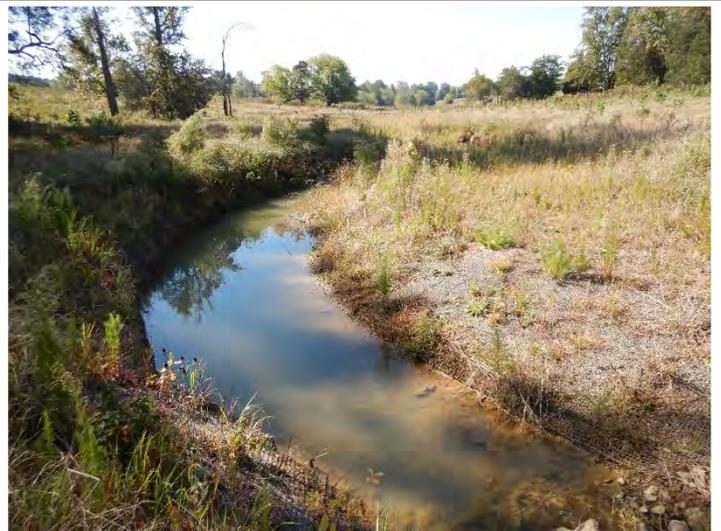
PHOTO POINT 6 Perry Branch R4 – downstream (10/21/2021)

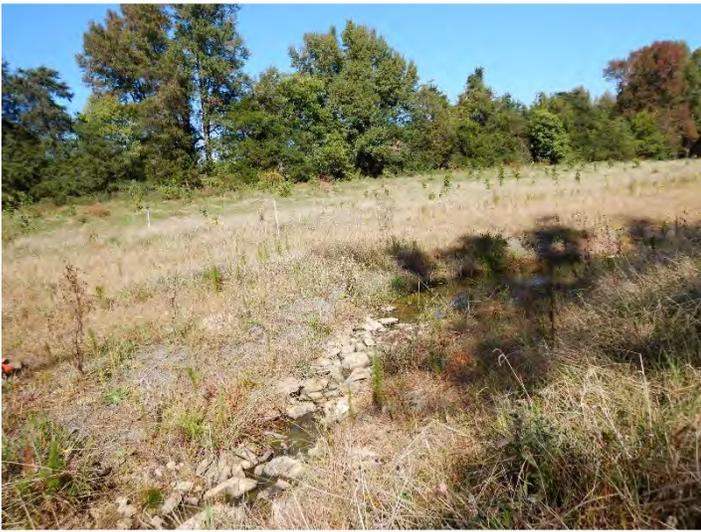
PHOTO POINT 7 Perry Branch R4 – upstream (10/21/2021)

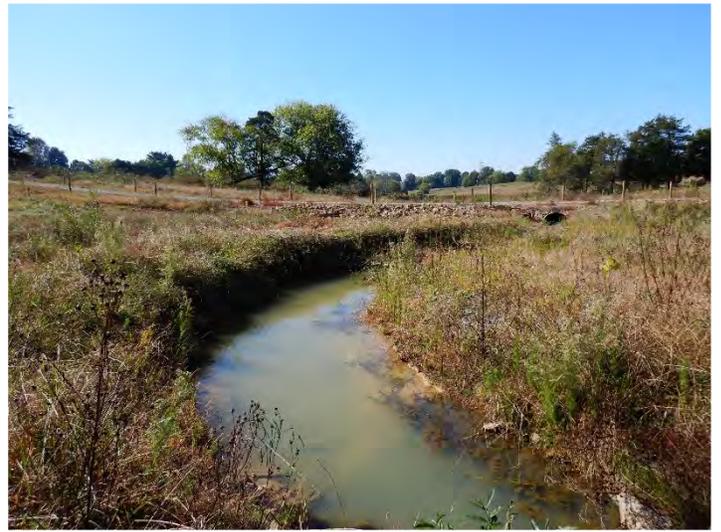
PHOTO POINT 7 Perry Branch R4 – downstream (10/21/2021)

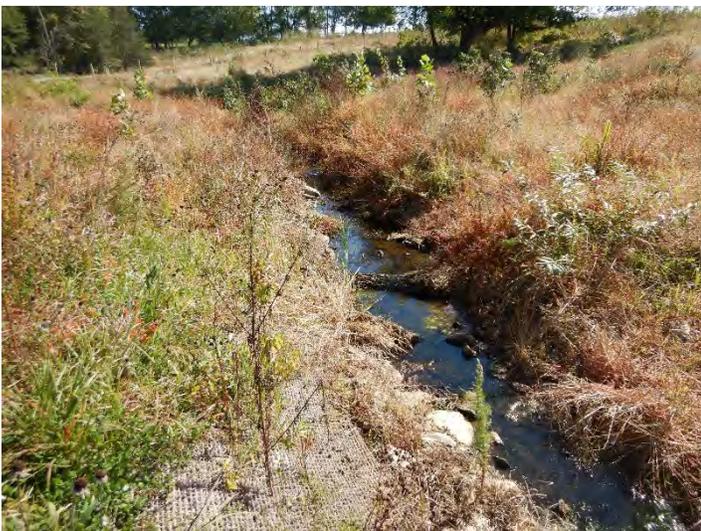
PHOTO POINT 8 Perry Branch R4 – upstream (10/21/2021)

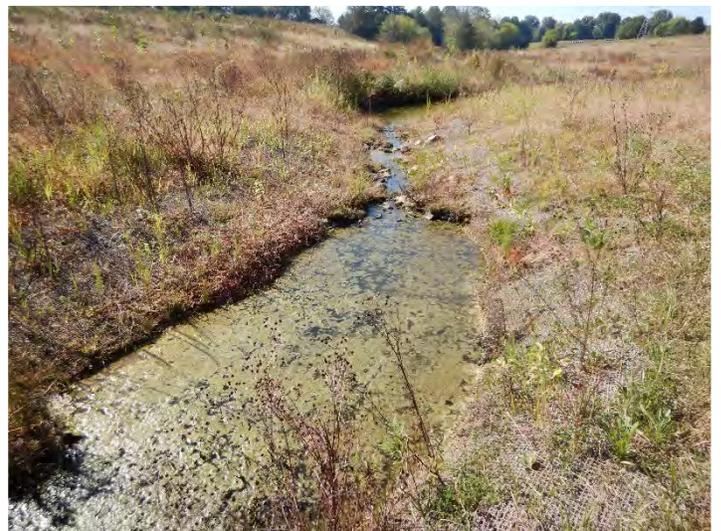
PHOTO POINT 8 Perry Branch R4 – downstream (10/21/2021)

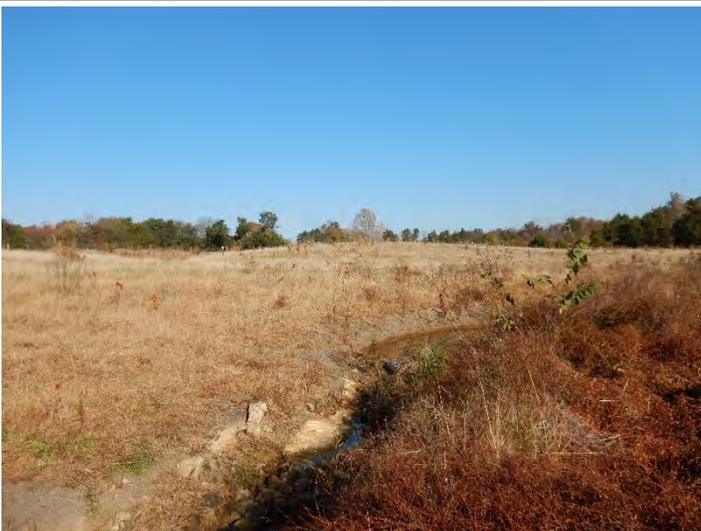
PHOTO POINT 9 Perry Branch R4 – upstream (11/17/2021)

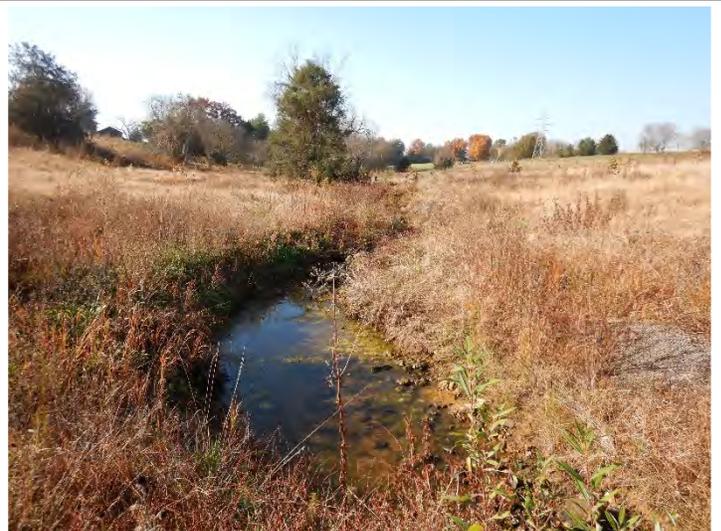
PHOTO POINT 9 Perry Branch R4 – downstream (11/17/2021)

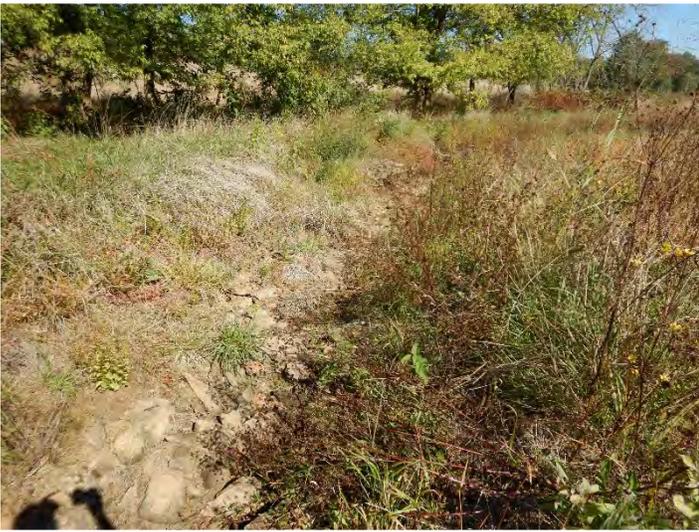
PHOTO POINT 10 Perry Branch R4 – upstream (10/21/2021)

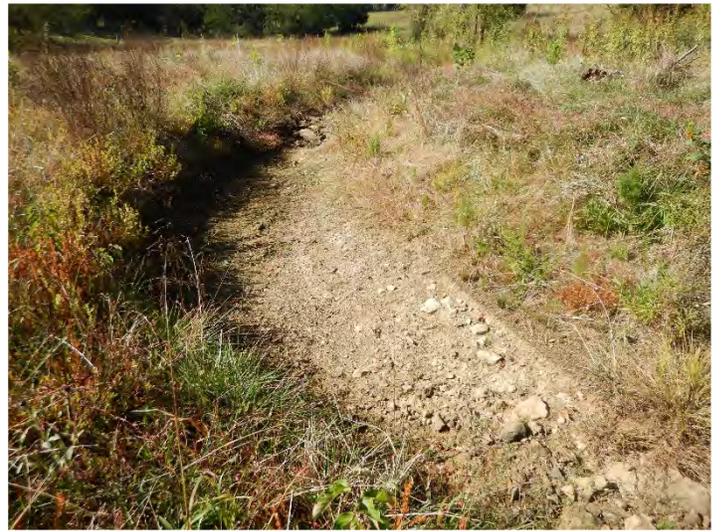
PHOTO POINT 10 Perry Branch R4 – downstream (10/21/2021)

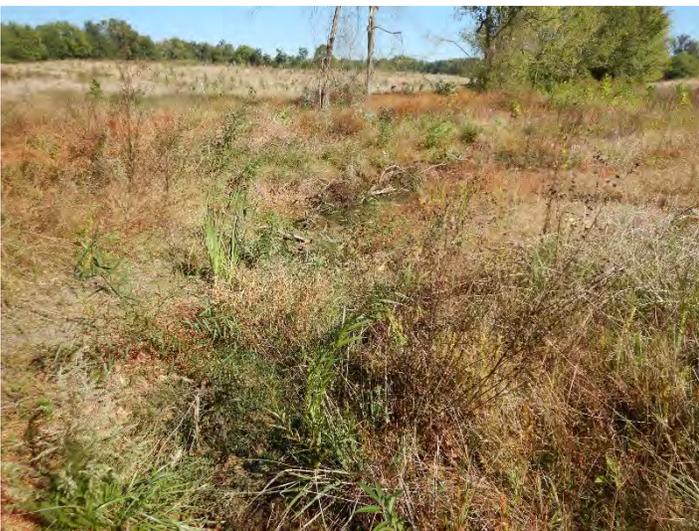
PHOTO POINT 11 Perry Branch R4 – upstream (10/21/2021)

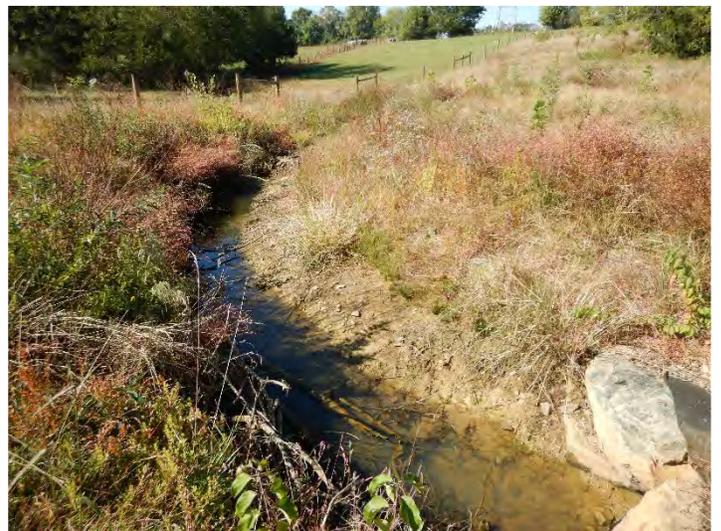
PHOTO POINT 11 Perry Branch R4 – downstream (10/21/2021)

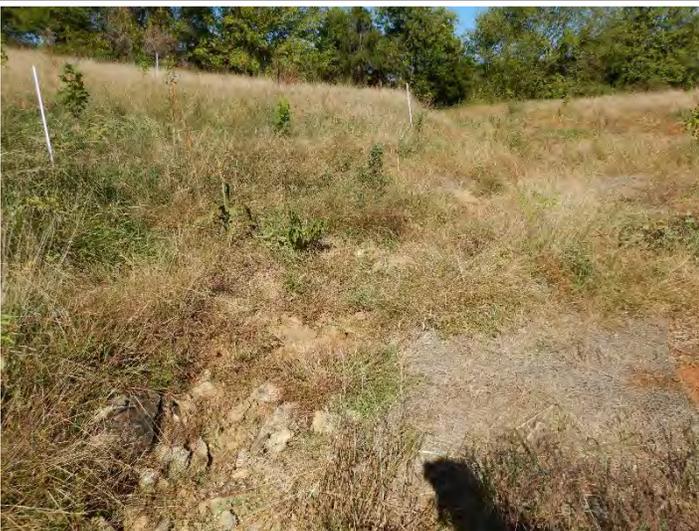
PHOTO POINT 12 UT1 R1 – upstream (10/21/2021)

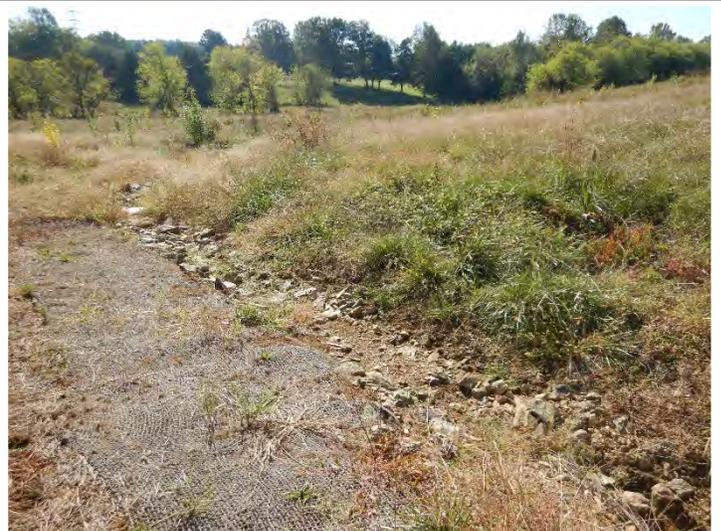
PHOTO POINT 12 UT1 R1 – downstream (10/21/2021)

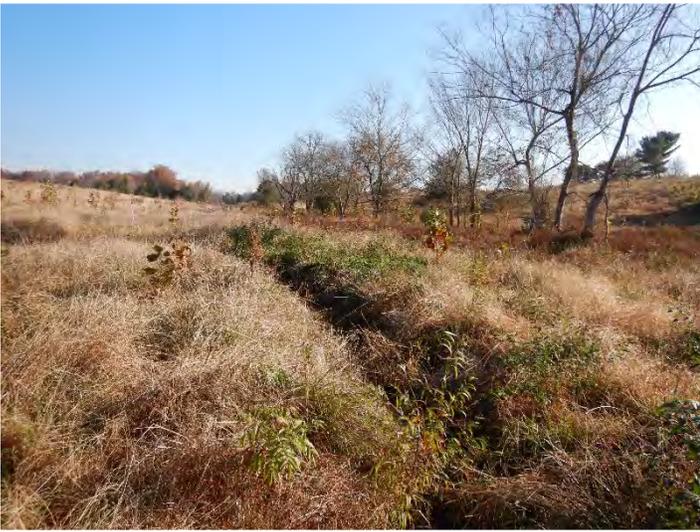
PHOTO POINT 13 UT1 R2 – upstream (11/17/2021)

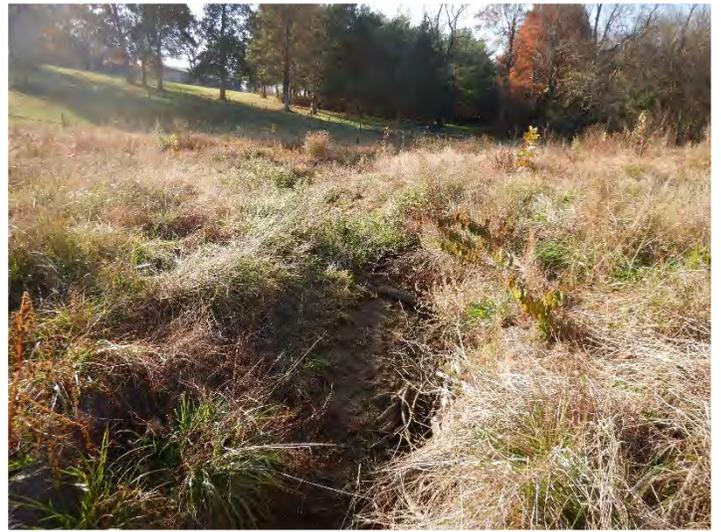
PHOTO POINT 13 UT1 R2 – downstream (11/17/2021)

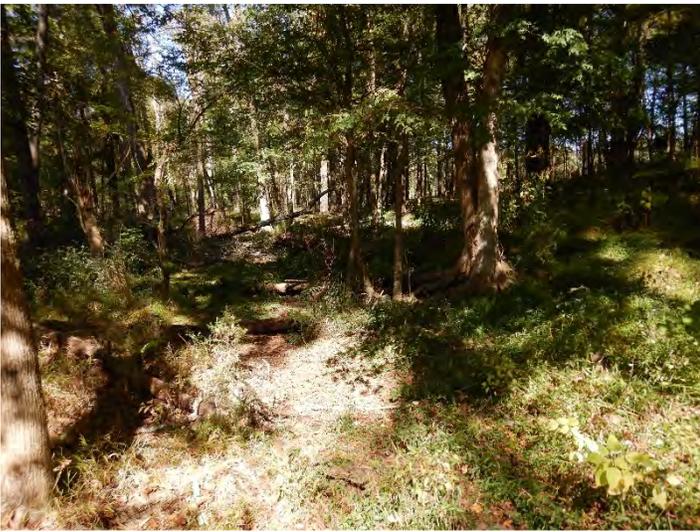
PHOTO POINT 14 UT2 R1 – upstream (10/21/2021)

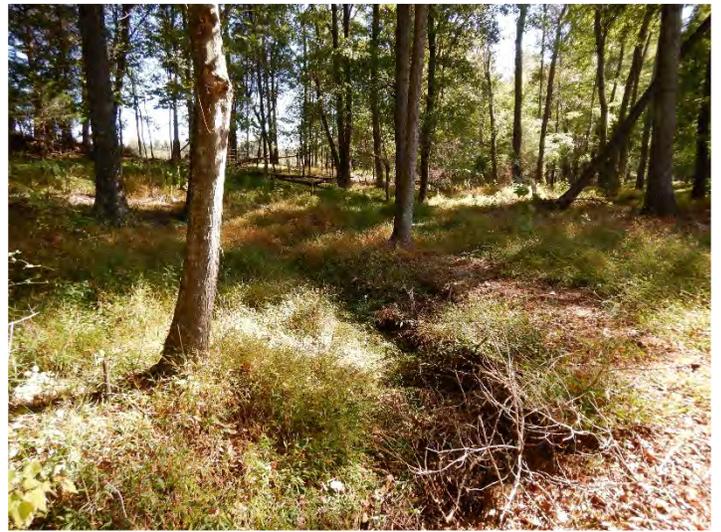
PHOTO POINT 14 UT2 R1 – downstream (10/21/2021)

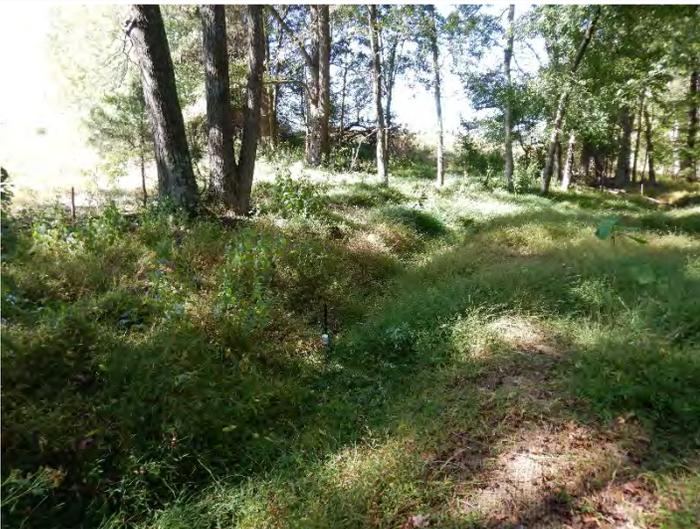
PHOTO POINT 15 UT2 R2 – upstream (10/21/2021)

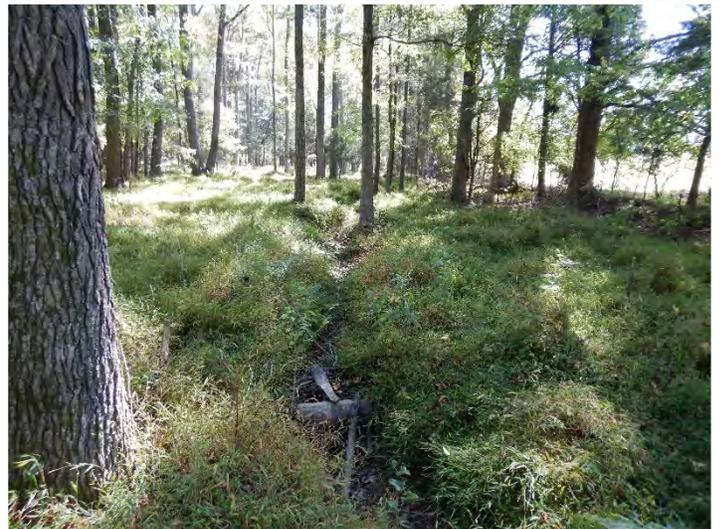
PHOTO POINT 15 UT2 R2 – downstream (10/21/2021)

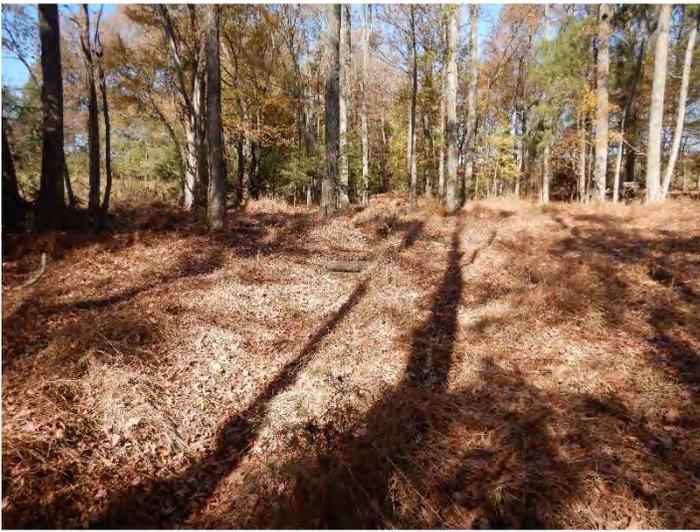
PHOTO POINT 16 UT2 R2 – upstream (11/17/2021)

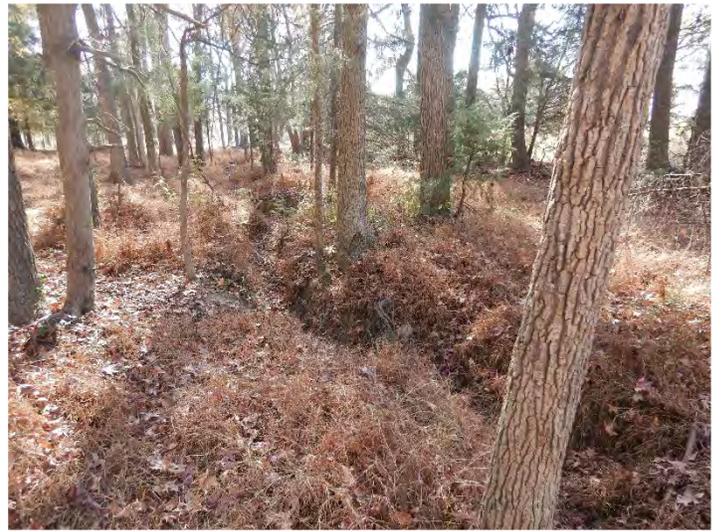
PHOTO POINT 16 UT2 R2 – downstream (11/17/2021)

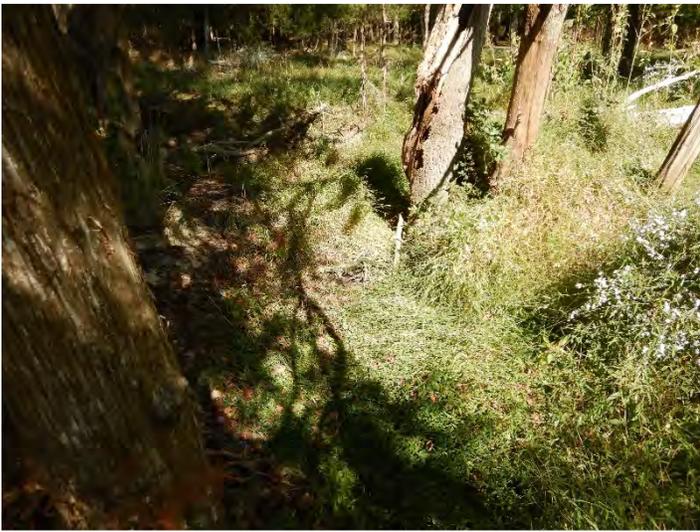
PHOTO POINT 17 UT2 R2 – upstream (10/21/2021)

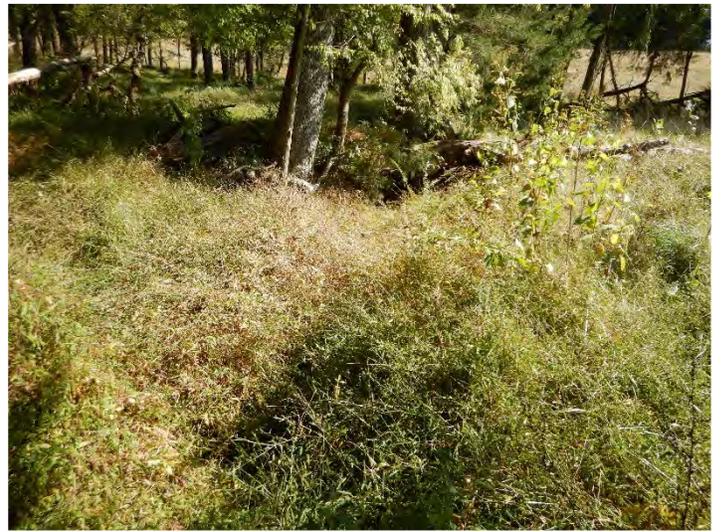
PHOTO POINT 17 UT2 R2 – downstream (10/21/2021)

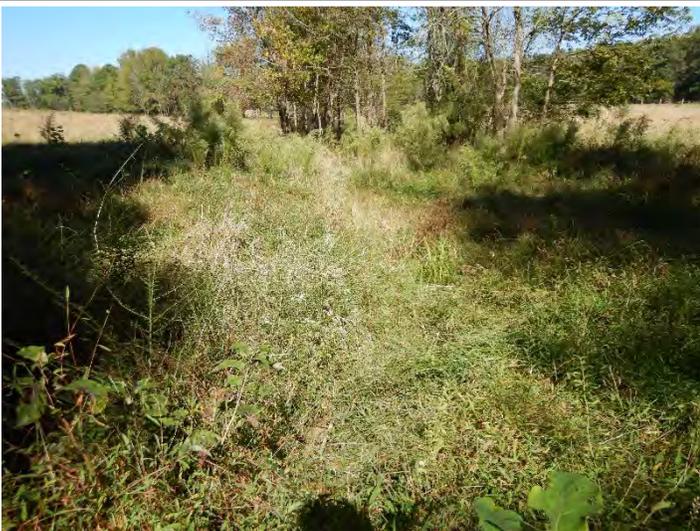
PHOTO POINT 18 UT3 – upstream (10/21/2021)

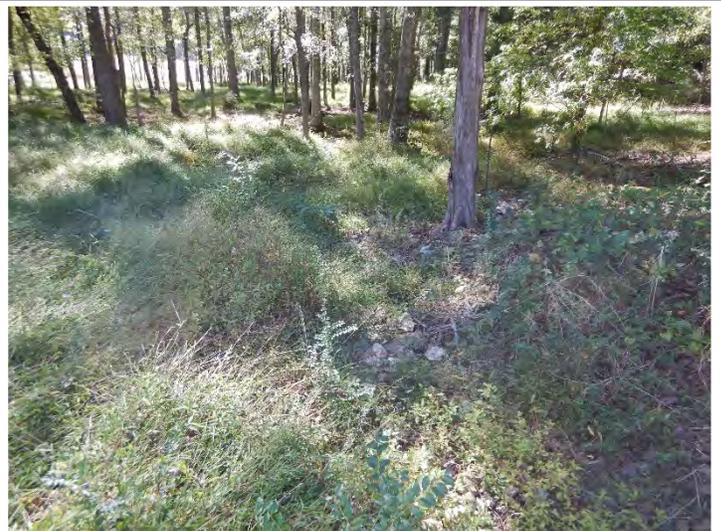
PHOTO POINT 18 UT3 – downstream (10/21/2021)

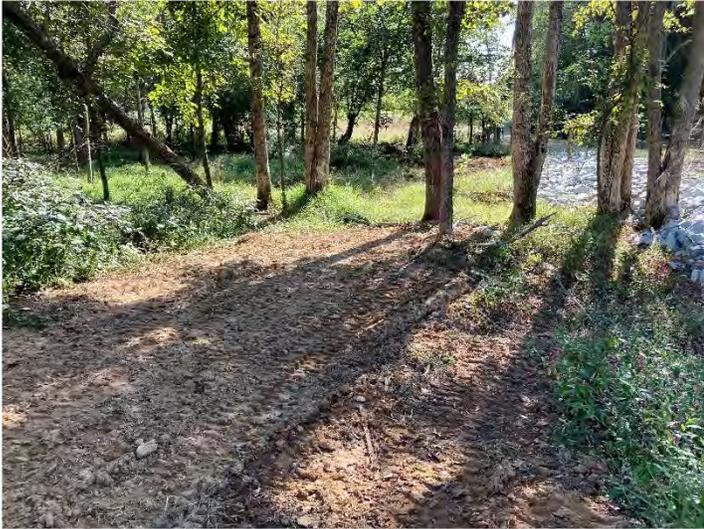
Perry Branch R2 – CE Encroachment (10/04/2021)
