## MY1 Monitoring Report

Owen Farms Mitigation Site  
Transylvania County, NC

NCDMS Project No. 100064  
NCDMS Contract No. 7532  
NCDMS RFP No. 16-007334  
(Issued 9/8/2017)

Data Collected: 2021

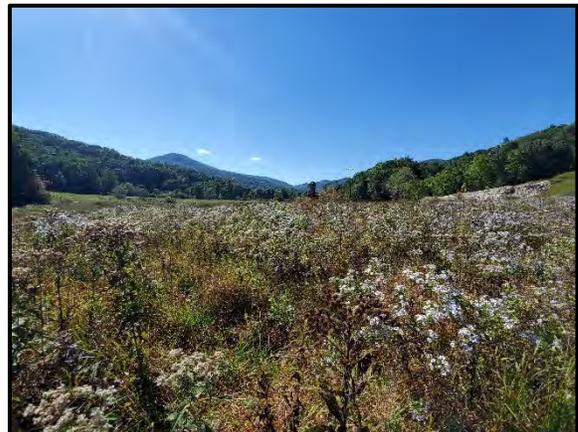
**3.12 Vegetation Plot 12, 9/28/2021**

14. Please submit the vegetation areas of concern as polygons (e.g. Bare Areas, Low Stem Density Areas, and Areas of Poor Growth Rates) and include these in the CCPV – here too, ensure that feature areas reflect the reported areas (Table 8). Also, please update # Encroachments noted to 0. *RE: Encroachments changed to 0 on Table 8. Features have been added to CCPV. Table 8 has also been updated to reflect sparsely vegetated areas more accurately. Woody stem density was based off vegetation plot 12 not meeting performance standards.*

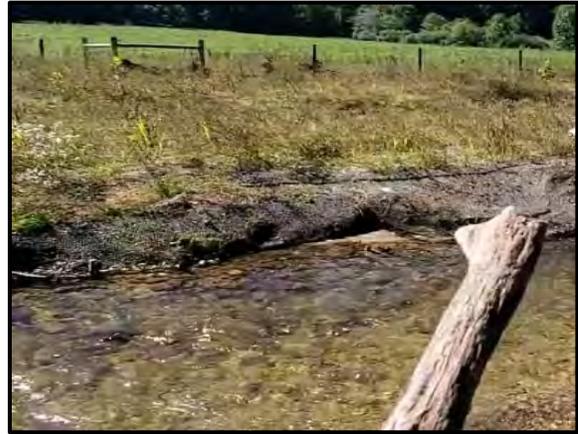
**3.32 Low bank erosion at station 14+00,  
9/27/2021**

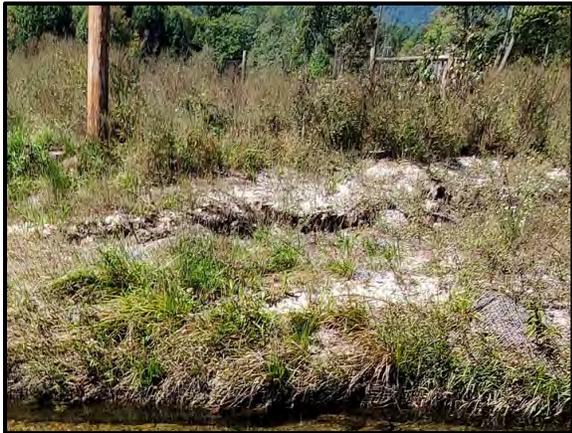
**3.33 Right floodplain erosion at  
Station 15+20, 9/27/2021**

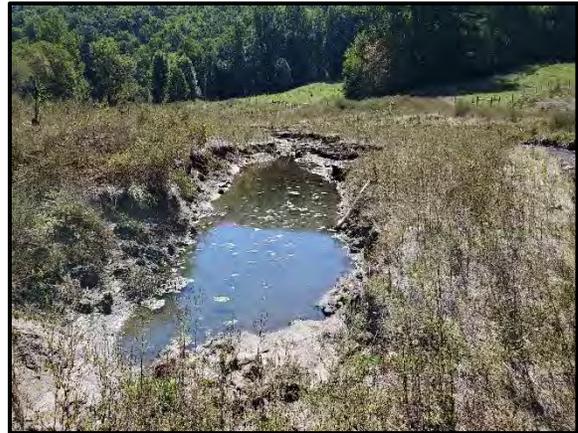
**3.34 Severe floodplain erosion  
between Station 16+25 and 18+10,  
9/27/201**

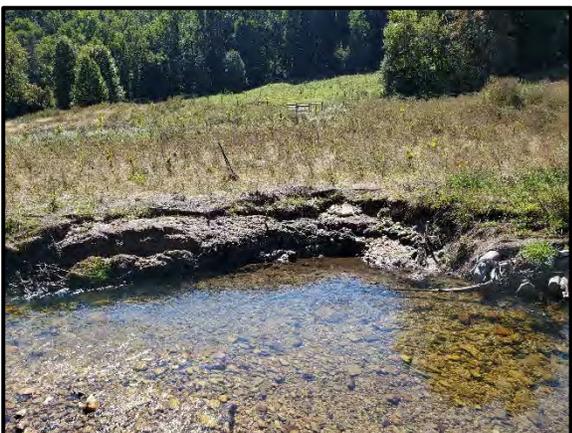
**3.35 Severe erosion at Station 18+80  
9/27/2021**

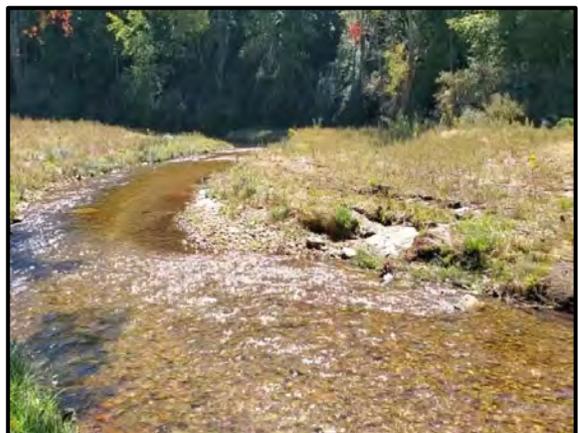
**3.36 Toe scour at station 24+30,  
9/21/2021**

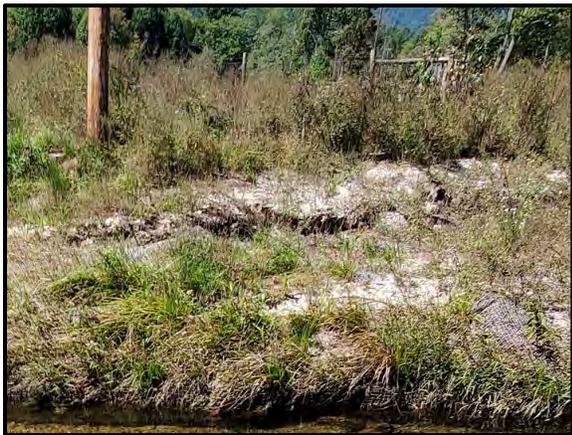
**3.33 Right floodplain erosion at  
Station 15+20, 9/27/2021**

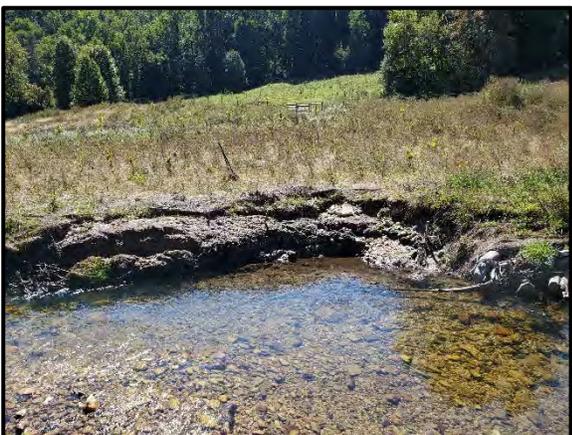
**3.35 Severe erosion at Station 18+80  
9/27/2021**

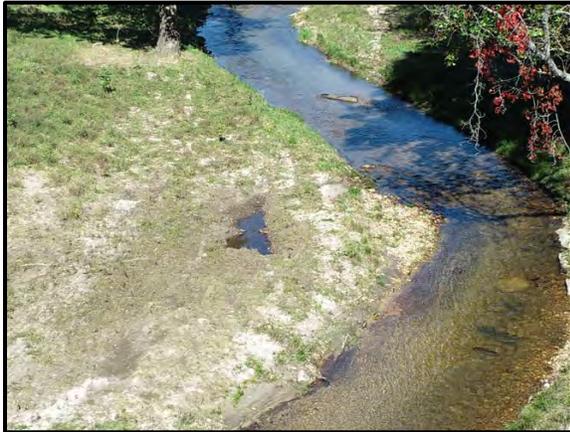
**3.37 Aerial photo of floodplain scour at Station 25+00, 9/27/2021**

LMG has developed a repair plan for the Site. Standard construction equipment will be used to repair degraded areas (i.e. excavator and off-road hauler). Scoured areas in the floodplain will be filled with on-site material excavated from adjacent terrace slopes. Excess cobble and gravel material deposited between stations 10+50 and 11+50, creating a transverse bar. This excess material will be removed and placed along the channel toe of repaired stream banks. Eroded Stream banks will be graded to approximate design dimensions and matted with coir fiber matting. Approximately 50 linear feet of soil lifts will be installed between stations 18+60 and 19+10. Overall, approximately 100 linear feet of stream bank grading and 100 linear feet of substrate removal is anticipated as a result of repair activities. Disturbed areas will be seeded with a permanent, native seed mix and replanted with native species as approved in the Mitigation Plan. A temporary seed mix consisting of rye (grass and/or grain) will also be applied to disturbed areas.

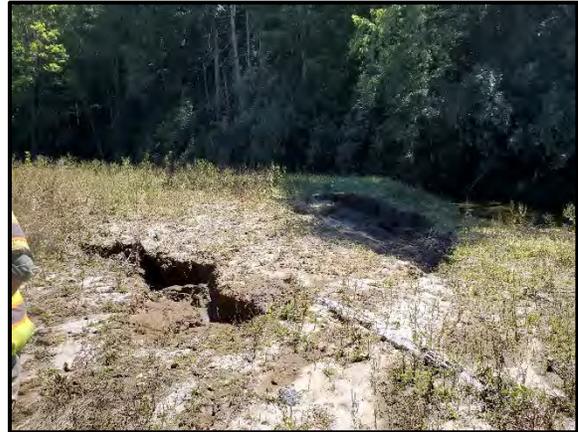
**3.38 Floodplain scour along left bank at Station 27+00, 9/27/2021**

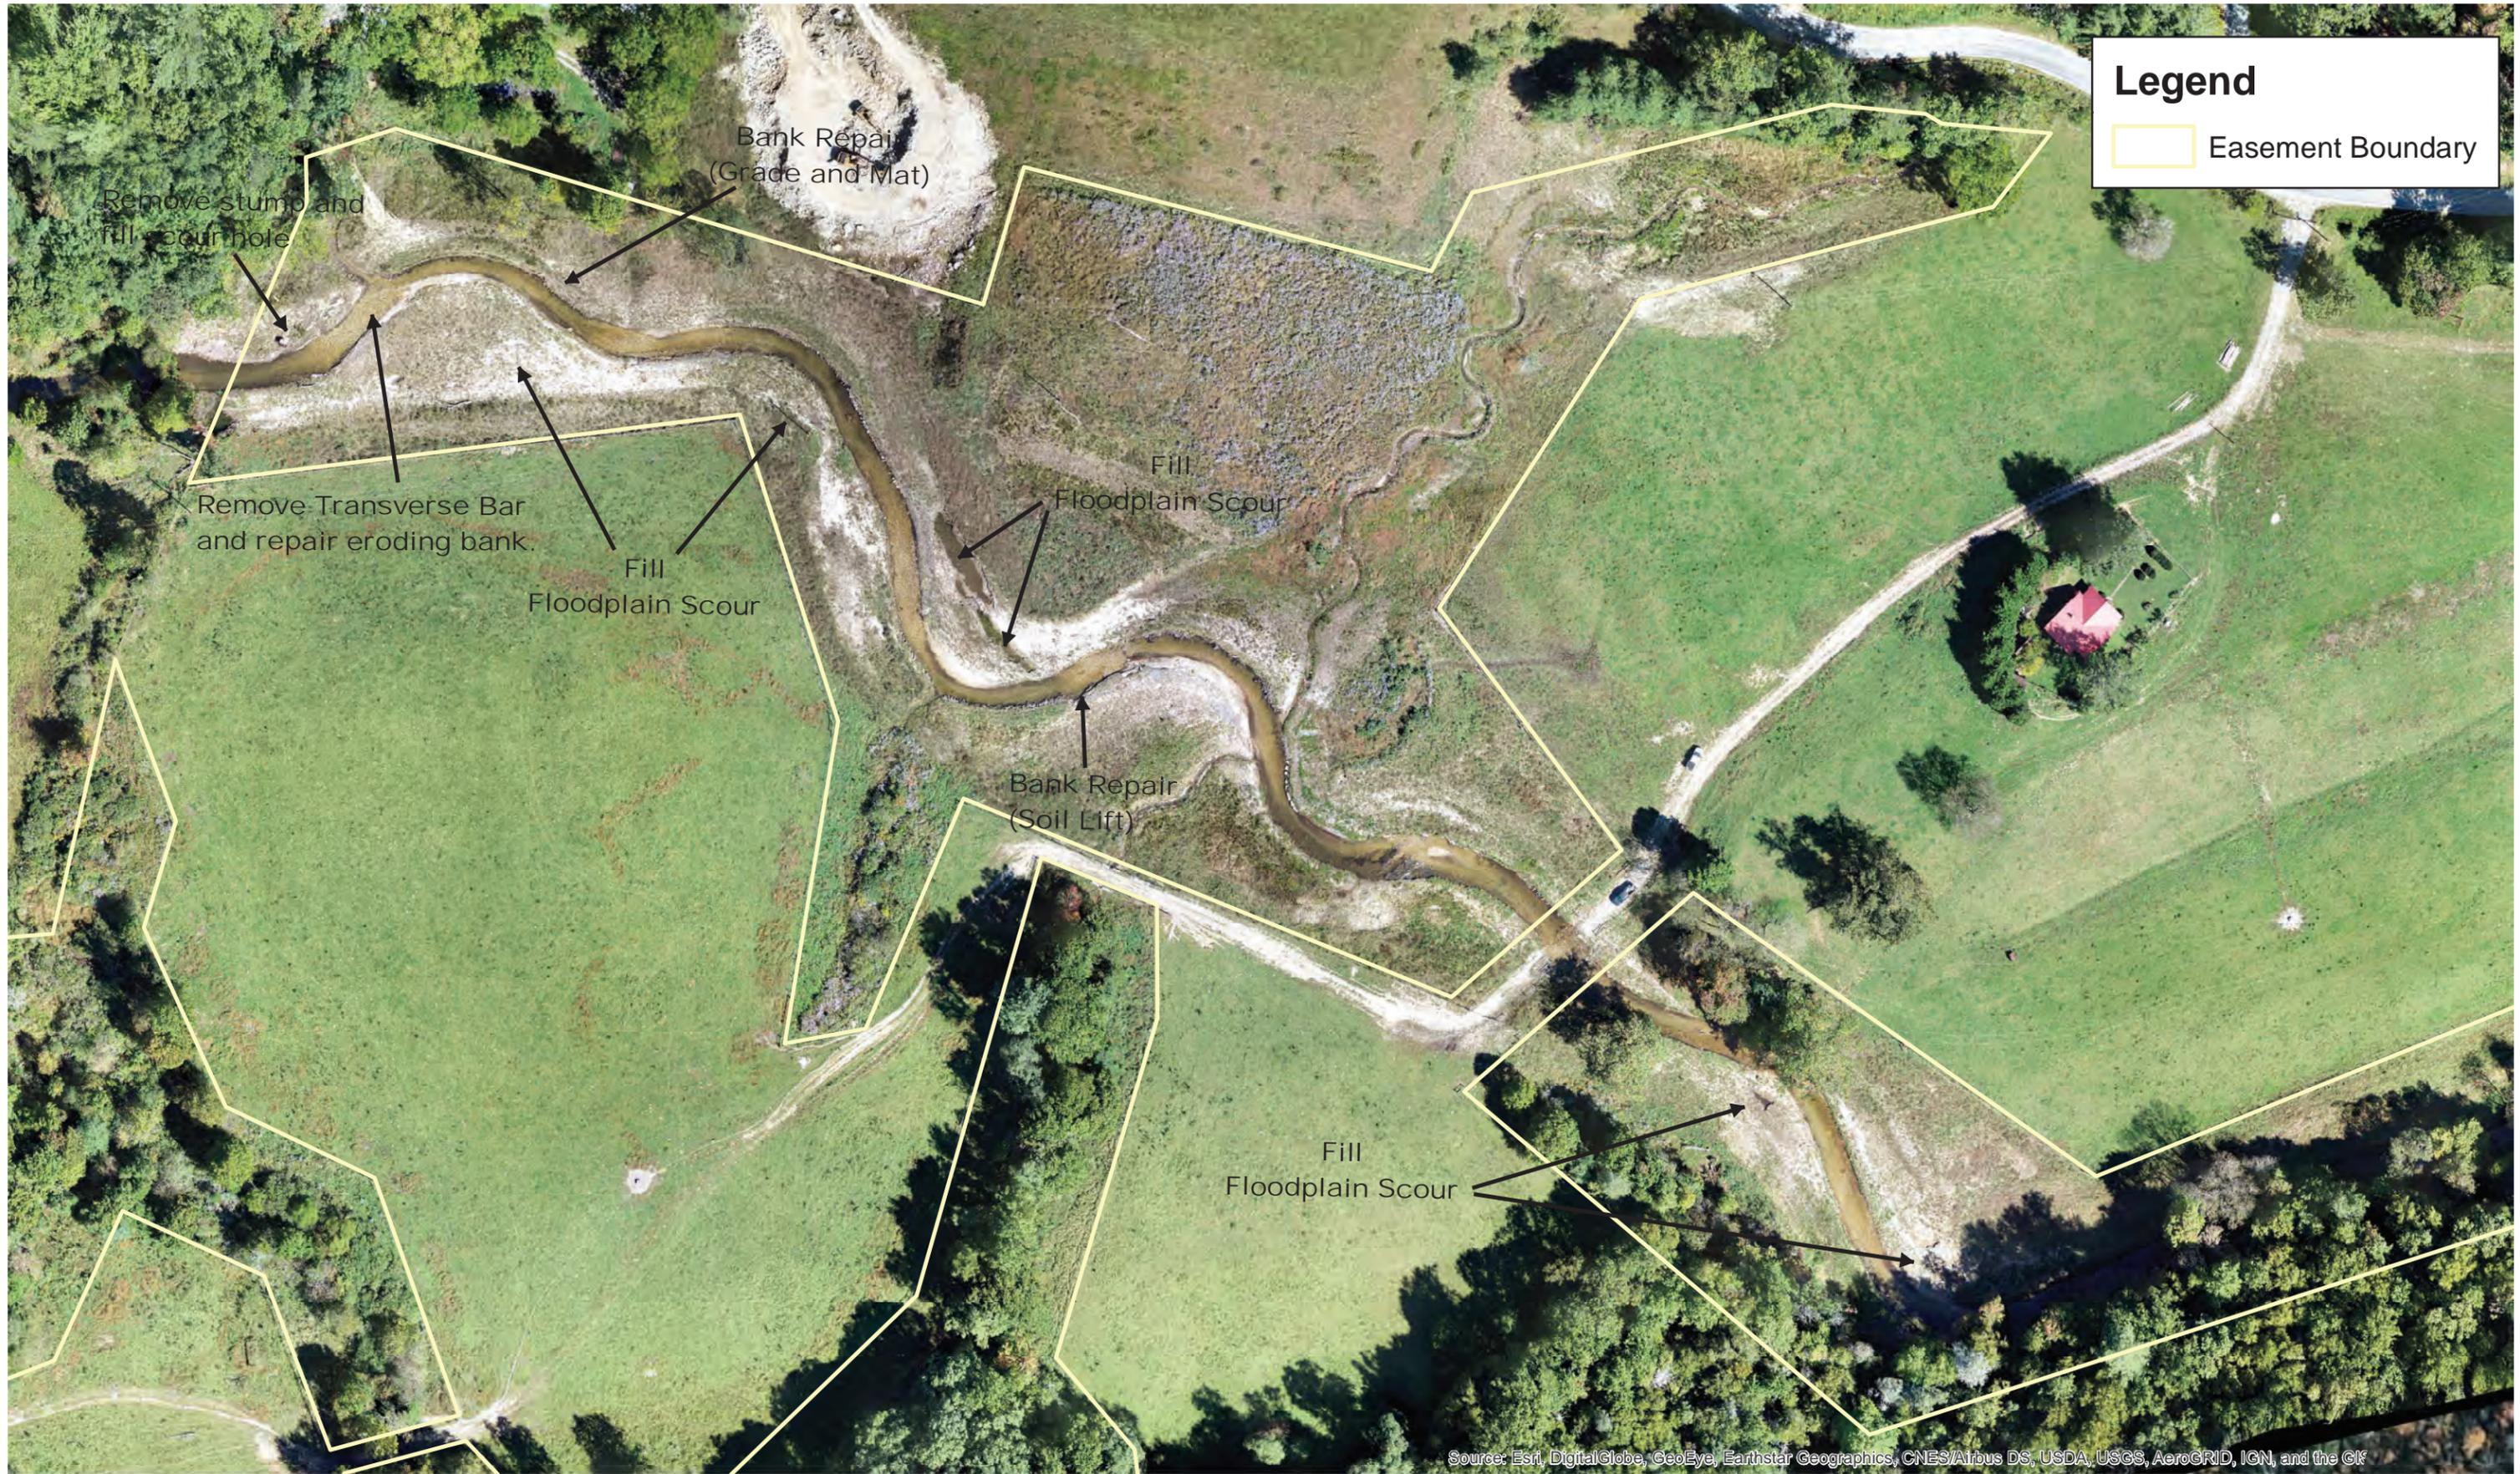
**REPAIR PLAN MAP**  
**OWEN FARMS MITIGATION SITE**

The purpose of this letter is to inform you of recent damage observed at the Owen Farms Mitigation Site (Site) and describe our plan for corrective action. The Site experienced a 200-year storm event between August 15-17. On-site rain data recorded 16.70 inches over a 72-hour period, with 6.07 inches falling within 3 hours on August 16. Monthly precipitation totals recorded at the site are attached. This storm event resulted in floodplain scour, eroded banks, and excess channel deposition. LMG used a drone to capture aerial imagery of the Site on September 29, 2021. Figure 1 (attached) depicts areas of disturbance discussed above overlain on aerial imagery from September 29, 2021. The attached photo log provides representative photos of disturbed areas.
