Annual Monitoring Report

**Mill Dam Creek Restoration Site
Yadkin River Basin - 03040101
Monitoring Year 01
DEQ Contract 6898
DMS Project Number 97136**

**DWR #: 18-1349
USACE Action ID: 2016-01335
Yadkin County, North Carolina**

**Data Collected: 2020
Date Submitted: January 2021**

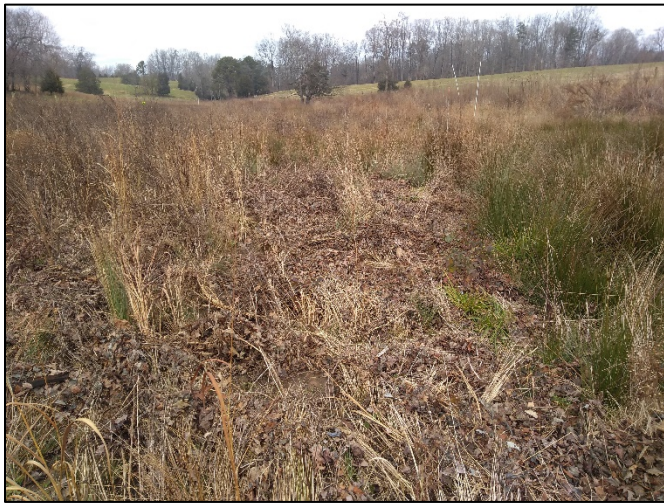
Photo 1. Wrack lines above bankfull, UTHC1 – 12/18/2020

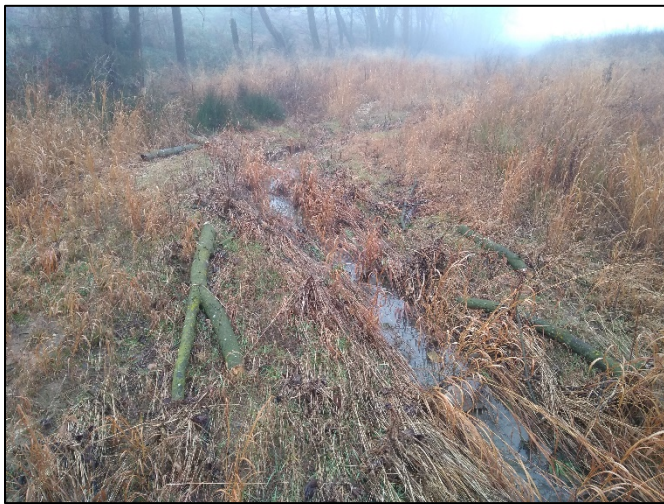
Photo 3. Wrack lines above bankfull, T1 – 12/18/2020

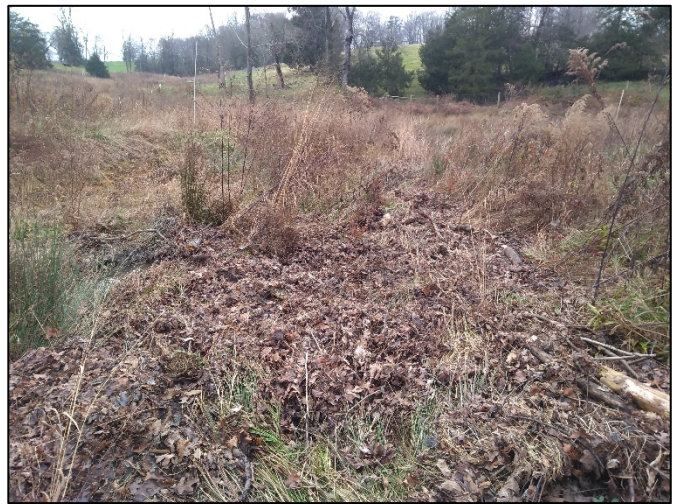
Photo 4. Wrack lines above bankfull, T2 – 12/18/2020

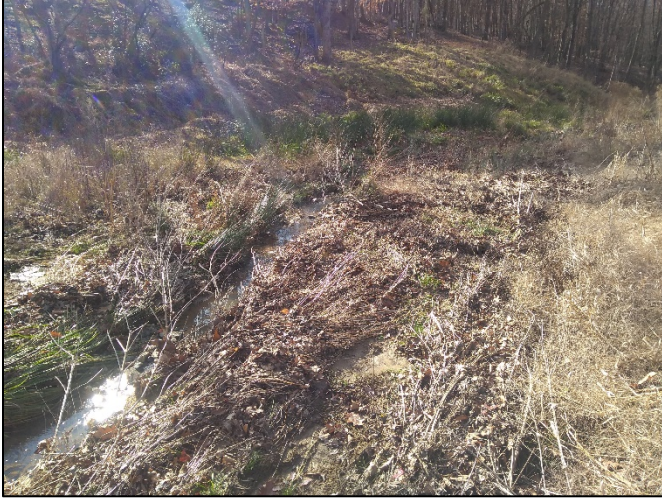
Photo 5. Wrack lines above bankfull, T6 – 12/18/2020

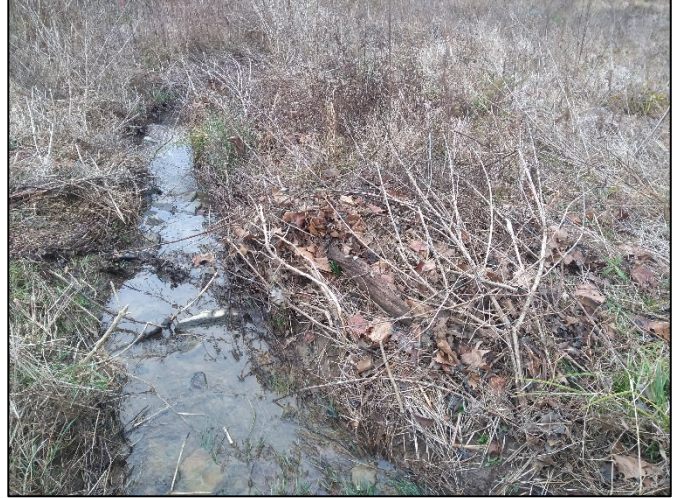
Photo 6. Wrack lines above bankfull, T8 – 12/18/2020
