Thomas Creek Restoration Project

Year 1 Monitoring Report

Wake County, North Carolina

DMS Project ID Number – 96074, DEQ Contract No. 5549

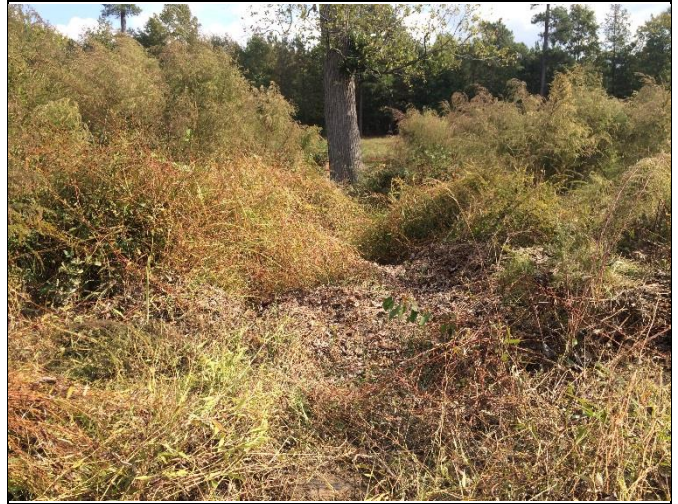
Reach 2, view of drainage on left bank at Station 32+90

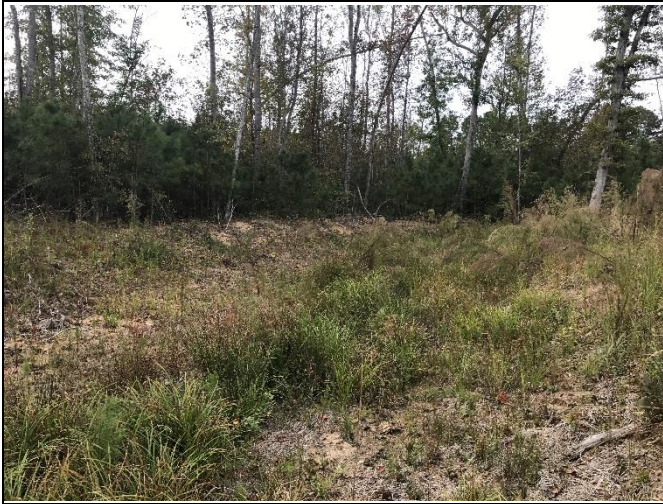
Reach 1, view of drainage on left bank at Station 44+00

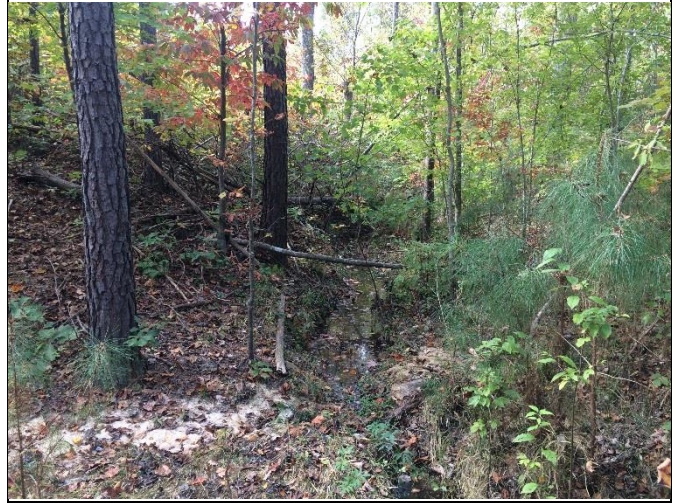
Reach 7, view of stabilized drainage at Station 13+50

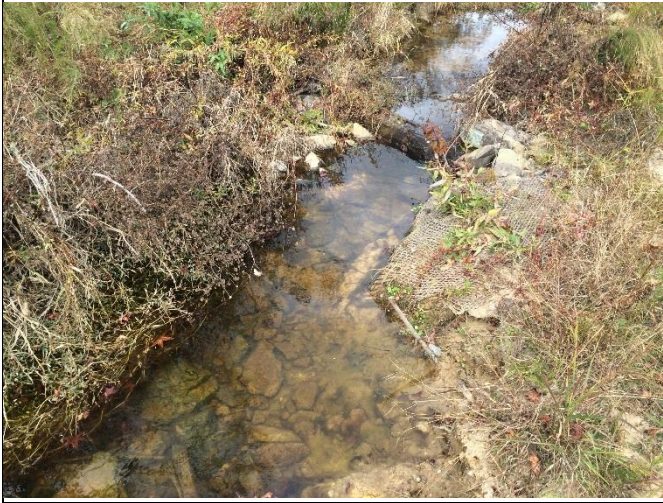
Stream Problem Area (upstream), Oct. 2016, Station 40+60

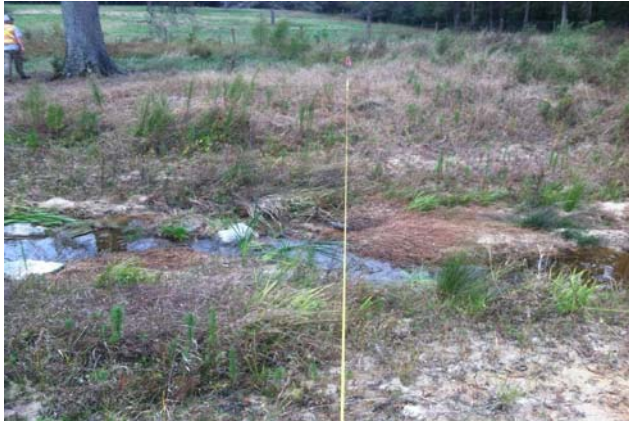
Permanent Cross-section 12
(Year 1 Data - Collected November 2016)

Looking at the Left Bank

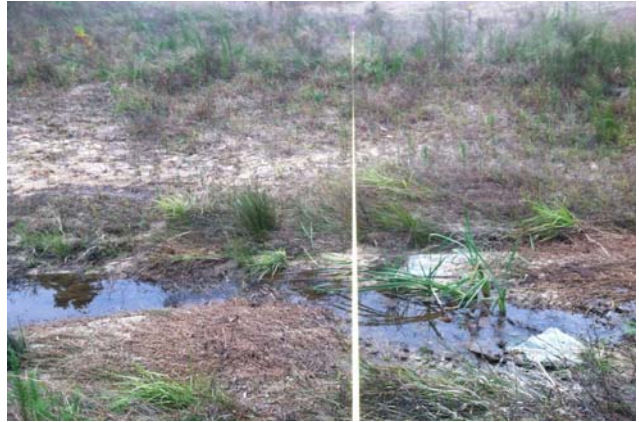
Looking at the Right Bank

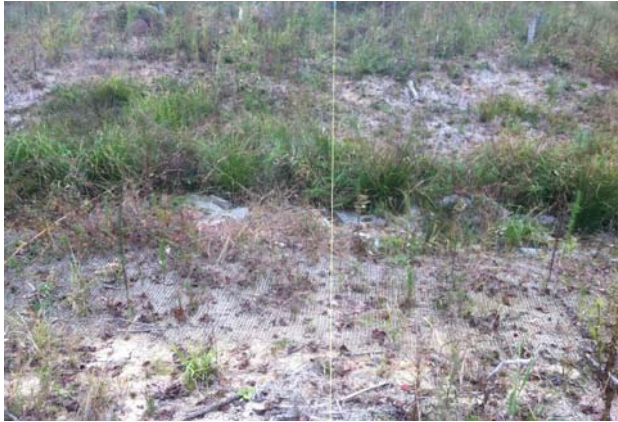
Permanent Cross-section 13
 (Year 1 Data - Collected November 2016)

Looking at the Left Bank

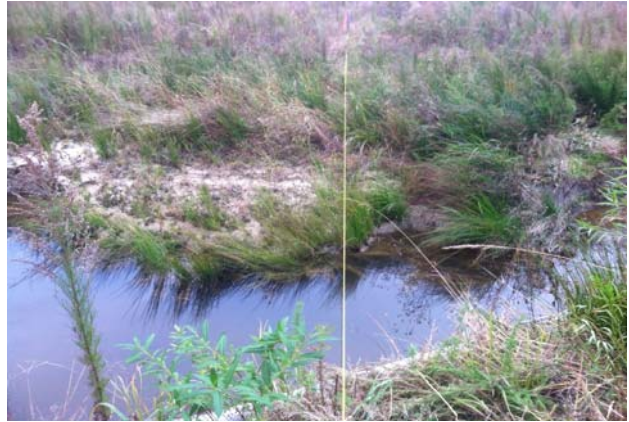
Looking at the Right Bank

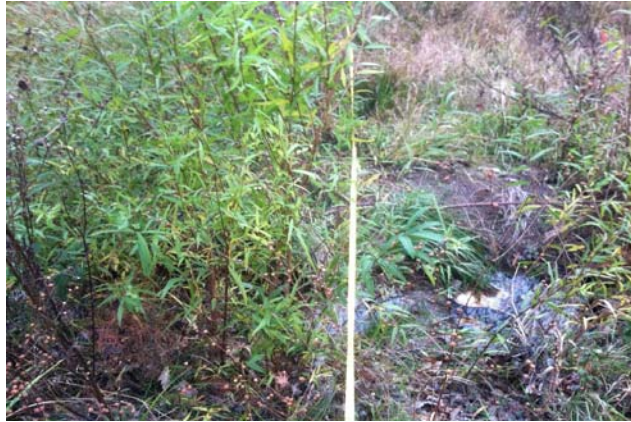
Permanent Cross-section 14
(Year 1 Data - Collected November 2016)

Looking at the Left Bank

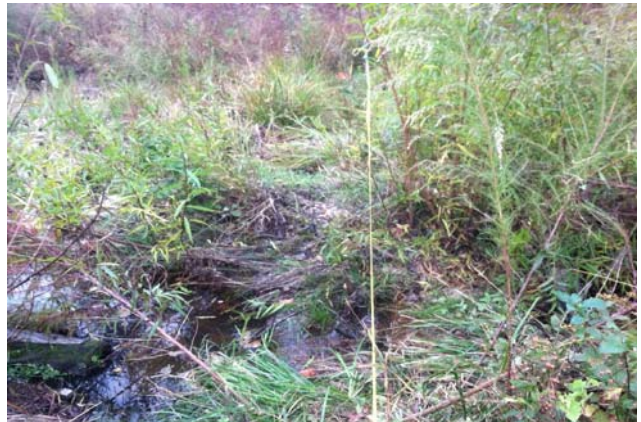
Looking at the Right Bank

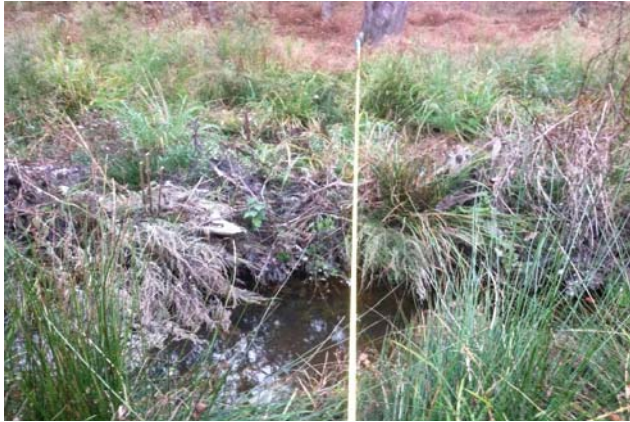
Permanent Cross-section 15
(Year 1 Data - Collected November 2016)

Looking at the Left Bank

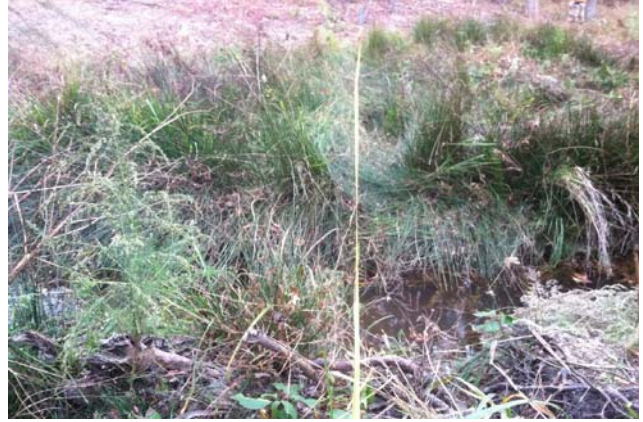
Looking at the Right Bank

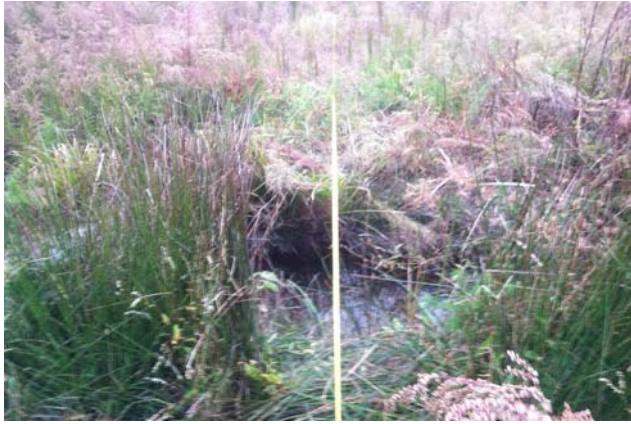
Permanent Cross-section 16
(Year 1 Data - Collected November 2016)

Looking at the Left Bank

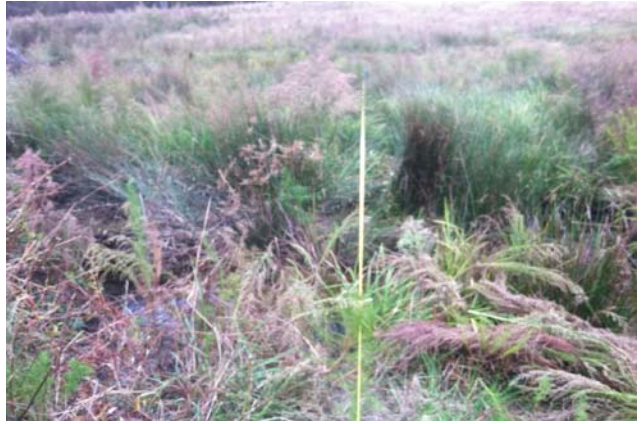
Looking at the Right Bank
