Subject: Response to DMS Comments for DRAFT Monitoring Year 2 Report
Thomas Creek Restoration Project, Wake County
DMS Project # 96074, DEQ Contract #5549, RFP# 16-005020

FINAL

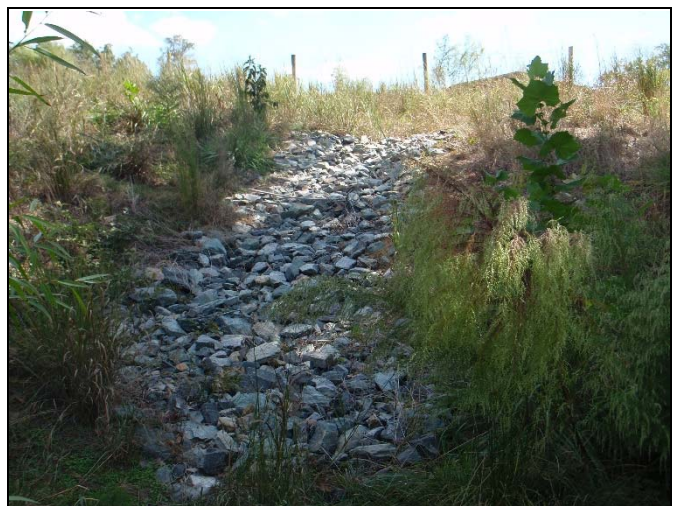
Reach 2, view of stabilized drainage on left bank at Station 20+80

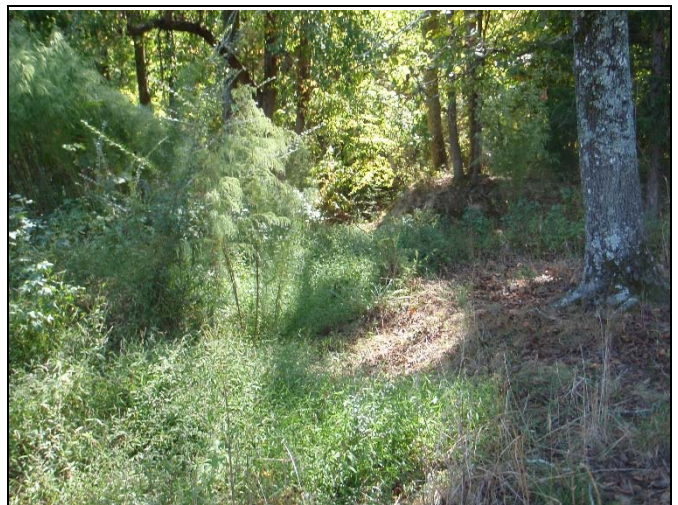
Reach 1, view of drainage on left bank at Station 44+00
