Subject: Response to DMS Comments for DRAFT Monitoring Year 3 Report
Thomas Creek Restoration Project, Wake County
DMS Project # 96074, DEQ Contract #5549, RFP# 16-005020

Figure 5 Index Map
Current Condition Plan View
Thomas Creek Site - MY3

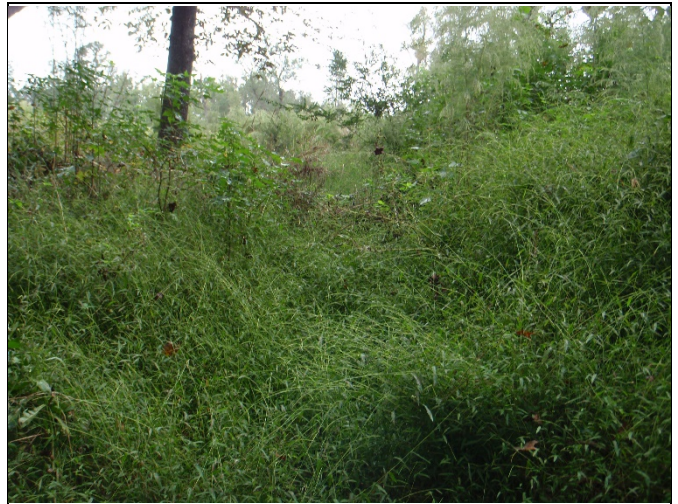
PP-36: Reach 1, view of drainage on left bank at Station 44+00

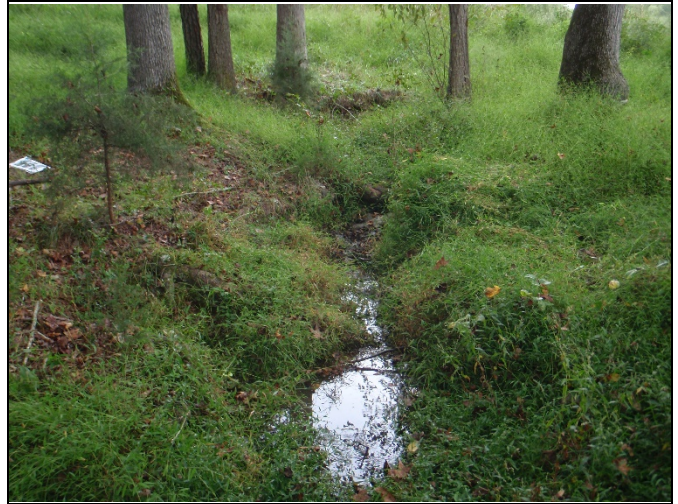
PP-58: Reach T2, view upstream at Station 10+80

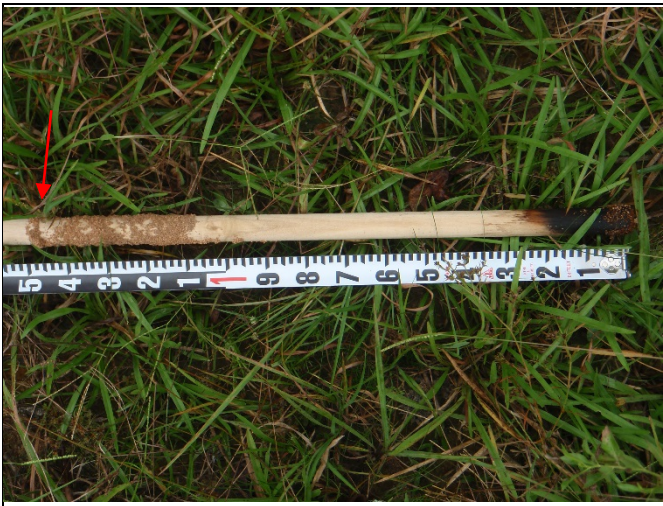
Overbank event of 1.49 ft from Hurricane Florence (photo: 10/10/18)

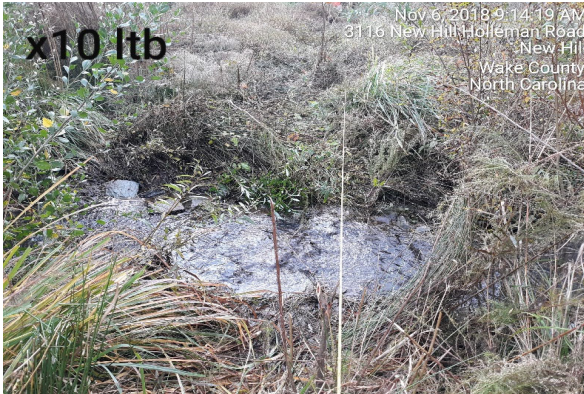
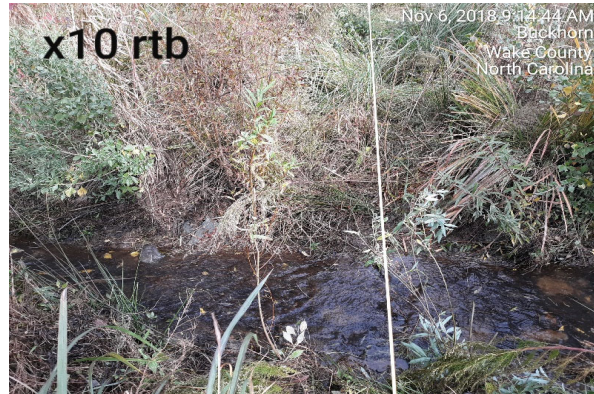
Permanent Cross-section 10

Feature	Stream Type	BKF Area	BKF Width	BKF Depth	Max BKF Depth	W/D	BH Ratio	ER	BKF Elev	TOB Elev
Riffle	C	5.7	8.5	0.7	1.0	12.7	0.9	8.8	254.18	254.32

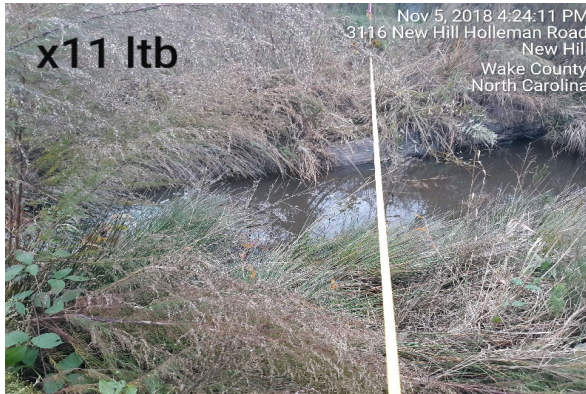
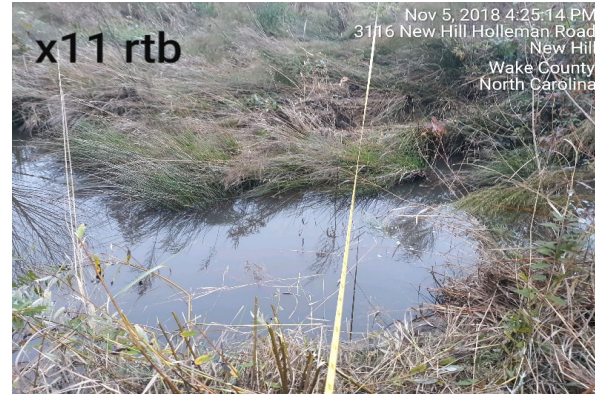
Permanent Cross-section 11

Feature	Stream Type	BKF Area	BKF Width	BKF Depth	Max BKF Depth	W/D	BH Ratio	ER	BKF Elev	TOB Elev
Pool	-	34.6	16.3	2.1	4.1	7.7	-	-	249.04	249.24

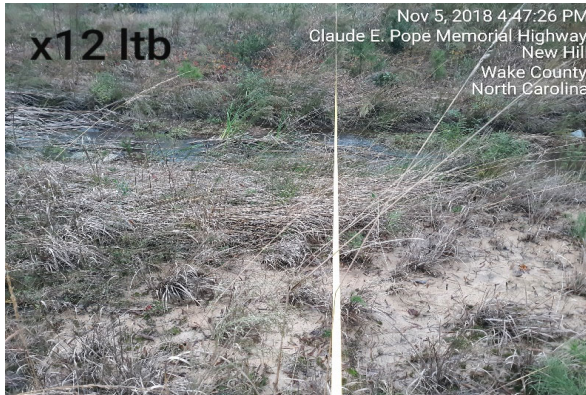
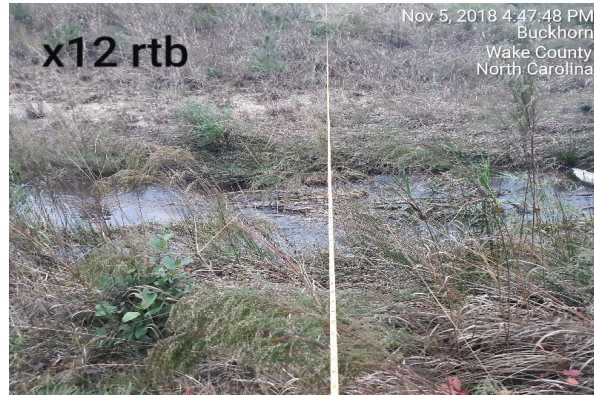
Permanent Cross-section 12

Feature	Stream Type	BKF Area	BKF Width	BKF Depth	Max BKF Depth	W/D	BH Ratio	ER	BKF Elev	TOB Elev
Riffle	C	7.7	13.1	0.6	1.0	22.3	0.9	2.2	247.88	247.98

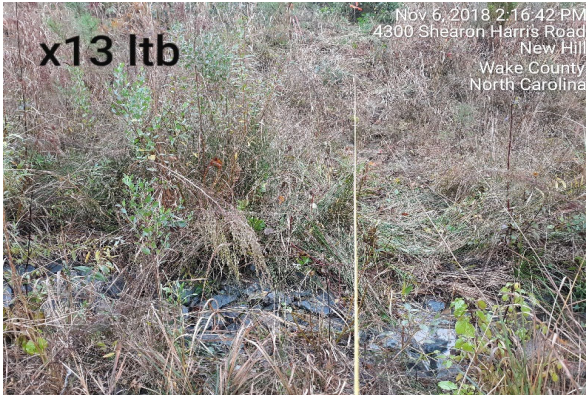
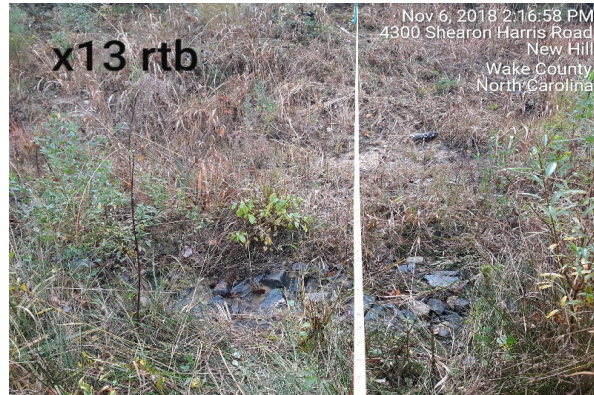
Permanent Cross-section 13

Feature	Stream Type	BKF Area	BKF Width	BKF Depth	Max BKF Depth	W/D	BH Ratio	ER	BKF Elev	TOB Elev
Riffle	C	0.9	3.7	0.2	0.4	15.5	0.7	4.5	295.07	295.12

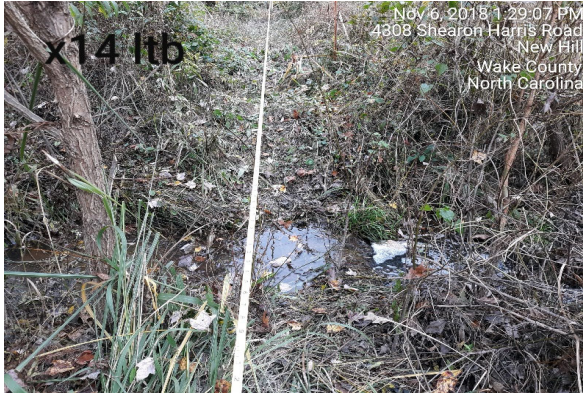
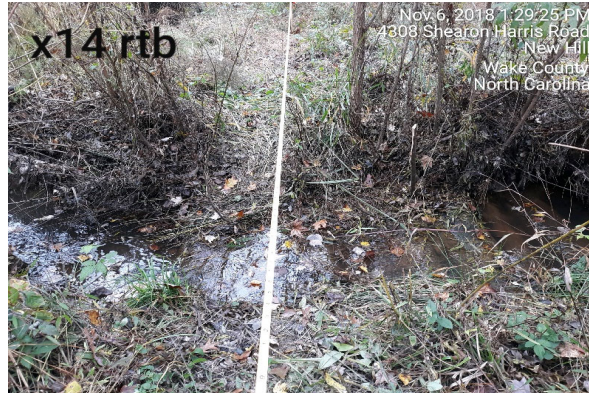
Permanent Cross-section 14

Feature	Stream Type	BKF Area	BKF Width	BKF Depth	Max BKF Depth	W/D	BH Ratio	ER	BKF Elev	TOB Elev
Riffle	E	3.5	6.4	0.5	1.1	11.6	0.8	7.8	260.96	261.05

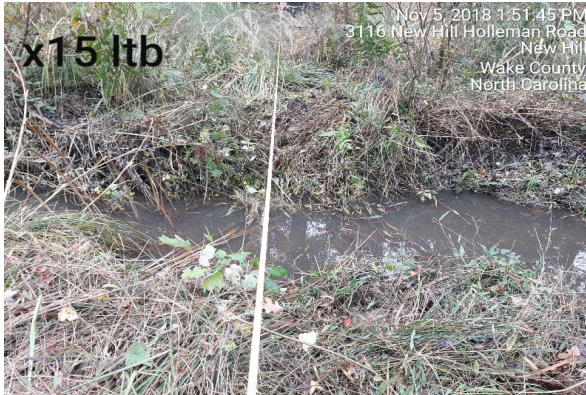
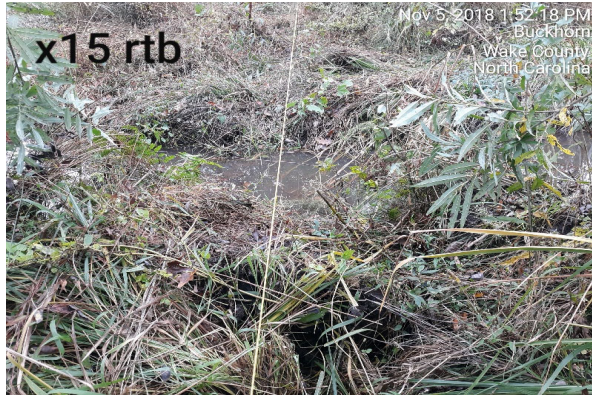
Permanent Cross-section 15

Feature	Stream Type	BKF Area	BKF Width	BKF Depth	Max BKF Depth	W/D	BH Ratio	ER	BKF Elev	TOB Elev
Pool	-	8.7	9.5	0.9	1.6	10.4	-	-	259.27	259.45

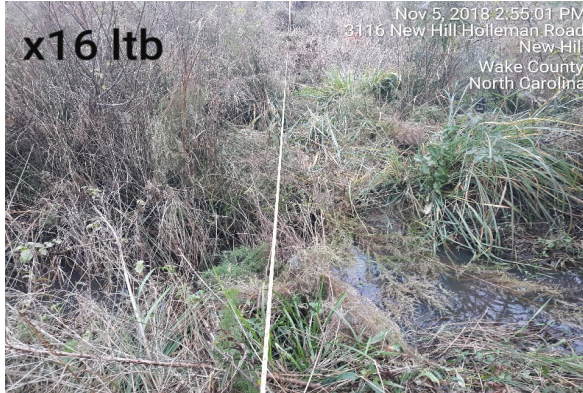
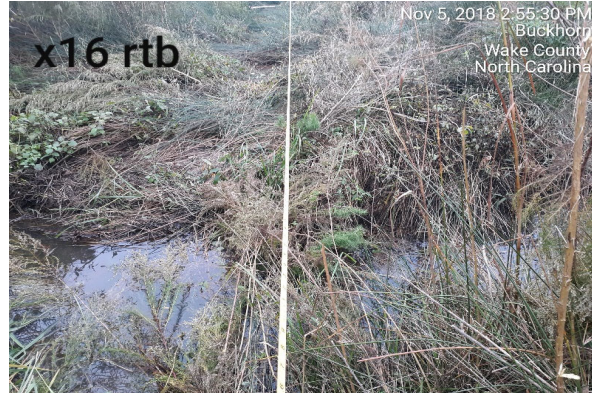
Permanent Cross-section 16

Feature	Stream Type	BKF Area	BKF Width	BKF Depth	Max BKF Depth	W/D	BH Ratio	ER	BKF Elev	TOB Elev
Pool	-	10.6	8.9	1.2	2.6	7.4	-	-	255.05	254.92
