# **Final Thomas Creek Restoration Project Year 4 Monitoring Report**

Wake County, North Carolina

DMS Project ID Number – 96074, DEQ Contract No. 5549

Report Prepared and Submitted by Michael Baker Engineering, Inc.

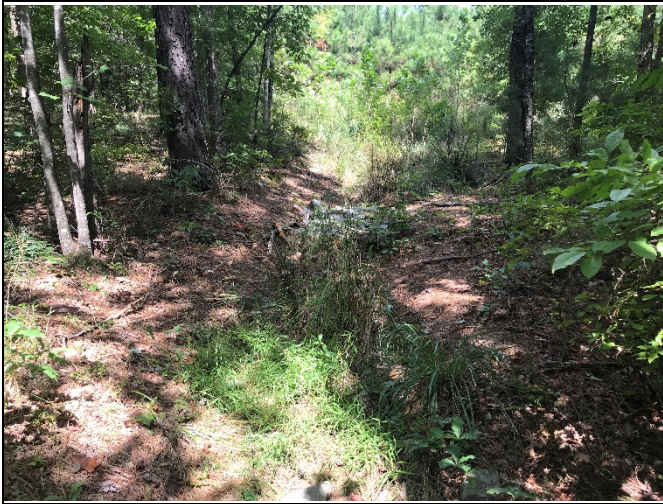
PP-43: Reach 7, view of stabilized drainage at Station 13+50
