# **Thomas Creek Restoration Project Year 5 Monitoring Report - FINAL**

Wake County, North Carolina

DMS Project ID Number – 96074, DEQ Contract No. 5549

Report Prepared and Submitted by Michael Baker Engineering, Inc.

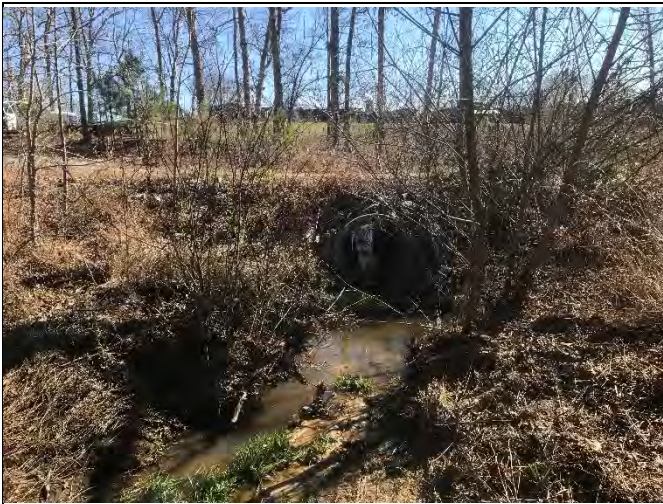
PP-5: Reach 3, view downstream towards pipe crossing,  
Station 18+50

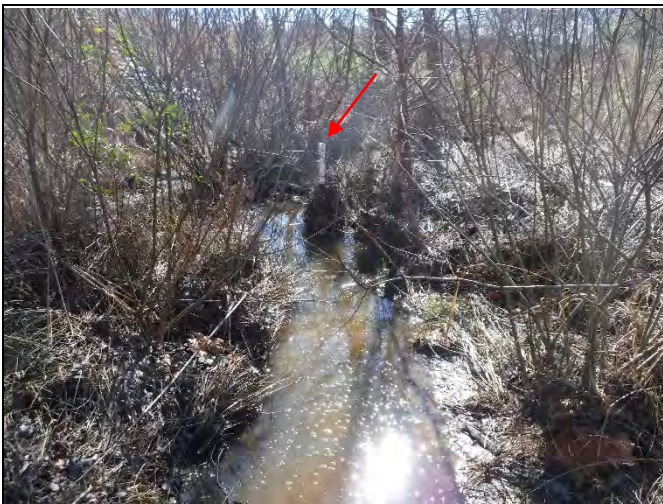
PP-17: Reach 2, Flow Gauge #1 at Station 20+75

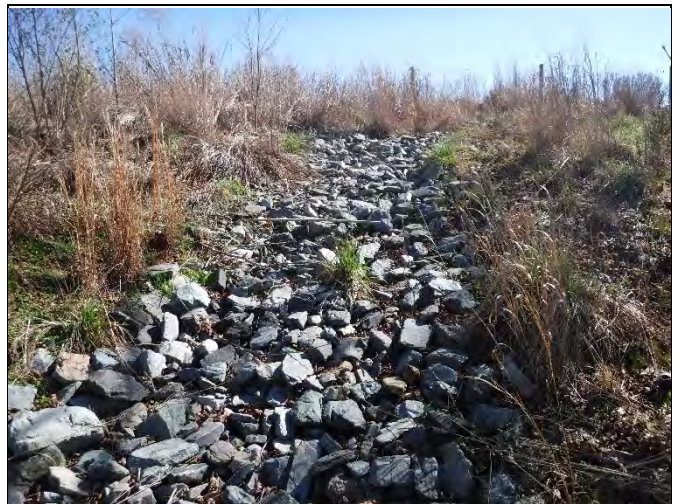
PP-18: Reach 2, view of stabilized drainage on left bank at Station 20+80

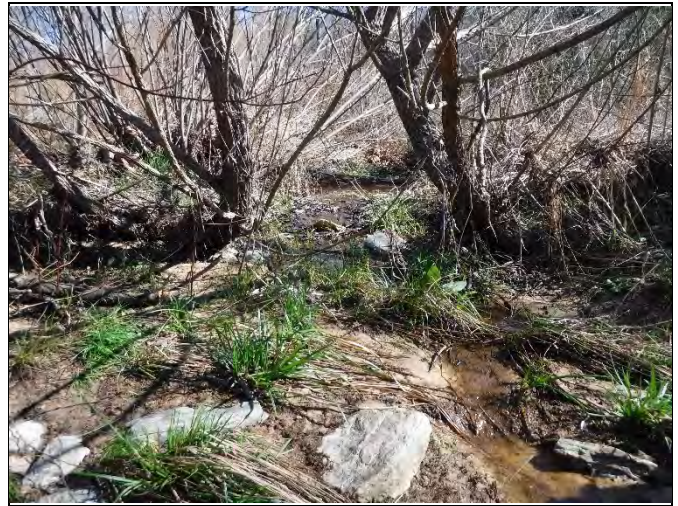
PP-26: Reach 2, view of drainage on left bank at Station 32+90

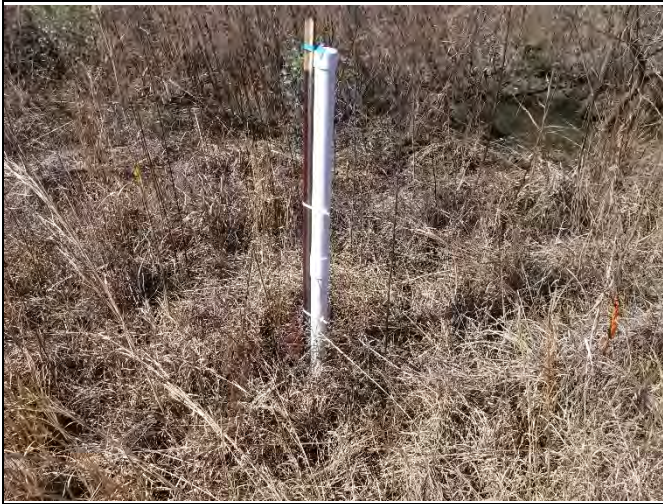
PP-31: Reach 2, Crest Gauge at Station 38+90

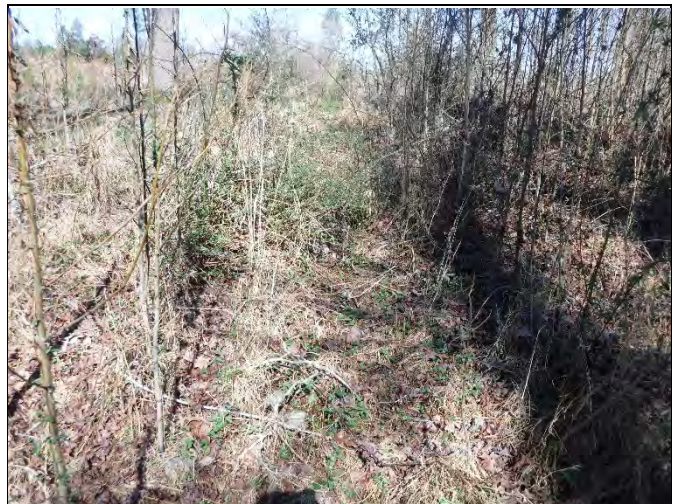
PP-36: Reach 1, view of drainage on left bank at Station 44+00

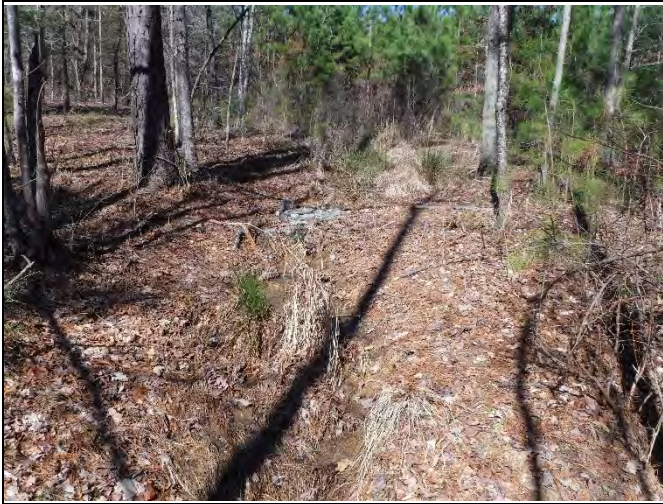
PP-43: Reach 7, view of stabilized drainage at Station 13+50

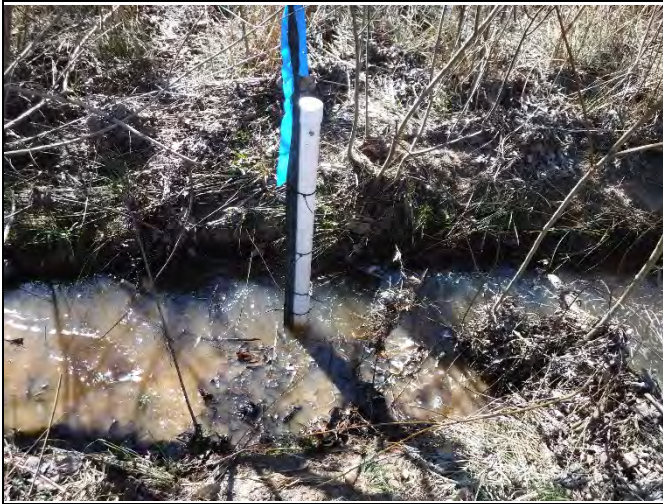
PP-51: Reach 5, Flow Gauge #2 at Station 33+90

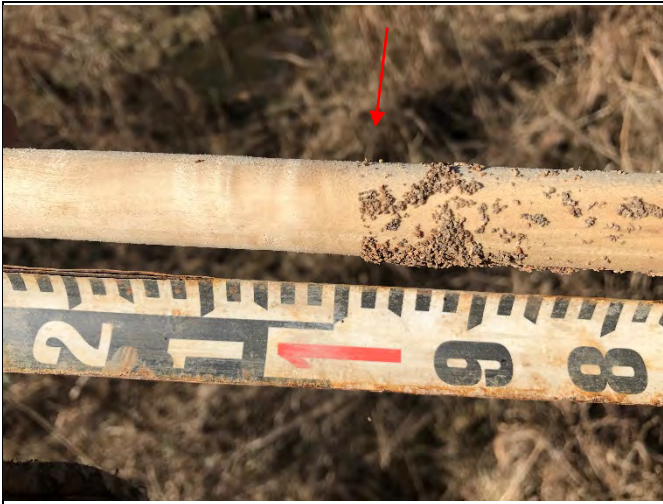
Overbank event of 0.98 ft on 2/6/20  
(photo from 2/14/20)

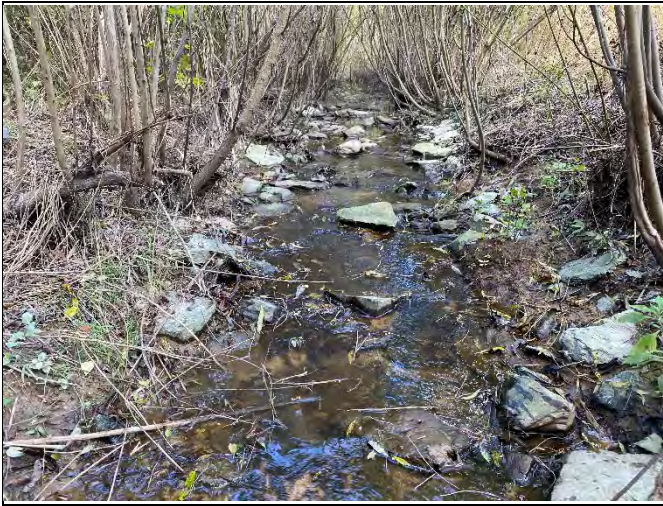
Reach R2 riffle (Station 37+00) used for pebble count

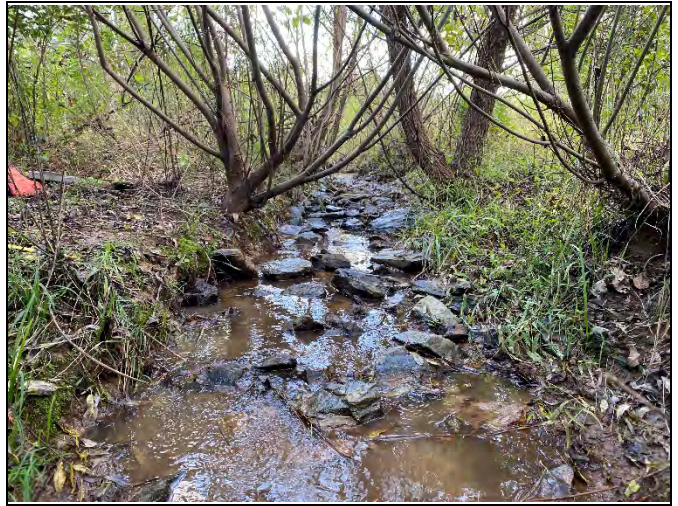
Reach R5 riffle (Station 37+00) used for pebble count

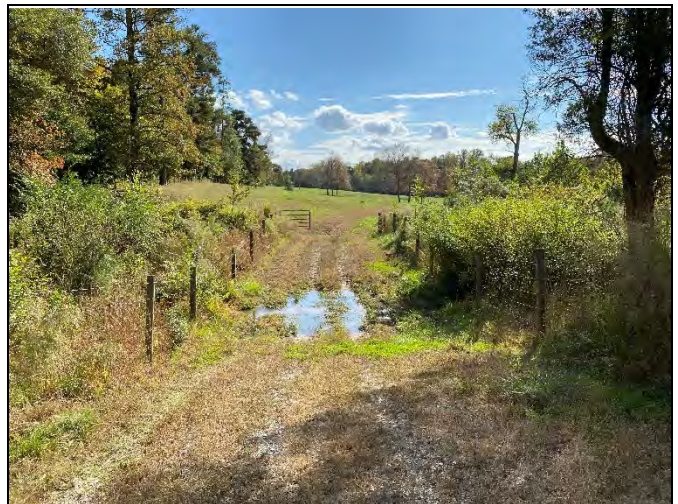
Crossing outside of CE on T1 (photo: 10/22/20)
