Thomas Creek Restoration Project Year 6 Monitoring Report - FINAL

Wake County, North Carolina

DMS Project ID Number – 96074, DEQ Contract No. 5549

Report Prepared and Submitted by Michael Baker Engineering, Inc.

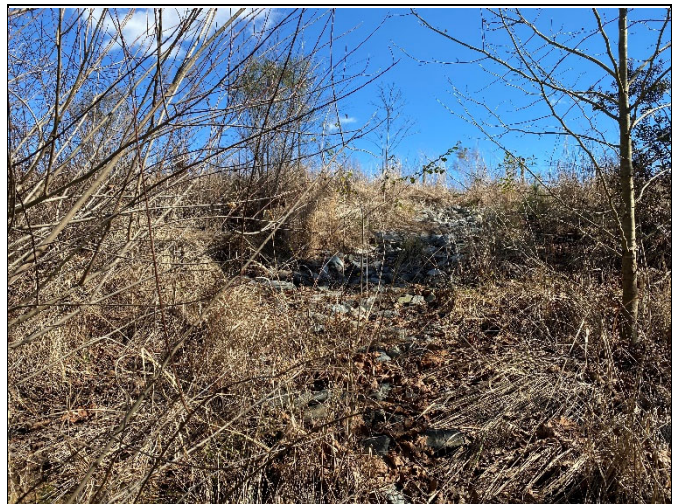
PP-18: Reach 2, view of stabilized drainage on left bank at Station 20+80

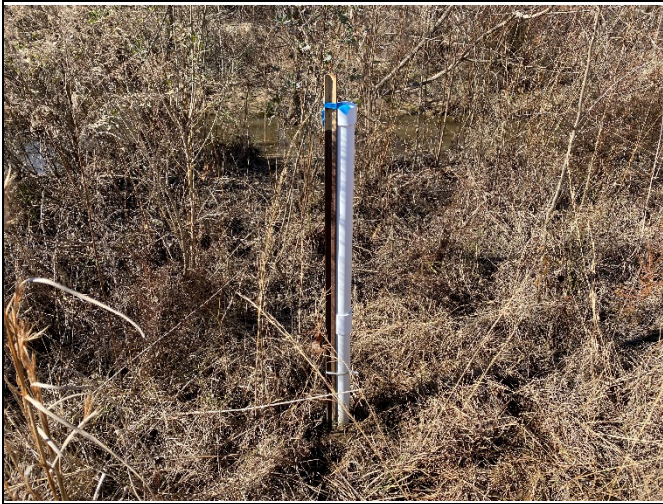
PP-31: Reach 2, Crest Gauge at Station 38+90

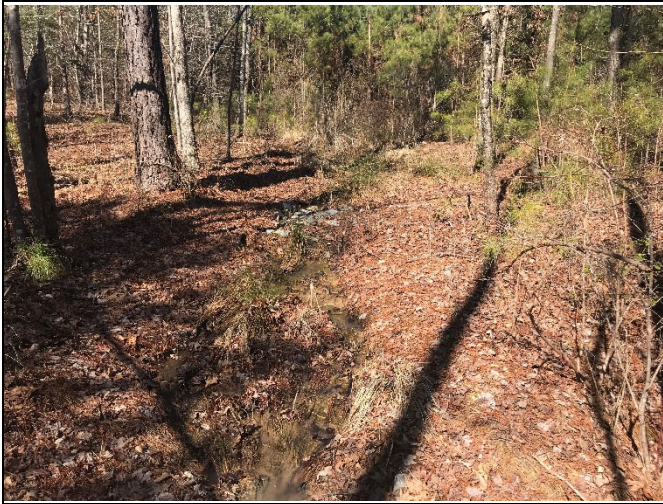
PP-43: Reach 7, view of stabilized drainage at Station 13+50

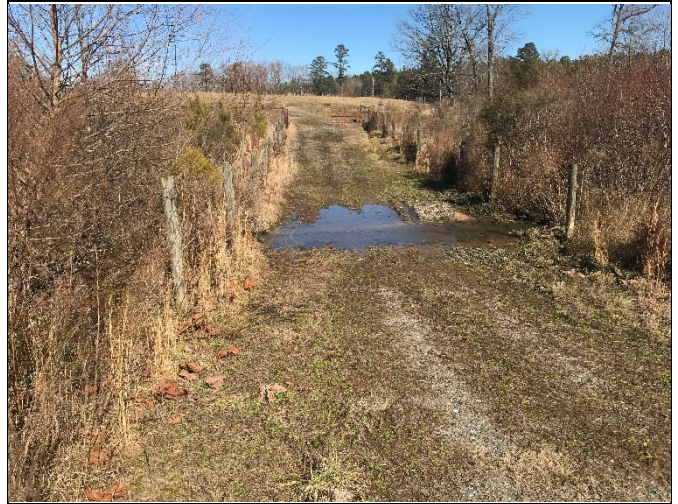
PP-52: Reach 5, view of crossing at Station 35+00 (note: no cattle in upper field so gate is OK to have open)
