# MONITORING YEAR 5 ANNUAL REPORT

## VILE CREEK MITIGATION SITE

Alleghany County, NC  
DEQ Contract No. 5999  
DMS Project No. 96582

Data Collection Period: April – October 2021  
Submission Date: January 19, 2022

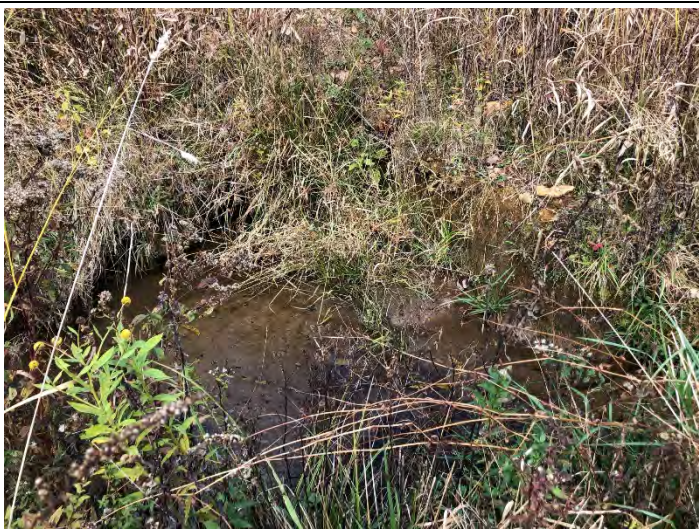
**Photo 11** – UT2: Station 306+30 – 306+70 – Bank scour. 10-26-2021

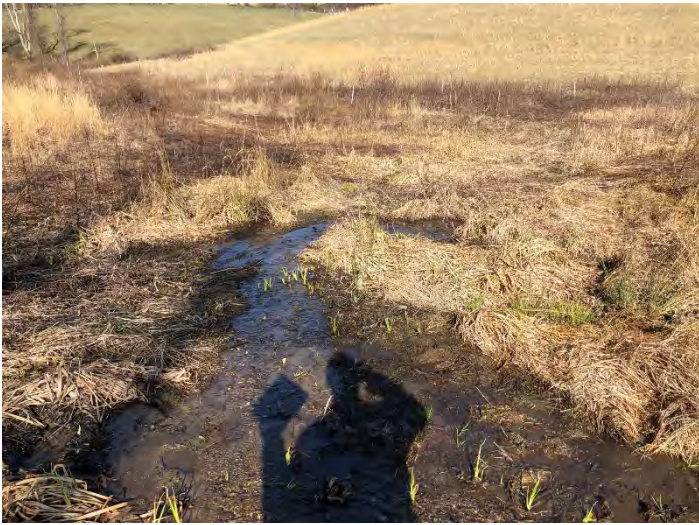
**Photo 13** – UT1B: Stream aggradation. 3-17-2021

- Wildlands will not repair UT1b and UT1c where they have filled in. These areas will likely be converted to wetland credits at closeout. Additional monitoring to be performed for MY5-MY7 is discussed in item #9 above.

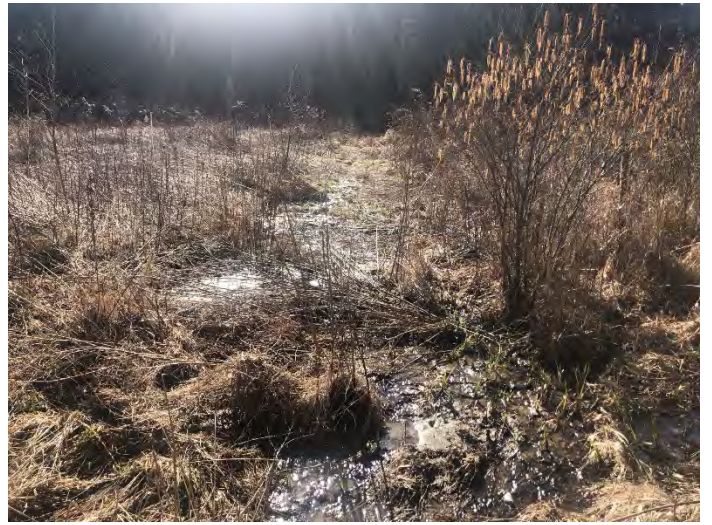
**Photo 14**– UT1C: Stream aggradation. 3-17-2021
