MONITORING YEAR 4 ANNUAL REPORT

BIG HARRIS CREEK MITIGATION SITE

Cleveland County, NC
DMS Project No. 739
DEQ Contract 006256
DWR 401 Project No. 10-0811
USACE Action ID No. SAW-2009-0475
Broad River Basin
HUC 03050105

Data Collection Period: May – November 2021

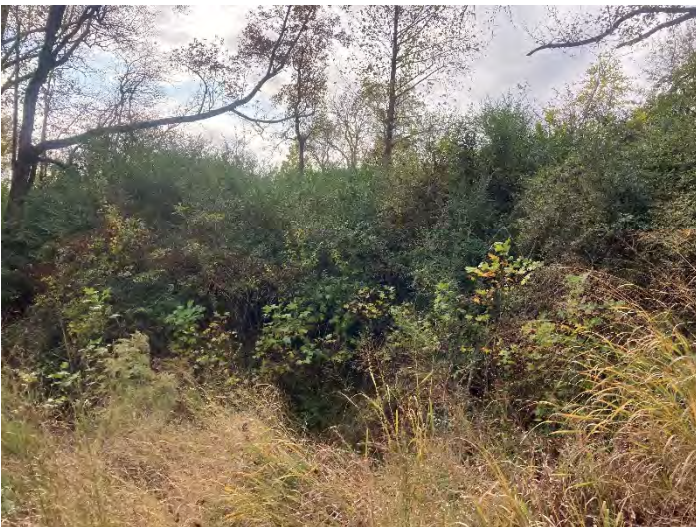
Royster Creek Reach 2 Chinese Privet (11/3/2021)

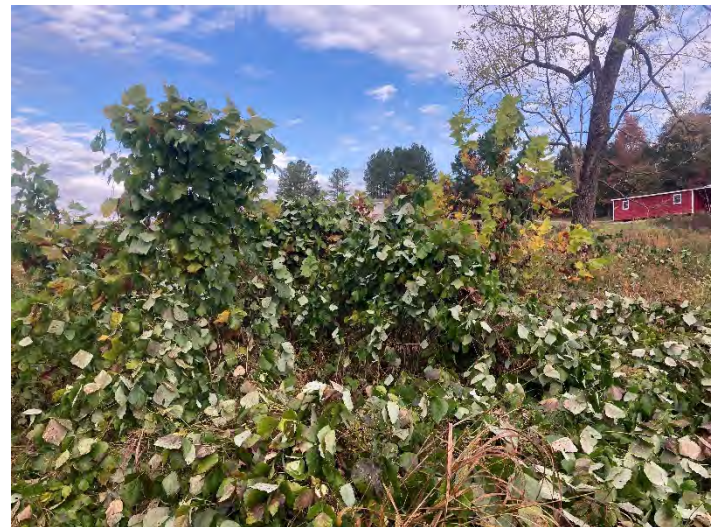
LBHC R1A Kudzu (10/27/2020)
