# **Brown Creek Tributaries Restoration Project FINAL Year 7 Monitoring Report/Closeout Report**

Anson County, North Carolina

DMS Project ID No. 95351  
DEQ Contract No. 004641  
USACE Action ID: SAW-2012-01108  
DWR Project #14-0345  
RFP #16-004108 (Issued 6/20/2011)  
Yadkin River Basin: 03040104-061030

Project Info:           Monitoring Year: 7 of 7  
                              Year of Data Collection: 2021  
                              Year of Completed Construction: 2015  
                              Submission Date: February 2022

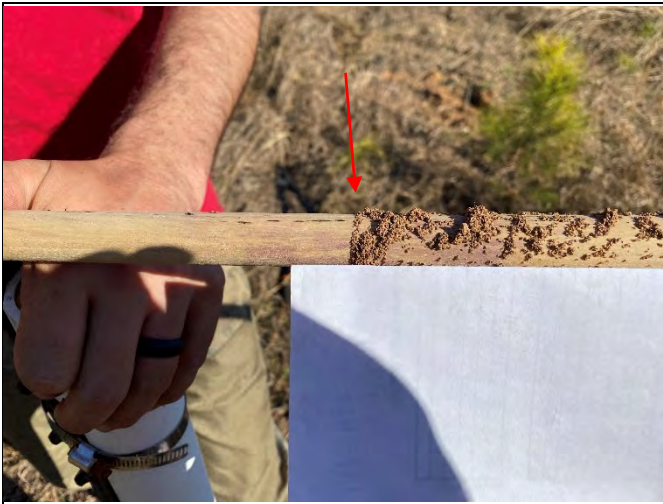
Crest Gauge Reach UT4-R2: Close up of gauge reading  
(photo from 3/8/21)

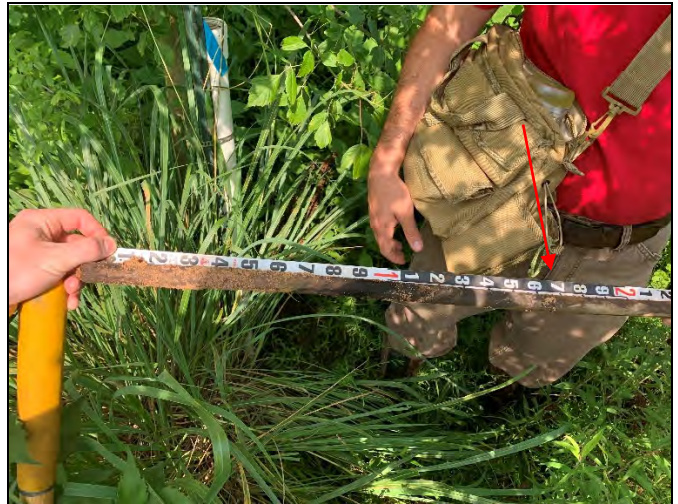
Crest Gauge Reach HC-R1: Overbank event of 1.65'  
(photo from 7/22/21)

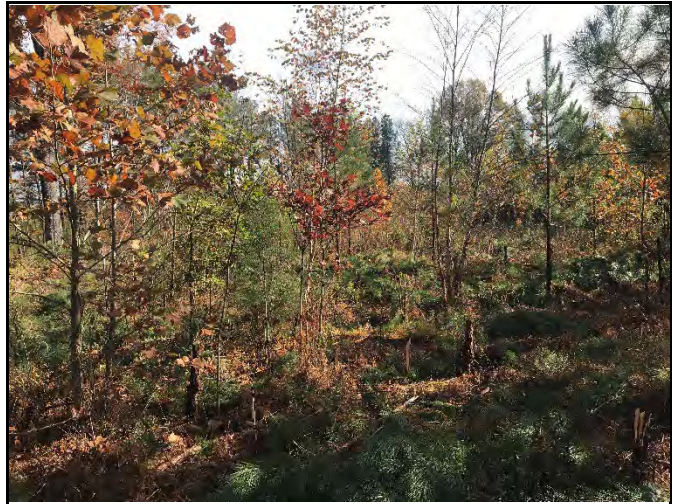
UT4: Accidental logging encroachment in July 2021 of about 12 mature pine trees in an 0.05-ac area (photo from Aug. 2021)

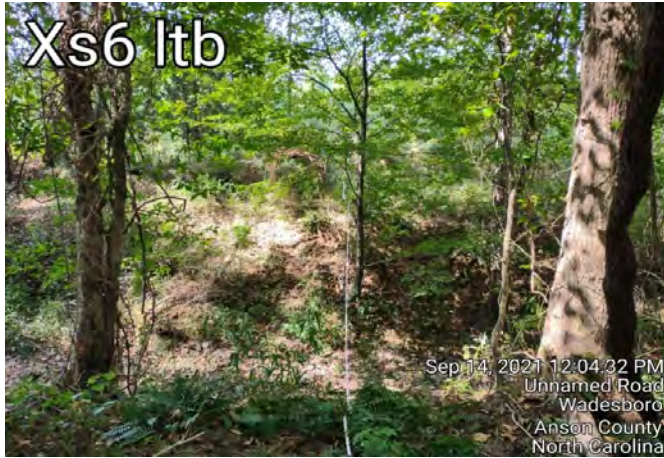
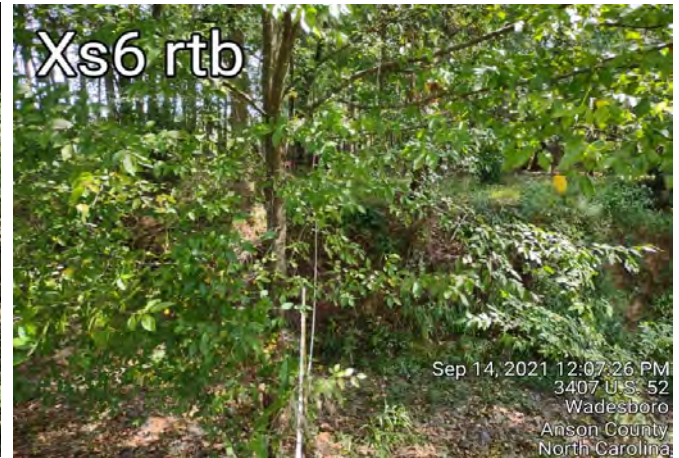
**Permanent Cross-Section 6**  
Year 7 Data - Collected September 2021

Feature	Stream Type	BKF Area	BKF Width	BKF Depth	Max BKF Depth	W/D	BH Ratio	ER	AB BKF Elev	TOB Elev
Riffle	G	34.4	16.1	2.1	2.9	7.6	2.1	1.3	205.59	209.19
